# ISLAND MARINE GROUP, LLC

## REPORT OF A MARINE SURVEY

2006 TIARA YACHTS 32 OPEN

***“FOLLOW ME”***

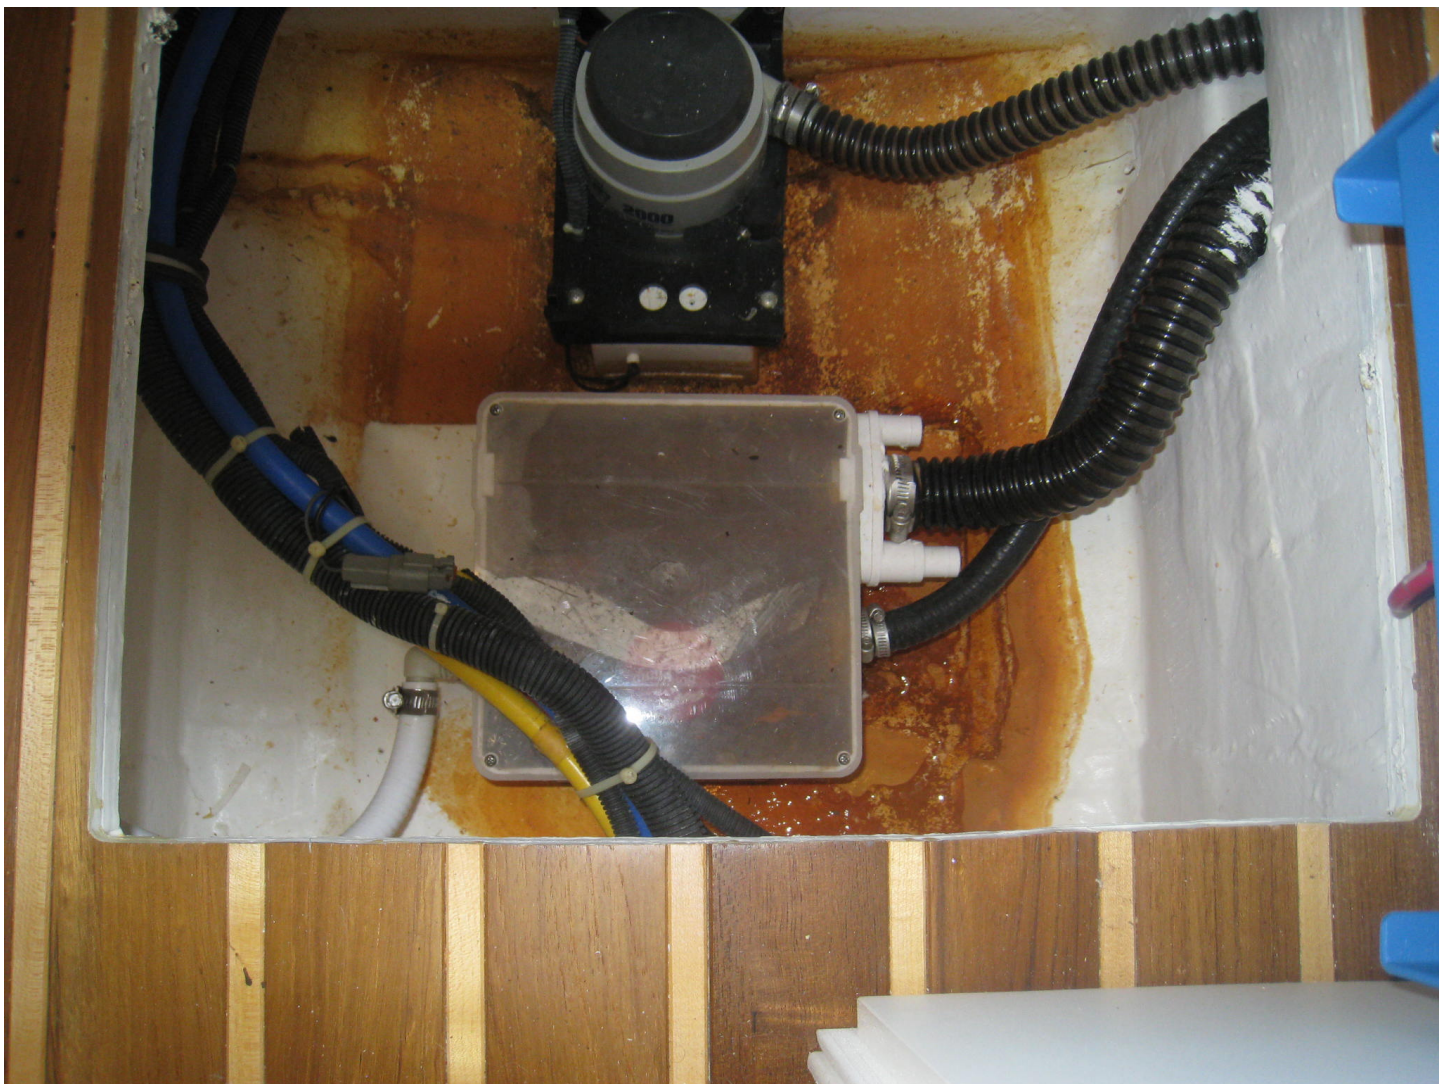
Galley and head wash basin drain overboard through the hull side. The shower and air conditioner condensate drain into a shower sump. **§C-3** Shower sump fails to drain when filled with water. The over current protection for this could not be determined. Either a fuse or circuit breaker could be defective. If not the pump or float switch might be defective.

SUMP COLLECTION BOX IS FULL OF WATER AND PUMP DOES NOT ACTIVATE. IT APPEARS THAT WATER COLLECTS IN THIS AREA. THE RUST APPEARS TO COME FROM THE AIR CONDITIONING CONDENSATE. WHEN ENOUGH WATER COLLECTS, IT IS EMPTIED BY THE BILGE PUMP.

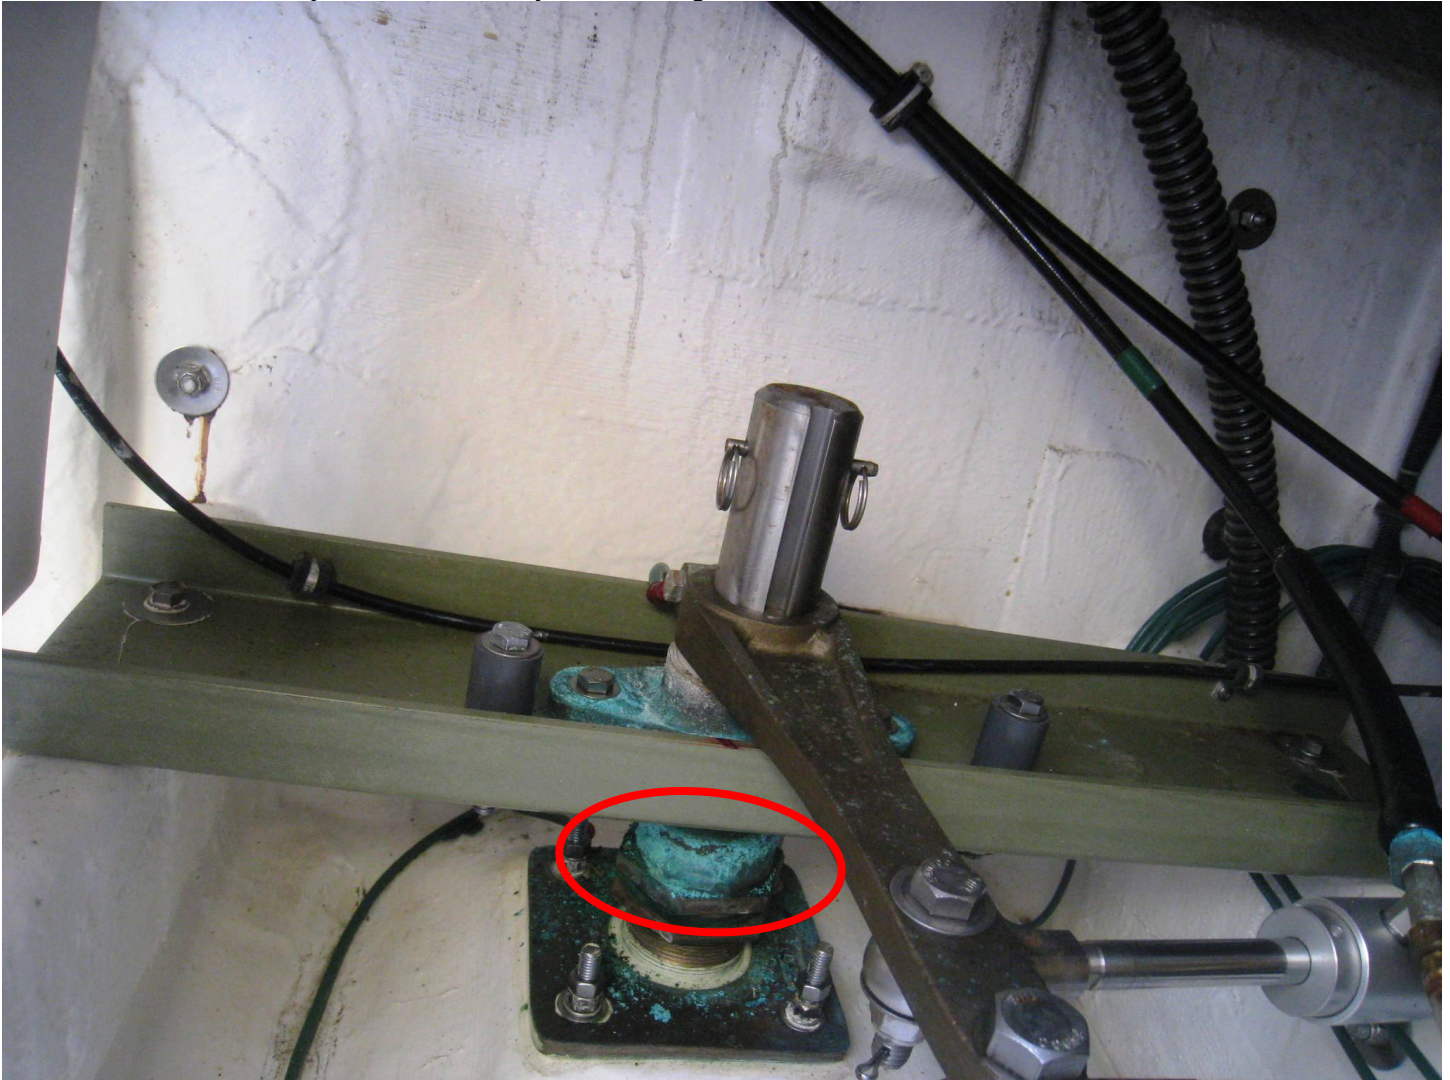
Mounted on composite beam attached to the boat structure. §C-4 Rudder post shows some signs of minor corrosion at the top seal. Disassembly and cleaning is recommended at the next haul out.

§C-4 Rudder post upper seals show corrosion

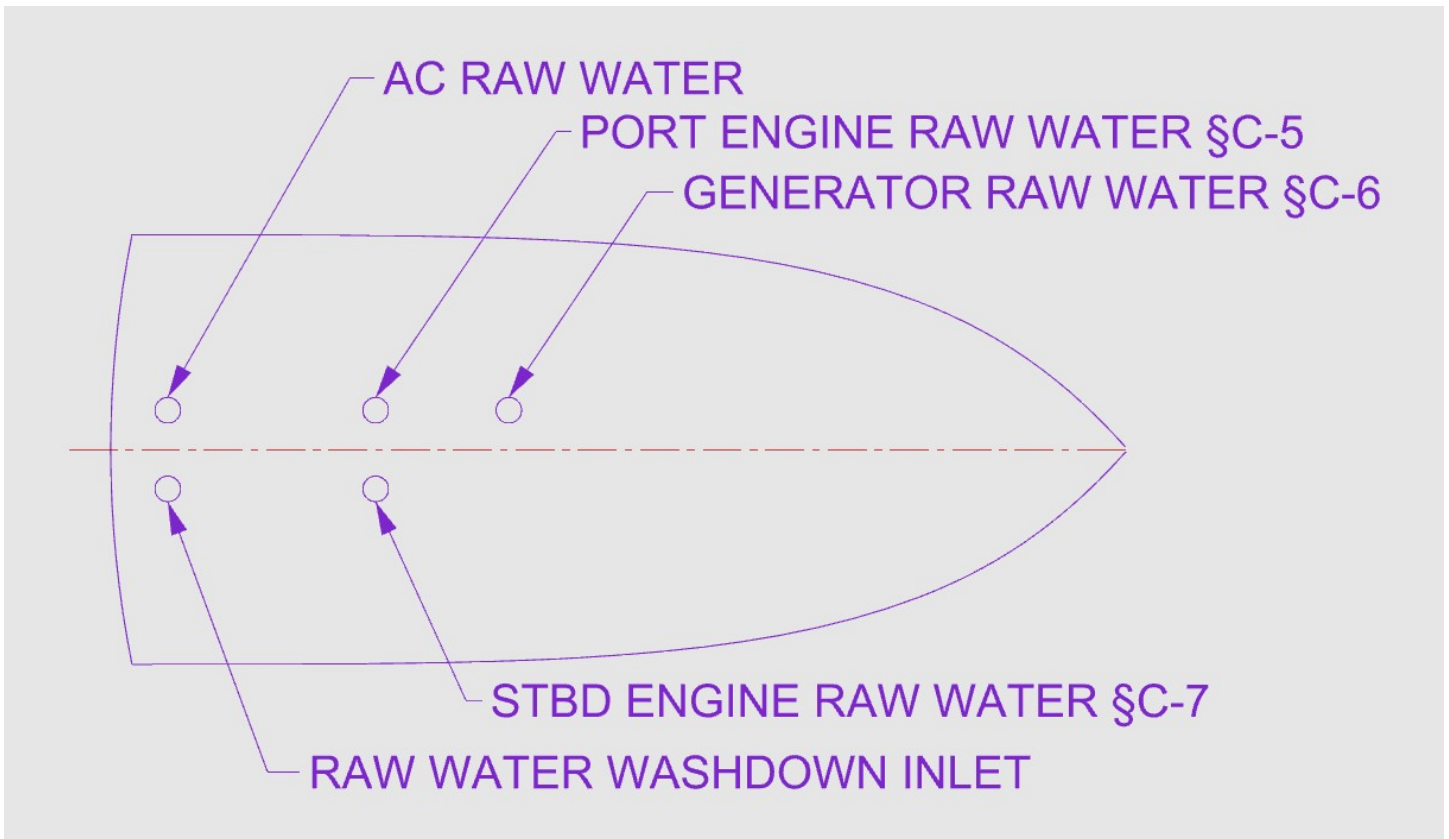
**§C-5, 6 & 7** Ball valves are stuck in the open position.
