# ISLAND MARINE GROUP, LLC

## SAMPLE WOOD BOAT SURVEY

1929 N.J. Blanchard Boat company

***“BOAT NAME”***

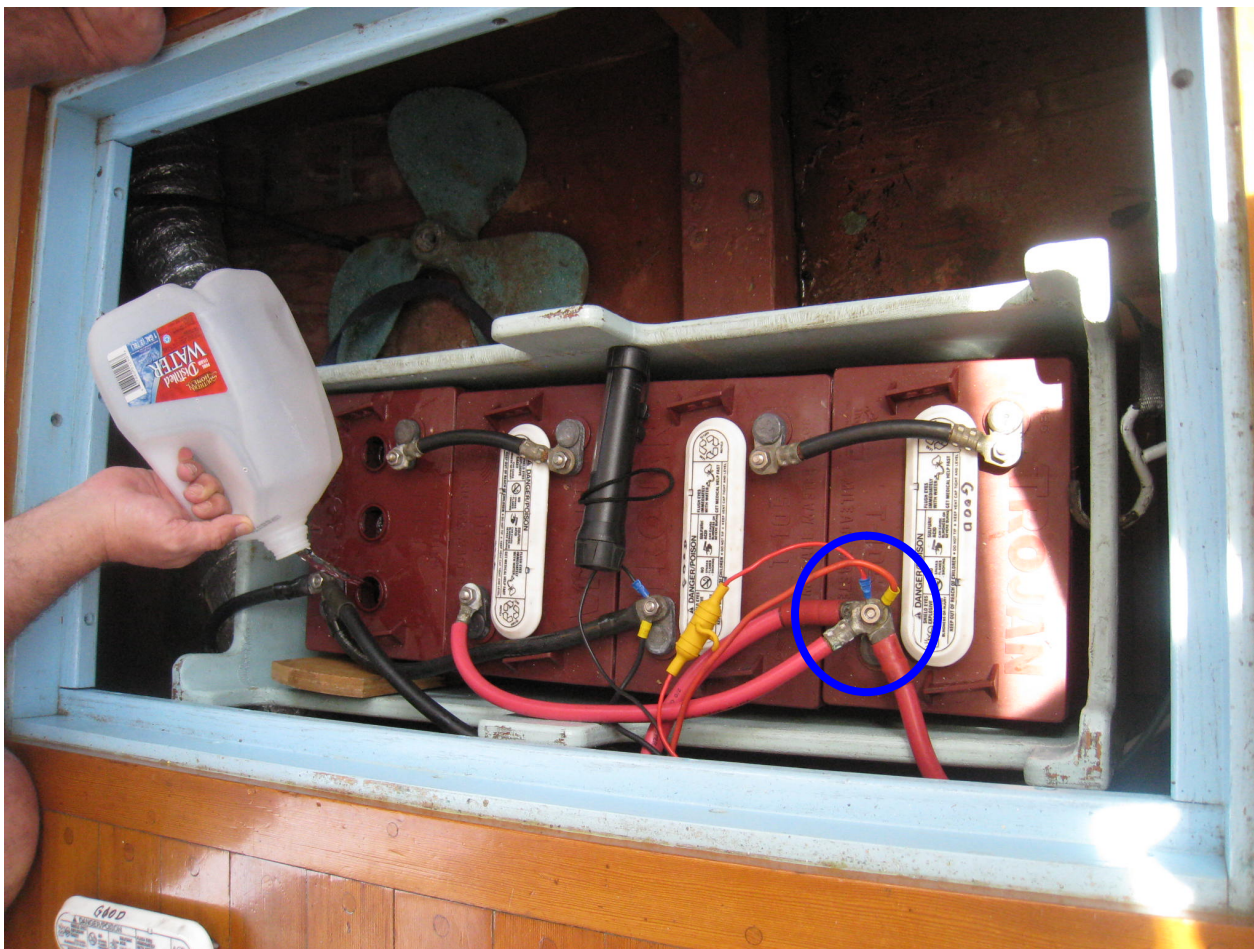
House service: Four (4) 6 volt batteries wired two each in series. House batteries appear be damaged due to gassing and loss of electrolyte from overcharging by the Trace battery charger. Once active battery material is allowed to dry out when the core is exposed, it is permanently lost. The batteries do not hold current without a charging source present for even a short period of time.

House battery bank being topped off with water. Per ABYC E-11. No more than four (4) terminals shall be mounted to a single battery stud.

It is recommended that each battery in the house bank be tested and replaced if necessary. The surveyor observed over one gallon of water from the boat's fresh water tanks added to top off the batteries. It is recommended that only distilled water be added to the batteries and never water from a possibly chlorinated source. The output of the Trace battery charger/inverter should be adjusted by a qualified marine electrician or replaced with a more modern unit. ABYC E-11 limits the number of terminals attached to a single battery post to four (4). One battery had five on a post. Remove one terminal to another positive battery post.

(§B-2) House batteries need testing and should be replaced if they fail to hold a charge under load. Battery charger/inverter needs adjustment or replacement with a more modern unit that will not over charge the batteries.

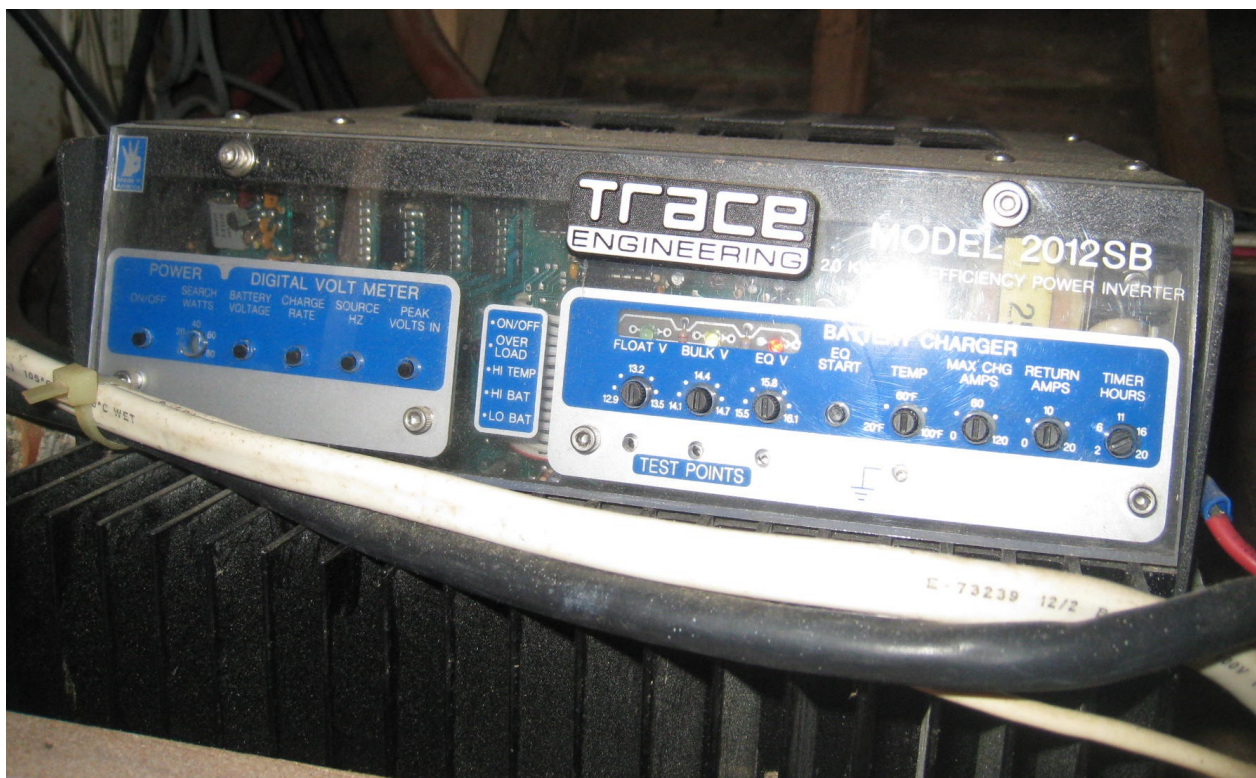
The battery charger appears to have the capability to be manually adjusted.

Trace battery charger/inverter model 2012 SB (See notes under batteries)

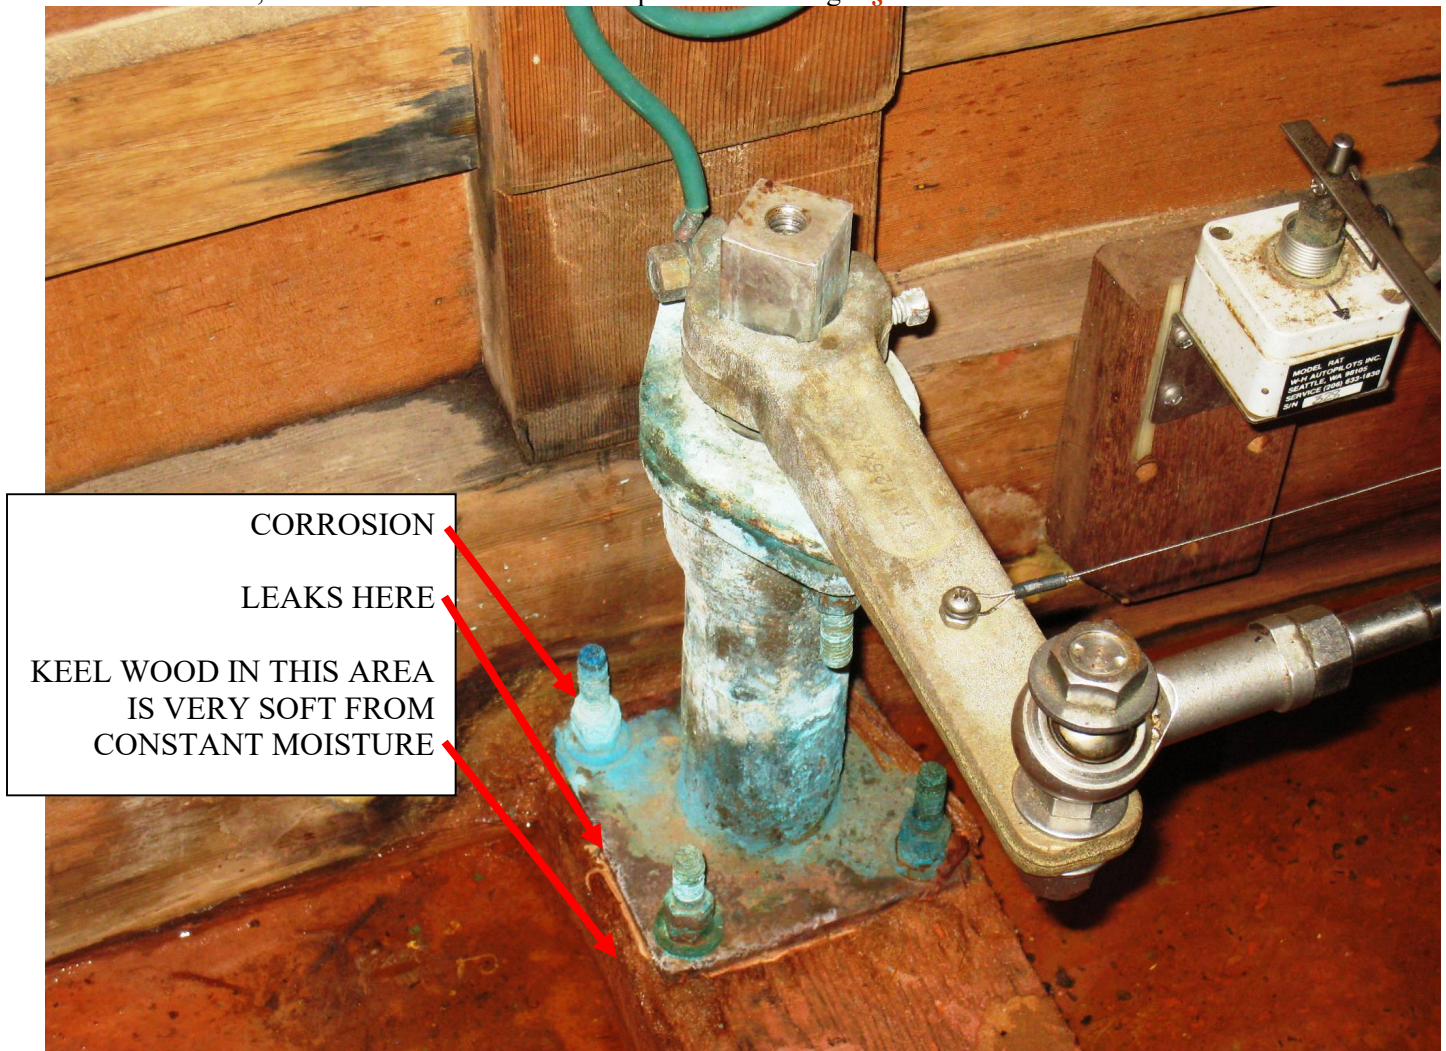
Hull is leaking where rudder post attaches. Fasteners show advanced corrosion. At haul out, rudder post should be removed, the area dried and the wood inspected for damage. §A-1

(§A-1) Rudder post has a leak where it attaches to the keel. This caused the wood keel to soften in this area. It is recommended that the rudder post be removed during the current haul out. The keel should be carefully inspected.

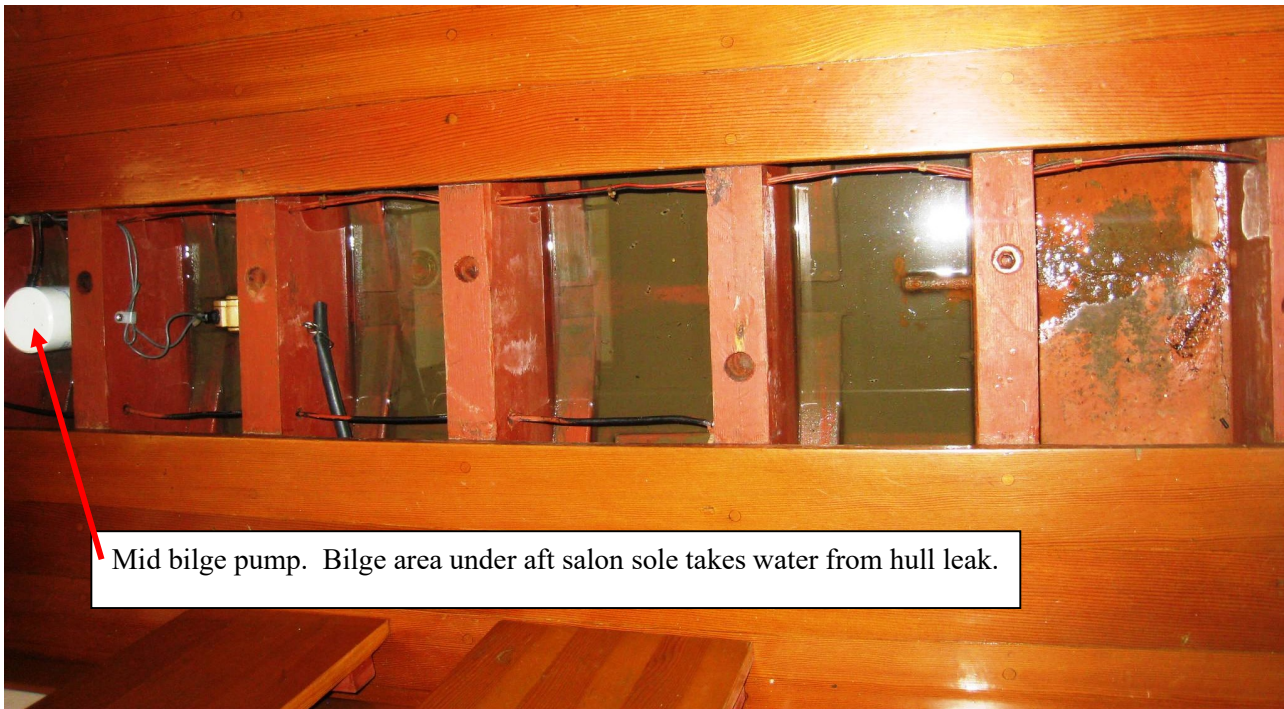
Shows wear and tear especially near the waterline. Some re-caulking is necessary. This vessel is over due for a haul out. It is recommended that a vessel of this age be hauled annually. Any defects should be tended to immediately. The hull appears to leak around mid-ship. The mid bilge pump float switch cycles on the pump about every twenty minutes while the boat is at the slip. Failure of the mid bilge pump or float switch could result in catastrophic failure. The source of the leak could not be determined during the survey. There are several areas shown in the photos that should be investigated by an experienced marine carpenter. **§A-3**

(§A-3) There is a substantial amount of water ingress somewhere around the forward engine room bulkhead. The source of this leak could not be located by the attending surveyor. The leak causes the bilge area to be constantly wet and the mid bilge pump to cycle at approximately 20 minute intervals. With the noted electrical deficiencies of this vessel, this hull leak could be catastrophic and potentially result in loss of vessel and life.
