# **GOLDEN GATE CONDOMINIUM ASSOCIATION, INC. POOL PROJECT MANAGEMENT UPDATES**

## **Pool Status Update (SEE ATTACHED PICTURES)**

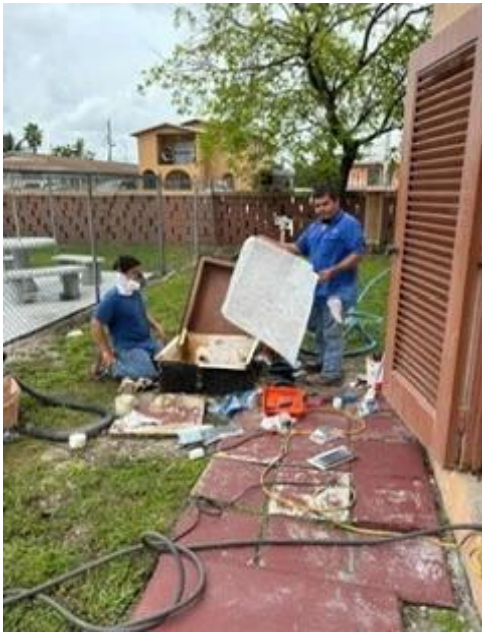
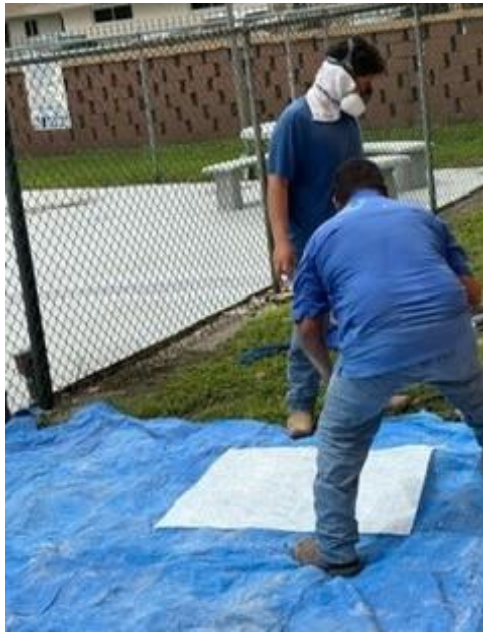
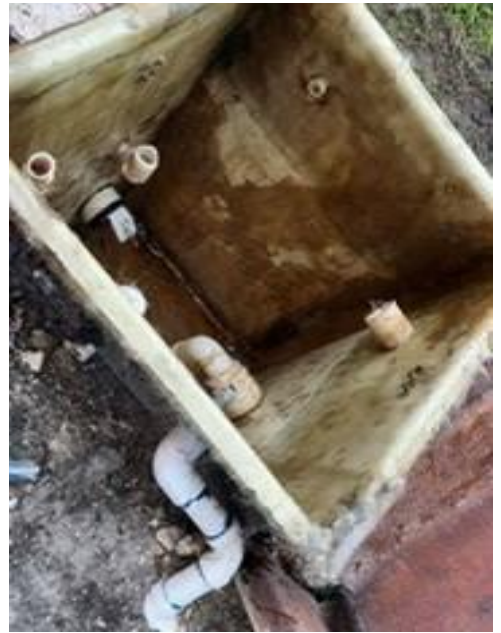
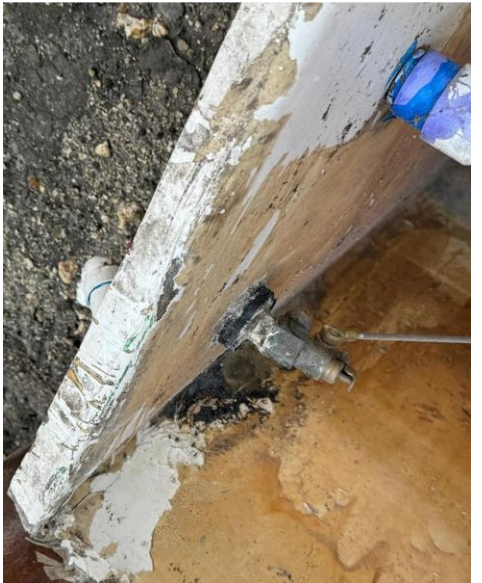
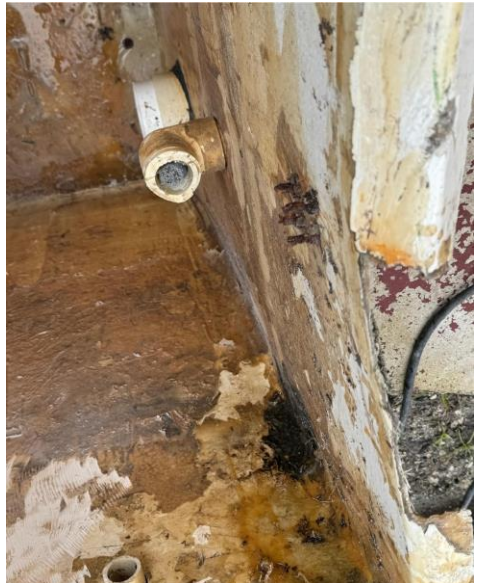
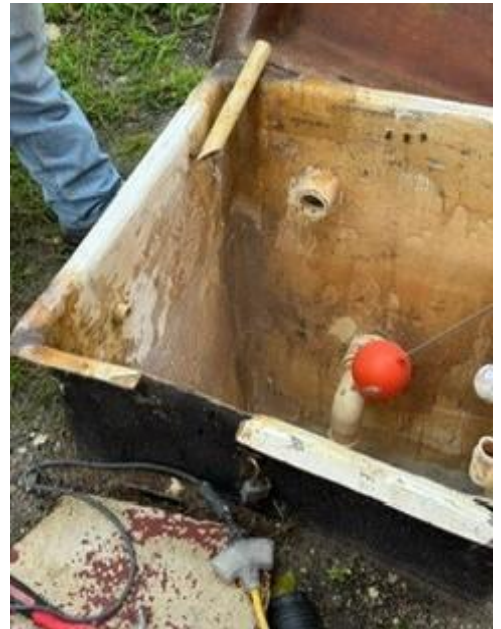
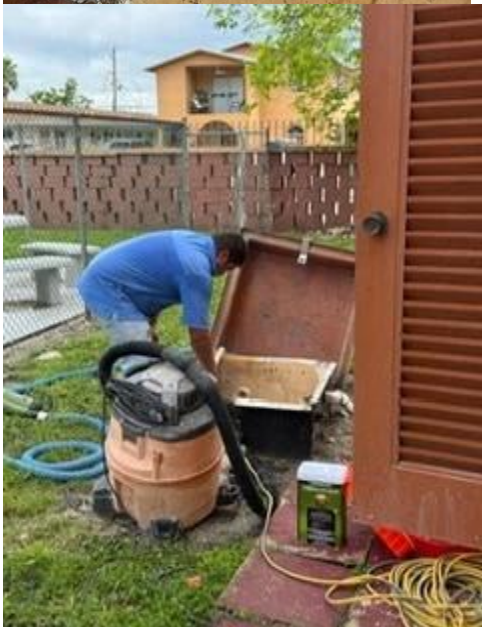
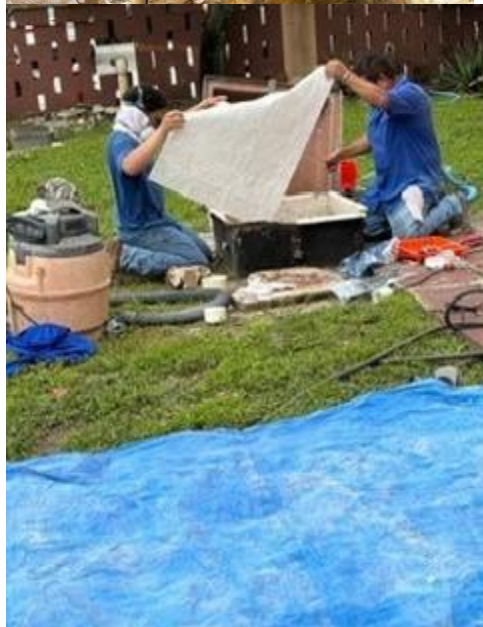
### Fiberglass Retrofit of the Pool Tank

440 Location - The pool tank has undergone a significant retrofit. Instead of purchasing a costly new tank, the existing tank was emptied and restored using fiberglass, essentially creating a new tank within the old one. This approach ensures proper circulation of entry and exit flows, providing a cost-effective and durable solution.
