RV Inspection Report

2020 Pleasure Way Tofino

RV VIN: VINOFRV4YOU528763 **Inspection Date:** 5/13/2024

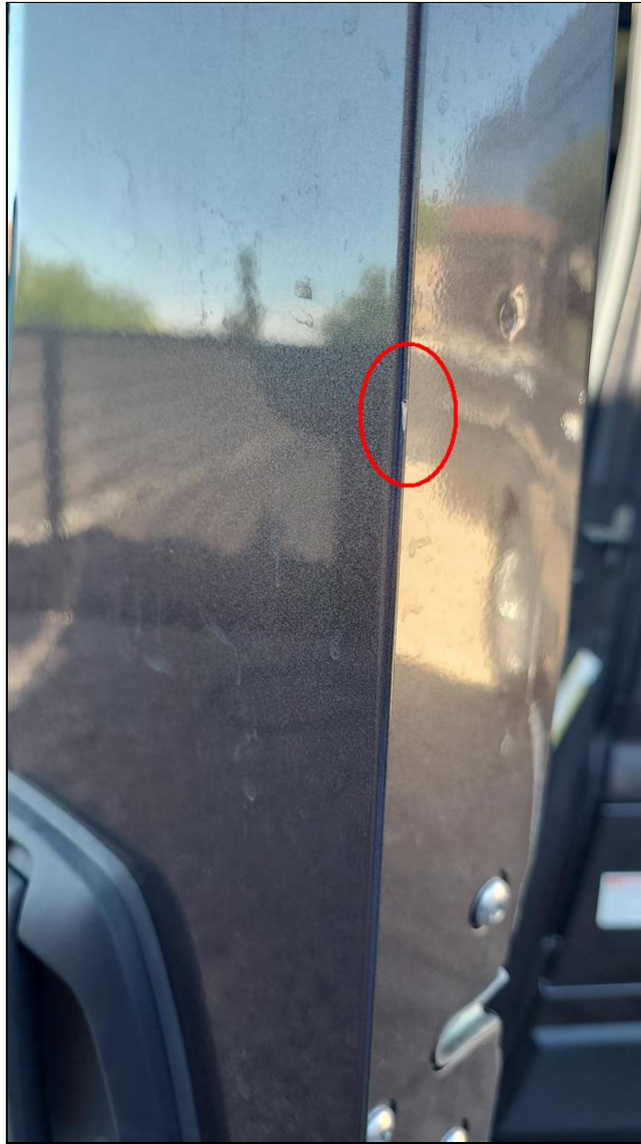
There is a small chip in the paint on the rear edge of the door.

Chip in Paint on Door Edge

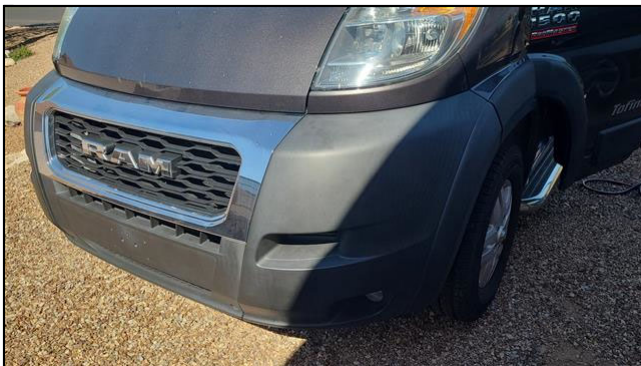
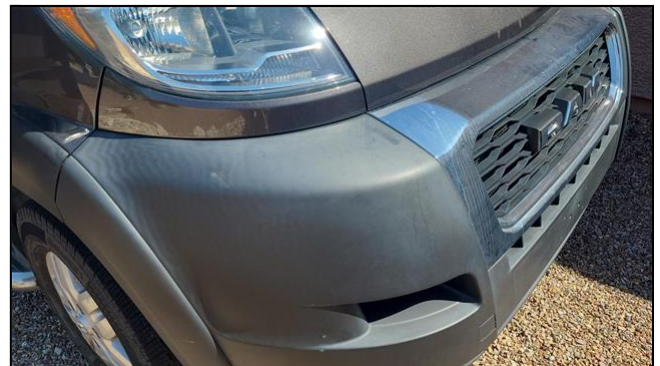
There is oxidation on the plastic body parts located on the front of the RV. It is recommended that these be treated with Automotive Plastic Protectant to prevent UV damage.

Front Bumper Oxidation

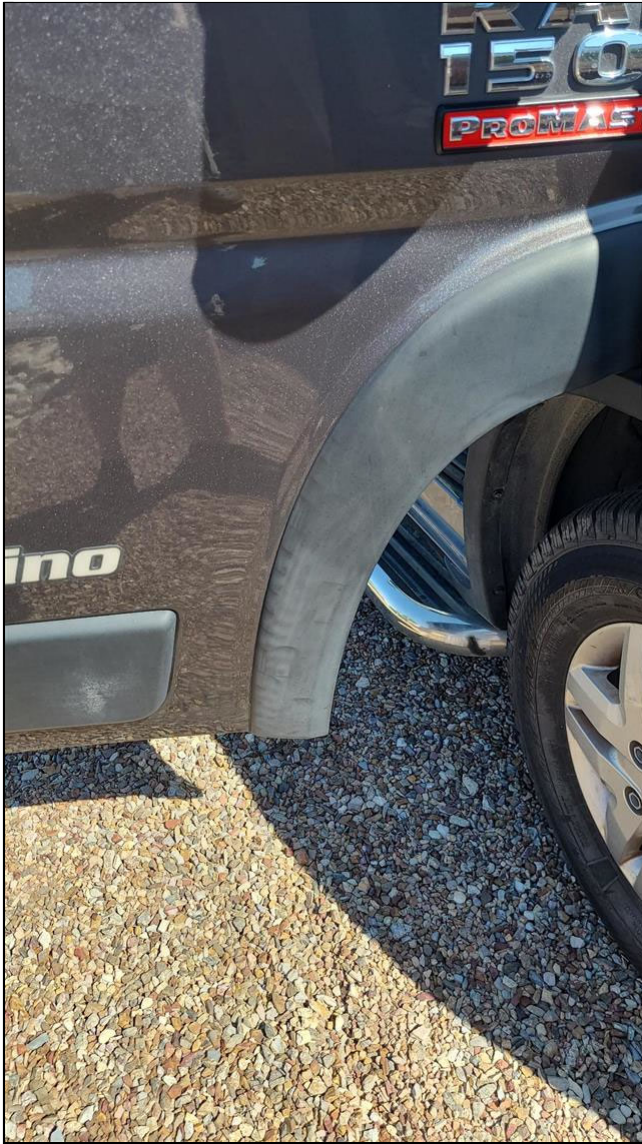
There is oxidation on the plastic body parts located on the side of the RV. It is recommended that these be treated with Automotive Plastic Protectant to prevent UV damage.

Oxidation on Wheel Well

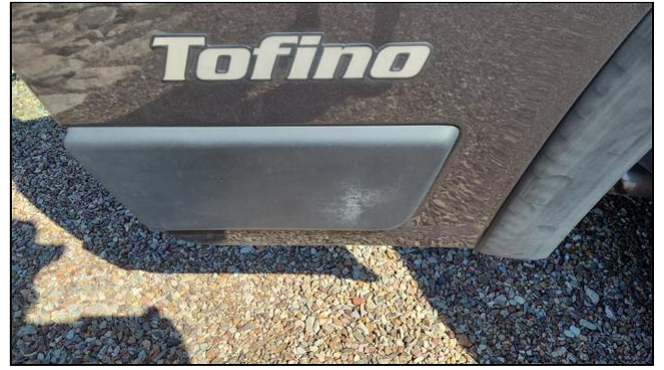
Oxidation of Plastic Parts

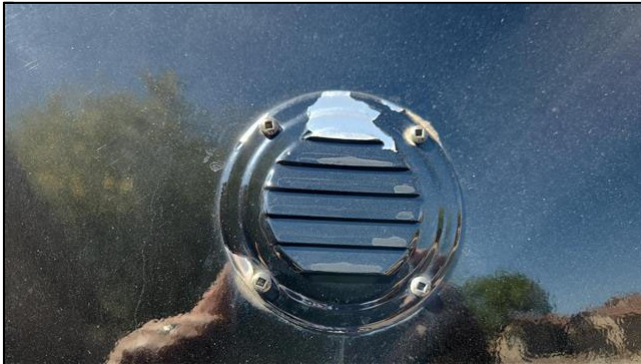
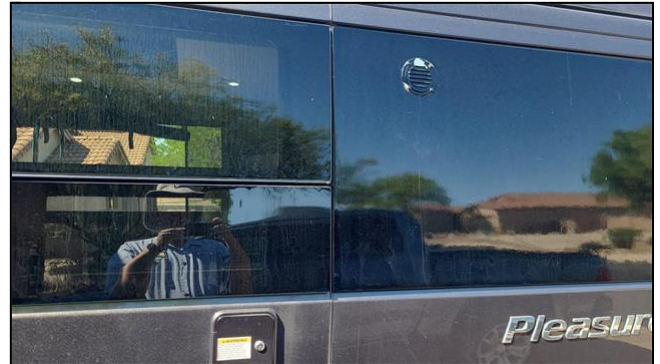
There is oxidation on the plastic body parts located on the side of the RV. It is recommended that these be treated with Automotive Plastic Protectant to prevent UV damage.

Paint is peeling on the vent located on the upper center of the sidewall. It is recommended that this be repaired by qualified RV technician.

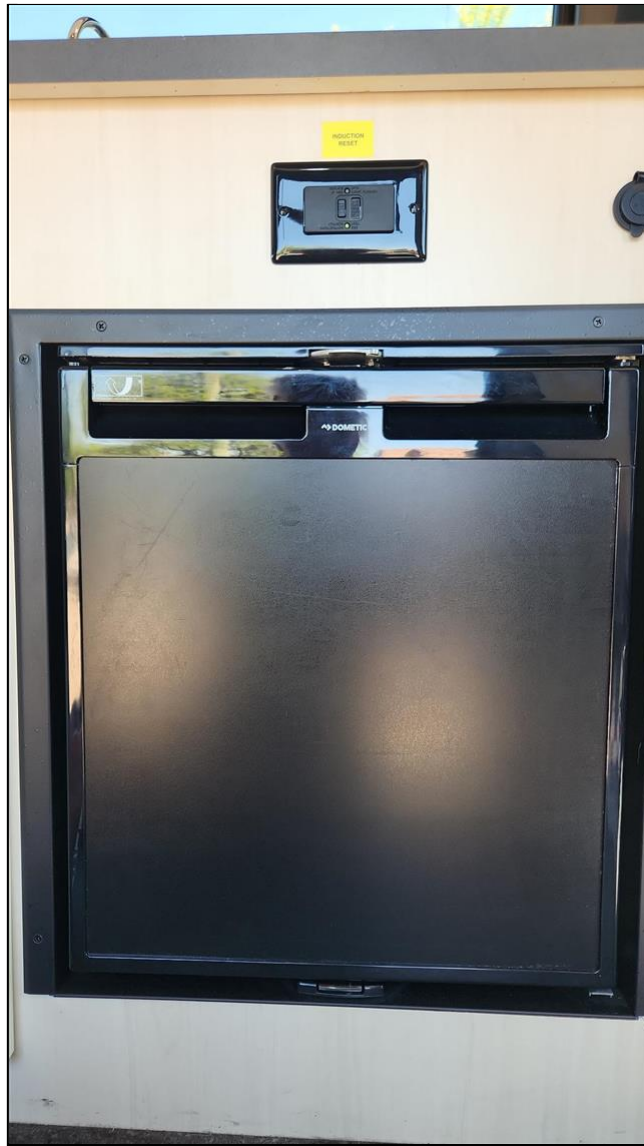
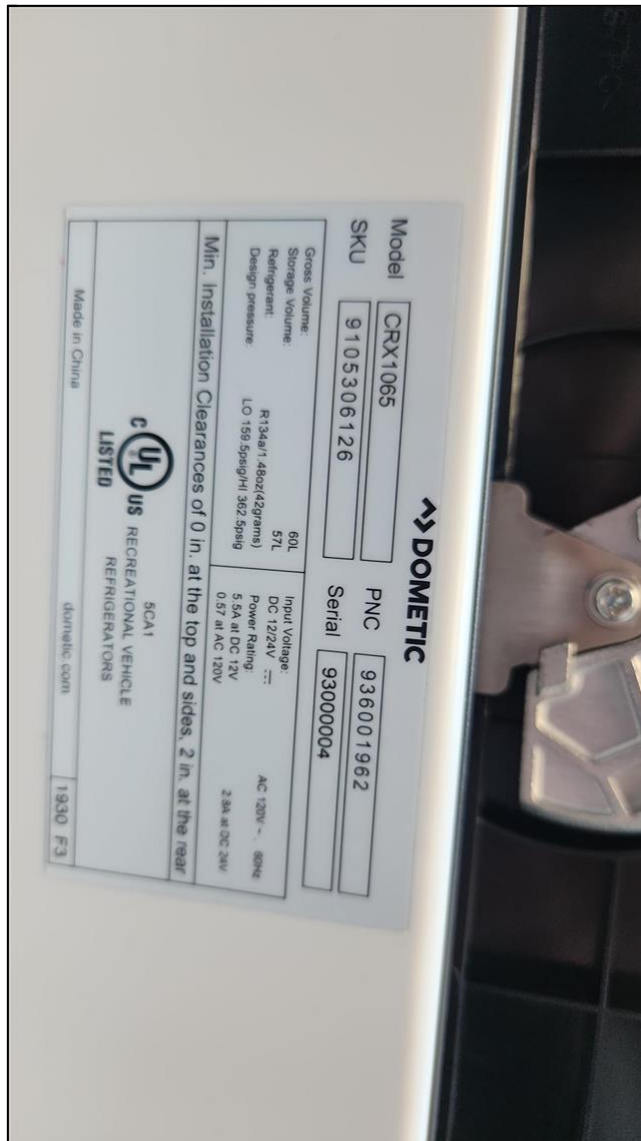
The refrigerator was not turned on prior to the start of the inspection. The refrigerator was run during the course of the inspection and only started to cool. The Refrigerator and Freezer did not reach a safe cooling temperature prior to the end of the inspection. RV refrigerators require at least 12 hours minimum to reach a food safe temperature. It is recommended that the refrigerator be turned on to AC electric operation and be given a minimum of 12 hours to cool and then retest.

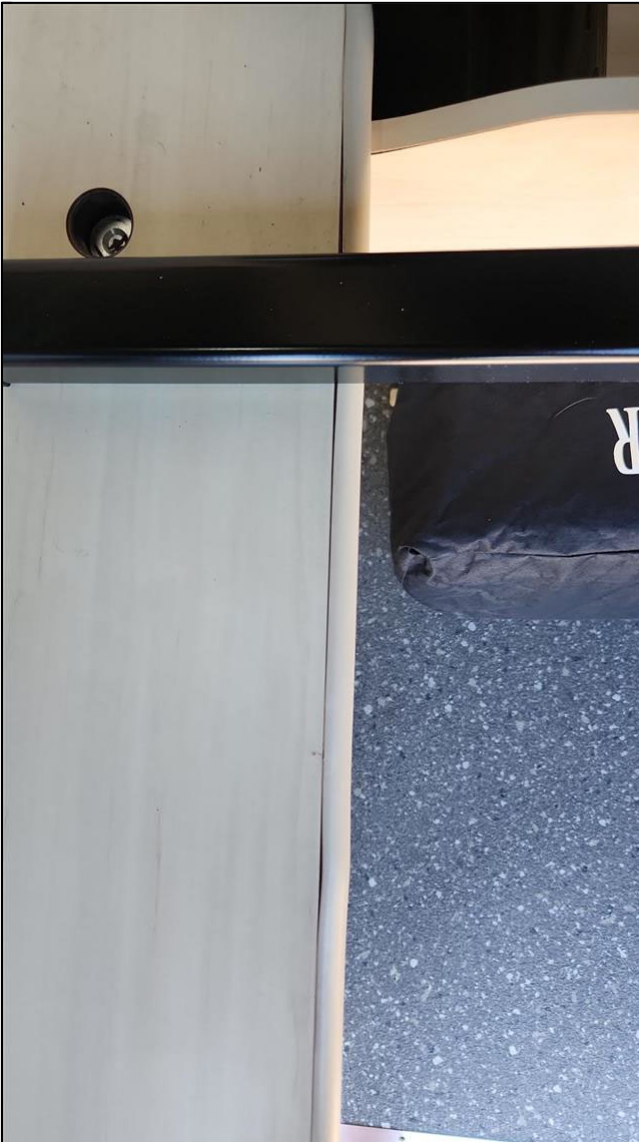
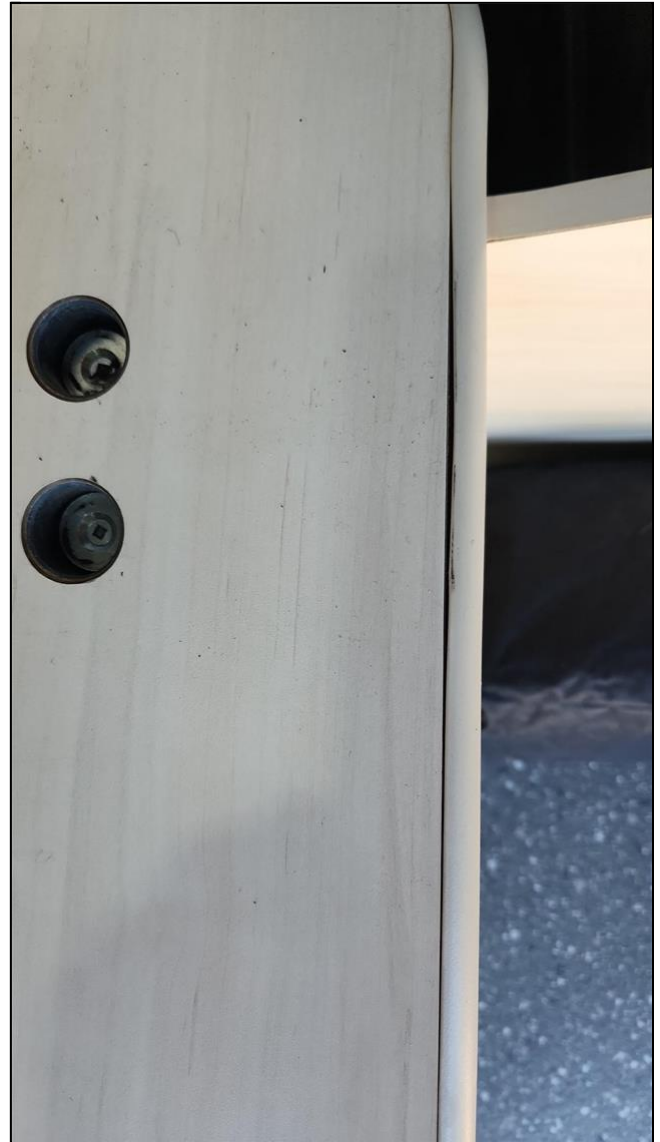
Trim on the left side compartment in the back is coming loose. Recommend repair by a qualified RV technician.

Trim on Cabinet by Back Door

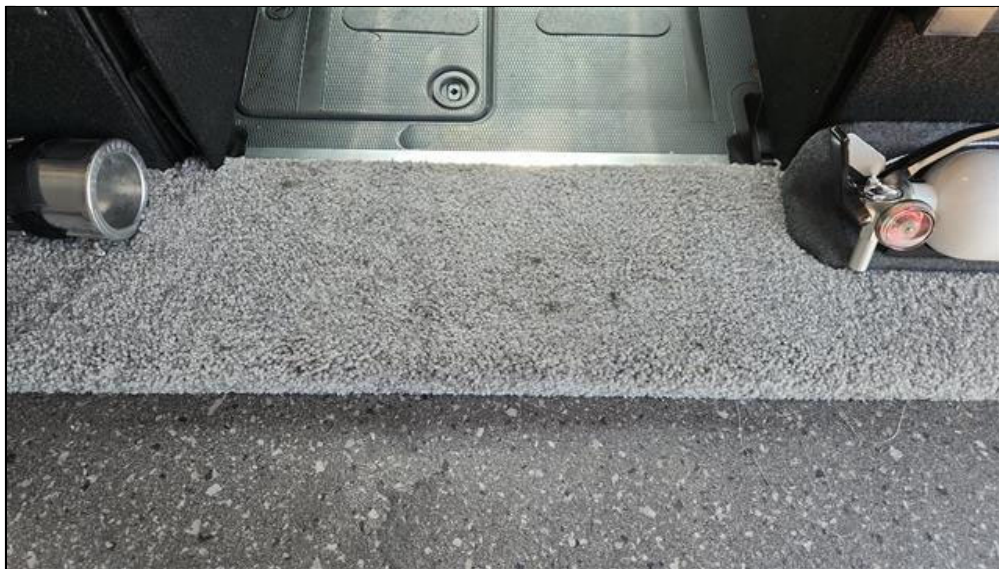
The carpet behind the front seats has some spots and stains.

Staining on Carpet between Front Seats

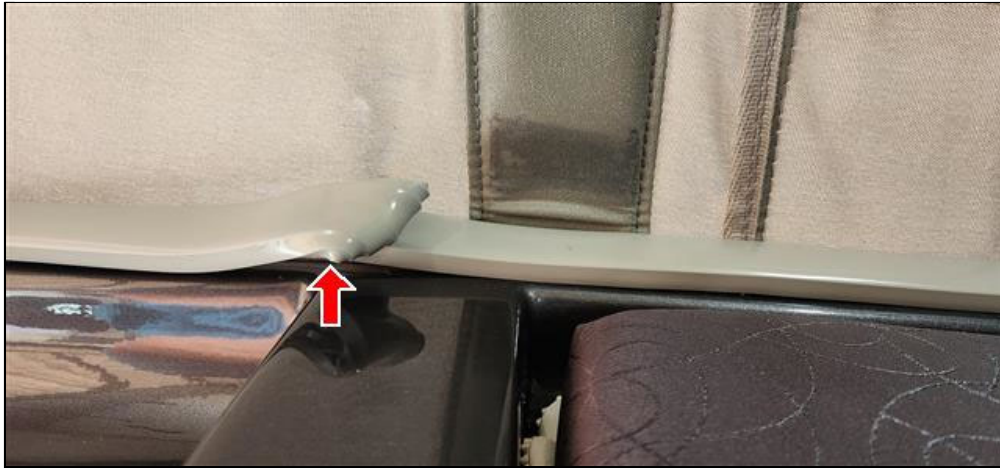
(1) Inspector identified trim in upper bunk area has melted. Trim shifted when upper bunk had been put into a lock position. The trim melted in the excessive heat. Recommend replacement by a qualified RV technician.

Trim Melted

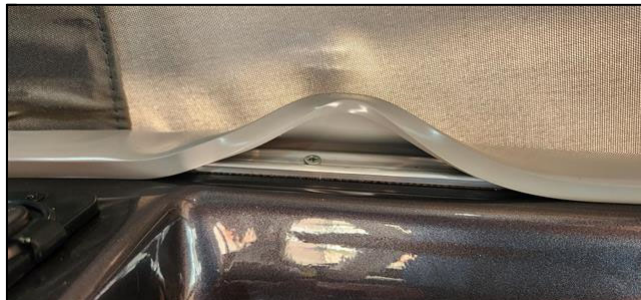
Trim Loose

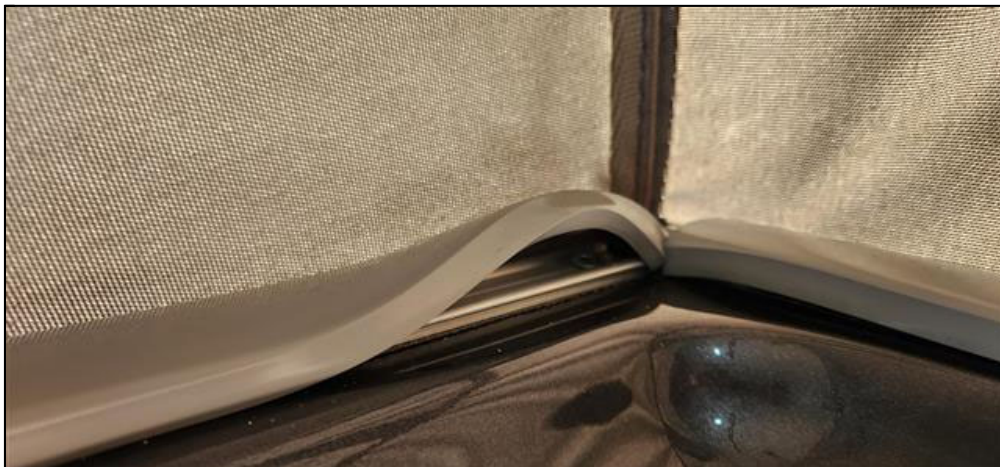
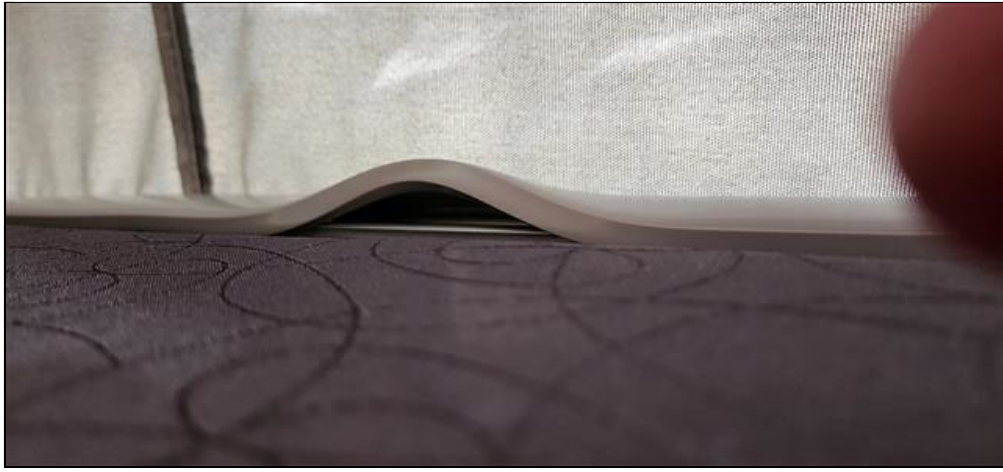
Trim In Bunk Area

Trim in Bunk Area

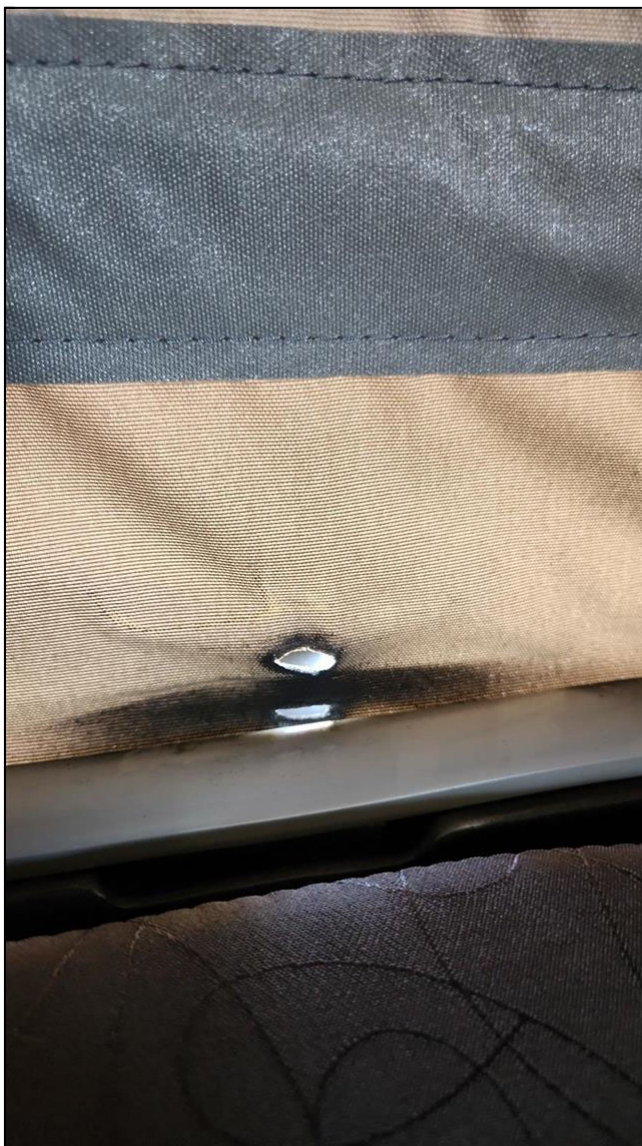
(2) Inspector identified a wear hole in the back of the upper bunk canvas. There is a pneumatic strut mounted on the outside of this hole. Recommend repair or replacement by qualified RV technician.

Wear Hole in Canopy

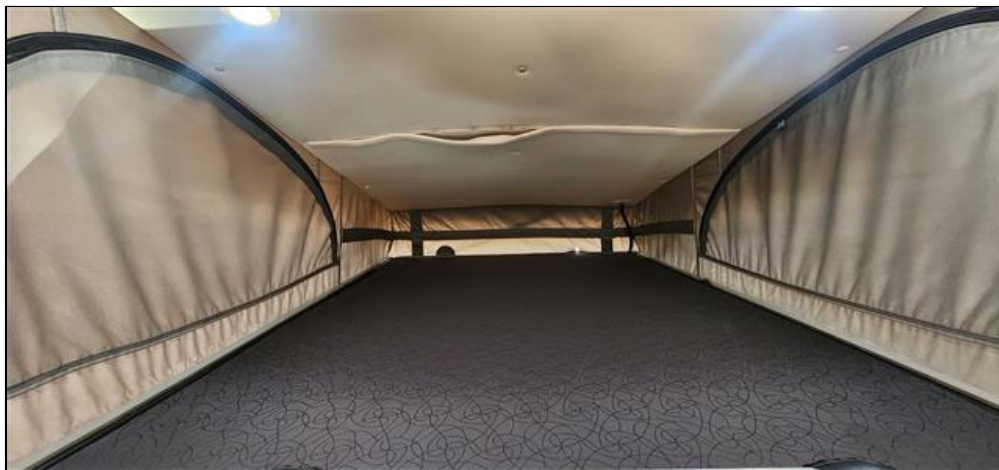
(3) Inspector identified seam in roofing material above the upper bunk area to becoming loose. Recommend repair or replacement by qualified RV technician.

Ceiling Coming Apart

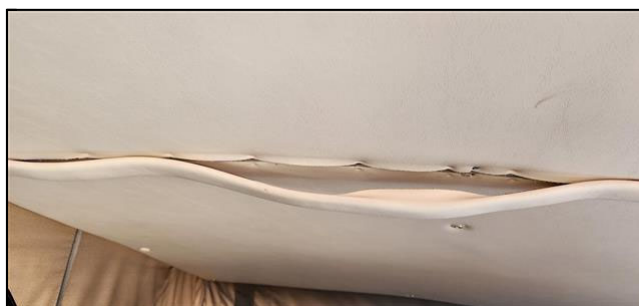
Ceiling Seam Coming Apart
