# EVERY INCH RV INSPECTION SERVICES

## RV Inspection Report

**Inspection Date / RV Model:  
11-29-2021 / 2010 Fleetwood Bounder 35H**

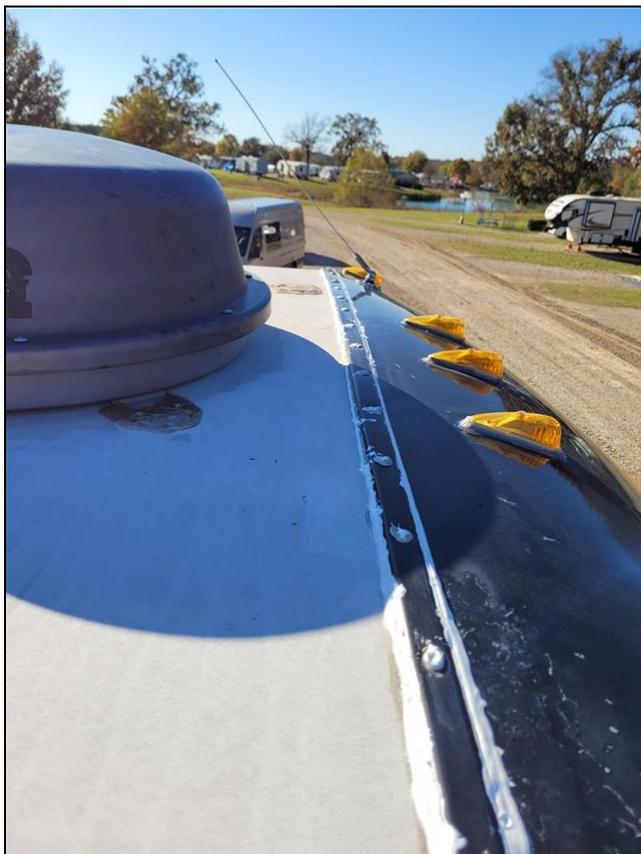
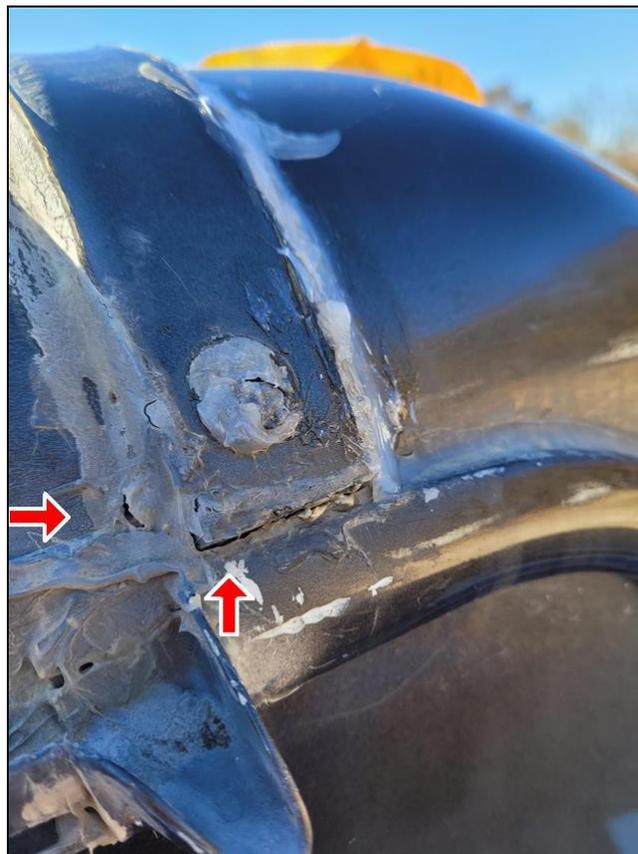
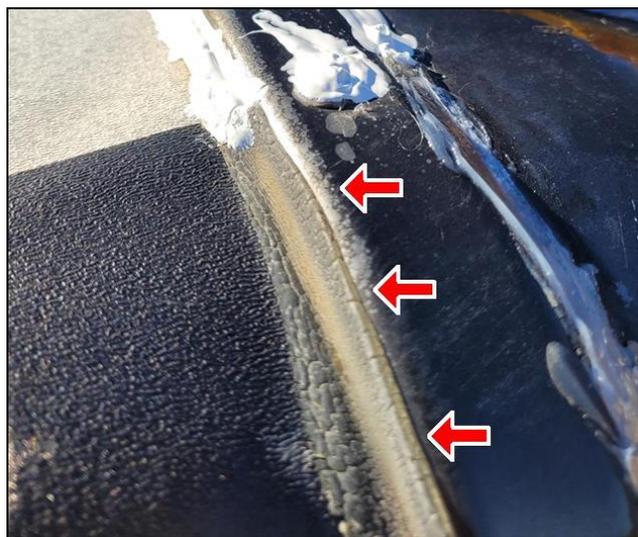
The sealant is cracking on the frontcap, curbside joint. It is recommended that this be repaired by a qualified RV technician to prevent future water intrusion.

Cracks in Sealant Curbside Front Cap Joint Corner

Sealant Cracking on Front Curbside Roof Joint

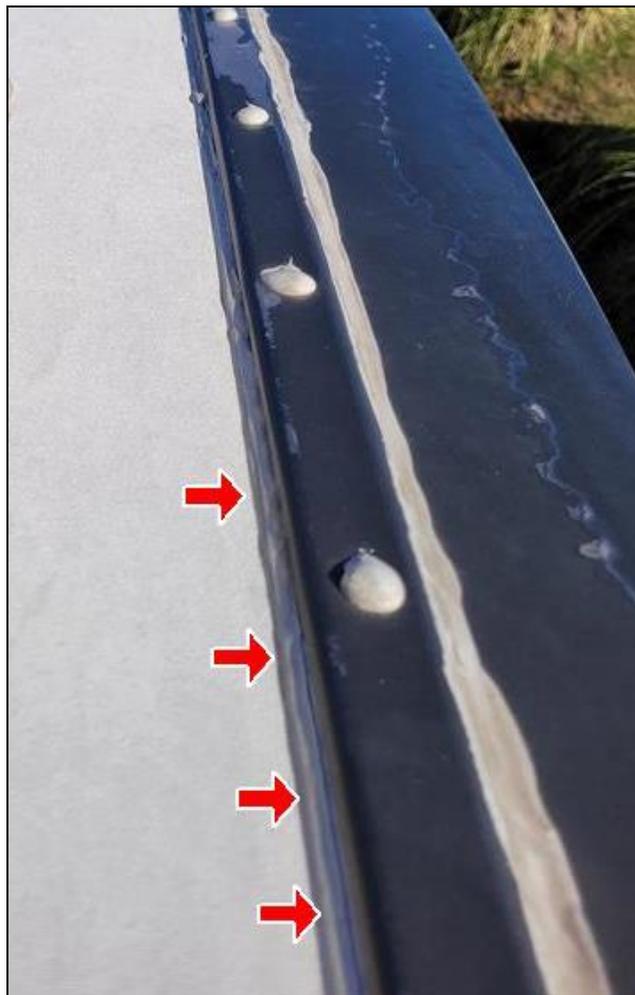
(1) The sealant is cracking on the rear cap joint seal, 16" from the curbside corner. It is recommend that sealant be replaced by a qualified RV technician to prevent water intrusion.

Rear Cap Seal from Streetside Looking to Curbside

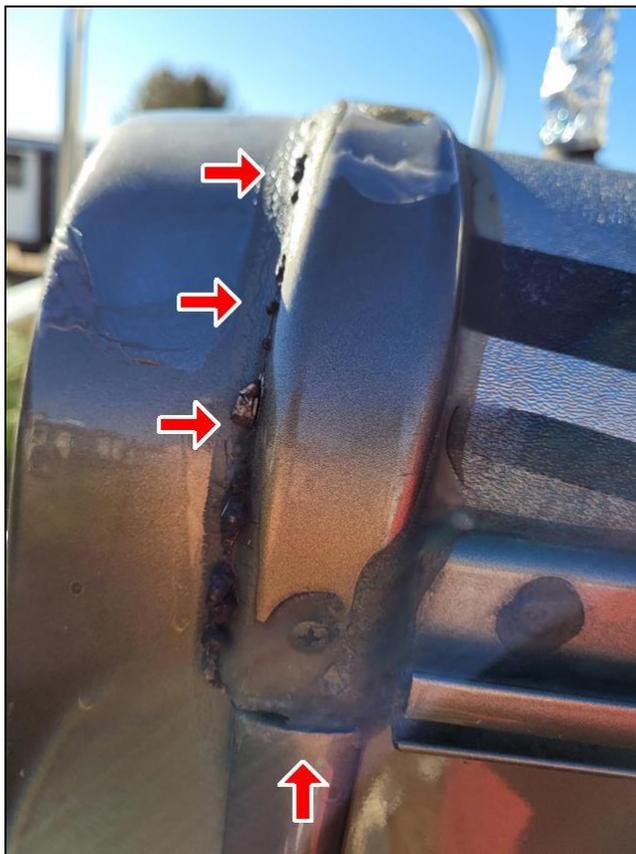
(2) The sealant is cracking on the curbside rear cap joint. It is recommended that this be repaired by a qualified RV technician to prevent future water intrusion.

Curbside Rear Cap Joint

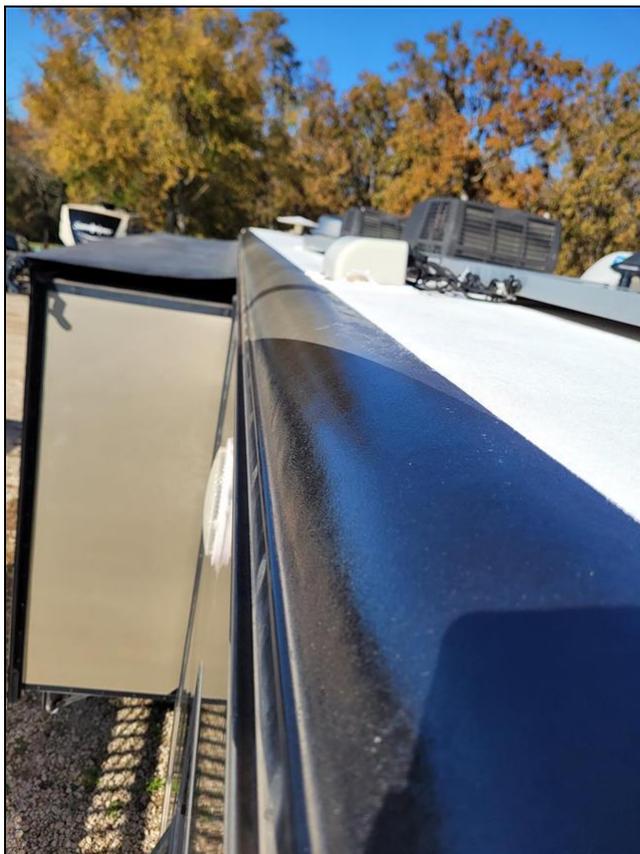
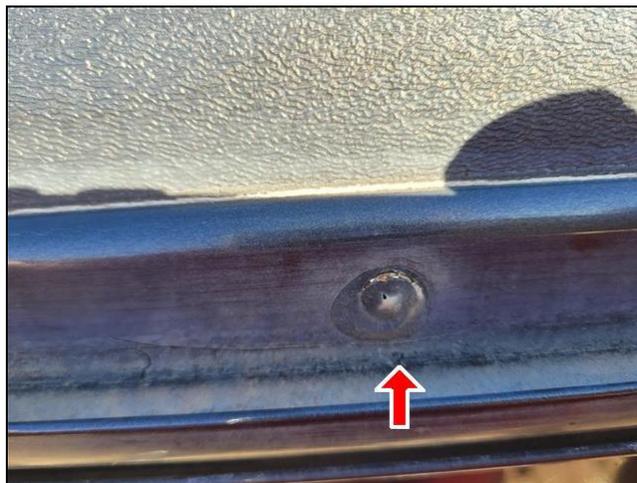
The sealant on the streetside trim rail screws from the frontcap joint and extending 9 feet back is coming off and has holes. It is recommended that sealant be replaced by a qualified RV technician.

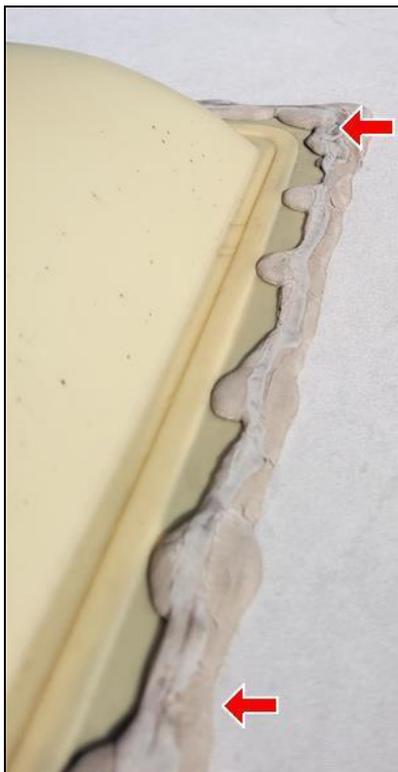
- 🐛 The sealant around skylight is cracking and peeling away from the roof. Recommend replacement of sealant to prevent future water intrusion.

Cracks in Skylight Sealant

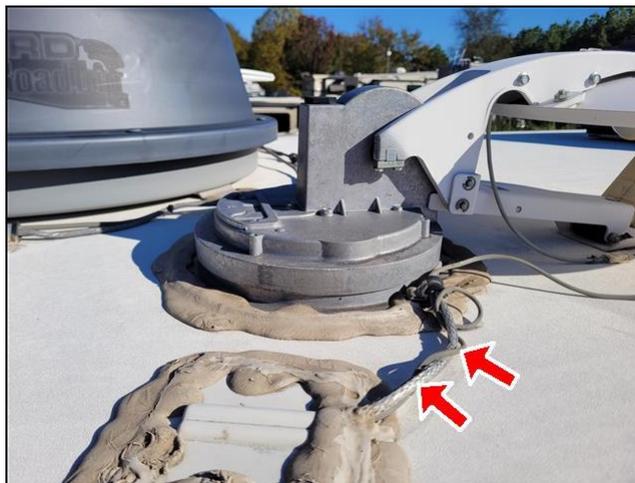
💰 (1) The coaxial cable going to the satellite antenna is missing the outer shielding, leaving the braided shielding exposed. It is recommended that this be replaced by a qualified RV technician.

Satellite Antenna Coax Cable Cracking

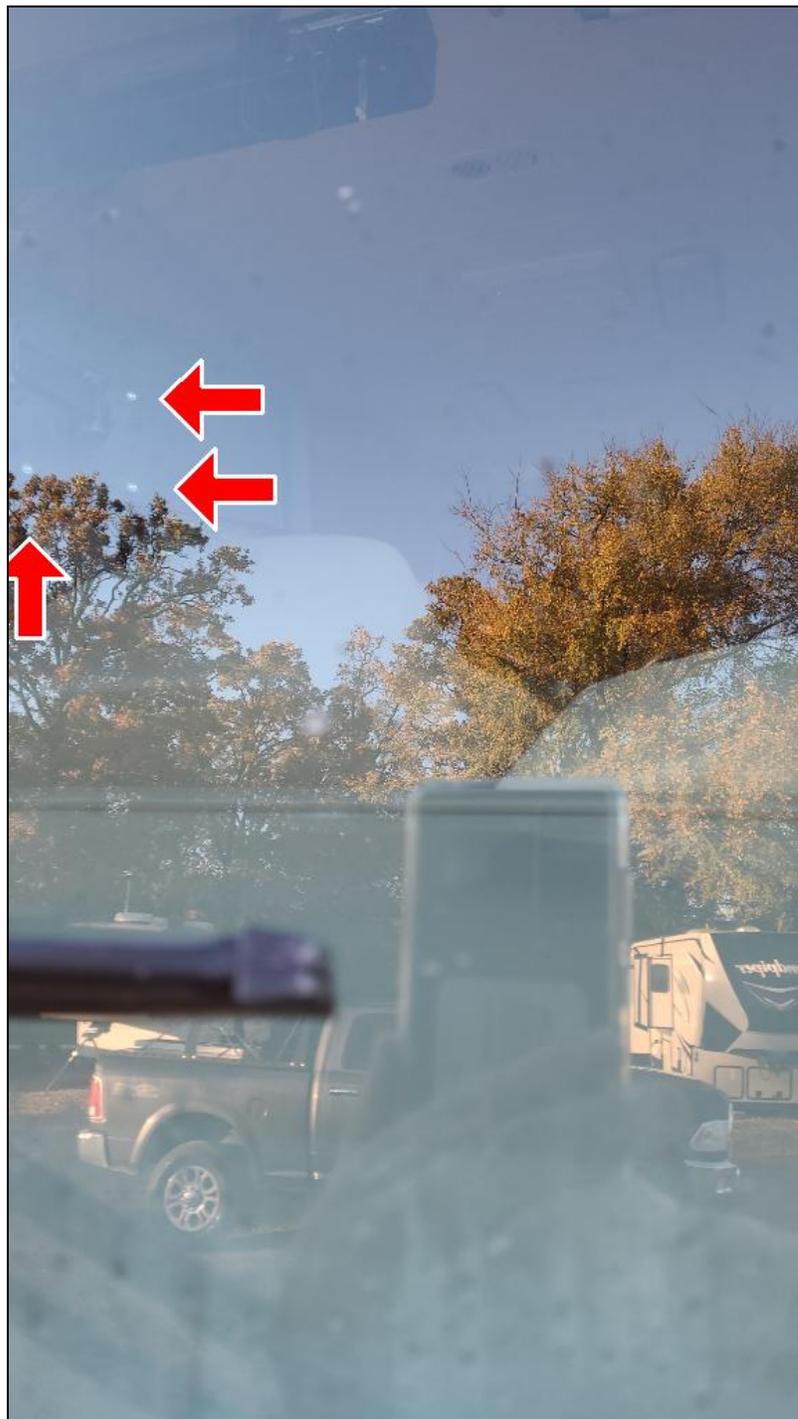
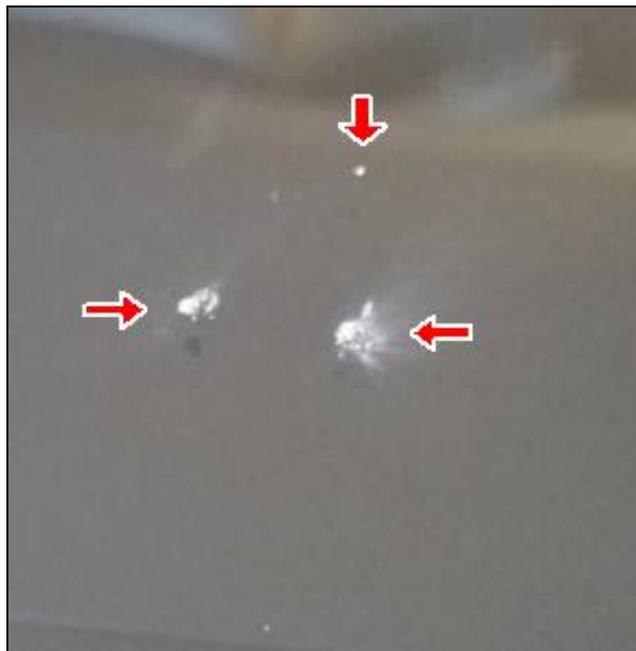
(1) Inspector observed three small pits on the driver's side windshield, immediately above the street side of the windshield wiper. It is recommended that these be repaired by a qualified glass technician to prevent further damage.

Surface Chips

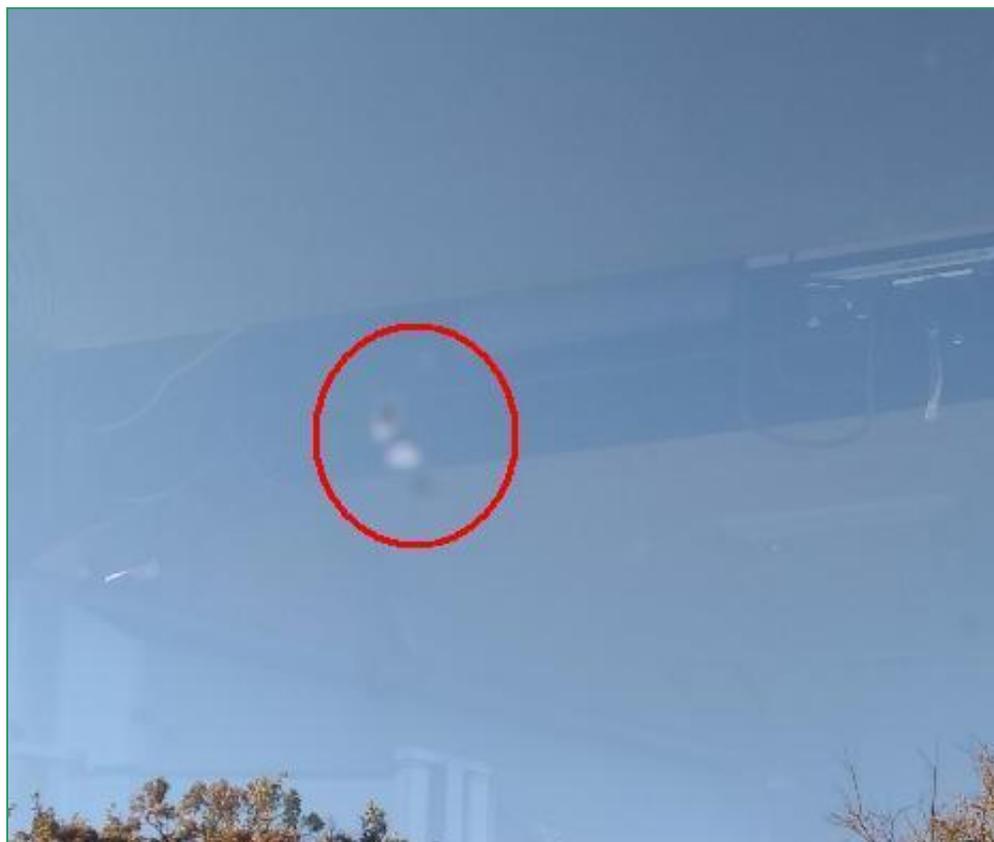
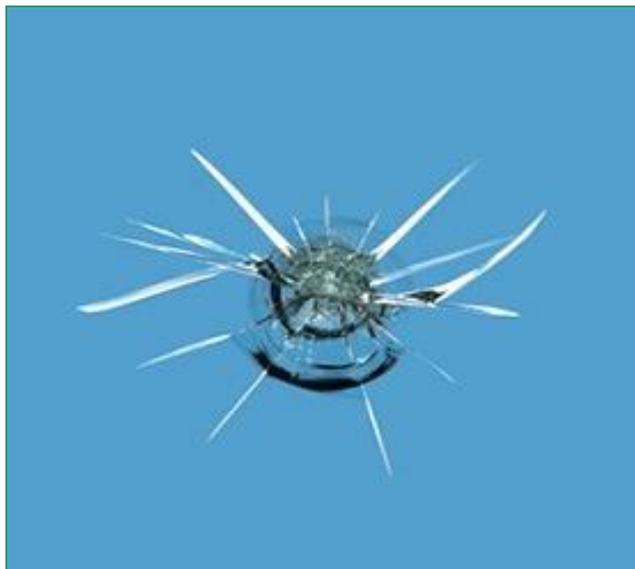
**\$** (2) Inspector observed a small spider crack located 7" from the center of the windshield and 18" up from the bottom edge of the windshield.

Spider Crack in Drivers side of windshield.

Spider Crack

It is recommended that this be repaired by a qualified RV Glass technician.

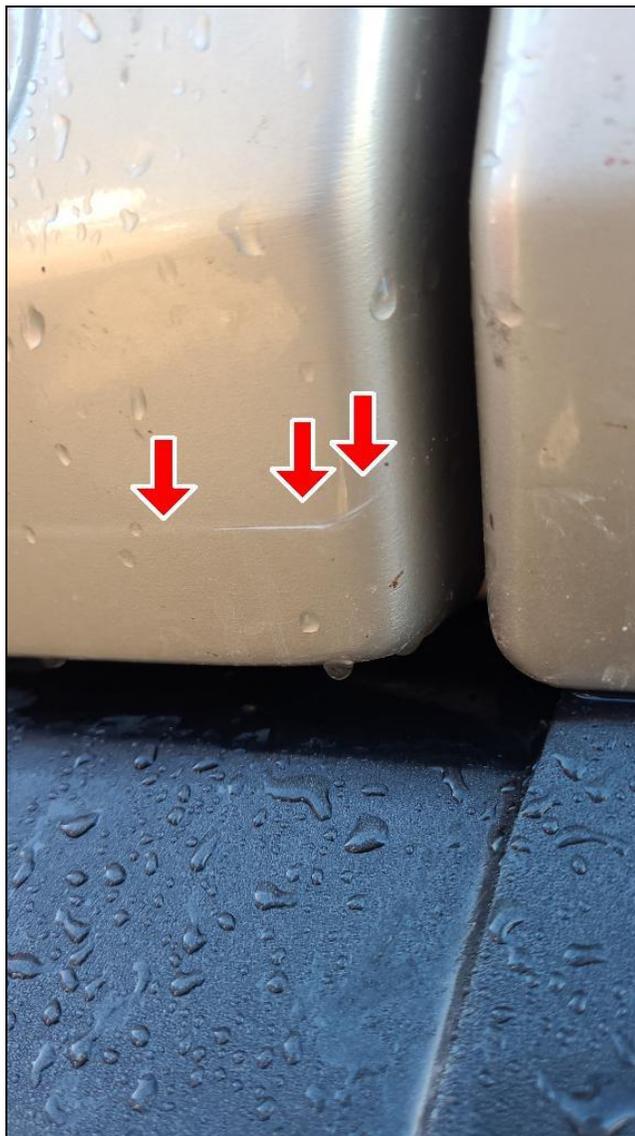
There is a small scratch on the street side of the engine door access panel.

Scratch on Engine Door Access Panel

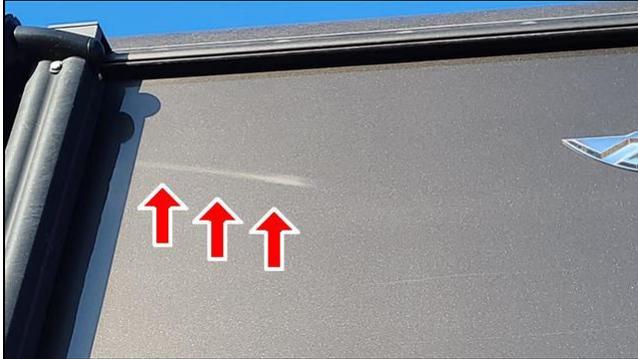
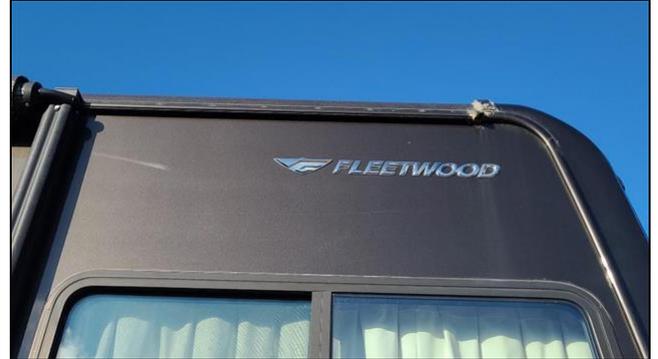
(1) There is a small scrape located above the passenger's window. Recommend repair by a qualified RV technician.

Scraped Paint above Passengers Window

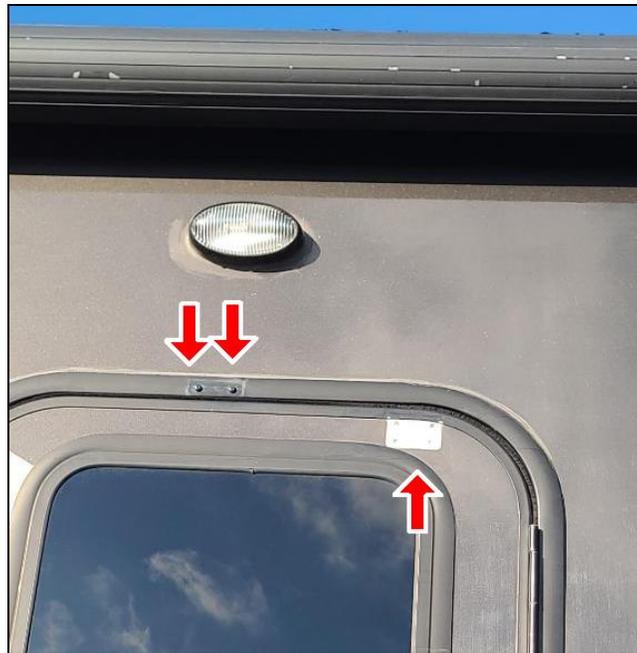
(2) The bracket above the door, to hold the door open, was removed by the owner. There are two holes in the sidewall. It is recommended that this be repaired by a qualified RV technician to prevent water intrusion.

Bracket above Door Removed

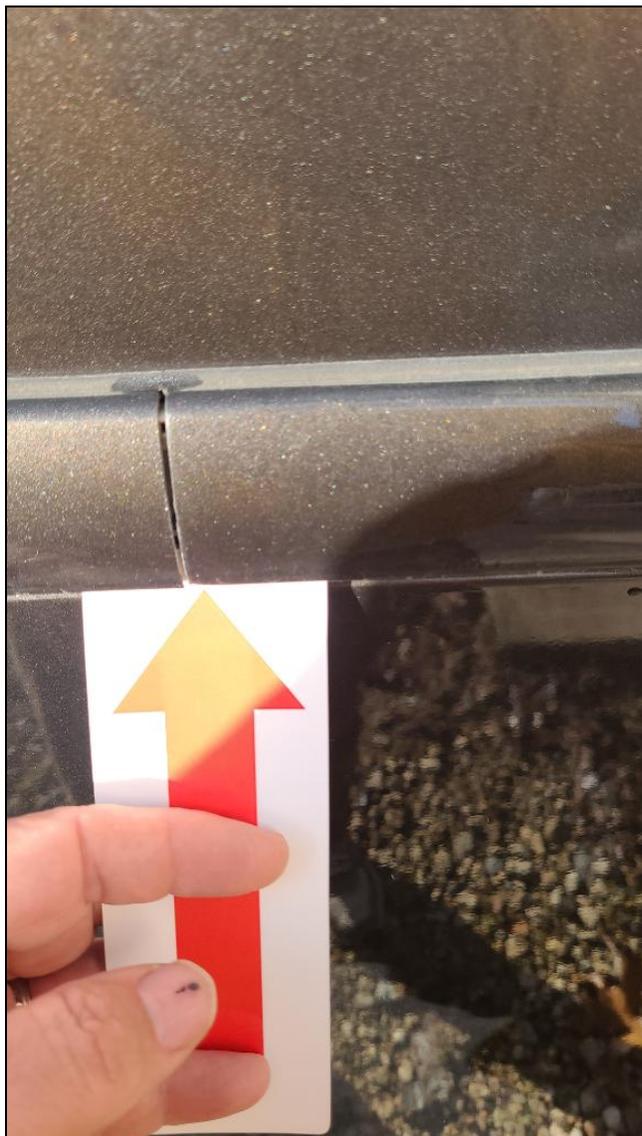
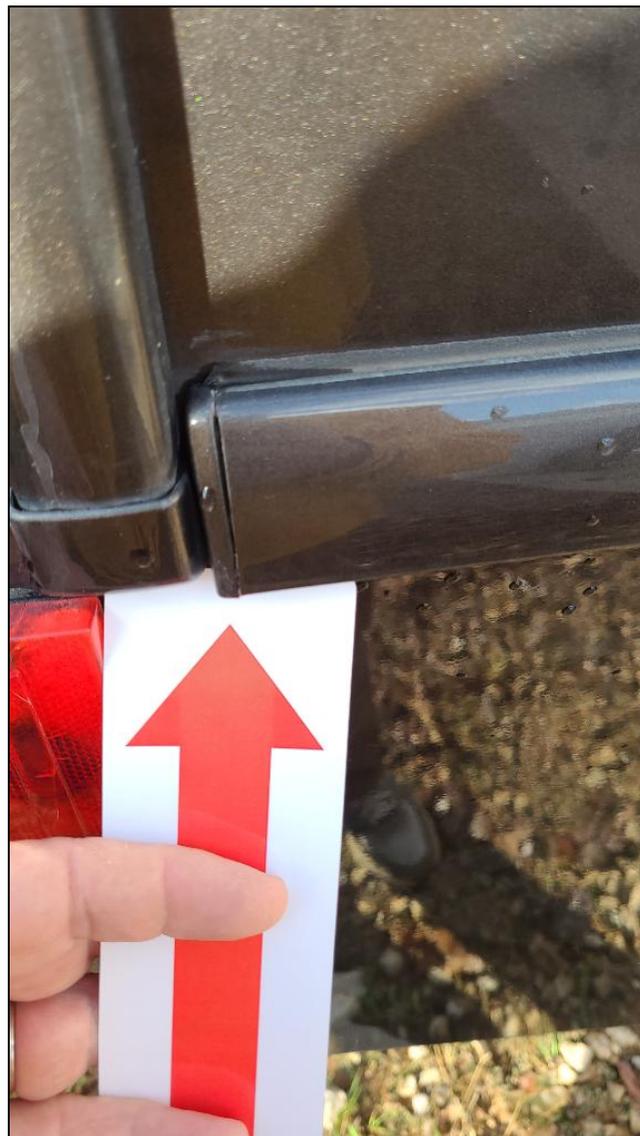
(3) There are gaps in the trim piece between the Sidewall and fender skirt along the floor joint 46" from the rear of the RV. It is recommended that these be repaired by a qualified RV technician to prevent water intrusion.

Gap in Floor Joint Trim

Gap in Floor Joint Trim and End Cap

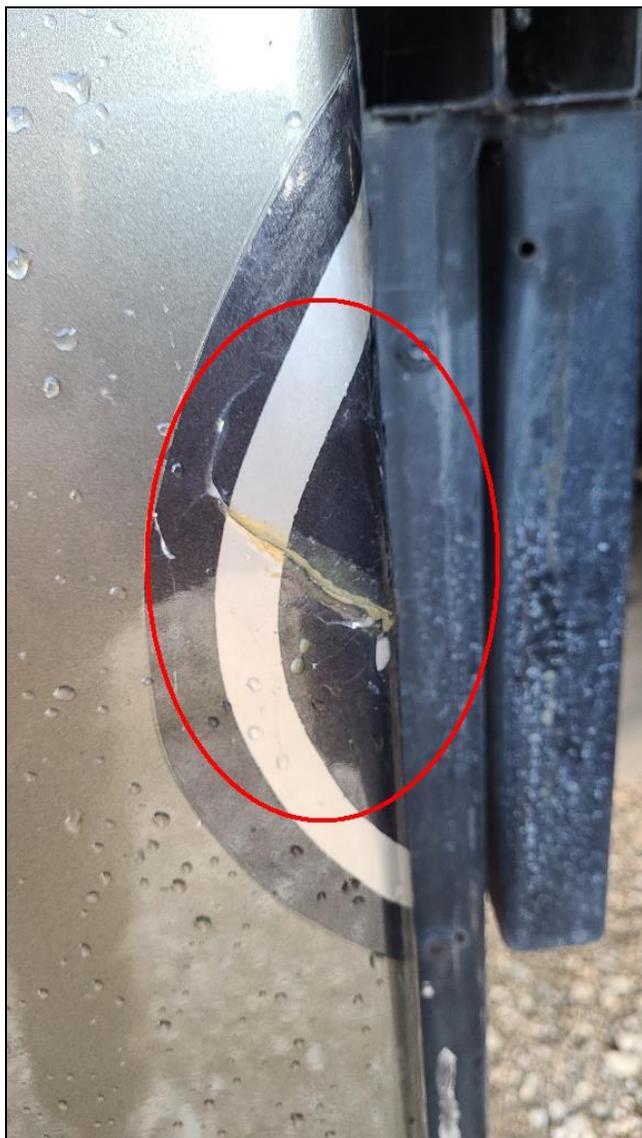
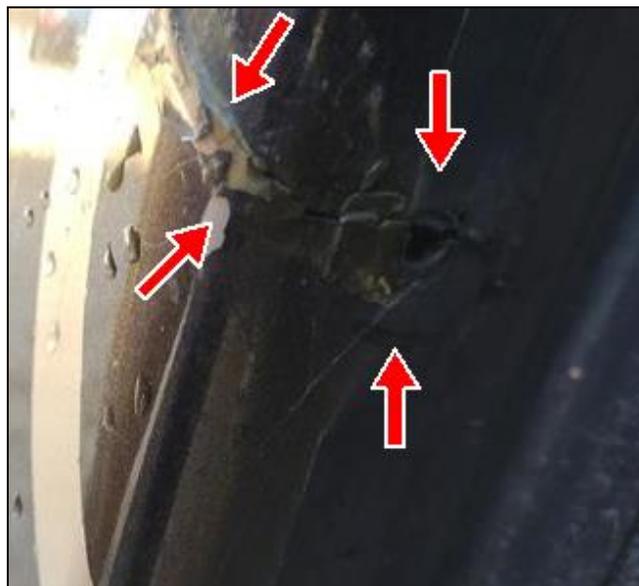
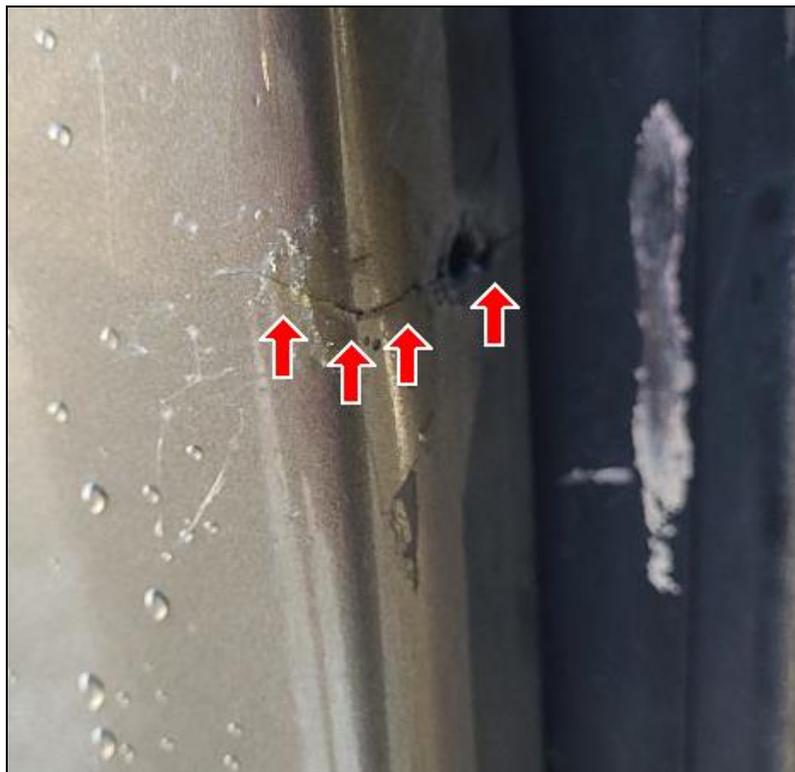
- There are 2 areas that are damaged along the street side side wall immediately behind the steering axle and forward of the first storage compartment. It is recommended that this be repaired by a qualified RV technician.

Streetside Sidewall Damage

Sidewall damage

Crack in Streetside Sidewall

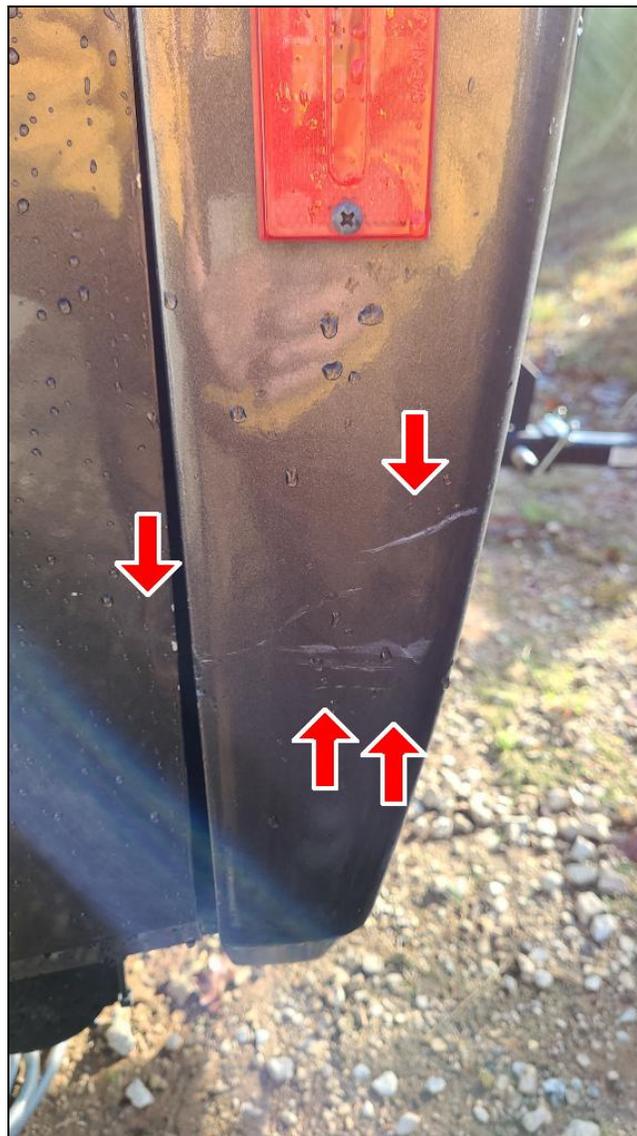
There is a scratch on the street side rear corner of the RV immediately behind the back access door.

Scratch on Streetside Sidewall by Rear Cap

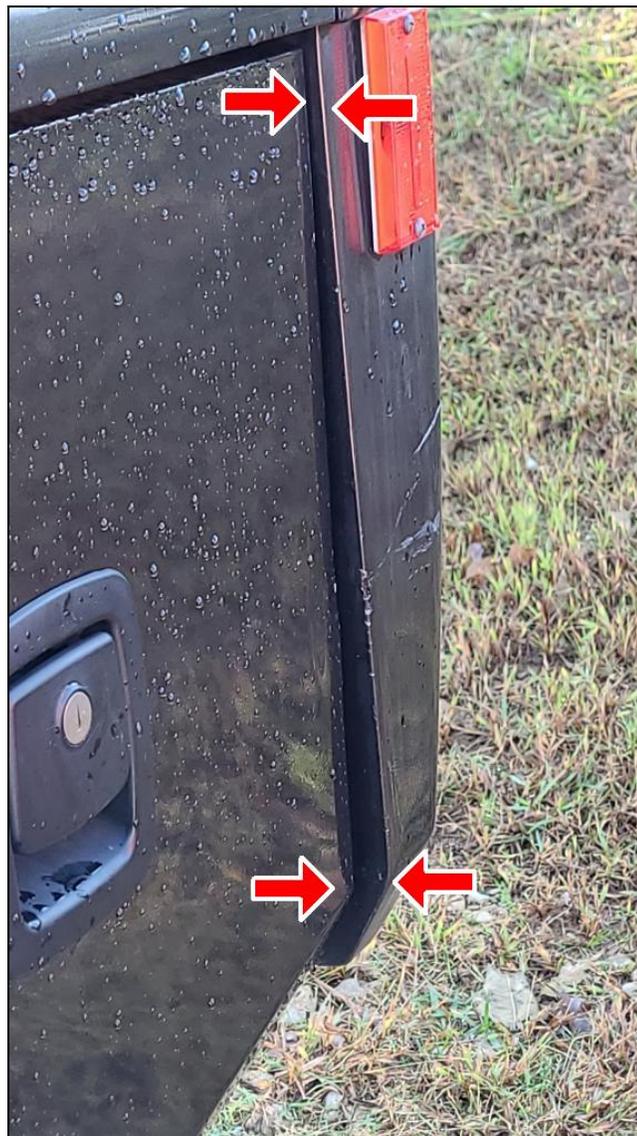
(1) The rear cargo door on the streetside sidewall does not line up with the rear cap.

Cargo Door Not Aligned with Endcap

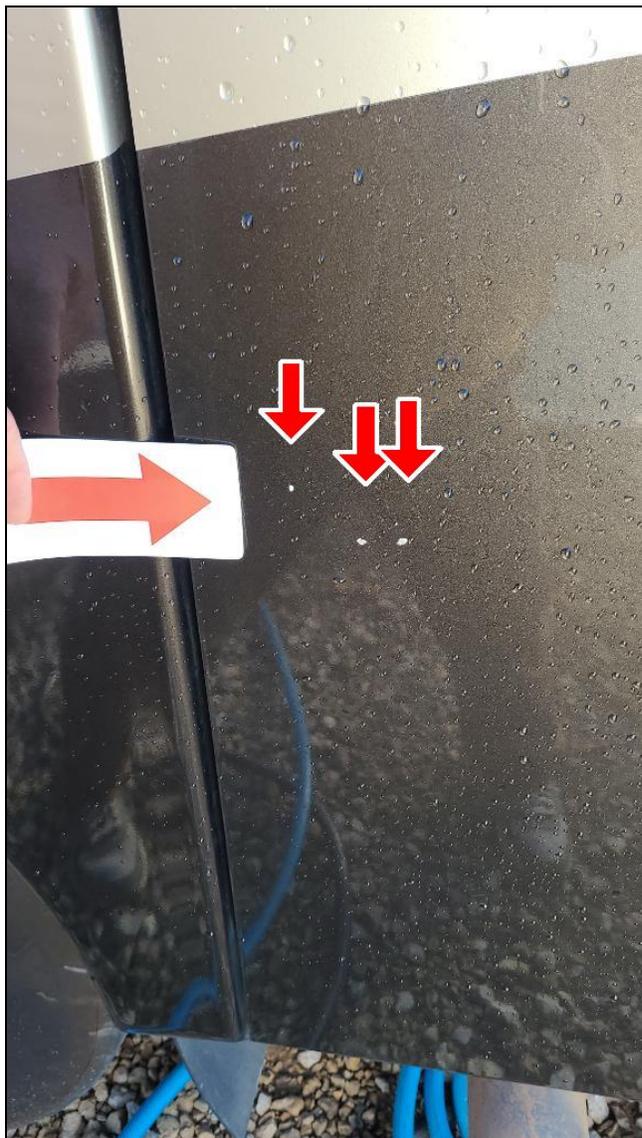
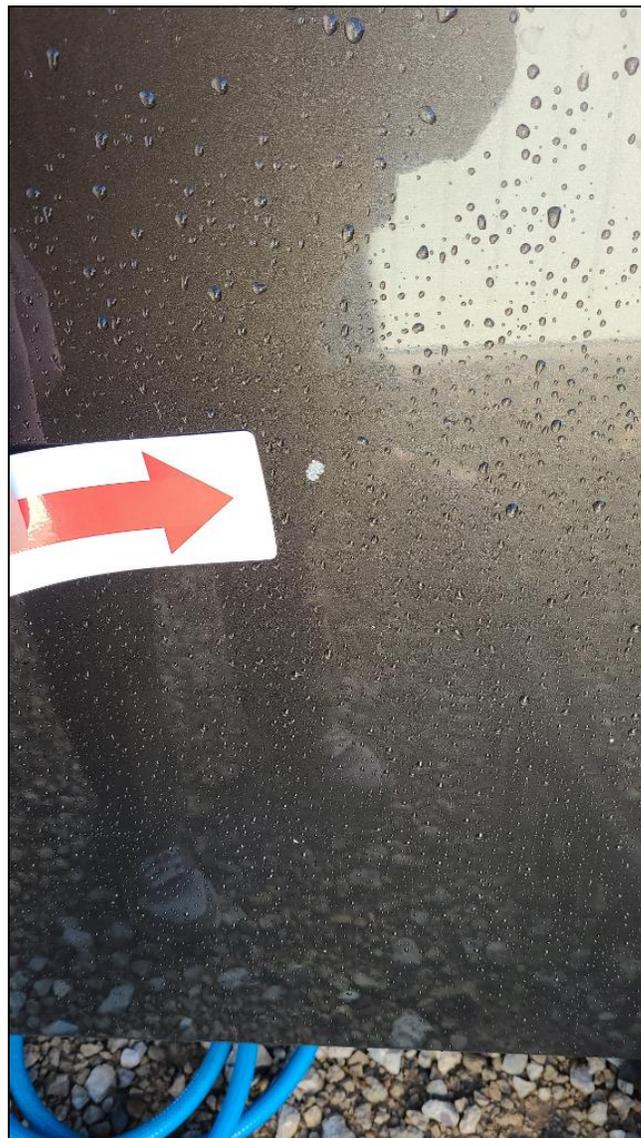
- 🐛 (2) There are 4 chips in the paint on the wet bay access door on the street side rear of the RV.

Three Chip in Paint on Front Edge of Door

Chip in Paint on Center of Door

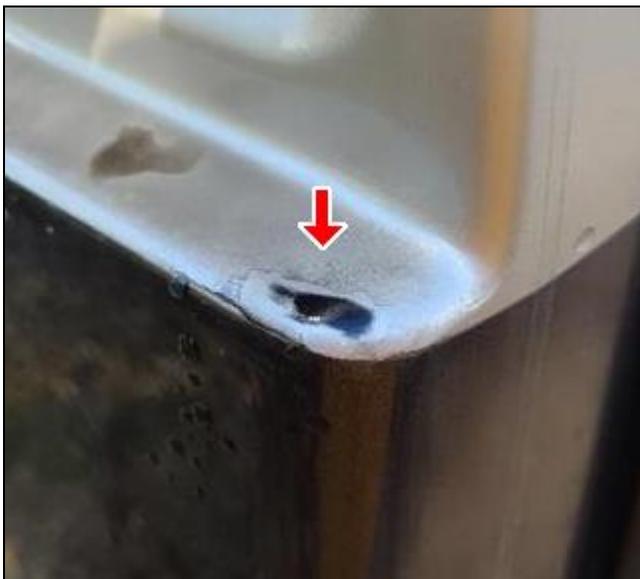
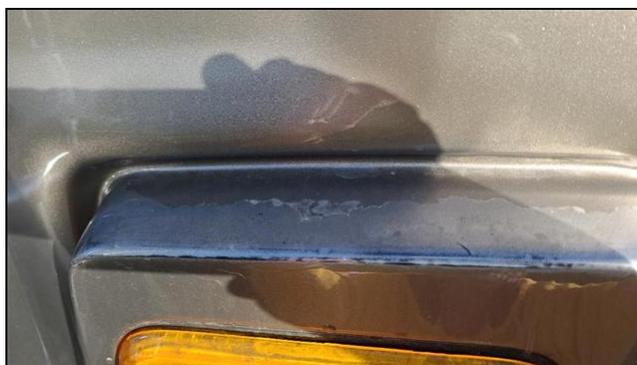
(1) There are multiple scrape in the paint on the rear cap wall immediately above the transition from the dark paint to the light paint.

Scraped Paint on Curbside and Rear Corner Joint

Paint Scrape above Left Taillight Assembly.

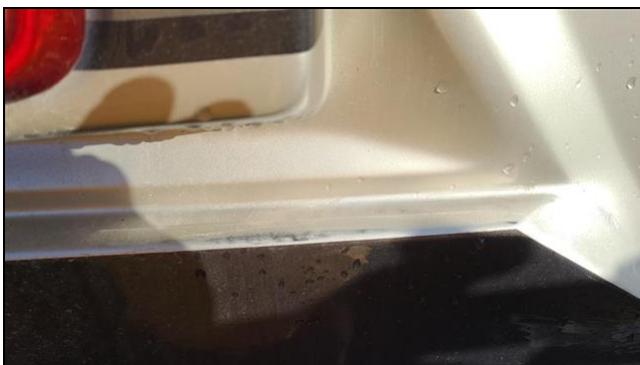
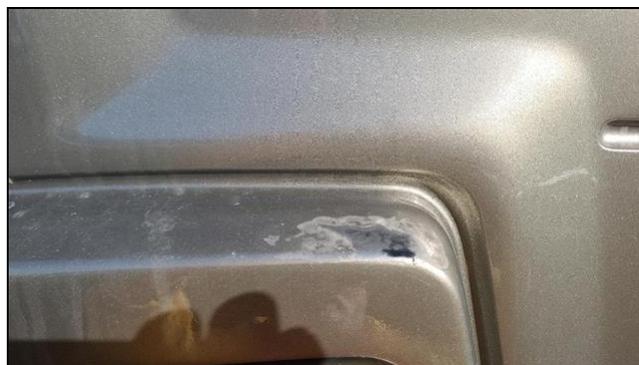
(2) There's additional scraping along the s If street side below and above the taillights. Is recommended these be repaired by a qualified RV technician.

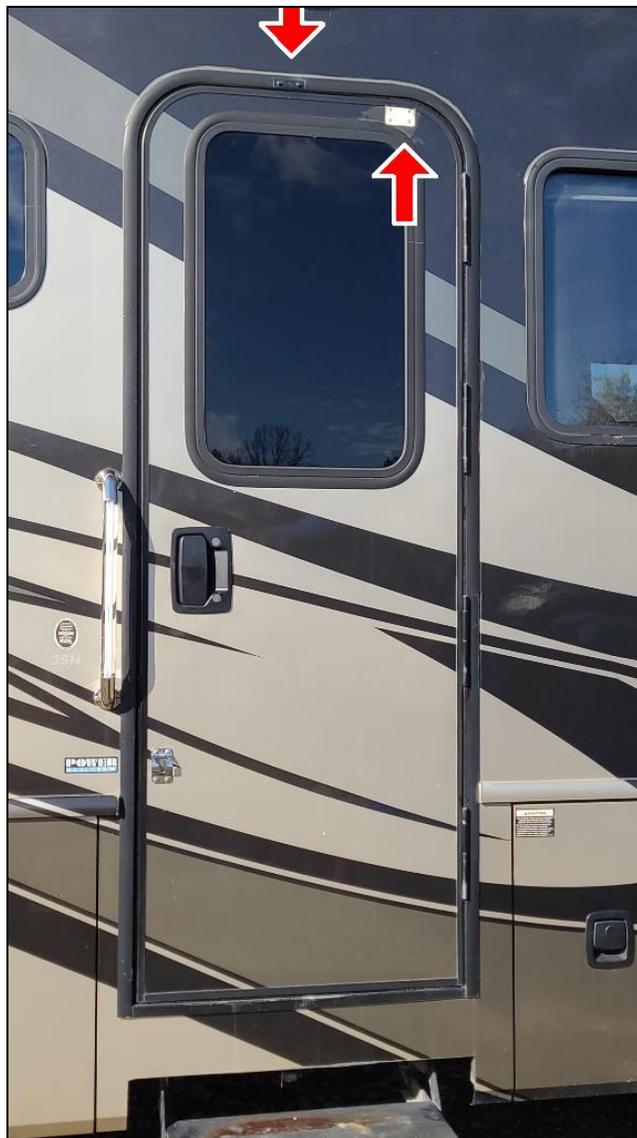
The entry door positioning bracket is not installed. The owner states that this was removed for owner convenience. It is recommended that this be replaced by a qualified RV technician to prevent damage to the door assembly.

Door Bracket Removed

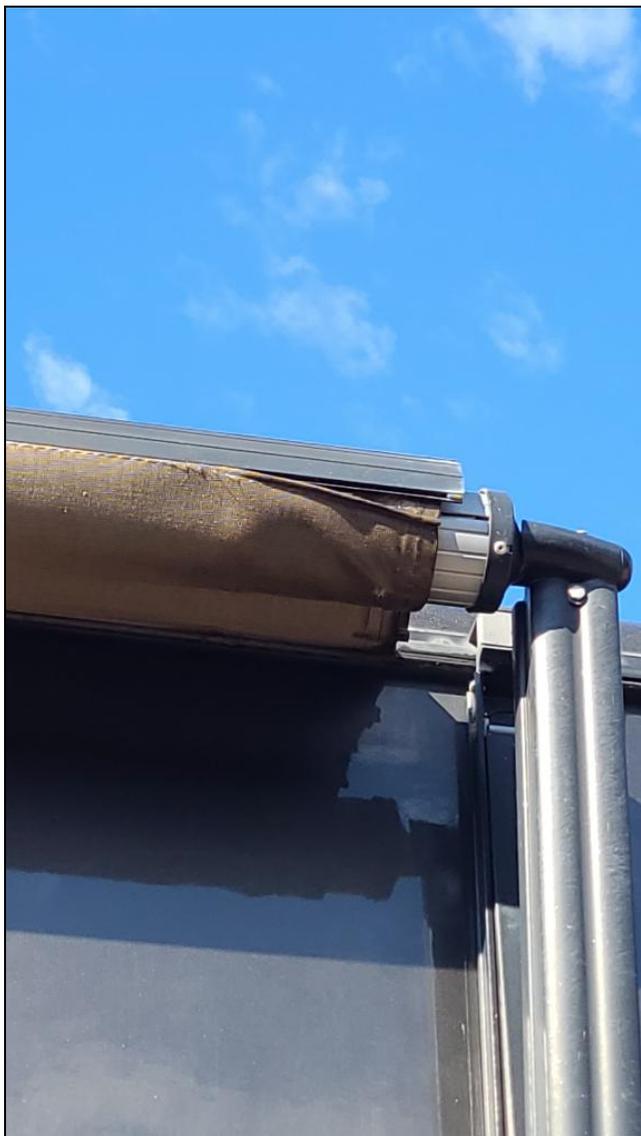
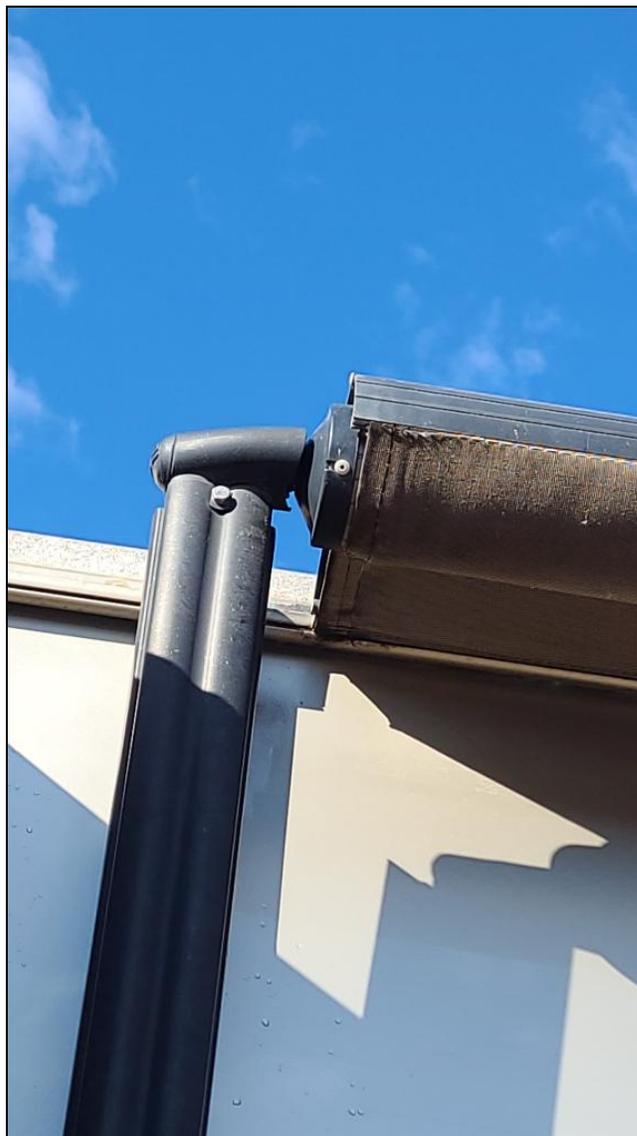
- (1) The awning fabric is separating from the awning cover. It is recommended that this be repaired by qualified RV technician to prevent further damage..

Awning Cover Separating from Awning on Front Edge

Awning Cover Separating from Awning on Rear Edge

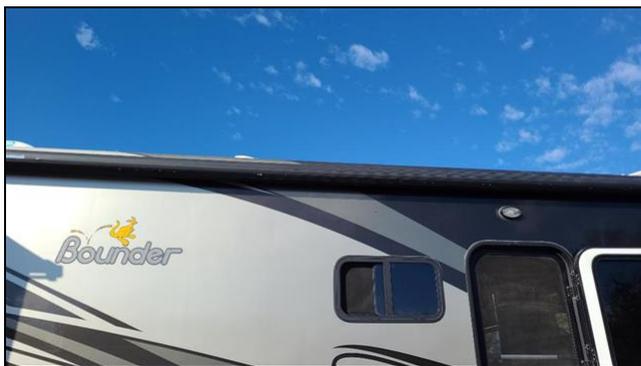
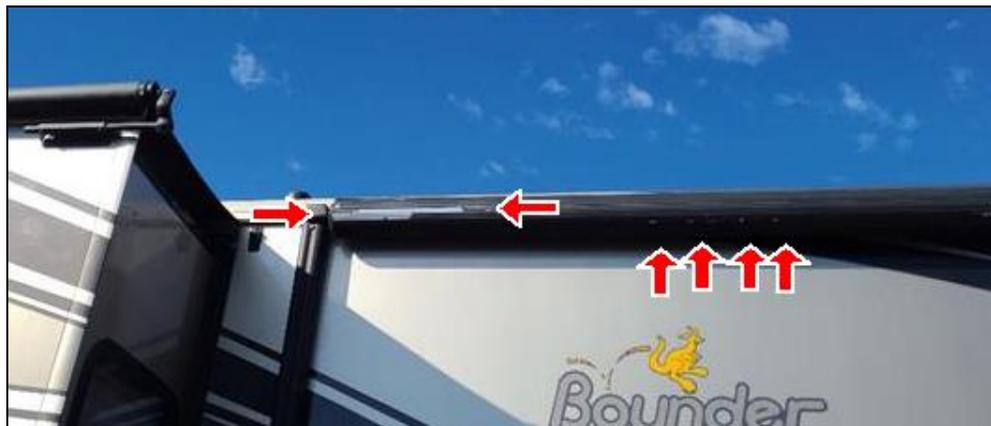
- (2) The paint is chipping along the awning cover. It is recommended that this be repaired by a qualified technician.

Awning Cover Paint Chipping

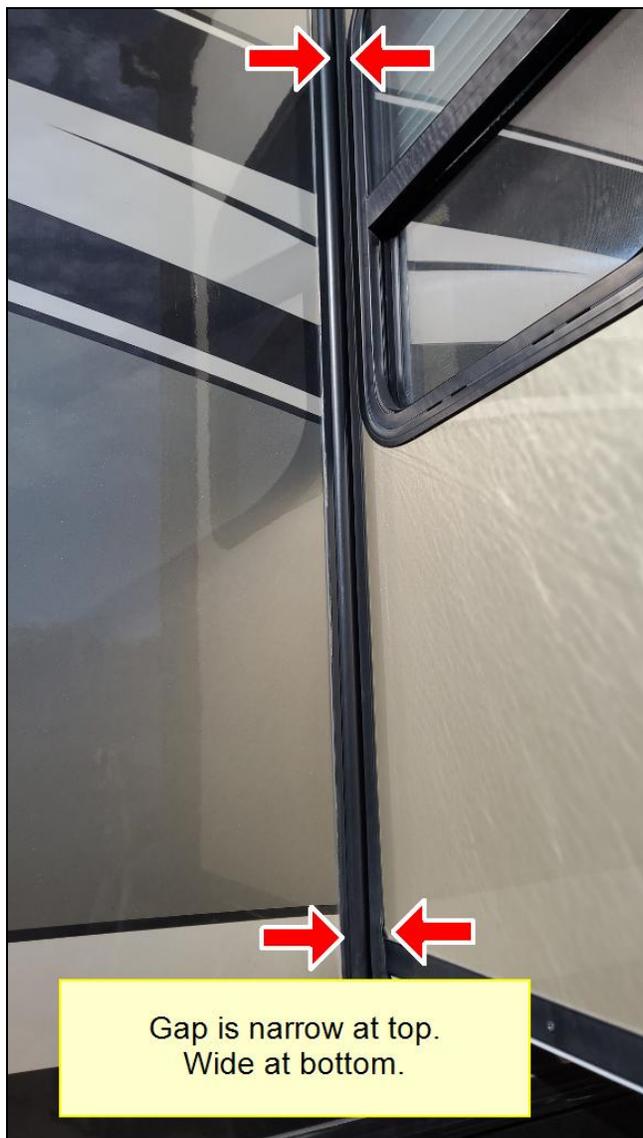
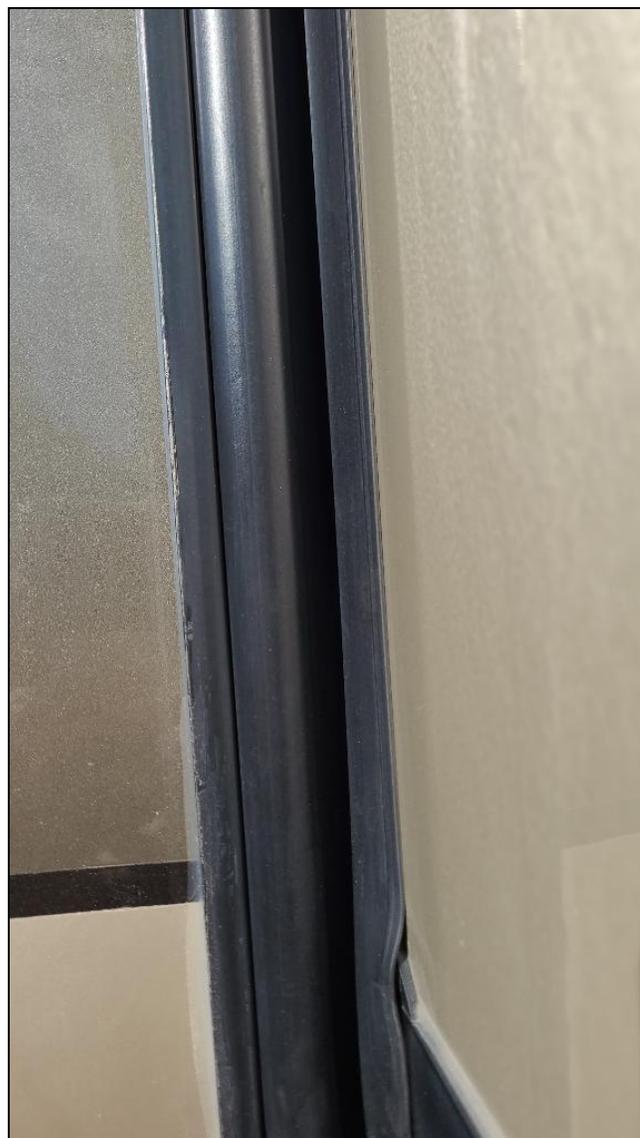
The curbside rear slideout is out of alignment.. The sweep seals on the front and rear edges of the slide out are not equal. It is recommended that this be repaired by a qualified RV technician.

Curbside Rear Slideout Alignment

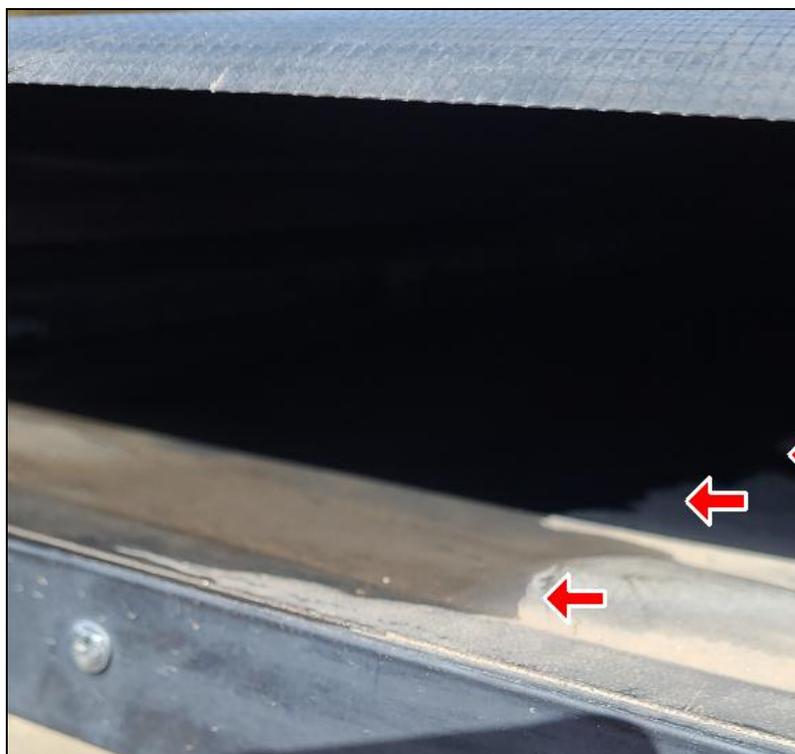
- 🔧 (1) Water has collected and is standing on the top of the streetside slideout under the awning topper.
- 🔧 (2) The tape along the rear edge of the slide out is peeling away from the roofing material it is recommended that this be repaired to prevent future water intrusion.
- 🔧 (3) The slide roof bulb seal has holes at the end of the seal where the T molding meets the trim moulding. It is recommended that this be repaired by a qualified RV technician to prevent future water intrusion.

Standing Water on Slideout Top

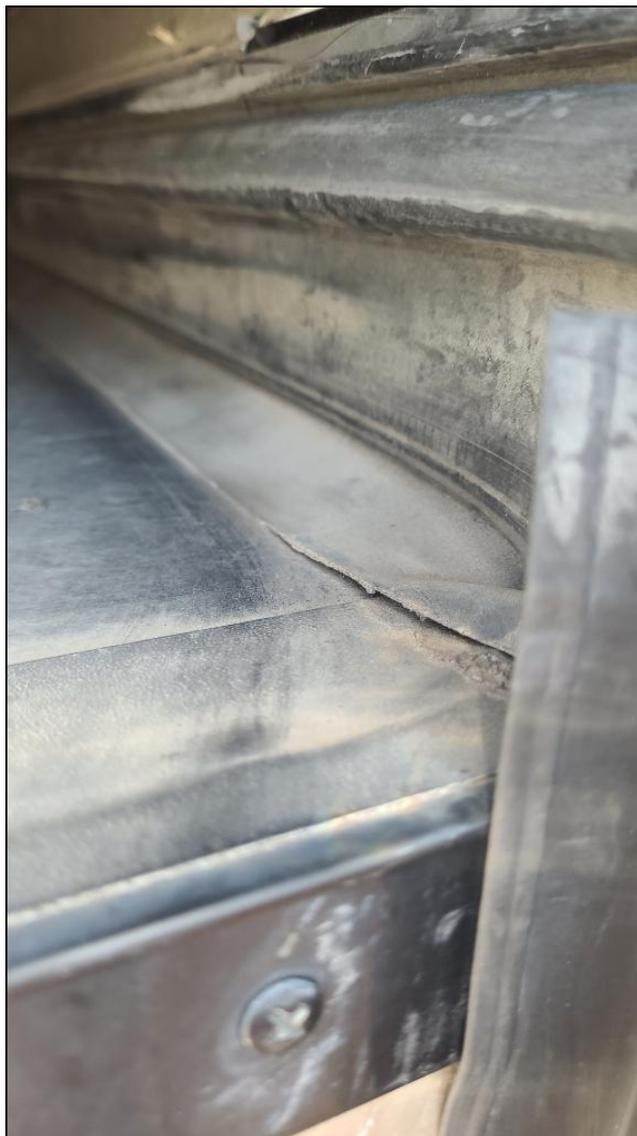
- ✎ (2) The tape along the rear edge of the slide out is peeling away from the roofing material it is recommended that this be repaired to prevent future water intrusion.

Tape Peeling on Streetside Slideout Rear Edge
