# EVERY INCH RV INSPECTION SERVICES

## RV Inspection Report

**Inspection Date / RV Model:  
11-29-2021 / 2010 Fleetwood Bounder 35H**

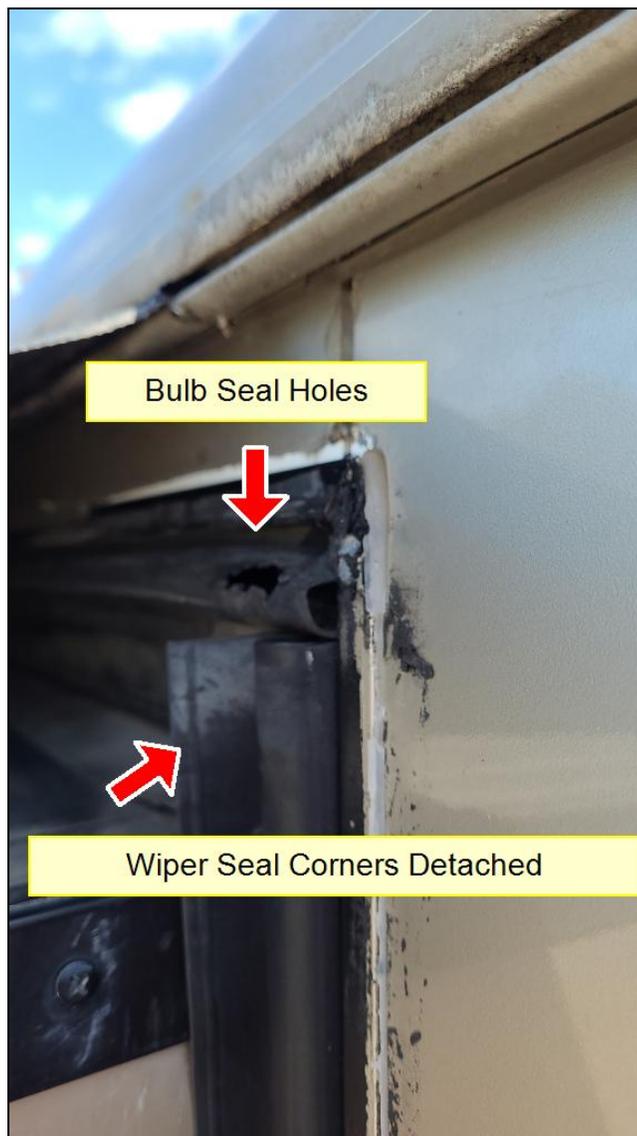
- ✎ (3) The slide roof bulb seal has holes at the end of the seal where the T molding meets the trim moulding. It is recommended that this be repaired by a qualified RV technician to prevent future water intrusion.

Streetside Slideout Rear Bulb Seal and Wiper Seal

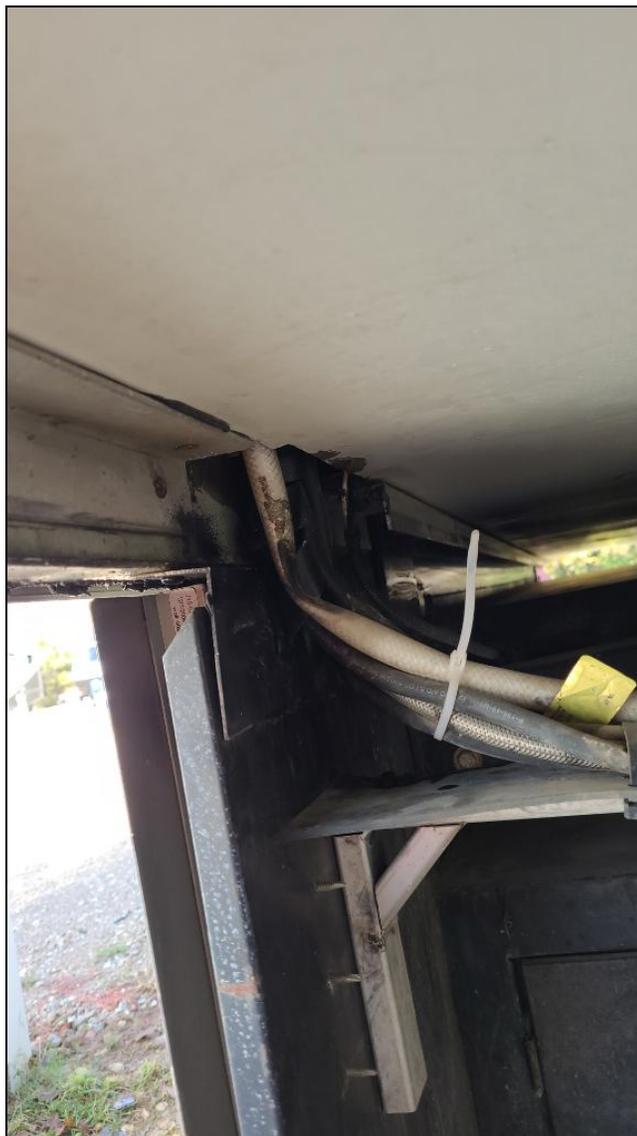
**\$** The hose and wiring harness are crushed when the slide out is in the retracted or closed position. It is recommended that this be repaired by a certified RV technician to prevent further damage

Wiring Harness Under Streetside Slideout

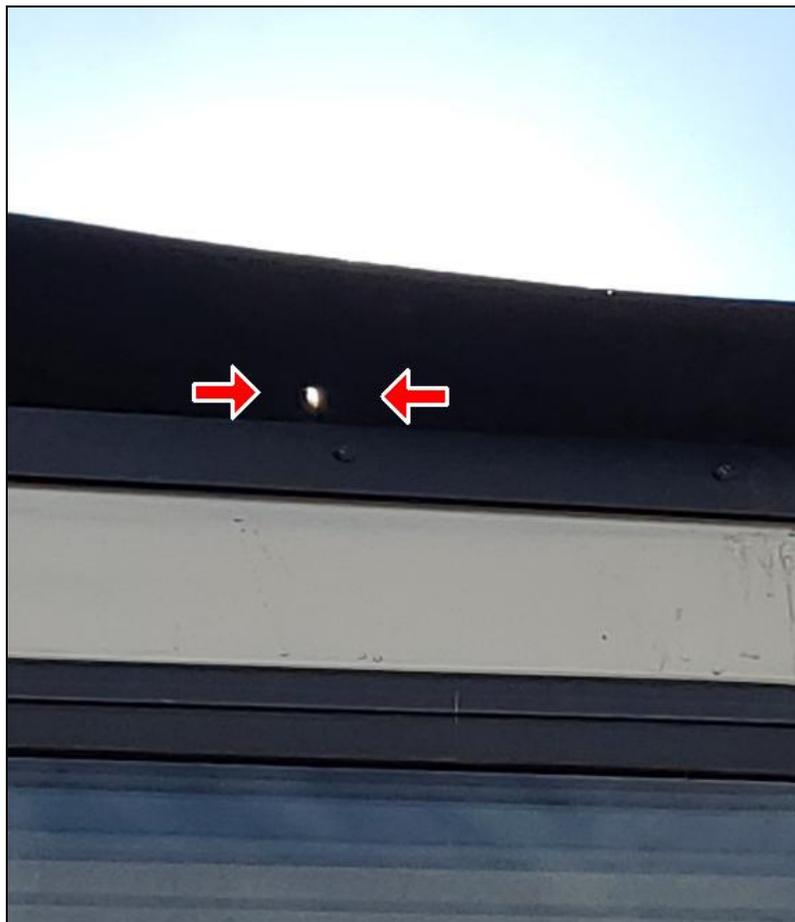
👉 There is a tear in the slide out topper fabric. It is recommended that this be replaced by a qualified RV technician.

Fabric Torn on Streetside Front Slideout Topper

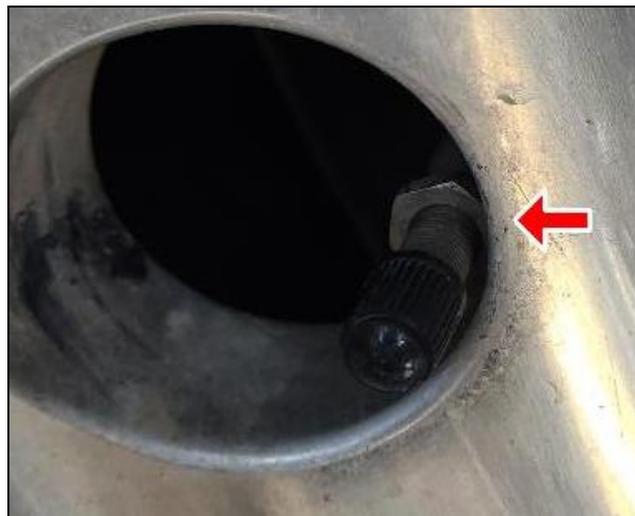
- + (1) The inspector observed that the tire is not set to the correct tire pressure based on the tire sidewall. Manufacturer's recommendation is not listed on the vehicle data plate. It is recommended that the tire be inflated to the tire manufacturers recommended cold pressure before the RV travels at highway speeds.
- (2) The valve stem extension is missing the mounting bracket allowing it to move around. It is suggested that this be repaired by a qualified RV technician.

Valve Stem Extension Missing Bracket

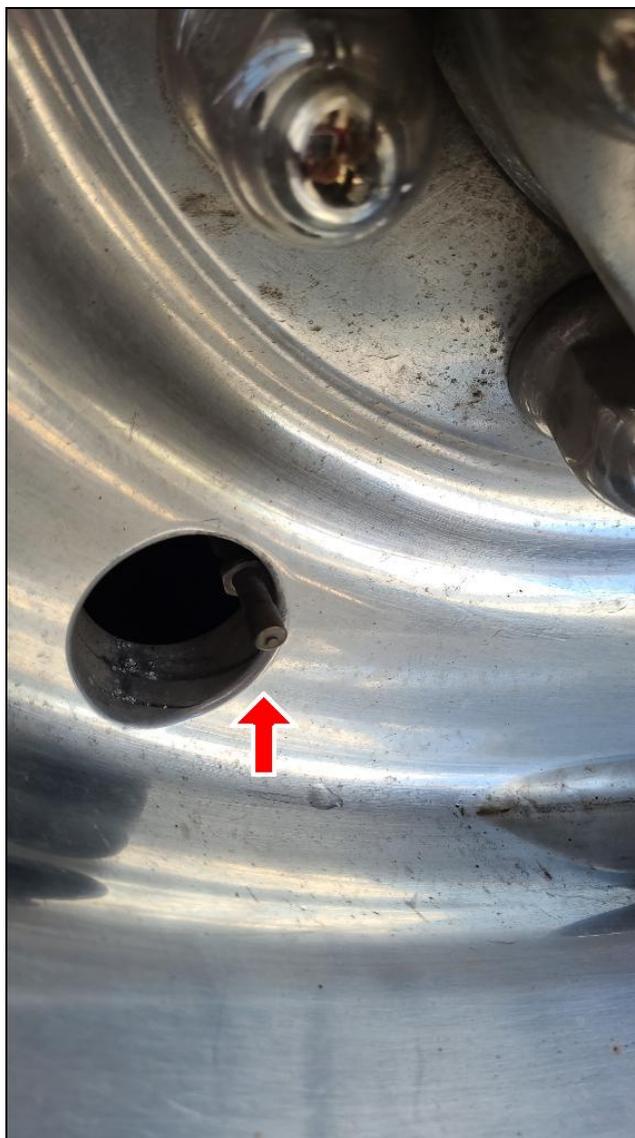
(2) The valve extension on the inside street side rear tire is missing the mounting bracket. It is recommended this be replaced to prevent tire pressure loss.

Valve Extension Missing Mounting Bracket

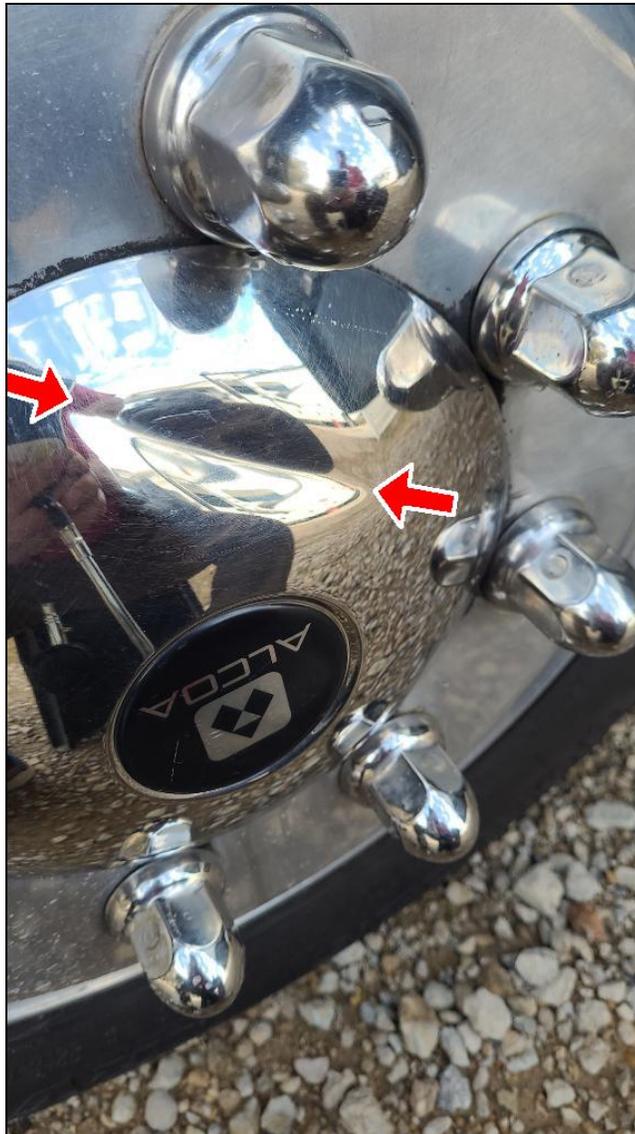
(2) If there is a crease in the hubcap.

Crease in Streetside Front Wheel

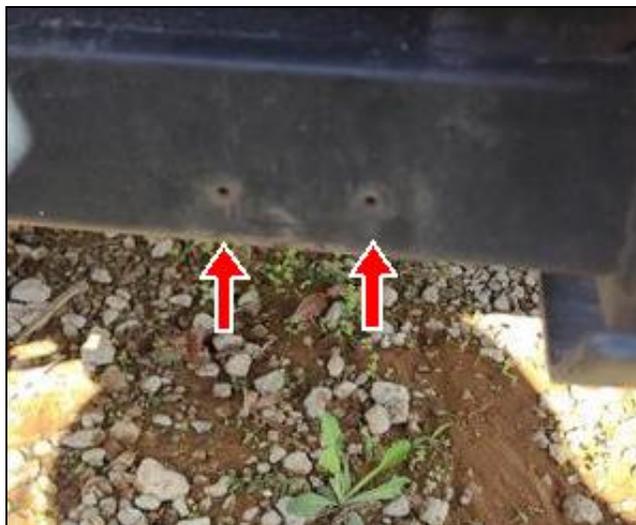
- (2) There are two hole drilled in the curbside end of the hitch assembly. It is recommended that this be repaired by a qualified RV technician.

Holes Drilled in Curbside of Hitch Assembly

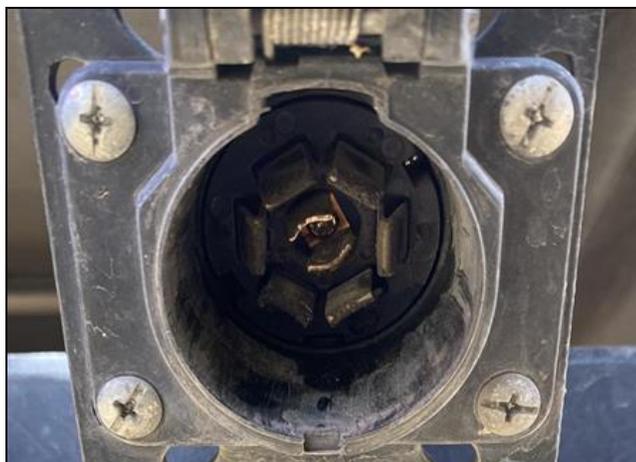
7-Pin Connector

- The 7-pin connector on the rear of the RV next to the hitch has contacts that are corroded. It is recommended that these be cleaned by a qualified RV technician to ensure a good connection to towed vehicle.

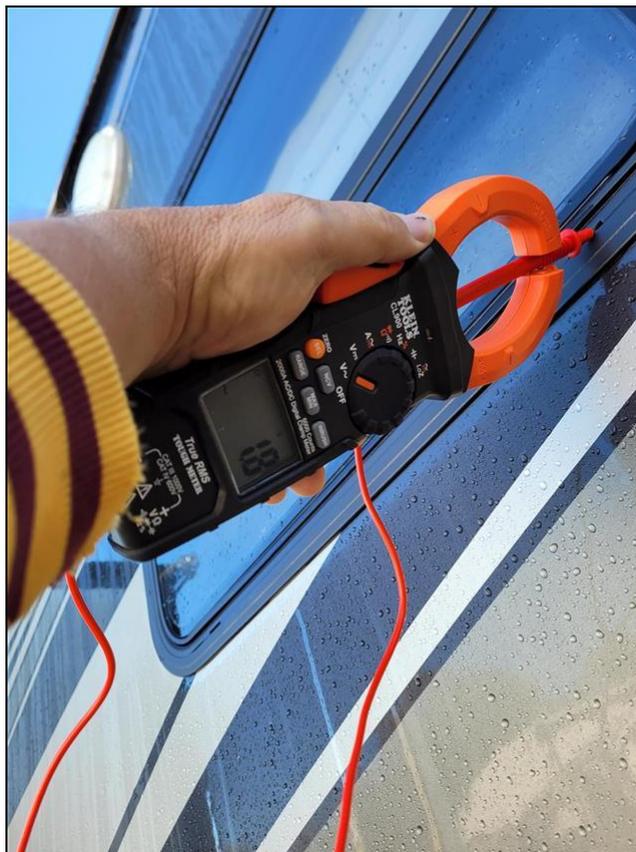
- 🔧 (1) Testing revealed that 1.8 Volts AC was present on the metal frame of the Streetside Slideout Rear Window Frame. It is recommended that this issue be repaired by a qualified RV technician.

Streetside Slideout Rear Window Frame

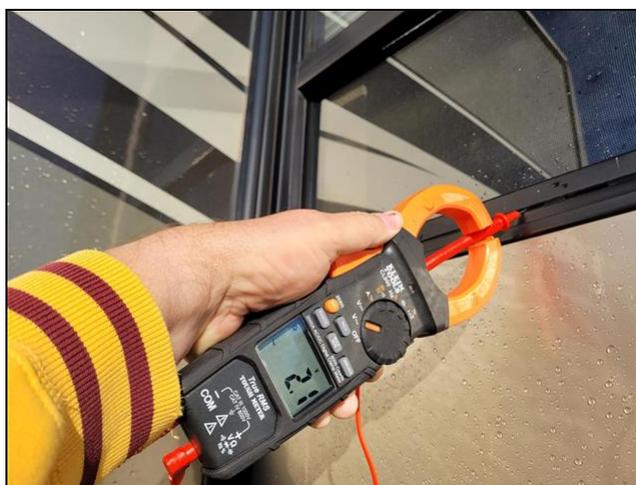
- ✎ (2) Testing revealed that 2.1 Volts AC was present on the metal frame of the Curbside Slideout Rear Window Frame. It is recommended that this issue be repaired by a qualified RV technician.

Hot Skin on Curbside Slideout Rear Window Frame

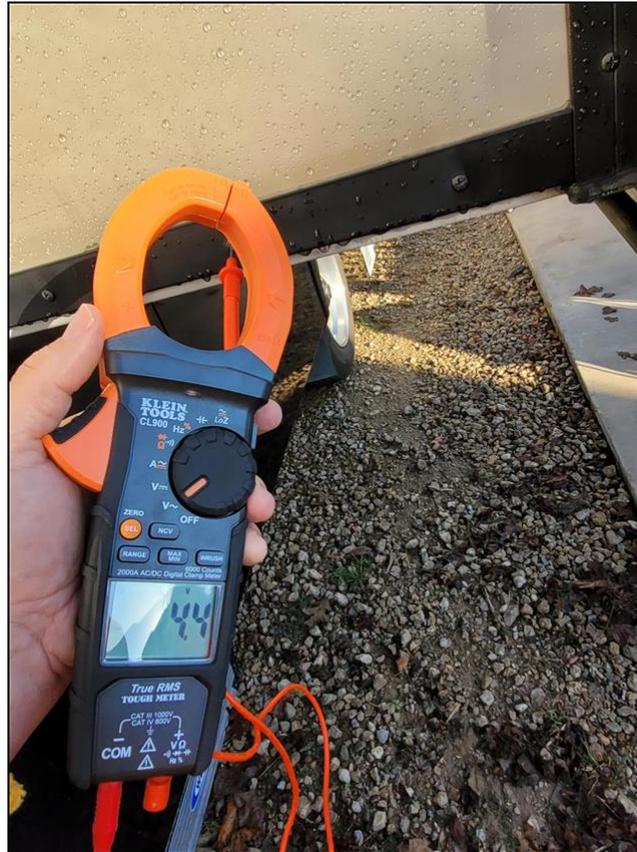
- ✎ (3) Testing revealed that 4.4 Volts AC was present on the metal frame of the rear of the curbside slideout. It is recommended that this issue be repaired by a qualified RV technician.

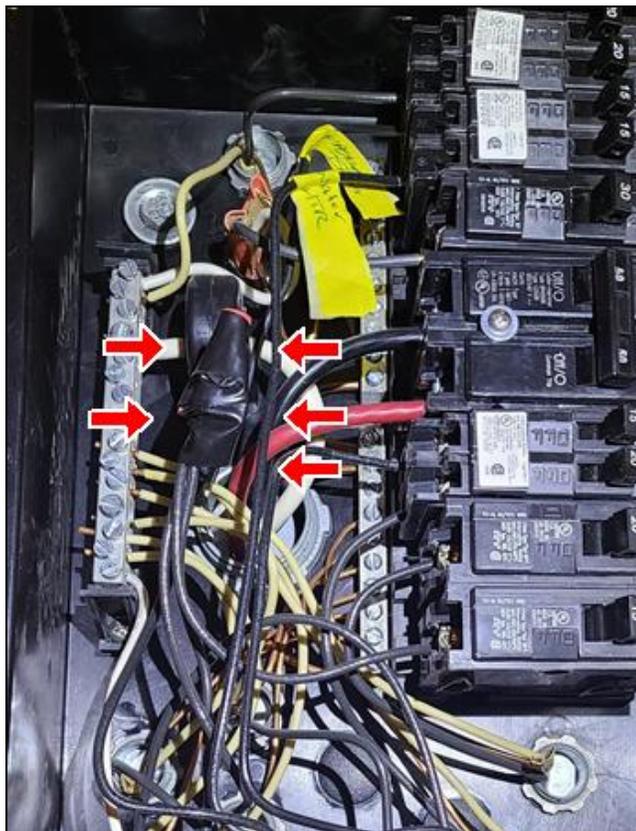
There is a slice in the electrical panel box that is splitting the power from one circuit breaker into three different loads. It is recommended that this be repaired by a qualified RV technician prior to occupancy due to risk of fire.

**+** There is a slice in the electrical panel box that is splitting the power from one circuit breaker into three different loads. It is recommended that this be repaired by a qualified RV technician prior to occupancy due to risk of fire.

Improper Slice in Circuit Breaker Panel

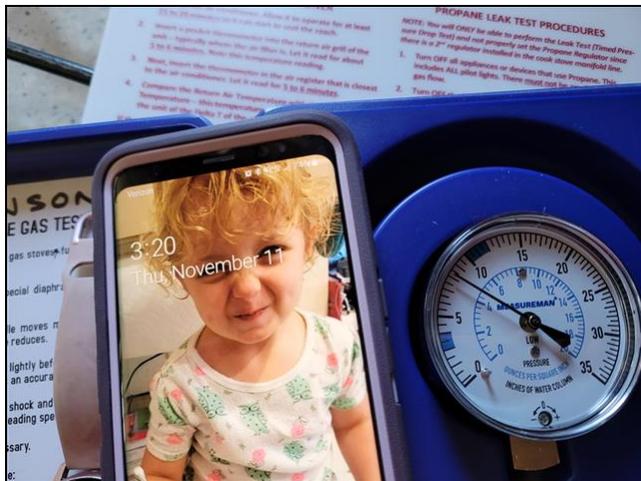
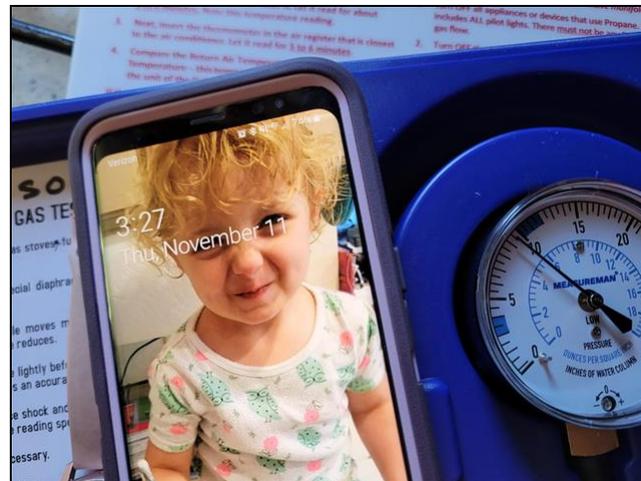
The LP Leak Test Failed. Initial Water Column reading at the stove burner stud fitting reached 9.5" WC. After shutting off ASME tank service valve and DOT cylinder service valve, the pressure would not decrease to 8" WC, even after lighting adjacent burner for about 10 minutes. Replaced DOT cylinder with known empty cylinder and was able to decrease to 8" WC. At end of test the pressure increased to 9.5" WC. Test was repeated 5 times with same results. There is no way to shut off LP flowing to the RV. Repair of the propane system by a qualified RV technician is required prior to occupation of the RV.

**+** The LP Leak Test Failed. Initial Water Column reading at the stove burner stud fitting reached 9.5" WC. After shutting off ASME tank service valve and DOT cylinder service valve, the pressure would not decrease to 8" WC, even after lighting adjacent burner for about 10 minutes. Replaced DOT cylinder with known empty cylinder and was able to decrease to 8" WC. At end of test the pressure increased to 9.5" WC. Test was repeated 5 times with same results. There is no way to shut off LP flowing to the RV. Repair of the propane system by a qualified RV technician is required prior to occupation of the RV.

LP Leak Test Start

LP Leak Test End

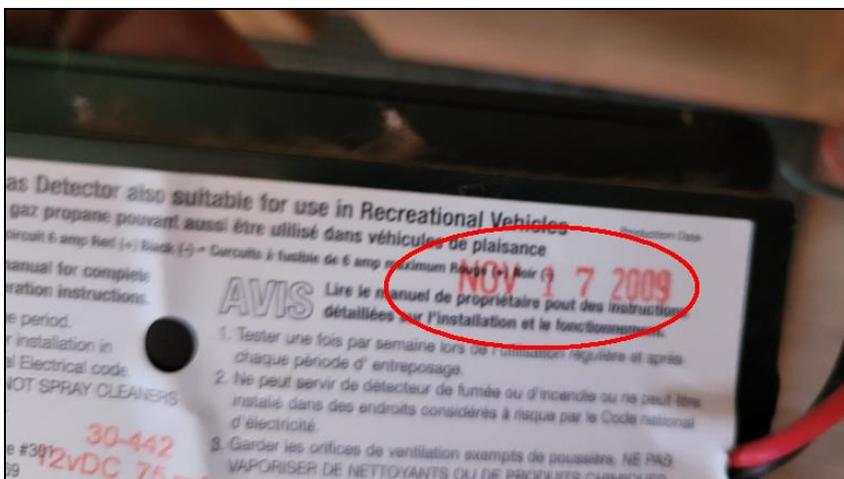
The LP detector located under the kitchen sink is expired. The LP detector should be replaced by a qualified RV technician prior to occupancy.

**+** The LP detector located under the kitchen sink is expired. The LP detector should be replaced by a qualified RV technician prior to occupancy.

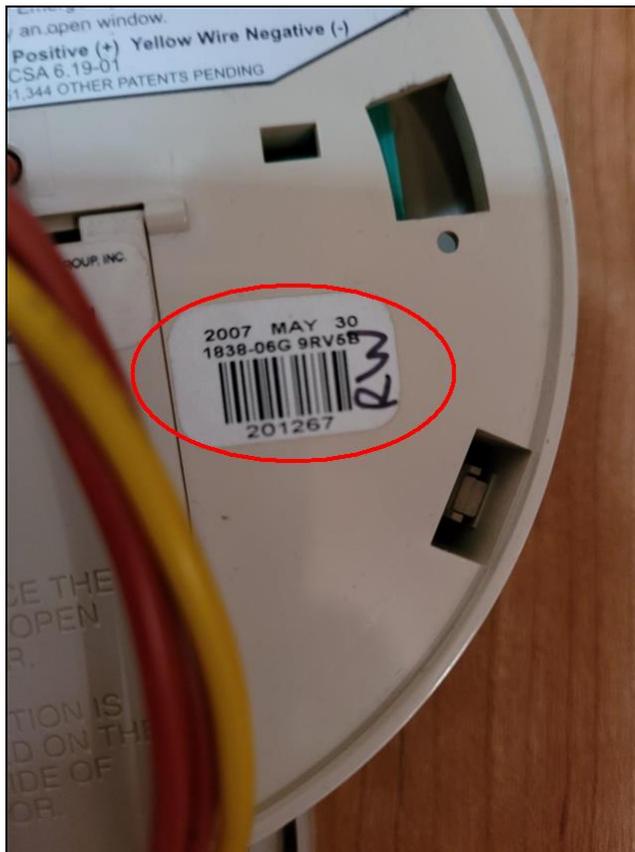
The carbon monoxide detector located in the bedroom failed to alarm when tested. The carbon monoxide detector in the bedroom passed its serviceable 7 year life in 2014. It is recommended that the unit be replaced by a qualified RV technician before the RV is occupied.

**+** The carbon monoxide detector located in the bedroom failed to alarm when tested. The carbon monoxide detector in the bedroom passed its serviceable 7 year life in 2014. It is recommended that the unit be replaced by a qualified RV technician before the RV is occupied.

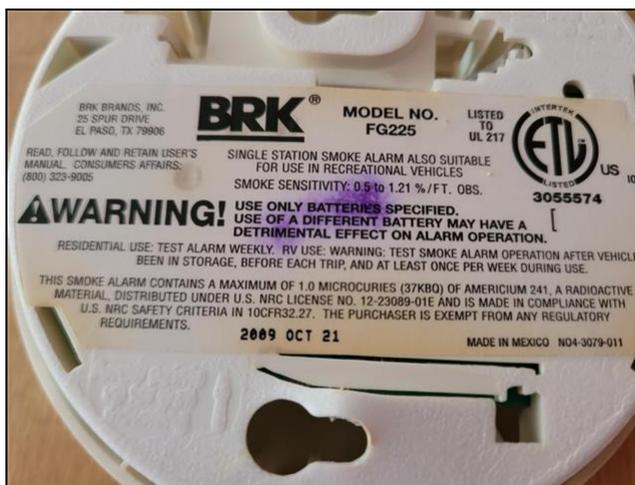
The smoke detector located in the kitchen area is past its useful service life. It is recommended that the unit be replaced by a qualified RV technician before the RV is occupied.

**+** The smoke detector located in the kitchen area is past its useful service life. It is recommended that the unit be replaced by a qualified RV technician before the RV is occupied.

Smoke Detector Information

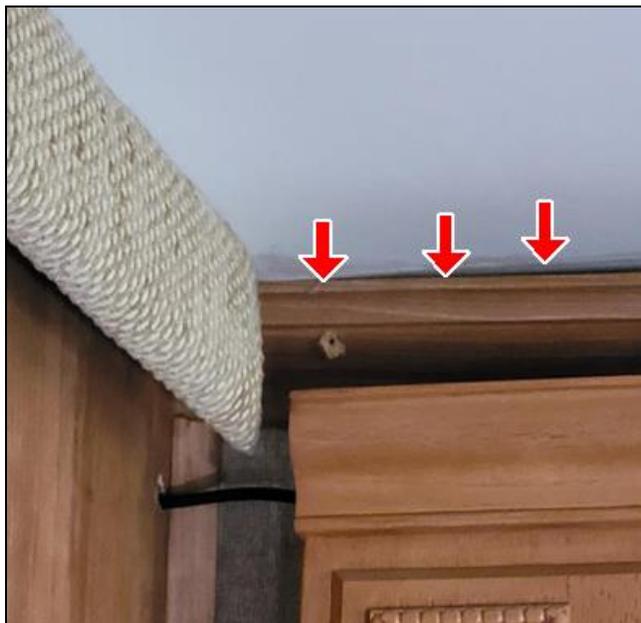
There are holes in the trim above the bedroom slide.

Trim Above Slide In Bedroom

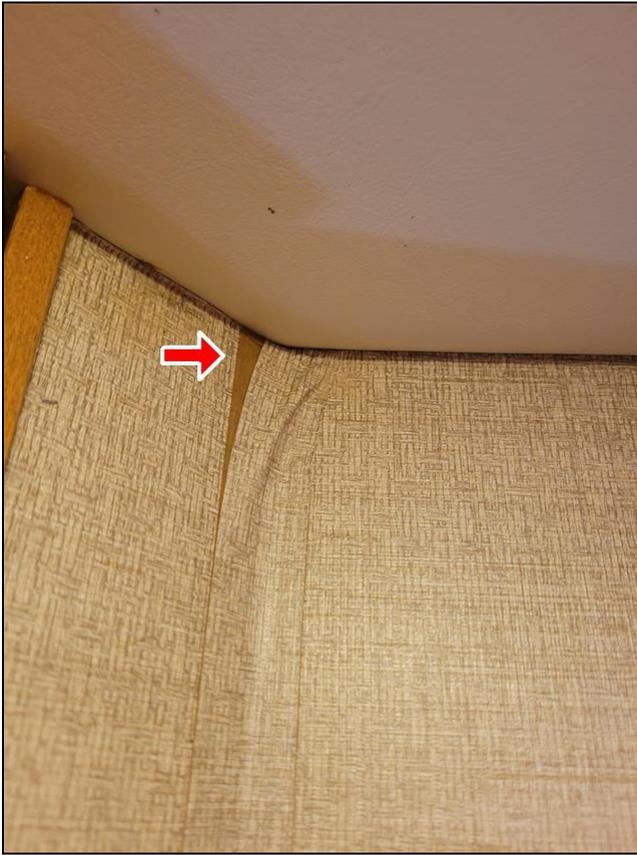
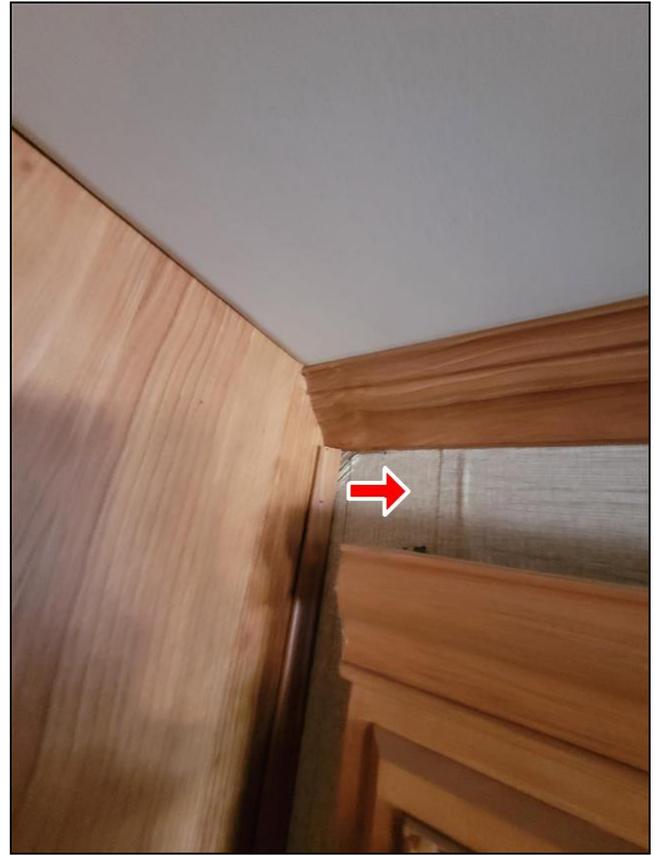
The wall paper above the 1/2 bath toilet and above the rear corner of the streetside slideout is pulling away at the seam.

Wallpaper Above Front Toilet

Wall Paper Above Streetside Slideout

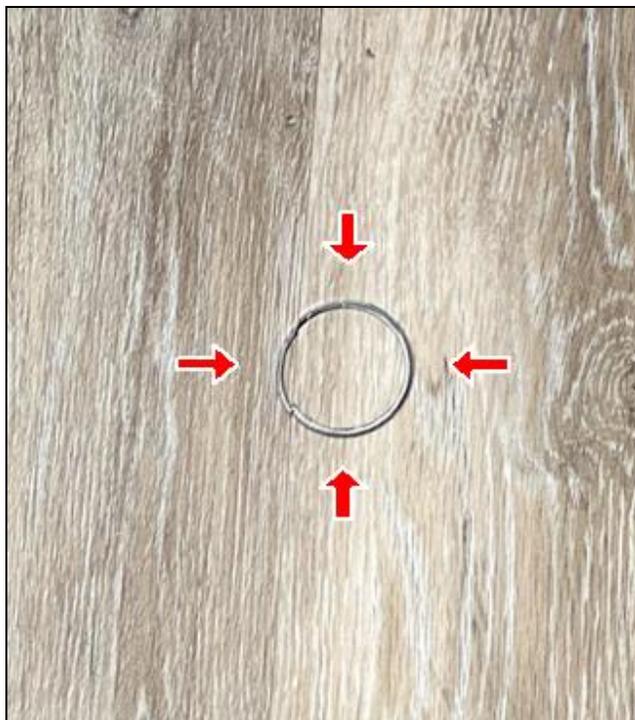
Owner states that carpeting was removed throughout the RV and replaced with vinyl plank flooring. There is one damaged spot in the center of floor immediately behind the drivers and passenger seats.

Damage to Floor
