## **Bentley Archers CC – an assessment of foreign objects in the surface of the outfield**

December 2025

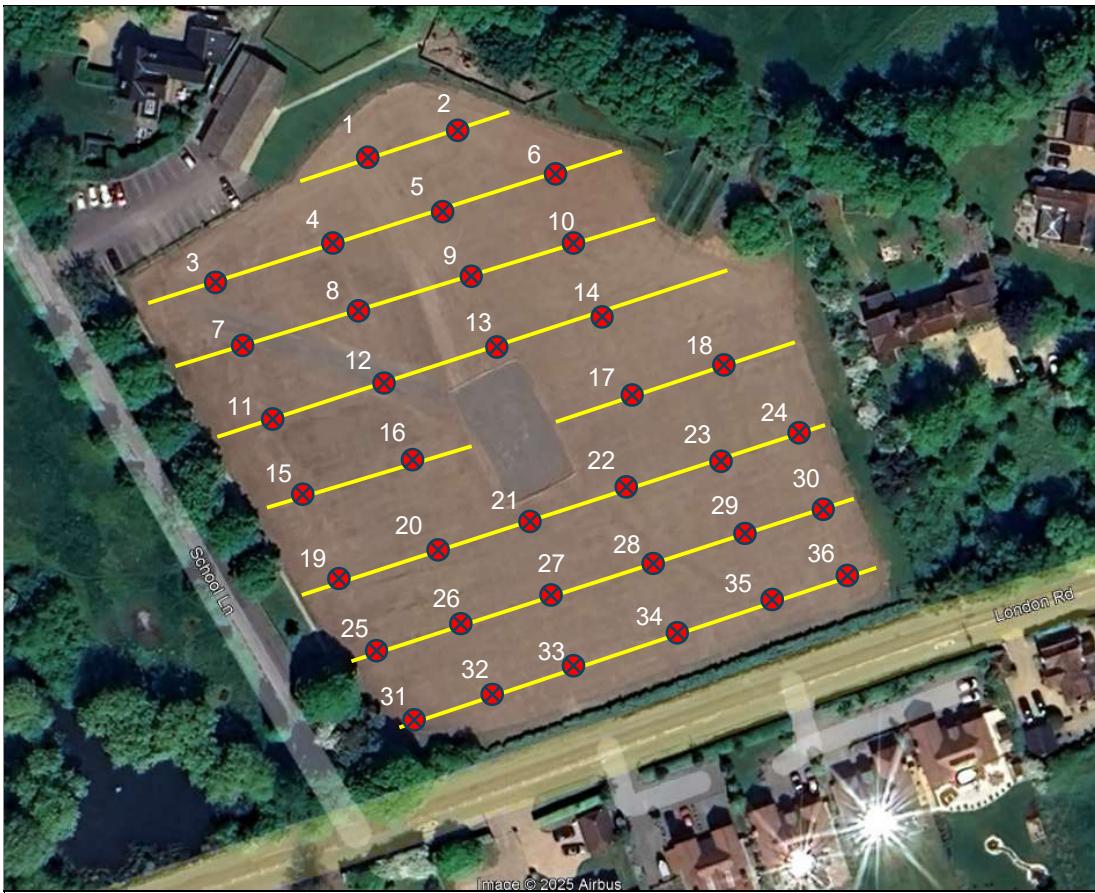
The outfield was divided into a grid and the grid was walked with samples taken at the approximate locations shown in Figure 1.

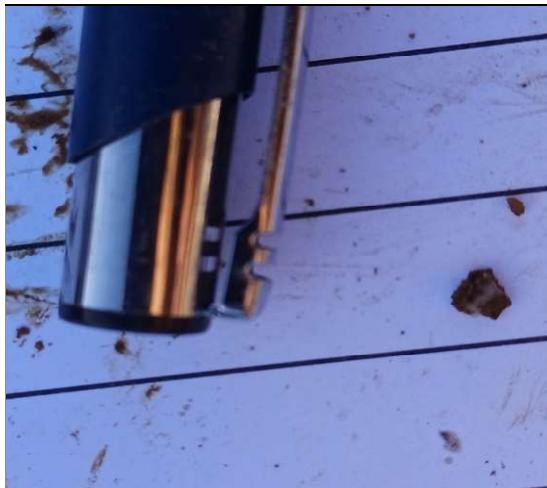
1. Of the 36 samples taken 11 items were found in the upper 100 mm, with multiple objects found at some points. These included:
  - a. Point 8 – a single 10 mm stone.
  - b. Point 16 – a 10 mm diameter flint, a 10 mm rounded stone and a 5 mm piece of plastic.
  - c. Point 18 – a 10 mm stone.
  - d. Point 21 – a 5 mm stone and an 8 mm stone.
  - e. Point 23 – a 3mm piece of rounded glass and a 5 mm stone.
  - f. Point 29 – a 5 mm stone.
  - g. Point 30 – a 3 mm flint.

**Figure 2.** Small flint at Point 30

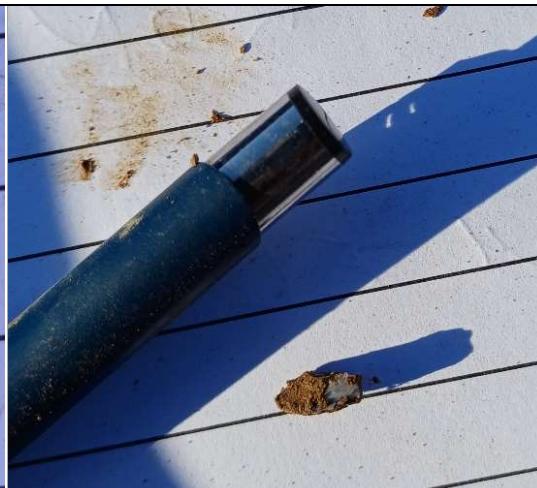
**Figure 3.** 5 mm stone at Point 29.

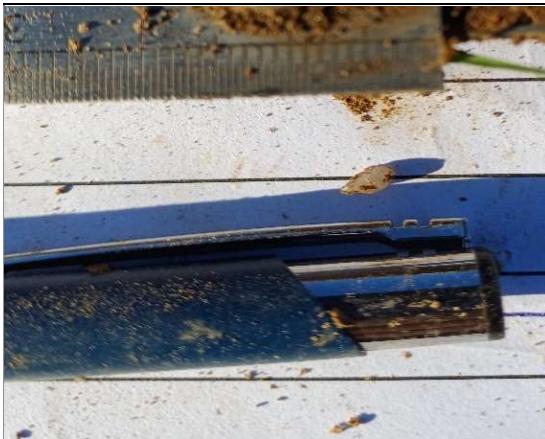
Of the objects found only one glass fragment was found and this was rounded glass and was not a safety risk. None of the objects found are likely to be a safety risk due to the small size and limited amount of material in the soil. The GMA consider any stone over 25 mm in any dimension in the upper 50 mm of topsoil to be a safety hazard. The latest Sport England guidance has reduced this to 20 mm in any dimension but even with this tighter requirement none of the material found in this survey would be deemed to be dangerous. Photos of the objects found are presented in Figures 2 – 9.

**Figure 4.** 3 mm rounded glass at Point 23

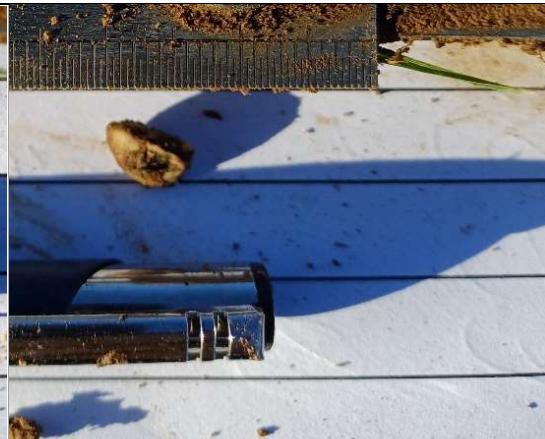
**Figure 5.** 5 mm stone at Point 23

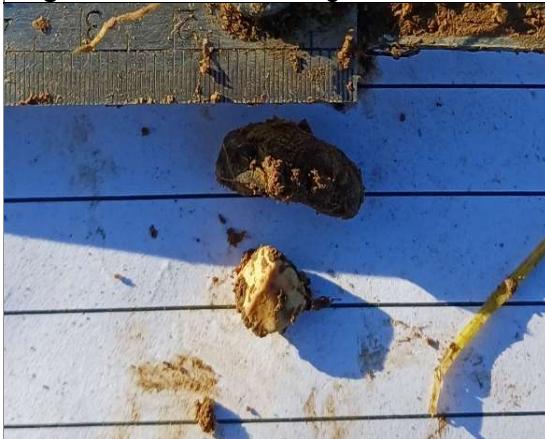
**Figure 6.** 5 mm stone and 8 mm stone at Point 21

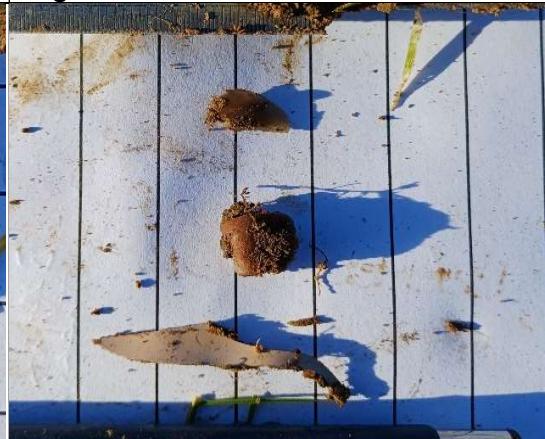
**Figure 7.** 10 mm flint, 10 mm stone and plastic at Point 16

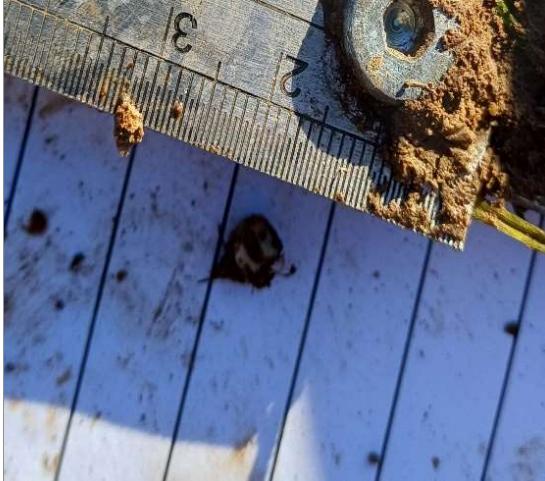
**Figure 8.** 10 mm stone at Point 18

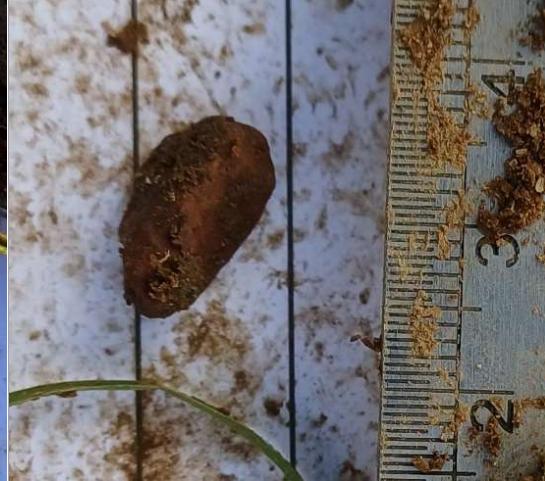
**Figure 9.** 10 mm stone at Point 8
