## 201 E 79<sup>TH</sup> STREET 2019

201 EAST 79<sup>TH</sup> STREET  
NEW YORK, NY 10001

### FISP EMERGENCY REPAIRS:

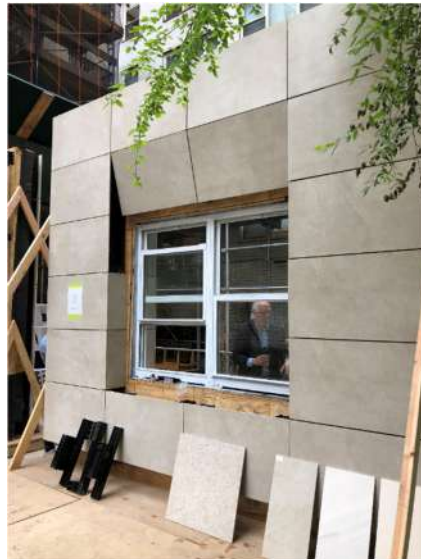
During the initial FISP inspection of this glazed white brick cavity-wall building MVN observed several areas of the façade in UNSAFE conditions. An apparent manufacturing defect in the glazed brick was causing large sections of the face brick to delaminate and spall off. This combined with an underabundance of aged and failing brick anchor ties put several panels at risk of collapse. MVN coordinated the emergency filing, stabilization and repair of these areas including a bulkhead screen. Emergency repairs bought the building time to examine the extent of the problem before deciding on a permanent solution.

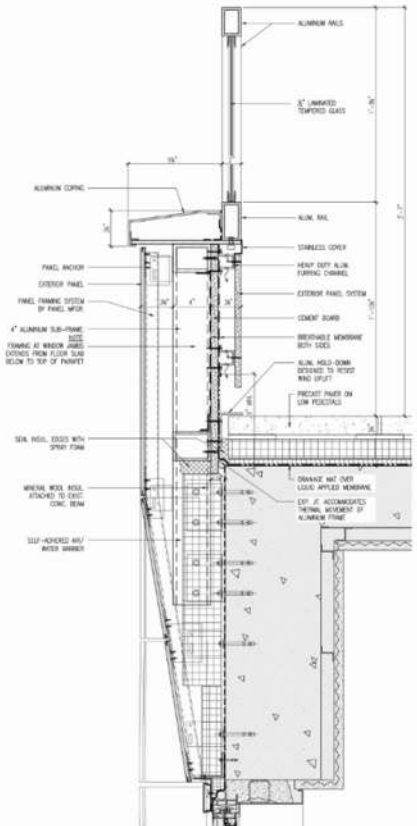
**PRE-CONSTRUCTION SERVICES:** After conducting follow up probes around the building MVN determined that the entire cavity wall system on the building was beginning to fail and recommended wholesale façade reskinning in-lieu of the continued nightmare of recurring maintenance. Several solutions were proposed before a rainscreen system was chosen. MVN then worked with the building to explore the implications of this change in façade type, document and test the existing conditions, create biddable documents for preliminary pricing, and coordinate with a design architect to finalize the design of the new envelope. Lastly, a series of scale mockups were designed and constructed to compare the look and installation issues associated with several different rainscreen products before a final system could be chosen and final bid documents prepared.
