39-60 54TH STREET

2019-2020

39-60 54TH STREET
WOODSIDE, NEW YORK 11377

FISP BUILDING

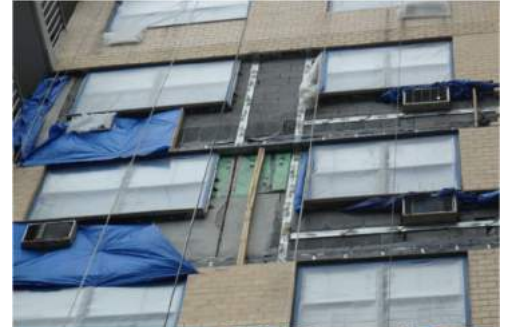
FAÇADE RESTORATION AND REINFORCEMENT: probes conducted early in the project revealed structural deficiencies in the back up masonry of this cavity wall building. Damaged concrete masonry backup was reinforced by introducing rigid steel structural members anchored to the concrete floor spandrels. New brick anchors were installed throughout to increase the stability of the cavity wall system and to bring the density of anchors up to today's standard of practice. Rusted, bowed, and loose steel shelf angles were removed and replaced with new waterproofed galvanized steel angles. The façade repairs were conducted in anticipation of and in compliance with stricter inspection and panel securement standards being implemented for cavity wall buildings in FISP Cycle 9 filings.

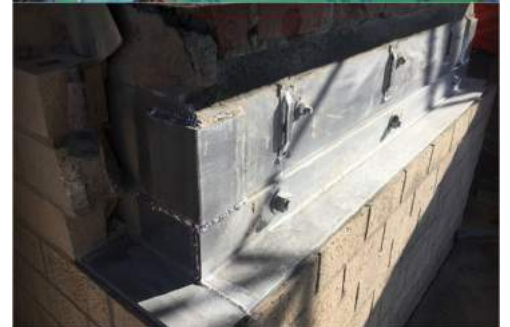
ELEVATOR BULKHEAD REPAIRS: failing of the brick anchors and shelf angles at the masonry cavity wall enclosure around the building's water tank lead to severe cracking and spalling of the outer face brick. The partial demolition and removal of the unnecessary enclosure was recommended to secure the unsafe conditions and remove a recurring maintenance item.
