# 40-50 E 10<sup>TH</sup> STREET 2018-2020

40-50 EAST 10<sup>TH</sup> STREET  
NEW YORK, NY 10003

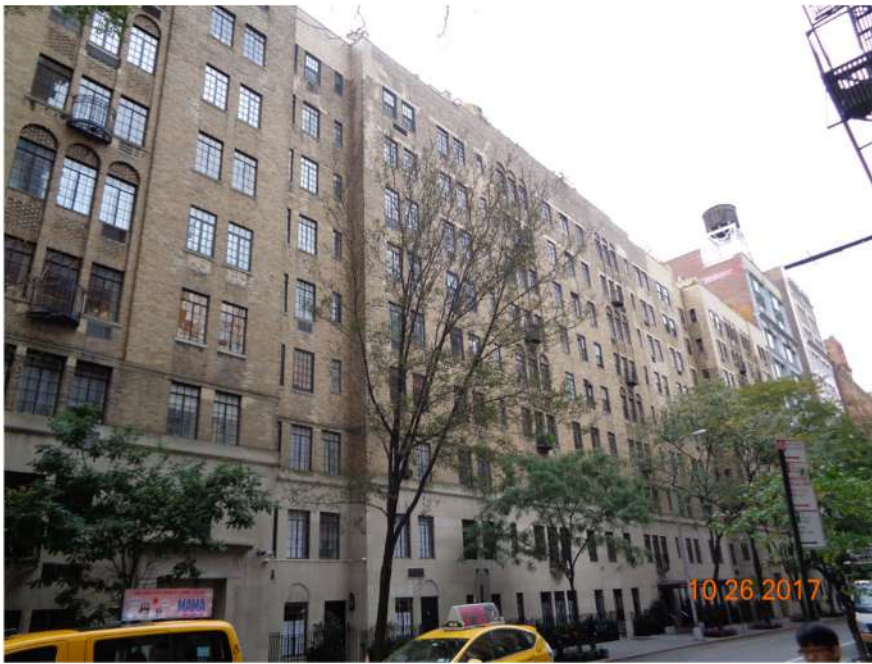
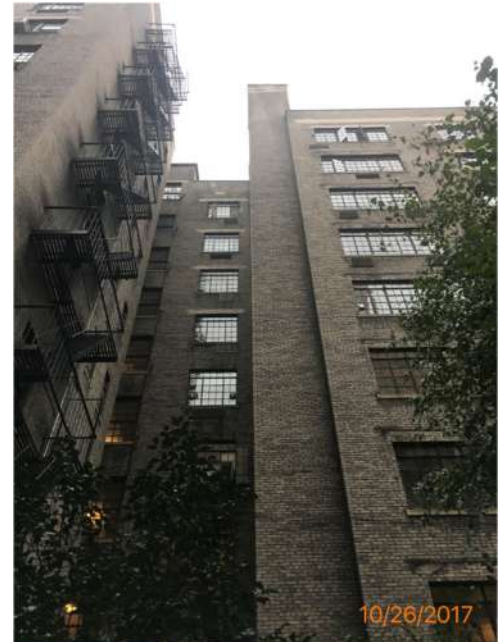
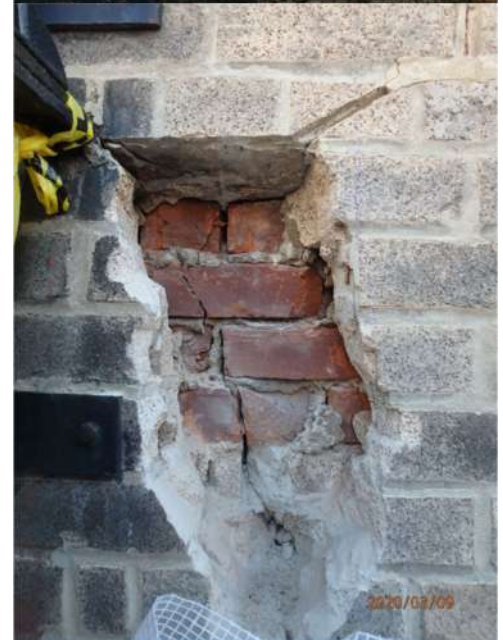
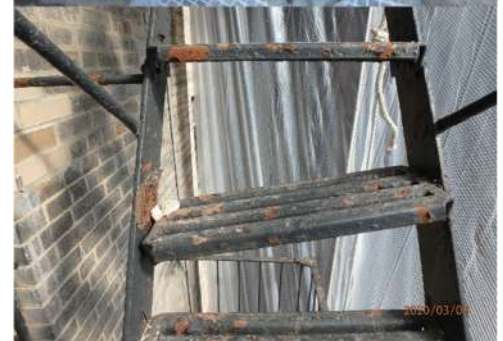
**FAÇADE RESTORATION WORK:** work currently underway includes replacement of deteriorated window lintels with new galvanized steel lintels and associated waterproofing; replacement of cracked and spalled face brick with new to match the existing color and profile; patching and limited replacement of limestone façade cladding panels on the street fronting façade; miscellaneous cutting and pointing of face brick mortar joints; reconstruction of deteriorated and failing sections of brick parapet wall

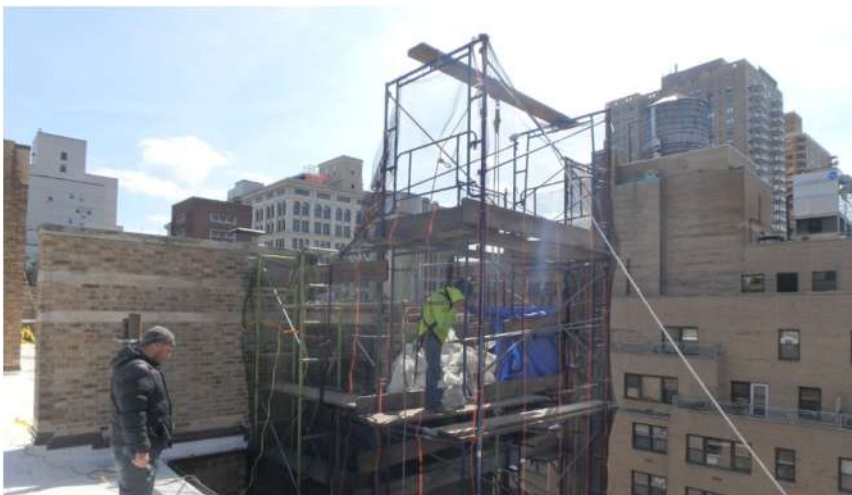
**BOILER CHIMNEY REBUILD** the building's main boiler chimney had severe spalls and cracks in the brick at the top fifteen feet of the chimney. The deterioration had progressed to the point that the top section of the chimney had to be completely rebuilt. Supplemental reinforcement and a new stainless-steel flue cover will be installed.
