Incident

Learning lessons from a nuclear event

Zsuzsanna Gyenes, European Commission JRC, Italy

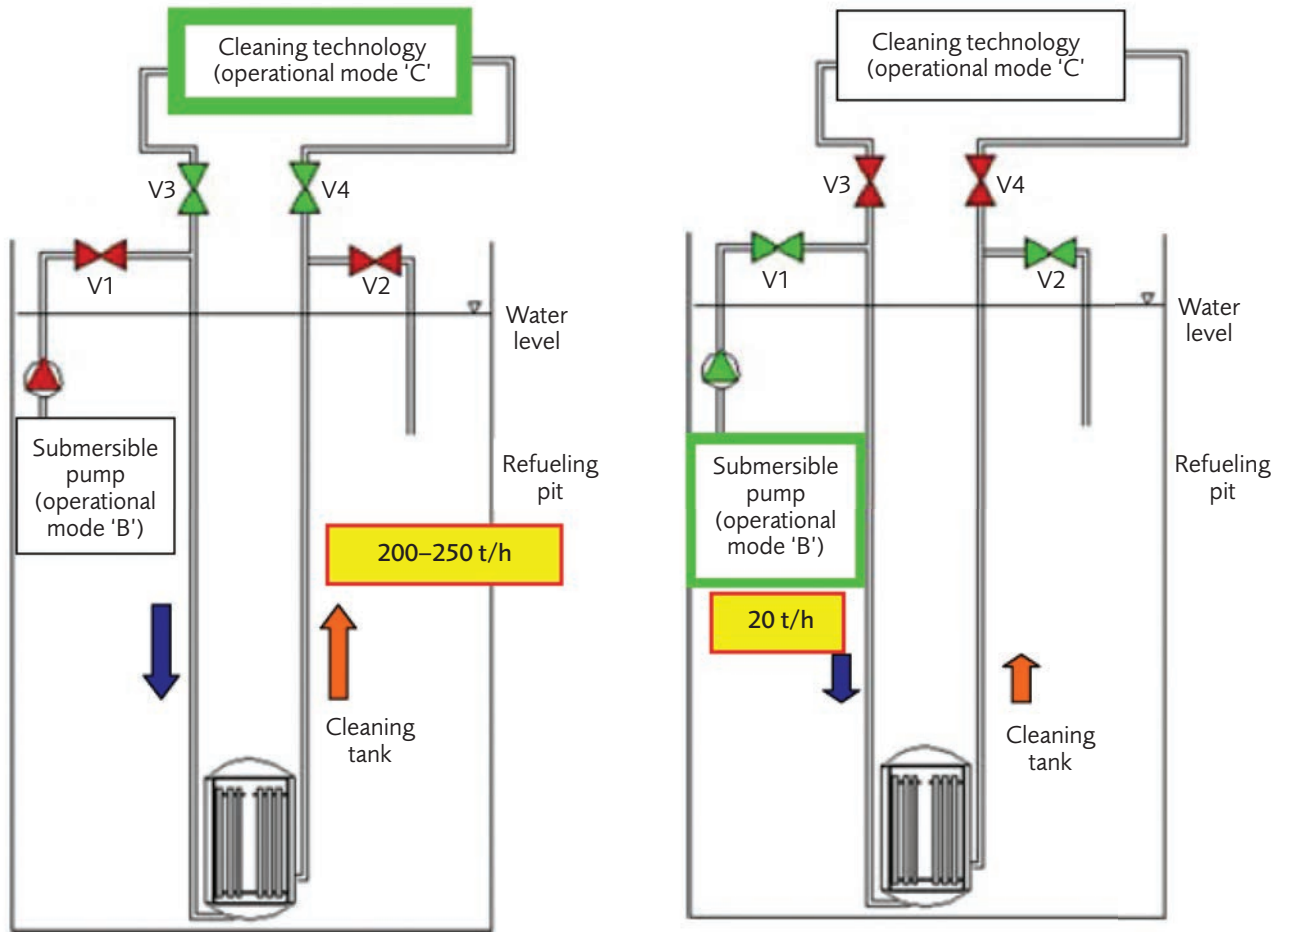
Figure 3 – Chemical cleaning process operational modes 'C' and 'B'³

It worked in two modes – operational mode 'C' and mode 'B' (Figure 3).

In mode 'C' the medium of mass flow rate of 200-250 t/h enters the cleaning module of the AMDA system, where the dissolved magnetite and heat are removed from the solute. After finishing the cleaning process, the system is changed over to mode 'B' where a submersible pump of 20 t/h mass flow capacity circulates the coolant of the refuelling pit through the cleaning tank in an open loop. On 10 April 2023, during the cleaning tank opening process – using the reactor hall crane – and during the loading and removing of the fuel assemblies, the AMDA system was cooled in the 'B' operational mode.

Apparently, the design of the cleaning system was deficient because the submersible pump provided for mode 'B' was inadequately sized and did not have adequate redundancy or back up. This is very similar to past incidents related to chemical runaway reactions when the cooling system of the reactor was inadequately sized and there was no redundant system in place. In other cases, the emergency relief system was inadequately sized and could not release the overpressure created by the exothermic reaction.

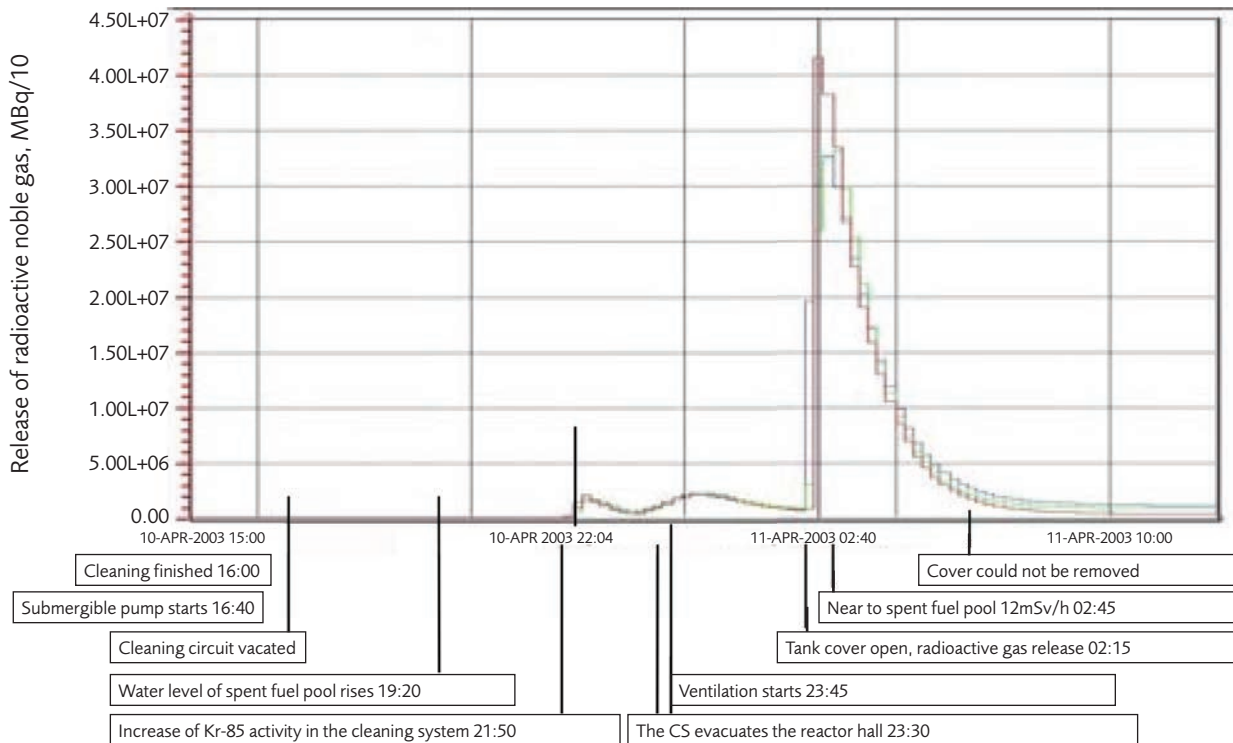
Figure 4 – Course of events³

Figure 4 shows the sequence of events on 10 April 2003.

The cleaning process was successfully completed for the first five batches without experiencing any problems. However, after finishing the sixth cleaning process the fuel was not removed from the cleaning tank immediately. The reason was that the crane used for this operation was busy with other tasks. At this time, the cleaning process was at mode 'B', therefore the coolant flow rate was much lower than in mode

'C' (see Figure 3). In addition to that, the fuel assemblies had been removed from the reactor a few days before rather than one or two years prior to the cleaning, as it was with the first five batches. That meant that these assemblies had significant residual heat. Combining that with the much lower flow rate in mode 'B', the coolant was not sufficient to remove the bulk of the decay heat.

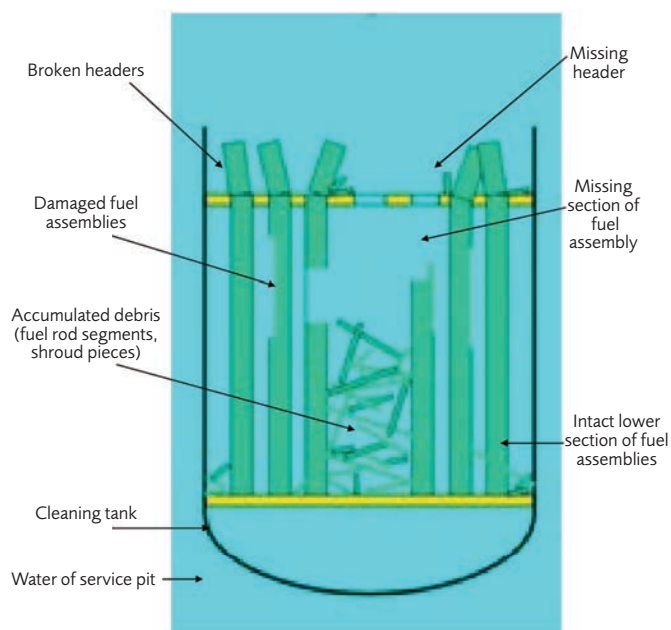
Figure 5 – Distribution of damaged fuel in the cleaning tank³

The damage to the 30 fuel elements was very serious, as it appeared that elements had been broken and uranium pellets had fallen to the bottom of the cleaning system. Oxidation in high temperature steam took place in the cleaning tank for several hours, which resulted in the embrittlement of the fuel assembly shrouds and the fuel pin claddings. At the opening of the cleaning tank, the injection of cold coolant caused the breaking up of the embrittled shrouds and fuel pin claddings.
