INSPECTION REPORT

For the Property at:
4321 NEW HOME BLVD.
5 COUNTIES OF THE ARROWHEAD, MN

Prepared for: JANE & JOHN HOMEBUYER
Inspection Date: Friday, June 18, 2021
Prepared by: Kyle Hotchkiss

RE: Report No. 1003, v.2
4321 New Home Blvd.
5 Counties of the Arrowhead, MN

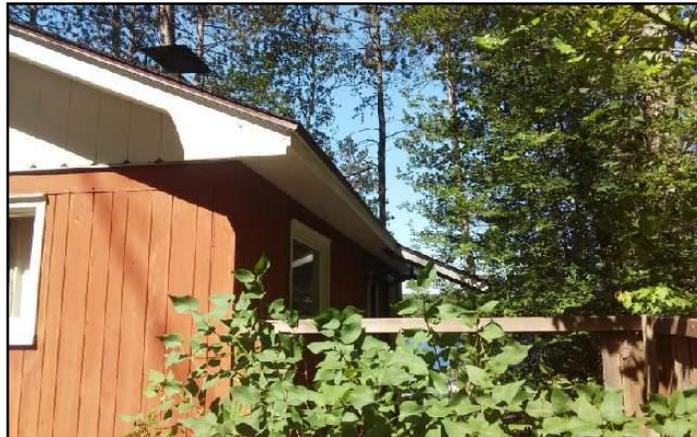
11. Missing

2. Condition: • Missing

Location: North Eave

Task: Install Gutter

Time: As soon as possible.

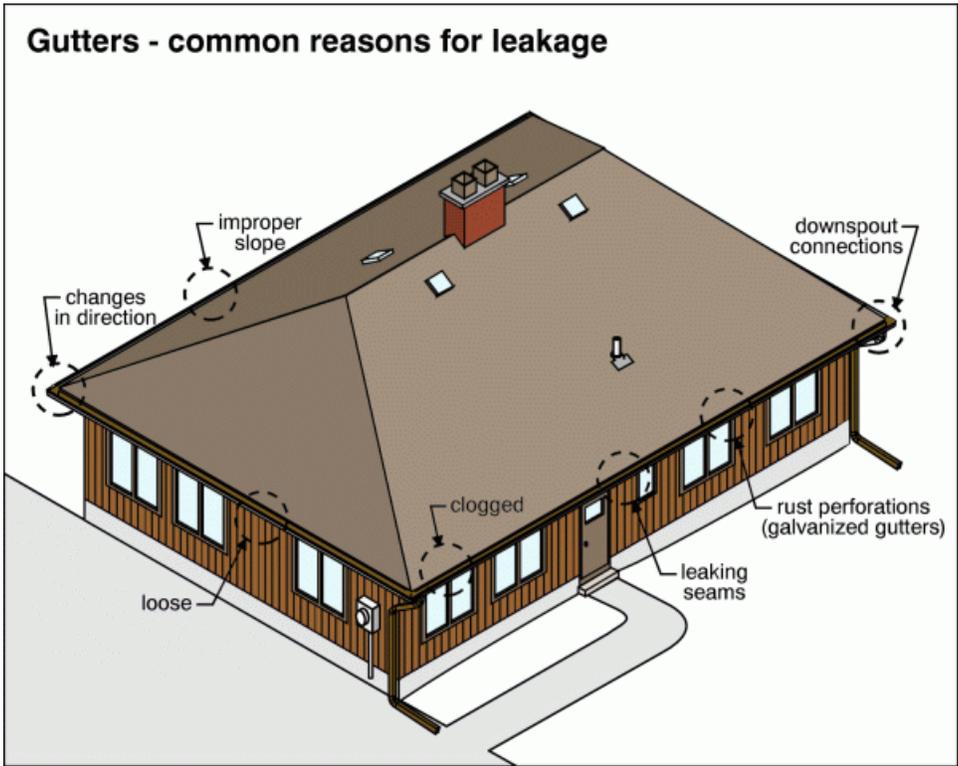
3. Condition: • Clogged

Implication(s): Chance of water damage to structure, finishes and contents

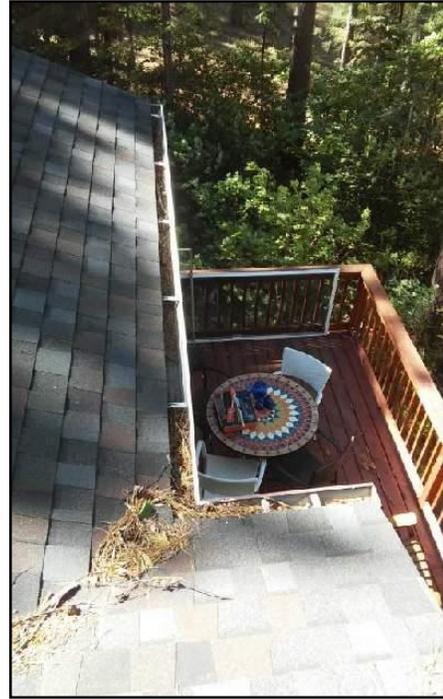
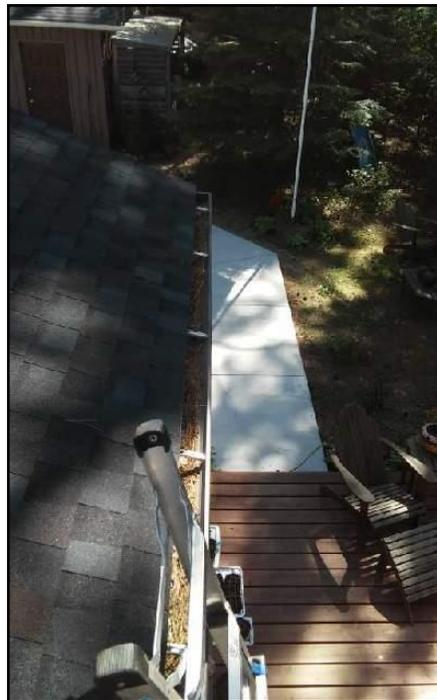
4. Condition: • Dirty/debris

Location: Various Roof

13. Dirty/debris

14. Dirty/debris

Task: Clean

Time: As soon as possible.

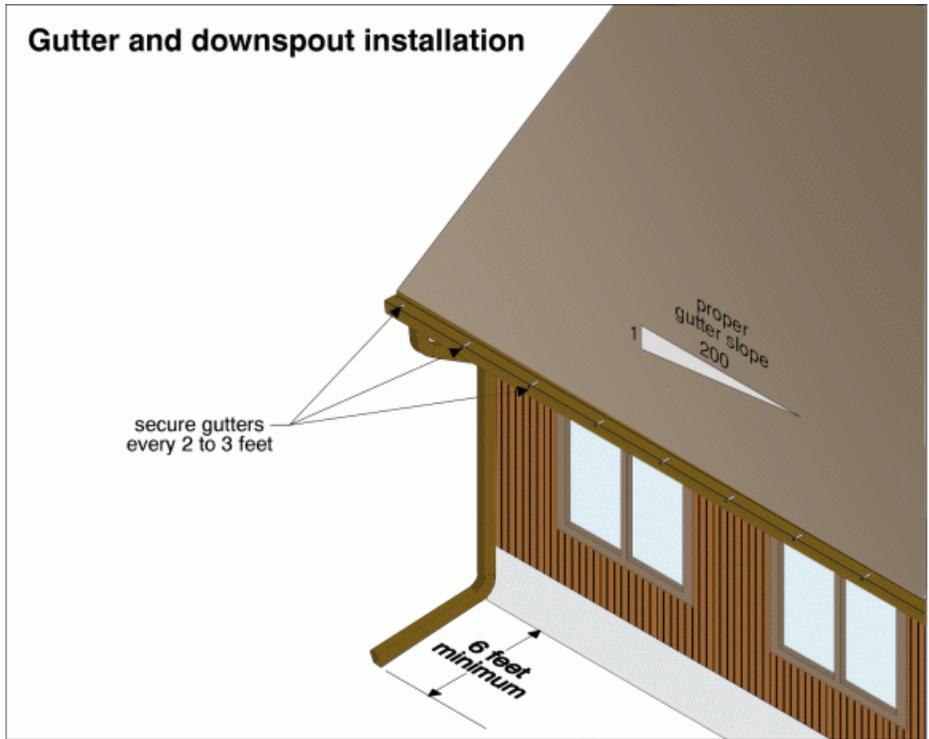
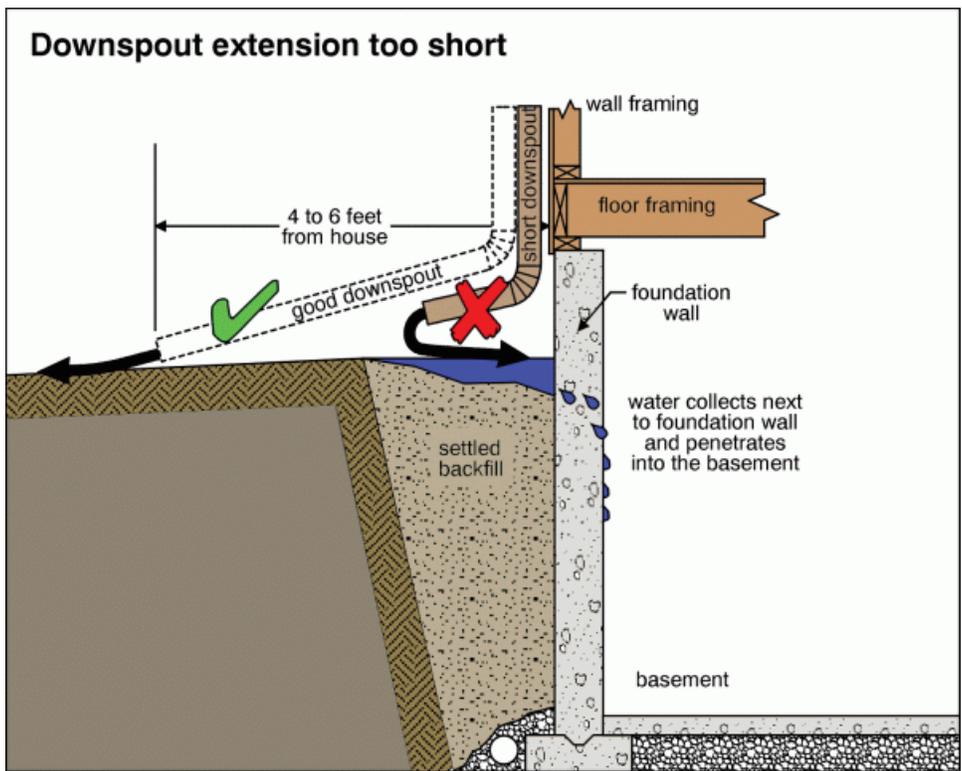
15. Discharge too close to building

5. Condition: • [Discharge too close to building](#)

Implication(s): Chance of water damage to structure, finishes and contents

Location: East Exterior

Task: Correct

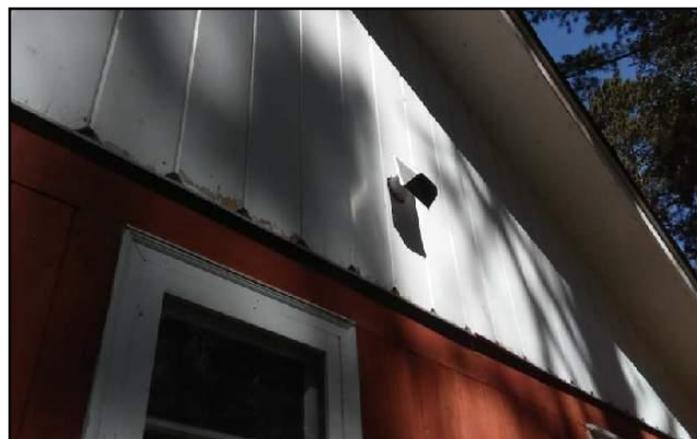
16. Caulking missing or ineffective

6. Condition: • [Caulking missing or ineffective](#)

Implication(s): Chance of water damage to structure, finishes and contents

Location: East Exterior

Task: Repair

Time: Discretionary

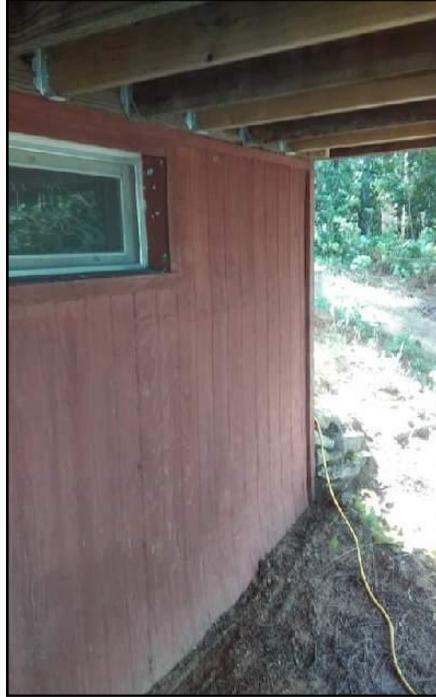
17. *Buckled*

7. Condition: • [Buckled](#)

Implication(s): Chance of water damage to structure, finishes and contents

Location: West Exterior
Task: Repair
Time: Discretionary

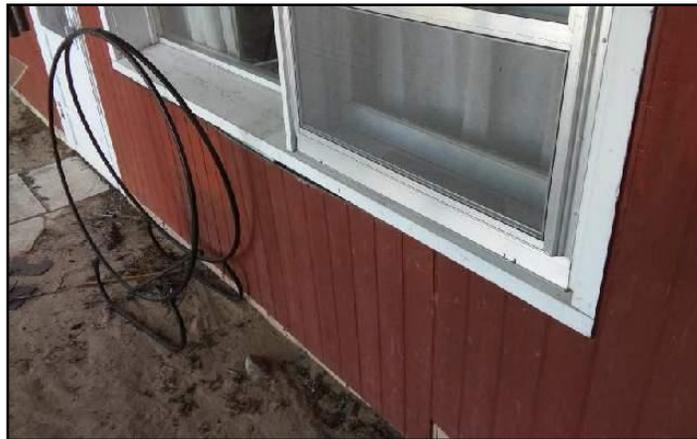
18. *Loose*

8. Condition: • [Loose](#)
Implication(s): Chance of water damage to structure, finishes and contents
Location: West Exterior Wall
Task: Repair
Time: Discretionary

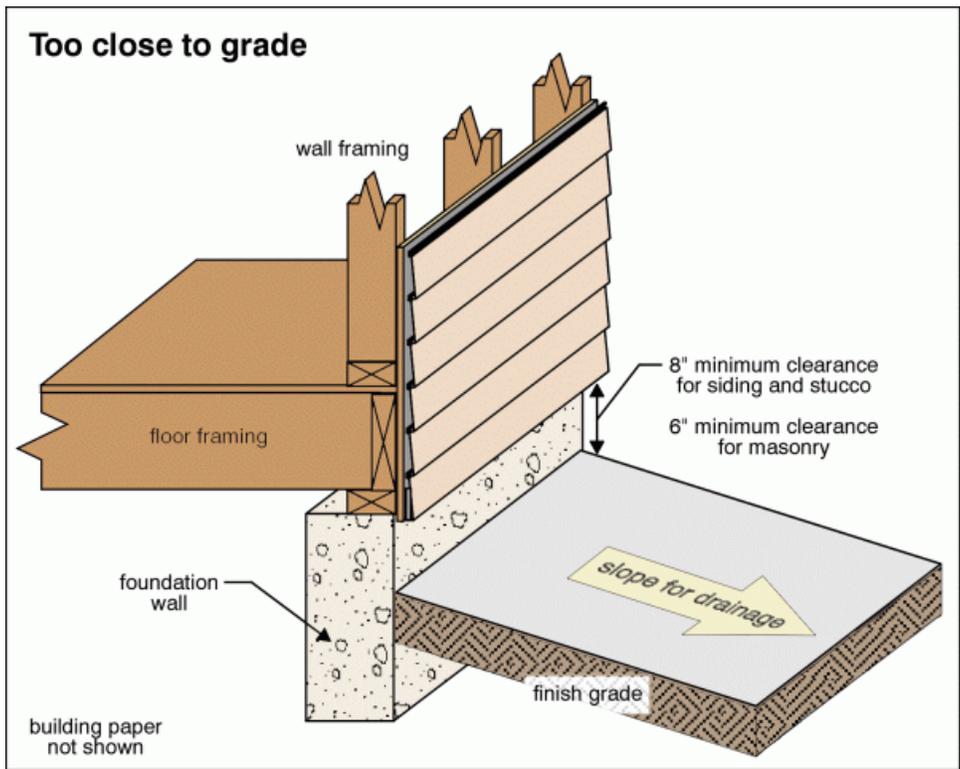
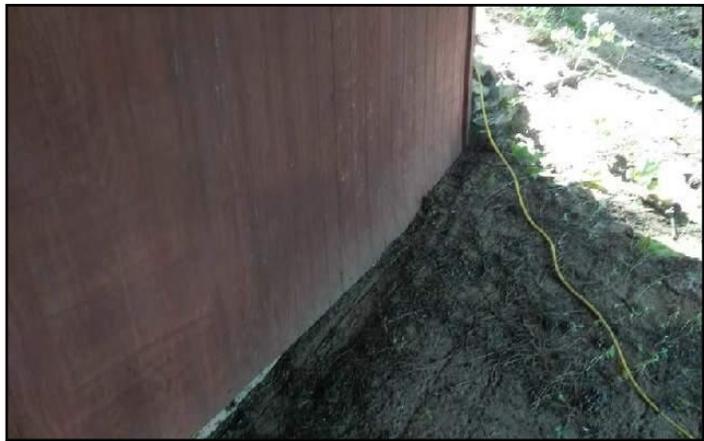
19. Too close to grade

9. Condition: • [Too close to grade](#)

Implication(s): Material deterioration | Rot | Insect damage | Chance of water damage to structure, finishes and contents

Location: West

Task: Remove soil from contact with siding.

Time: As soon as possible.

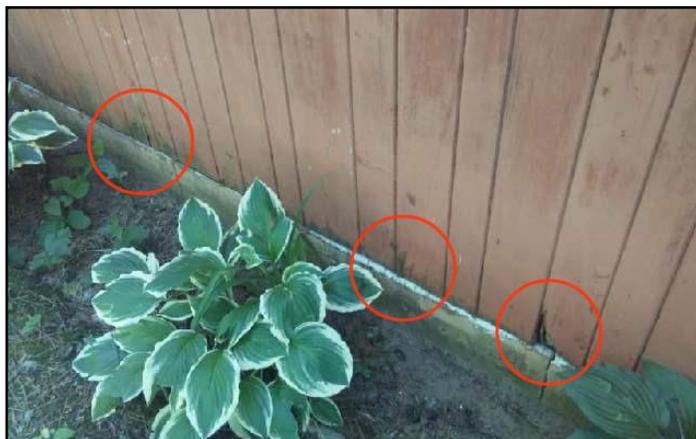
20. Rot

Condition: • [Rot](#)

Implication(s): Weakened structure | Material deterioration

10. Condition: • [Rot](#)

Location: North Exterior Wall

Task: Repair or replace

Time: Discretionary

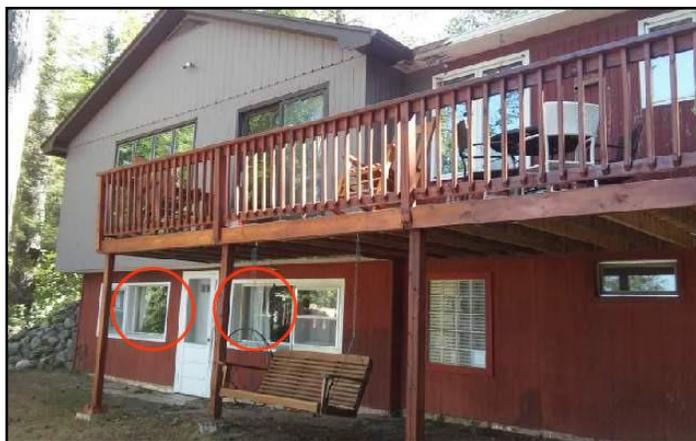
21. Lost seal on double or triple glazing

Condition: • [Lost seal on double or triple glazing](#)

Basement fixed windows are home-made and have low insulating properties. It is recommended that these windows be replaced with more thermally efficient units.

11. **Condition:** • [Lost seal on double or triple glazing](#)

Location: West Basement Family Room

Task: Replace

Time: Discretionary

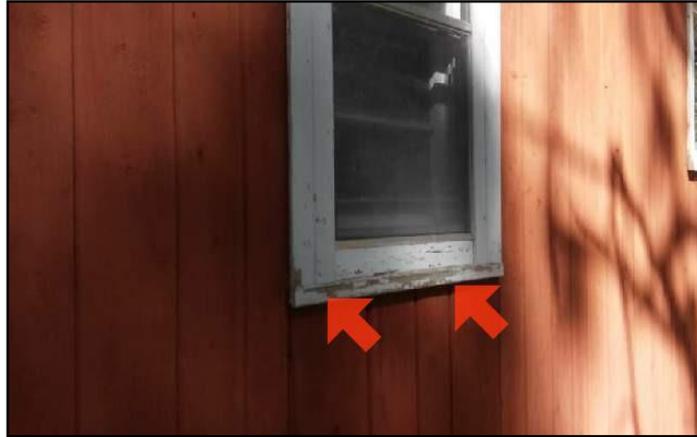
22. *Paint or stain needed*

12. **Condition:** • [Paint or stain needed](#)

Implication(s): Chance of water damage to structure, finishes and contents | Material deterioration

Location: East Exterior

Task: Repair

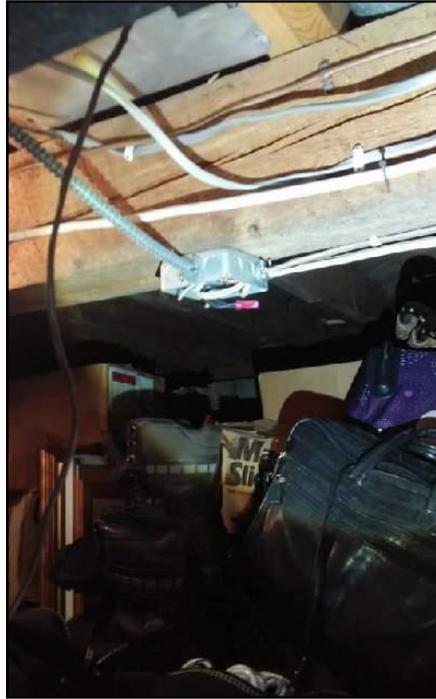
31. Cover loose or missing

13. Condition: • [Cover loose or missing](#)

Implication(s): Fire hazard | Electric shock

Location: Basement Utility Room

Task: Replace

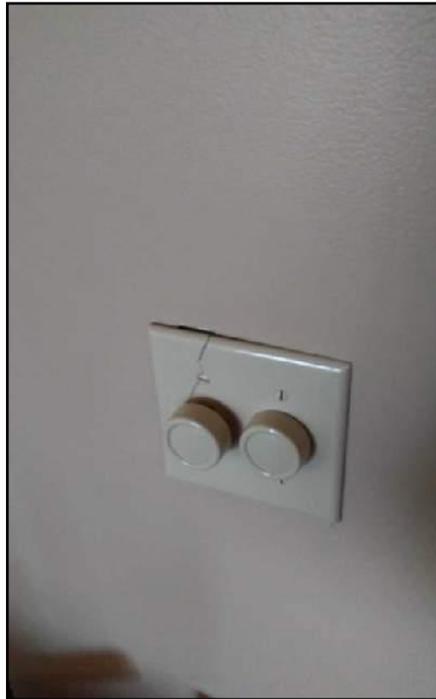
32. *Damage*

14. Condition: • [Damage](#)

Implication(s): Fire hazard | Electric shock

Location: Staircase

Task: Replace

Time: Discretionary

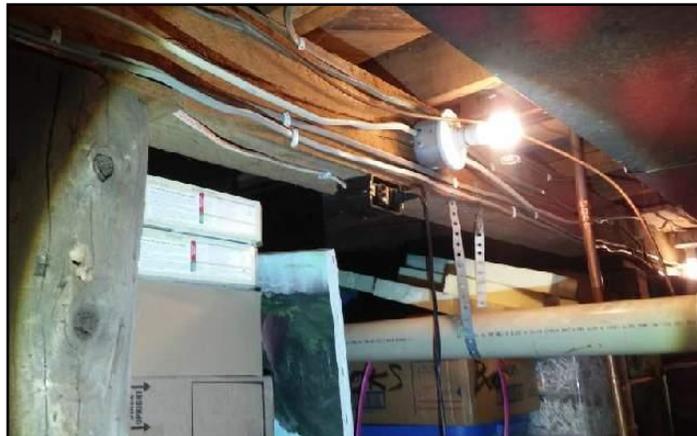
33. *Missing*

15. Condition: • [Missing](#)

Implication(s): Electric shock

Location: Basement Utility Room

Task: Replace

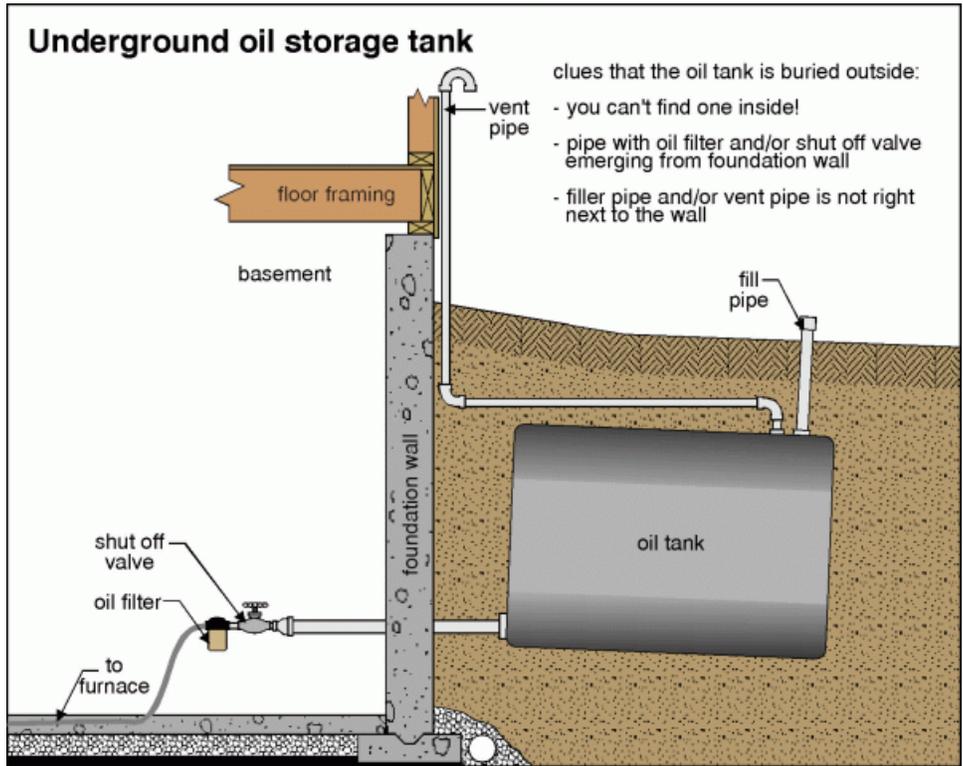
- OIL FURNACE \ Oil tank**
- 16. Condition:** • [Underground](#)
- Implication(s):** Environmental contamination | Leakage
- Location:** North Yard
- Task:** Replace
- Time:** Unpredictable

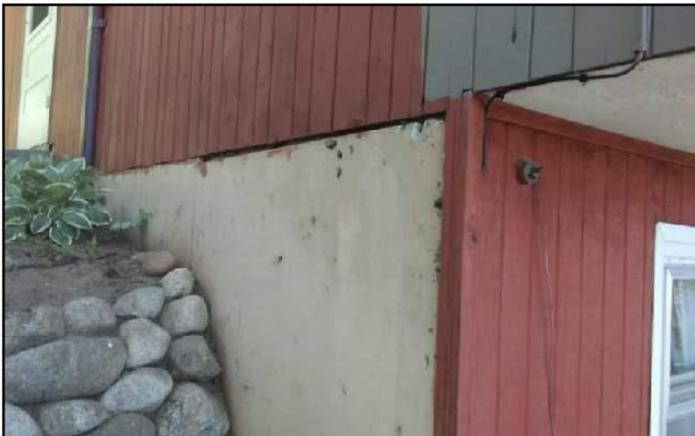
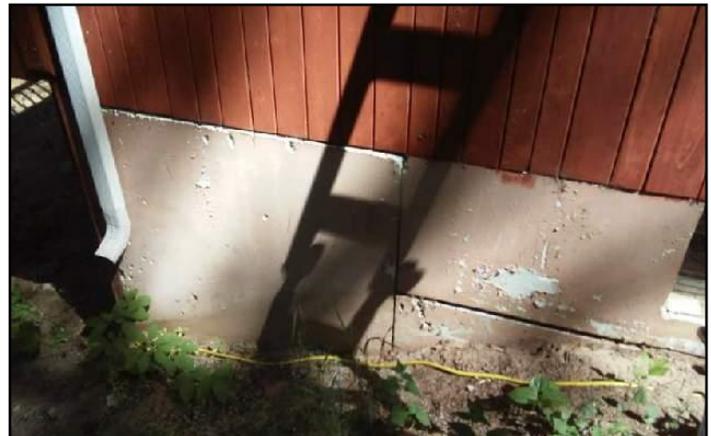
- 19. Condition: • Damaged
- Location: North Exterior
- Task: Repair

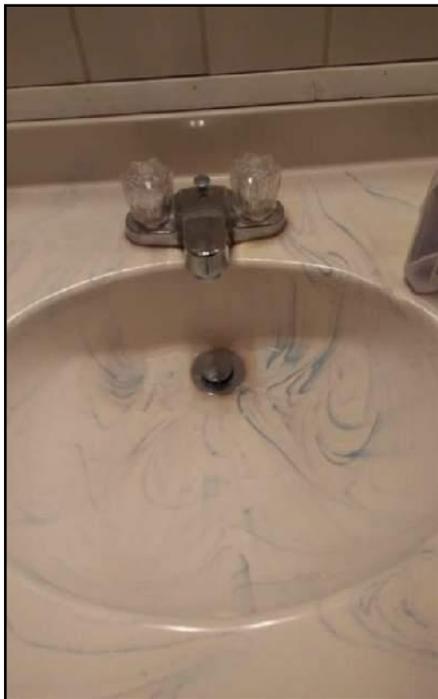
38. Clogged

20. Condition: • [Clogged](#)
Implication(s): Sewage entering the building
Location: Bathroom
Task: Clean
Time: Discretionary

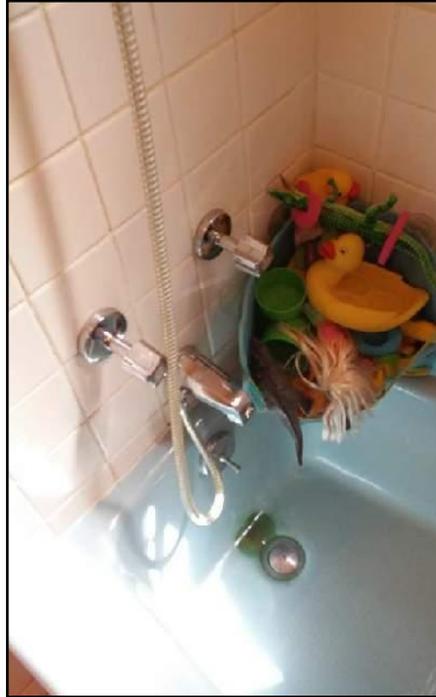
39. Leak

21. Condition: • [Leak](#)

Implication(s): Chance of water damage to structure, finishes and contents

Task: Repair

Time: Discretionary

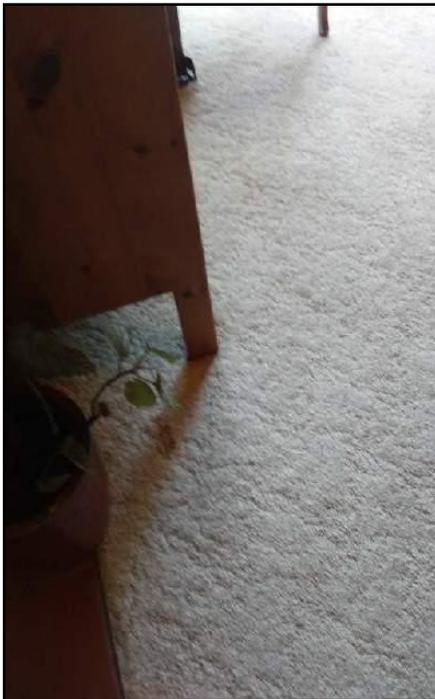
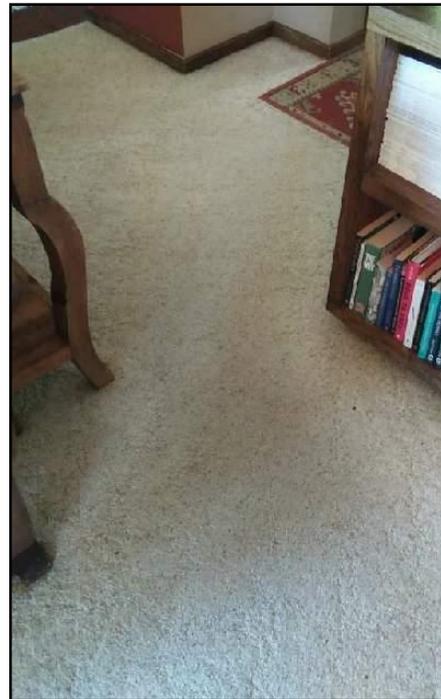
27. Condition: • [Stains](#)

Implication(s): Chance of water damage to structure, finishes and contents

73. Stains

74. Stains

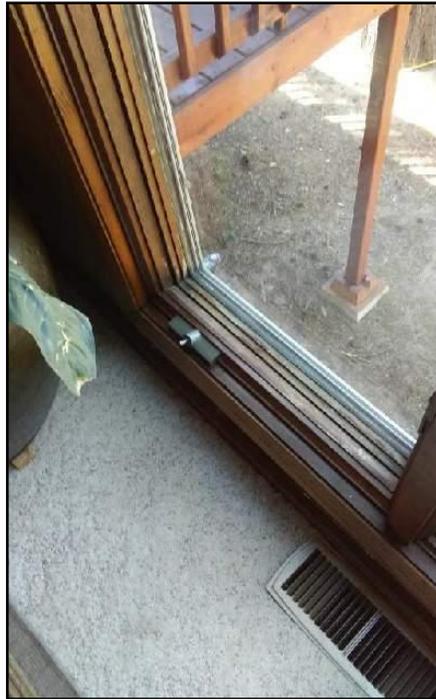
78. Broken

30. Condition: • [Broken](#)

Task: Repair or replace

Time: Discretionary

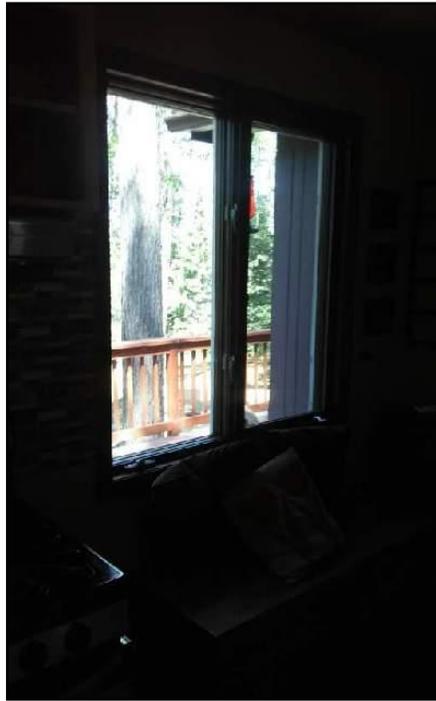
79. Broken

31. Condition: • [Broken](#)

Task: Replace

Time: Discretionary

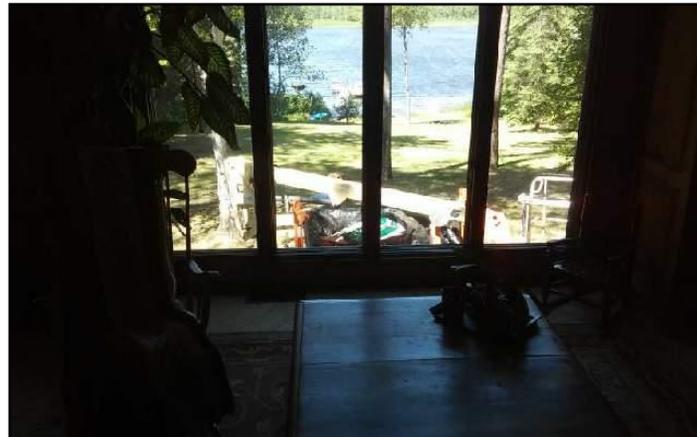
80. Missing

32. Condition: • [Missing](#)

Implication(s): System inoperative or difficult to operate

Location: Living Room

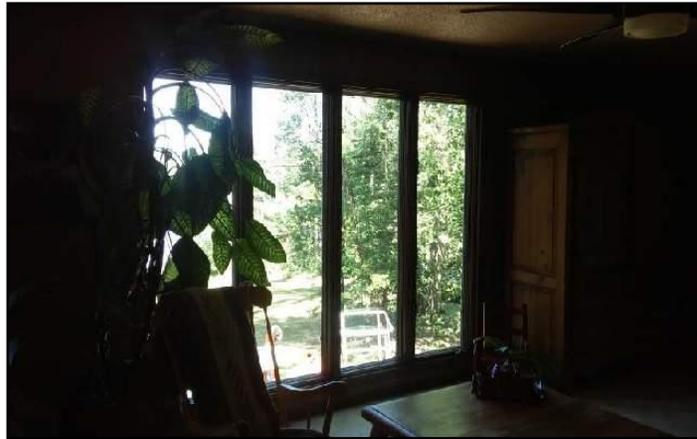
81. Missing

33. Condition: • [Missing](#)

Location: First Floor Living Room

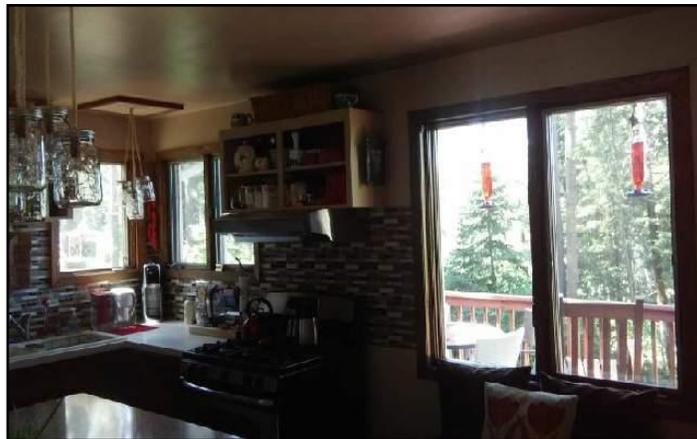
82. Missing

34. Condition: • [Missing](#)

Implication(s): Increased heating costs | Reduced comfort | Chance of pests entering building

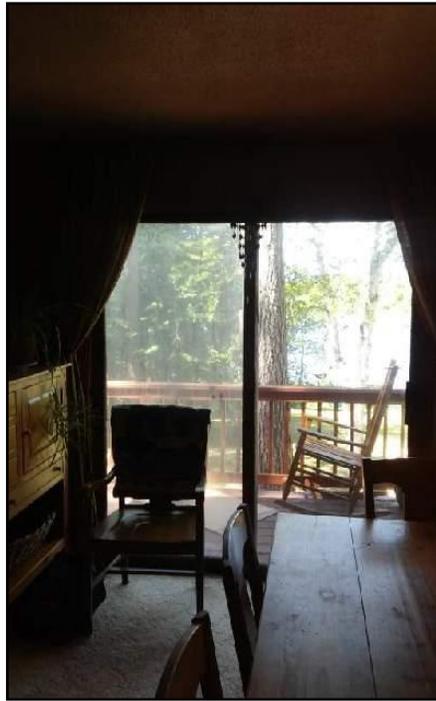
83. *Lost seal on double or triple glazing*

Condition: • [Lost seal on double or triple glazing](#)

Implication(s): Shortened life expectancy of material

Location: First Floor Dining Room

35. Condition: • [Lost seal on double or triple glazing](#)

Task: Replace

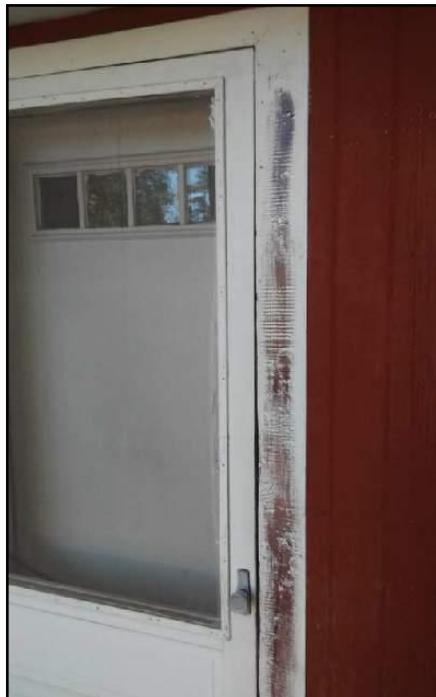
84. *Loose*

36. Condition: • [Loose](#)

Implication(s): Reduced comfort | Increased heating and cooling costs

Location: West Exterior Wall

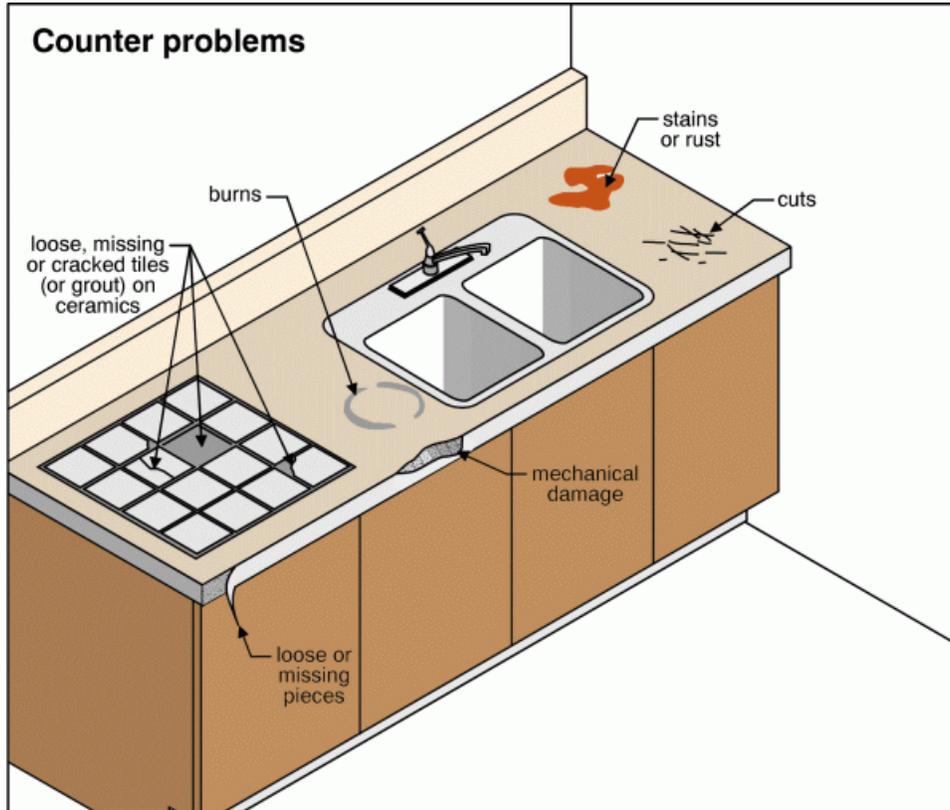
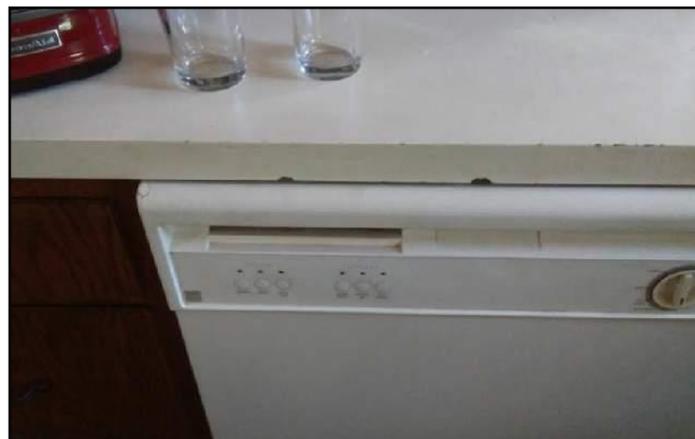
85. Damage, stained

37. Condition: • [Damage, stained](#)

Implication(s): Hygiene issue

Location: Kitchen
