Greg Beste, AIA, NCARB

RE: Building Envelope Study for Building L
Harbor Island Beach House and Ocean Villas HPR
Saint Helena Island, SC

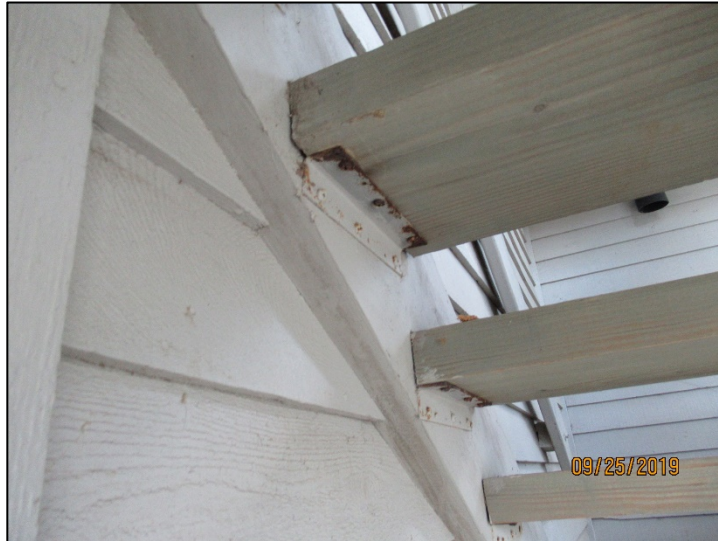
- a. **Treads at Stair towers.** The treads are solid timber with open risers and are supported originally by steel angles or with replacement supports consisting of extensively mitered 2x4 treated lumber. The steel angles appear to be present on approximately 50% of the treads with the remaining treads using the mitered 2x4 material. The steel angles have minor evidence of corrosion in most locations and have moderate corrosion present at the fasteners. A limited number of fasteners are completely corroded away and ***may present a safety hazard for the support of the tread.*** A number of the 2x4 mitered supports have

corroded fasteners also and have split the mitered support piece due to numerous fasteners used within close proximity to each other. This again ***may present a safety hazard for the support of the tread.***

Corroded steel tread bracket

RECOMMENDATION: The corroded steel angle tread supports should be wire brushed clean and prime the surface with a primer made for metal. Apply two topcoats of paint on top of the primer. Any replacement fasteners shall be minimum #8 stainless steel wood screws.

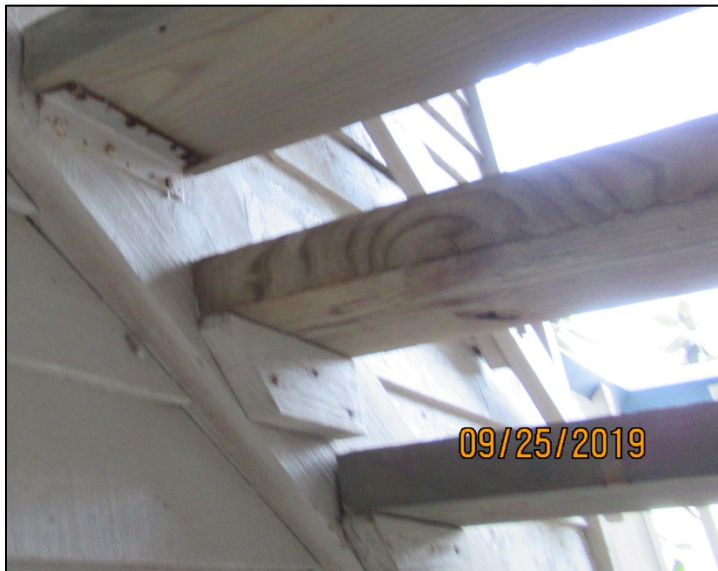
Mitered 2x4 tread bracket and typical steel tread bracket

All mitered wood supports shall be inspected and those with corroded fasteners or split/cracked wood shall be replaced with the new steel angle treated in the same manner as noted above.

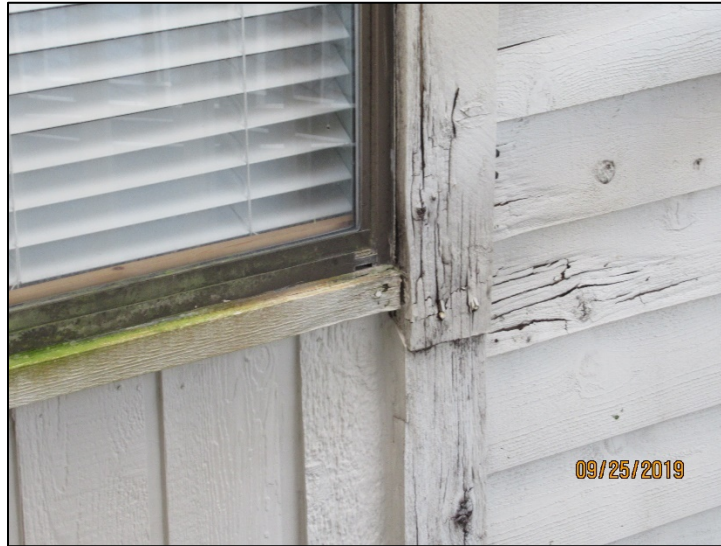
- b. **Siding & Trim.** In a number of locations, it was observed that varying degrees of deterioration of the siding and trim was occurring on all four facades of the building. The worse conditions are in the “light wells” which are located between the walkways and the front facades near the entry doors and bedroom windows on the units. The trim and siding around the windows have severely deteriorated in this area and may be associated by the overflow scupper location above and general roof water runoff.

Typical deteriorated window trim and siding near “light well”

RECOMMENDATION: The window trim should be replaced. There may be undiscovered wood framing deterioration discovered during repairs. Timeline for replacement should be considered as most of these areas also involve the original windows and flashing associated with the window units. It would be

proactive to replace the windows at the same time that the siding and trim are replaced.

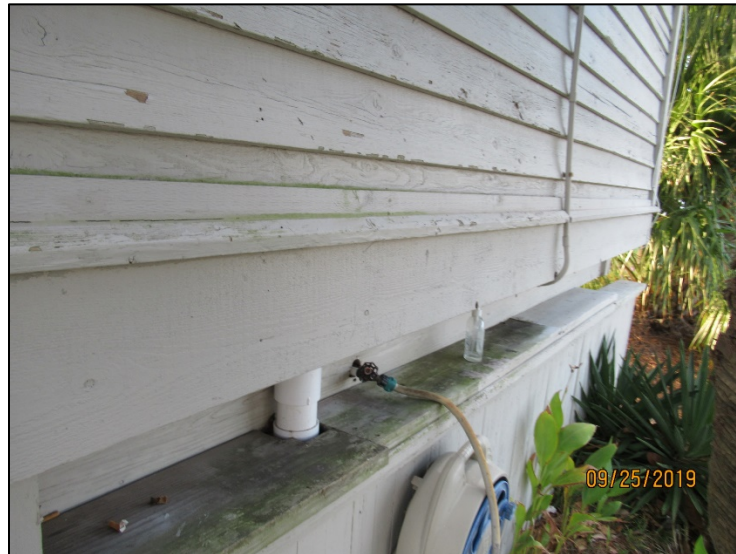
Typical condition of wood siding with peeling, pitting and deterioration of horizontal wood fibers.

The exterior siding that is still the original wood material and has not been replaced. Consideration should be given to the use of cementitious fiber board siding (equal to “Hardiplank”) in the next 2-5 years depending on the condition of the siding and its location or exposure to the weather elements. This work could be done in phases and in coordination with the window replacement.

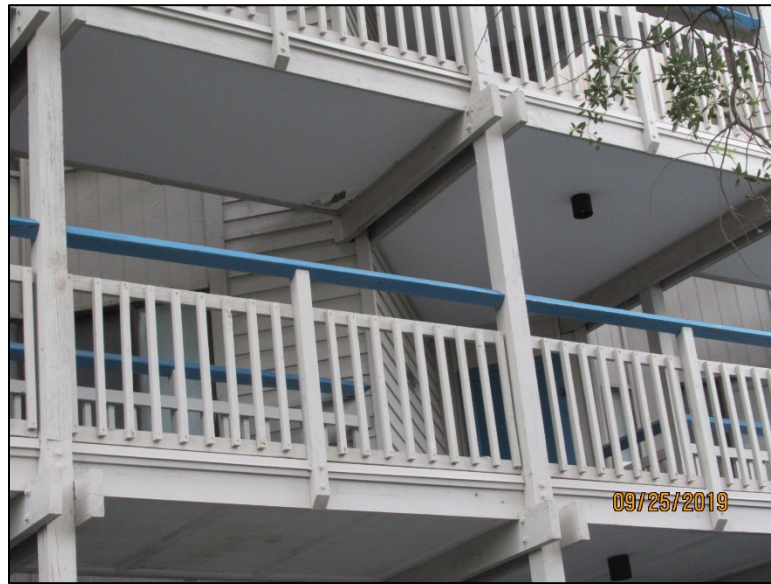
- c. **Walkway/Stair Guardrails.** The guardrails consist of nominal 2x2 pickets with vertical supports of nominal 4x4 posts with a nominal 3x3 on an angle top rail and are in good condition. The fasteners in the majority of the pickets are in good condition and have limited visible corrosion. The bottom rail which is a nominal 2x4.

Typical Walkway/Stair Guardrails

RECOMMENDATION. Any corroded fastener conditions should be replaced with minimum #8 stainless steel wood screws.

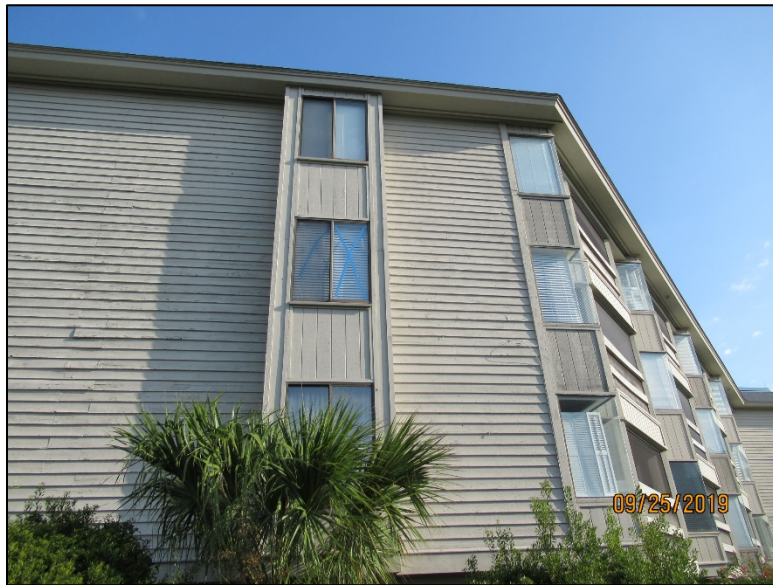
Windows & Doors. The aluminum framed windows are original and have exceeded their life expectancy as a building component. It has been reported that several windows have either been replaced or are in need of immediate replacement.

Typical side façade windows and siding condition

RECOMMENDATION: Develop a plan and select a replacement window manufacturer and unit specification and complete replacement on an as needed basis with the understanding that all windows in the building should be replaced with the next 3-5 years or sooner. This also includes any sliding glass doors.

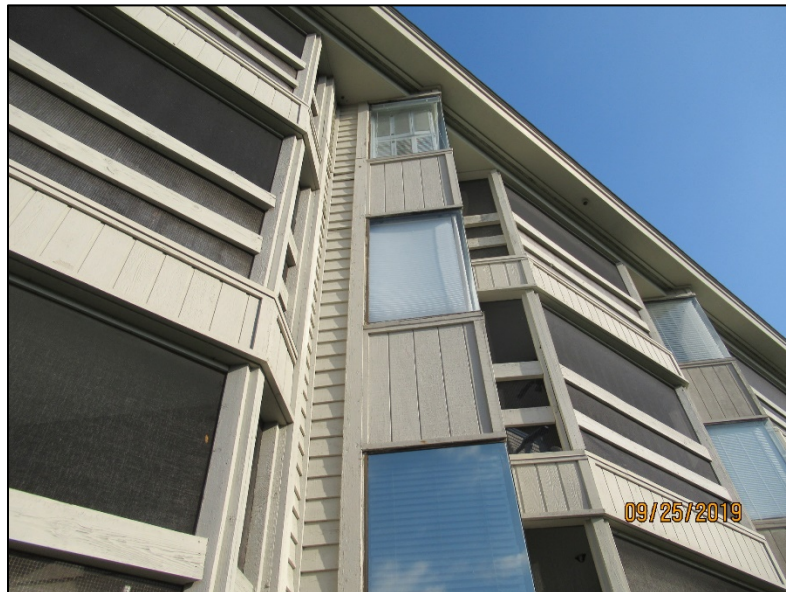
Typical corner window condition on rear facade

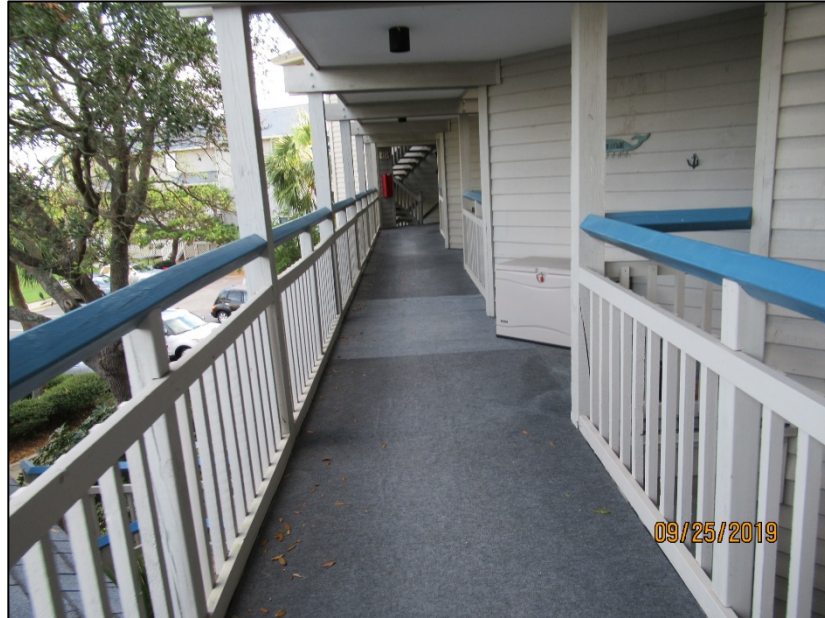
- d. **Walkways.** The front walkways on each floor having a carpet and a reported water-resistant membrane over a plywood decking. The deterioration of the decking was observed on the end face of the decking at the walkway edge, especially noted at the stairway tread locations. Delamination and deterioration of the inner layers of the plywood decking was observed in limited areas.

Wall and decking transition had several areas of poor or limited continuous flashing observed.

Typical walkway, note various replacements and water staining currently on carpet surface

RECOMMENDATION: Complete removal of the carpeting and complete removal of the water-resistant barrier. Removal of all plywood decking. Install minimum of 5/8" KDAT (Kiln Dried after Treatment) exterior grade treated plywood decking. Use "Hydrostop Traffic Coat Decking Coating" with a "Textured" finish for non-slip applications. Use with "PremiumCoat System" for extendable 5-year warranty by GAF, the manufacturer, when applied by an approved applicator at all plywood decking locations. Prep surface as required by manufacturer. Coordination with the wall/decking detail shall be required and in strict compliance with manufacturer's installation requirements. Provide minimum of 8" up the wall at deck/wall transitions with "Hydrostop" materials. Coordinate with siding replacement schedule as required.

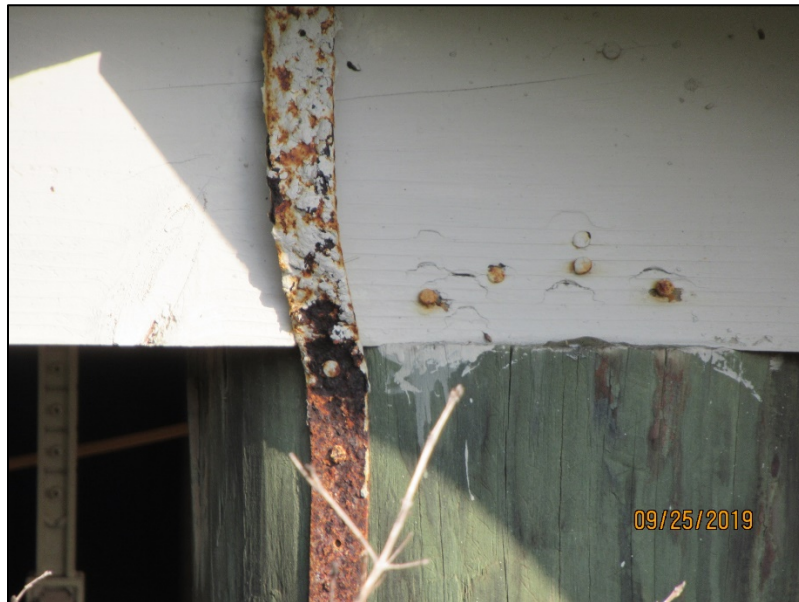
- e. **Pilings.** A number of foundation pilings were observed to have corroded strapping and fasteners.

Typical corroded metal strapping at piling.

RECOMMENDATION: As part of the routine maintenance program, straps should be reinstalled to all pilings where corrosion is observed on existing strapping. Use stainless steel fasteners and double-dipped galvanized straps.
