Greg Beste, AIA, NCARB

August 2, 2019

RE: Building Envelope Study for Building M
Harbor Island Beach House and Ocean Villas HPR
Saint Helena Island, SC

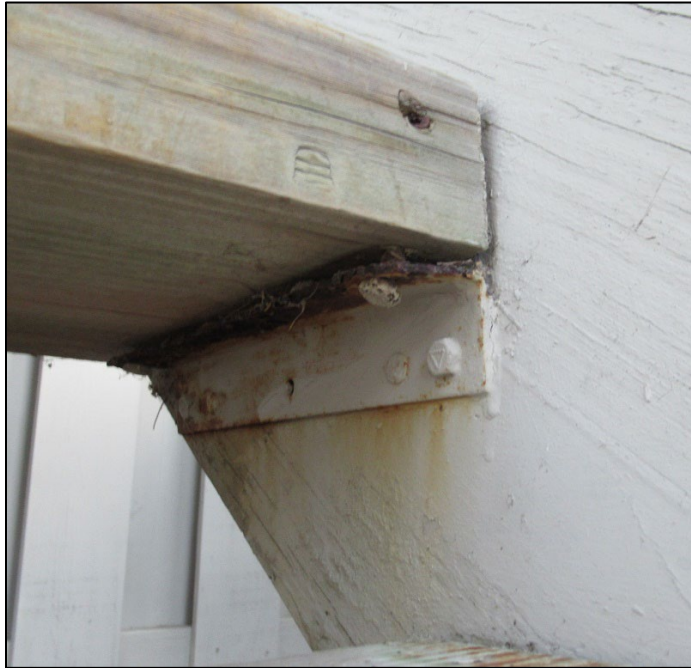
- a. **Tread at Stair towers.** The treads are solid timber with open risers and are supported originally by steel angles or with replacement supports consisting of extensively mitered 2x4 treated lumber. The steel angles appear to be present on approximately 50% of the treads with the remaining treads using the mitered 2x4 material. The steel angles are severely corroded in many locations and have severe corrosion present at the fasteners. Some fasteners are completely corroded away and ***may present a safety hazard for the support of the tread.*** A number of the 2x4 mitered supports have corroded fasteners also and have split

Corroded steel tread bracket

RECOMMENDATION: All steel angle tread supports should be at a minimum of double-dipped galvanized steel angles. Go over the metal with a wire brush to remove any oxidation. Wipe the galvanized surface down with white vinegar. The vinegar is a mild acid which acts to etch the galvanized coating so the paint will stick. Prime the surface with a primer made for metal. Apply two topcoats of paint on top of the primer. Fasteners shall be minimum #8 stainless steel wood screws.

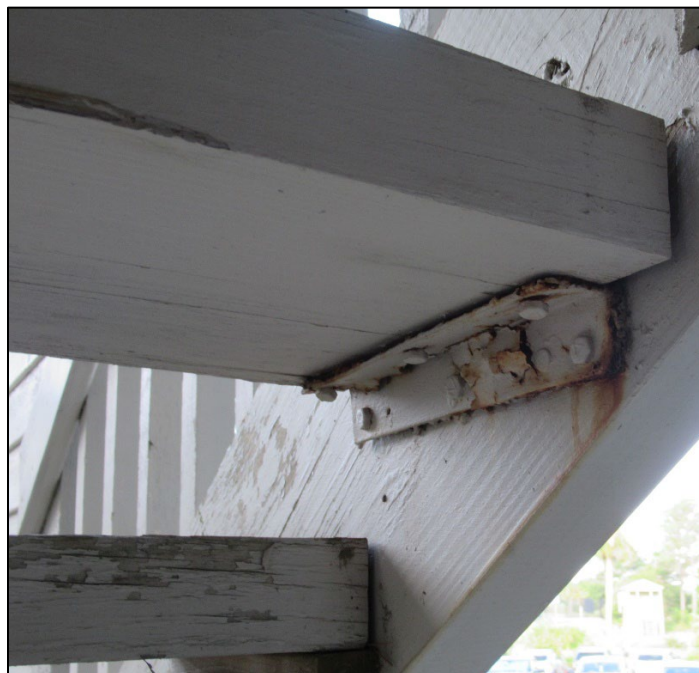
Corroded steel tread bracket

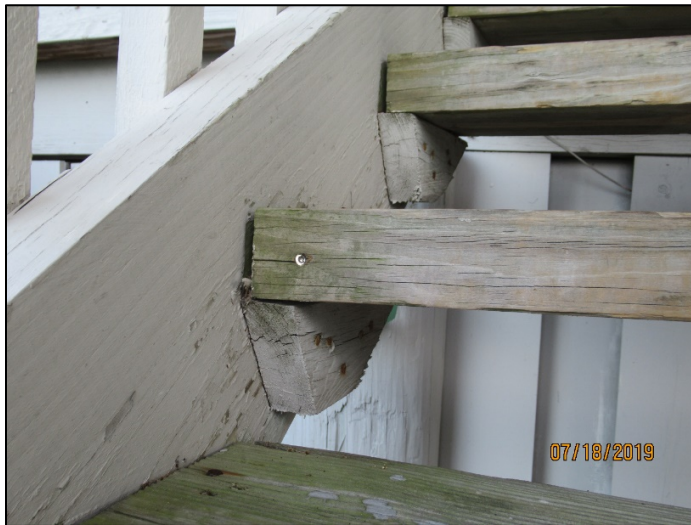
the mitered support piece due to numerous fasteners used within close proximity to each other. This again ***may present a safety hazard for the support of the tread.***

Mitered 2x4 tread bracket

All mitered wood supports shall be inspected and those with corroded fasteners or split/cracked wood shall be replaced with the new steel angle as noted above.

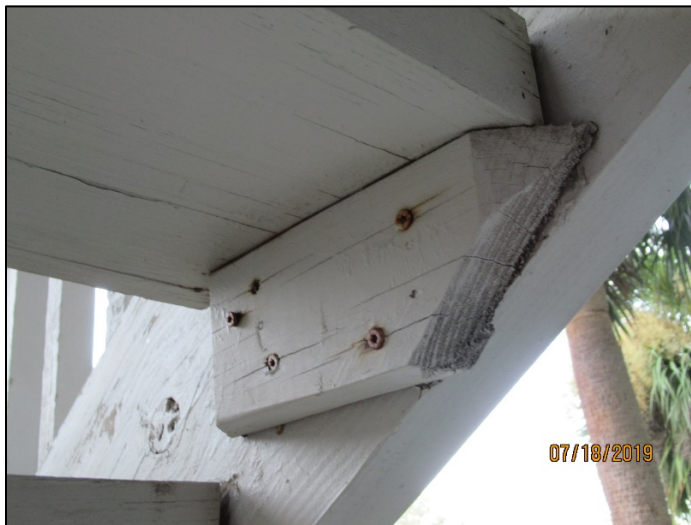
Mitered 2x4 tread bracket

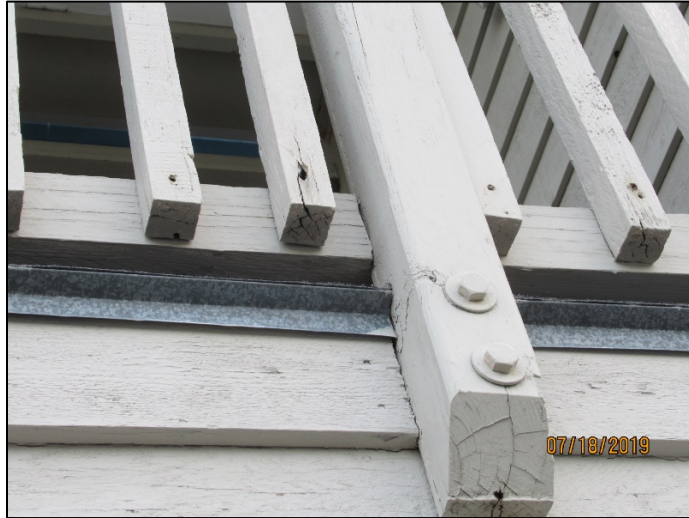
- b. **Walkway/Stair Guardrails.** The guardrails consist of nominal 2x2 pickets with vertical supports of nominal 4x4 posts with a nominal 3x3 on an angle top rail. The fasteners in the majority of the pickets, especially at the base have corroded and have split the 2x2 picket. The bottom rail which is a nominal 2x4 also has many corroded fasteners, splitting of the wood at the fastener locations extending to the end of the piece and has excessive gaps at the vertical support from movement

due to moisture and shrinkage. The top rail has the same issues as the bottom rail. These corroded fastener conditions and split wood ***may present a safety condition*** which would not provide the code requirement to withstand a concentrated 200 lb. force anywhere along the top of the rail.

Guardrail deterioration

RECOMMENDATION: Complete replacement of the guardrails should be considered in the next 2-3 years to an alternate material and design such as aluminum which would not have the corrosion and deterioration of the various components in the salt air environment present at the site.

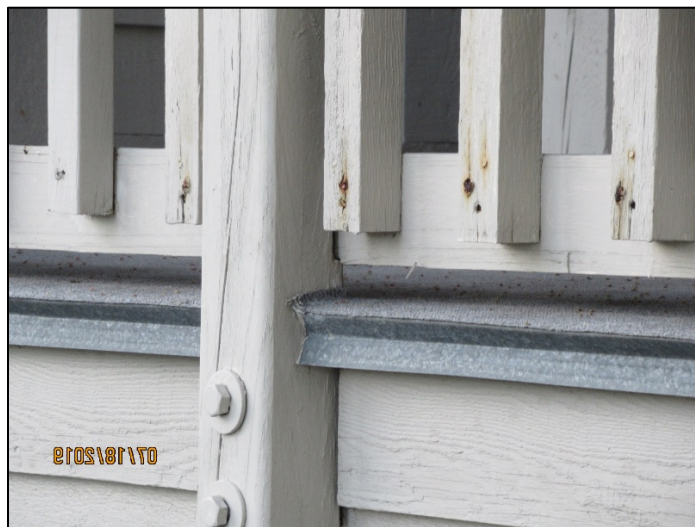
Guardrail deterioration

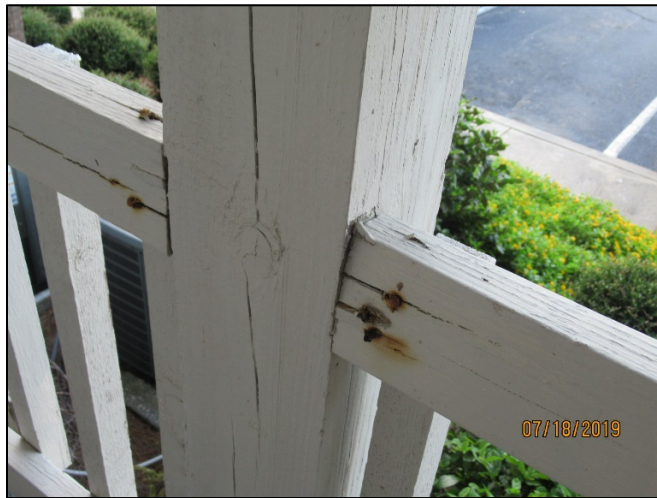
Upper rail of guardrail deterioration

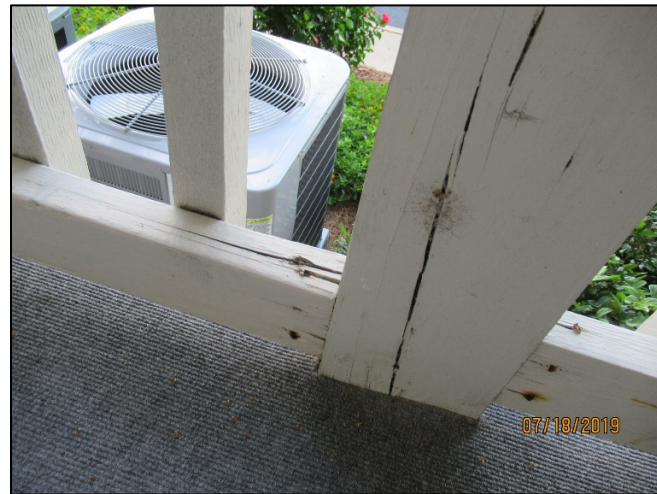
Lower rail of guardrail deterioration

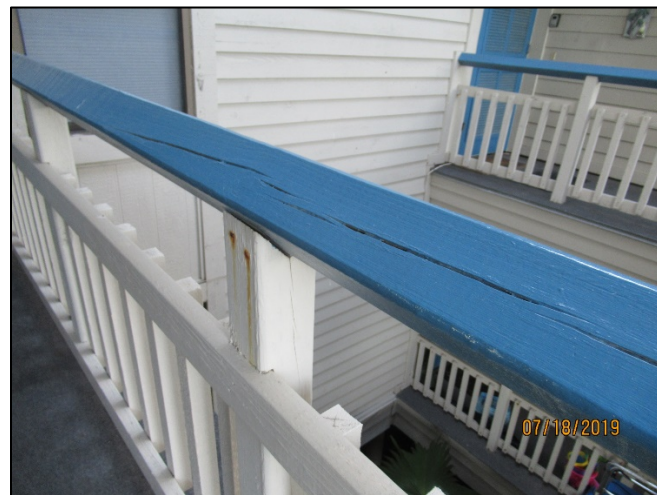
Top rail of guardrail deterioration

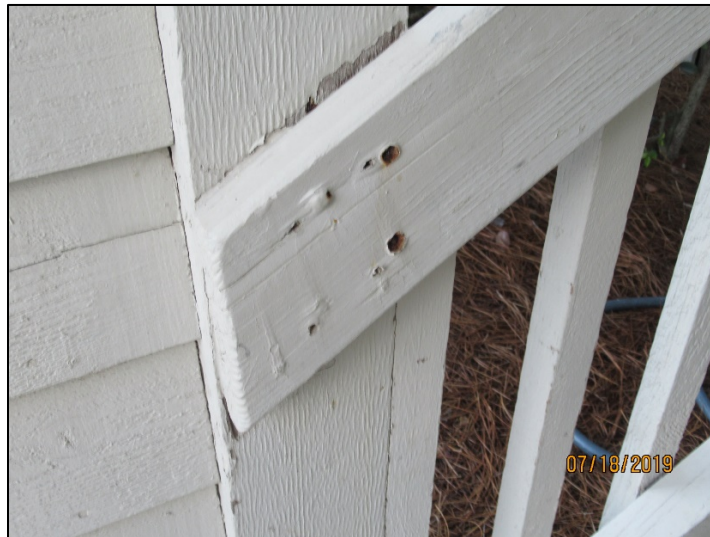
- c. **Stairway Handrails:** The handrails in the stair towers are solid nominal 2x6 components with corroded fasteners in many locations. These handrails also have many split ends due to excessive fastener placements. The handrails also do not provide the code required continued clearance of 1.5" between the handrail and any vertical surface, such as the supporting walls.

Handrail connection, deterioration

RECOMMENDATION: Complete replacement of the stairway handrails in the next 2-3 years due to deterioration and corrosion of the fasteners with an alternate material such as an aluminum handrail which would be code complaint in design and a more sustainable material for the salt air environment at the site.

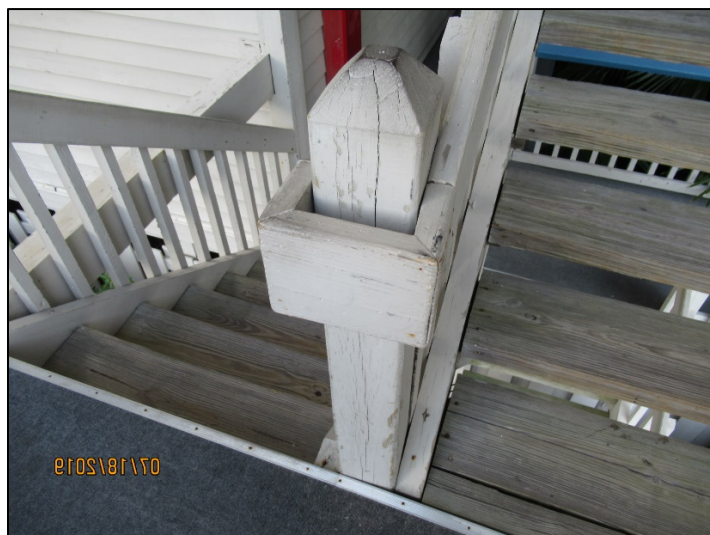
Handrail connection

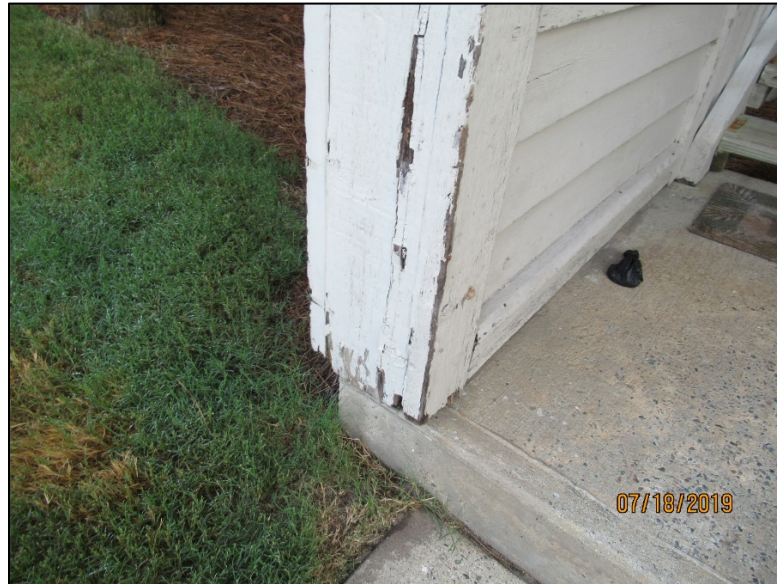
- d. **Wood trim:** Various locations throughout the building exterior, especially on the lower level, numerous locations of rotted or extensive deteriorated wood trim pieces were observed.

Wood trim deterioration

RECOMMENDATION: Routine maintenance program begin a periodic replacement of the wood trim pieces beginning with the most deteriorated pieces first.

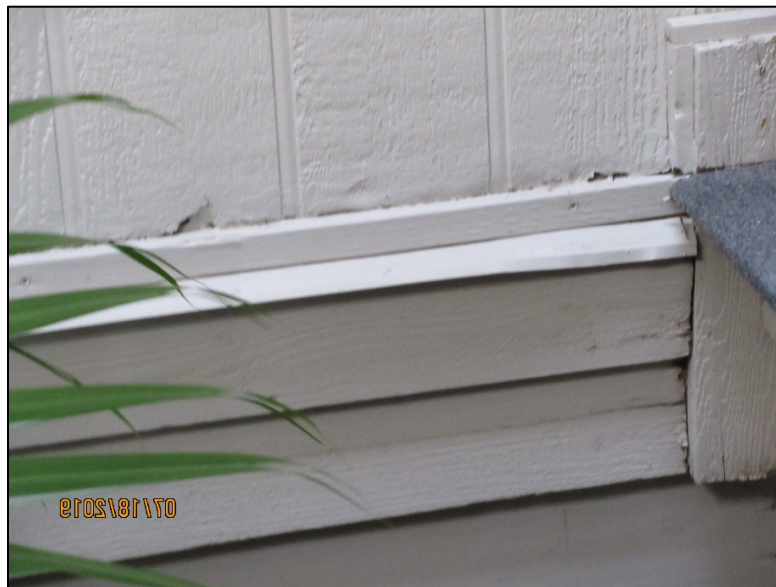
Siding and trim deterioration

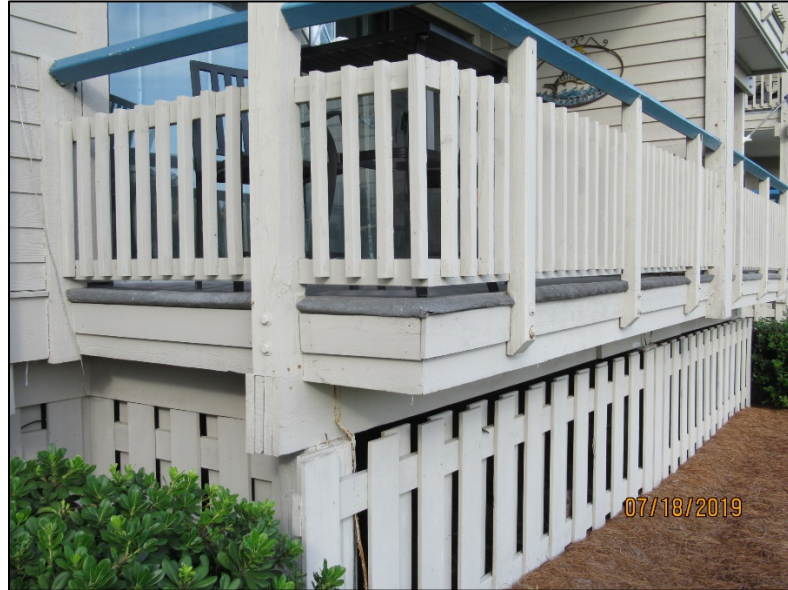
- e. **Balconies.** The balconies were in generally good condition with the same issues on some of the guardrails as on the walkways.

Typical Balcony

RECOMMENDATION: If front walkway guardrails are replaced with an alternate material, the balcony guardrails should be replaced at the same time. Until then, a routine maintenance program should begin a periodic replacement of the wood components beginning with the most deteriorated pieces first.

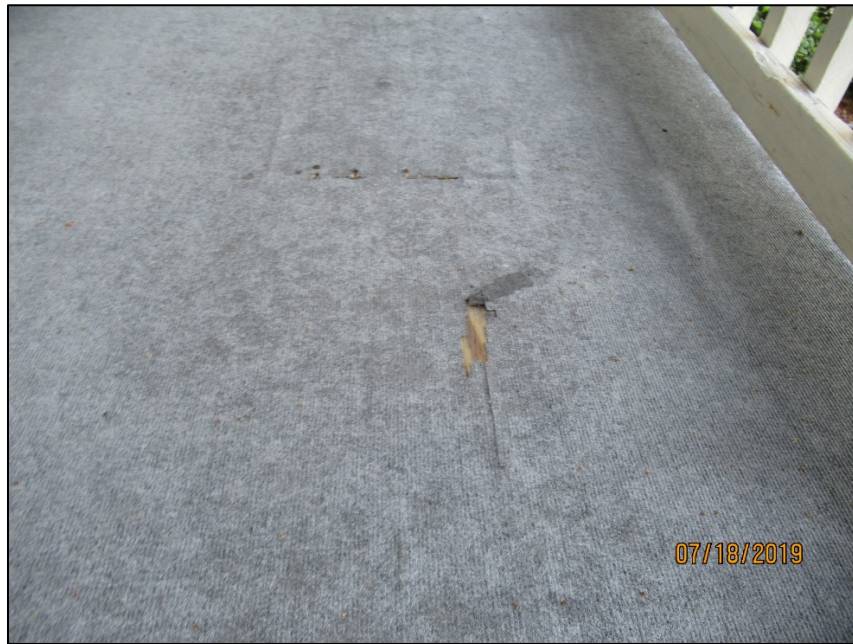
- f. **Walkways.** The front walkways on each floor (and rear balconies) having a carpet and a reported water-resistant membrane over a plywood decking. The deterioration of the decking was observed on the end face of the decking at the walkway edge, especially noted at the stairway tread locations. Delamination and deterioration of the inner layers of the plywood decking was observed. On the 3rd floor walkway excessive ripples were noted in the carpeting and water-resistant membrane indicating failure of the protection barrier installed. Note also several areas of the soffit were deteriorated.

Typical walkway condition

RECOMMENDATION: Complete removal of the carpeting and complete removal of the water-resistant barrier. Removal of the deteriorated and delaminating plywood decking. Install minimum of 5/8" KDAT (Kiln Dried after Treatment) exterior grade treated plywood decking. Use "Hydrostop Traffic Coat Decking Coating" with a "Textured" finish for non-slip applications. Use with

“PremiumCoat System” for extendable 5-year warranty by GAF, the manufacturer when applied by an approved applicator at all plywood decking locations. Prep surface as required by manufacturer. Coordination with the wall/decking detail shall be required and in strict compliance with manufacturer’s installation requirements. Provide minimum of 8” up the wall at deck/wall transitions with “Hydrostop” materials.

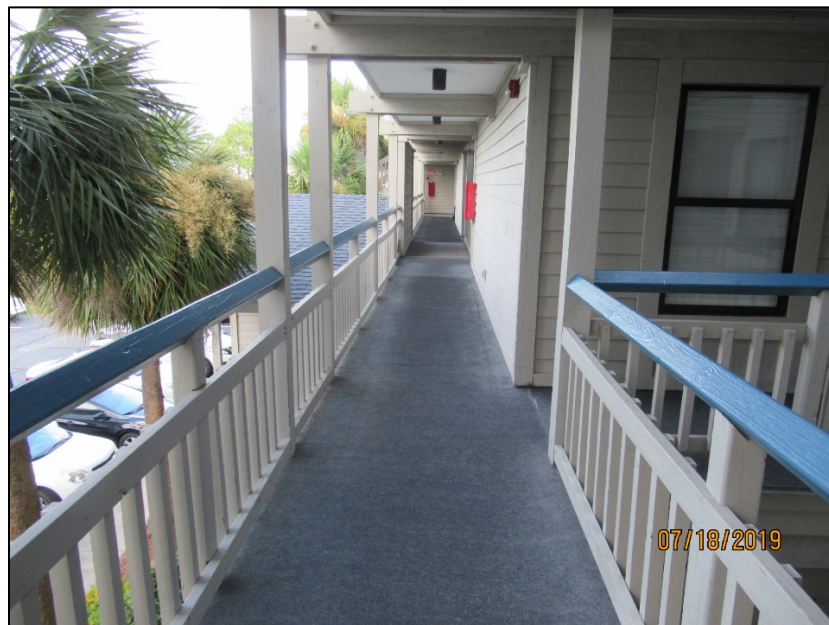
Typical walkway condition

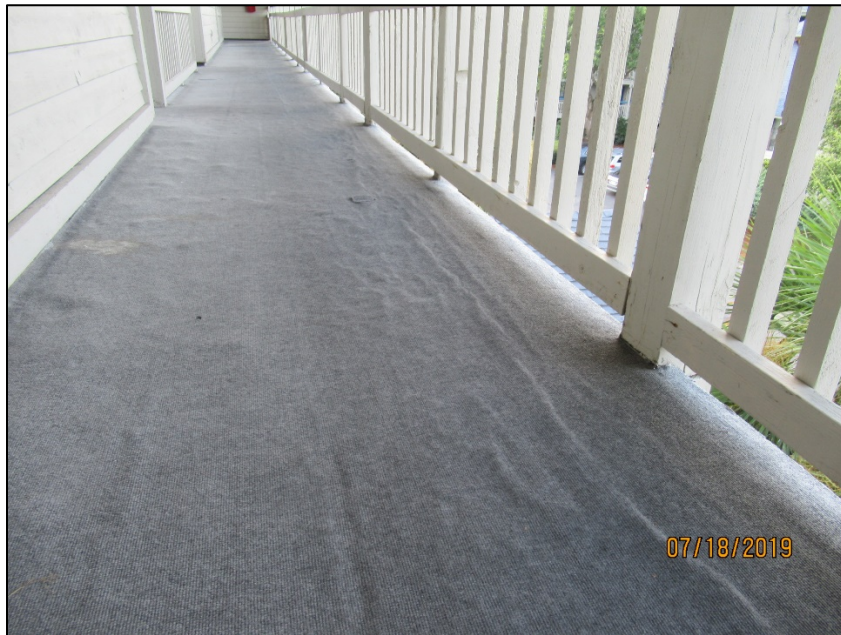
Third floor walkway condition

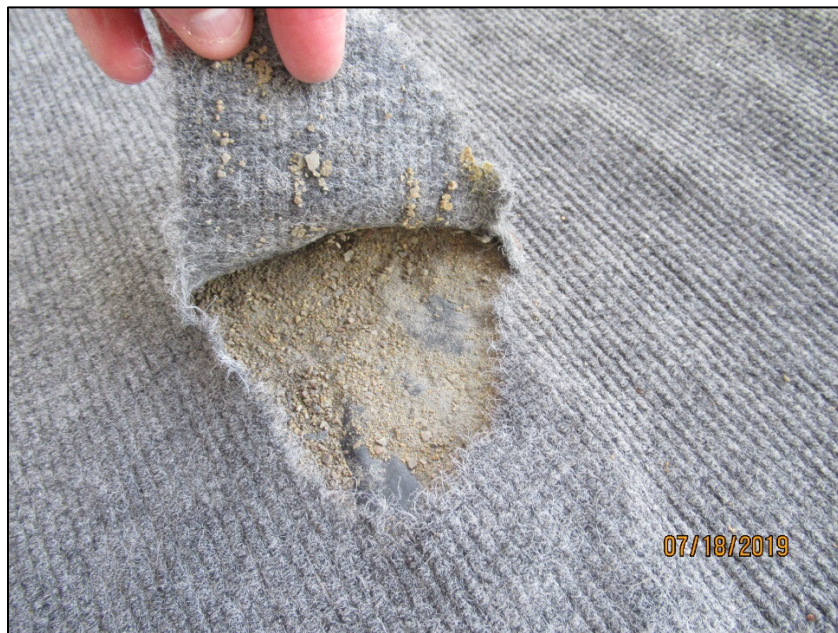
Tear in Third floor walkway carpeting exposing rippled water-resistant membrane

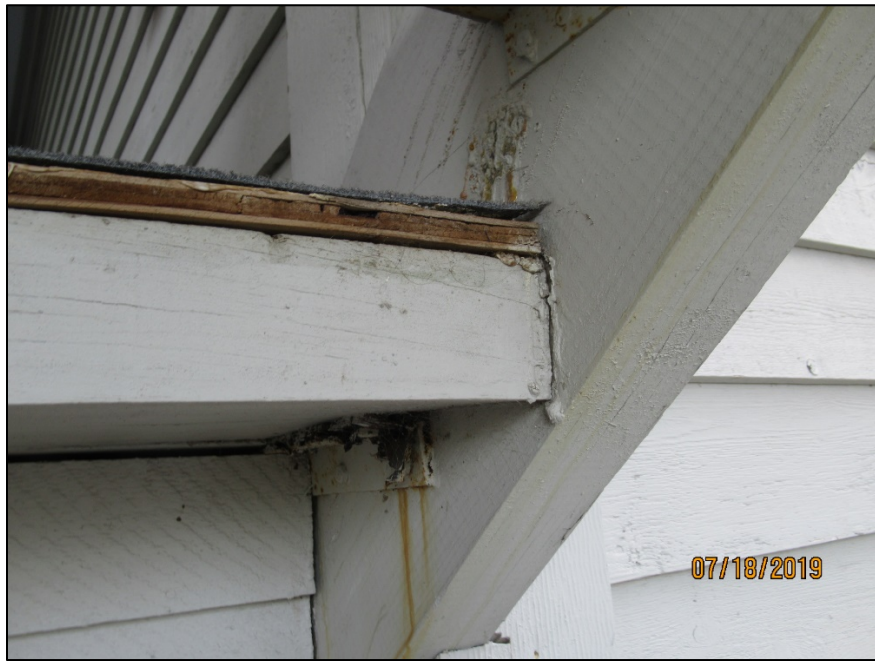
Deteriorated and delaminating walkway decking

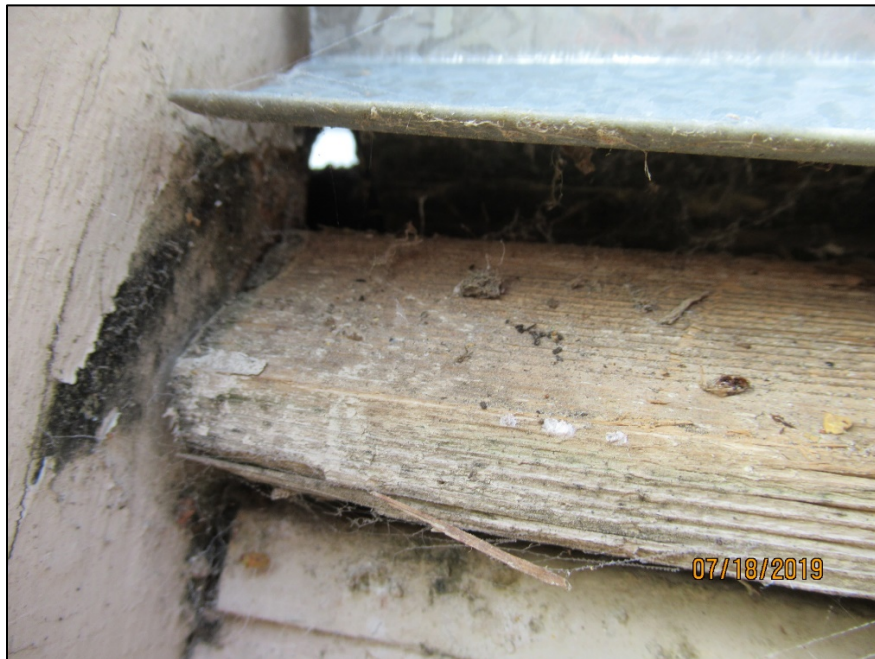
Decking condition at one of the rear balconies

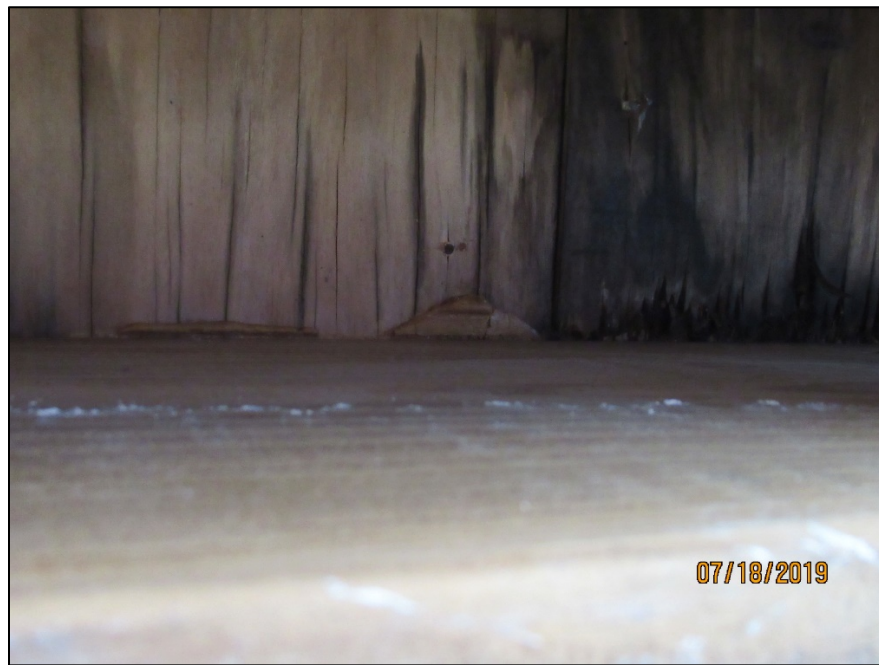
Underside of deteriorating decking as viewed from level below

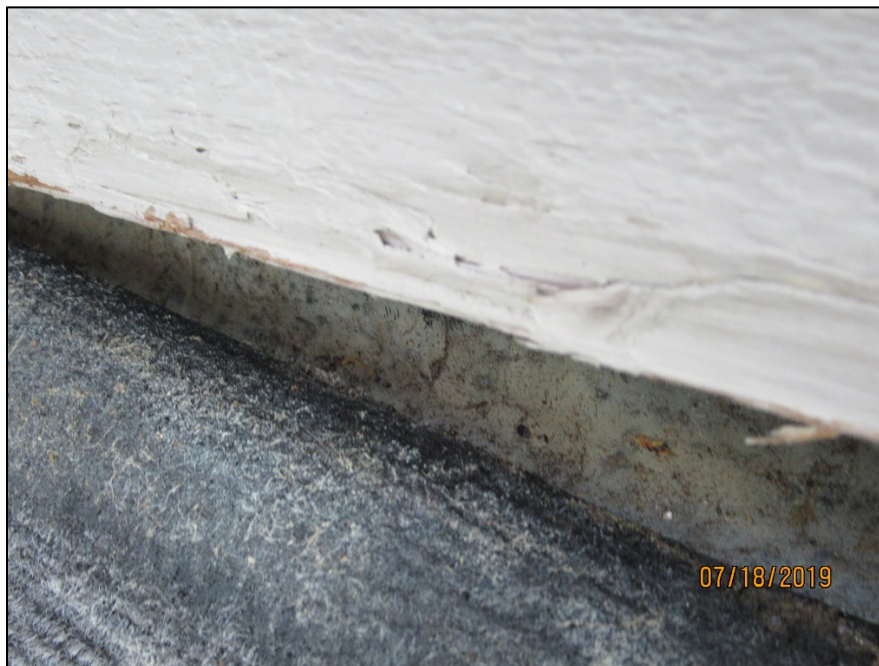
Wall/walkway transition with no continuous flashing up the wall

Wall and decking transition had numerous areas of poor or limited continuous flashing observed.

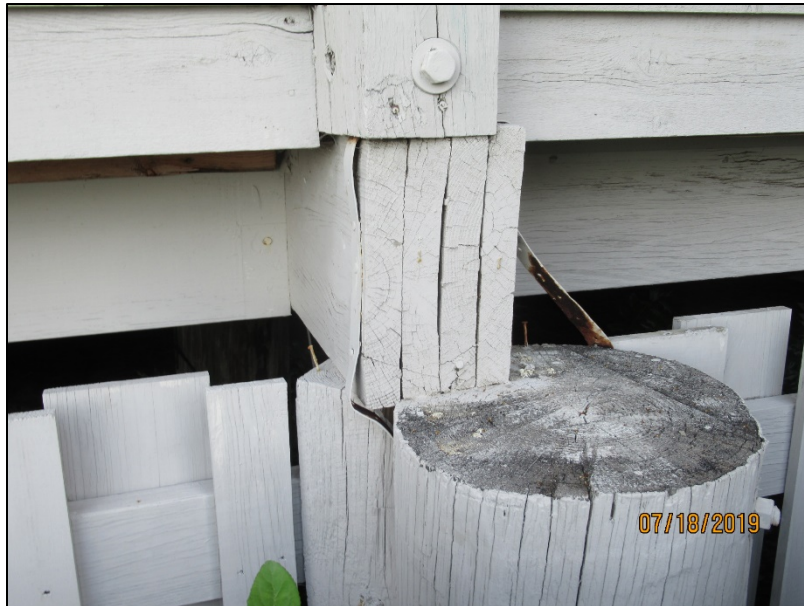
- g. Pilings.** A number of foundation pilings were observed to have corroded strapping and fasteners. Several main framing members along the front façade appear to “miss” the main bearing point of the piling and had supplemental framing added to provide bearing and structural load transfer to the pilings.

Misaligned framing at piling and corroded strapping.

RECOMMENDATION: As part of the routine maintenance program, straps should be reinstalled to all pilings where corrosion is observed on existing strapping. Use stainless steel fasteners and double-dipped galvanized straps. The front façade pilings should be checked immediately and then annually for supplemental support components and fasteners to ensure no changes have occurred. If corrosion or deterioration of the wood supplemental framing is observed, this should be replaced immediately.

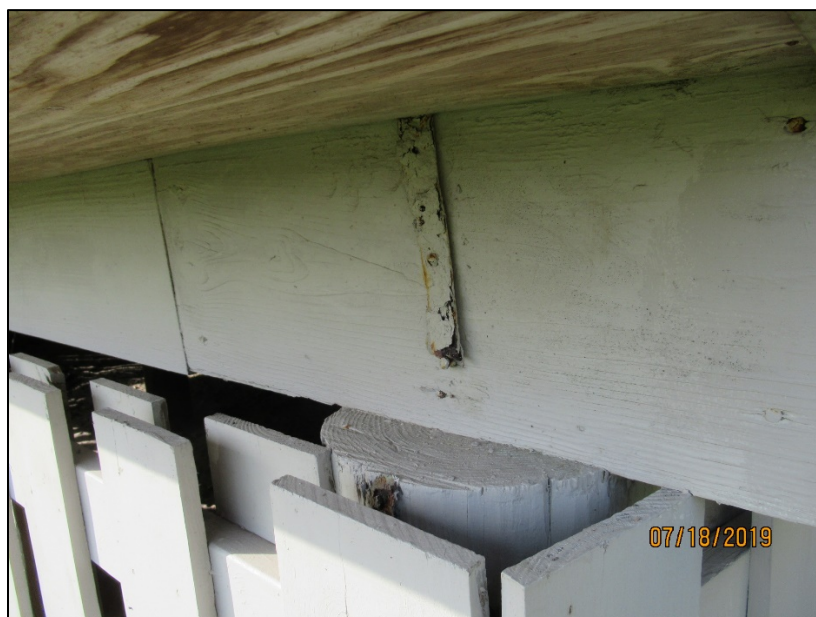
Corroded/missing strapping at piling

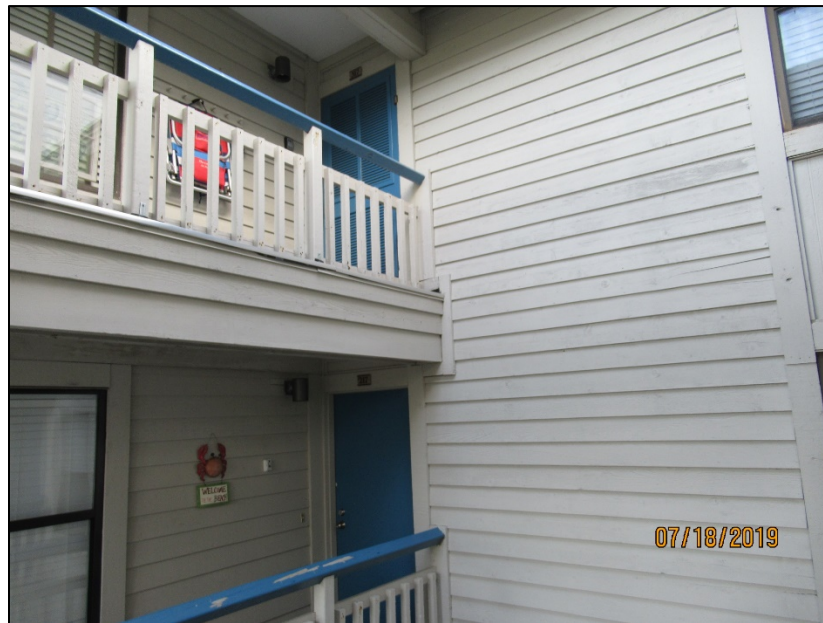
- h. **Siding.** The exterior siding that is still wood material and has not been replaced recently by the use of cementitious fiber board siding (equal to “Hardiplank”) should be monitored and replaced in the next 2-5 years depending on the condition of the siding and its location or exposure to the weather elements.

Typical siding condition

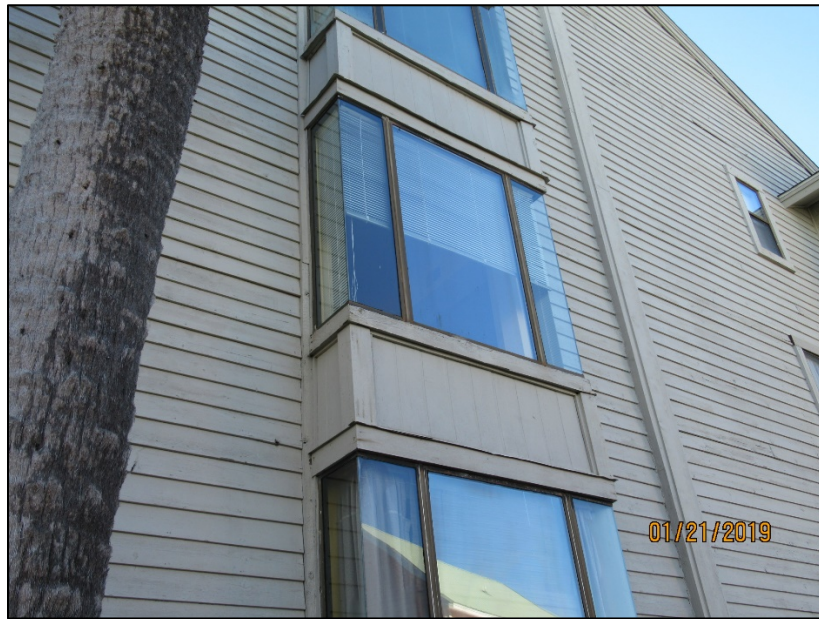
- i. **Windows.** The aluminum framed windows are original and have exceeded their life expectancy as a building component. It has been reported that several windows have either been replaced or are in need of immediate replacement.

Typical “box bay” window with corner glass

RECOMMENDATION: Develop a plan and select a replacement window manufacturer and unit specification and complete replacement on an as needed basis with the understanding that all windows in the building should be replaced with the next 3-5 years or sooner. This also includes any sliding glass doors.

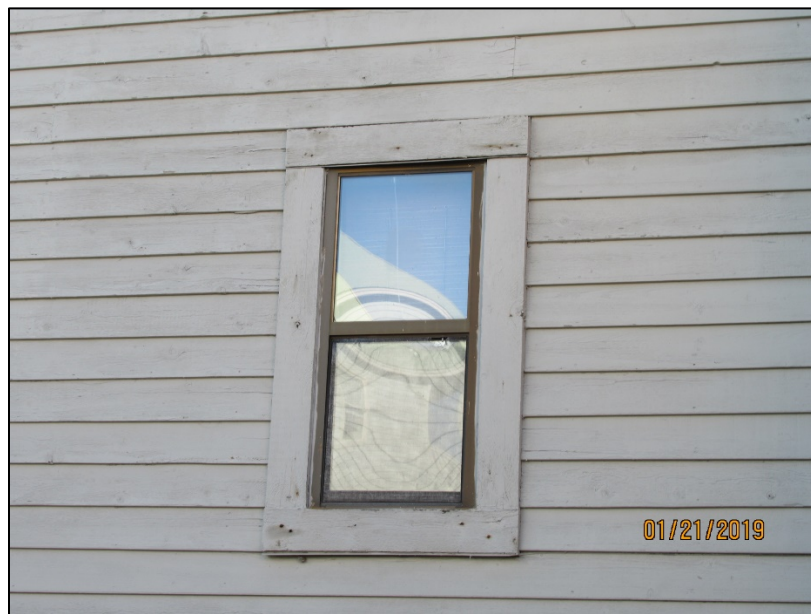
Typical window unit
