FULL RESERVE STUDY

**Harbor Island Beach House and Ocean Villas,
HPR, Inc.**

**St. Helena, South Carolina
August 30, 2018**

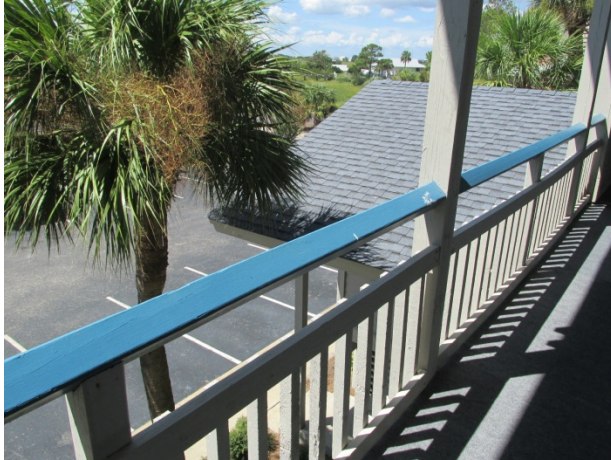
Conditions: Good overall with isolated deterioration evident

Wood railing overview

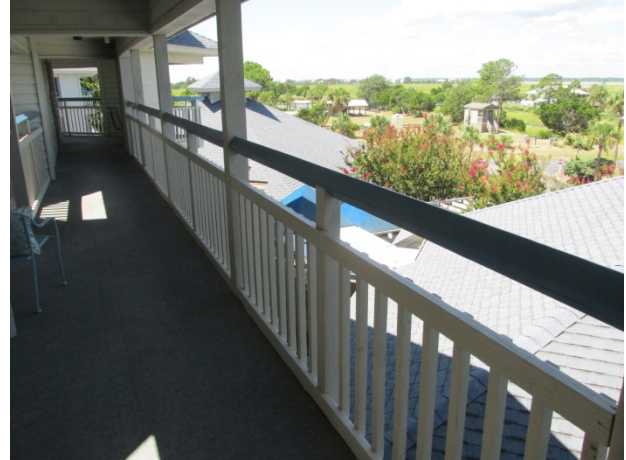
Wood railings in good condition

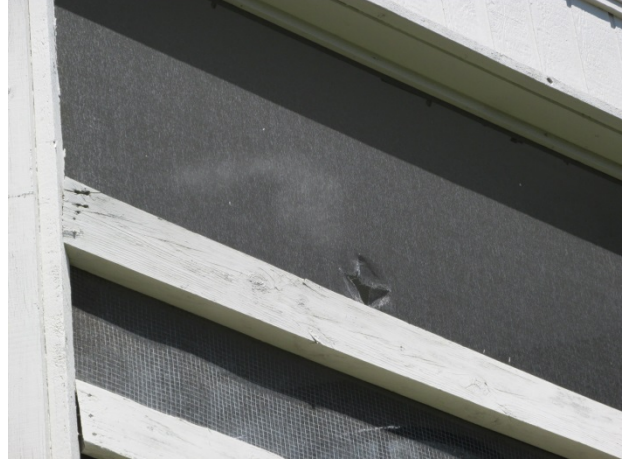
Condition: Good overall with isolated tears evident

Isolated tears

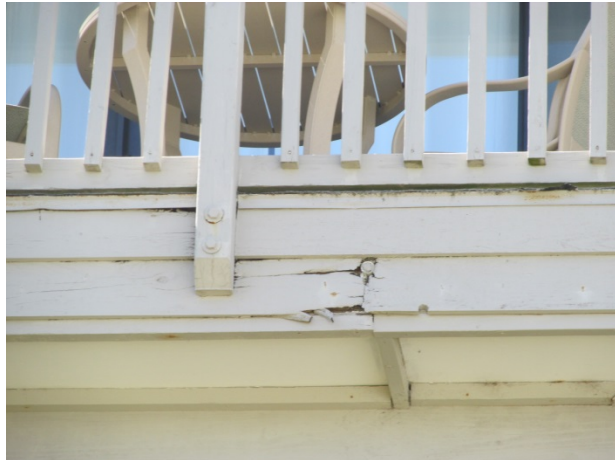
Condition: Good overall with isolated deterioration evident

Isolated fascia deterioration at the balconies

- Annual inspections to identify and correct any unsafe conditions
- Securing of loose fasteners and replacement of deteriorated fasteners
- Replacement of deteriorated wood components
- Power washing with an algaecide and application of a sealer/stain

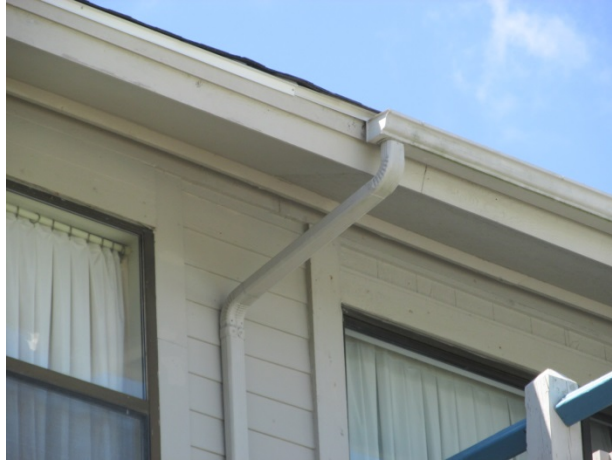
Condition: Good overall

Typical gutter and downspout assembly

Component Detail Notes: Downspouts that discharge directly onto roofs cause premature deterioration of the roofs due to the high concentration of storm water. We recommend either routing these downspouts directly to the ground, connecting the downspouts to the gutters of the lower roof or distributing the storm water discharge over a large area.

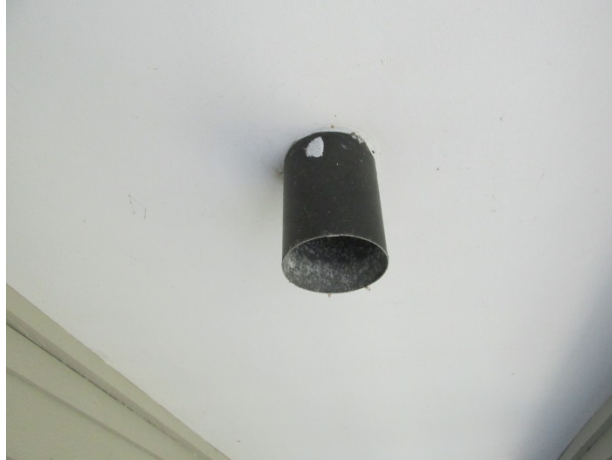
Condition: Fair overall

Ceiling light fixture

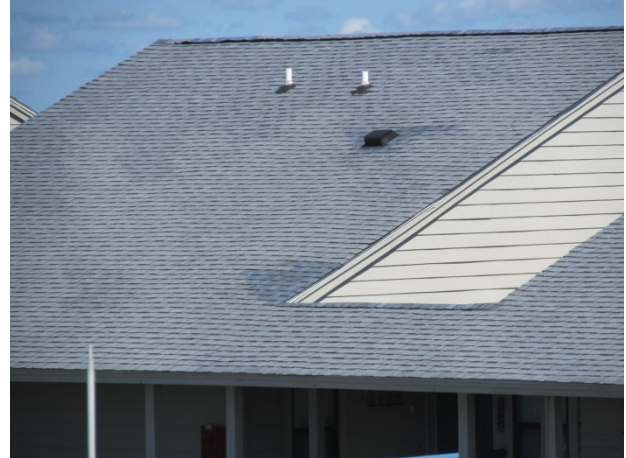
Isolated replaced sections of shingles

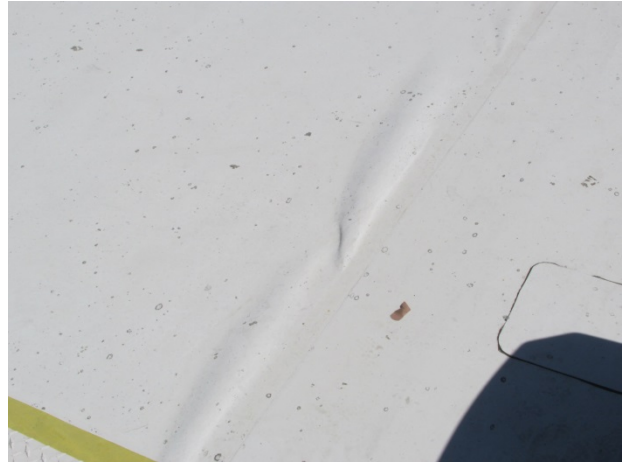
Condition: Good overall with isolated bulges and standing water

Isolated bulges at the roof

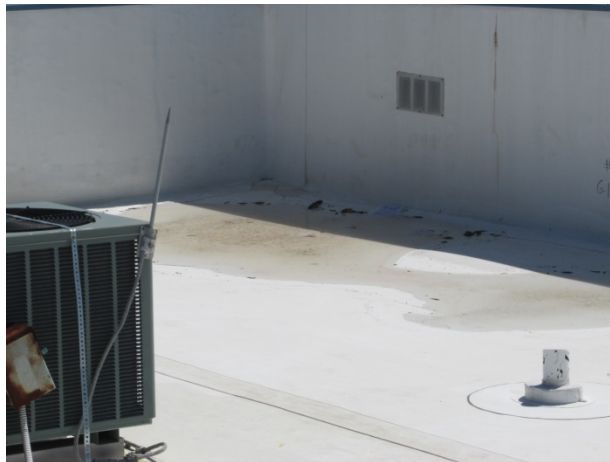
Standing water at the roof

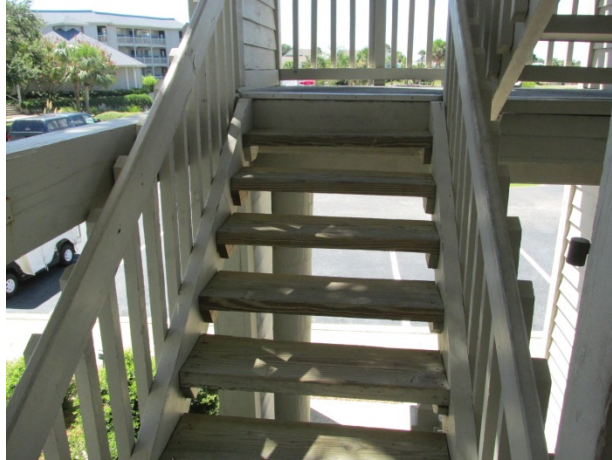
Stairs in good condition

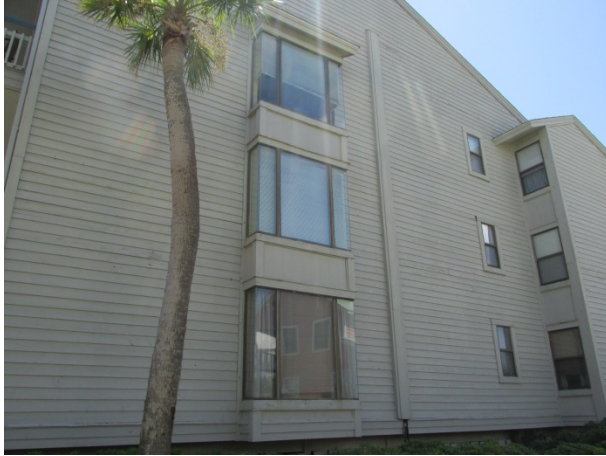
Condition: Fair- to poor-overall with deterioration and stains evident

Paint finishes in fair- to poor-condition

- Perform paint finish applications to the wood siding and trim to ensure the wood siding can reach its full useful life and prevent future costly repairs

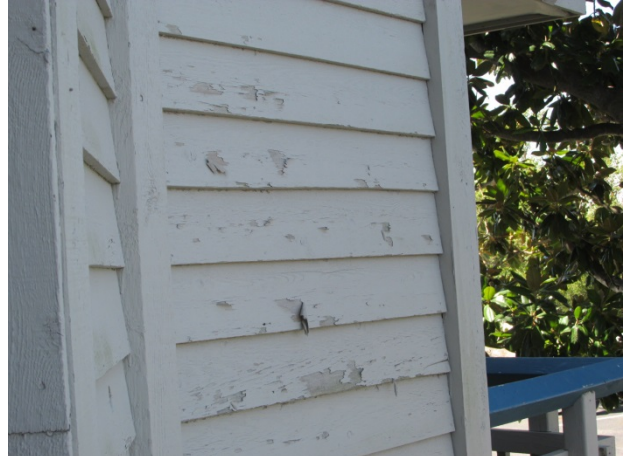
Paint finish deterioration

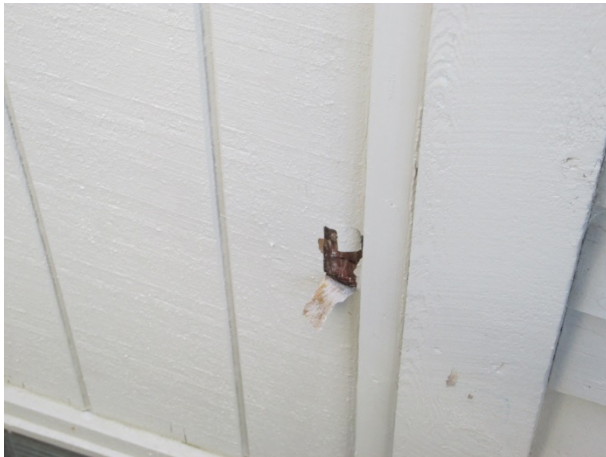
Paint finish deterioration

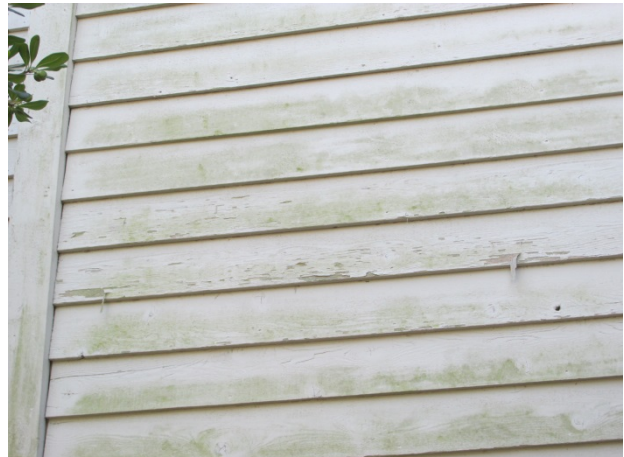
Stains

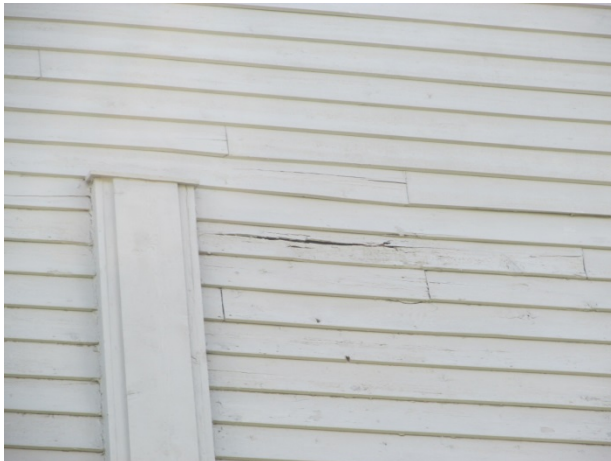
Condition: Fair overall with deterioration evident throughout the community

Wood siding deterioration

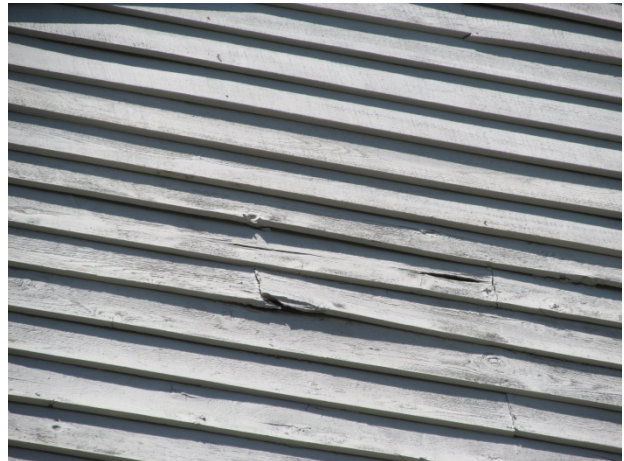
Wood siding deterioration

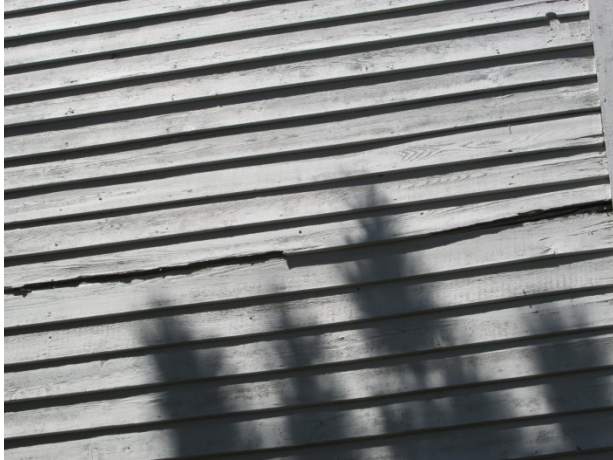
Wood siding deterioration

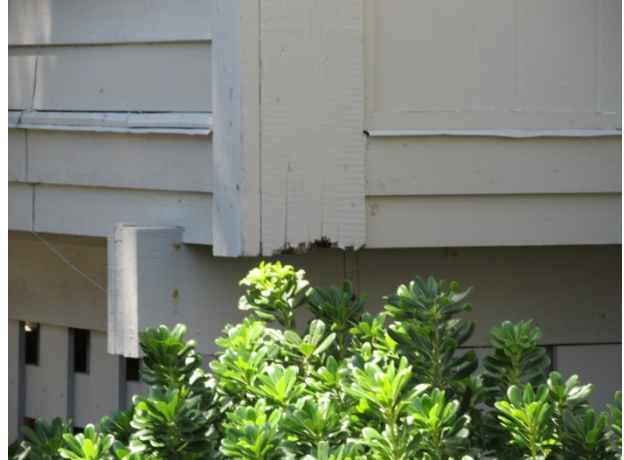
Wood trim deterioration

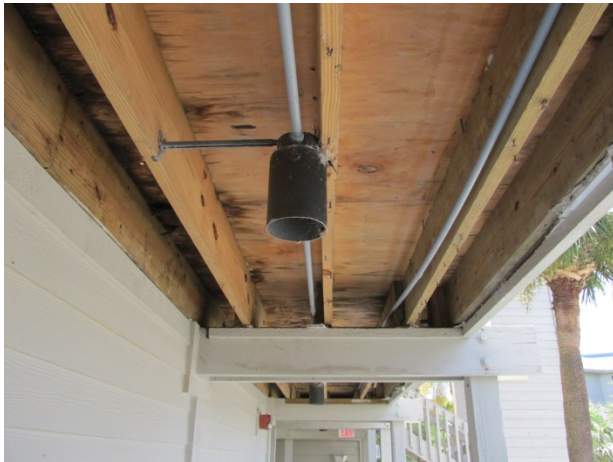
Wood soffit being replaced

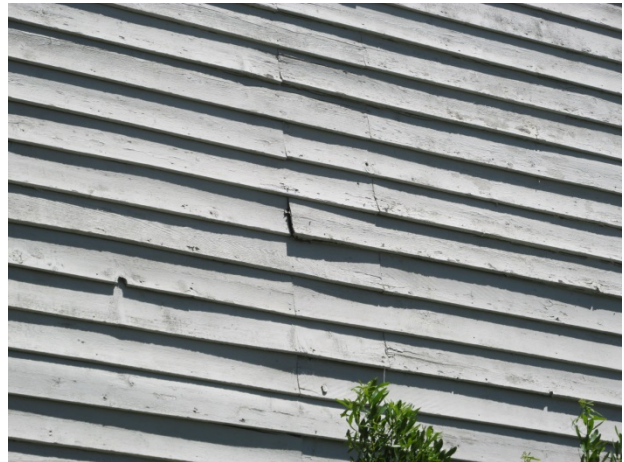
Wood siding deterioration

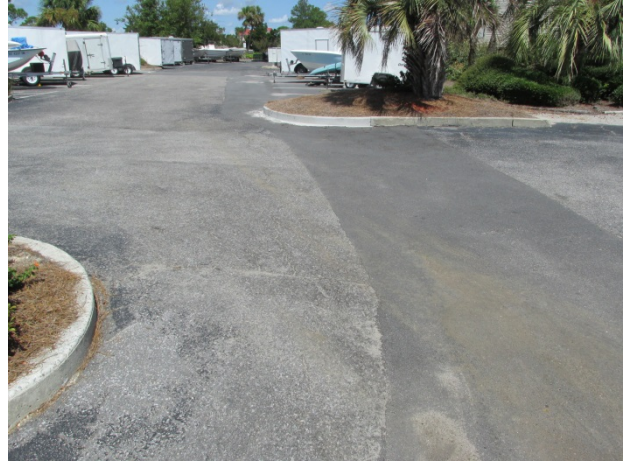
Condition: Fair overall with previously replaced sections and cracks evident

Replaced section of asphalt pavement

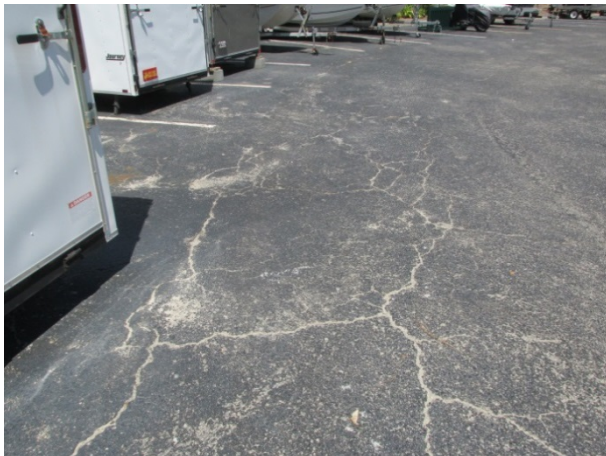
Cracks

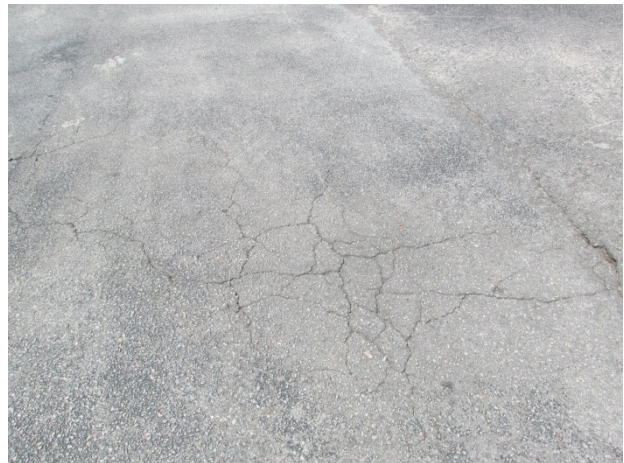
Cracks

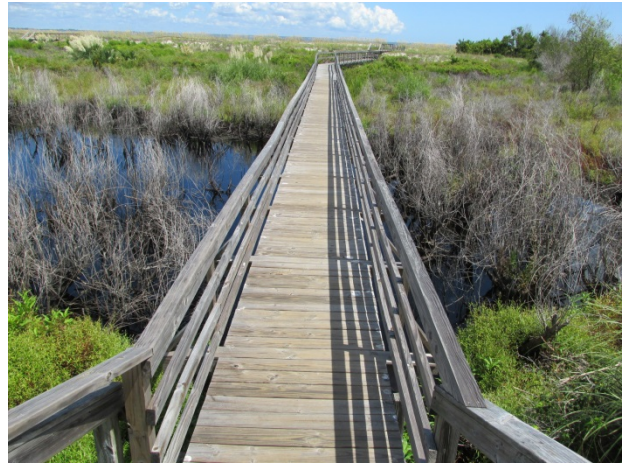
Boardwalk in good condition

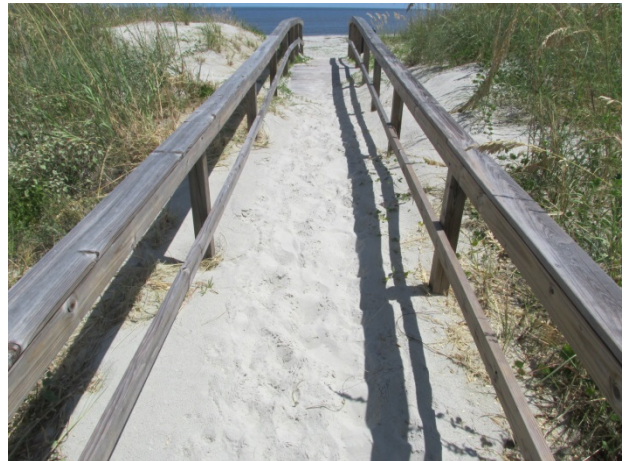
Condition: Good- to fair-overall with isolated wood deterioration and sand atop the boardwalk

Sand atop the boardwalk

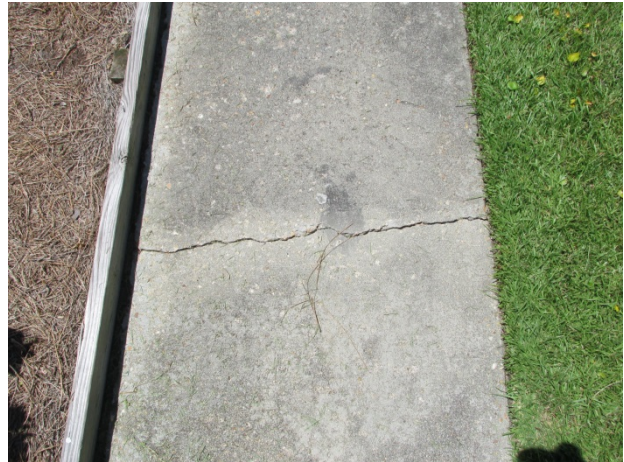
Condition: Good- to fair-overall with isolated cracks evident

Isolated cracks

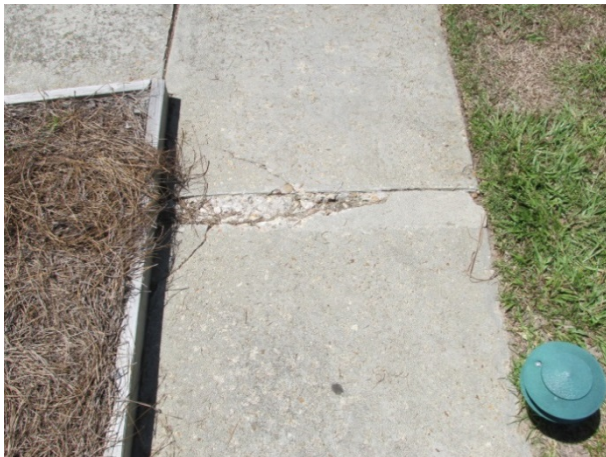
Isolated cracks

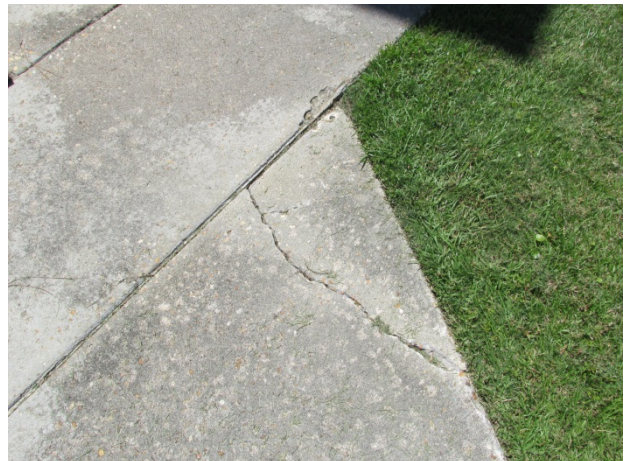
Isolated cracks

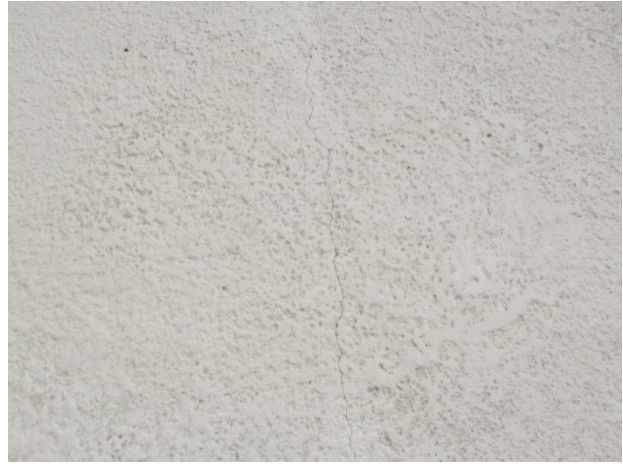
Condition: Good condition with isolated cracks evident

Isolated crack at the deck

Useful Life: The useful life of a concrete pool deck is up to 60 years or more with timely repairs. We recommend the Association conduct inspections, partial replacements and repairs to the deck every 8- to 12-years in conjunction with coating replacements.

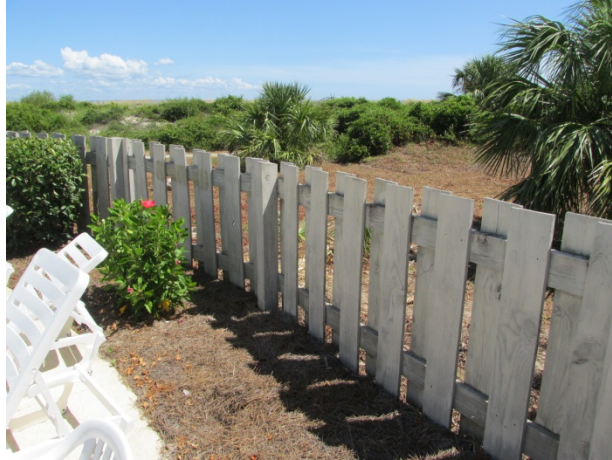
Condition: Fair overall

Wood fence at the pool
