# **UNITED ENGINEERING CONSULTANTS, INC.**

August 26, 2026  
Project No: 25-1441

Subject: **Building Condition Survey Report  
Fountain Beach Resort, Daytona Beach, Florida**

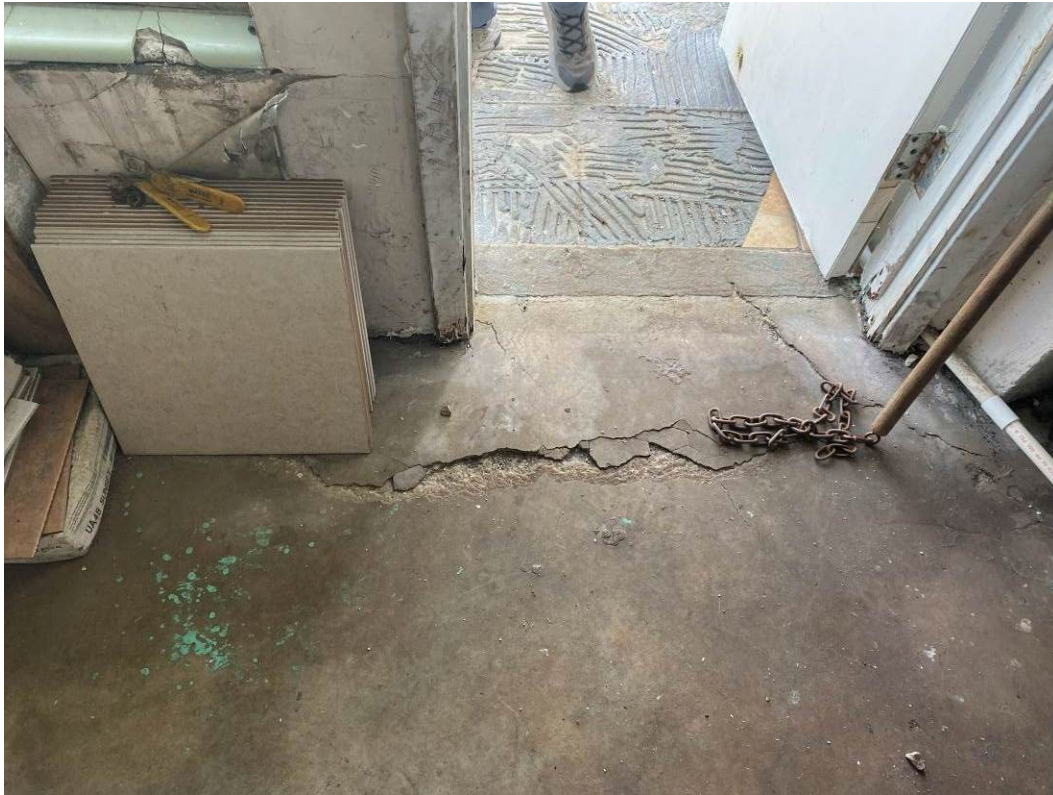
**Photograph #1 – Typical interior topside concrete spall**

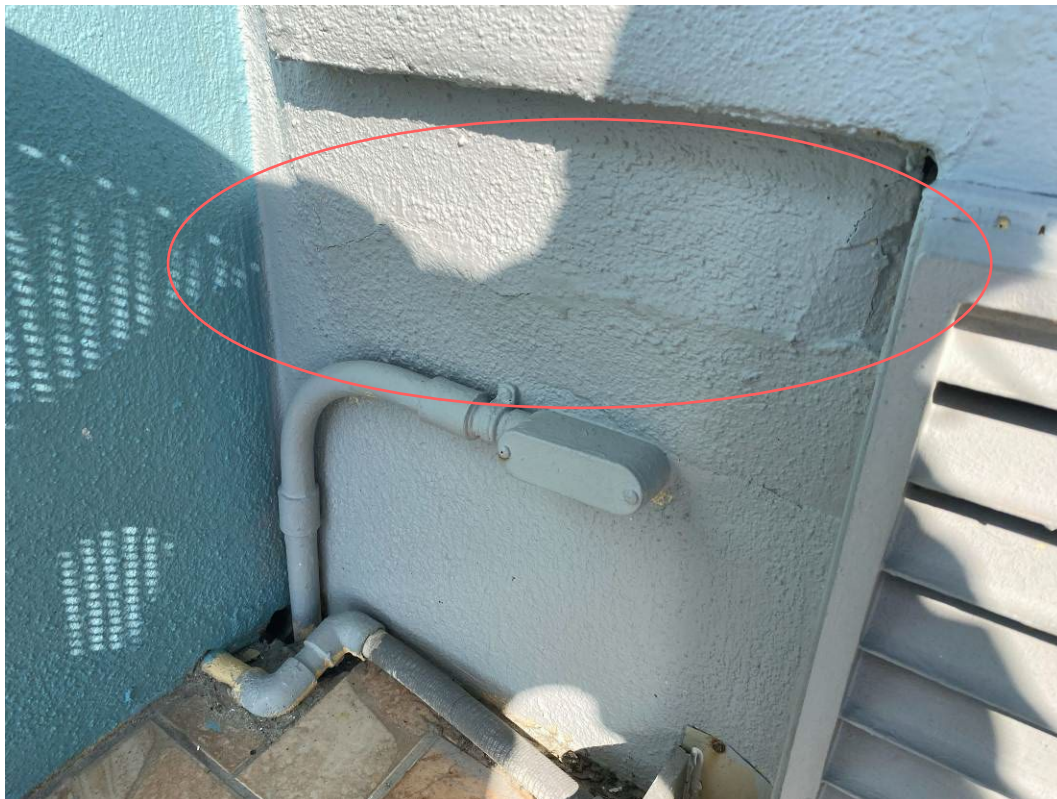
**Photograph #2 – Typical concrete wall spall**

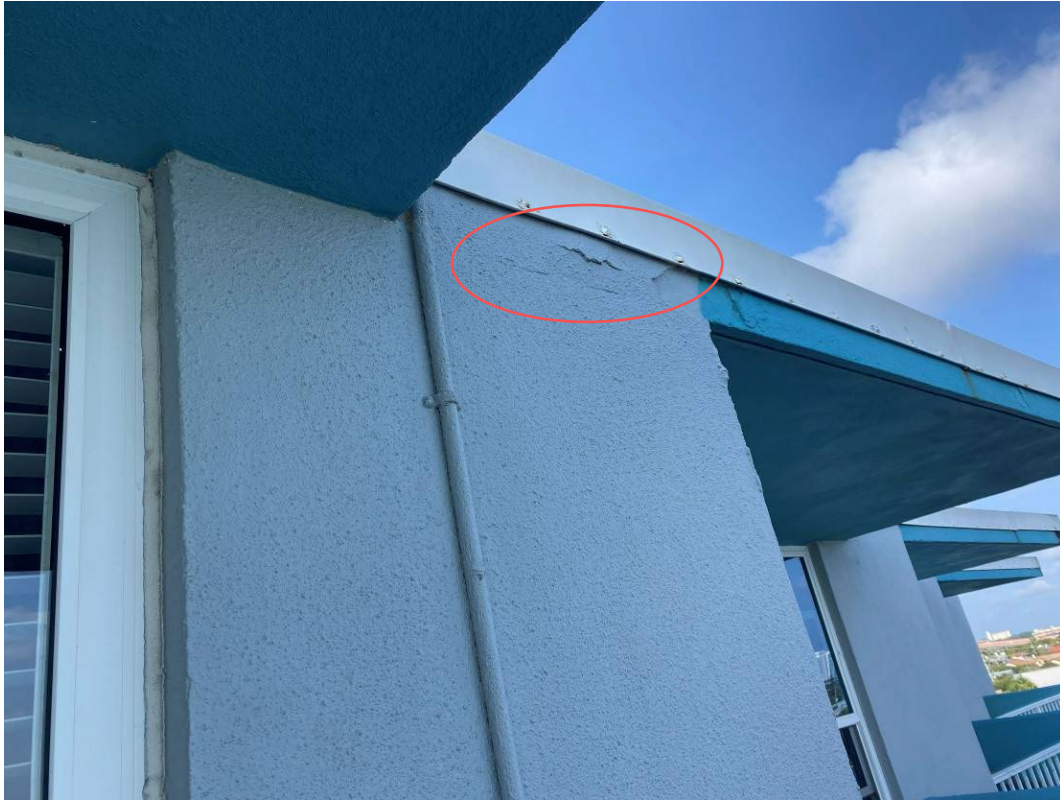
**Photograph #3 – Typical concrete slab edge spall**

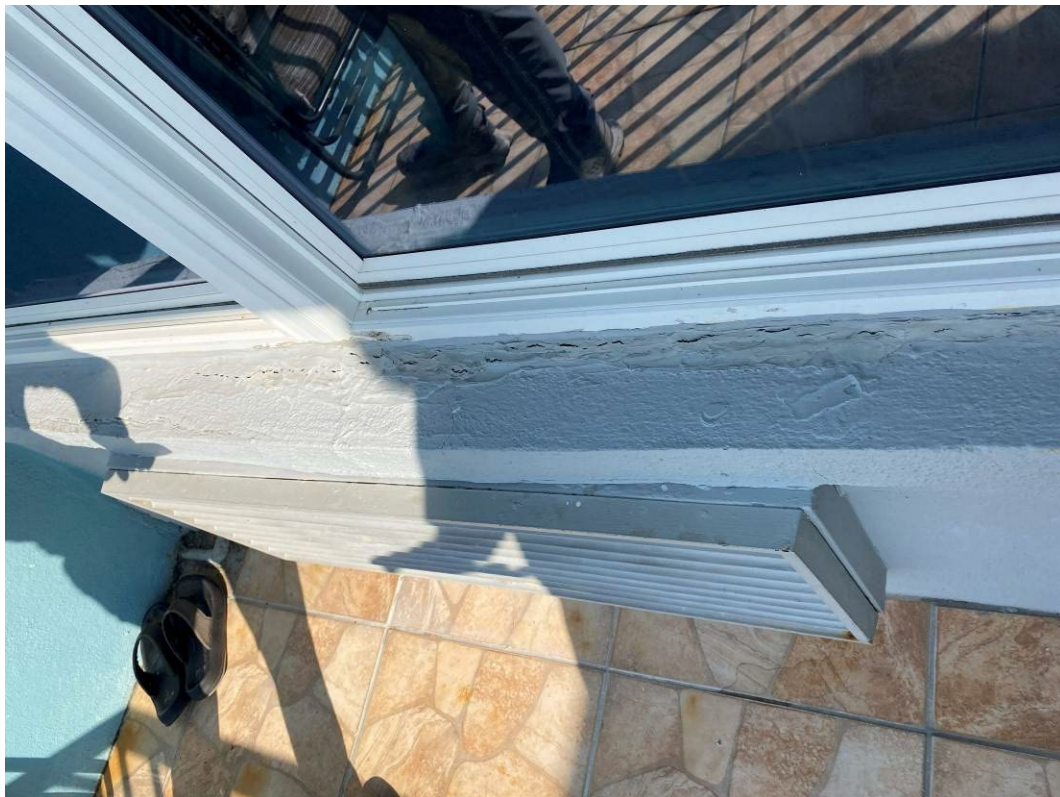
**Photograph #4 – Typical window sill spall**

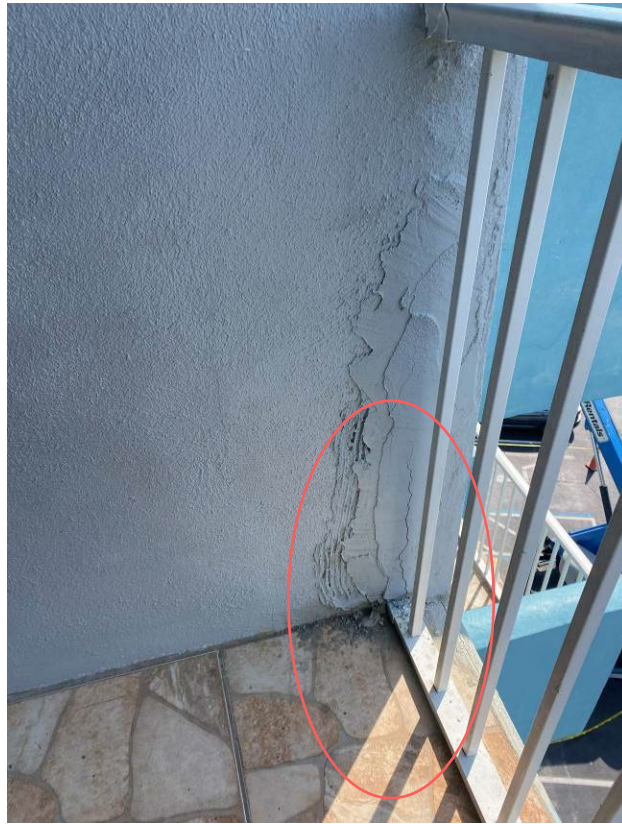
**Photograph #5 – Typical concrete wall spall**

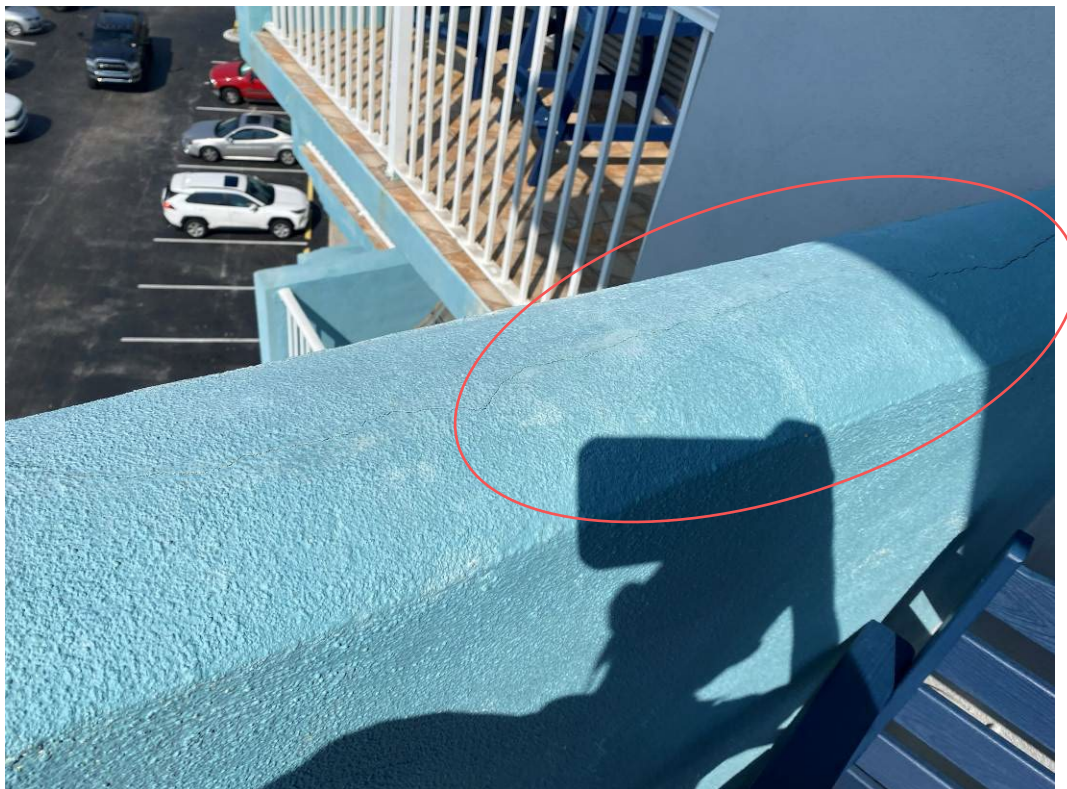
**Photograph #6 – Typical guard wall concrete spall**

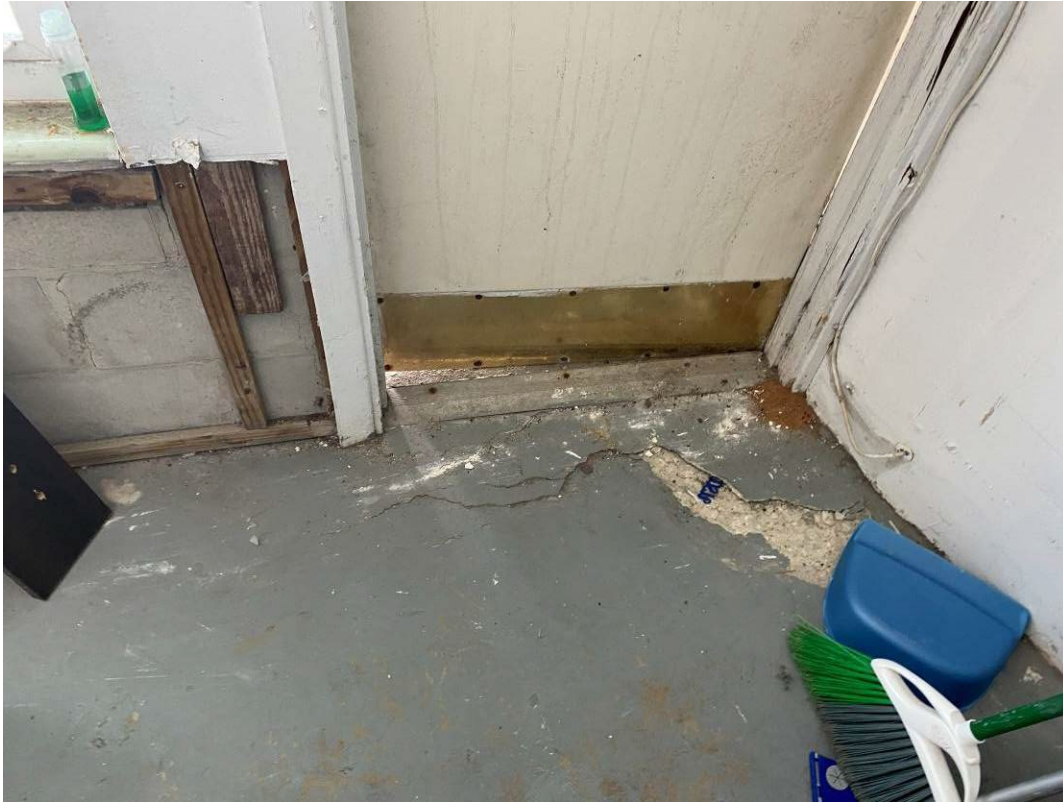
**Photograph #7 – Typical interior topside concrete spall**

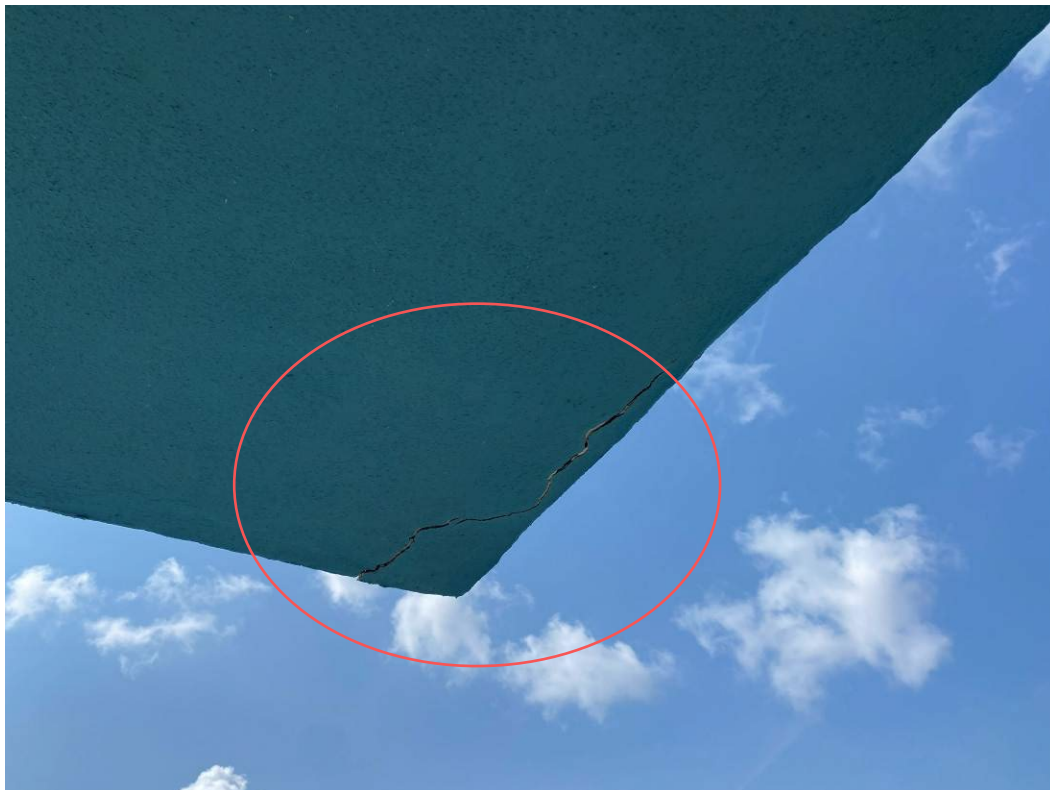
**Photograph #8 – Typical slab edge spall**

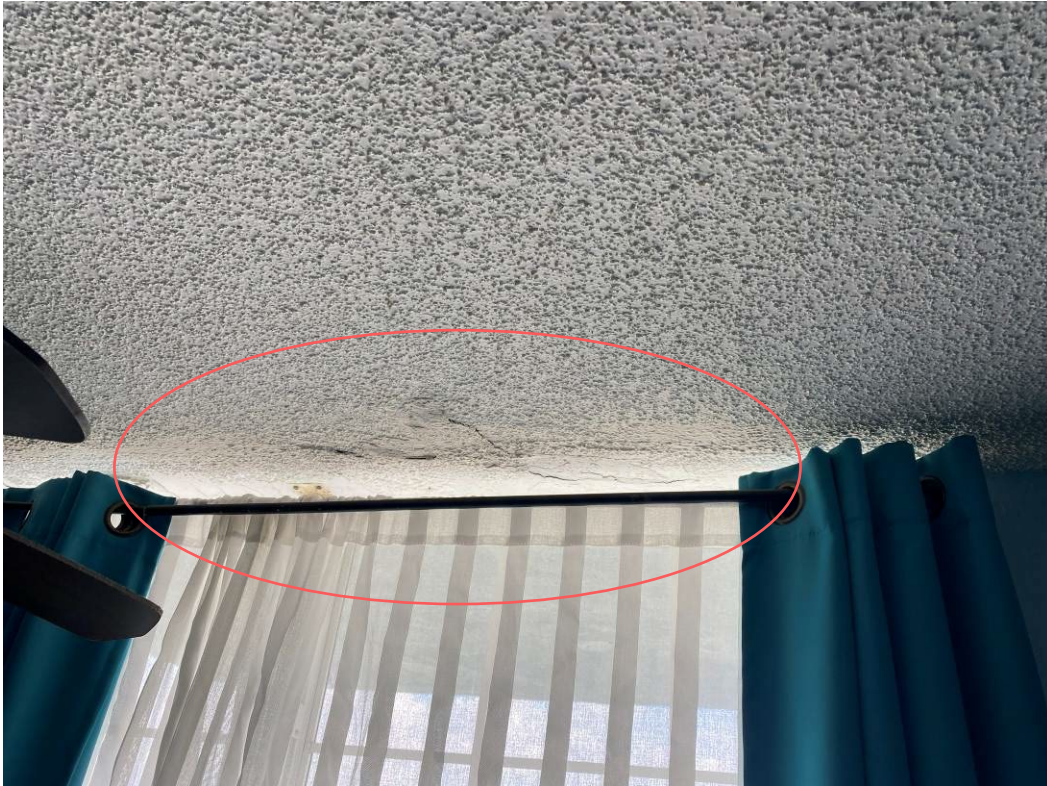
**Photograph #9 – Typical interior ceiling spall**

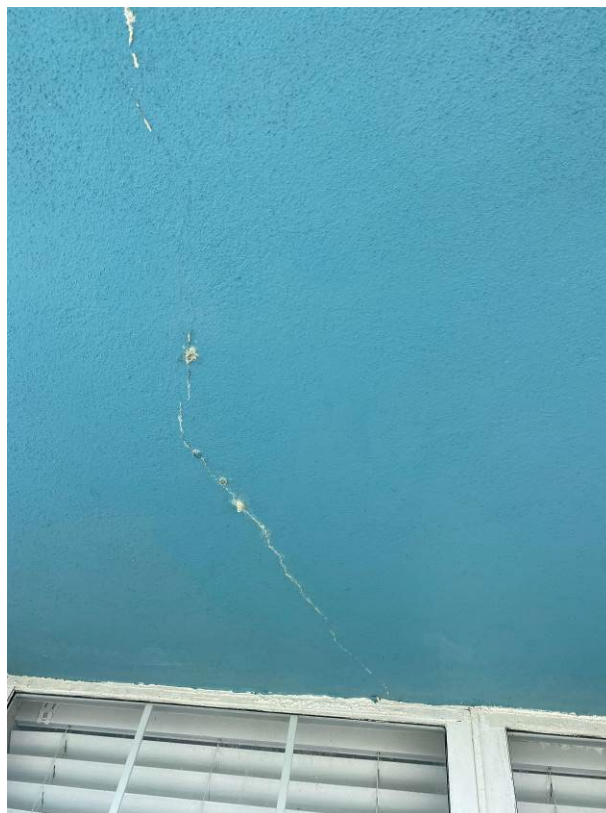
**Photograph #10 – Typical concrete ceiling damage and stalactites**

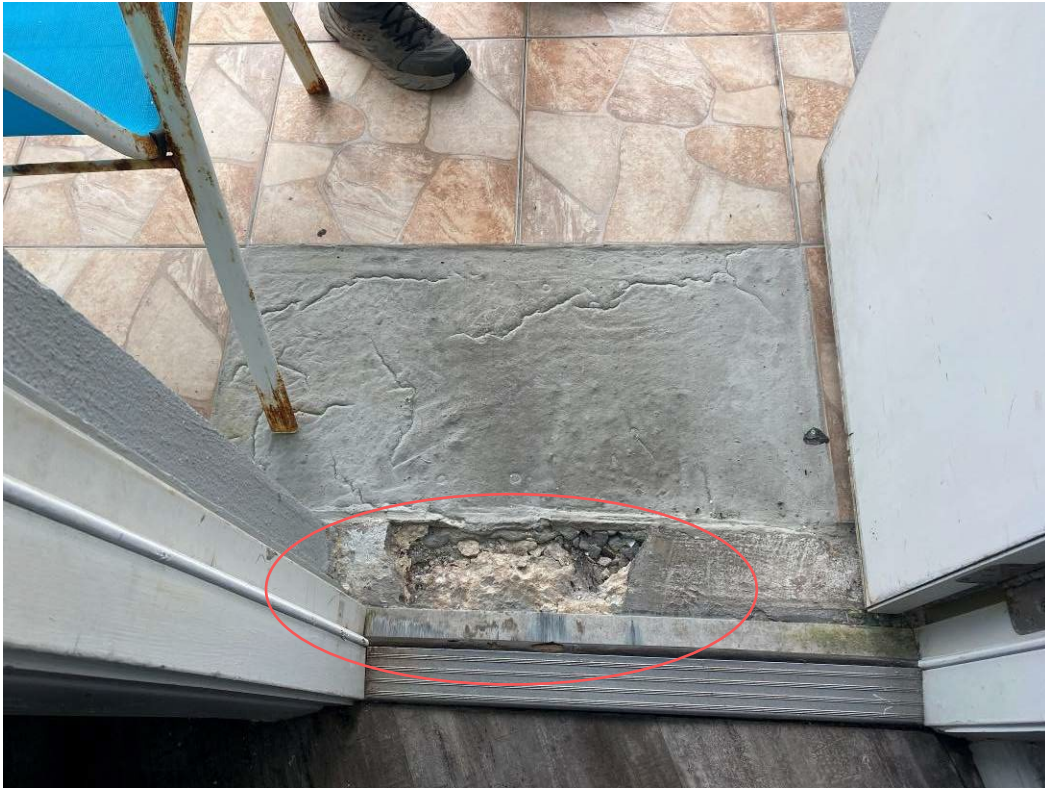
**Photograph #11 – Typical topside concrete damage**

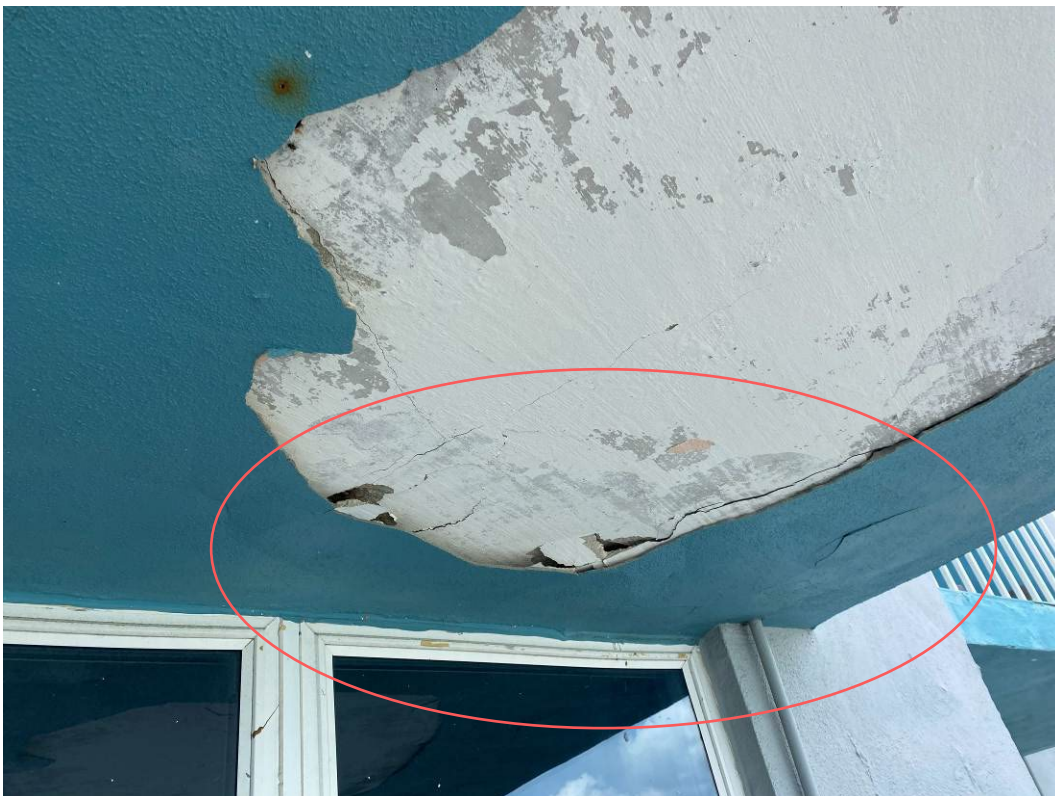
**Photograph #12 – Typical ceiling spalling**

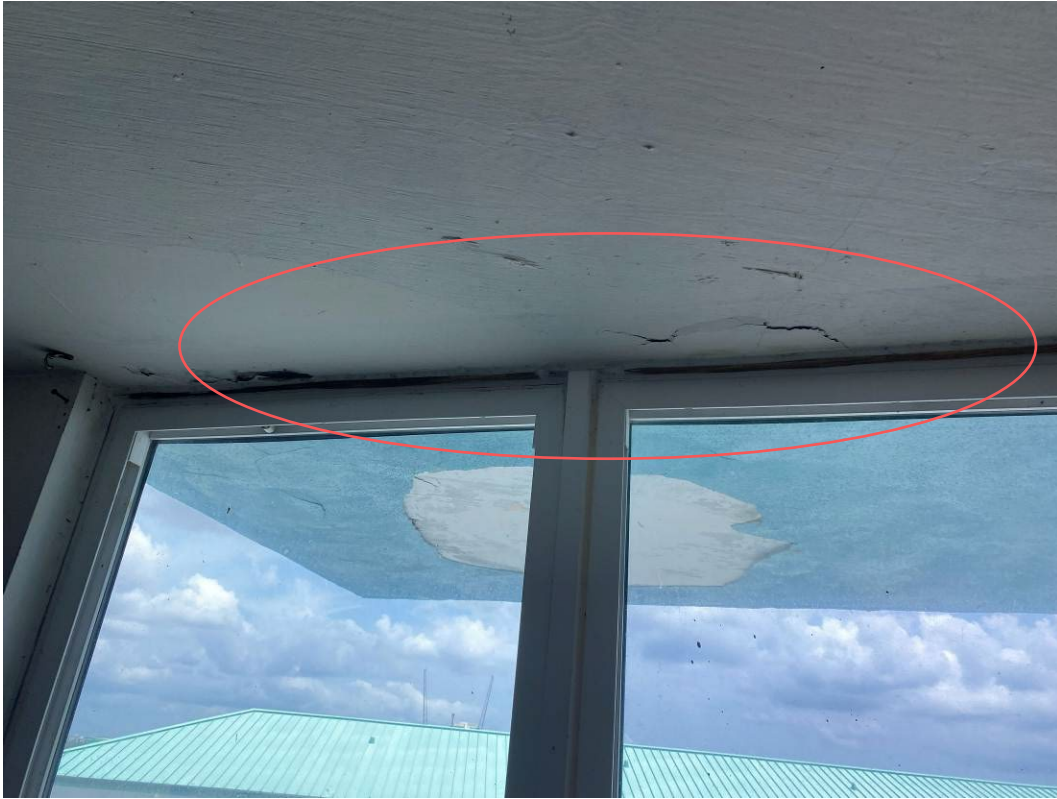
**Photograph #13 – Typical interior ceiling spalling**

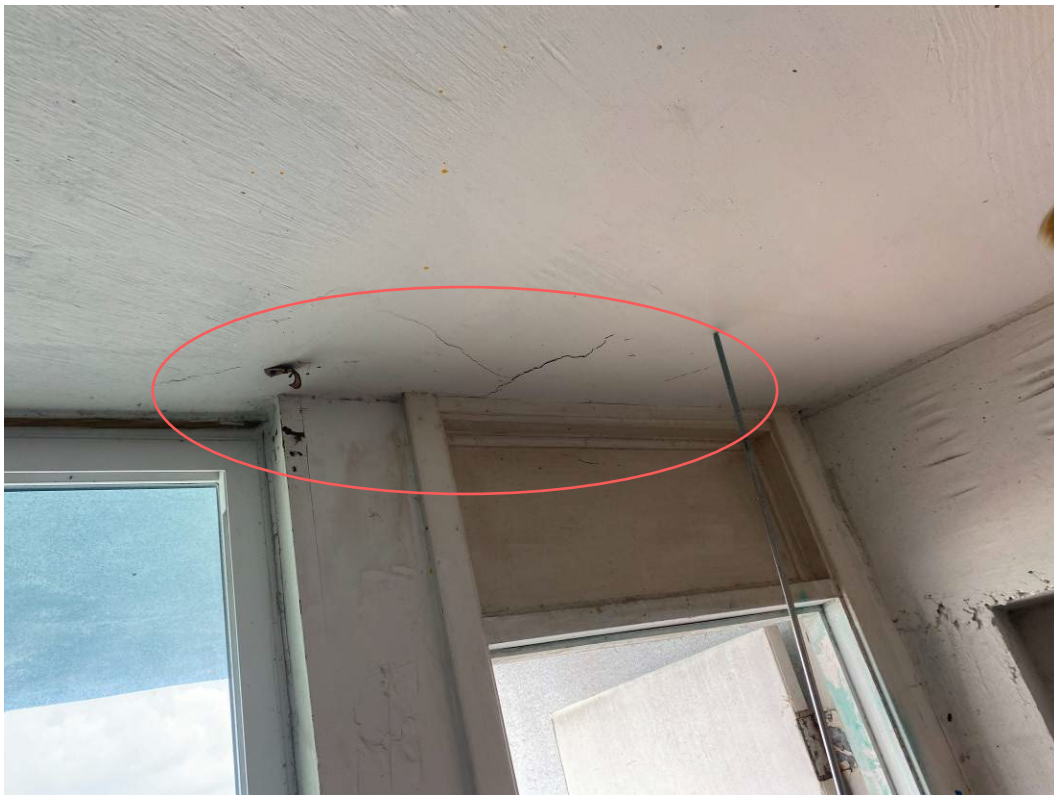
**Photograph #14 – Typical interior ceiling concrete spalling**

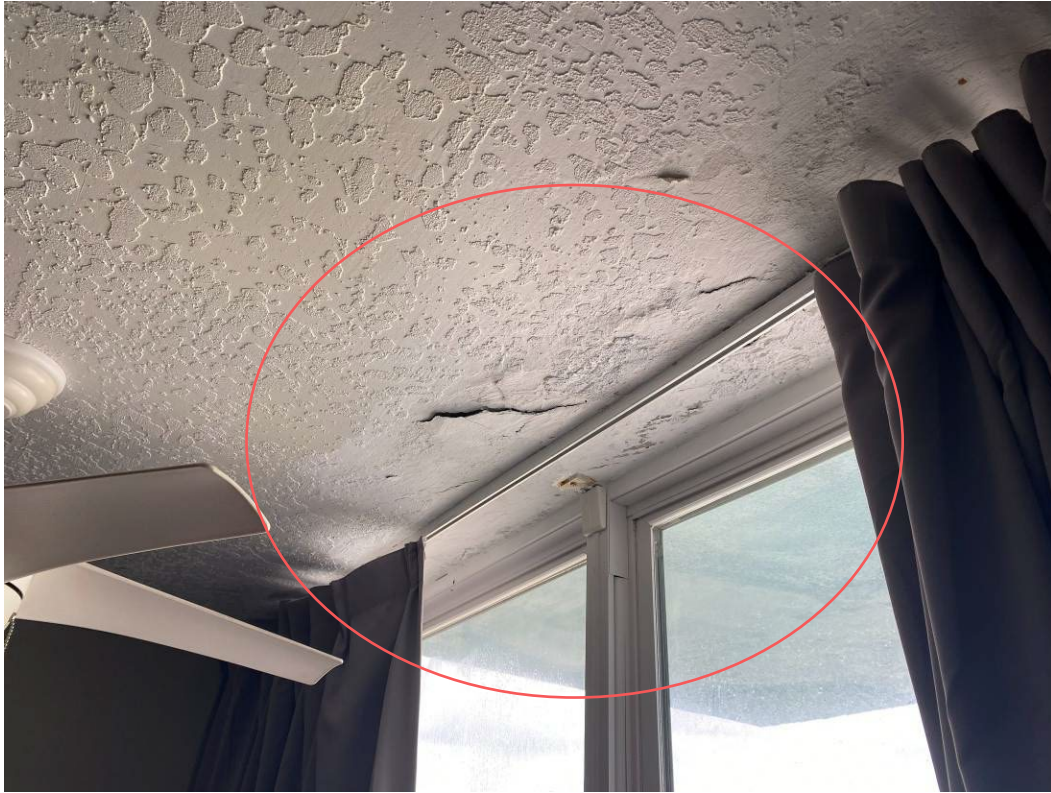
**Photograph #15 – Typical interior ceiling concrete spalling**

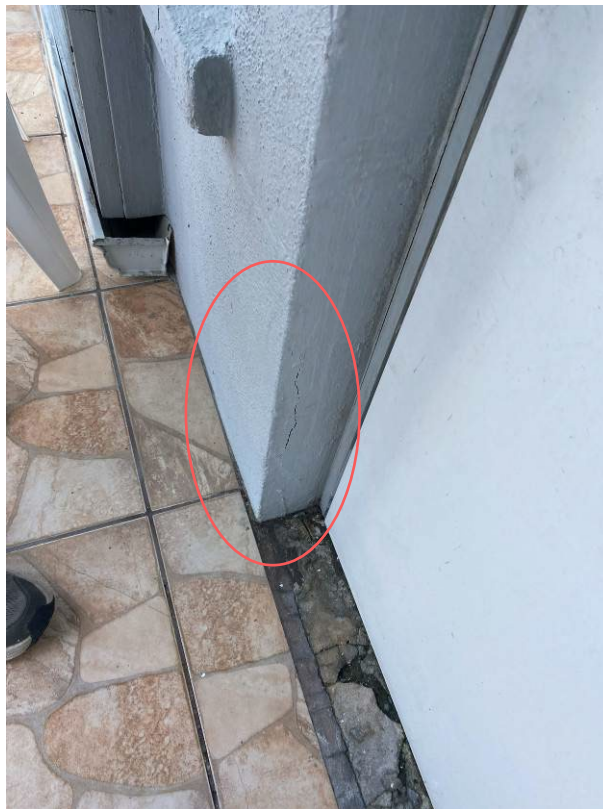
**Photograph #16 – Typical wall spalling**

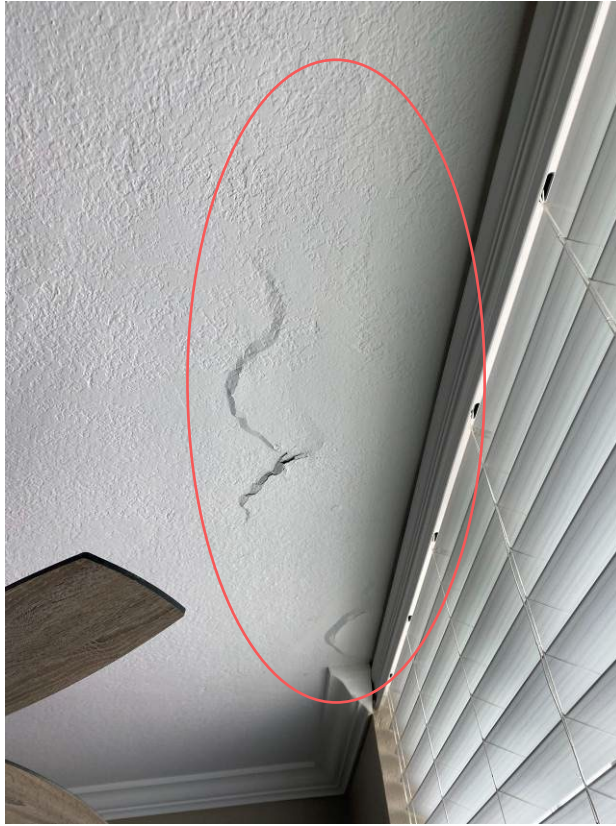
**Photograph #17 – Typical interior ceiling concrete spalling**

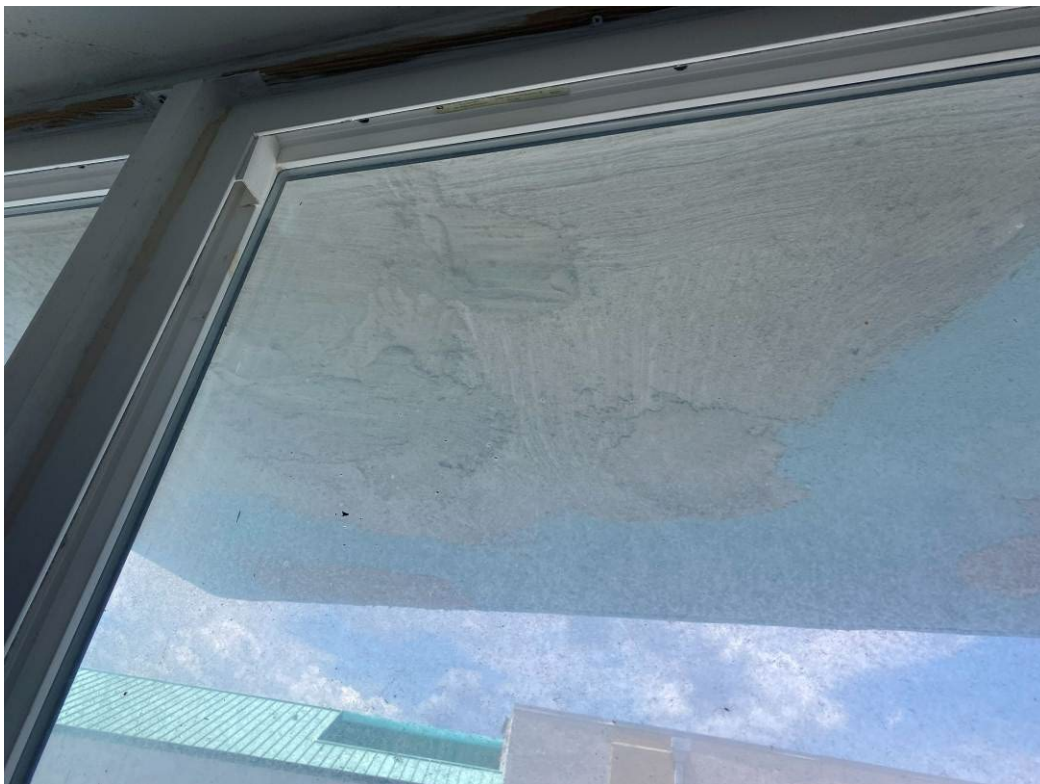
**Photograph #18 – Typical ceiling concrete spalling**

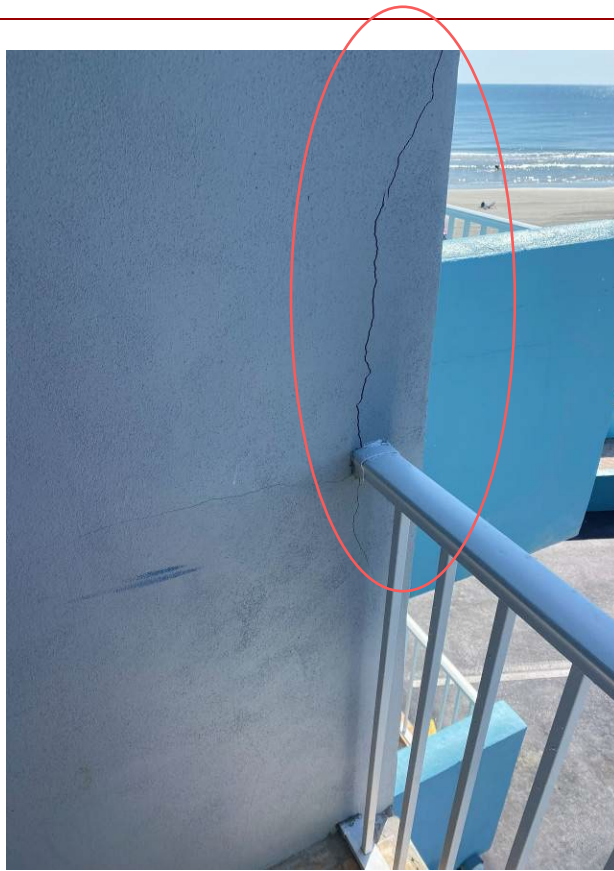
**Photograph #19 – Typical wall spalling**

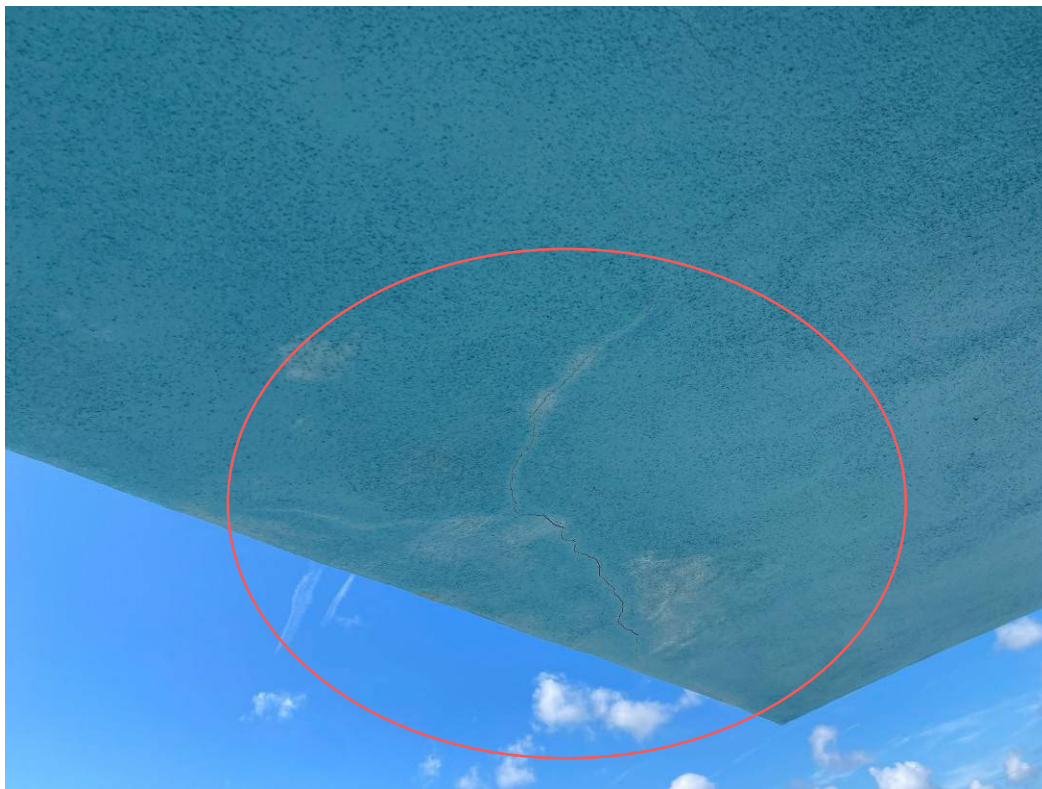
**Photograph #20 – Typical ceiling spalling**

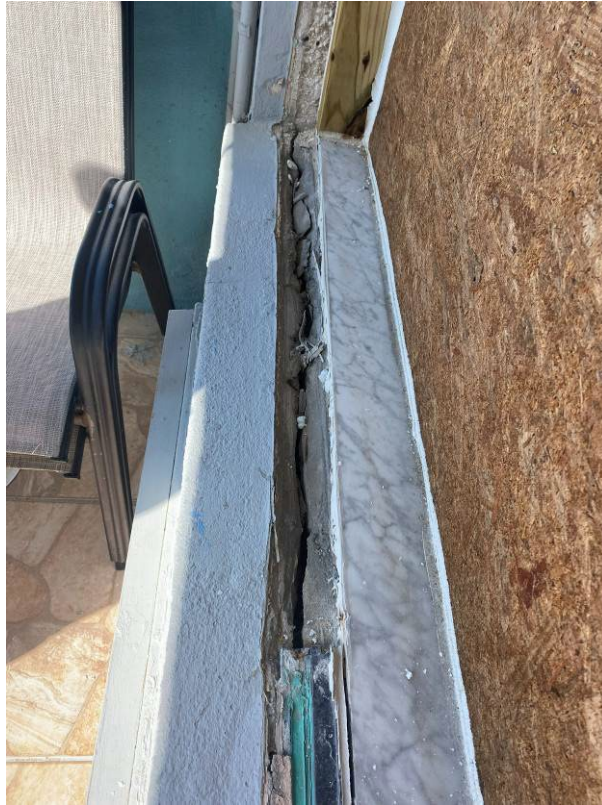
**Photograph #21 – Window sill spalling with window removed**

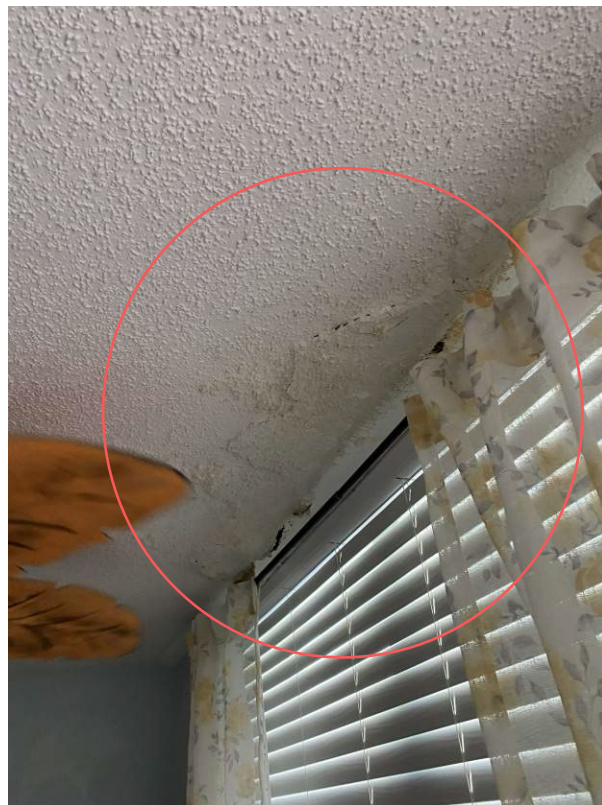
**Photograph #22 – Typical interior ceiling spalling**

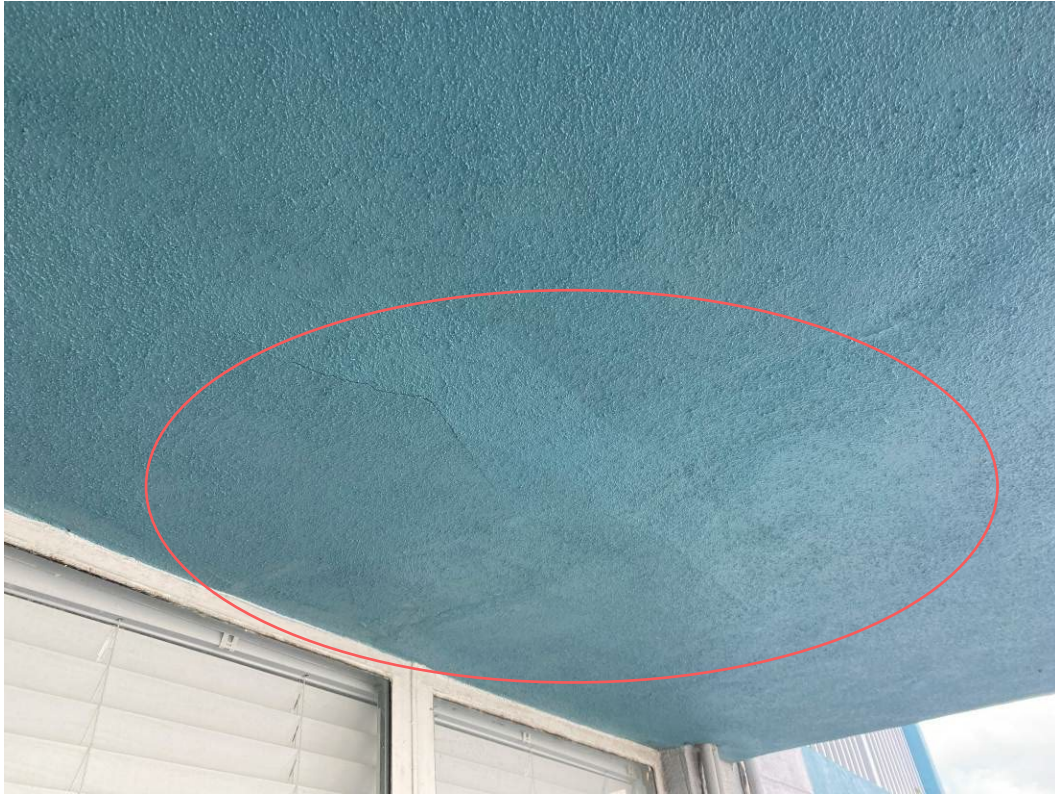
**Photograph #23 – Typical ceiling spalling**

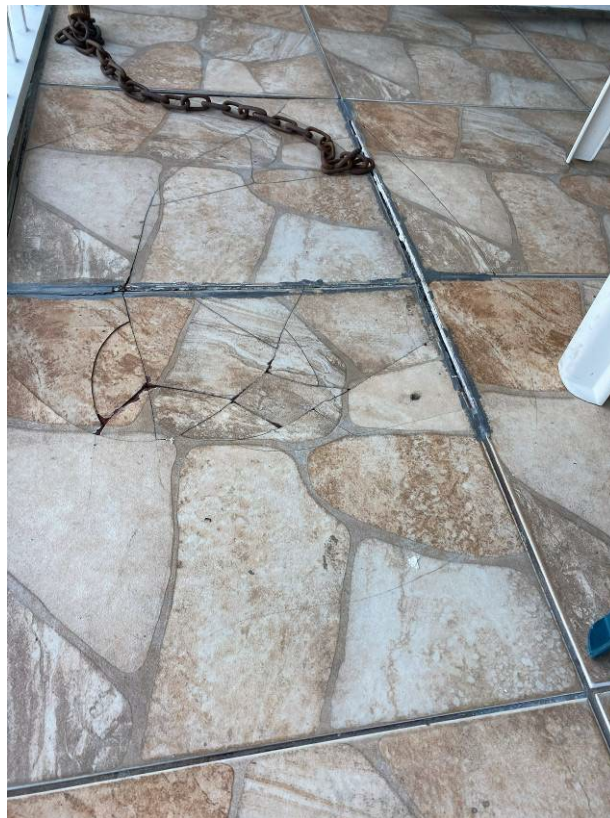
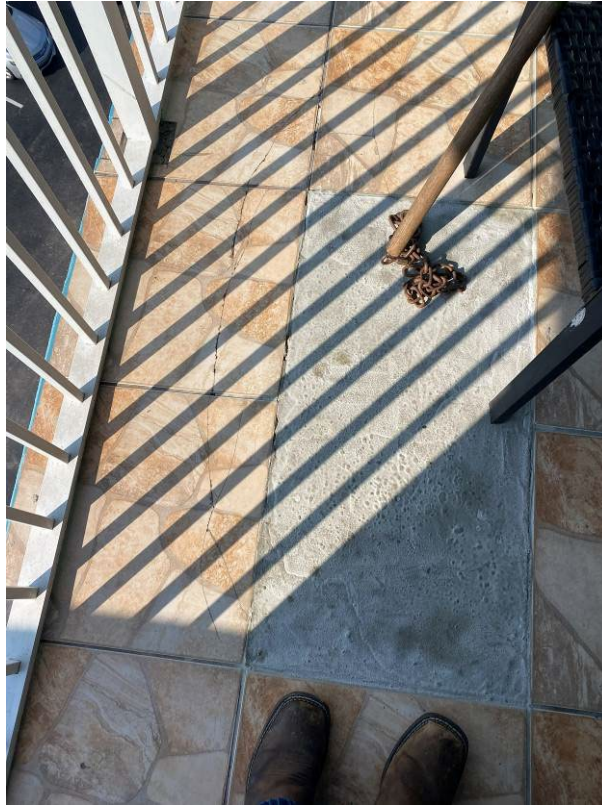
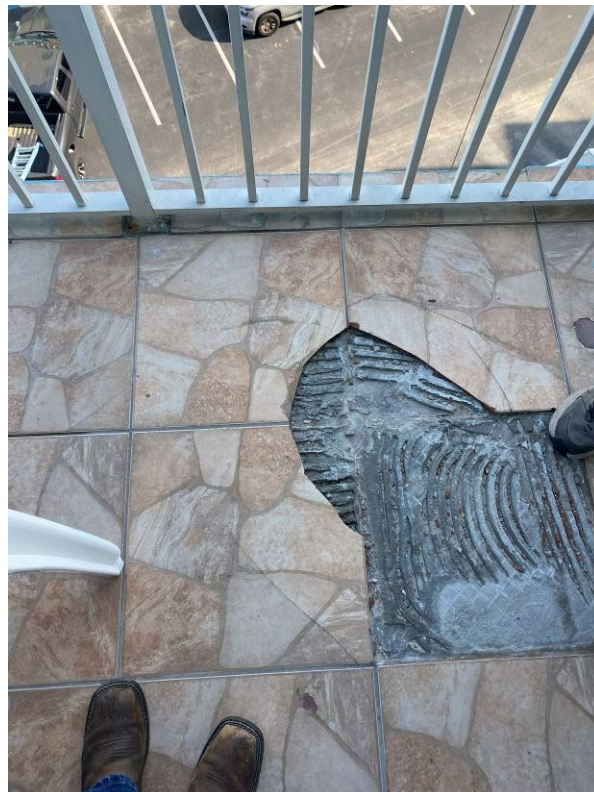
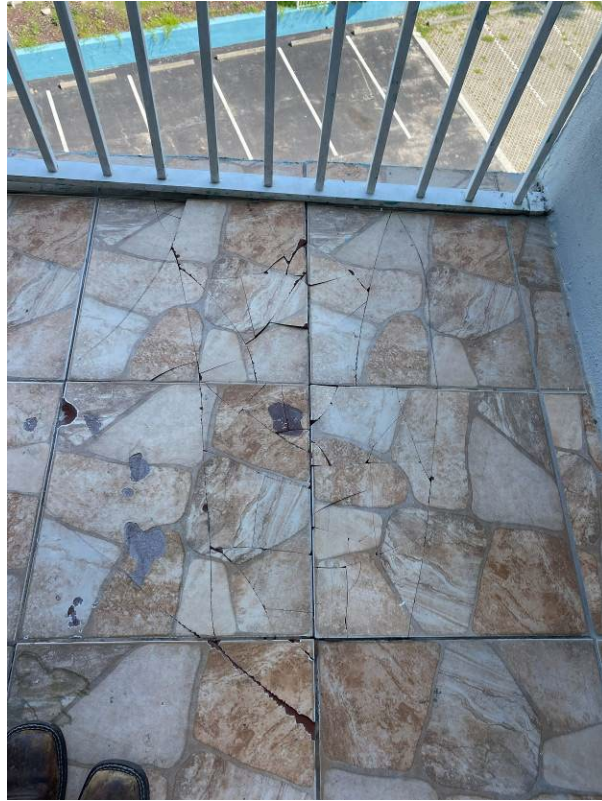
The tile on the topside of the balcony slabs was mostly delaminated. There were units where the tile was cracked and pitched which is indicative of concrete spalling below the tile.

**Photograph #24 – Typical tile cracking**

**Photograph #25 – Typical tile cracking**

**Photograph #26 – Typical tile cracking**

**Photograph #27 – Typical tile cracking**

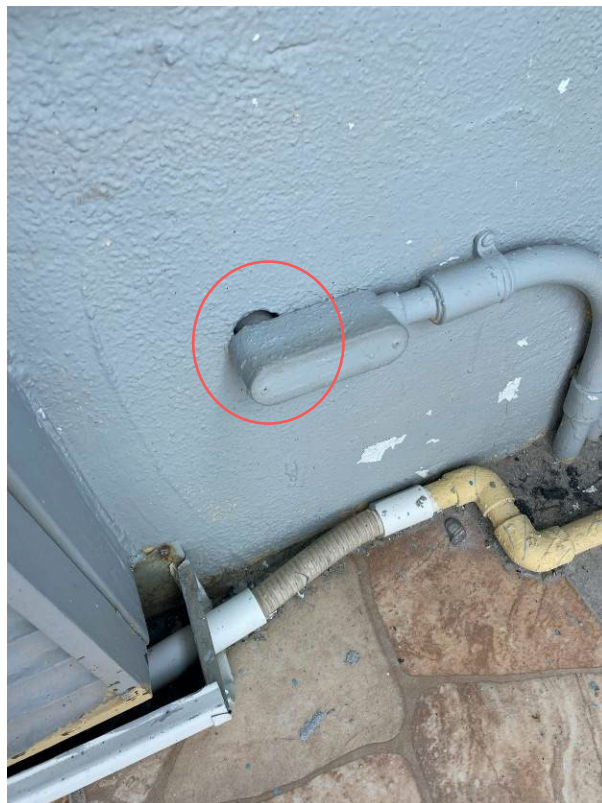
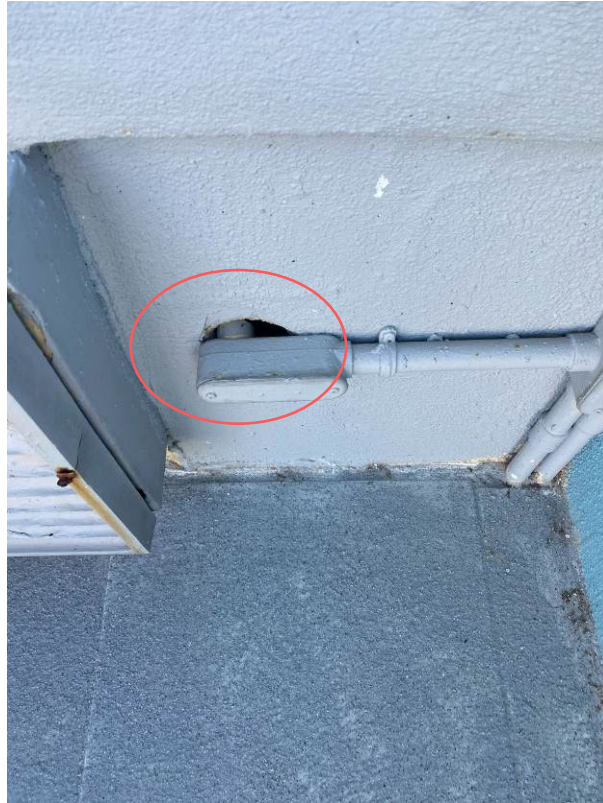
The electrical conduit that runs into the units adjacent to the PTAC units was not sealed at many units.

**Photograph #28 – Typical unsealed hole at electric penetration**

**Photograph #29 – Typical unsealed hole at electric penetration**

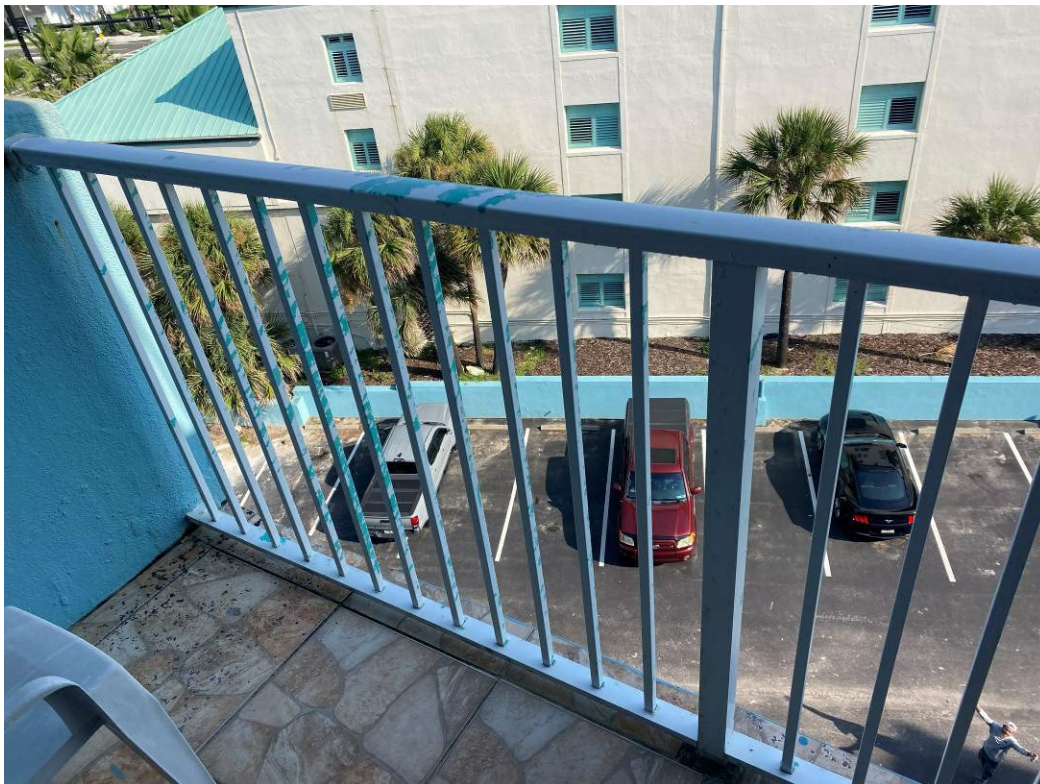
**Guardrail System:** The aluminum guardrails are in fair to poor condition. Typically, oxidation is occurring on the guardrail members. It appears that the guardrails have been painted. The coating is flaking and peeling in many areas.

**Photograph #30 – Typical paint peeling on guardrail**

Based on the condition of the existing balcony guardrails, the rails should be replaced with a new surface mounted, aluminum, AAMA 2605 coated rail.
