Confidential Inspection Report
2468 Sample Lane
Elkins Park, PA 19027

Prepared for: Somebody Sample

Prepared by: Abundant Home Inspection Services
7715 Crittenden Street #315
Philadelphia, PA 19118
888-808-9542 info@abundanthomeinspection.com

July 17, 2008

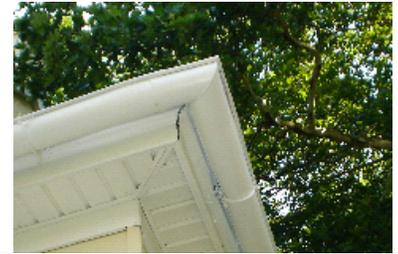
Serviceable. Wood. Metal. Vinyl. Fascia loose at: the right side corner of the lower roof to the addition (facing the street). **(Maint.)**

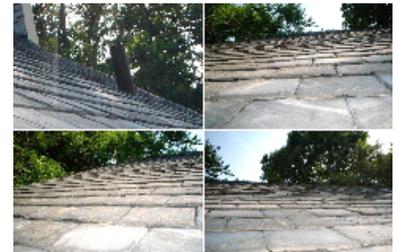
At the front the roofing materials appear to be in serviceable condition at time of inspection. Trimming of tree branches away from the roof is highly recommended. (Maint.)
Rear of the main roof was only partially viewed from the ground with binocular due to trees. Missing/loose slate shingle is present at the rear right side of the home. This condition will eventually cause water damage to the roof framing and interior ceiling and wall. Recommend repair/replacement and further evaluation by a licensed roof with experience with slate roofs. (Maint.),(Verify)

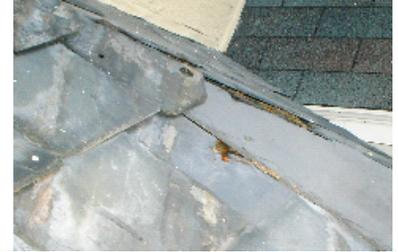
There are several crack, damaged and loose tiles. The sheathing is exposed. Recommend repair/replacement to prevent water damage to the interior ceiling and wall. **(Verify)**

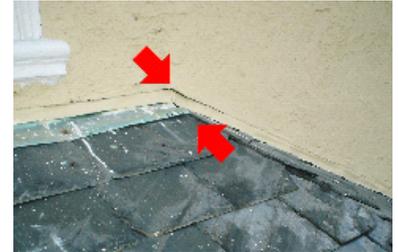
Flashing is loose at the front left, 1st floor dormer. Caulking/sealing of all flashings is recommended. **(Maint.) (Verify)**

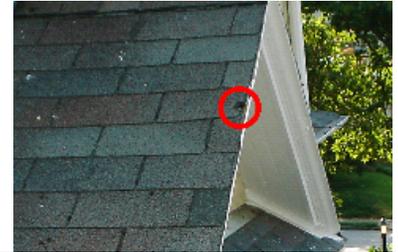
Roofing materials appear to be in serviceable condition at time of inspection. EXCEPT: There is a damaged shingle at the left side about 3/4 up. Recommend repair/replacement. **(Maint.)**

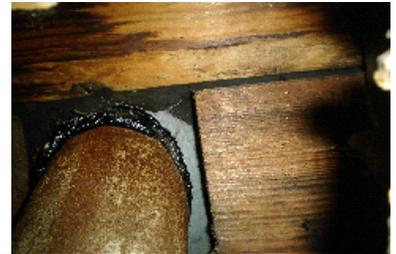
Moisture stains present on the roof sheathing around the plumbing pipe vent. Those stains that could safely be reached tested moist to wet at time of inspection, indicating recent or ongoing leakage from above. (Maint.)(Verify)

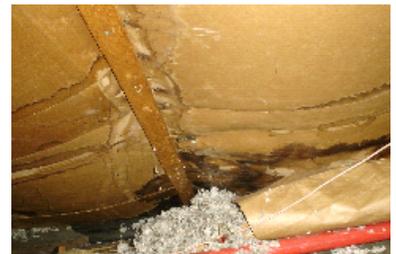
Insulation is wet at: the lower left side. This condition can lead to mold build up in the attic. Recommend removal to the wet insulation and replacement. (Maint.)(Verify)

Insulation is wet at: the lower left side. (Maint.)(Verify)

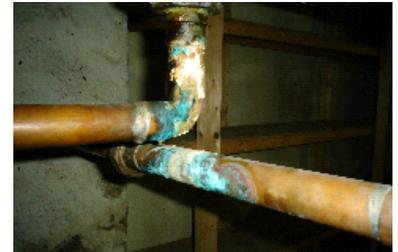
Major corrosion is noted, Leaks noted at: the elbow/fittings (where pipes are connected). (Verify)

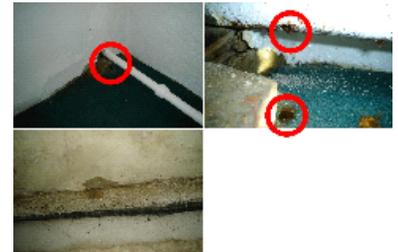
Leaks noted in the piping under the steps. Recommend repair/replacement. (Verify)
Rust/Corrosion noted in cast iron pipe at the rear of the basement at the rear wall. No leaking observed in this area however, the front portion of the cast iron pipe near the doorway has been replaced with plastic (ABS pipe). Recommend repair/replacement to prevent future leaking. (Maint)(Monitor)

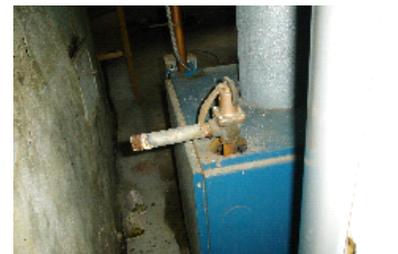
A temperature/pressure relief valve is installed as a safety feature. A discharge line is present, but should be extended to within 6" of the floor. **(Safety)** There is evidence of leaking on the discharge line indicating replacement of the temperature pressure relief valve may be necessary. **(Verify)**

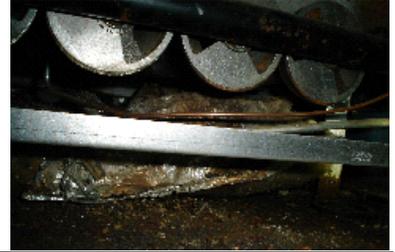
Severe rust and scale are present in the burner compartment which indicates this unit has not been properly maintained. (Verify)

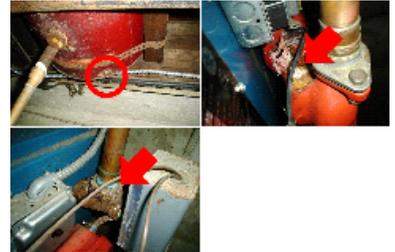
This unit should be further evaluated by an HVAC contractor for necessary cleaning, tuning and necessary repairs to enhance safety and to ensure proper working order. (Verify)

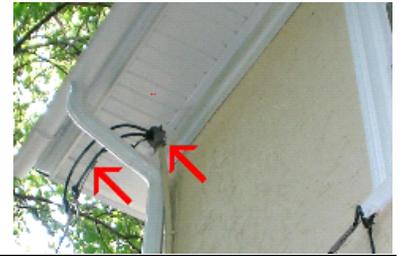
Power supply is overhead/service drop. The weather head is loose, not properly attached to the building. Recommend resealing. (Maint)(Safety)
The drip loop is not sufficient enough to allow rain water to drip off the service wiring. Drip loops are recommend in the main servicing wiring (below the weather head) so that rain water drips off the bottom of the service wiring instead of entering the weather head. Otherwise, water could flow down the wiring and into the weather head which could cause rusting and poor connections. Re-orienting of the service wiring is recommended to ensure rain water does not enter the weather head. (Maint)(Upgrade)

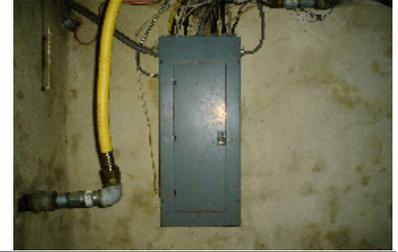
The panel is installed directly on the masonry wall. This is considered improper as this may allow for moisture to penetrate the panel. Recommend mounting onto a wood frame. (Verify)

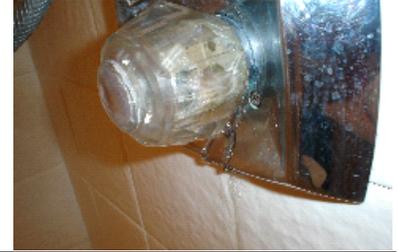
Faucet leaks around handle/valve seals. (Maint.)

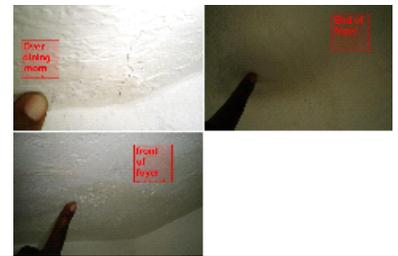
Drywall. Tile.
 Ceilings are serviceable with the exception of: Moisture stains observed in: the foyer under the master bath, in the foyer to the left just as you come into the home and in the dining room in the left side corner over the window .
 Stains tested active at time of inspection. **(Maint.)(Verify)**
 Loose wall paper noted in the master bedroom closets. **(Maint)**
