PROPERTY CONDITION REPORT

Concerning: 6575 Rambler Ct, Spring, TX 77386
(Address of Inspected Property)

By: Matthew Brading, Lic #TREC # 22654 04/01/2021
(Name of Inspector) (Date)

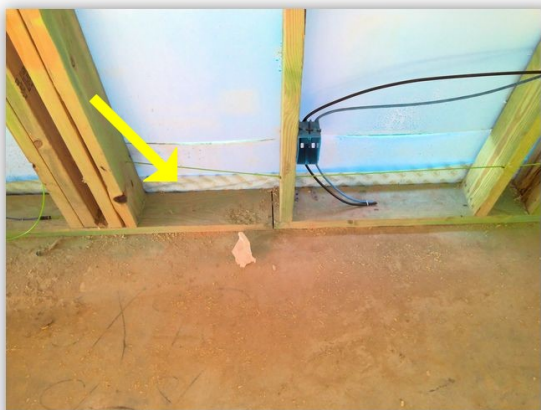
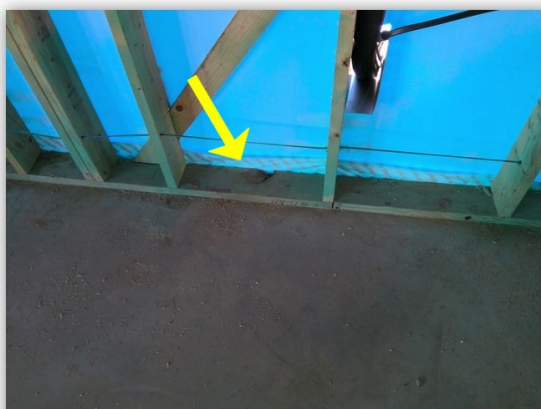
- There are not enough anchor bolts or straps in place in the hall bathroom, dining room, breakfast area and master bedroom closet. Under current code requirements bottom plates shall be anchored to the foundation with anchor bolts or strap spaced a maximum of 6 feet on center. There should be a minimum of two bolts or straps per plate section with one bolt or strap located not more than 12 inches or less than seven bolt diameters from each end of the plate section.

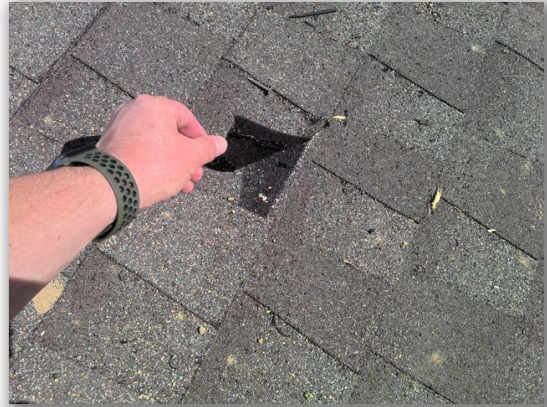
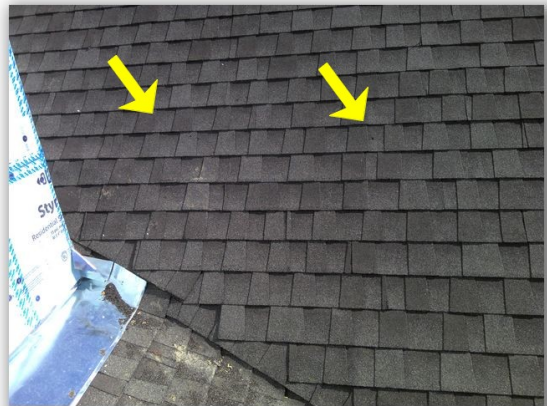
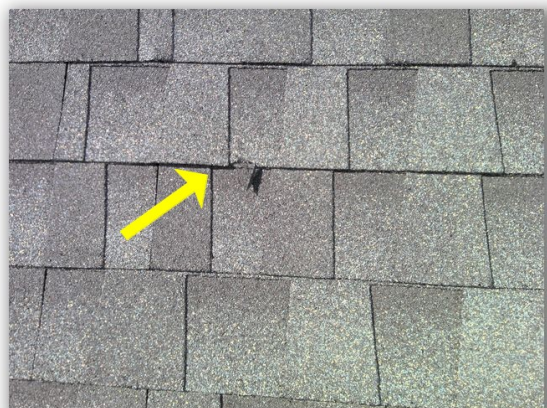
- Damaged shingles were observed on the front side of the roof structure.

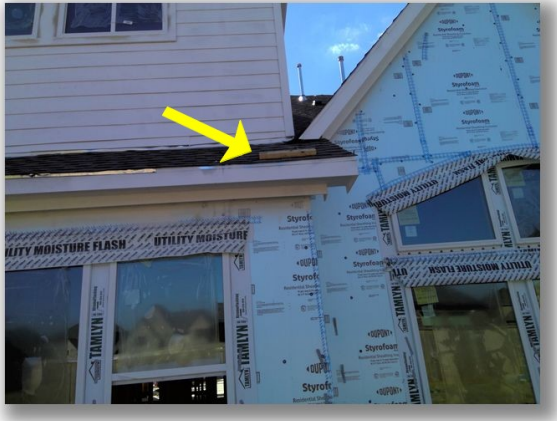
- A toe board was observed to be nailed to the shingles at the back side of the structure. Recommend removing the toe board and repairing any damaged shingles.

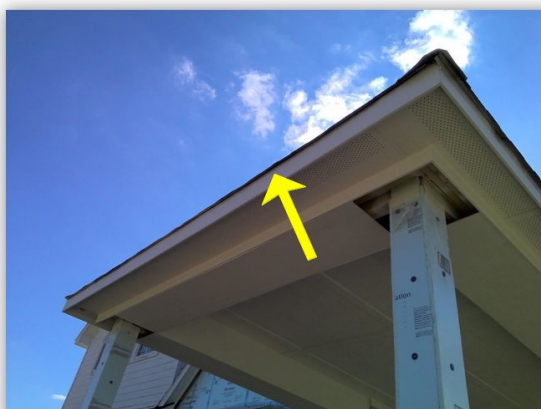
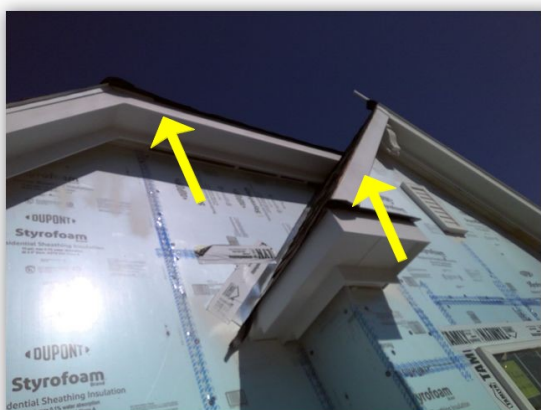
- Missing drip edge flashing observed at the front and back sides of the structure.

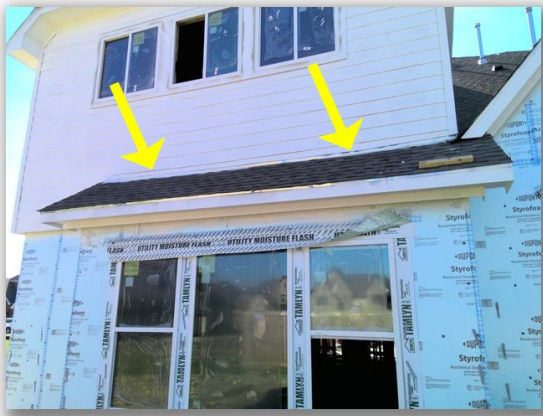
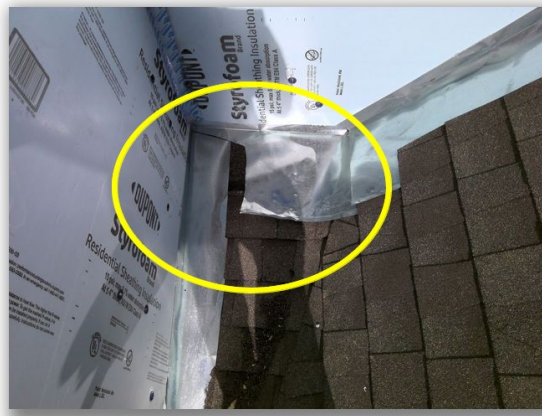
- Poorly installed flashing observed at the front and back sides of the structure.

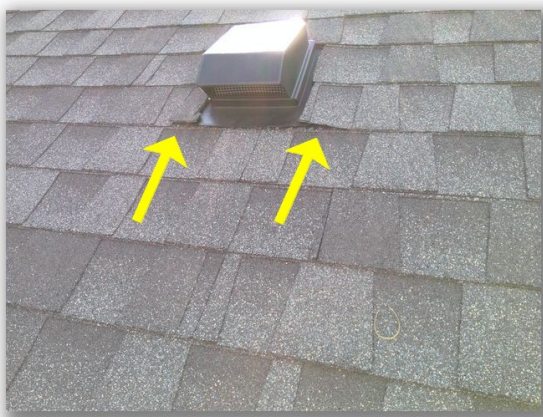
- One or more of the flashing detail flanges are not properly set into the roofing material. This condition needs to be corrected to help prevent water intrusion at this points.

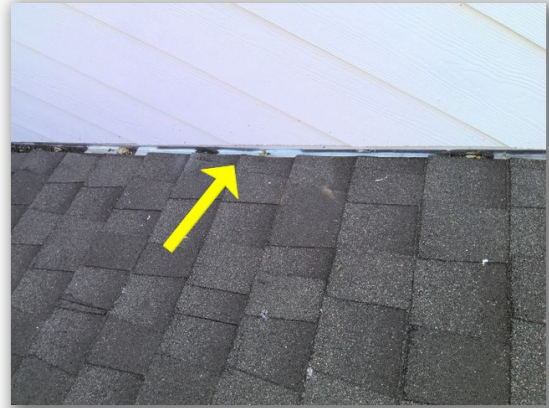
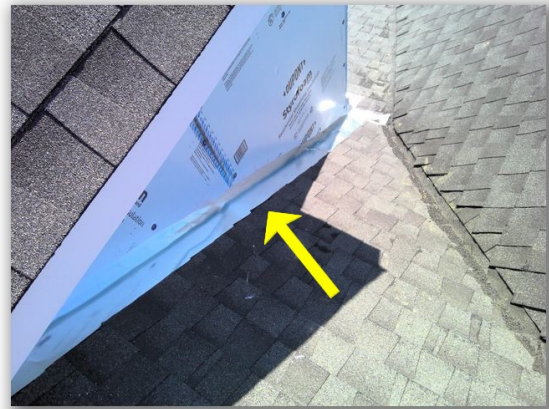
- Recommend painting all metal flashing & flues to help prevent rust/deterioration.

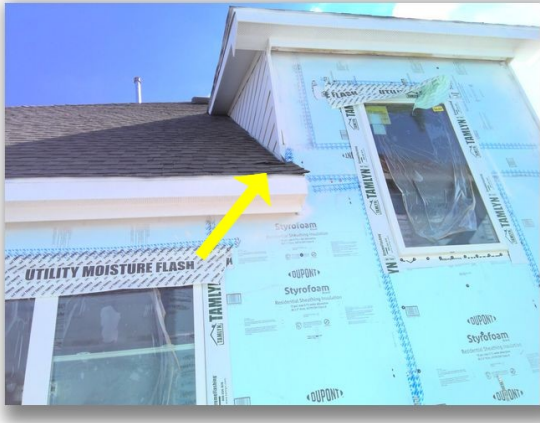
- The flashing is lifting and/or pulling loose and should be re-secured on the left side of the roof structure.

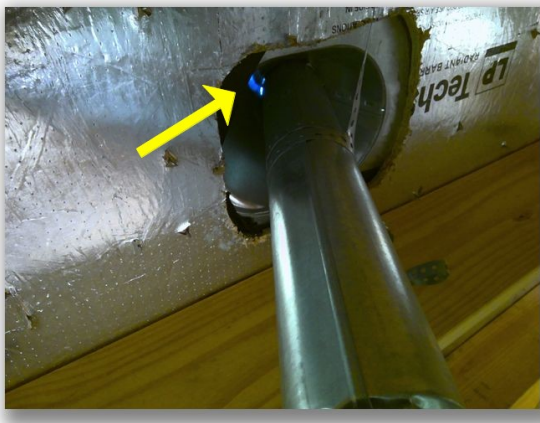
- The storm collar(s) at the roof level gas equipment vent pipe(s) need to be properly sealed to help prevent water intrusion into the structure.

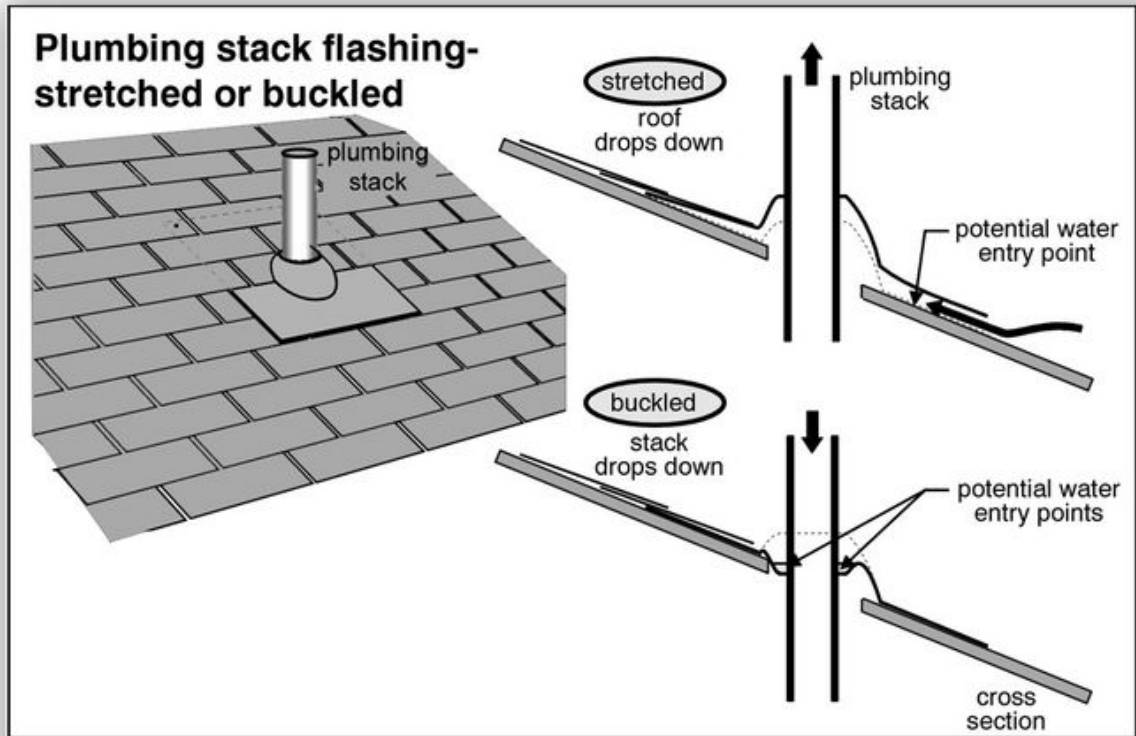
- One or more of the roof level plumbing vent stack flashing details are buckled downward around the plumbing stack. This condition could allow water penetration at this point and corrective measures are recommended.

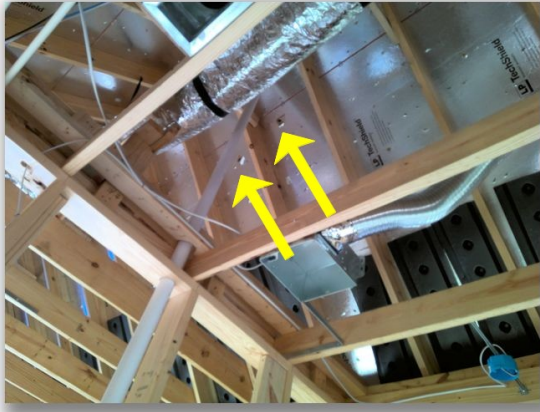
- Some roof sheathing (decking) deterioration and/or damage was observed in one or more locations.

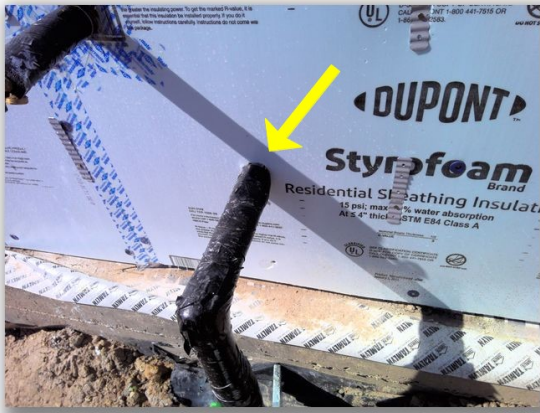
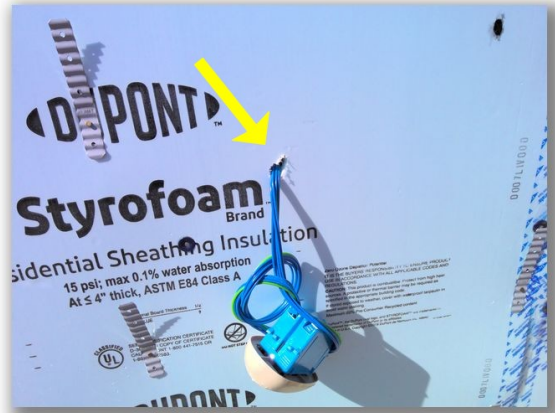
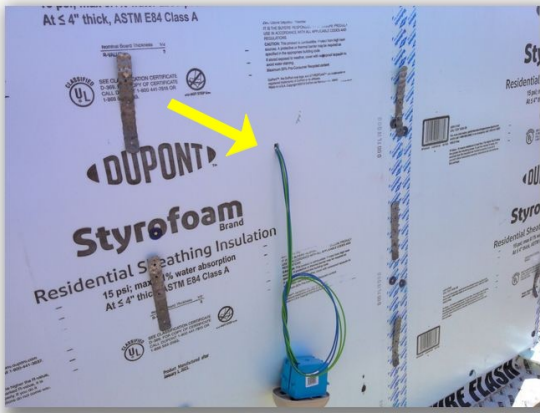
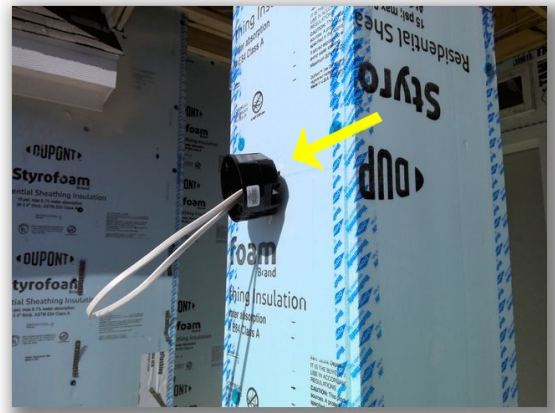
- No tape flashing observed for one or more wall penetrations at the front, right & left sides of the structure.

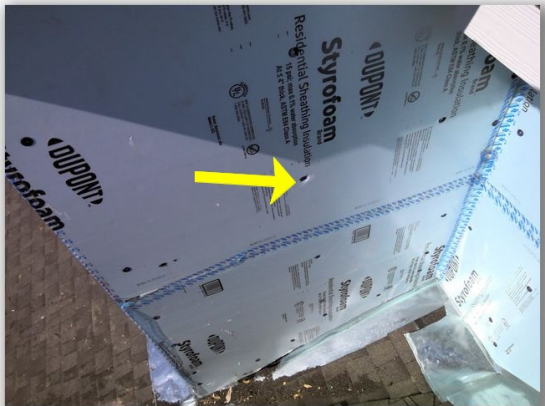
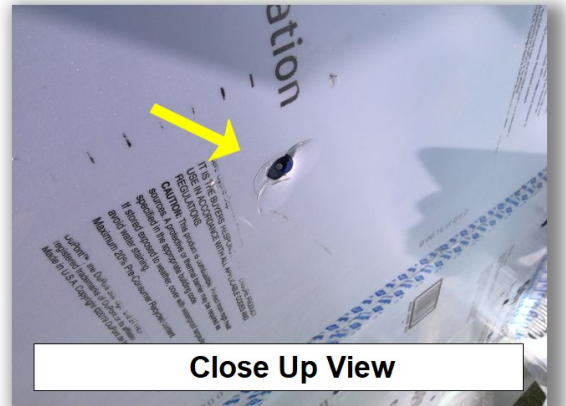
- The over driven nails in the exterior sheathing / weather barrier should be properly sealed (mastic or tape) on the above front garage area of the structure.

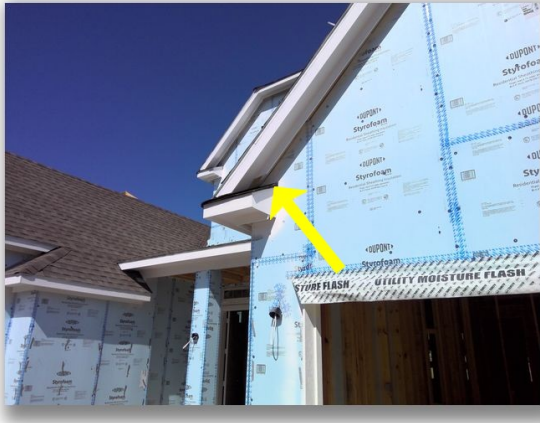
Damaged frieze board observed at the front of the structure.

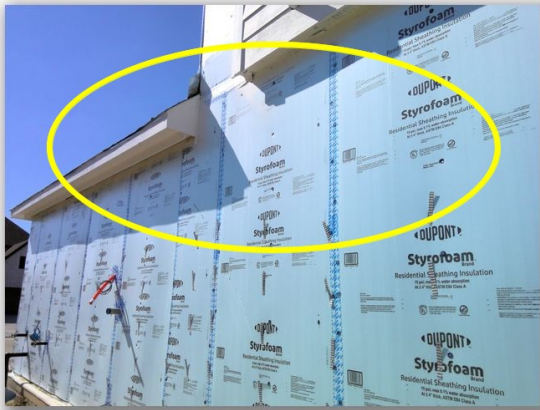
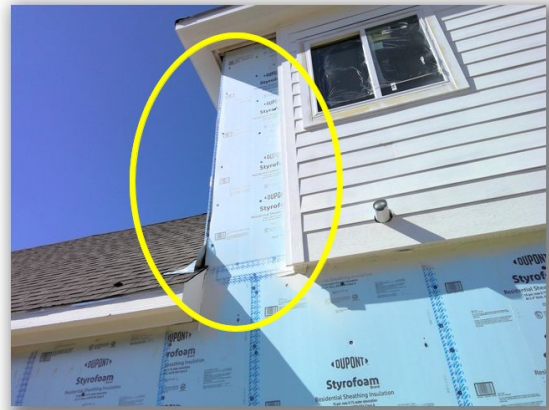
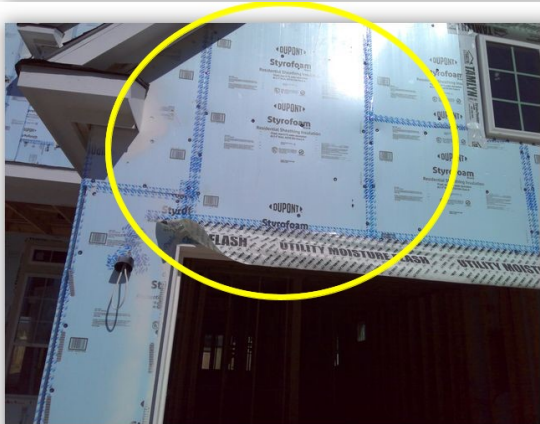
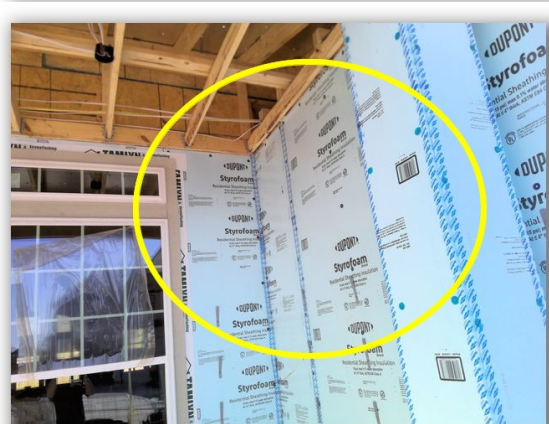
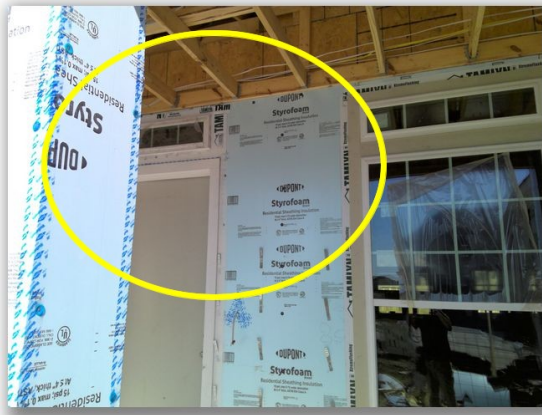
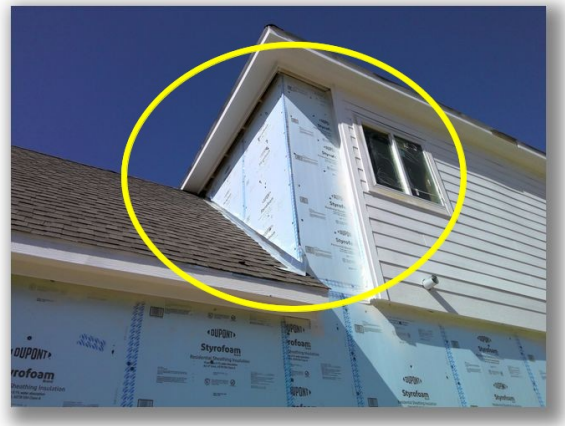
- There are not enough veneer ties “brick-ties” in place on various locations of the structure. Under current building standards, each tie shall support not more than 2.67 square feet of wall area and shall be spaced not more than 32 inches on center horizontally and 24 inches on center vertically.

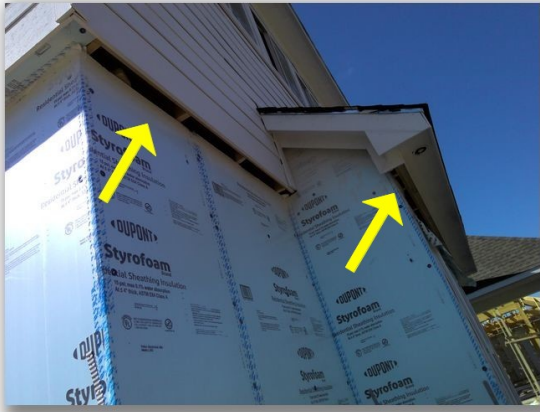
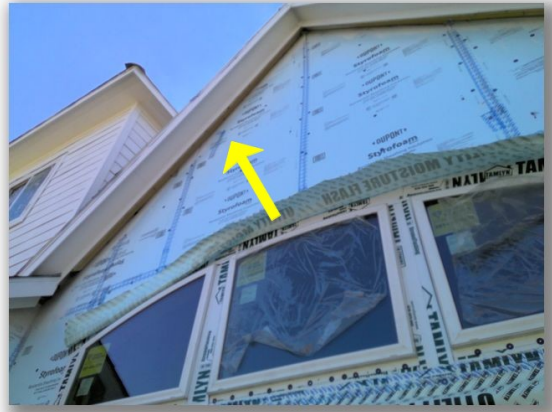
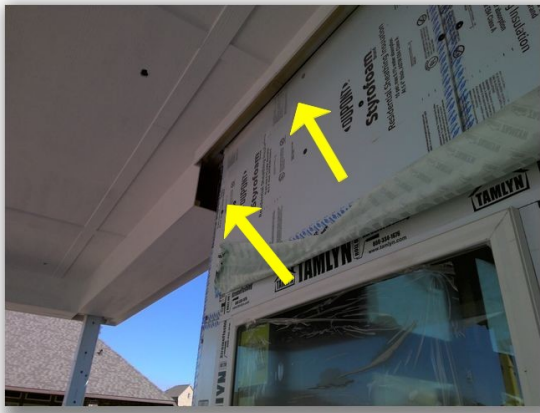
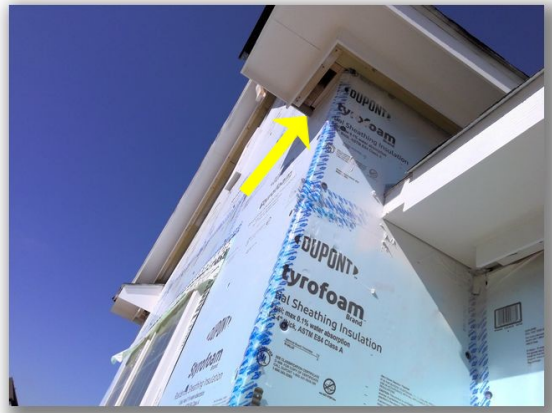
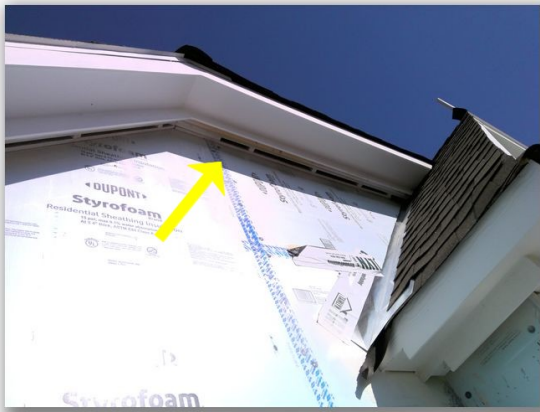
Missing sheathing and/or blocking observed at the front and back sides of the structure.

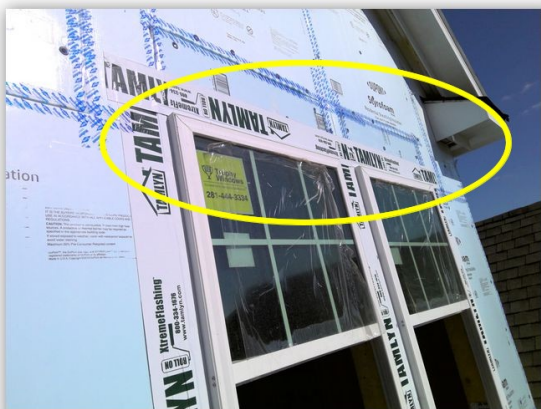
- There is no visible through wall "head" flashing details install above the exterior windows on the front side of the structure. Under current building standards, through wall "head" flashing is required to be installed to help prevent water intrusion from occurring at this point.

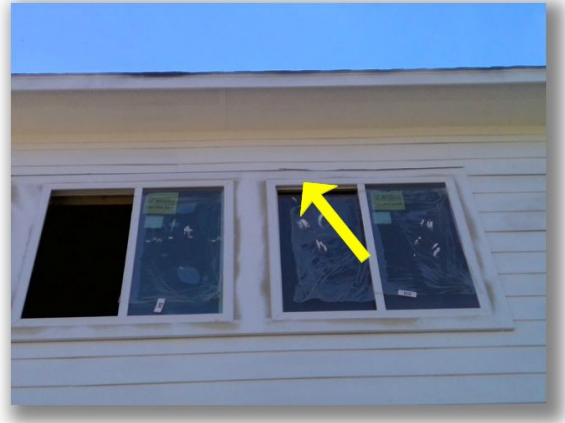
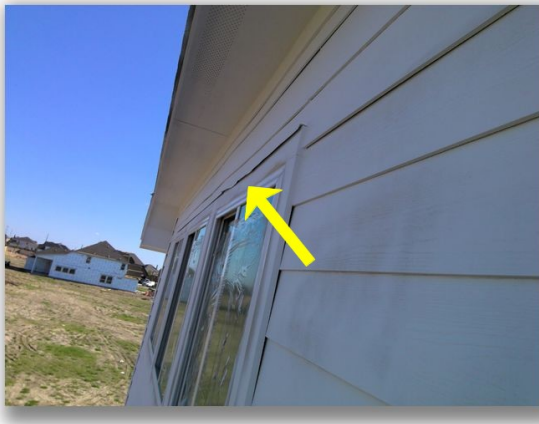
Poorly installed Z flashing observed over the windows in att the back of the structure.

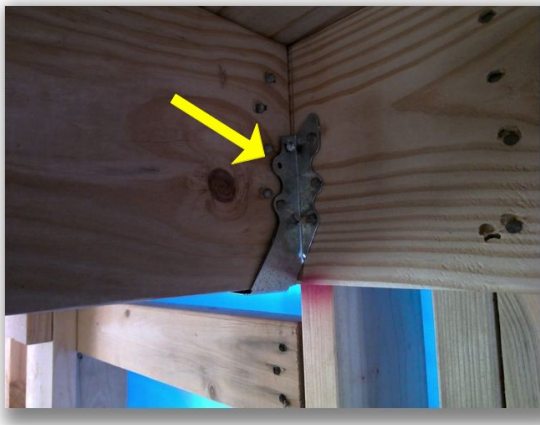
- One or more joist hanger(s) do not have enough fasteners (nails) installed in the under under stairway closet.

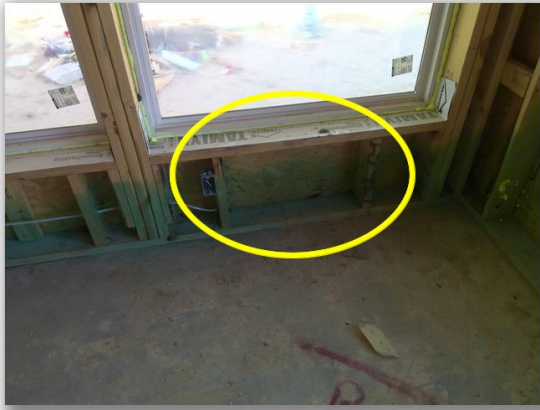
- Missing cripple stud observed in the living room.

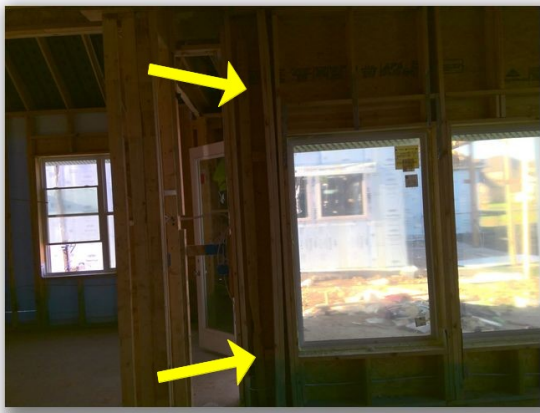
- One or more of the wall studs was observed to be bowed in the living room. This condition should be corrected prior to installing the drywall finish.

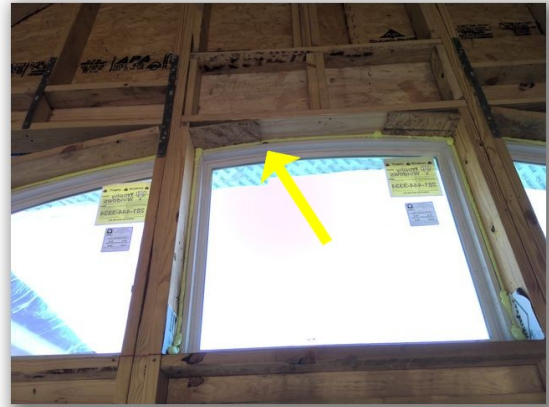
- Missing or gaps in the insulating foam were observed in the upstairs front middle bedroom.
- Missing or gaps in the insulating foam were observed in the living room.

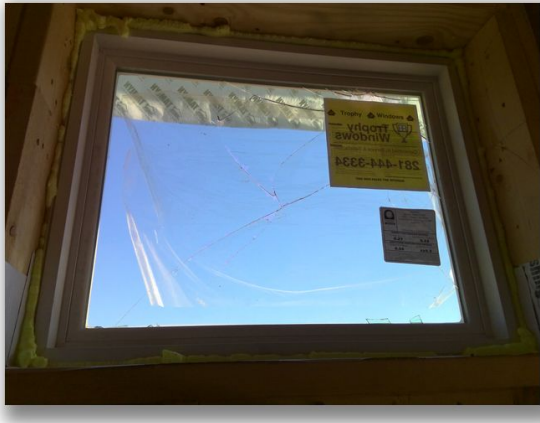
- Cracked and/or broken window glass was observed in the master bathroom.

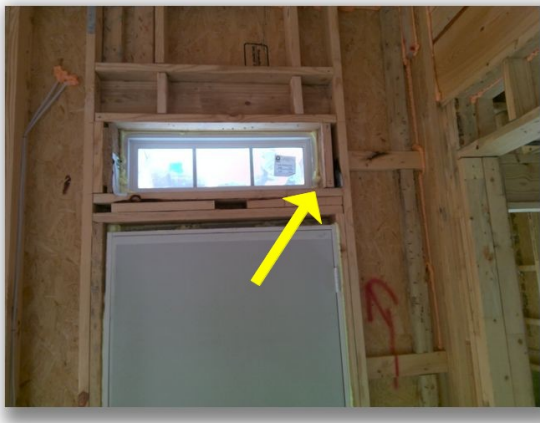
- The tape flashing is not properly installed at and around one or more of the windows on the front side of the structure above front entry door.

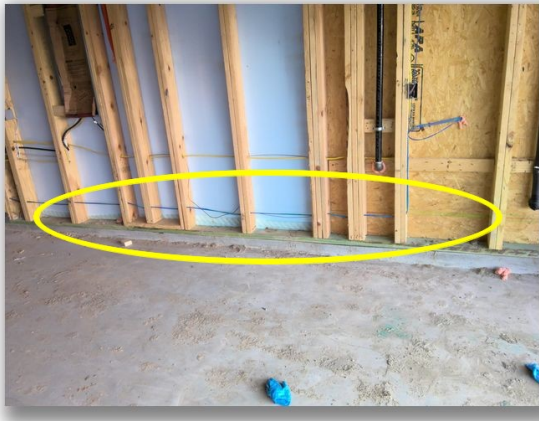
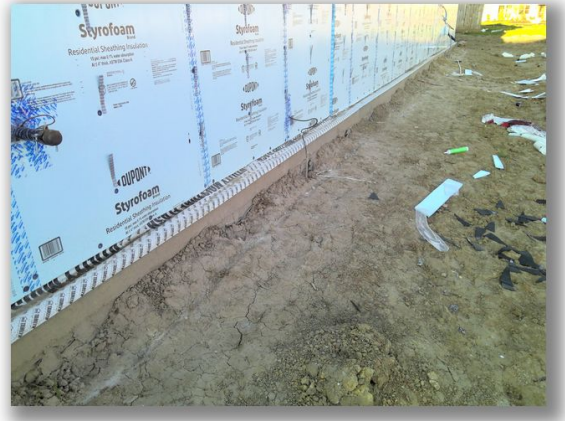
- No secondary grounding rod was observed at the time of inspection. This does not meet current building standards. Further evaluation is recommended.
- No concrete encased grounding electrode (Ufer ground) was observed at the time of inspection. This does not meet current building standards. Further evaluation is recommended.

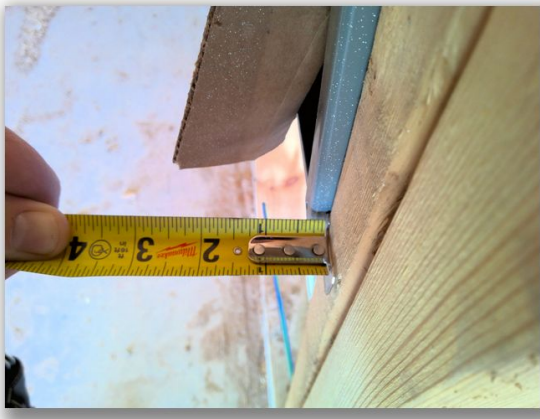
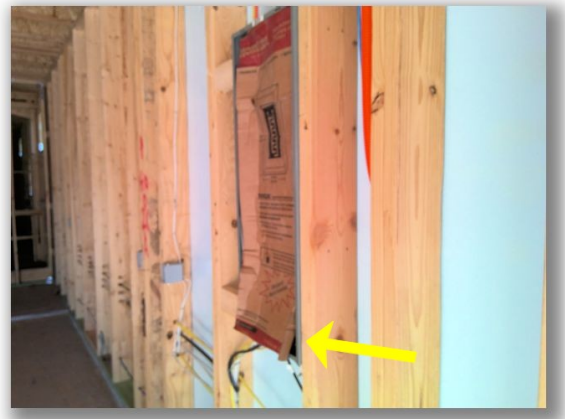
- The panel box does not properly set out 1/2-inch from the wall stud in the gameroom.

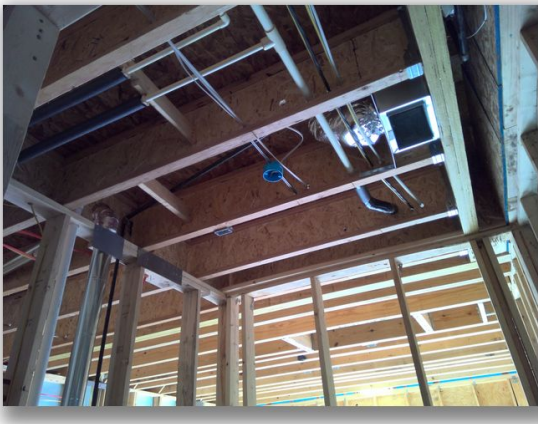
- No mechanical exhaust fan was observed in the laundry room area.

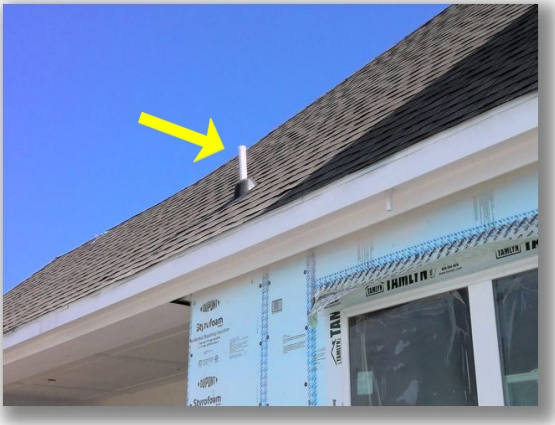
- One or more of the plumbing stacks are capped at the roof level termination.
