January 16, 2020

PROPERTY INSPECTION REPORT

Concerning: Sample, Houston, TX 77063

By: Matthew Brading, Lic #TREC # 22654

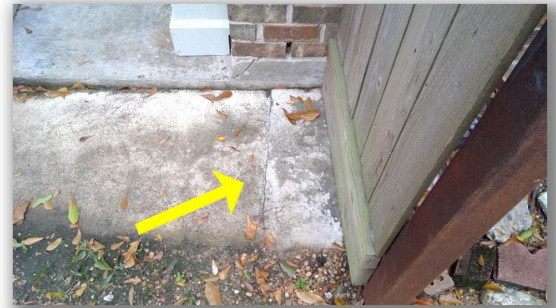
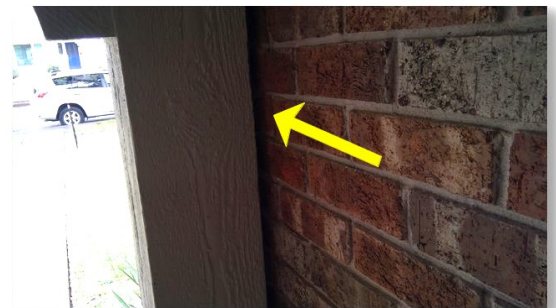
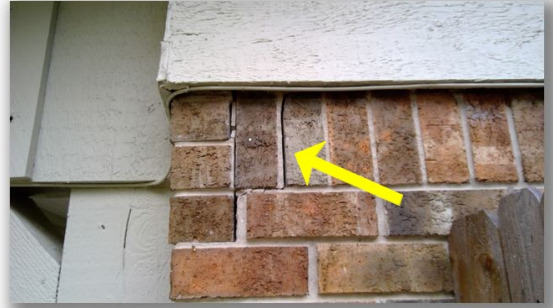
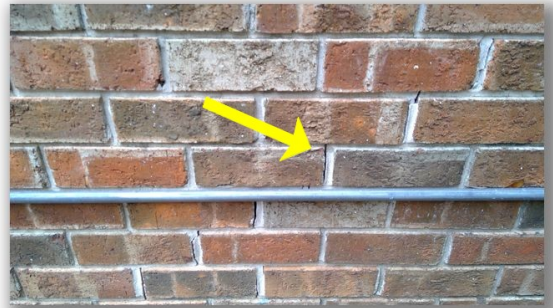
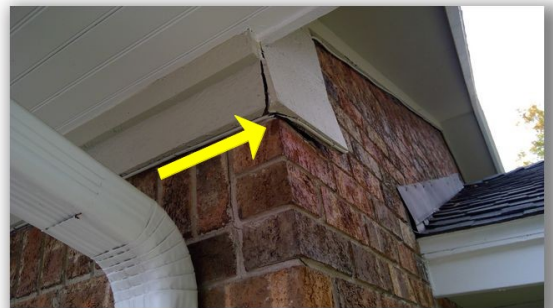
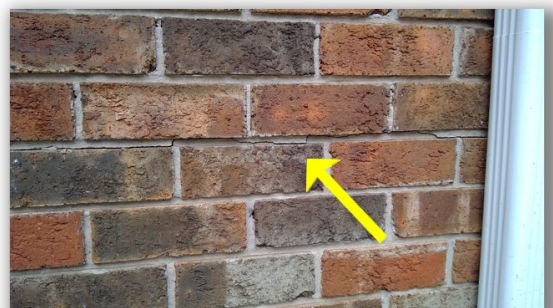
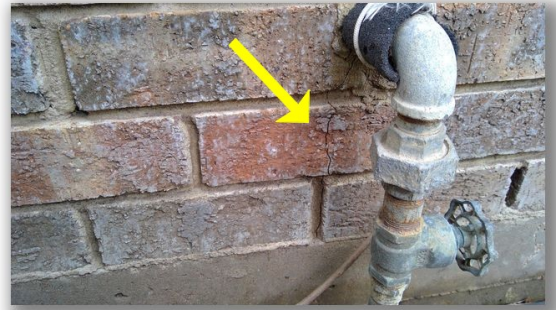
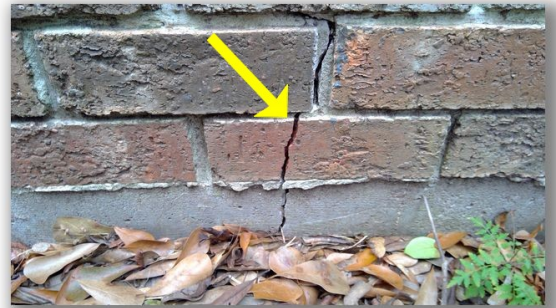
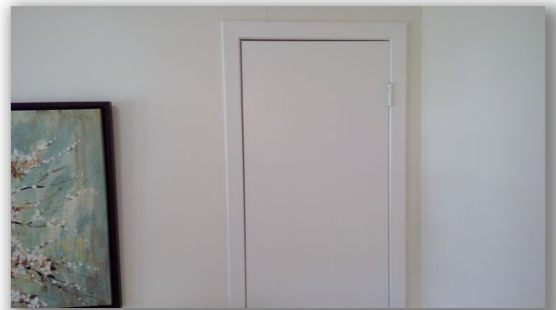
The foundation appears to have had movement that may be beyond normal. There has been some previous foundation work performed but it appears that additional movement has occurred since the foundation work was completed. A Professional Engineer licensed by the State of Texas should be consulted on the current integrity of the foundation and any repairs that may be necessary (If Any). The observations made to support the rendering of this opinion are listed but not limited to the following:

I. In my opinion, this foundation is showing signs of movement that exceeds normal tolerances. The changes in the floor elevation of the structure were greater than would normally be expected.

- Deflection cracks were observed in the exterior veneer.
- Separations of the exterior veneer and window frames were observed.
- Frieze board separations were observed.
- Stress crack(s) were observed in the exterior foundation perimeter beam.
- Interior drywall cracks and/or stress indicators.
- Misalignment of interior doors due to foundation movement.
- Interior door(s) stick and/or not closing due to foundation movement.
- Floor slopes and/or unlevelness were observed.

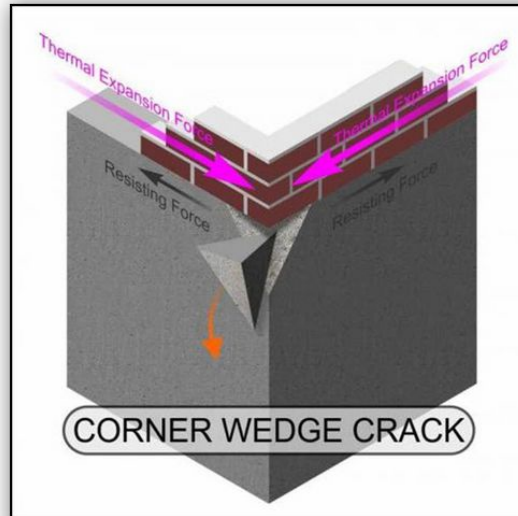
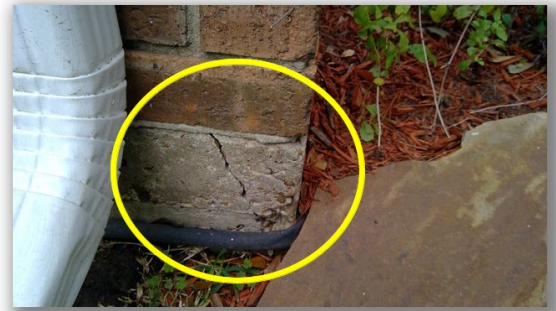
- One or more of the foundation perimeter beam corners were observed to be sheared off (corner pop). This is a common condition to observe and is do to thermal expansion and contraction of the different building materials. This condition does not adversely affect the foundation performance. However, in some cases, some cosmetic improvements may be necessary.

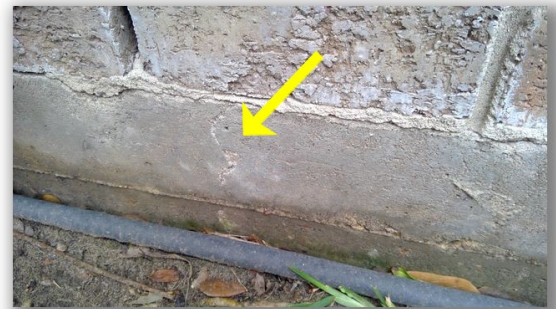
- Hairline crack(s) observed in the foundation grade beam. There was no height differential from one side to the other, and no shearing movement along the crack. We were not able to determine the extent or if this crack continued any distance across the slab due to the floor covering. The degree of visible cracking does not indicate a major structural defect; however, is consistent with a minor to moderate degree of settlement in the foundation system.

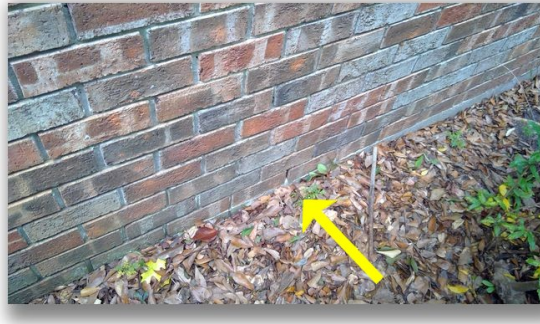
- The soil line is too high on the left side of the structure. Under current building standards there should be at least 4-inches of foundation visible below masonry veneer and 6-inches of foundation visible below wood type veneer.

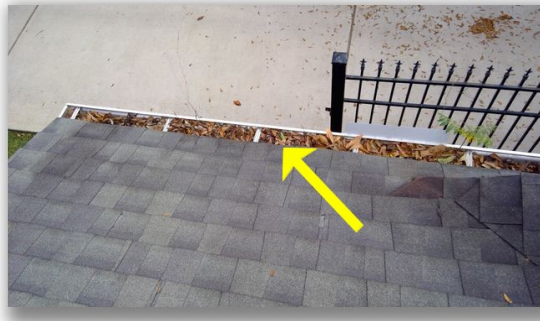
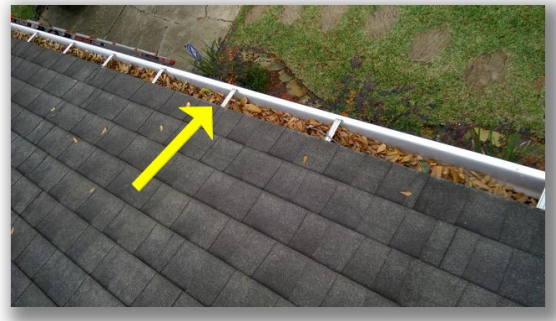
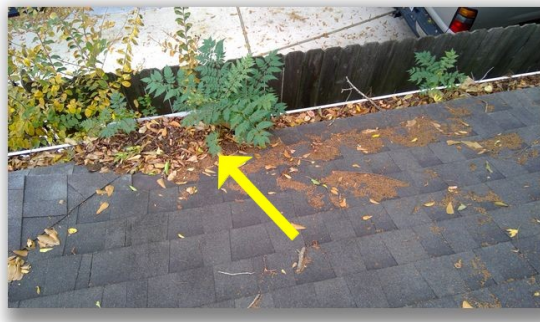
- The gutters require cleaning.

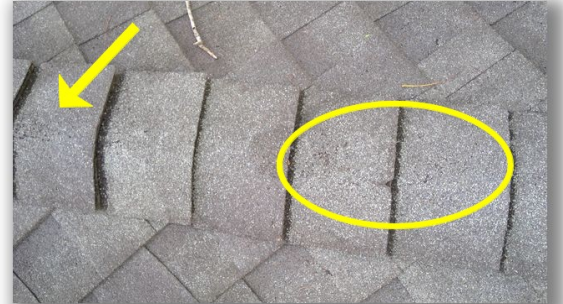
- One or more of the ridge cap shingles were observed to be damaged.

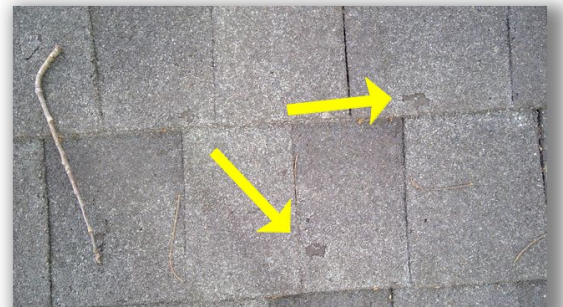
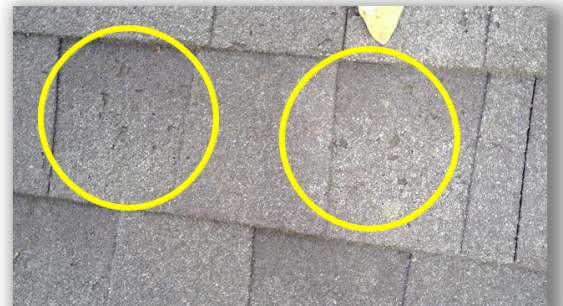
- Damaged shingles were observed on the back side of the roof structure.

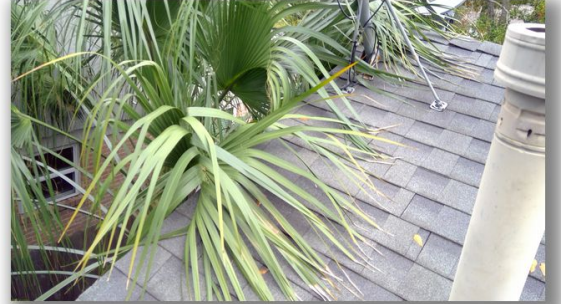
- **Note:** All debris, such as leaf's and branches, should be removed from the roof structure.
- **Note:** The tree and shrub branches should be trimmed away from the roofing material at all times.

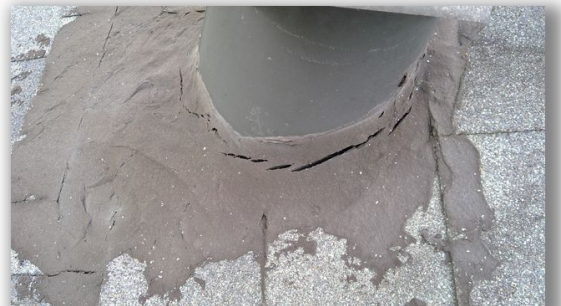
- **Note:** It appears that tar has been used to perform previous roof repairs in one or more locations on the roof. This type of repair is temporary in nature and is not considered to be a long term solution to an existing roofing problem.

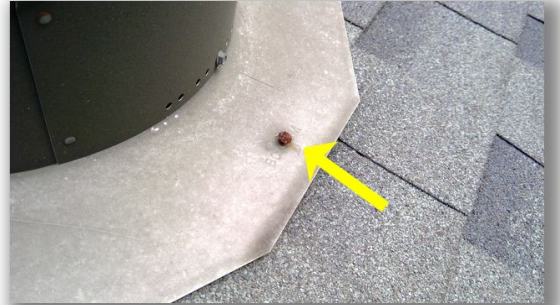
- **Note:** High shingle fasteners (staples and/or nails) were observed in various locations.
- **Note:** Roof fasteners (nails and/or staples) were observed to be exposed and should be properly sealed at the ridge caps and flashing areas.

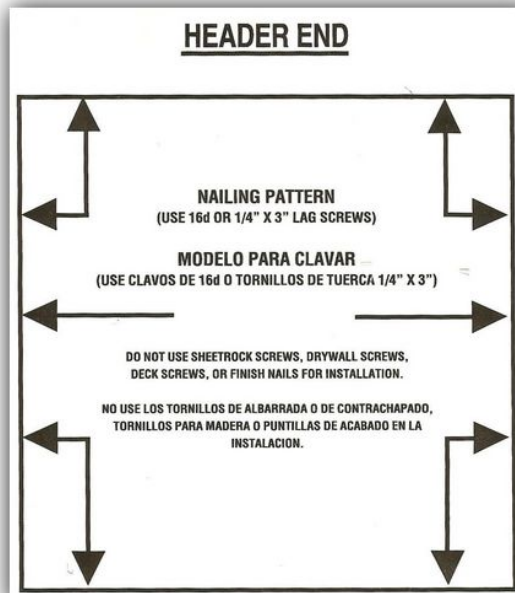
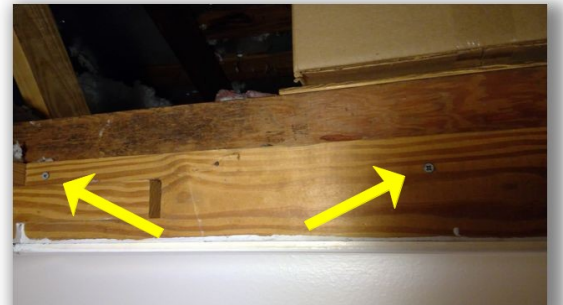
- The attic ladder was observed to be installed with improper fasteners. The attic ladder should be secured in place with 16d nails or 3-inch lag bolts. This condition should be further evaluated and corrected as necessary.

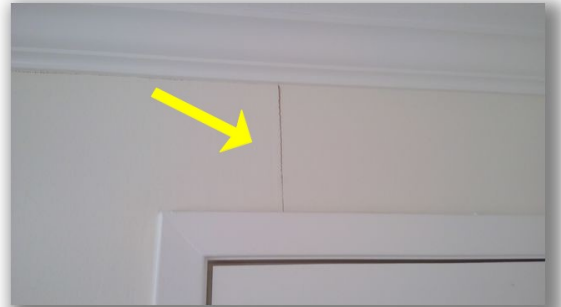
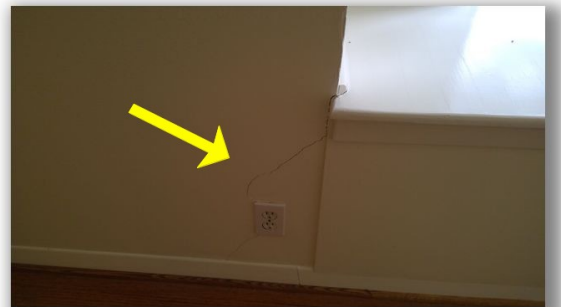
- Interior wall stress cracks were observed in various locations throughout the house.

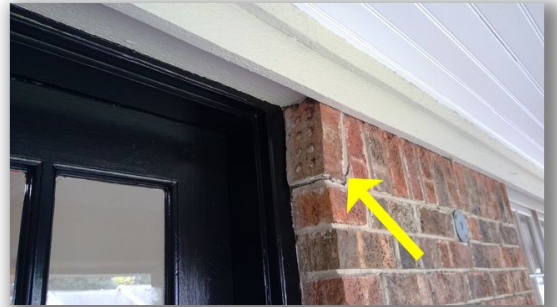
- One or more of the exterior bricks were observed to be loose on the front side of the structure.

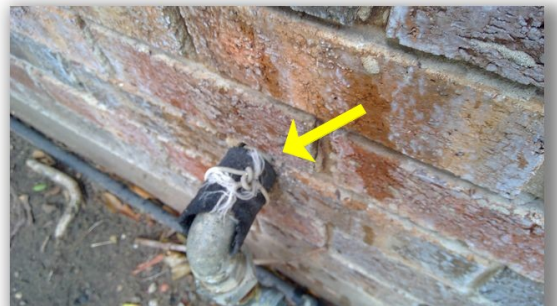
- The area between the exterior cladding / veneer and all of the wall penetrations / openings need to be properly sealed. Areas such as utility connections, downspouts, hose bibbs, lighting fixtures, receptacles etc. It is recommended to use an elastomeric caulking / sealant.

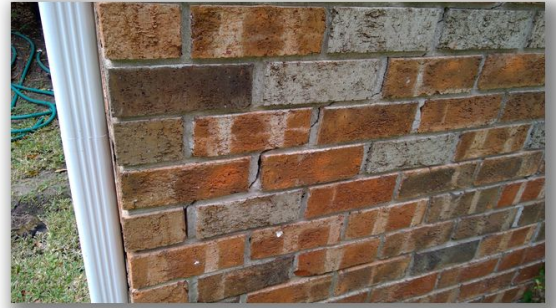
- Cracks observed in the exterior veneer. See foundation section.

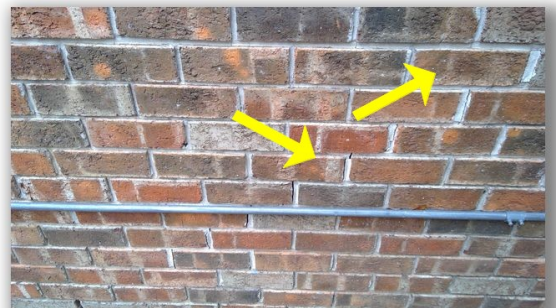
- **Note:** Previous repairs to the exterior masonry mortar / grout was observed on the right side of the structure.

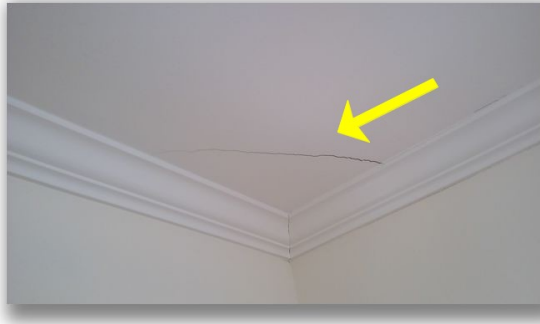
- Ceiling stress cracks were observed in the front entrance area.

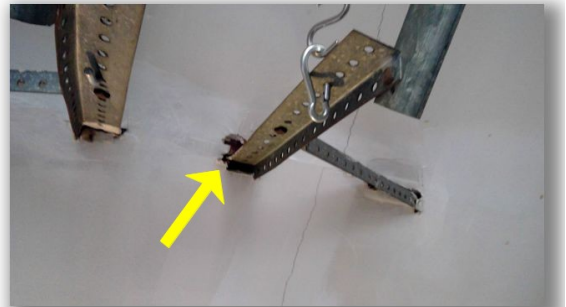
- The garage ceiling is opened to the attic space. Under current building standards the garage ceiling should be enclosed / separated from the attic space.

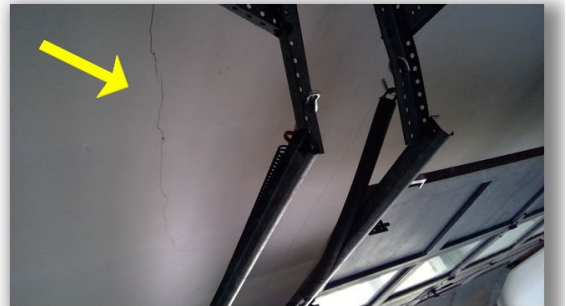
- Ceiling stress cracks were observed in the garage.

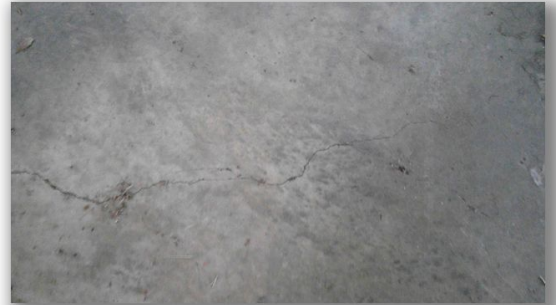
- **Note:** Some cracking of the garage concrete floor finish was observed.

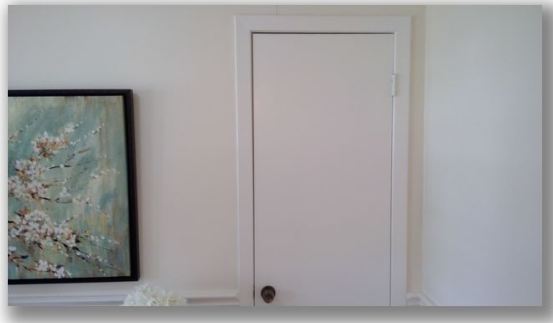
- Some of the interior doors are out of square and have been shaven at the top to help them fit the opening. This may be due to adverse foundation performance.
- The door is sticking to the front entry closet.

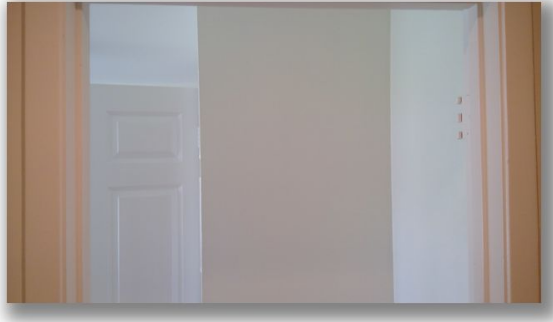
- The door is missing to the front corner bedroom.

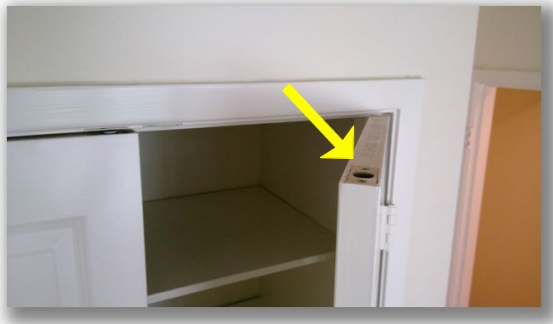
- The door spring latch(es) are damaged and/or missing to the front corner bedroom closet.

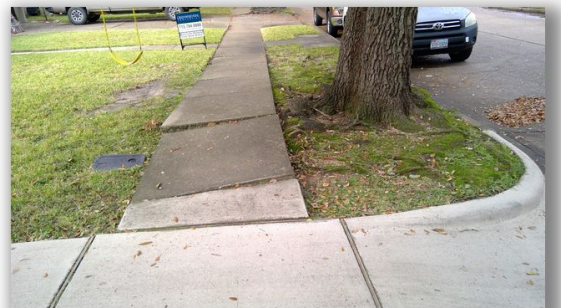
- The sidewalk was observed to have larger than typical cracks and/or deficiencies.

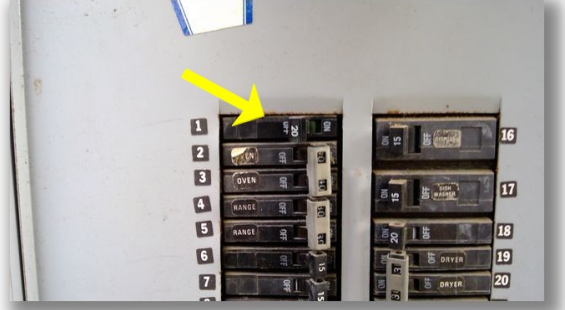
- All openings (missing knockouts) in the electrical cabinet cover plate (dead front) and /or cabinet need to have fillers.
- The electrical cabinet does not appear to be properly bonded to the electrical system. Breaker #1 was observed to be in the off position. When turned on, a buzzing sound can be heard and the breaker then trips to the off position.

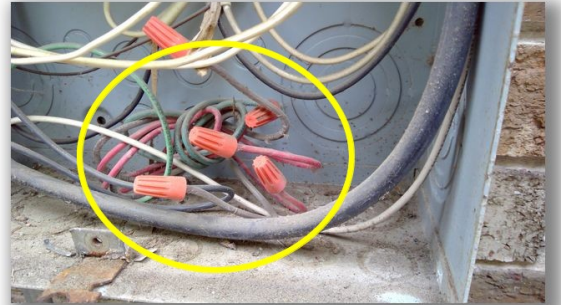
- Unused wires & conduit should be removed and blank spaces filed.

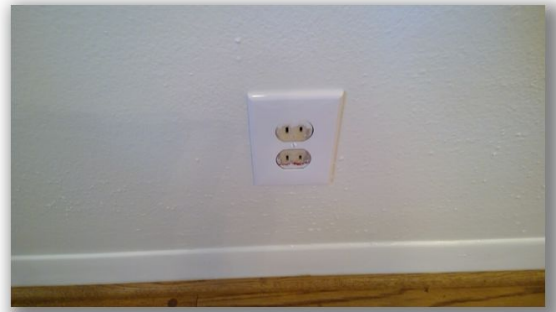
- **Note:** Old style 2 wire system in place in various areas throughout the house. This does not meet the current standard.

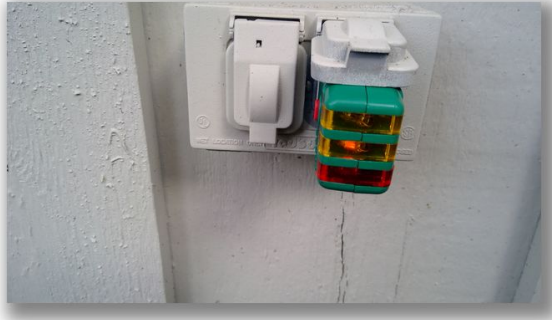
- One or more of the receptacles were observed to have an open ground connection in the exterior area.

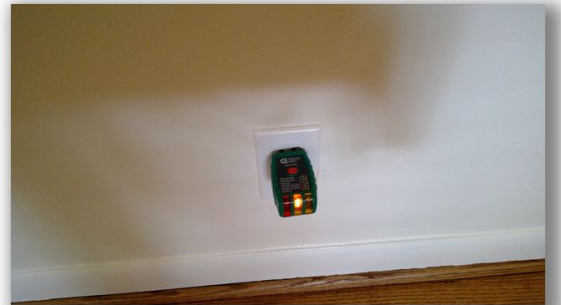
- Most to all of the three-prong receptacles are observed to be ungrounded. This is an older two-wire system. Note: Placing three prong receptacles on an older two-wire system does not meet current National Electrical Code standards.

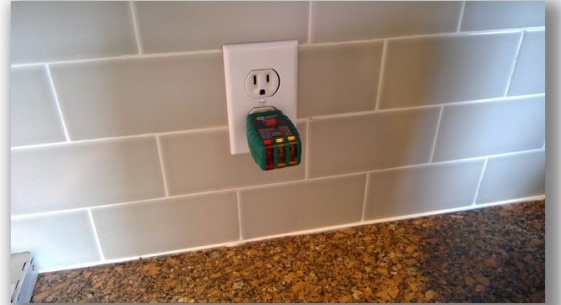
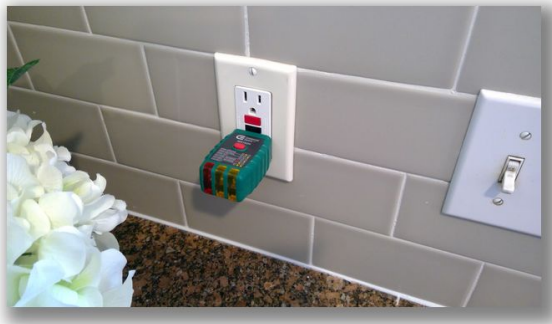
- One or more of the receptacles appears to be inoperative. This receptacle(s) and circuit should be investigated and corrected as necessary. Receptacle(s) were located in the front corner bedroom & kitchen.

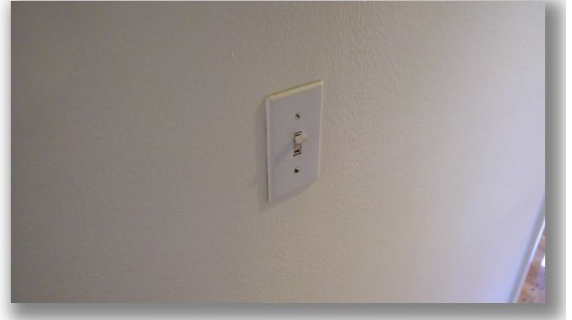
- **Note:** I was unable to determine the operation end of one or more of the switches.

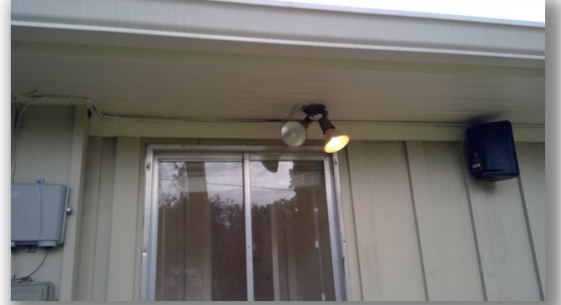
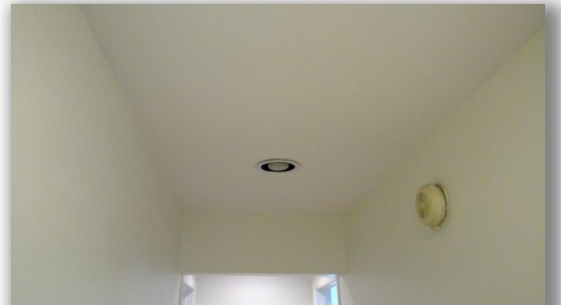
- One or more of the light fixtures appear to be inoperative in various locations throughout the house. This may be due to a bad bulb or some other unknown condition. This condition should be further evaluated and corrected as necessary.

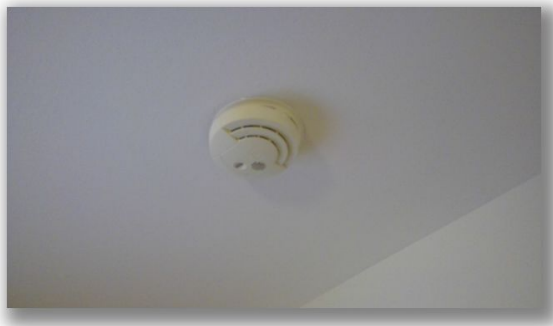
- One or more of the smoke alarms did not respond properly when tested in the side middle bedroom.
- There are not enough smoke alarms located in the home. Under current building standards, there should be a smoke alarm located in each sleeping room, outside each separate sleeping area in the immediate vicinity of the sleeping rooms, and on each additional story of the dwelling.

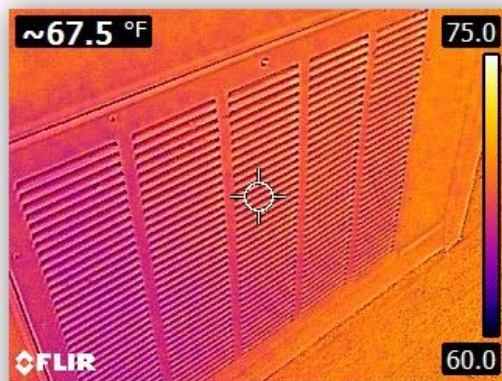
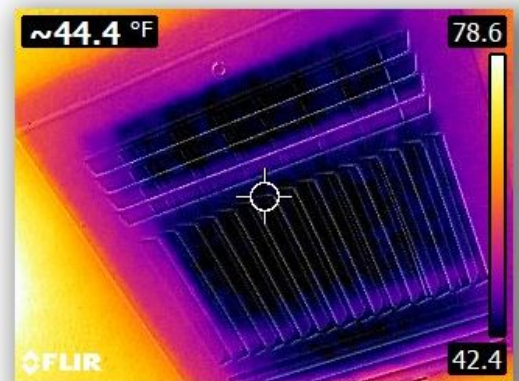
- The temperature differential measured across the evaporative coils of the air conditioning system is higher than considered normal. The cooling system is not performing properly and servicing is needed.

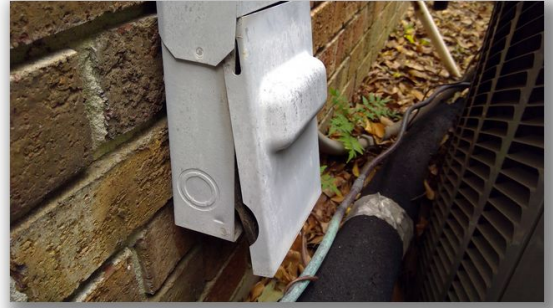
- The electrical service disconnect is installed behind the outside condenser/coil. This does not meet the clearance requirements of the National Electrical Code or the International Residential Code and should be corrected as necessary.
- The electrical disconnect was observed to be damaged.

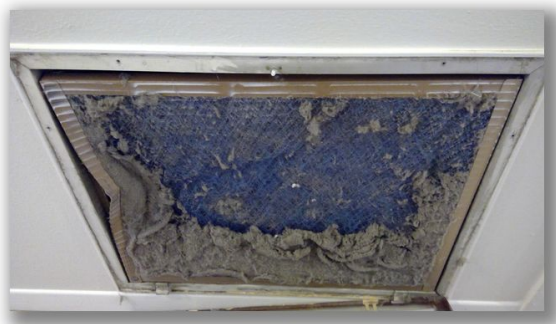
- The dirty air filter should be replaced.

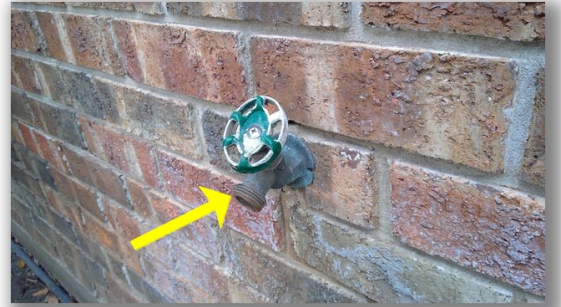
- One or more of the exterior water hose bibbs (faucet) do not have a back-flow or anti-siphon device (Vacuum Breakers) in place. **Note:** *This is not uncommon to observe with a home of this age.*
- The exterior water hose bibb (faucet) is leaking at the handle when operated on various locations of the structure.

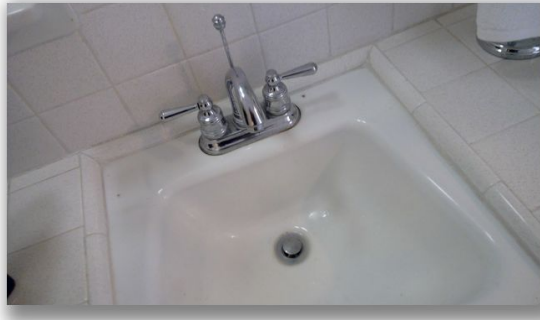
- The stopper does not appear to be functioning properly.

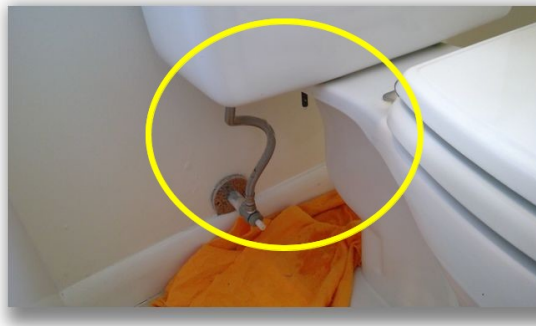
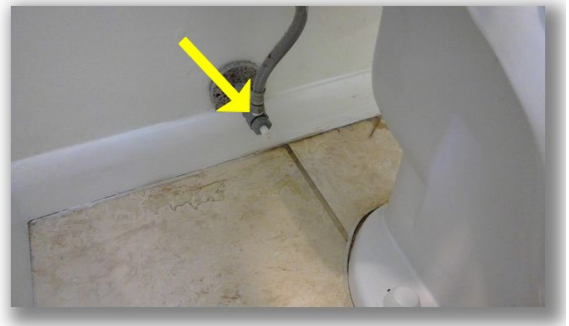
- The commode leaks water onto the floor. The cause and remedy should be further evaluated and corrected as necessary.
- The commode shutoff valve handle is damaged and/or missing.
- The commode appears to be excessively loose at the floor mount. This condition should be further evaluated and corrected as necessary.

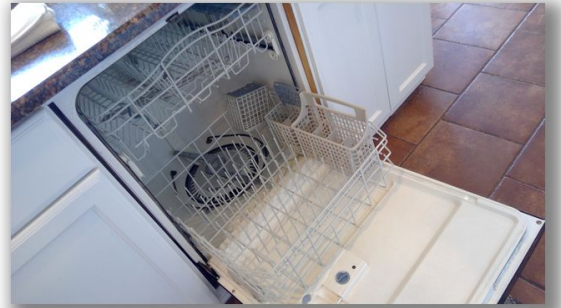
- Some rusting of the dishwasher interior components was observed.

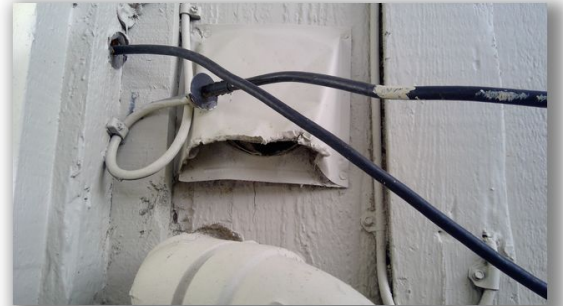
- The exterior dryer duct termination cover is damaged.
- The damper at the dryer exhaust termination does not function properly. The damper does not reset to the closed position when not in use.
