Beau Brown
7894 Salt Lake Dr
Conroe, TX 77304

October 16, 2025

PROPERTY INSPECTION REPORT FORM

Beau Brown <i>Name of Client</i>	10/16/2025 <i>Date of Inspection</i>
7894 Salt Lake Dr, Conroe, TX 77304 <i>Address of Inspected Property</i>	
Louis Escobar <i>Name of Inspector</i>	25708 <i>TREC License #</i>
<i>Name of Sponsor (if applicable)</i>	<i>TREC License #</i>

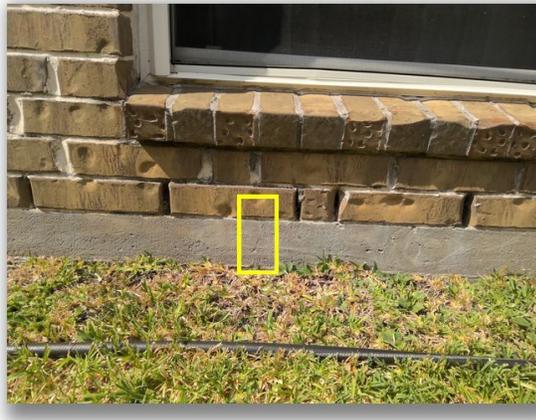
- Hairline crack(s) observed in the foundation grade beam. There was no height differential from one side to the other, and no shearing movement along the crack. We were not able to determine the extent or if this crack continued any distance across the slab due to the floor covering. The degree of visible cracking does not indicate a major structural defect; however, is consistent with a minor to moderate degree of settlement in the foundation system.

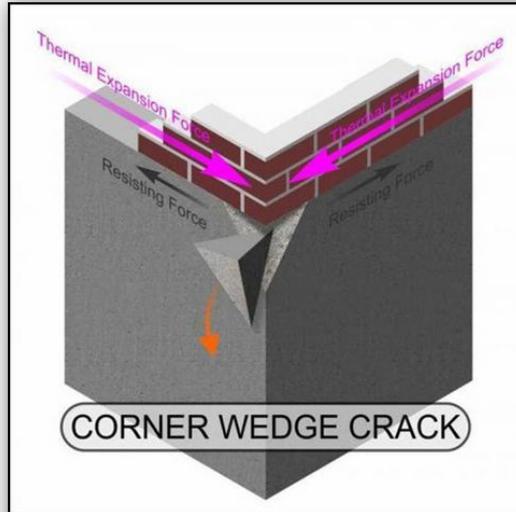
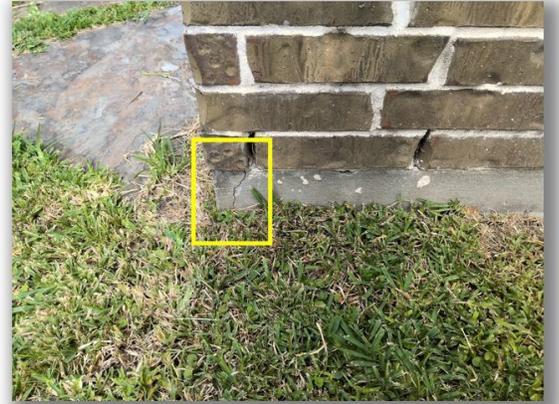
- One or more of the foundation perimeter beam corners were observed to be sheared off (corner pop). This is a common condition to observe and is do to thermal expansion and contraction of the different building materials. This condition does not adversely affect the foundation performance. However, in some cases, some cosmetic improvements may be necessary.

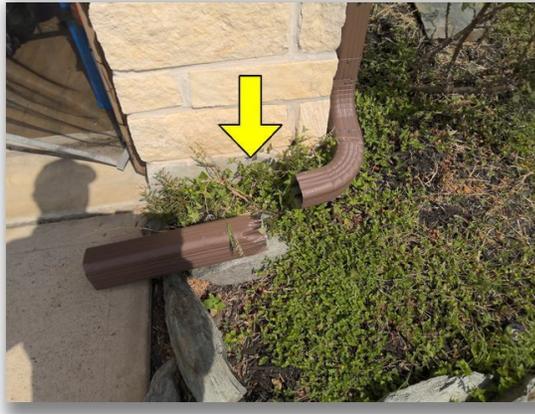
- The downspout is separated on the front side of the structure.

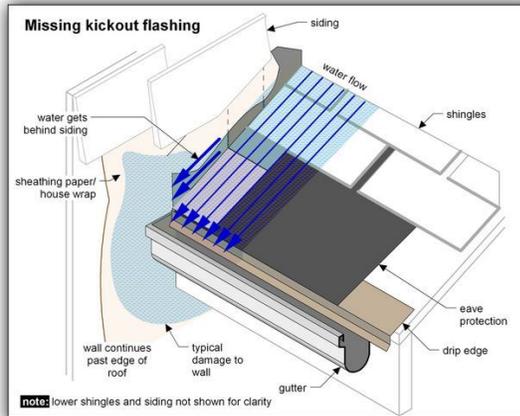
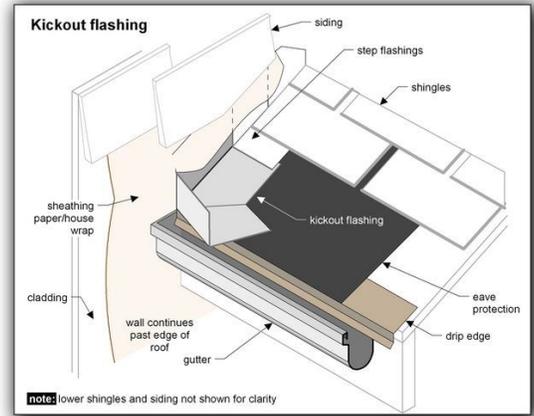
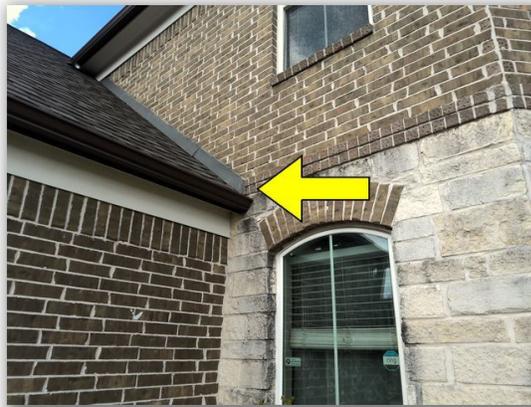
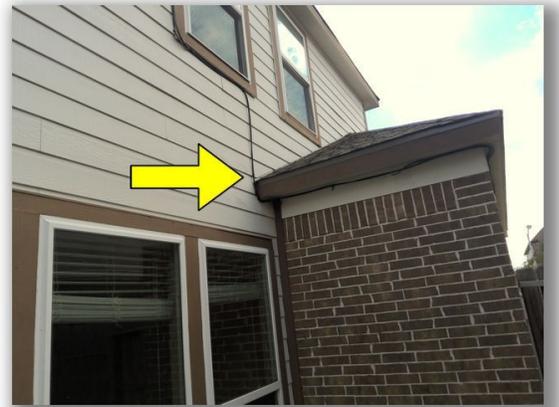
- There was no kickout flashing details observed at the lower bottom edge of the roof line interface and the sidewall that continues past the edge of the roof. The lack of this kickout flashing will allow water to penetrate at these points.

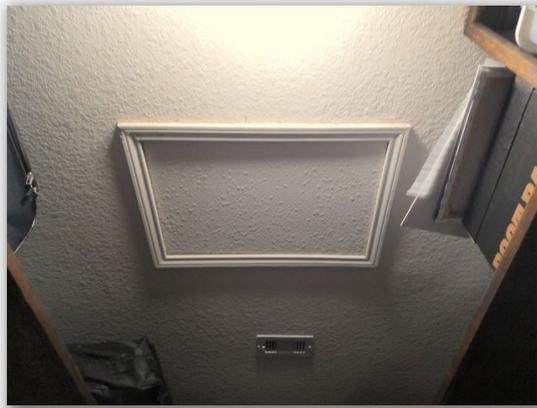
Note: Attic space above the ceiling was not accessible due to obstructions at the access point. As a result, the attic could not be inspected for framing, insulation, ventilation, or other conditions. Recommend clearing the obstruction and re-evaluating the attic space as needed.

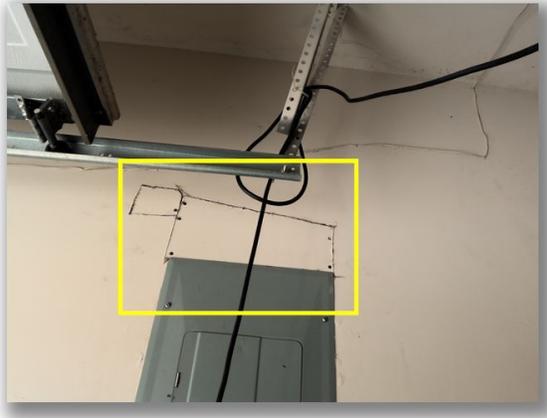
- There was damage observed at one or more areas of the drywall at the garage.

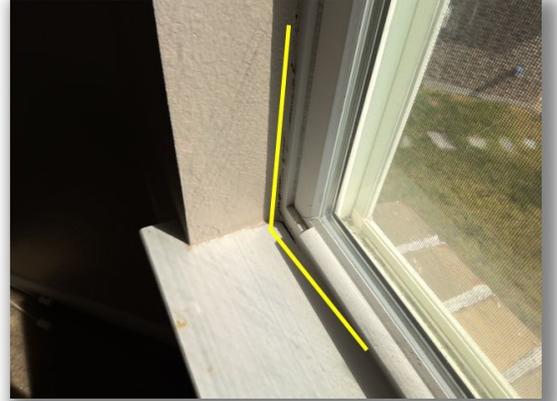
- Caulking improvements are recommended at one or more of the interior windows. Examples are pictured below but not limited to:

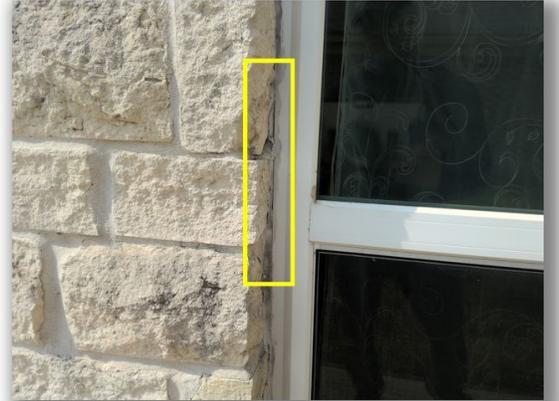
- Caulking improvements are recommended for the area between the exterior veneer and the window frames. It is recommended to use an elastomeric caulking. Examples are pictured below but not limited to:

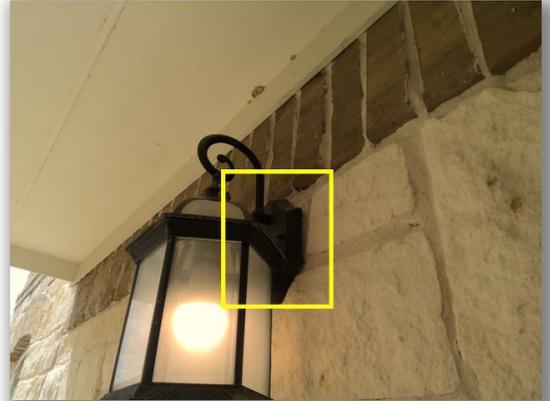
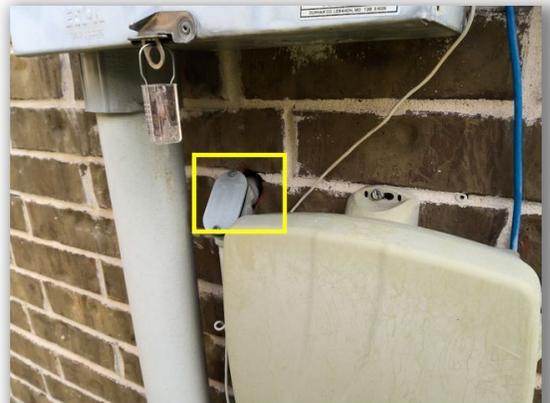
- The area between the exterior cladding / veneer and all of the wall penetrations / openings need to be properly sealed. Areas such as utility connections, downspouts, hose bibbs, lighting fixtures, receptacles etc. It is recommended to use an elastomeric caulking / sealant. Examples are pictured below but not limited to:

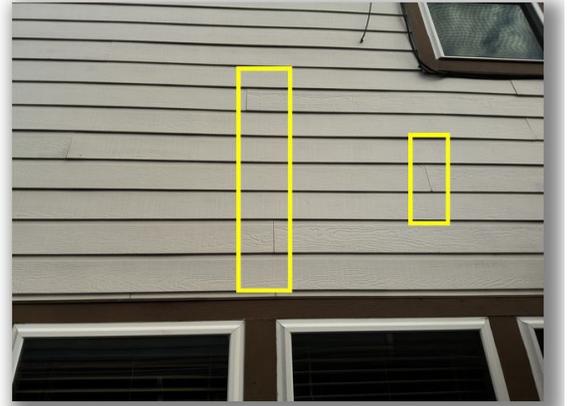
- Caulking improvements are recommended for the area between the exterior fiber cement board joints in various locations. It is recommended to use an elastomeric caulking. Examples are pictured below but not limited to:

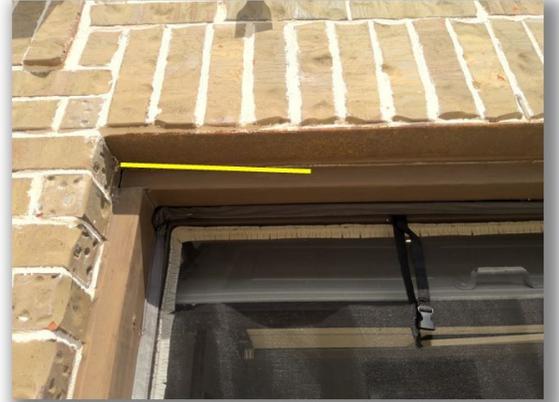
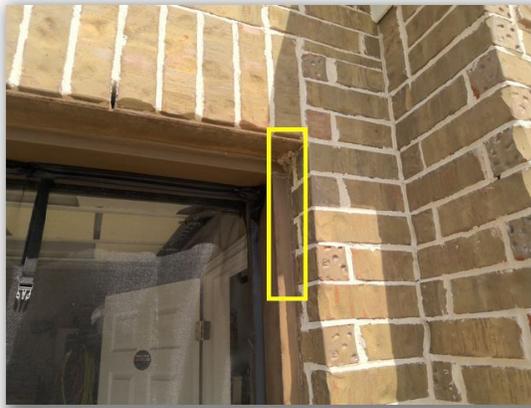
- Caulking improvements are recommended for the area between the exterior veneer and the garage door trim boards. It is recommended to use an elastomeric caulking. Examples are pictured below but not limited to:

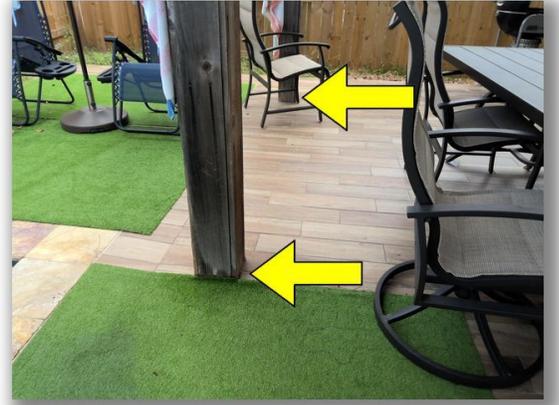
- All wood to ground contact at the base of the siding should be eliminated. Rotted or damaged siding that is uncovered should be repaired. The siding was observed to be in contact with the finish grade (ground) on the back side of the structure.

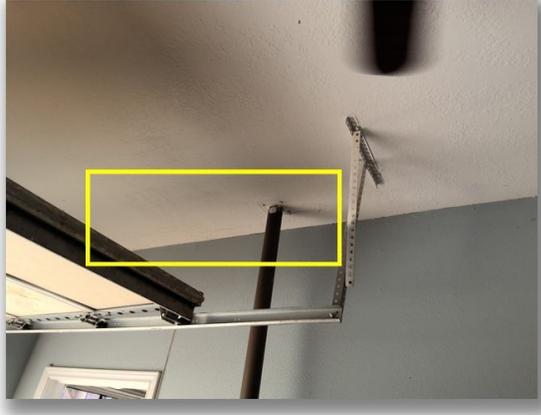
- Ceiling stress cracks were observed in the garage.

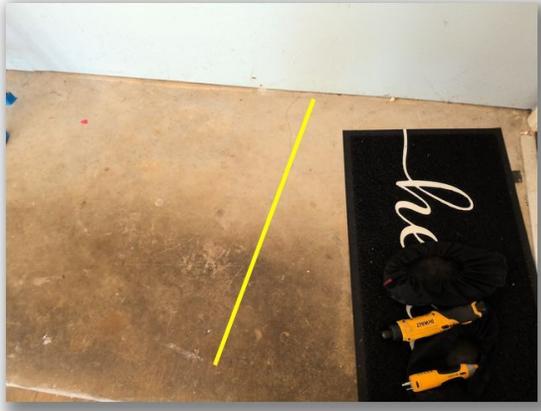
- **Note:** Some cracking of the garage concrete floor finish was observed.

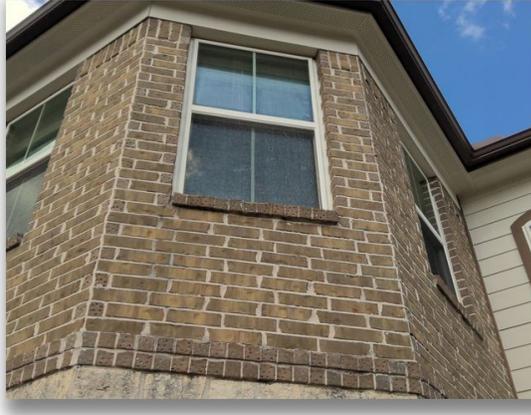
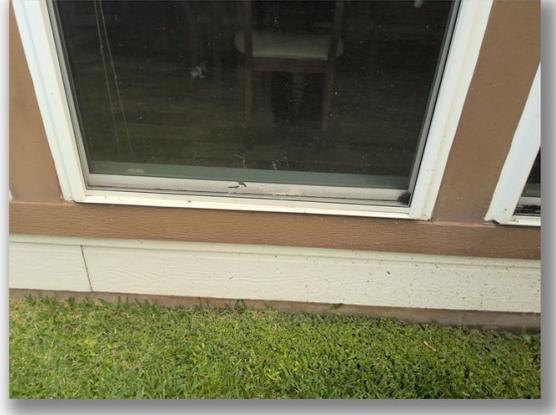
- One or more of the window screens were observed to be damaged.

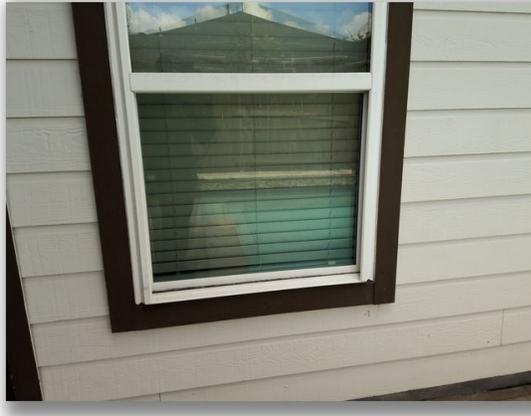
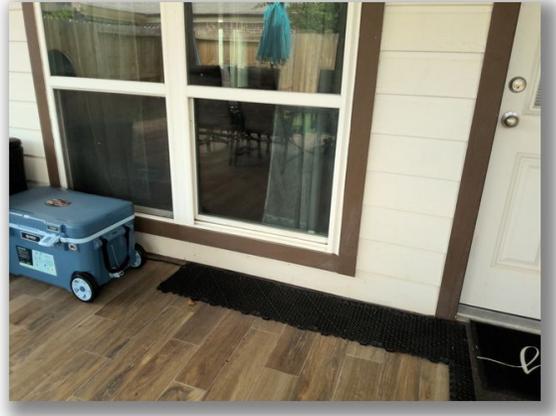
- One or more of the window screens were observed to be missing.

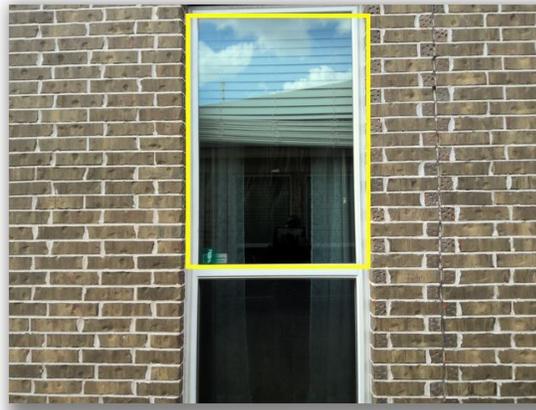
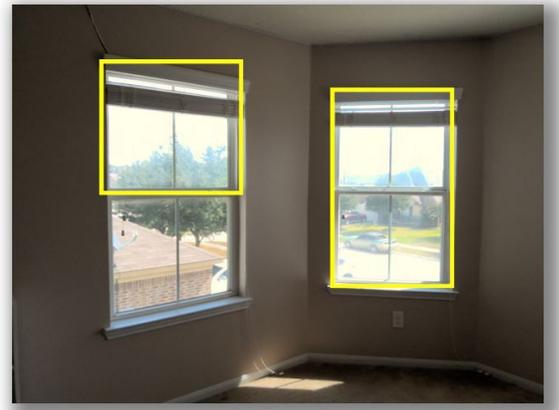
- One or more of the thermal pane windows were observed to have lost their seals. This has resulted in condensation or a fog like film to develop between the panes of glass. The thermal pane windows no longer function as designed when they loose their seal and replacement may be necessary. The windows that have noticeably lost their seals are listed but may not be limited to the following: living room, upstairs front corner bedroom.

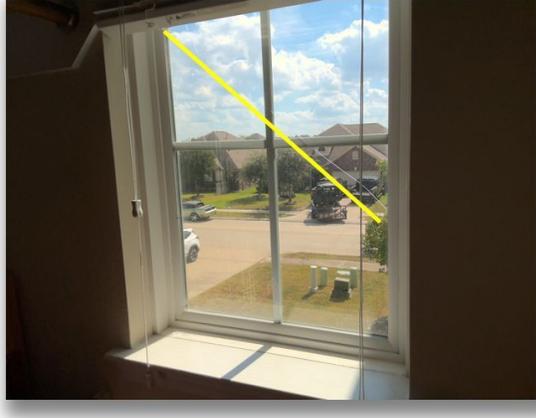
- Cracked and/or broken window glass was observed in the upstairs front corner bedroom closet.

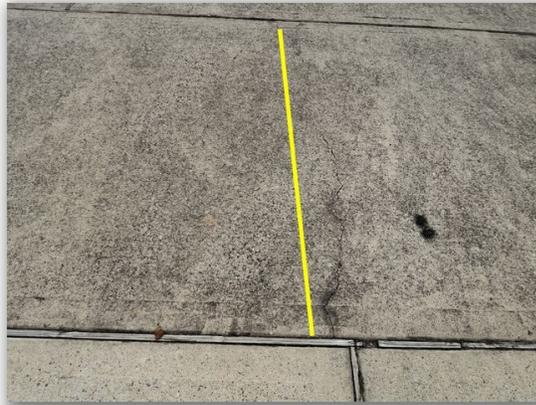
- Minor cracks and/or deficiencies were observed in the driveway.

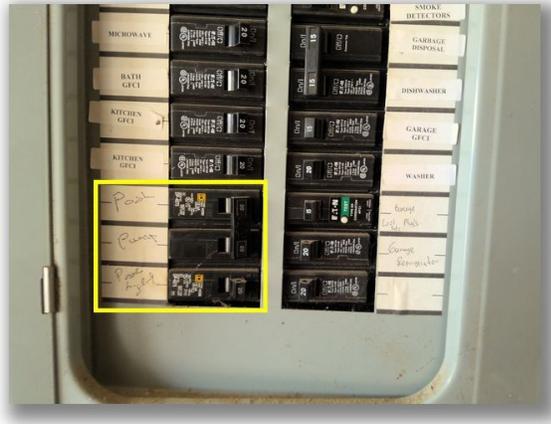
- Note: There were circuit breakers in the main electrical service panel that were not listed by the panel manufacturer. Because circuit breakers were made by different manufacturers, they vary in design. Panel manufacturers typically require that breakers manufactured by their company be used in their panels unless otherwise indicated on the panel label. Breakers from one manufacturer used in the panel of another manufacturer may result in poor connections which can create a potential fire or shock hazard. I recommend correction by a licensed electrician.

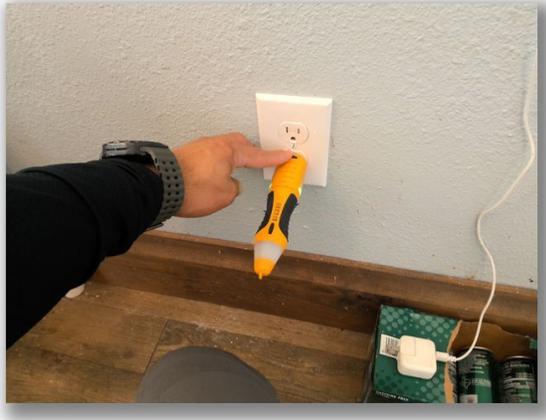
- The receptacle(s) in the kitchen cabinet under the kitchen sink do not appear to be connected to a ground fault circuit interrupter (GFCI) device. Under current electrical standards, all receptacles within 6-feet of the sink, including the receptacles in cabinetry, should have GFCI protection.
- Not all of the garage receptacles appear to be connected to a ground fault circuit interrupter (GFCI) device. Under current electrical standards, all of the garage receptacles should have GFCI protection. There New National Electrical (NEC) Code no longer has an exception for “non-appliance dedicated”.

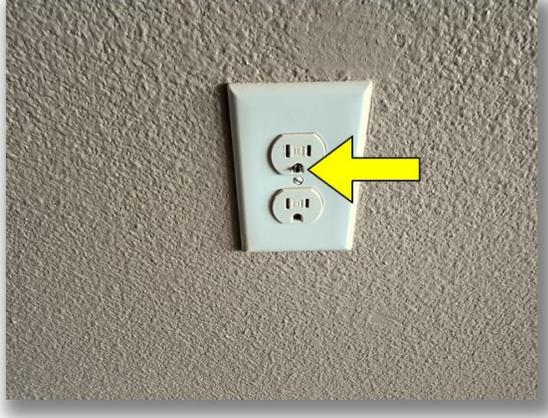
- The ground prong was observed to be obstructed for the outlet in the upstairs living room.

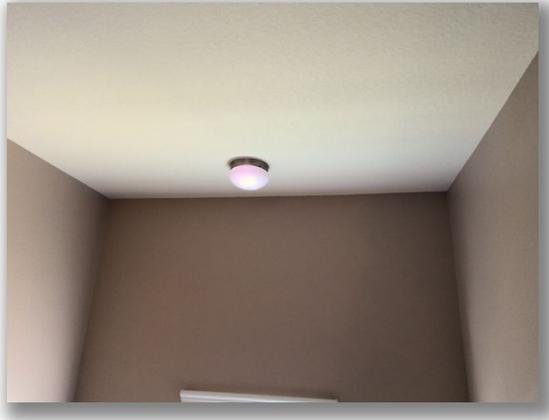
- One or more of the light fixtures appear to be inoperative in the stairway. This may be due to a bad bulb or some other unknown condition. This condition should be further evaluated and corrected as necessary.

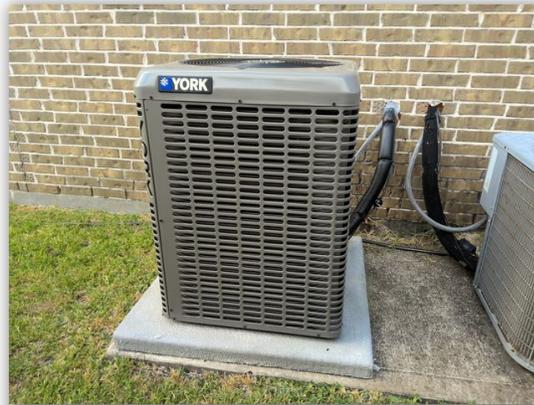
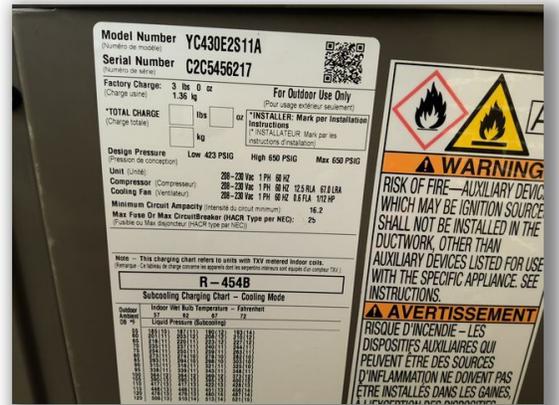
- The temperature drop measured across the evaporative coils of the air conditioning system is lower than considered typical. The unit is not cooling properly and servicing is needed.
- The dirty air filter should be replaced.

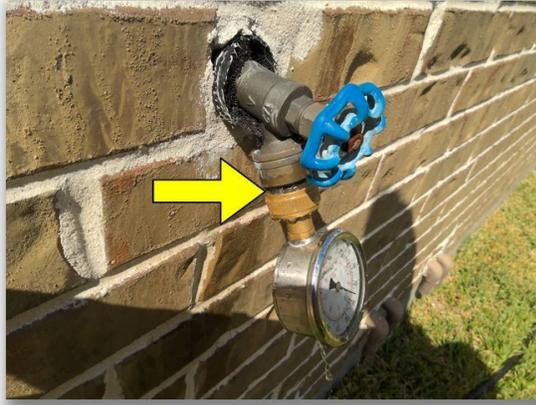
- Water was observed to be leaking back through the vacuum breaker on the right side of the structure. The vacuum breaker is not working as designed.

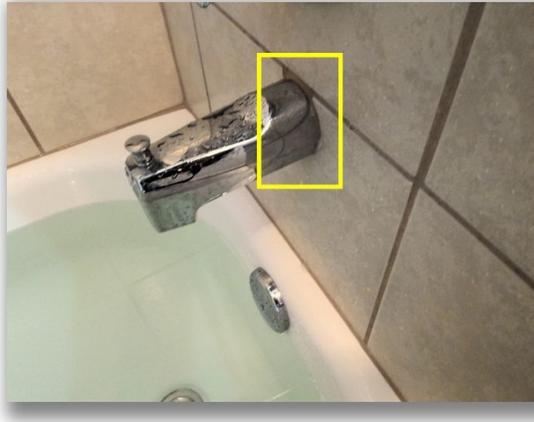
- The faucet assembly is not sealed at the wall. This condition has the potential to allow water to leak back into the wall cavity.

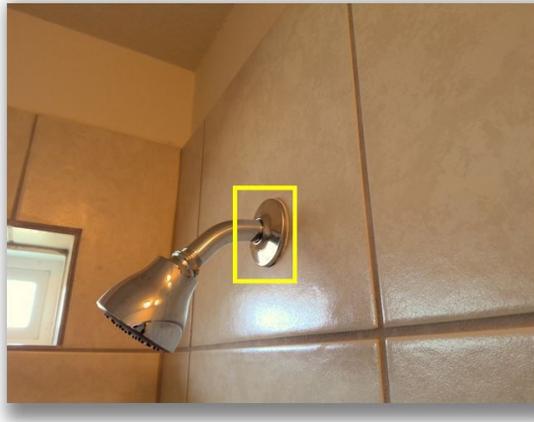
- The shower head escutcheon is loose/not sealed at the wall.

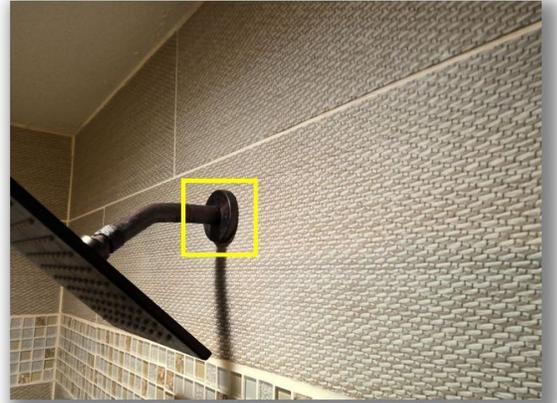
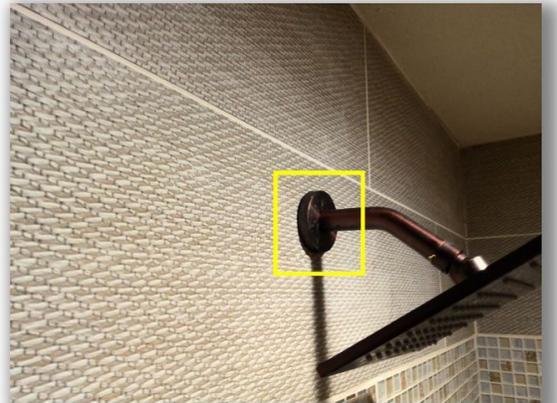
- The shower head escutcheon is loose/not sealed at the wall.
- The faucet assembly is not sealed at the wall. This condition has the potential to allow water to leak back into the wall cavity.

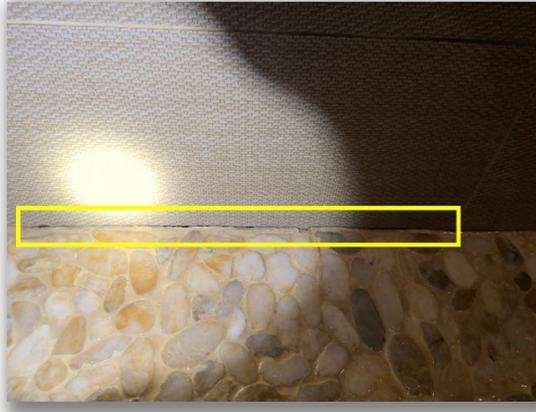
- Cracked, deteriorated and/or missing shower stall grout and/or caulking should be repaired or replaced as necessary.

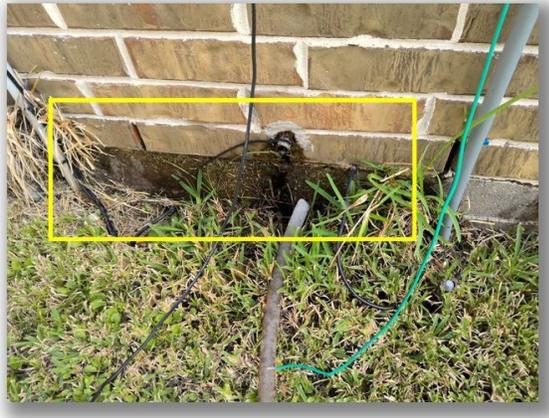
- Observed drain line terminating directly at the brick exterior without a 90-degree turn or extension to direct water away from the structure. This configuration allows water to run down the wall, contributing to algae growth and potential moisture-related damage to the brick or foundation over time. Recommend correction by a qualified contractor to properly terminate the drain line with an elbow or extension to direct discharge away from the structure.

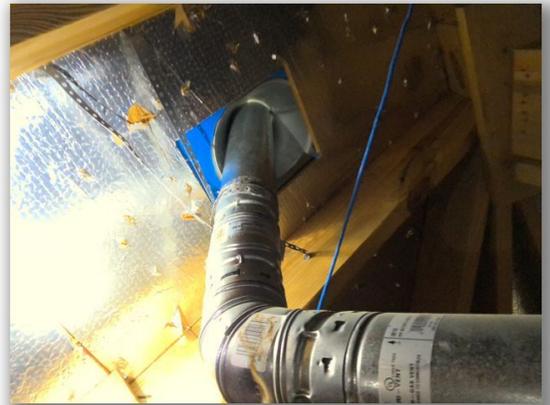
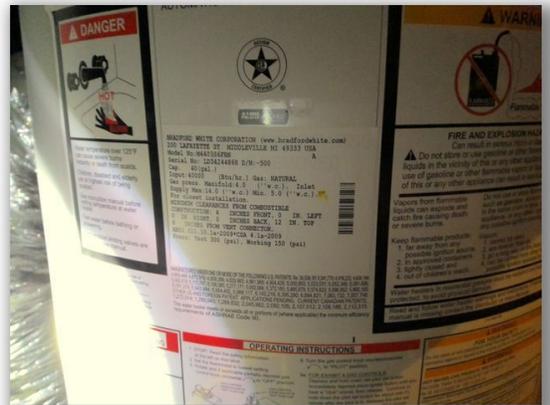
- The water heater vent pipe is separated in the attic. This configuration will emit Carbon Monoxide into the attic area, which is a known safety hazard.

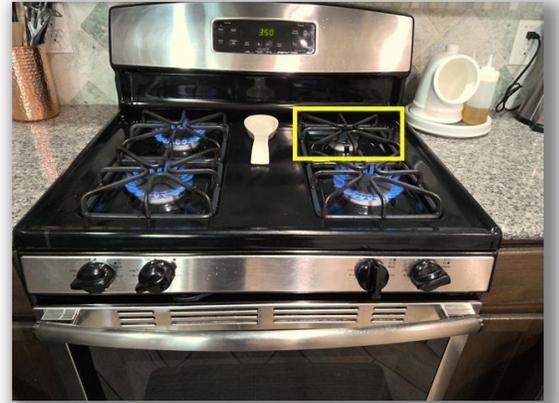
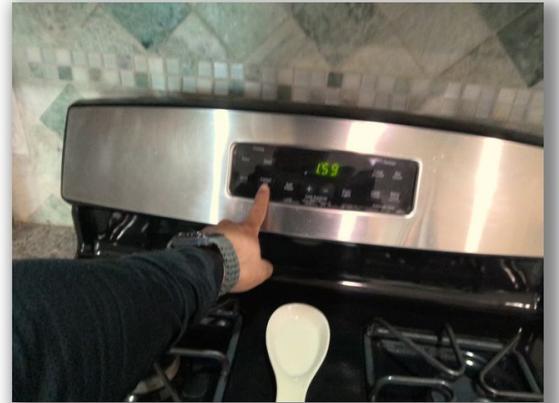
- One or more of the cooktop burners would not light by the pilot and should be further evaluated.

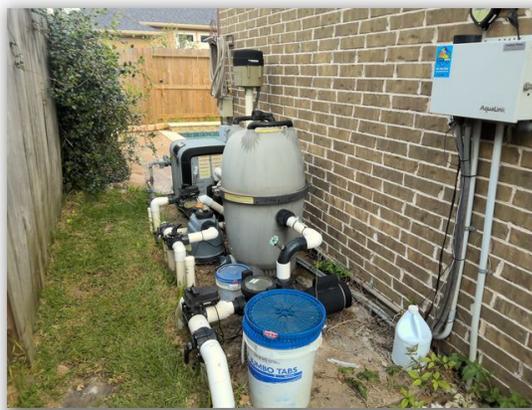
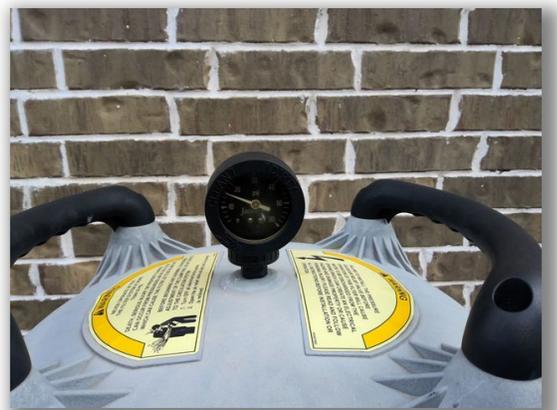
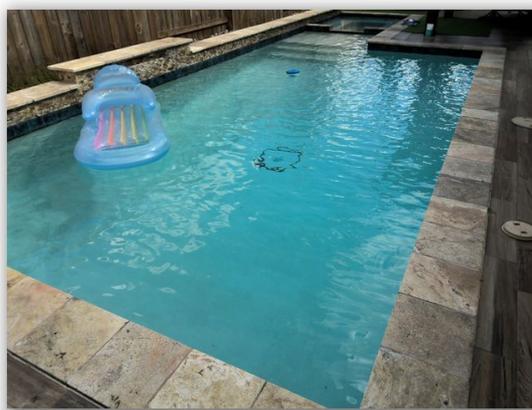
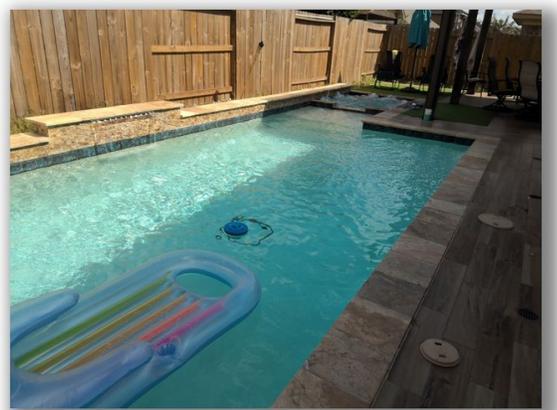
Some of the pool components appear to have deficiencies that are beyond normal. The buyer should have this condition further evaluated by a pool technician familiar with pool structures and associated pool components for remedial cost estimates. The observations made to support the rendering of this opinion are listed but may not be limited to the following:

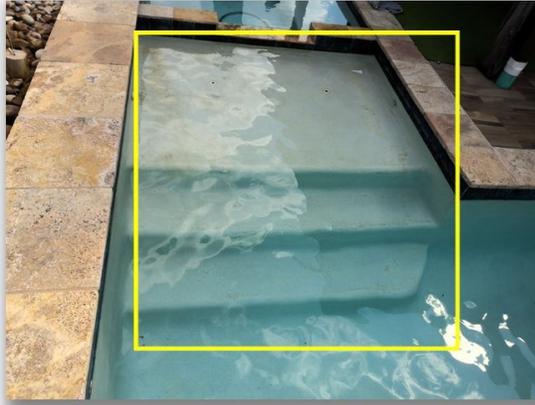
- Some discoloration of the pool surface was observed at the time of this inspection. A qualified technician should investigate the cause and remedy of this condition.

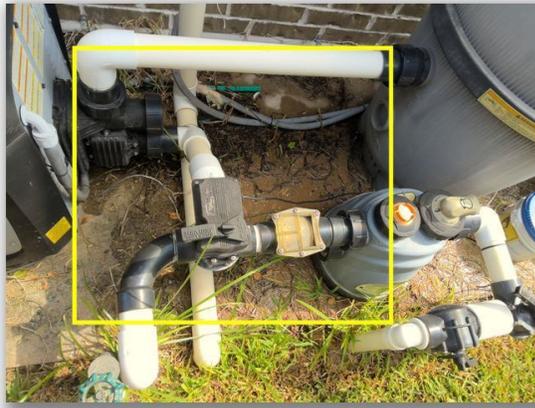
- There appears to be a water leak at the above ground plumbing lines at and around the equipment. The cause and remedy should be further evaluated and corrected as necessary.
