Reserve Study

*The Oak  
Hammock Preserve*

October 30, 2024  
November 12, 2024 rev.

Reference: **The Oak Hammock Preserve  
Reserve Study  
Kipcon Project No. 15735-01**

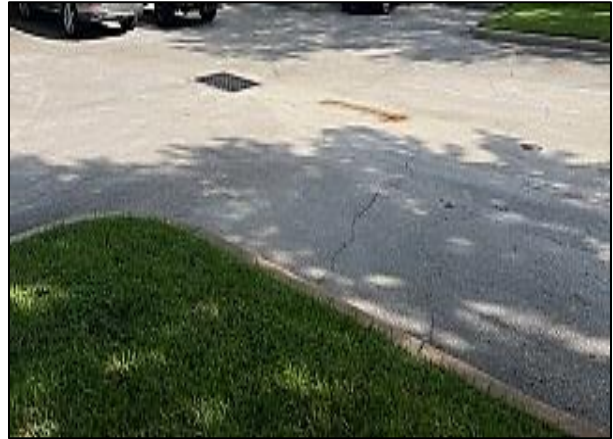
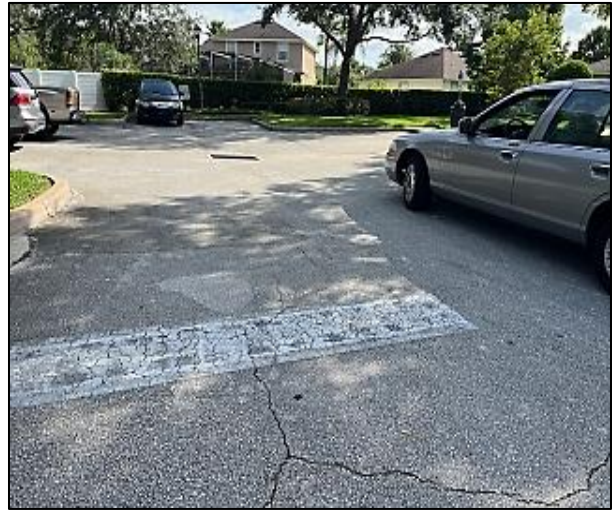
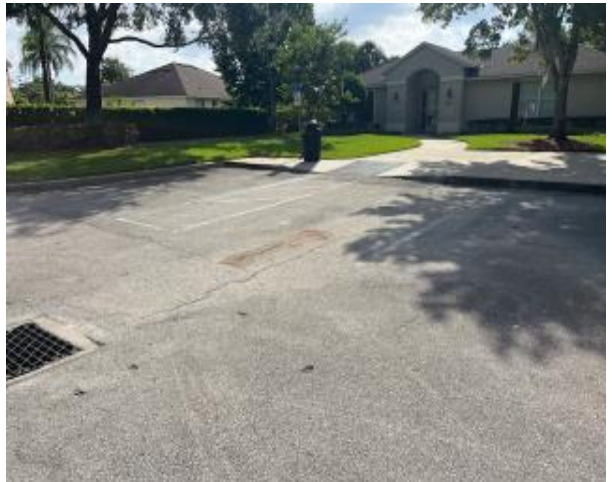
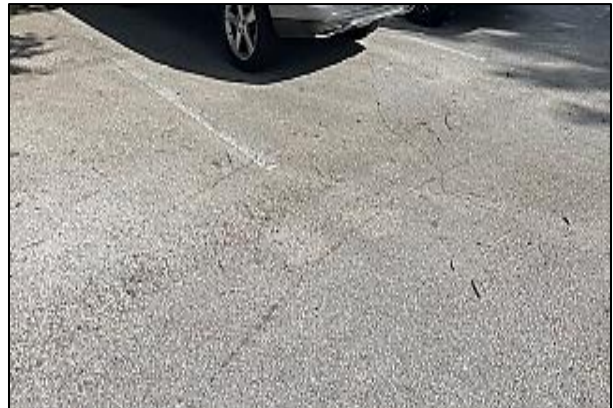
1. Asphalt Parking Lot

1. The asphalt pavement for the parking lot at the pool amenity was observed to be in fair condition at the time of inspection. There was cracking, low areas holding water and worn asphalt. It is recommended that the association include the asphalt in annual inspections and a preventive maintenance program to address repairs in a timely manner to prevent further damage to the asphalt. The cost shown for the is component is to address remediation as needed.

2. The cost shown is for crack sealing and seal coating of the asphalt parking lot. This has not been completed in the past and should be addressed after the milling and repaving of the asphalt is completed. It is recommended crack sealing and seal coating should be performed after the new asphalt has cured. This is usually 6 months to a year. It is recommended that crack sealing and seal coating should be included in a regular maintenance program for the community. This improves appearance, also assists with increasing the lifespan of asphalt, protects against water and oxidation of the asphalt. This will assist the community in reducing overall costs for repairs in the future. The cost shown is for the recommendation of this to be completed at least every 5 years or as needed.

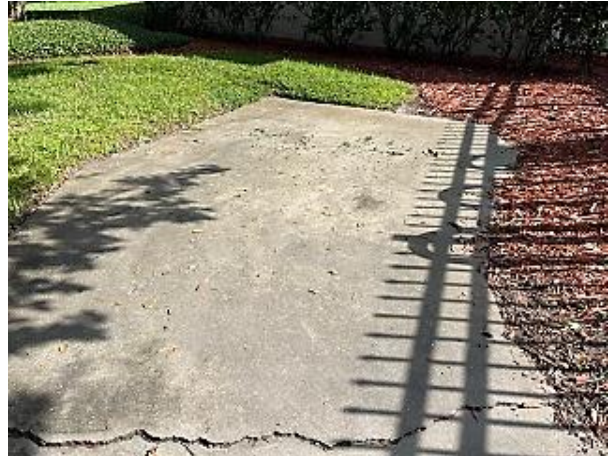
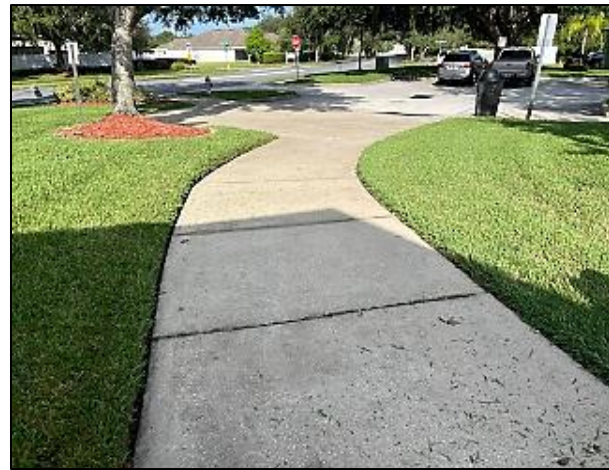
## 3. Sidewalk

3. The Association is only responsible for the sidewalks and concrete located at pool cabana fence drain. There were areas that require some repairs due to excessive cracking or displacement. Since concrete sidewalks will not require full replacement at the same time it is recommended that annual inspection should be performed to determine the areas that require repair. This will assist the community in avoiding safety issues overtime. The cost shown is for remediation of concrete areas as needed.

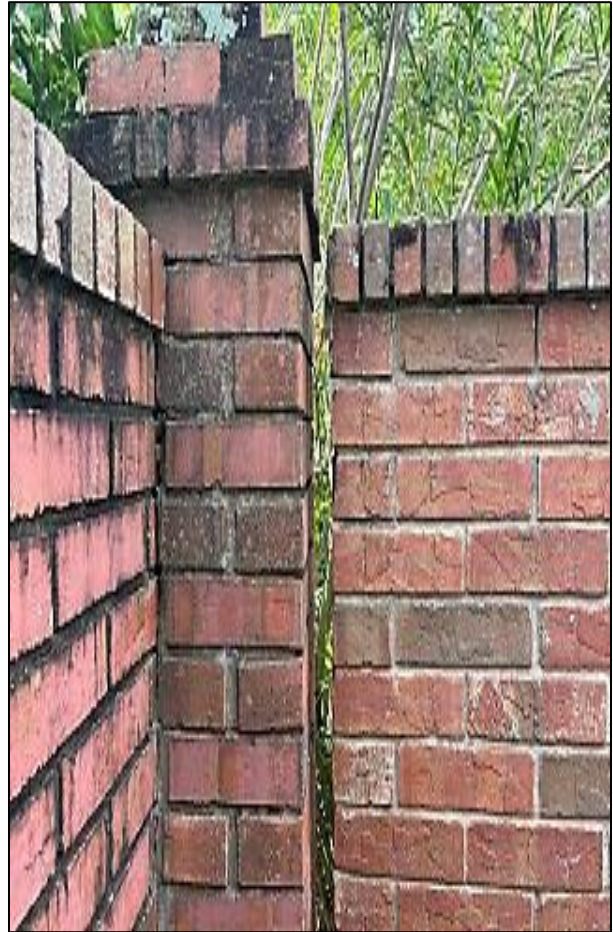
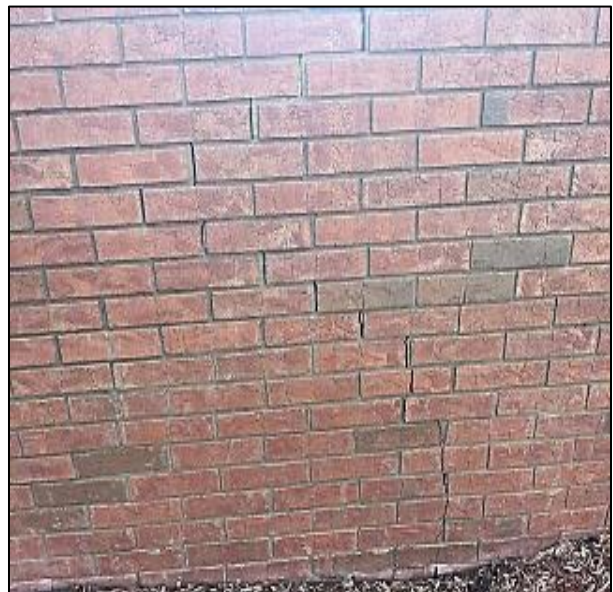
## 4. Cracked retaining wall

4. The retaining wall around the community was observed to be in poor to fair condition at the time of inspection. There were areas cracked, separating, missing mortar, efflorescence present, algae and environmental growth present. This will reduce the integrity of the structure and reduce the useful life expected. It is recommended that annual inspections should be performed to allow the community to address issues as needed. A preventative maintenance program should be implemented to determine the type of maintenance that is required at that time. This may include power washing the wall, re-pointing the mortar, addressing cracks so they don't damage the walls integrity over time. By performing these inspections and maintenance will assist the community in improving the useful life, appearance and reducing the cost that may be required to replace larger sections of the wall. At this time the Association is working on getting proposals to perform repairs that are currently needed based on the conditions observed.

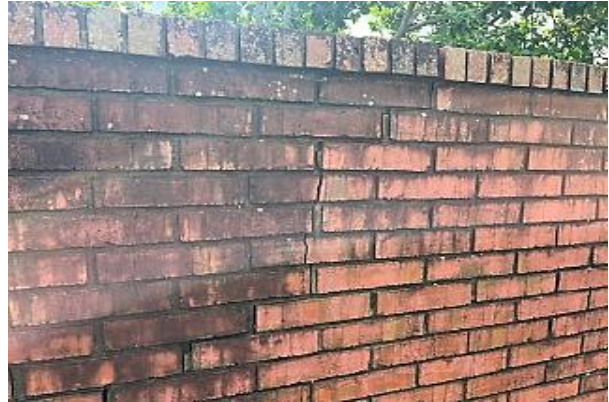
4. Cracked retaining wall

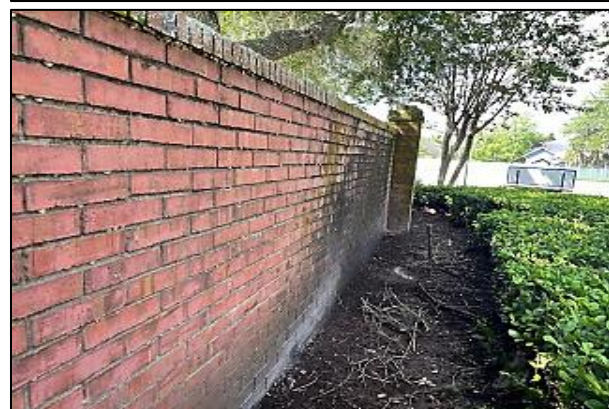
4. Algae and Environmental Growth

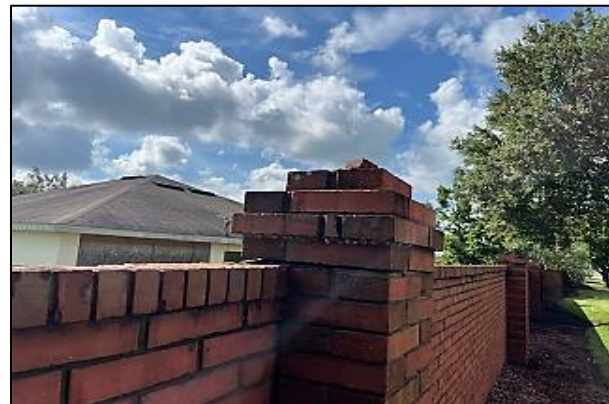
4. Damaged Cap

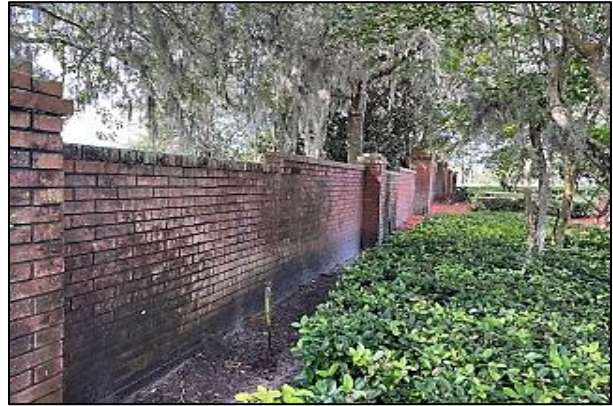
## 4. Retaining Wall Algae and Environmental Growth

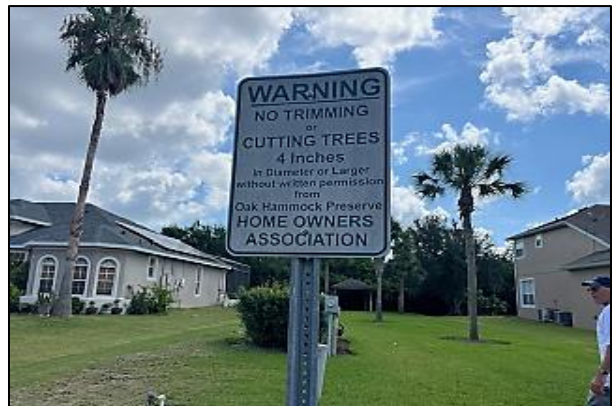
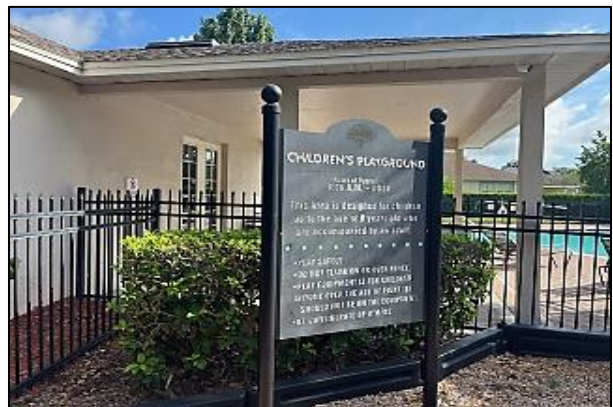
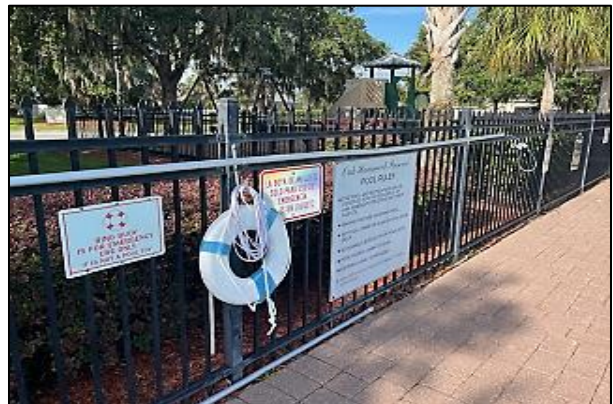
## 5. Signage

5. The cost shown represents the removal and replacement of signage throughout the community. This includes traffic signs, safety signs, information and identification signs. The current signage was observed to be in good condition at the time of inspection and should be included in annual inspections to determine replacements as needed.

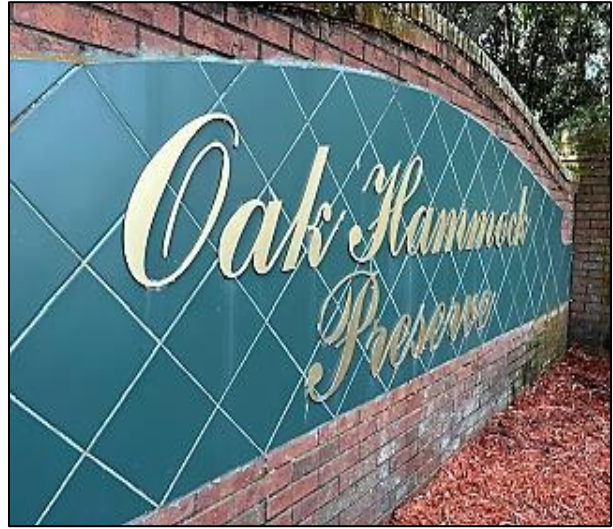
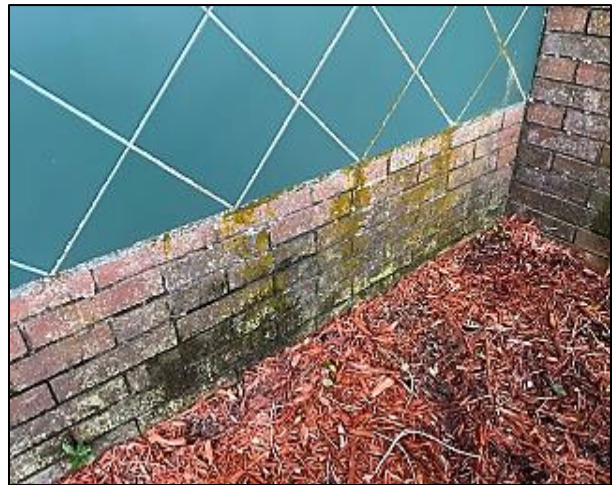
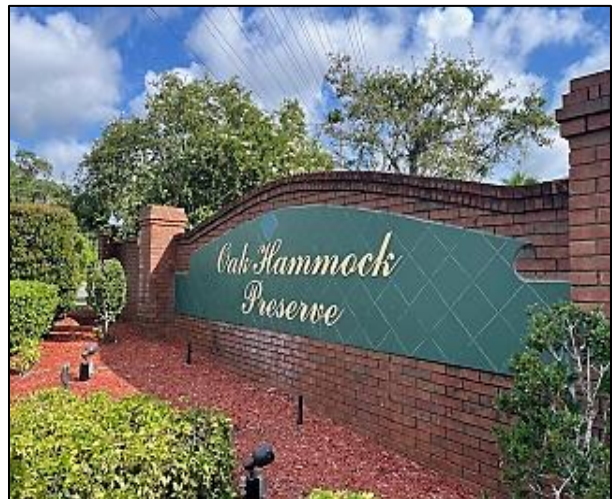
6. Monument Sign for Community

6. The monument sign for the community is posted on the brick retaining wall. The sign is currently in good condition but should be included in regular maintenance which include cleaning, removal of algae and environmental conditions that could reduce the life expectancy of the sign along with periodic sealing and touch up painting. The cost show is to removal and replace as needed.

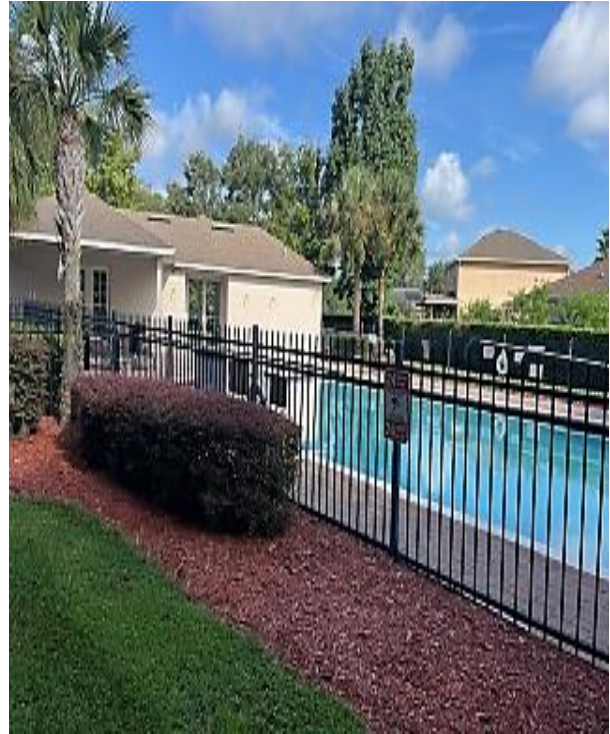
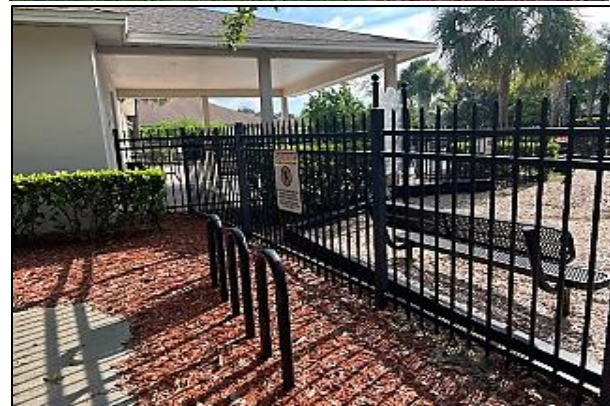
## 7. Fencing and Gates

7. The metal fencing and gates for the community are located at the pool area, tot-lot and the pool mechanical equipment area. The metal fencing was observed to be in fair to good condition at the time of inspection. The gates are locked on the outside and inside of the areas they can be unlocked with a key. It is recommended that the fencing and gates should be included in annual inspections and maintenance which includes cleaning, removal of rust, tightening hardware and bolts, lubrication of hardware, painting as needed. This improves it's appearance, provided the community with safe fencing and gates, reduces overall costs by improving the life expectancy of the equipment. The cost shown represents removal and replacement of sections as needed.

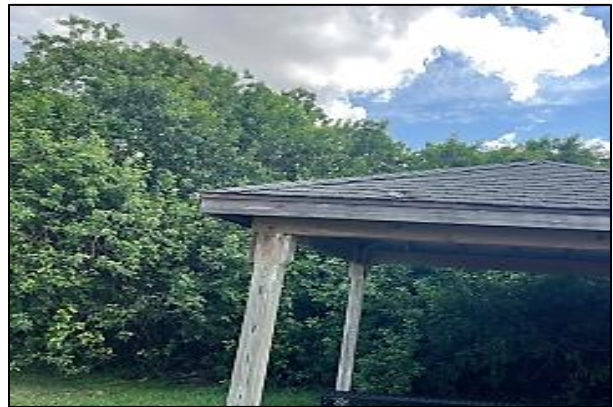
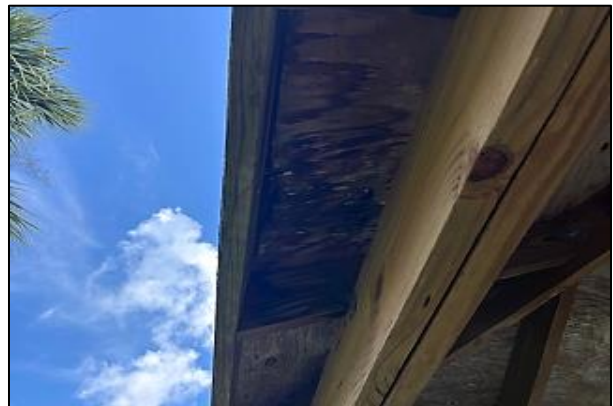
## 12. Gazebo Framing

12. The gazebo for the community was observed to be in poor condition at the time of inspection. It is recommended that the current gazebo should be removed and a new one installed. Annual inspections will assist the Association in determining maintenance that will be required to keep the structure in good condition and provide the community with a safe environment.

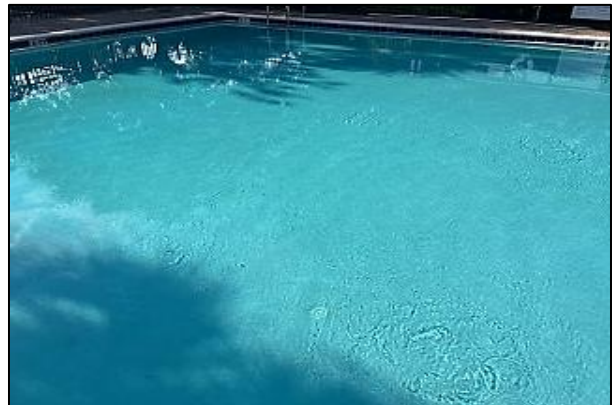
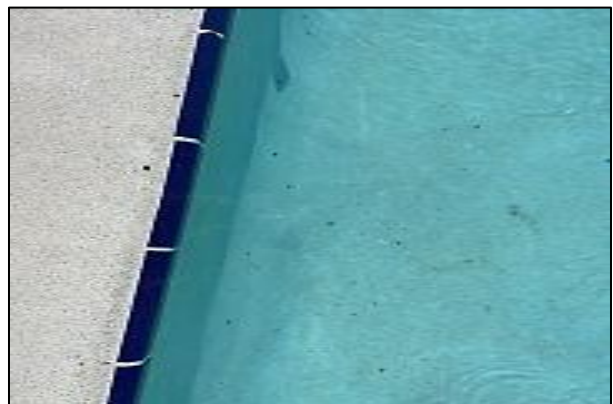
## 14. Pool-Black Spots

14. The resurfacing of a pool is a process that includes cleaning, prepping and then applying a new finish to the current existing swimming pool. A good service and maintenance program should be implemented to keep the pool in good condition and safe. Proper use of chemicals and reduce the life expectancy of the pool surface and allow algae, staining of the grout and tiles and erode the pool surface over time.

16. The cost of the pool filtration system is to remove and replace the system. It was reported that black spots were observed in the pool several times. This could be an indication that the system is not being serviced properly. Since improper use of the chemicals for the pool could lead to black spots. Black spots are sometimes associated with algae growth, mineral deposits, metal staining or even organic debris. Some reasons for this may be low phosphate levels, high pH levels, low chlorine levels or even pool water circulation caused by the filtration system not functioning as intended. It is recommended to have the filtration system tested along with the water to find the underlying cause of the issue.

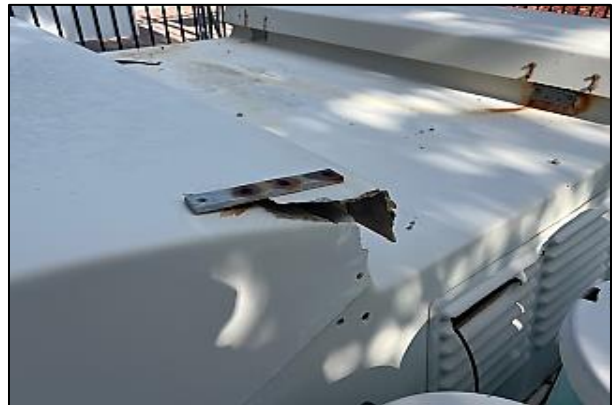
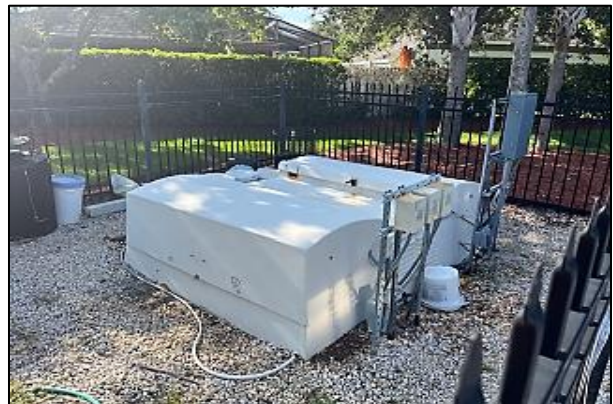
## 17. Pool Equipment Covers

17. The cover for the pool equipment is in poor condition and should be removed and replaced. The damage could allow damage to the equipment since it is cracked and open in areas.

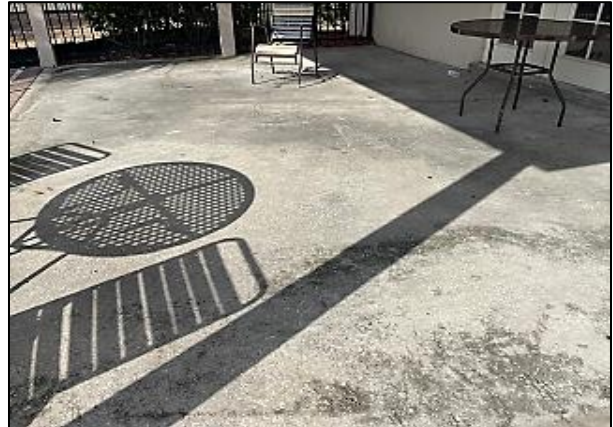
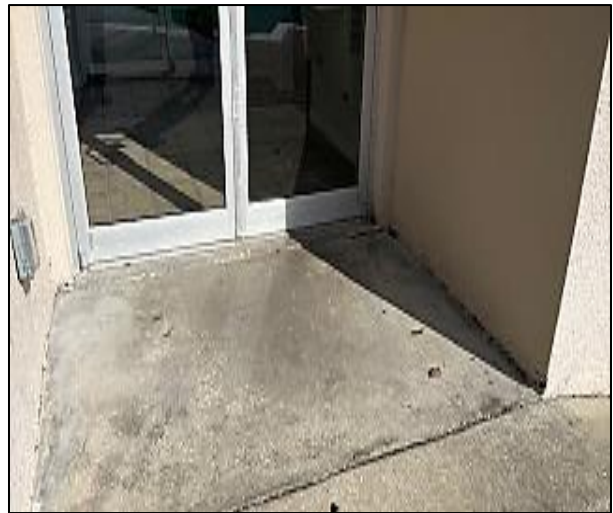
30. Concrete Pad at Cabana

30. The cost shown is for the removal and replacement of the concrete pad located at the pool cabana patio. The concrete pad was observed to be in fair condition at the time of inspection. It is recommended that the pad should be included in preventative maintenance. This should include annual inspections and power washing, sealing of cracks and remediating any damage or settlement as it is identified.
