AmeriSpec Inspection Services of Central East Ontario

Inspection Number: 108480 Inspector: Reg Deck
Inspection Date: 10/21/2021
Inspection Address: 430 Eldon Road
Little Britain ON, K0M 2C0
Listing Agent: Krista Craig Real Estate Company: Coldwell Banker RMR

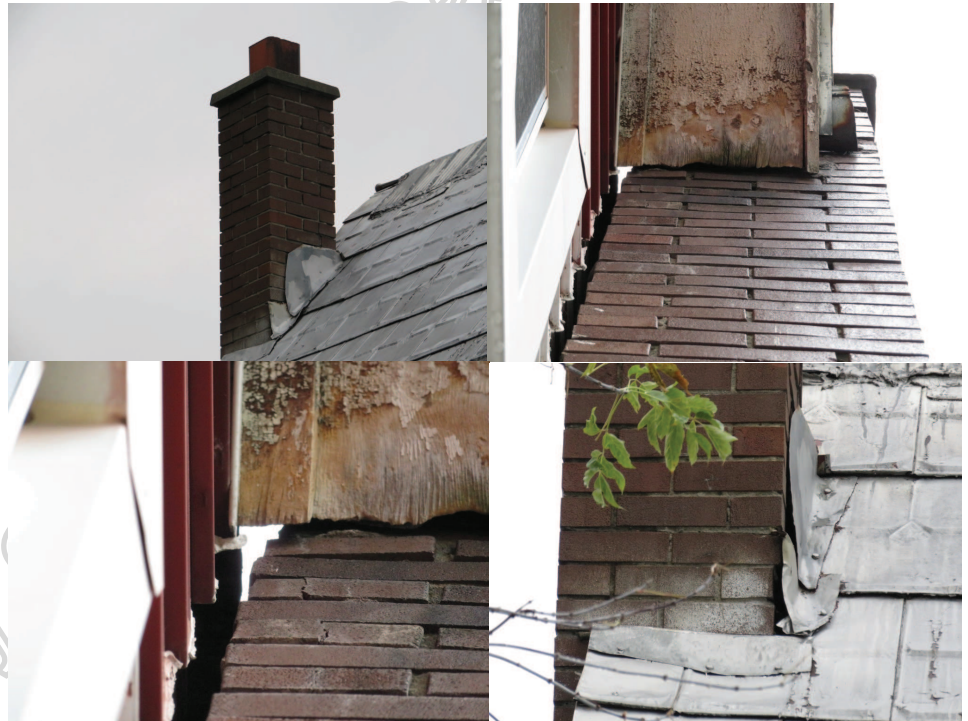
1160. Chimney

Review. Located at the right side of the home. The chimney structure is comprised of brick masonry. Due to the unsafe roof mounting conditions and/or inaccessibility of the roof, the chimney was viewed from the ground only. Therefore, our inspection was limited to the visible components observed from this vantage point. Chimney appears to be redundant (i.e. no longer being used for venting purposes). Chimney has no spark arrester/rain cap installed. We recommend installing as a safety measure and to reduce the possibility for pest intrusion and water infiltration into the chimney. Chimney flashing appears to be inadequately sealed or missing. We recommend properly sealing the flashing to eliminate potential leaks into home. Maintaining the flashing seal should be considered part of routine maintenance. See Roof - Flashings section for additional information. The chimney appears to be pulling away from the side of the home. Recommend further review by a qualified contractor for repair/removal options and associated costs in order to ensure safety.

We recommend sealing throughout the entire chimney area as part of routine maintenance to reduce the potential for water infiltration which could deteriorate the chimney and enter into the home.

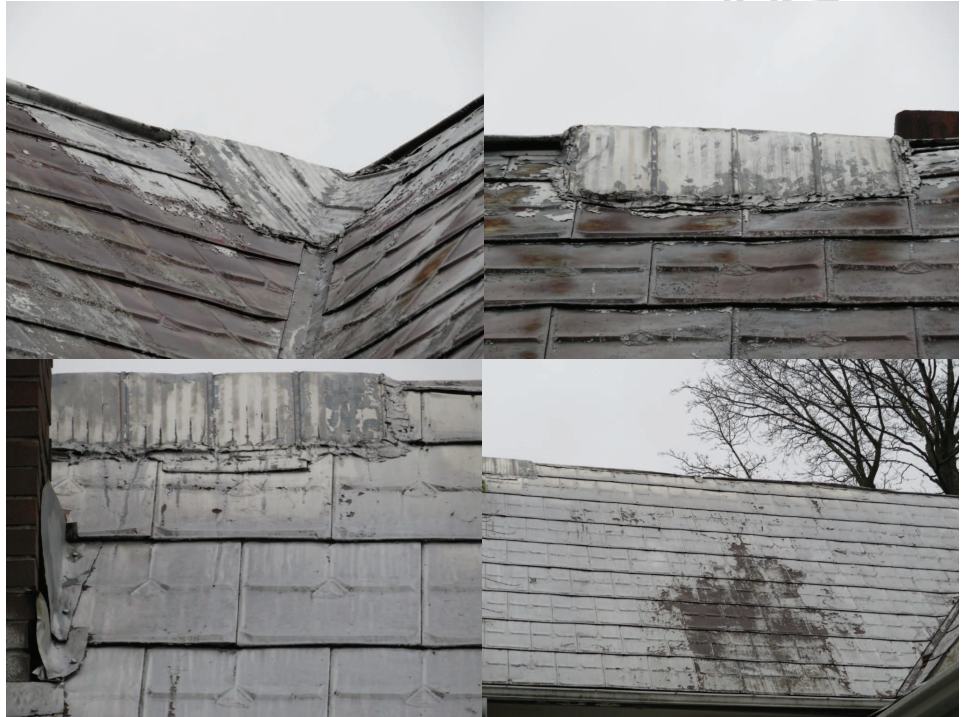
Review. Worn/weathered condition noted. Evidence of patching observed at several areas, most likely covering since-removed chimney protrusions (as visible in the attic). We were unable to determine the effectiveness of these repairs.

1215. Conditions **Review. Worn/weathered condition noted. Evidence of patching observed at several areas, most likely covering since-removed chimney protrusions (as visible in the attic). We were unable to determine the effectiveness of these repairs.**

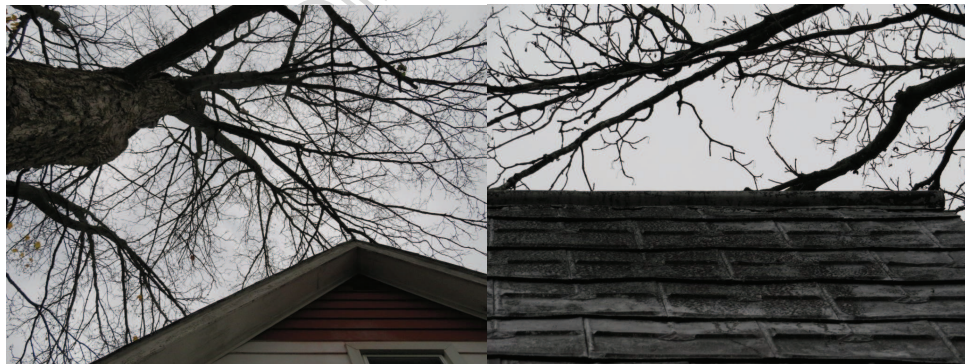
Comments | <p>Review. Vegetative overgrowth noted at the front left of the home. We recommend trimming all trees/vegetation away from the roof to prevent damage and premature wear to the roofing materials, prohibit rodent/pest access and reduce the potential for vegetation/debris accumulation in the gutters/downspouts.</p> |

1240. Roof Comments **Review. Vegetative overgrowth noted at the front left of the home. We recommend trimming all trees/vegetation away from the roof to prevent damage and premature wear to the roofing materials, prohibit rodent/pest access and reduce the potential for vegetation/debris accumulation in the gutters/downspouts.**

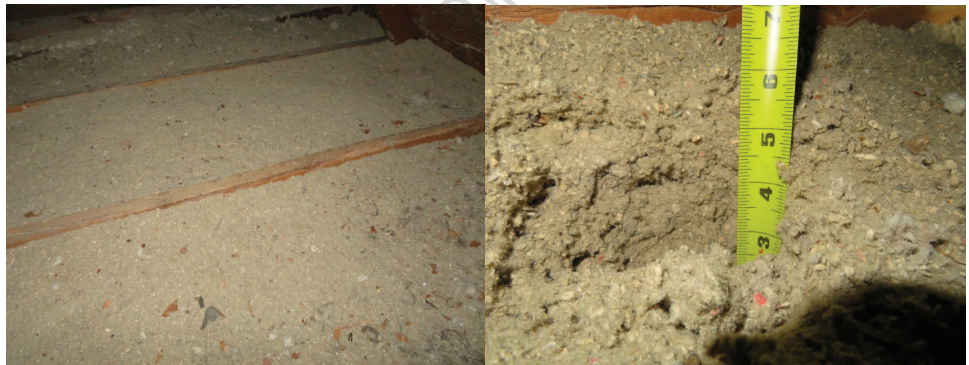
1920. Insulation **Review. Blown-In, Cellulose Fibre. Insulation thickness varies from 5 to 7 inches. Approximate thermal resistance value is R-24. No air/vapour barrier noted under the insulation. Ideally, an air/vapour barrier should be installed under the insulation to reduce the potential for warm moist air to enter the attic space. No evidence of any significant or adverse effects were noted due to the missing air/vapour barrier at the time of the inspection. Little to no insulation noted on the attic side of the attic hatch. We recommend insulating the attic hatch cover as an energy conservation measure. In addition, we recommend installing weather stripping around the attic hatch to reduce the potential for warm moist air to enter the attic space. R-values obtained with current insulation levels are below modern standards (R-60). We recommend increasing the quantity of insulation as an energy conservation measure and to assist with the prevention of ice damming.**

1920. Insulation **Review. Little to no insulation noted on the attic side of the attic hatch. We recommend insulating the attic hatch cover as an energy conservation measure. In addition, we recommend installing weather stripping around the attic hatch to reduce the potential for warm moist air to enter the attic space. R-values obtained with current insulation levels are below modern standards (R-60). We recommend increasing the quantity of insulation as an energy conservation measure and to assist with the prevention of ice damming.**

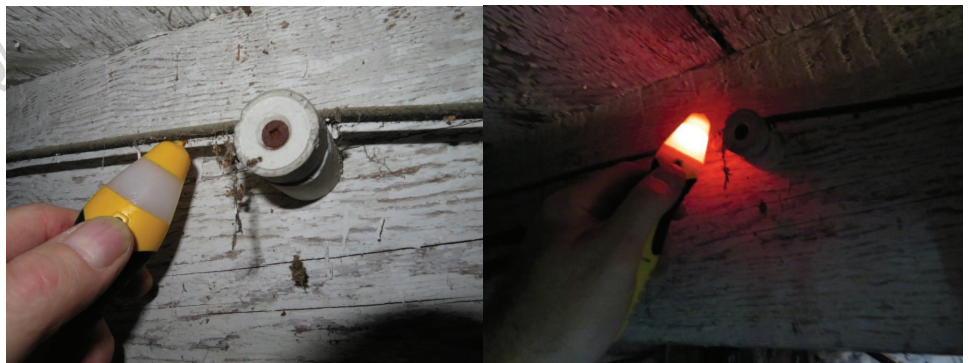
2520. Distribution Wiring

Review. Overload protection of the distribution wires provided by breakers. Where visible, the electrical distribution wiring in the home is copper. **Doubled-up circuitry noted (circuit #11). A doubled-up circuit is the connection of two wires (circuits) to one circuit breaker. This condition can add to the electrical load of the affected circuit causing potential overloading and nuisance "tripping" of the breaker. Doubled-up circuitry typically indicates the potential need for the division of several of the homes circuits and the installation of additional breakers. Although this condition is more of a possible nuisance issue versus a safety issue, we recommend consulting with a licensed electrical contractor for further review. See Electrical - Comments section for additional information. Ungrounded conditions observed at several outlets around the home. This is not uncommon for a home of this age. At a minimum, receptacles in the vicinity of water sources, exterior locations and locations where grounded equipment (appliances with three-prongs) will be used should be grounded to enhance safety. See Electrical - Comments section for additional information. Active knob-and-tube wiring was observed in this home. This type of wiring consists of an older style distribution wiring characterized by separately run hot and neutral wires, paper insulated wires and the absence of junction boxes at wire splices. This type of wiring was standard in homes constructed prior to 1950. Ungrounded conditions and breakdown of the wire insulation and resultant fire/safety issues are the main reasons why knob-and-tube wiring requires replacement. Each home containing knob-and-tube wiring should be reviewed by a licensed electrical contractor to verify integrity and safety of the system. In addition, more recently, many home insurance companies are requiring knob-and-tube wiring in homes to be updated for new insurance policies in order to reduce their risk. On this basis, we recommend consulting with your insurance company to determine their policy regarding knob-and-tube wiring.**

2520. Distribution **Review. Doubled-up circuitry noted (circuit #11). A**
 Wiring **doubled-up circuit is the connection of two wires (circuits) to**
 one circuit breaker. This condition can add to the electrical
 load of the affected circuit causing potential overloading and
 nuisance "tripping" of the breaker. Doubled-up circuitry
 typically indicates the potential need for the division of
 several of the homes circuits and the installation of additional
 breakers. Although this condition is more of a possible
 nuisance issue versus a safety issue, we recommend consulting
 with a licensed electrical contractor for further review. See
 Electrical - Comments section for additional information.
 Ungrounded conditions observed at several outlets around
 the home. This is not uncommon for a home of this age. At a
 minimum, receptacles in the vicinity of water sources,
 exterior locations and locations where grounded equipment

(appliances with three-prongs) will be used should be
 grounded to enhance safety. See Electrical - Comments
 section for additional information. Active knob-and-tube
 wiring was observed in this home. This type of wiring consists
 of an older style distribution wiring characterized by
 separately run hot and neutral wires, paper insulated wires
 and the absence of junction boxes at wire splices. This type of
 wiring was standard in homes constructed prior to 1950.
 Ungrounded conditions and breakdown of the wire insulation
 and resultant fire/safety issues are the main reasons why
 knob-and-tube wiring requires replacement. Each home
 containing knob-and-tube wiring should be reviewed by a
 licensed electrical contractor to verify integrity and safety of
 the system. In addition, more recently, many home insurance
 companies are requiring knob-and-tube wiring in homes to
 be updated for new insurance policies in order to reduce their

risk. On this basis, we recommend consulting with your
 insurance company to determine their policy regarding
 knob-and-tube wiring.

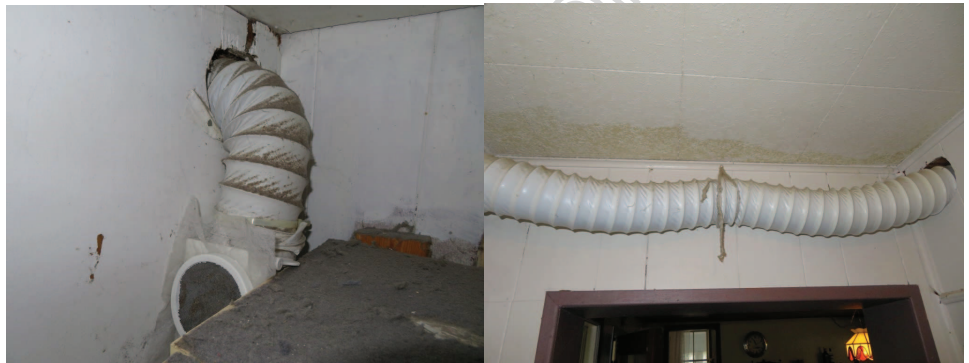
3650. Washer Hookup In order to prevent possible damage, we do not disconnect the supply hoses to the washer, nor do we operate the valves. Valves are unpredictable and can leak at any time. Repairs to these areas should be considered a part of normal maintenance.
3655. Dryer Hookup **Safety.** Electric (220). We recommend cleaning the interior of the dryer vent of accumulated lint as part of routine maintenance to improve dryer efficiency and for increased fire safety. **The flex hose at the dryer exhaust is a plastic/vinyl material that, under certain conditions, has been known to be a fire hazard. As a safety measure, we recommend upgrading to an approved metal dryer vent duct.**

3655. Dryer Hookup **Safety. The flex hose at the dryer exhaust is a plastic/vinyl material that, under certain conditions, has been known to be a fire hazard. As a safety measure, we recommend upgrading to an approved metal dryer vent duct.**

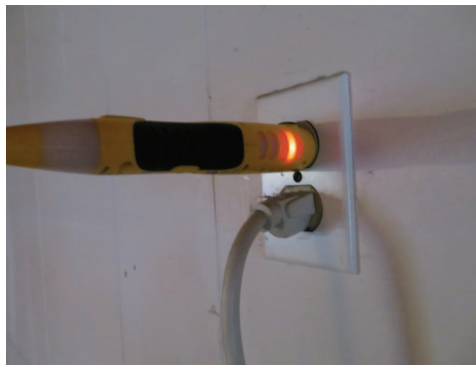
3825.	Doors	Serviceable. Wood.
3830.	Windows	Serviceable. Vinyl Frame, Double Hung.
3835.	Cabinets	Serviceable.
3840.	Counter Tops	Serviceable. Laminate.
3845.	Electrical	Review. Ungrounded outlet(s) noted at the prep area (detached from the main countertop). See Electrical - Distribution Wiring section for additional information.

3845. Electrical **Review. Ungrounded outlet(s) noted at the prep area (detached from the main countertop). See Electrical - Distribution Wiring section for additional information.**

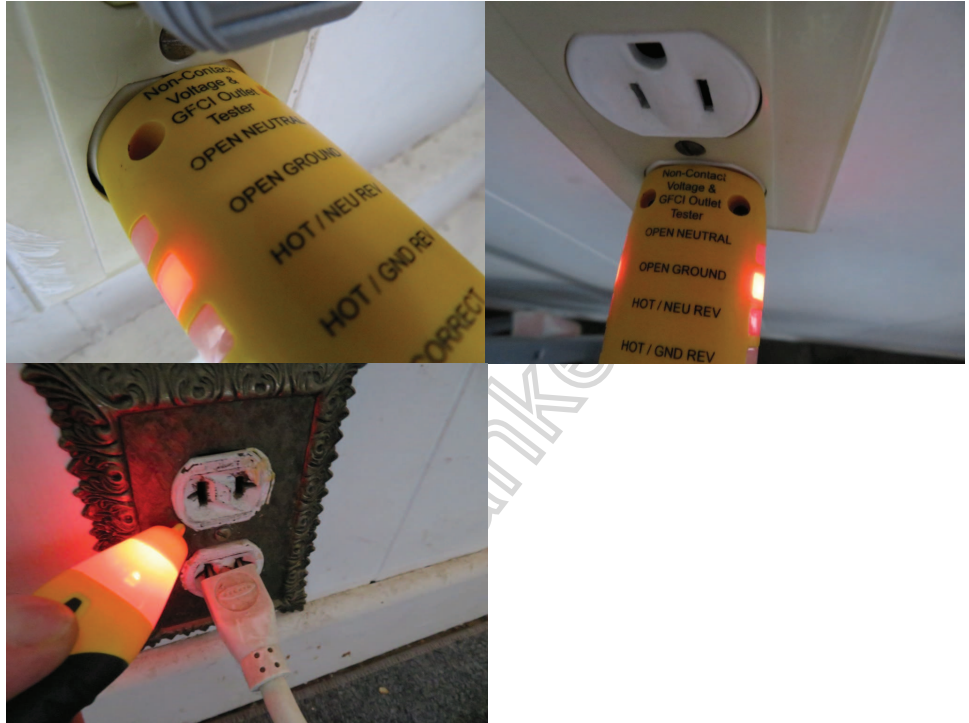
Review. Ungrounded outlet(s) noted. See Electrical - Distribution Wiring section for additional information.

4560. Electrical **Review. Ungrounded outlet(s) noted. See Electrical - Distribution Wiring section for additional information.**
