## "Full" Reserve Study

### **Sunflower Condominium Association, Inc. Boca Raton, FL**

**Report #: 39848-0**  
**For Period Beginning: January 1, 2021**  
**Expires: December 31, 2021**

**Date Prepared: September 10, 2020**

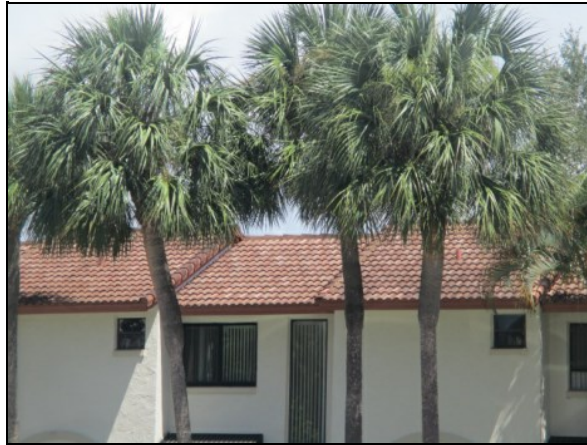
**Comp #: 2383 Roofing (Tile) - Replace****Quantity: Approx 164,000 GSF**

Useful Life:  
25 years

Remaining Life:  
3 years

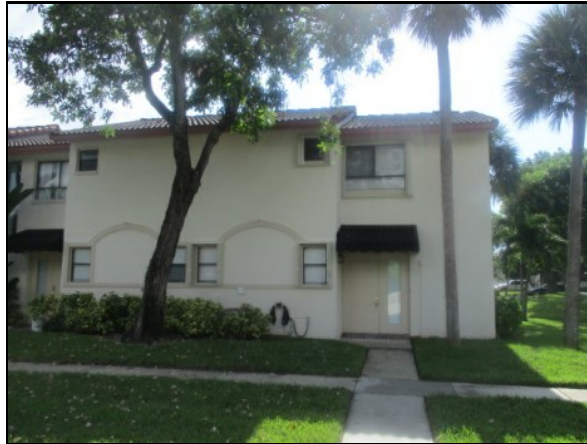
Useful Life:  
7 years

Remaining Life:  
1 years

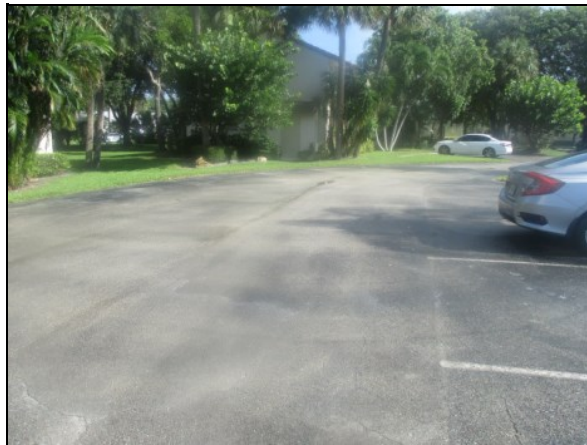
Useful Life:  
4 years

Remaining Life:  
2 years

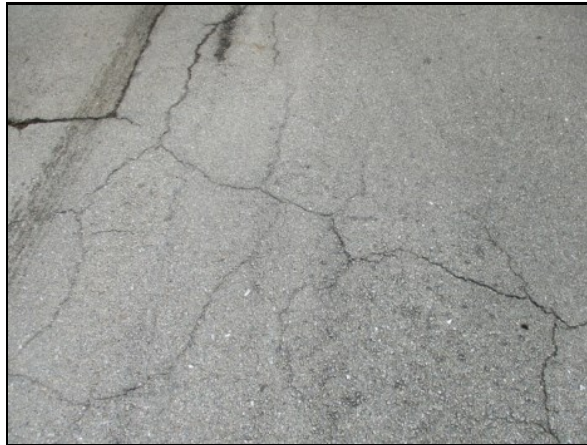
Useful Life:  
20 years

Remaining Life:  
1 years

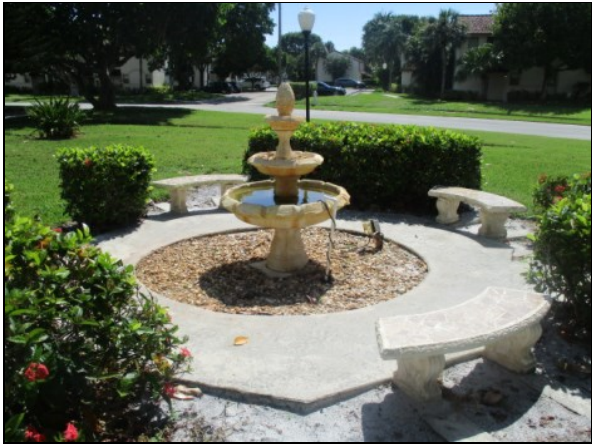
Useful Life:  
10 years

Remaining Life:  
3 years

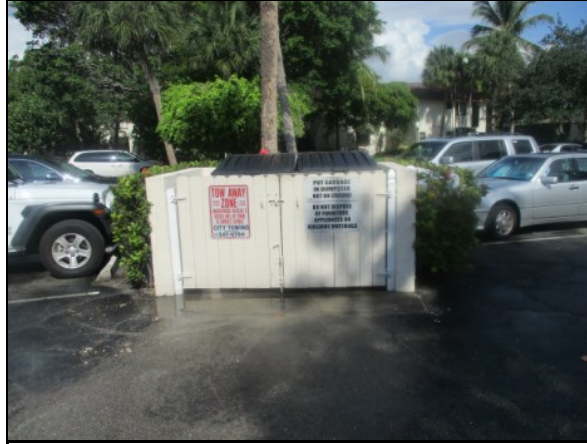
Useful Life:  
15 years

Remaining Life:  
5 years

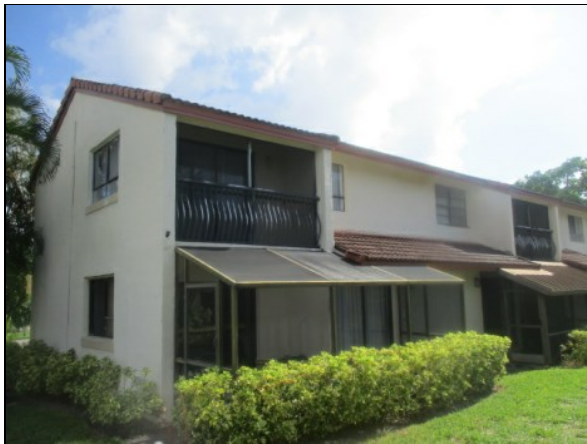
Useful Life:  
25 years

Remaining Life:  
2 years

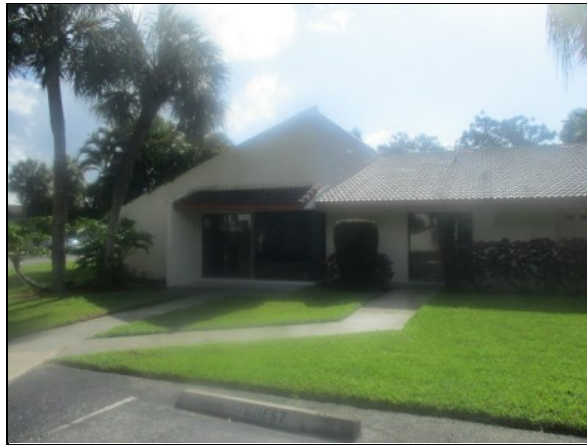
Useful Life:  
40 years

Remaining Life:  
8 years
