Home Inspection Report

Prepared for: Your Name

Prepared by: Eagle Eye Inspection Services, LLC

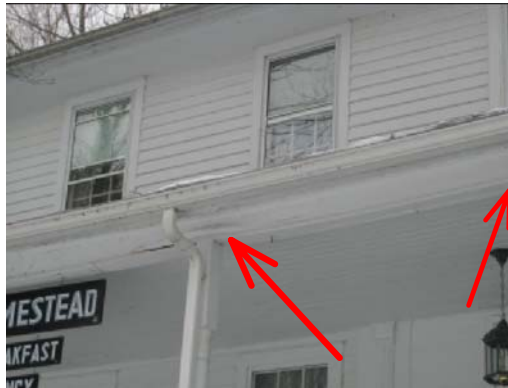
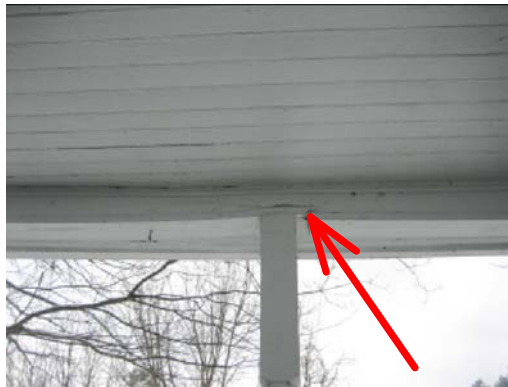
Porch: Wood -Water damage noted, A qualified contractor is recommended to evaluate and estimate repairs

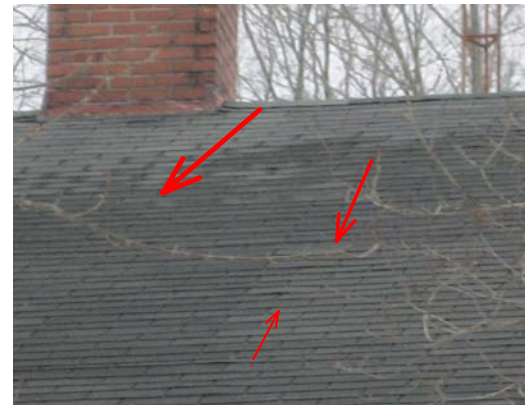
| 2. Repair or replace | Material: Composition Shingle

-Loose or damaged shingles,
Moisture noted in the attic,
Evaluation by a qualified
roofing contractor is
recommended |

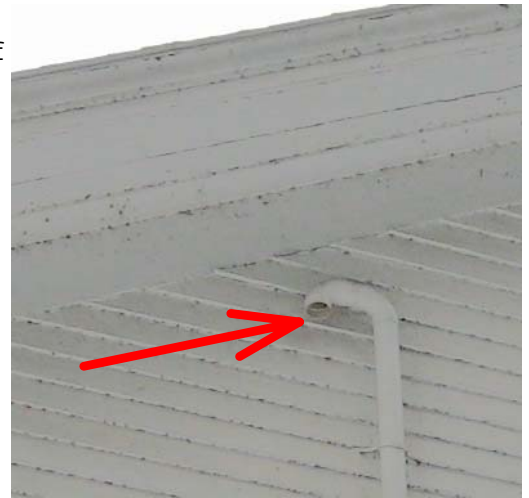
Plumbing Vents: PVC -All vent pipes should extend above the eaves of the roof

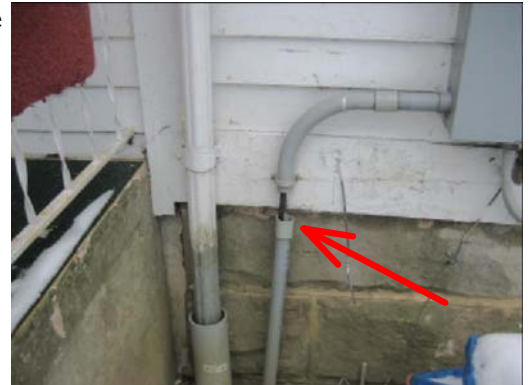
Electrical Mast: Surface mount -Loose conduit

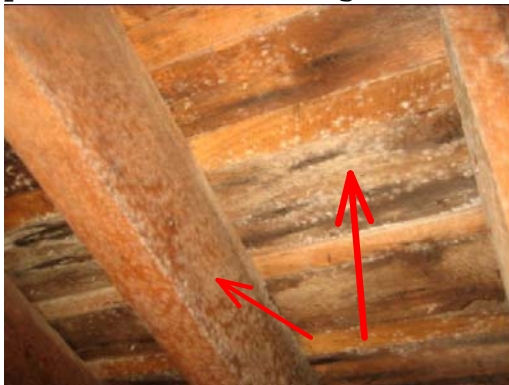
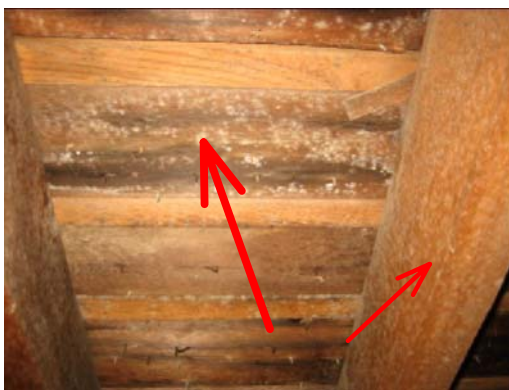
- 1. Method of Inspection: In the attic
- 2. Serviceable Roof Framing: 2x6 Rafter
- 3. Maintenance Sheathing: Dimensional wood -Possible mold noted, Recommend professional testing

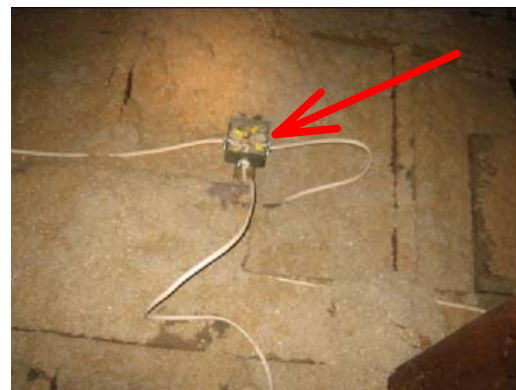
- 4. Serviceable Ventilation: Roof & Gable vents
- 5. Serviceable Insulation: Fiberglass
- 6. Serviceable Insulation Depth: 1"
- 7. Serviceable Attic Fan: Direct drive
- 8. Safety Enhancement Wiring/Lighting: 110 VAC -Open junction box

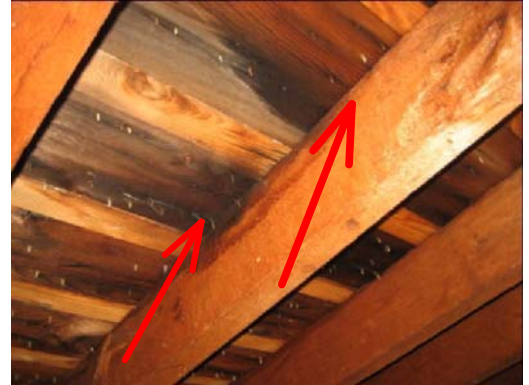
- 11. Serviceable
 - 12. Serviceable
 - 13. Serviceable
 - 14. Repair or replace
- Sheathing: Dimensional wood
Insulation: Blown in
Insulation Depth: 6 "
Moisture Penetration: Ongoing water penetration noted -A qualified roofing contractor is recommended to evaluate and estimate the cost of repair

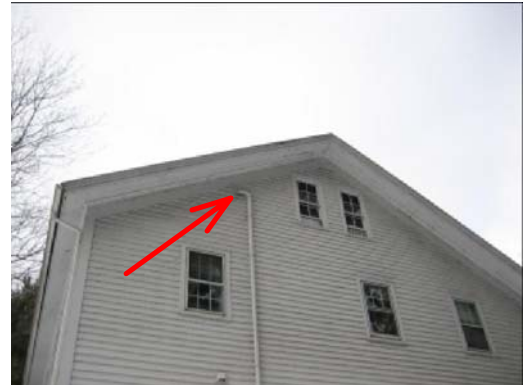
5. Maintenance Vent Pipes: PVC -The vent pipe terminates improperly, All vent pipes should extend above the eaves

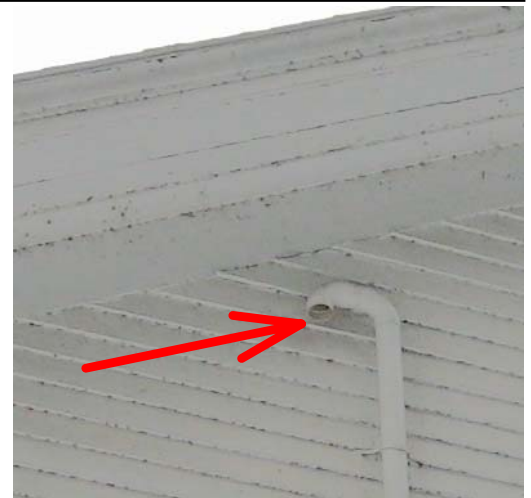
1. Plumbing Vents: PVC -All vent pipes should extend above the eaves of the roof

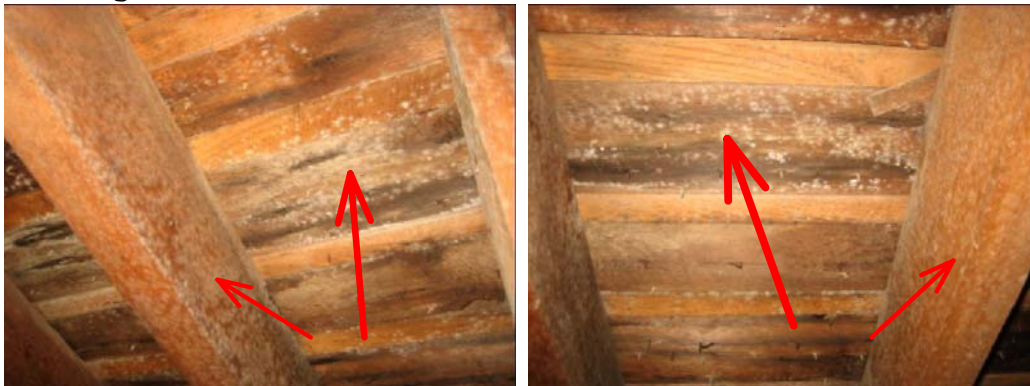
3. North Attic Sheathing: Dimensional wood -Possible mold noted, Recommend professional testing

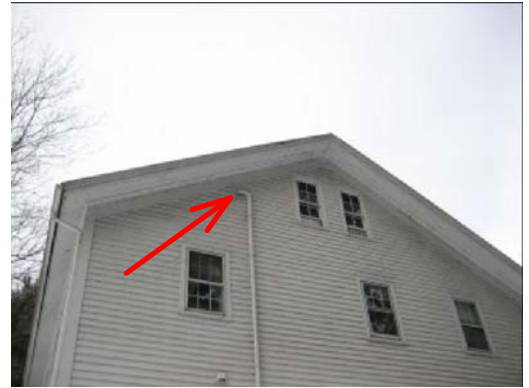
5. Vent Pipes: PVC -The vent pipe terminates improperly,
All vent pipes should extend above the eaves

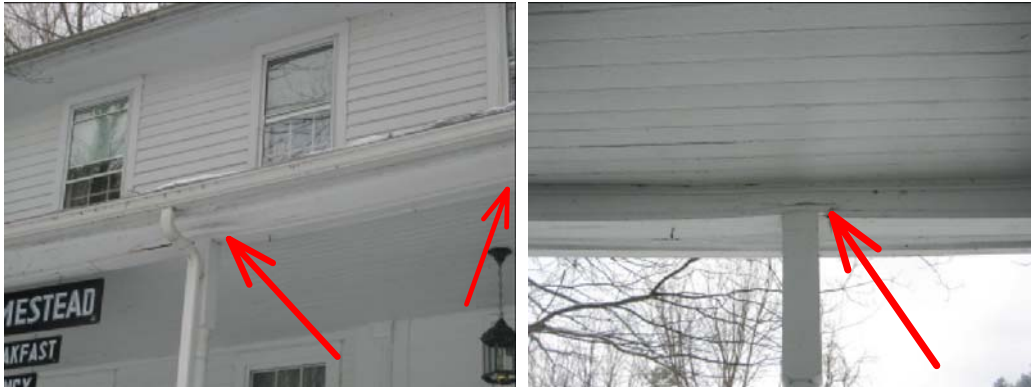
1. Porch: Wood -Water damage noted, A qualified contractor is recommended to evaluate and estimate repairs

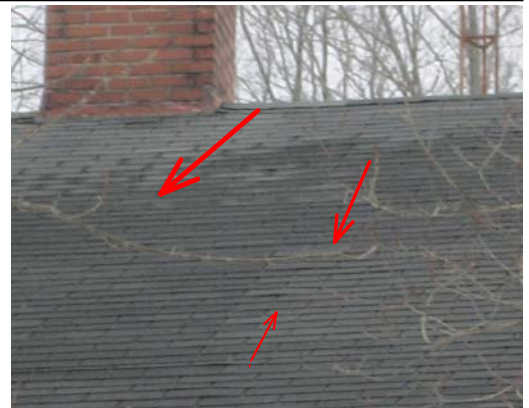
2. Main Roof Surface Material: Composition Shingle -Loose or damaged shingles, Moisture noted in the attic, Evaluation by a qualified roofing contractor is recommended

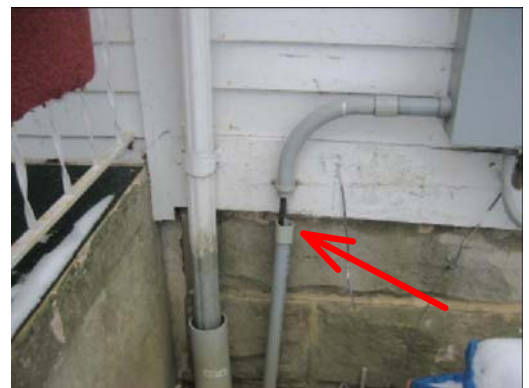
3. Electrical Mast: Surface mount -Loose conduit

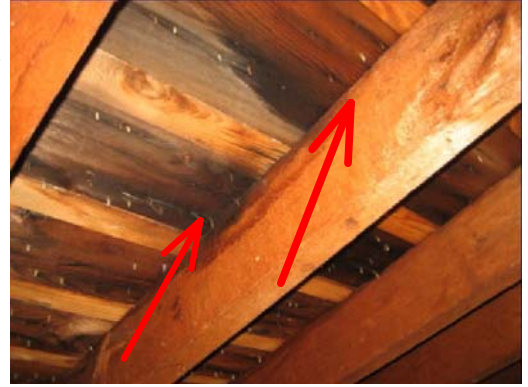
4. South Attic Moisture Penetration: Ongoing water penetration noted -A qualified roofing contractor is recommended to evaluate and estimate the cost of repair
