# Sample Report

123 Snagging Lane

05 Dec 2022

Description: New Build Inspection of 3 Bedroom Semi-Detached House

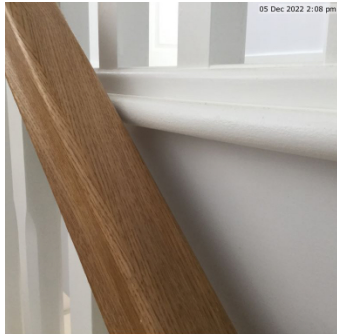
## Stair Handrail Incorrectly Fitted

Handrail does not provide a minimum 25mm clearance all round, as per Part K of the Building Regulations.

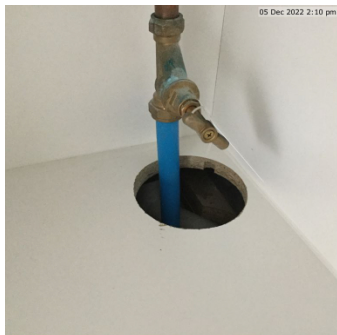
## Kitchen Unit

The cut-out in the sink unit for the entry of the water mains is excessive.

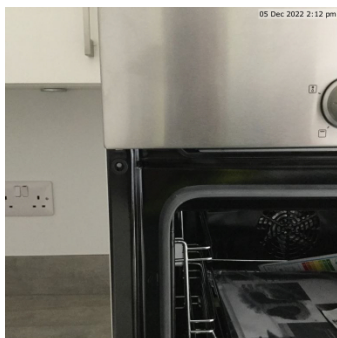
## Oven

The oven has not been secured correctly into the housing unit.

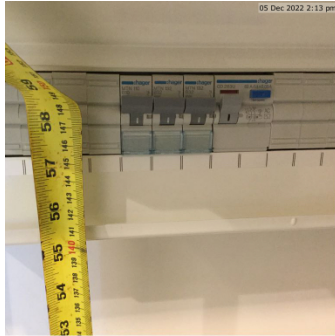
## Consumer Unit

Consumer unit height is slightly above the 1350mm to 1450mm permissible range.

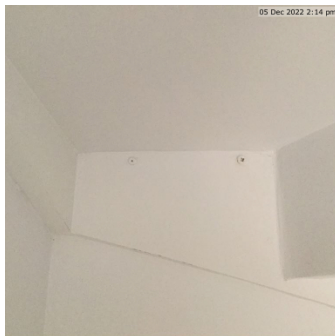
## Stair String

Fixings remain visible on underside of stair string.

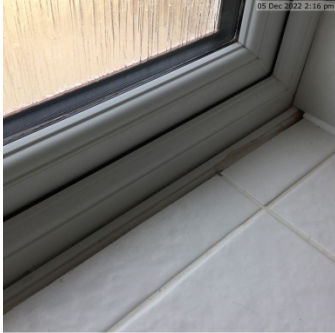
## Wall Tiling

Poor finish at junction between wall tiling and window frame in bathroom.

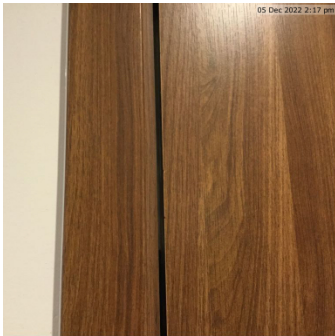
## Bedroom 1 Door

Minor dents to leading edge of bedroom 1 door.

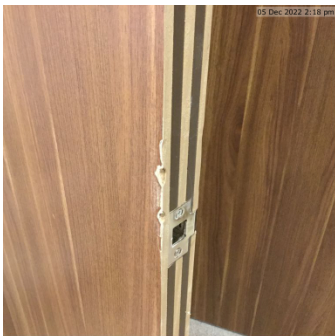
## Airing Cupboard Doors

Damage to left hand leaf of double doors to airing cupboard.

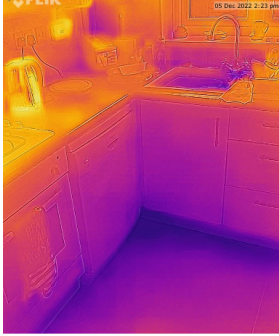
## Kitchen

Thermal imaging scan identified areas of heat loss underneath kitchen sink unit.

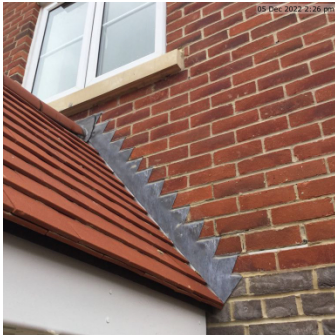
## Front Porch

Brickwork stepped tray to front porch incorrectly set out and not aligning with lead.

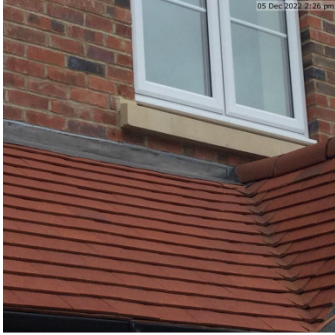
## Front Porch

Weep holes missing in brickwork above front porch.
