SENTRY HOME INSPECTIONS, LLC

COMMERCIAL PROPERTY INSPECTION

714 W Broad Ave
Albany, GA 31701

King Randall
FEBRUARY 3, 2022

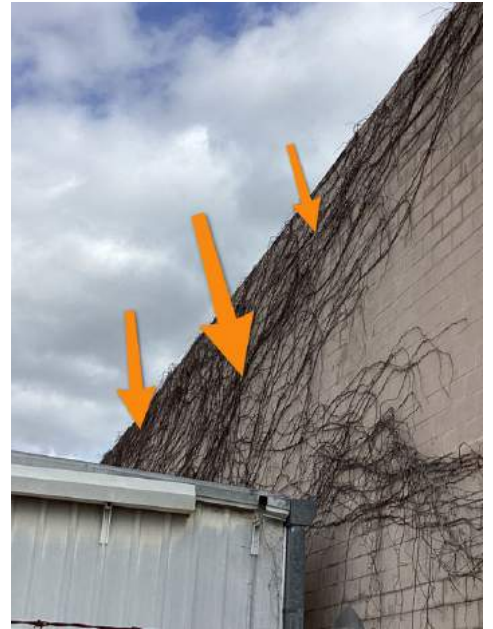
Right Side of Structure

Marginal Defect

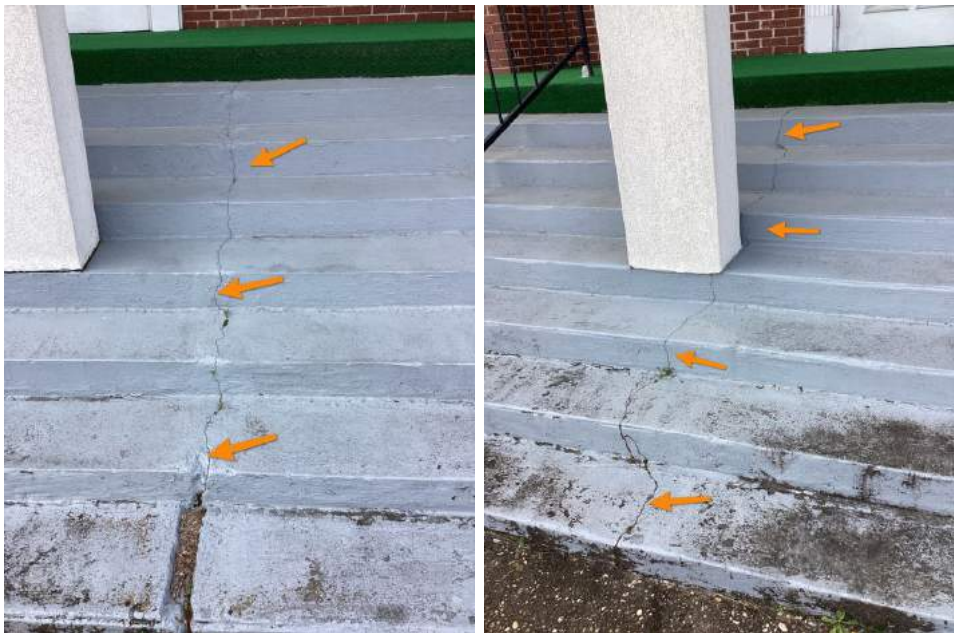
Marginal Defect

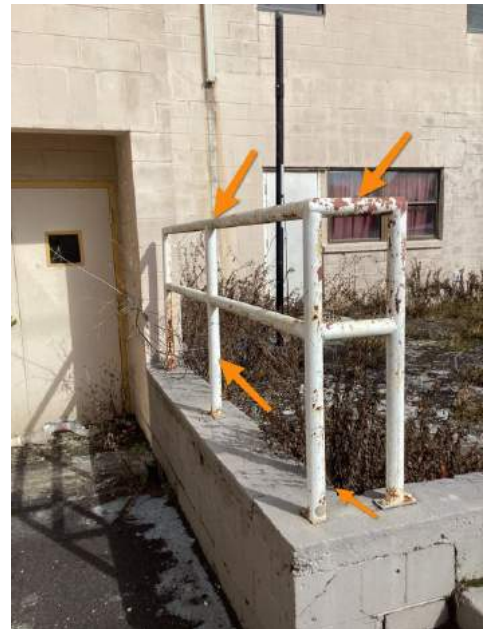
Rear of Structure

HEAVY RUST PRESENT ON METAL HANDRAIL

Marginal Defect

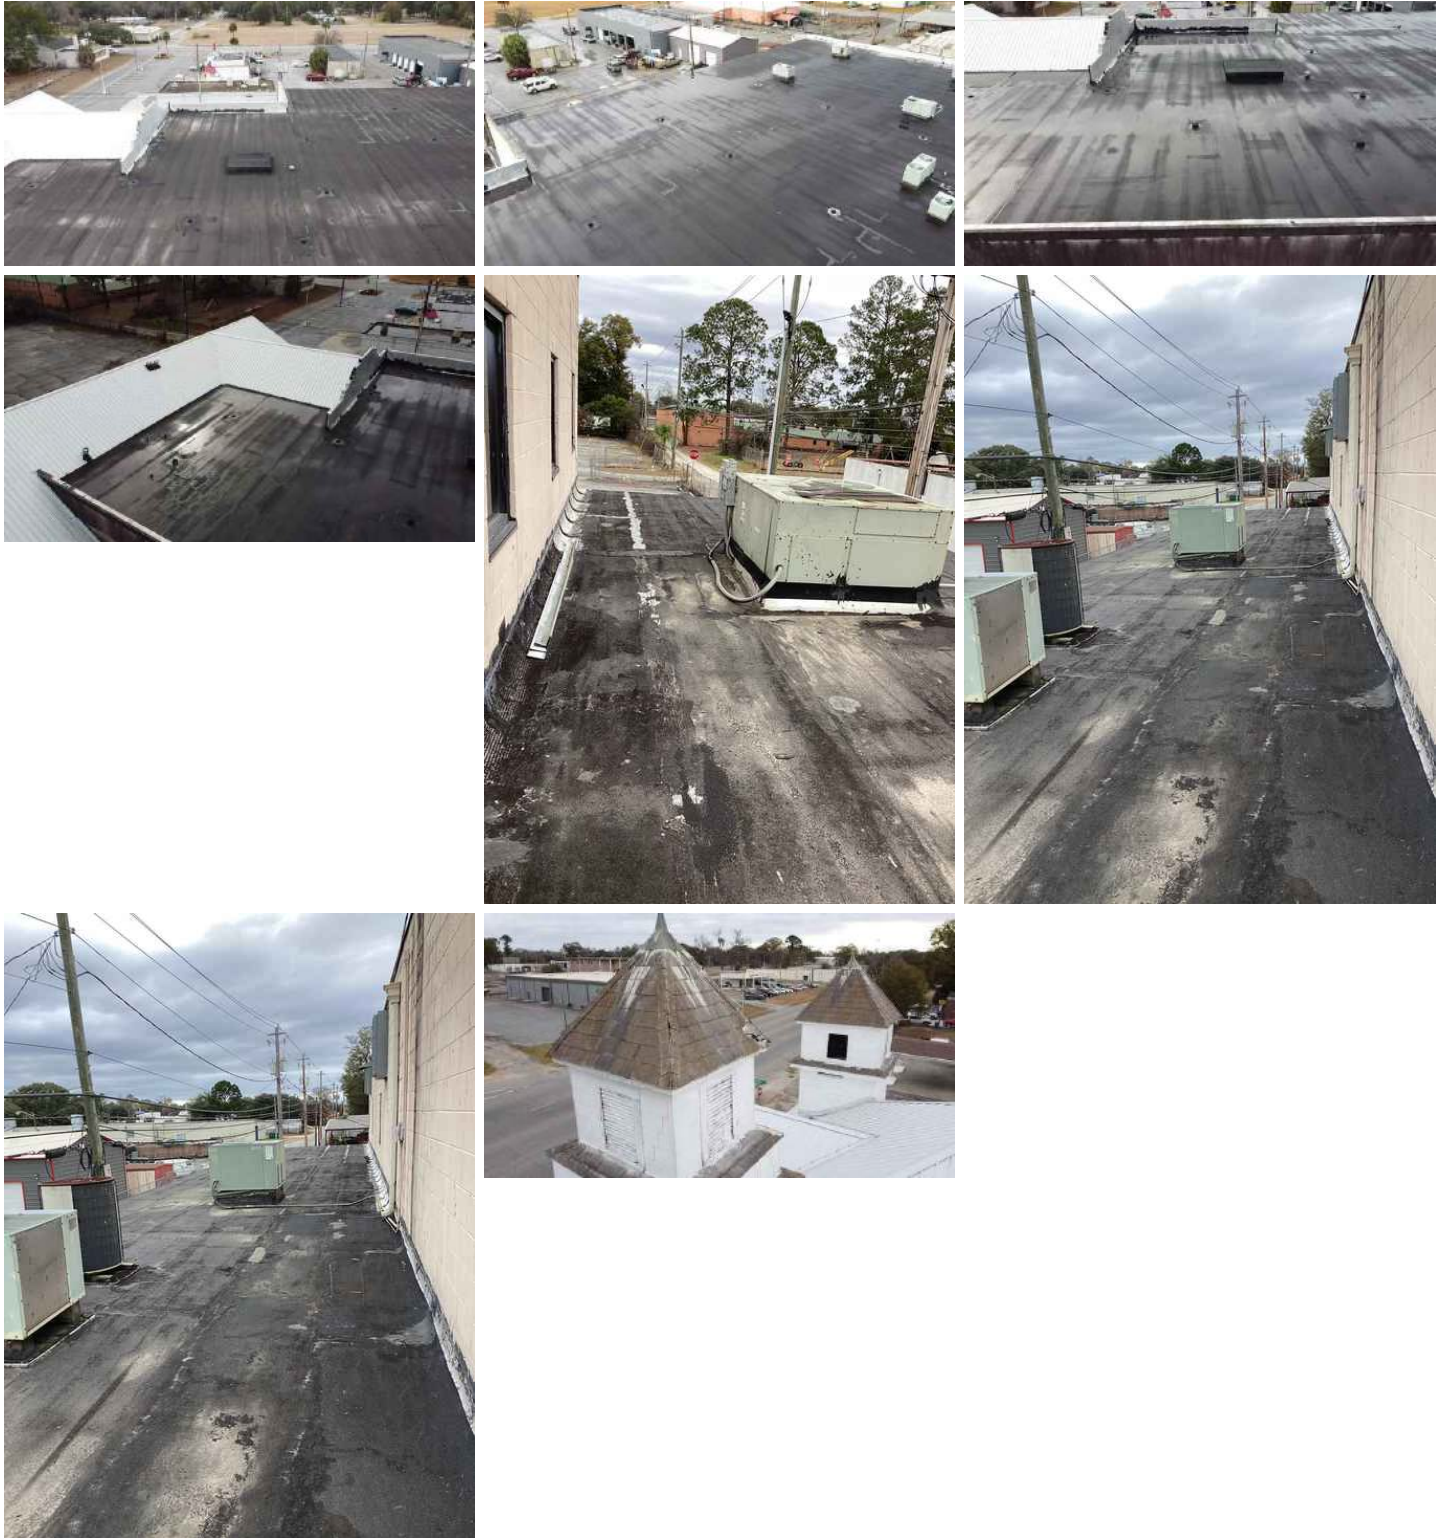
FULL ROOFING EVALUATION RECOMMENDED

Contact a qualified roofing professional.

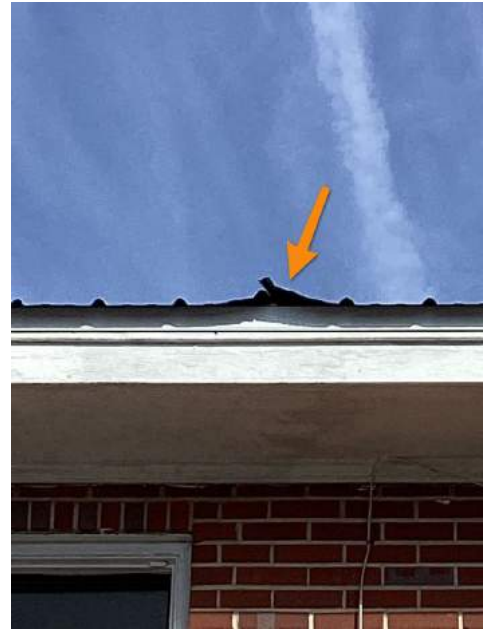
LOOSE METAL ROOF PANELS

Marginal Defect

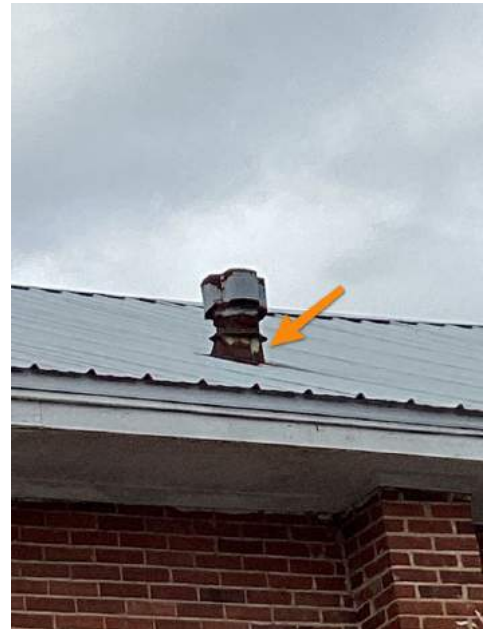
HEAVY SEALANT PRESENT ON ROOF VENTS

Marginal Defect

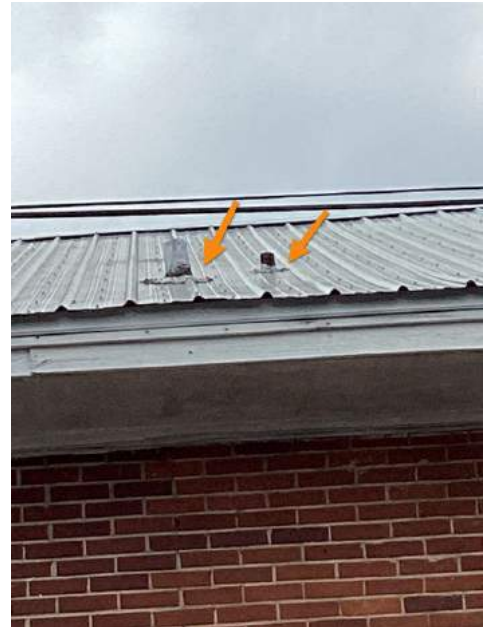
HEAVY USE OF SEALANT ON PLUMBING STACK VENTS

Marginal Defect

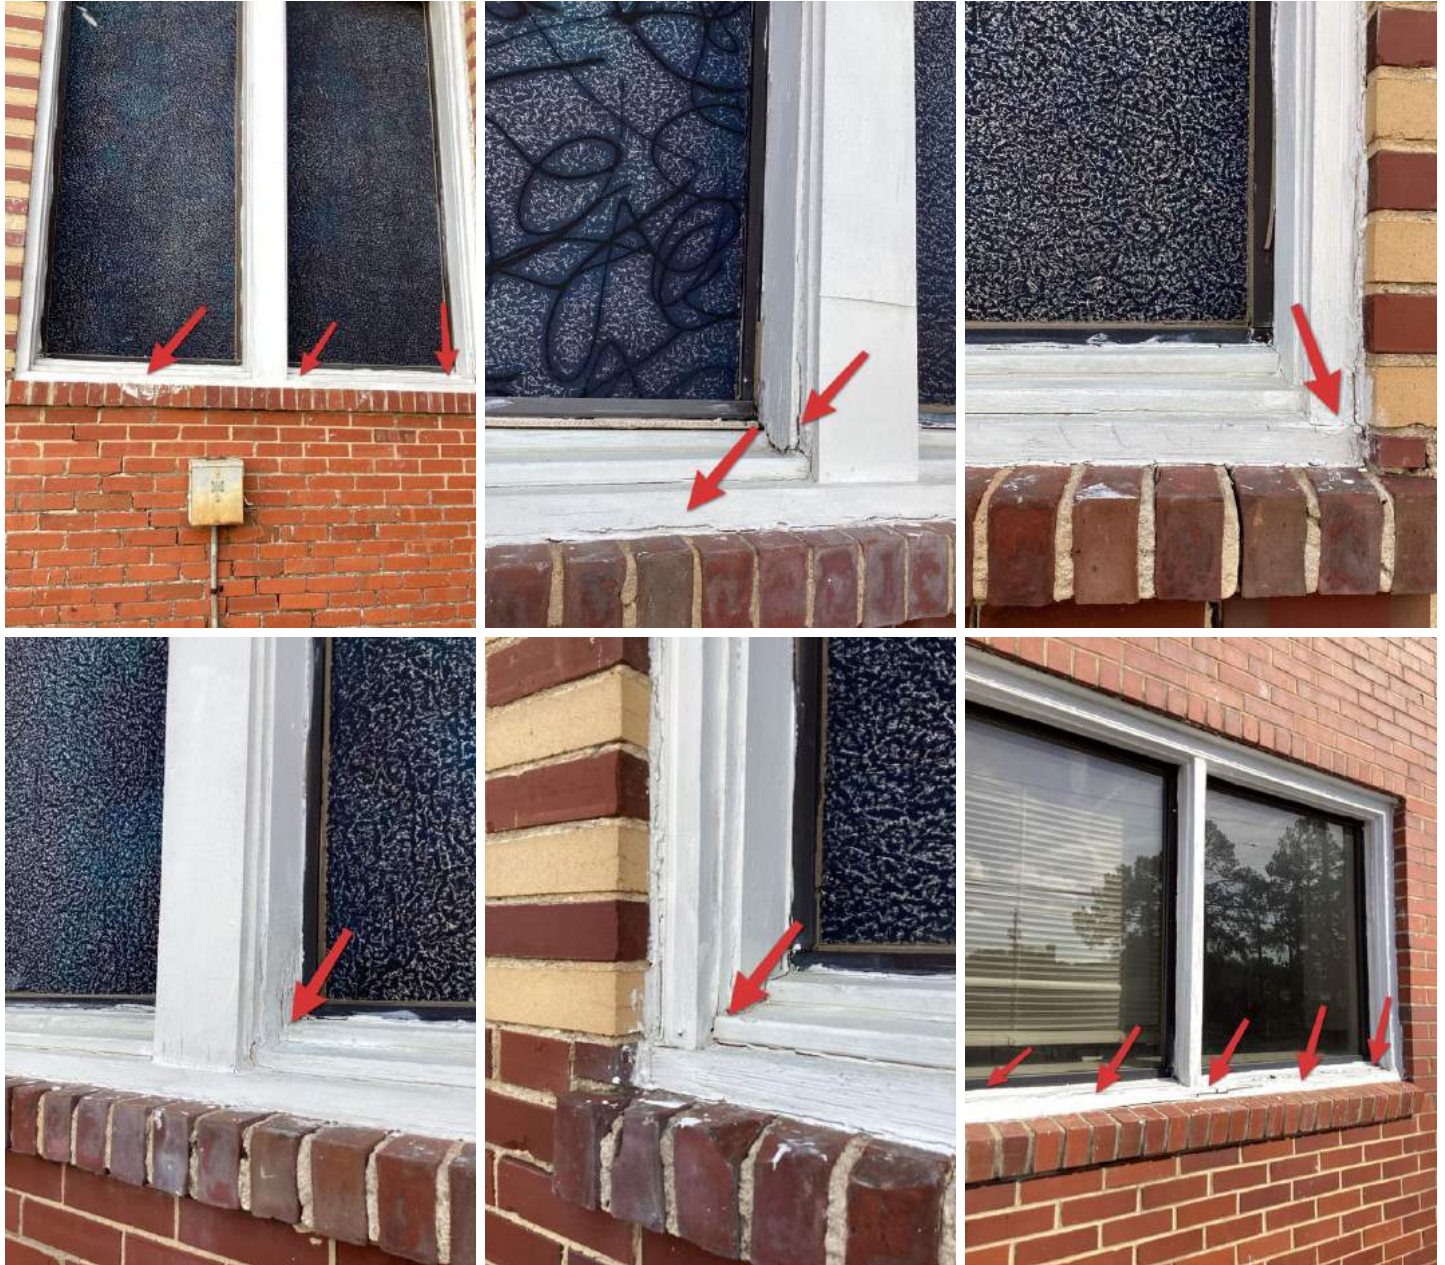
WATER DAMAGE TO WOOD

Contact a qualified window repair/installation contractor.

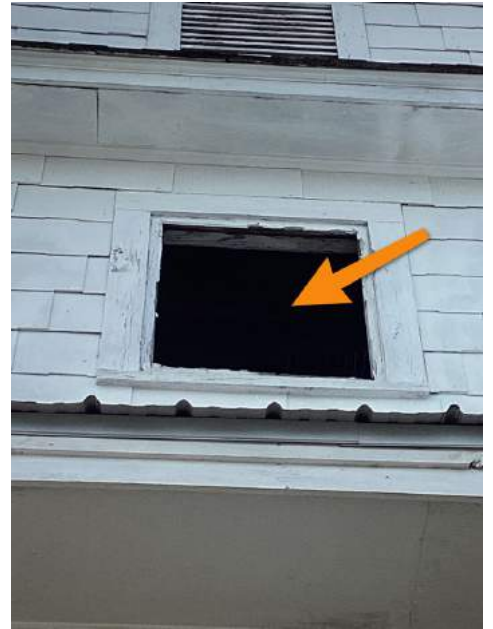
WINDOW MISSING

Marginal Defect

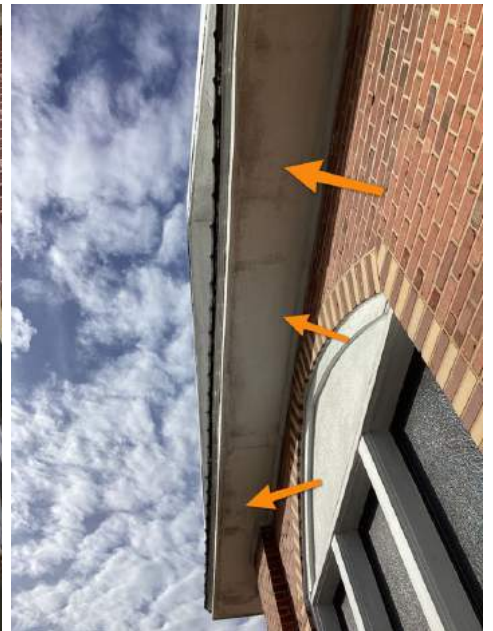
WEATHERED WOOD PRESENT

Marginal Defect

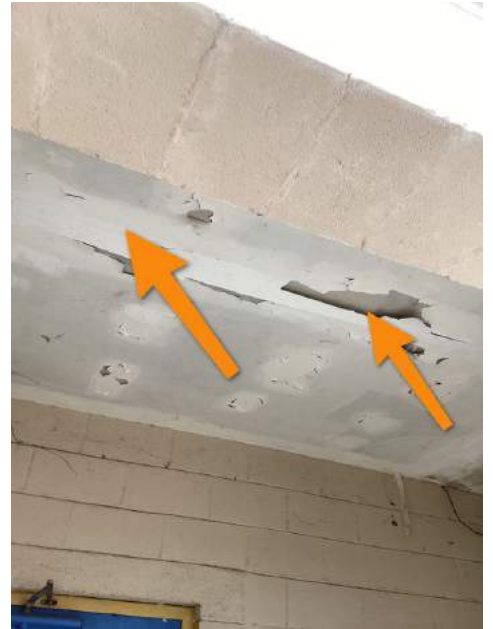
Rear Entry Ceiling

FLAKING PAINT

— Marginal Defect

Contact a qualified painting contractor.

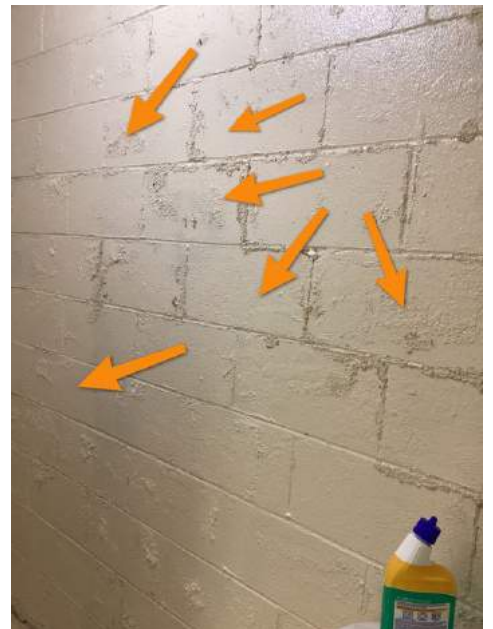
Middle Conference Half Bath

INDICATIONS OF MOISTURE ON WALL - NO ELEVATED MOISTURE CONTENT

Marginal Defect

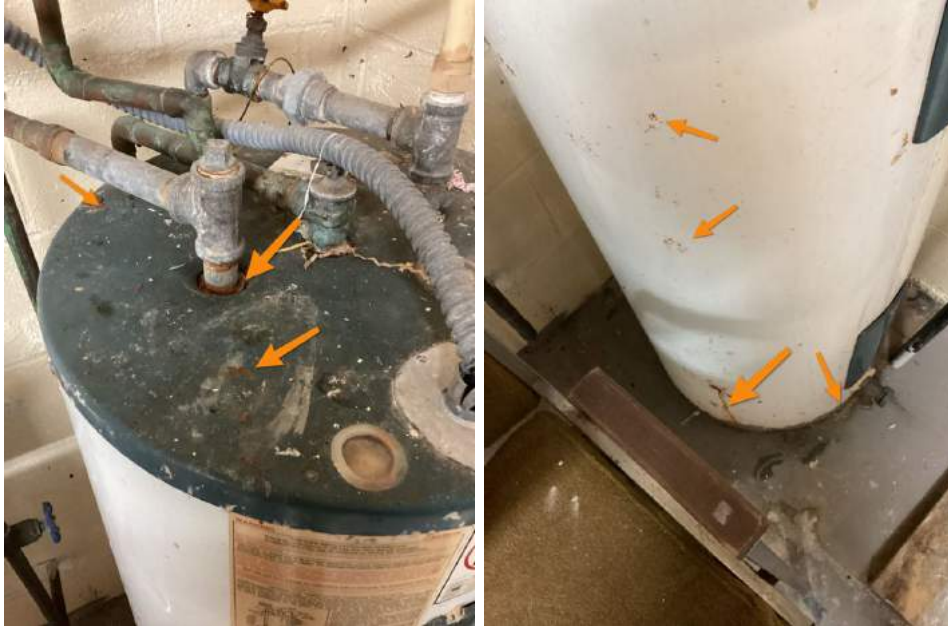
ENCLOSURE RUSTED

Contact a qualified plumbing contractor.

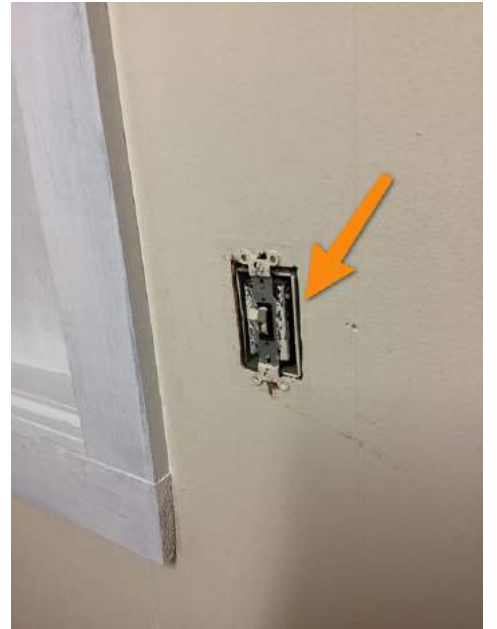
Upstairs Office

MISSING LIGHT SWITCH PLATE

Marginal Defect

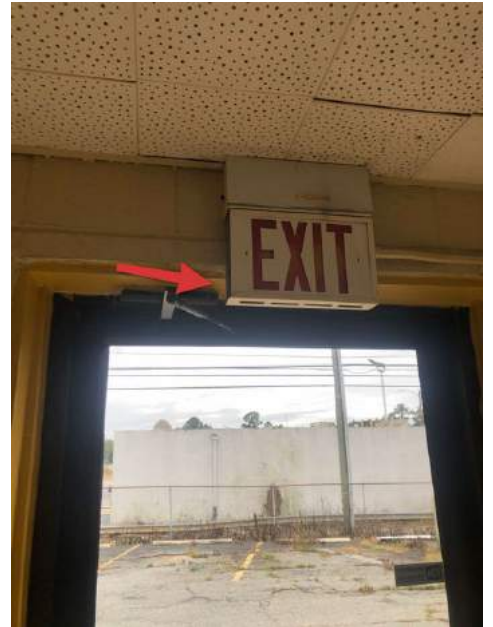
POORLY ILLUMINATED EMERGENCY EXIT DOOR SIGNAGE

Contact a qualified professional.
