## Condition Survey For Bergmann Hotel - 434 3rd Street, Juneau Sept 2021

### General Notes

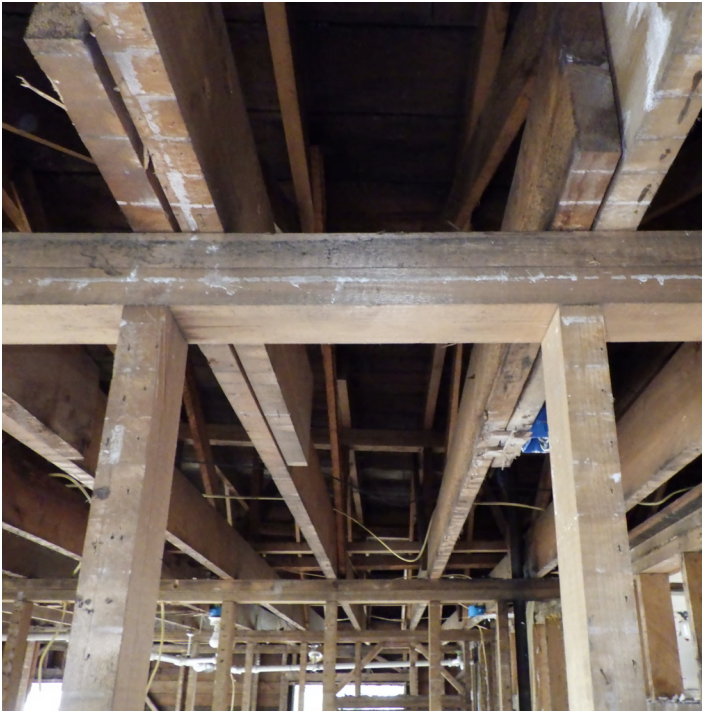
Typical example of sistered joists. This location is the south roof framing. Lumber is straight and relatively knot free. See plans for callouts of bearing and sistering.

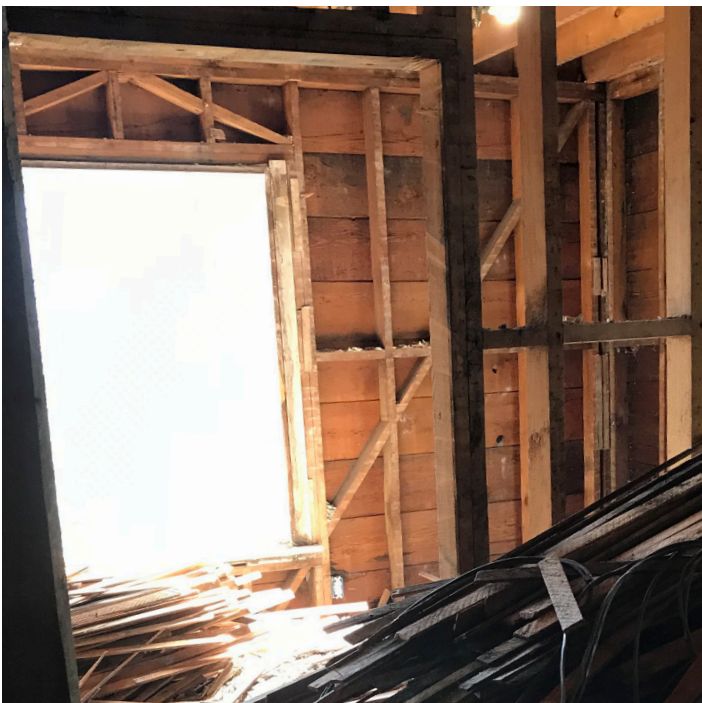
Bracing framing at corner exterior walls. Some interior partition walls have similar brace frame which are called out in the drawings. Header details uses bracing as well and all appear in good condition.

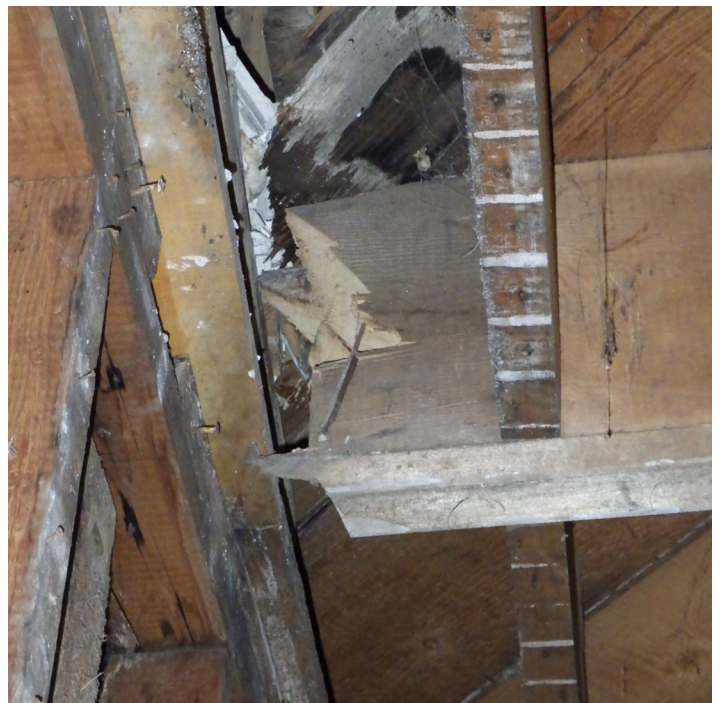
Significant shear failure of beam joist viewed looking up from level 1 along north corridor. This is likely due to and contributing to the settling of the north corridor.

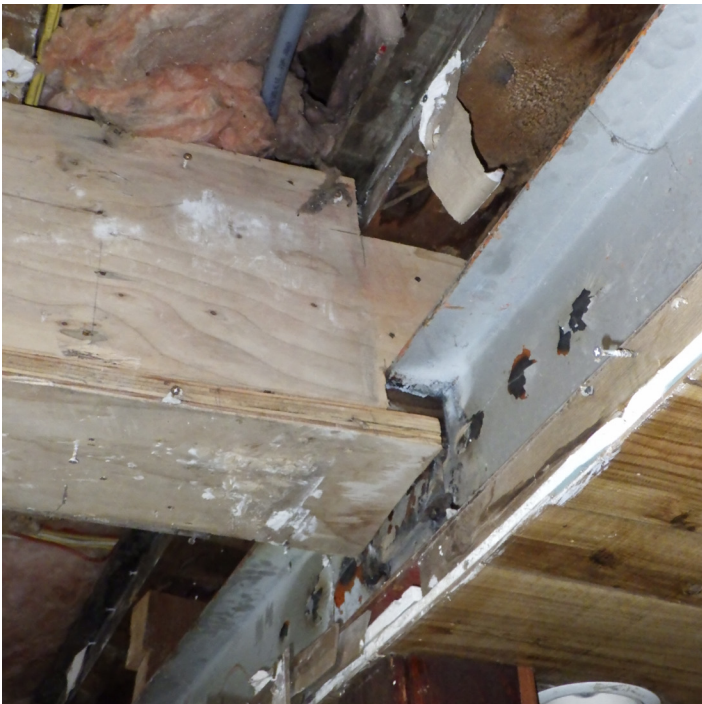
Steel beam and connecting beam above bar on lower level. Beam size and connection unknown and in locations with significant settling. Structural analysis is needed. (paint was not tested for lead.)

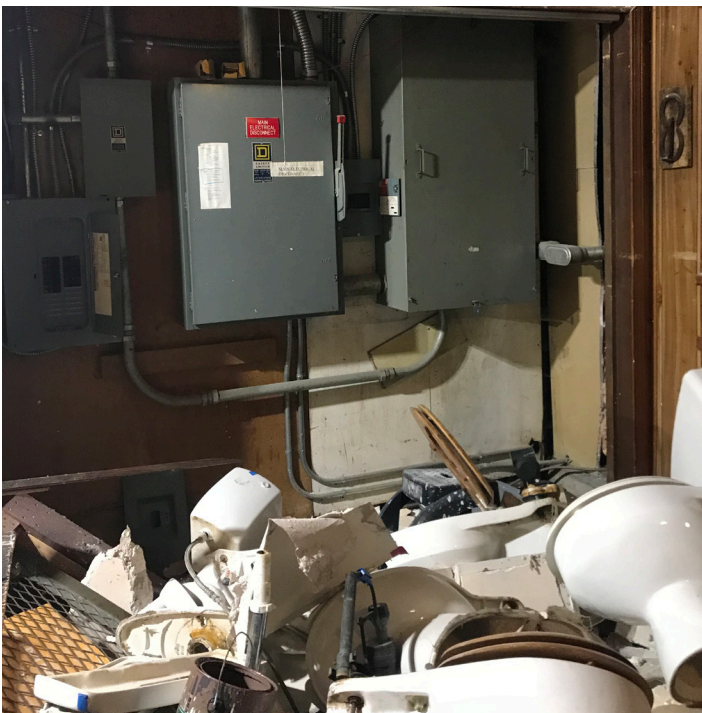
Main electrical shutoff and power in. Appears contemporary and in good condition. We did not ascend toilet mountain to inspect closer.

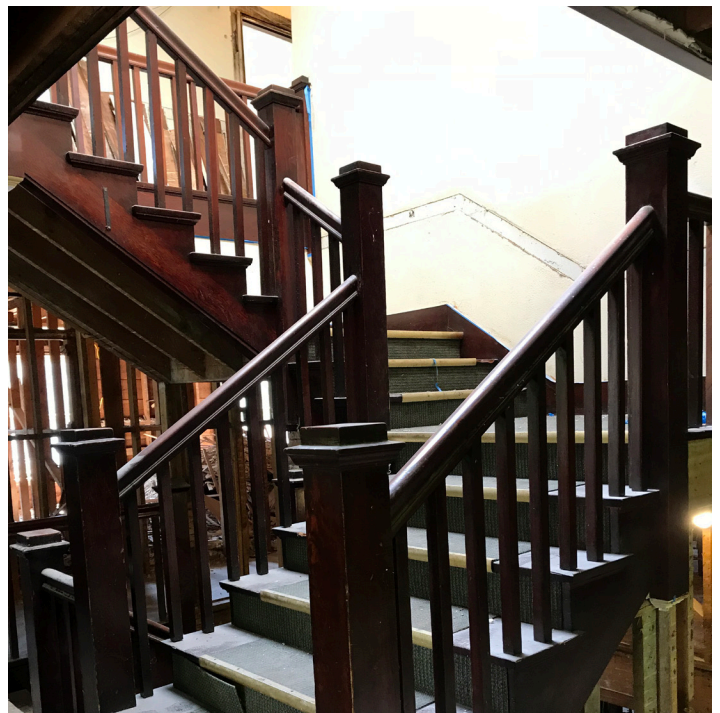
Main historic interior stairway. Recommend wrapping and protecting during demolition.

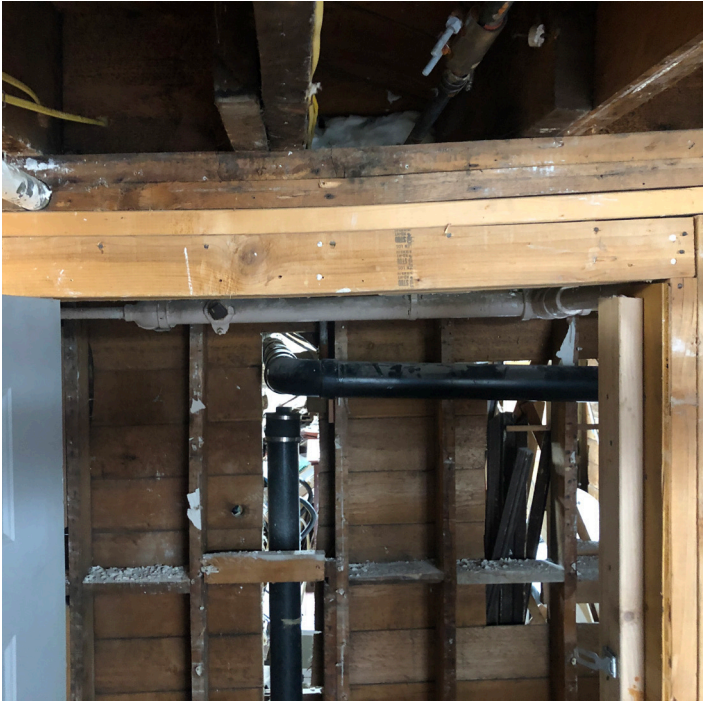
Sagging header above door to workroom. Telltale sign this is a bearing wall.

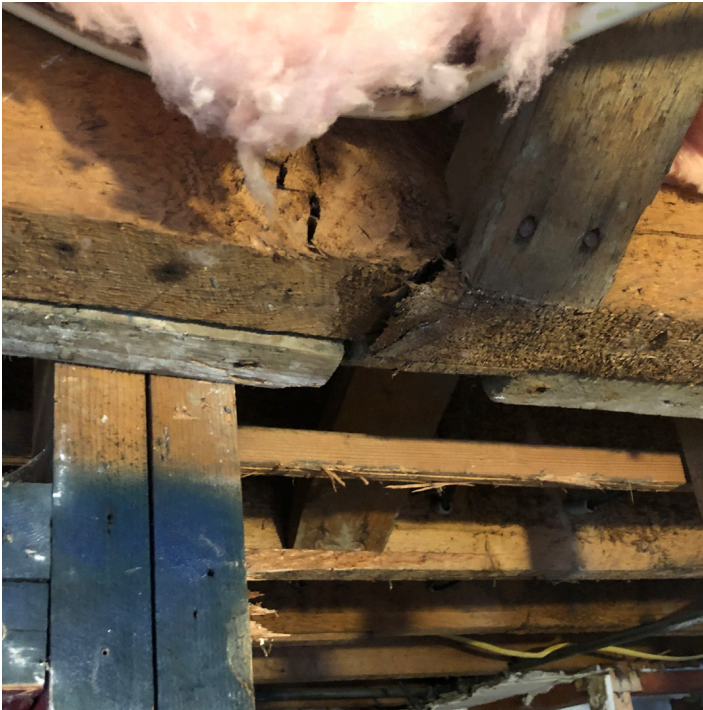
Load bearing joist/beam failure near work room. See drawings for callout.

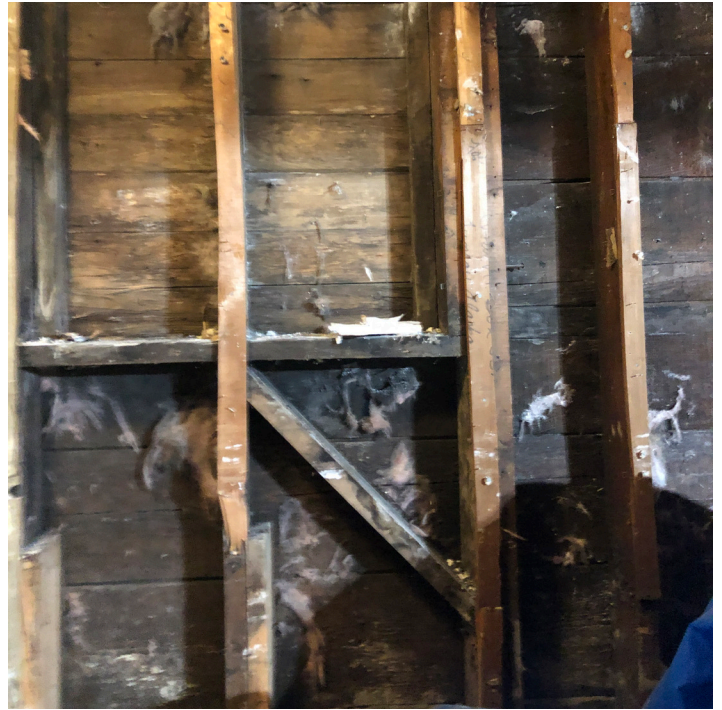
In general, lower level walls have moisture and mold issues that need remediation.

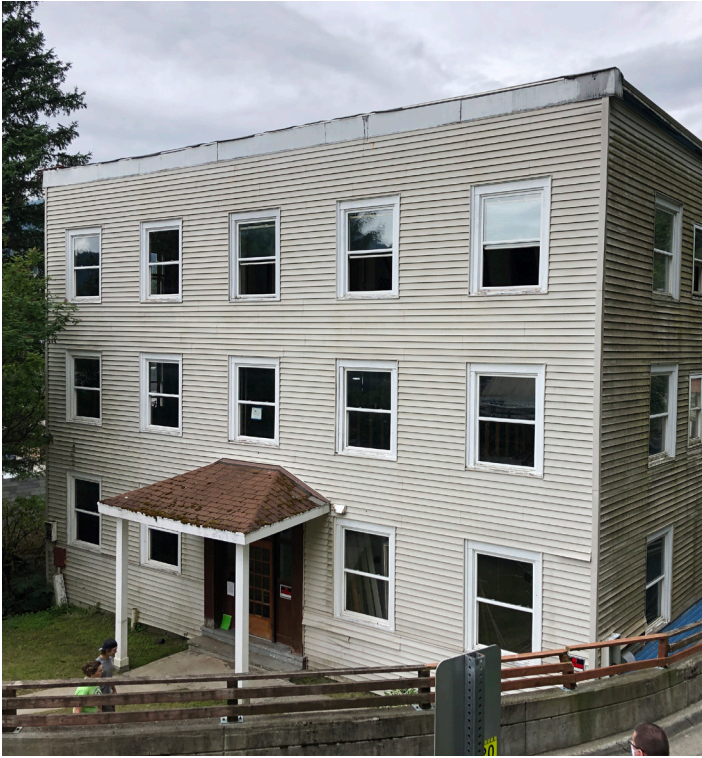
Main historic interior stairway. Recommend wrapping and protecting during demolition.

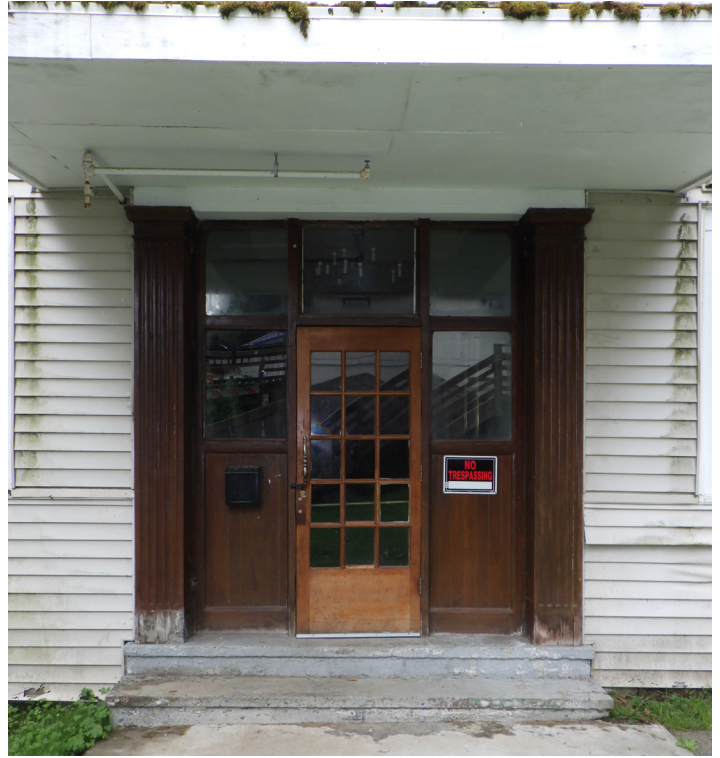
Historic South Entry

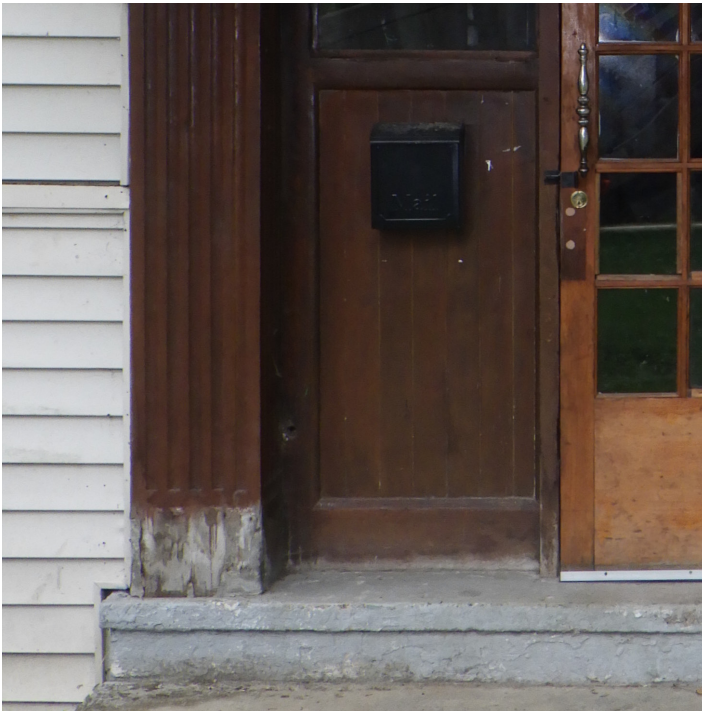
Main south entry detail image. Some water damage at grade that needs repair. Door does not appear original, however, is made similar to historic.

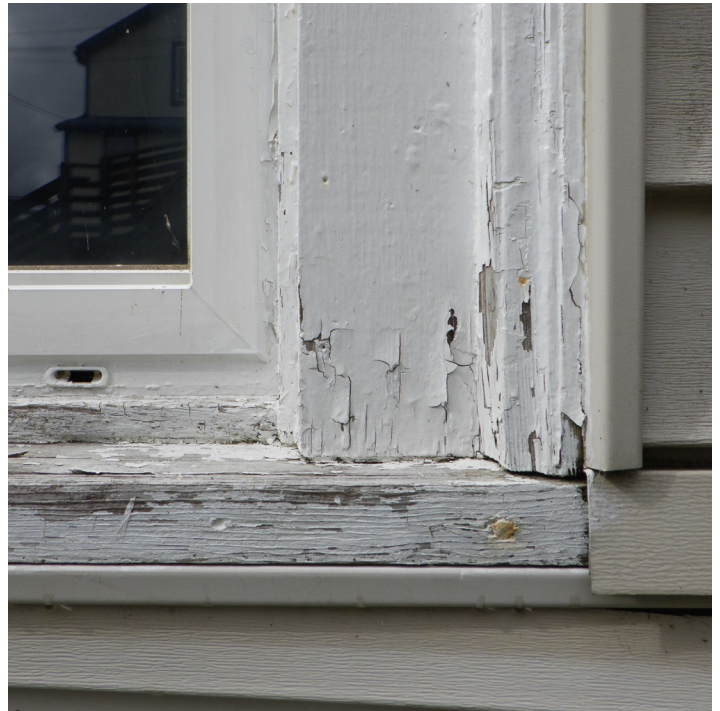
Window detailing. Contemporary vinyl window with painted wood trim surround. Wood trims appear to be historic in style, though no exact record of detailing was found.

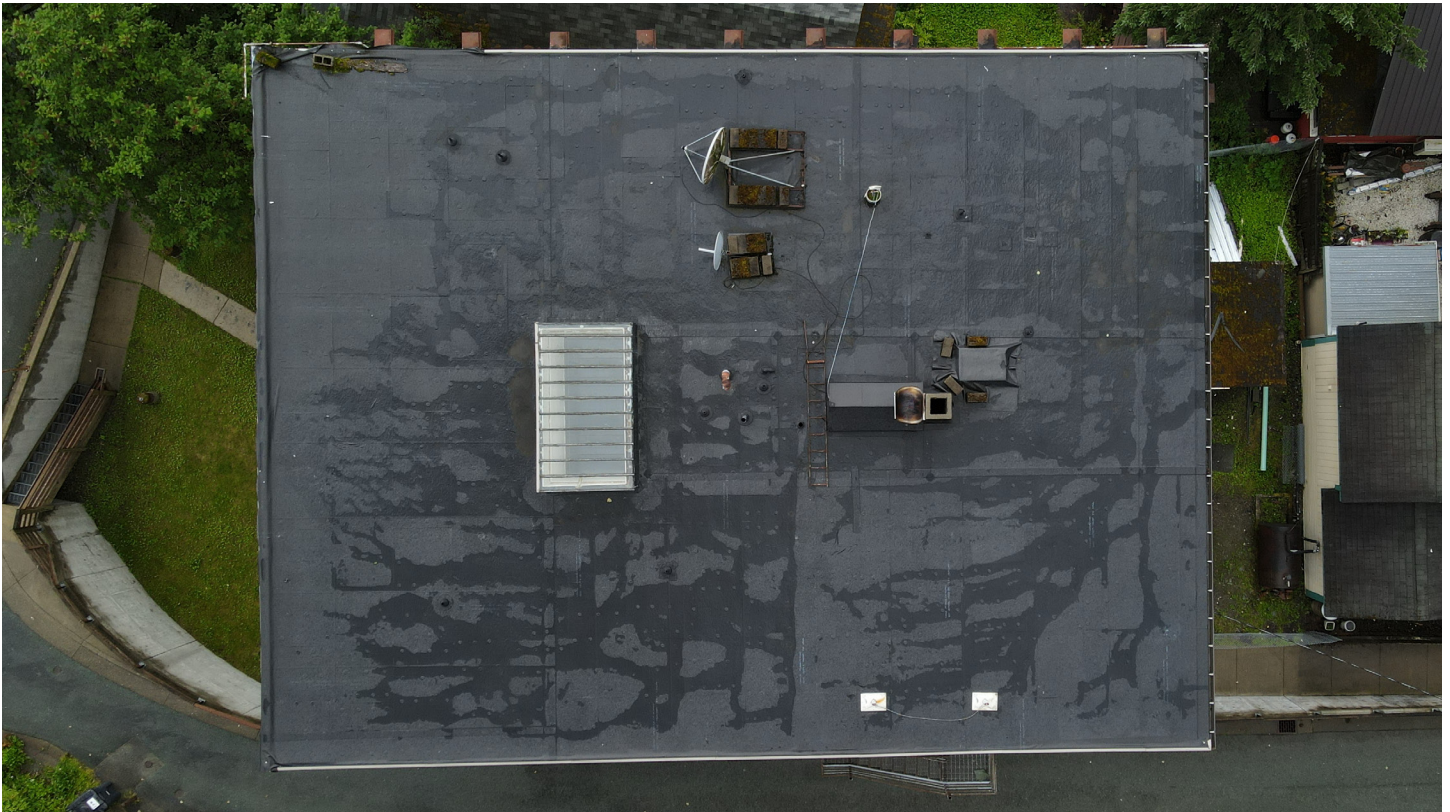
Roof drone photo. Drainage pattern make settling of building apparent. Roof membrane appeared in good condition. Penetrations appeared fully wrapped or termination bars are in place and functioning.

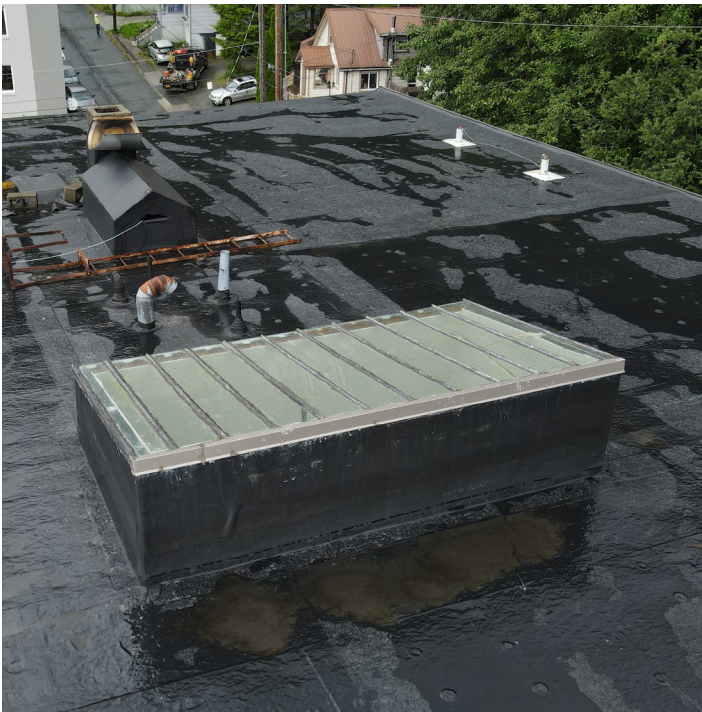
No cricket in front of skylight. Minor ponding concern.

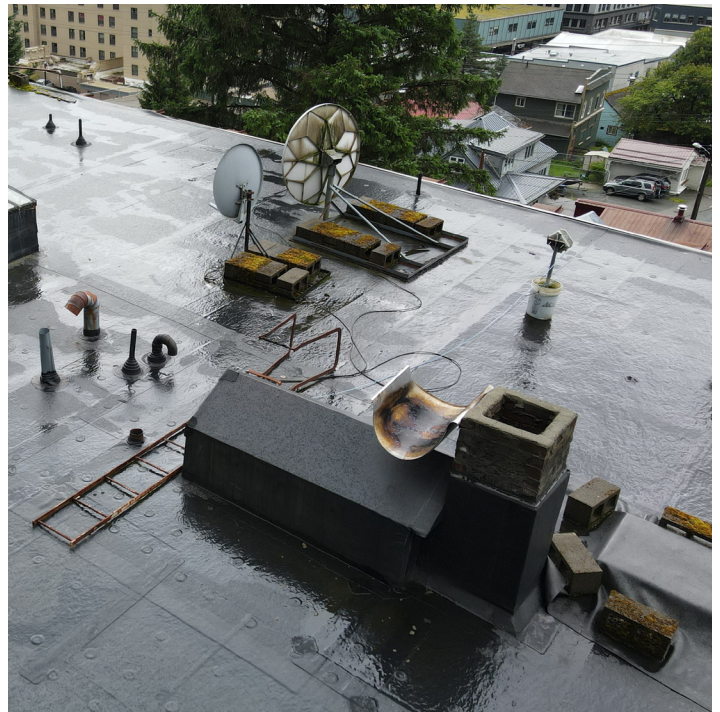
No crickets. Chimney cap blown off. Recommend replacing chimney cap.

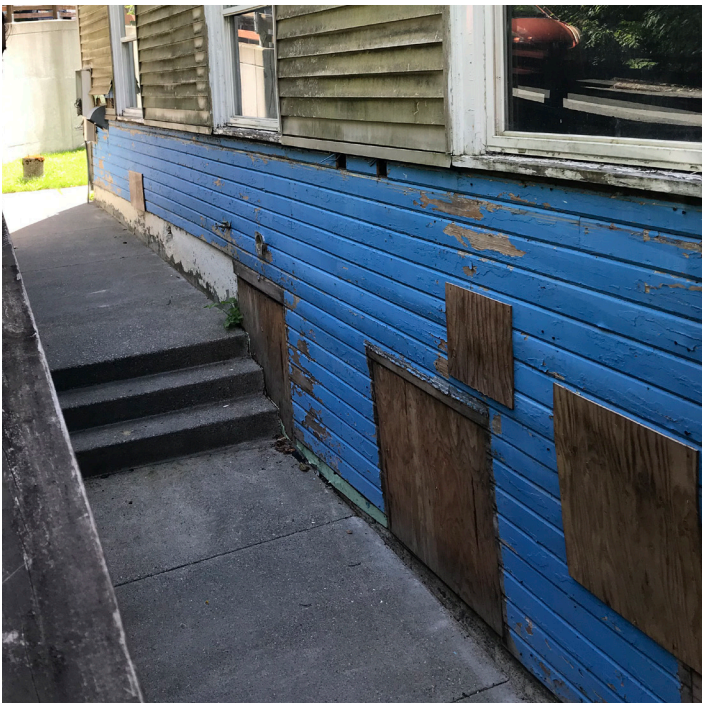
Bracing framing at corner exterior walls. Some interior partition walls have similar brace frame which are called out in the drawings. Header details uses bracing as well and all appear in good condition.

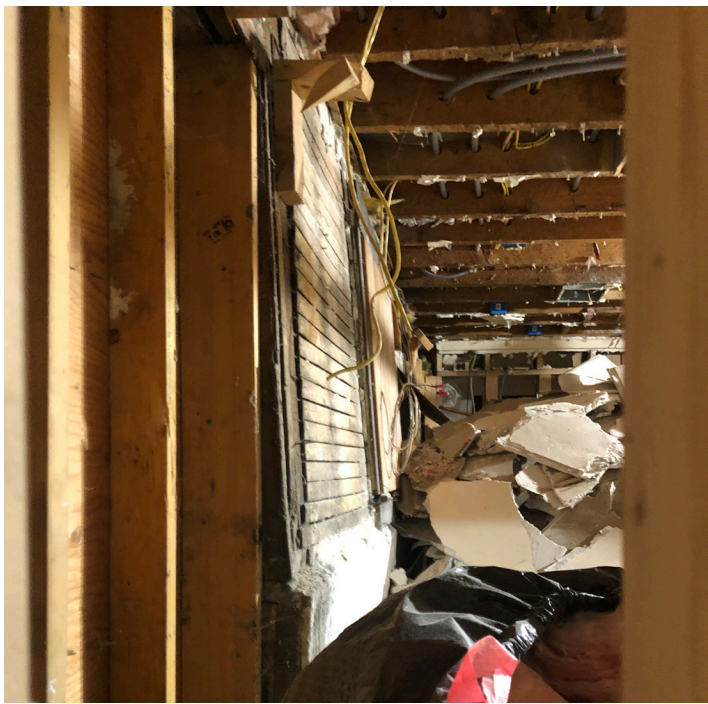
Inside view of landslide damage. If shored properly, this may be of historic merit for renovation.

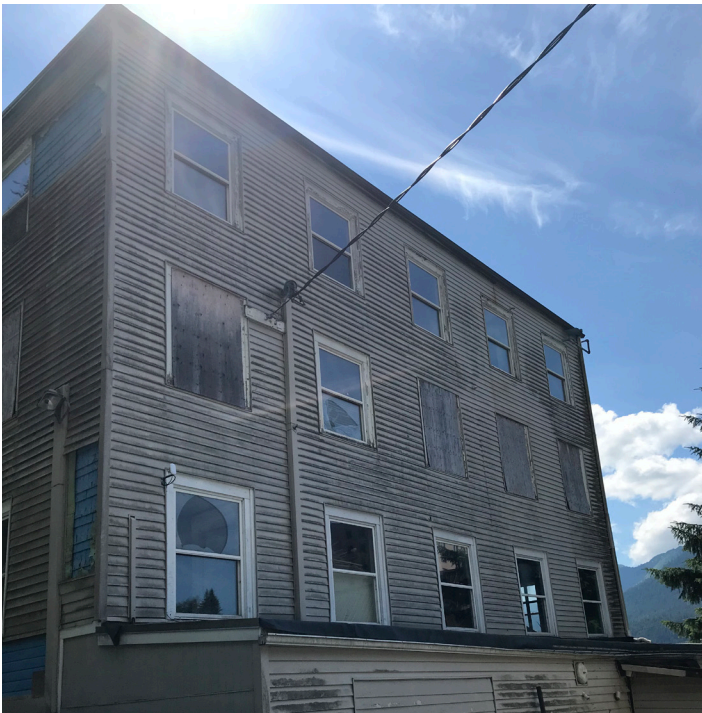
Main south entry detail image. Some water damage at grade that needs repair. Door does not appear original, however, is made similar to historic.

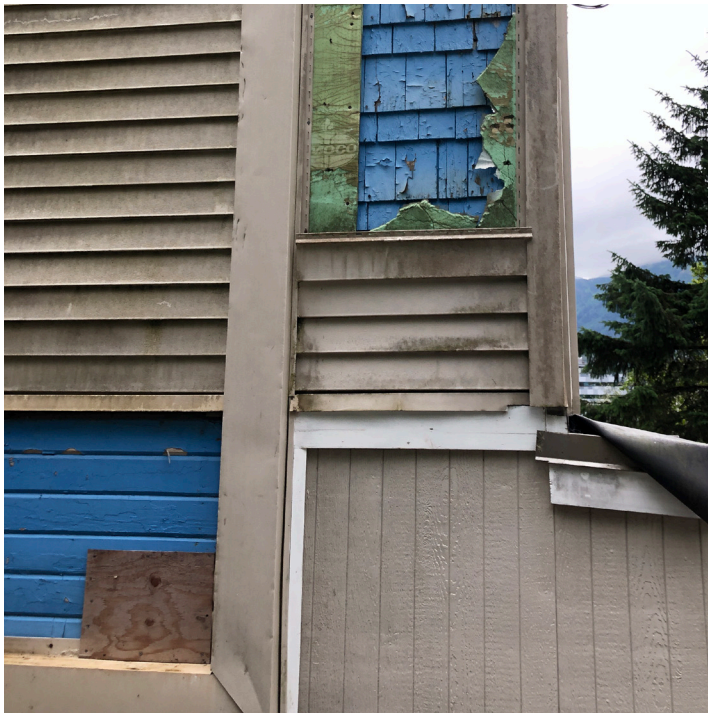
Differing vintages of siding, and added exterior items such as conduit flashing for lighting. Recommend full tear off and new exterior envelope.
