BERGMANN HOTEL STRUCTURAL ASSESSMENT

AUGUST 2024

Project Number I1893.24001

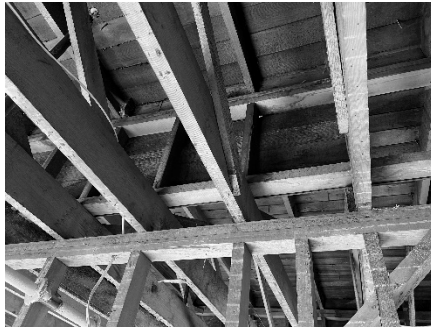
The roof trusses do not have diagonal bracing from the roof diaphragm to the shear wall (Figure 2). Diagonal bracing or sheathing can be installed up to the bottom of the roof diaphragm to transfer the loads to the interior shear wall.

Figure 2 - Roof trusses do not have diagonal bracing from the roof diaphragm to the shearwall.

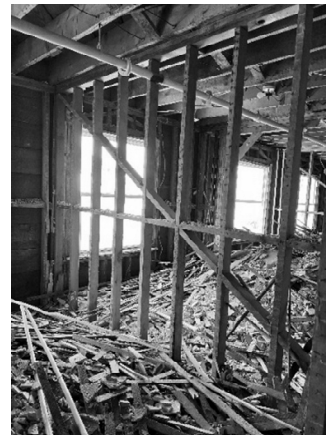
It is assumed the diagonal bracing in the walls is intended to transfer shear forces. Some of the walls had been removed during previous renovations, so the braced walls do not always stack. The walls were covered with lath and plaster, which is not as strong for transferring shear as plywood (Figure 3-Figure 6). The shear walls would be most effective if they stack, have connections between them, and are sheathed with plywood.

Figure 3 - Typical diagonally braced interior wall.

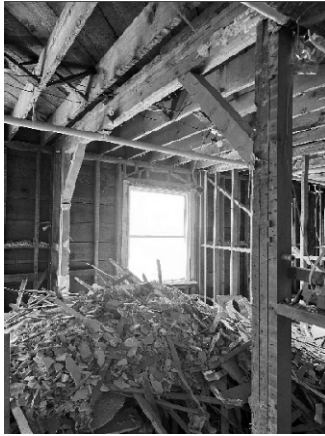
Figure 4 - Wall was removed, so diagonally braced walls do not stack.

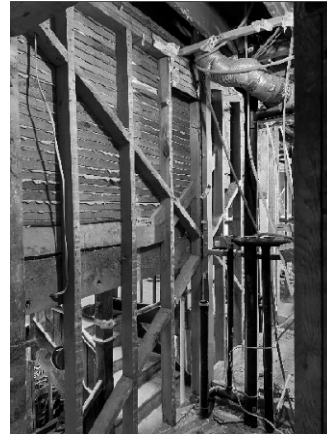
Figure 5 - Lath and plaster is on both sides of diagonally braced wall.

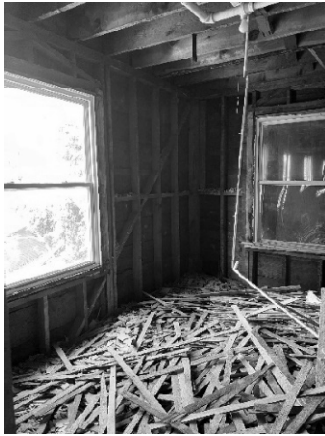
Figure 6 - Diagonally blocked exterior wall.

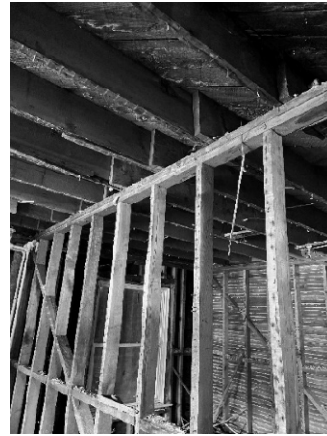
The joists have a splice on an interior bearing wall but are not blocked between joists. In a seismic event, these joists have the potential to rotate (Figure 7). Blocking should be added.

Figure 7 - Joist splice on wall is not blocked.

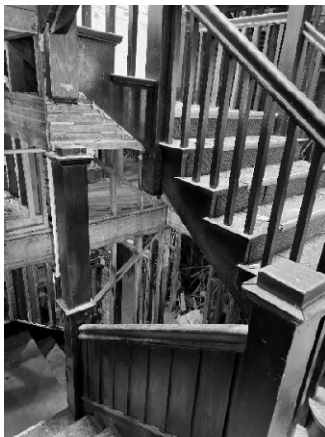
At the stairs, there is a column supporting a landing, but there is no mechanical connector from the beam to the column. If this column were to shift, the stairs could collapse (Figure 8). Install connectors, so the column cannot shift from under the stair landing.

Figure 8 - No connections from column to stair landing.

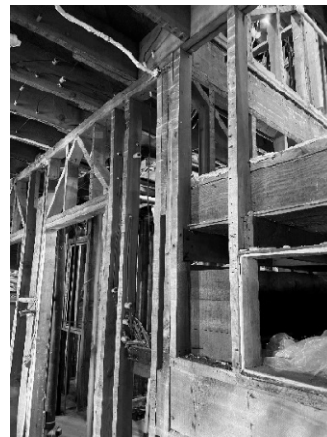
The beam adjacent to the stair opening is very long and is critical, since the stairs are a main path of egress. Where the beam terminates, there is a built-up beam below. No mechanical connectors are present at this location (Figure 9). Connectors should be installed to prevent the shifting of the beam on the column in a seismic or wind event.

Figure 9 - No connection between beam and column.

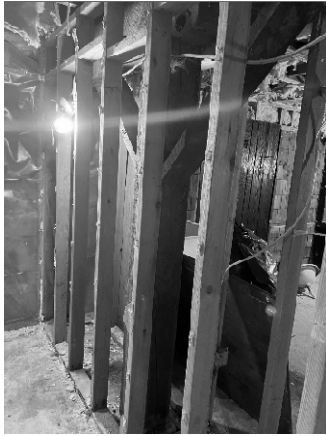
On the ground floor, there is a row of columns that have knee braces to transfer lateral forces. No visible connectors were observed from the beam to the column or the column to the floor (Figure 10). This should be analyzed for the anticipated lateral loads and connectors should be added.

Figure 10 - Knee braces to transfer lateral loads.

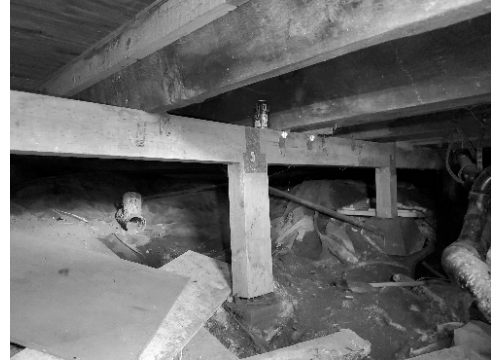
In the crawl space, one of the isolated footings has a corner that is undermined (Figure 11). This should be repaired to avoid the footing rotating or settling.

Figure 11 - One of the isolated footings has a corner that is undermined. Unknown if or how columns are connected to concrete footing.

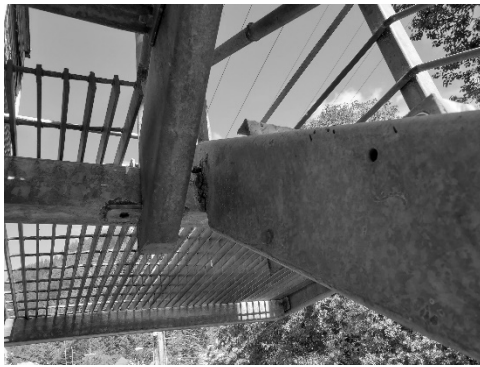
The emergency stair landing had been installed with welds due to the misalignment of bolt holes (Figure 12). Slag from the welds has not been removed and the welds underneath have excessive porosity and inclusions. In a seismic event, this can cause the landing to shift off the support. Stair stringers need to be ground off and redone by a certified welder.

Figure 12 - There is a bolt missing from an emergency exit stair landing.

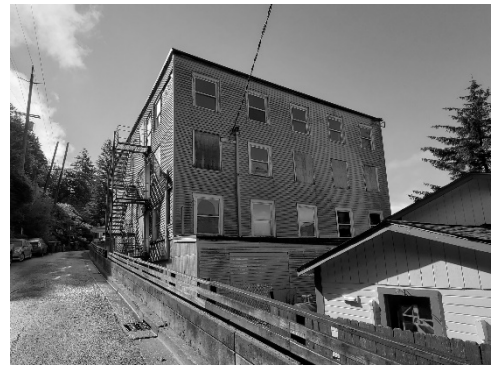
The building has openings spaced uniformly around (Figure 13). As the hotel is protected as a historic building any alterations made to the exterior walls need to be altered in the interior to preserve the façade. It is recommended analysis be performed to determine the capacity of the available exterior shear walls; the existing lap-siding will not be sufficient to act as sheathing and will need to be sheathed from the inside. Alternatively, interior shear walls may serve as the lateral system with the reconfiguration of the interior layout; in combination with plywood sheathing installed over the diagonal decking.

Figure 13 - Building envelope has openings uniformly spaced around.

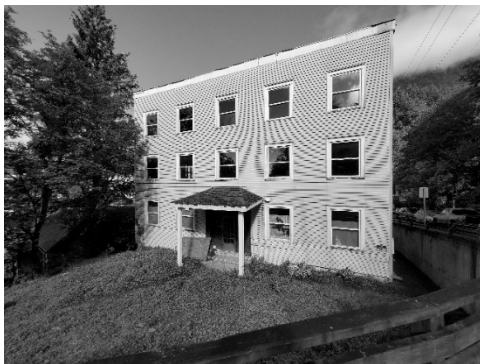
The main entrance awning does not appear to have lateral resisting elements (Figure 14). Inclusion of knee braces at the corners of the columns, parallel to the main building wall, may be installed to resist inertial forces from earthquake motions. Alternatively, holdown tie back connections from the awning diaphragm to the second-floor diaphragm may be able to be installed to resist earthquake forces and attempt to preserve the outward appearance of the historic building.

Figure 14 - The main entrance awning does not have lateral bracing.

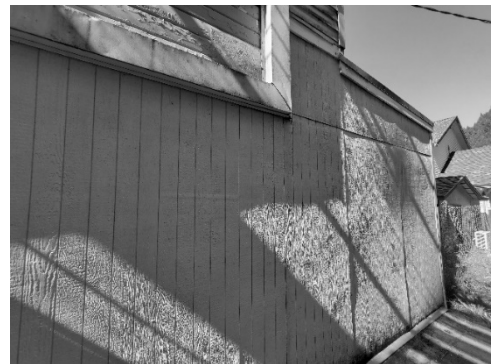
The sheathing at the north side of the building appears to be new T1-11, where the building addition was constructed (Figure 15). The sheathing at the east side near the side entrance to the restaurant has T1-11 that is rotting and in poor condition (Figure 16). In all areas, the nail pattern on T1-11 is insufficient to resist lateral loads. A layer of structural sheathing needs to be installed behind the new T1-11 to resist earthquake loads and transfer forces to the foundation.

Figure 15 - New siding at the building addition warped and not fastened with enough nails.

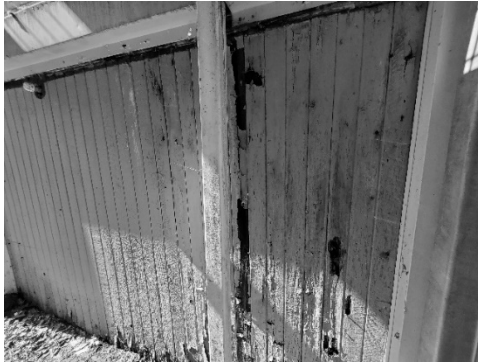
Figure 16 - Rotting T1-11 on the east side of the ground floor.

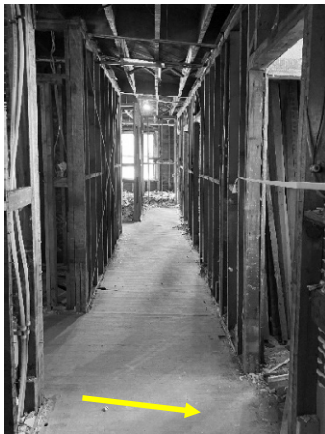
In the north hallway on the 3rd, 2nd, and 1st levels, the floor slopes down toward the north. It is suspected the combination of interior wall framing and beams is not supporting the end of each floor's joists between floors through to the foundation (Figure 17). Further load analysis is required to determine support locations to remove this deflection.

Figure 17 - Sloping hallway, similar on all levels.

- / The sloped floor needs to be leveled by a contractor and columns and support framing installed at the framing discontinuities causing the slope in the floor.

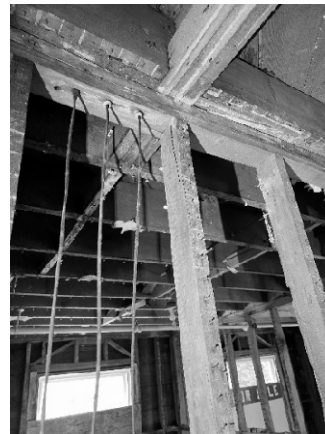
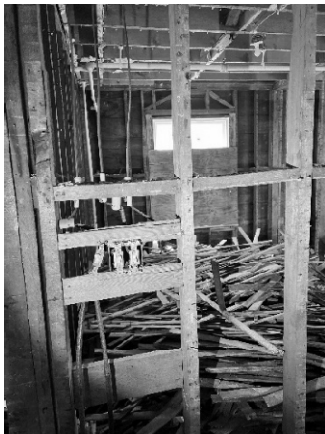
1. Near the stairs, there is a beam adjacent to the opening. The beam terminates on a stud wall. On the first level, the top plate is crushed and the stud is cracked, and there is blocking in place to prevent bowing (Figure 18-Figure 19). There should be a column placed here to transfer the loads. This condition occurs at each level.

Figure 18 - Beam adjacent to stairway bears on stud wall, similar on all levels.

Figure 19 - Beam adjacent to stair opening bears on stud wall.

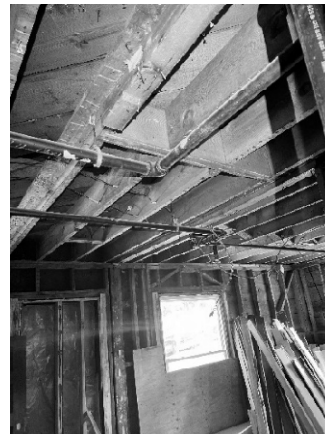
2. On the first level, there was a larger room, where it appears a wall may have been removed. The beam supporting floor joists does not have any support (Figure 20). Support should be placed under each end of the beam.

Figure 20 - Support for beam appears to be missing.

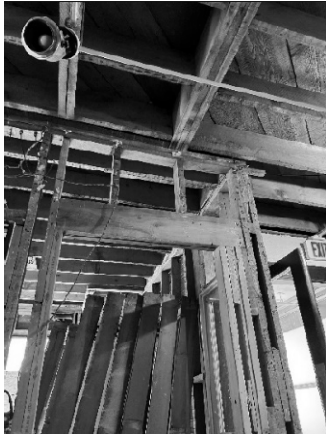
3. On the first level, the large beam adjacent to the stair opening rests on a wall, which has an opening in it (Figure 21). This requires a larger header, or additional support, to bear the load.

Figure 21 - Beam adjacent to stairway is bearing on a header.

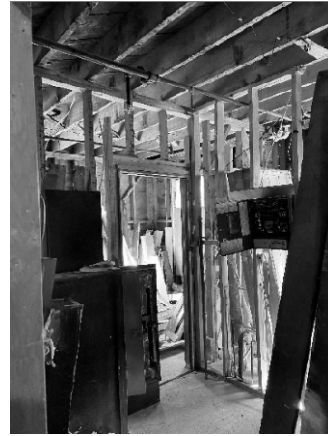
4. On the first level, there is a doorway through an interior wall, where the king studs are not continuous (Figure 22). The studs on either side of the door need to be continuous up to the top plate.

Figure 22 - King studs are discontinuous on either side of the door opening.

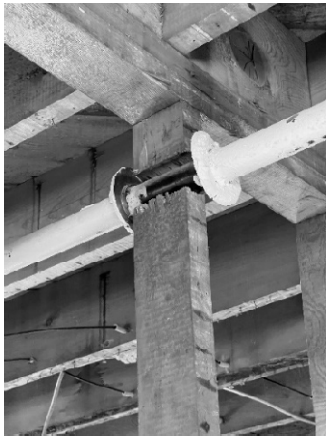
5. There were a couple of locations observed where studs were cut for piping. This reduces the capacity of the wall (Figure 23). Replace the stud or add a stud on either side of the damaged stud.

Figure 23 - Stud was cut for piping.

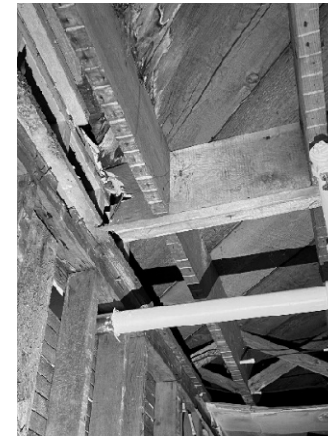
6. The 2nd level floor joists connect to a beam, which is broken. Because of this damage, the joists have an incomplete load path. This may contribute to the sloping hallway on the level above (Figure 24). Replace this beam and connect it to each wall.

Figure 24 - Beam is broken.

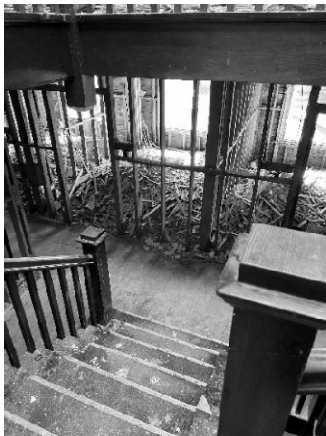
7. The framing around the stair opening span exceeds the member strength, without any intermediate support (Figure 25). Analysis is recommended to ensure the beams can handle the design live loads at the stairs (path of egress).

Figure 25 - Framing is long around stair opening with no intermediary support.

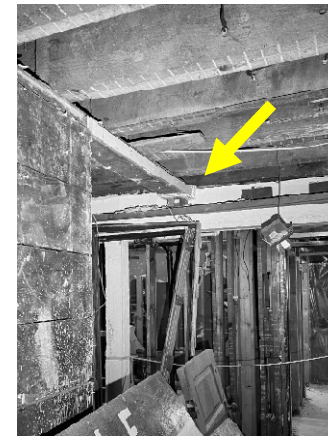
8. Under the stairs on the ground floor, there is a beam resting on its wide face supporting floor framing. This appears to be undersized for this member size and does not have an adequate load path (Figure 26). This should be analyzed, and the structural elements sized and replaced.

Figure 26 - Under the stairs, there is some framing with inadequate support.

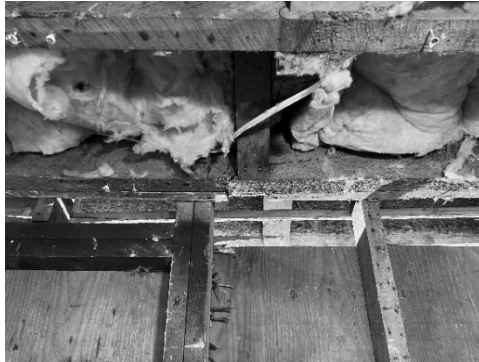
9. One location of the 1st floor framing has a joist that is cracked and deflected. It is assumed the load path loads this joist instead of the adjacent wall (Figure 27). The load path should be field verified and the damaged joist replaced or repaired and supported.

Figure 27 - A joist on the 1st level floor framing has a lot of deflection and is cracked.

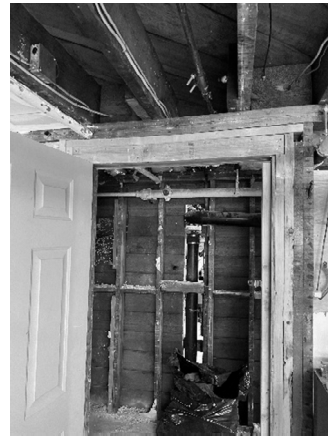
10. On the ground floor there is some floor framing spanning across the top of a header. The header has a noticeable deflection (Figure 28). The header needs to be analyzed and sized for the design loads.

Figure 28 - The header has a lot of deflection and appears to be overloaded.

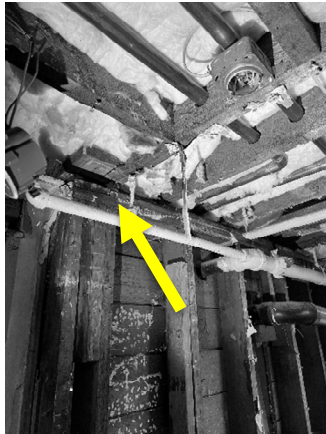
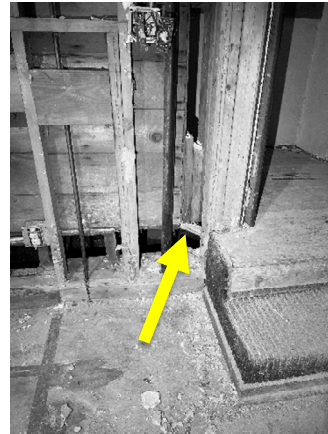
11. At the 1st floor framing, where the framing direction changes, it bears on a column. However, the column is discontinuous and is not supported on the floor (Figure 29-Figure 30).

Figure 29 - Floor framing bears on a column, which is not supported.

Figure 30 - The column is not supported. There is an incomplete load path.

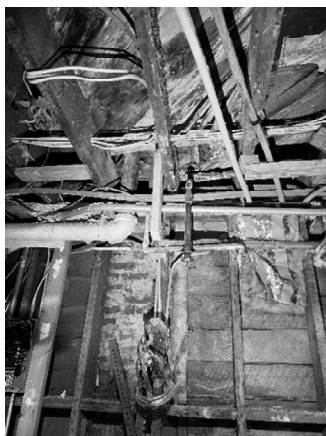
Figure 31 - The 1st level floor framing has a location where the diagonal boards are broken and appear to have been exposed to moisture.

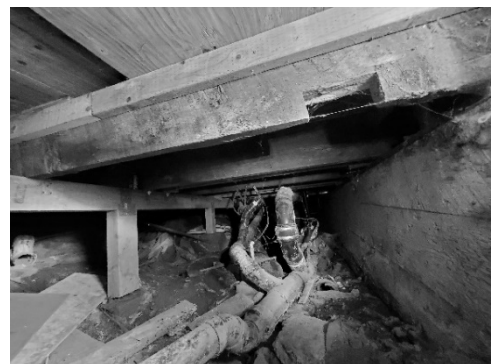
Figure 32 - Floor joist is notched in the crawl space.

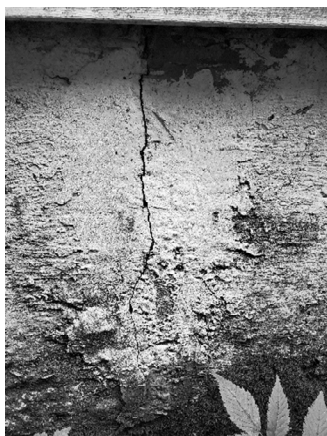
Figure 33 - There are a few cracks visible in the stem wall of the foundation.

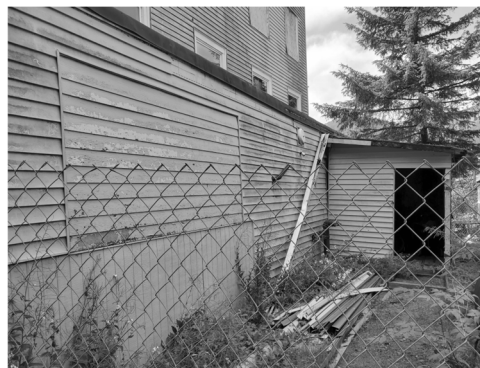
There is an exterior shed roof that appears to be caving in (Figure 34). The building was not accessible at the time of the site visit and the framing type and spacing could not be determined. Recommend complete demolition of the structure.

Figure 34 – Lower Shed Roof Failing

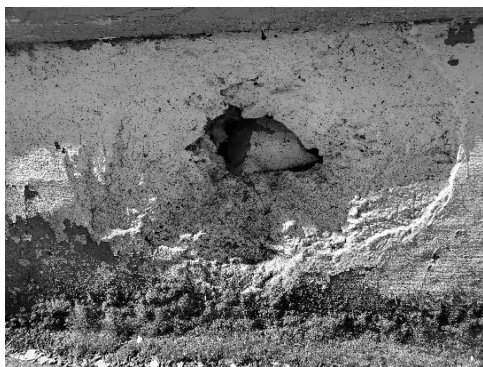
The foundation was intermittently spalled at the visible portions of the exterior but was free of traverse cracks associated with settlement and shear failure (Figure 35). The concrete stem wall has occasionally spaced crawl space vents on the East side of the building and the finish of the concrete appears to be imprinted by rough-sawn form boards (Figure 36). The overall condition of the foundation appears to be sound and does not require modification.

Figure 35 - Worst case of spauling found at the perimeter stem wall.

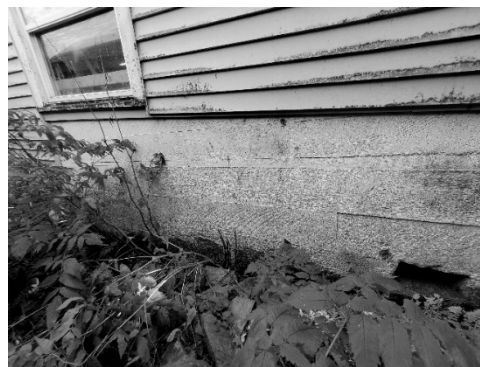
Figure 36 – Typical condition of concrete stem wall finish. Occasional crawl space vent penetration.

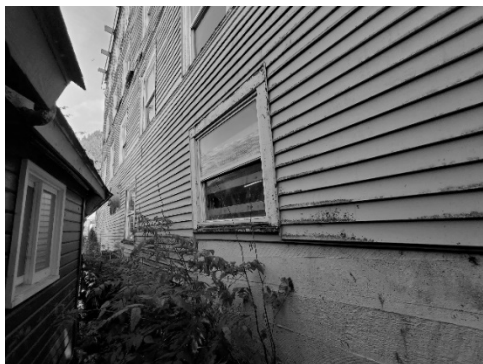
The exterior walls along all sides, excluding the east side, appear to be in decent condition, with the exception of the window trim and surrounding siding showing evidence of rot and black mold (Figure 37). The siding and trim should be removed, and the condition of materials be assessed and/or replaced to match the historic condition of the building. Modifications to the building envelope to prevent future water intrusion, which may include flashing, is recommended to mitigate water damage to the framing and exterior finishes around openings. Consult a licensed architect for potential solutions to prevent future water damage.

Figure 37 - Typical condition of exterior walls. There is potential rot at the window trim and siding where black mold is present.

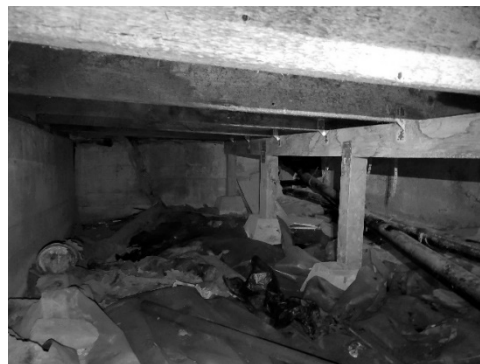
13. New foundation elements along the east side of the building are supporting the floor (Figure 38). The new foundation consists of wood 6x6 posts and beams on concrete pier blocks supporting the floor joists at mid-span. It appears some of the existing floor joists around the hatch, at the middle of the wall, are rotting and likely the cause of the new foundation post-and-beam construction under the floor (Figure 39).

Figure 38 - New post-and-beam foundation for floor framing along West side of ground floor.

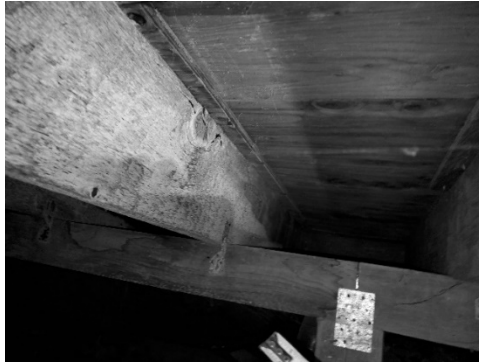
Figure 39 - Rotting joists along West side of the building near crawl space access hatch.

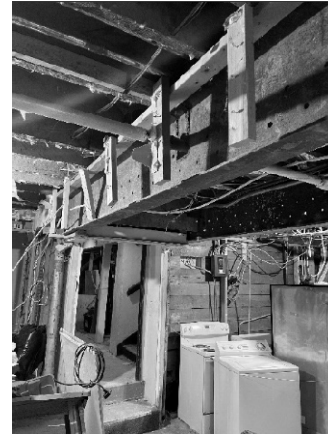
12. The steel beams located on the east side of the building have multiple penetrations in the web which alter the structural integrity of the member (Figure 40). Recommend an analysis of the steel beam with reduced strength be conducted to ensure the beams are adequate.

Figure 40 - Perforated steel beams supporting first-floor.

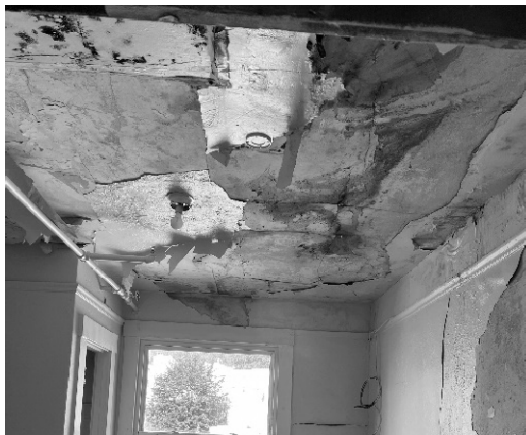
Figure 41 - Black mold and signs of water damage.

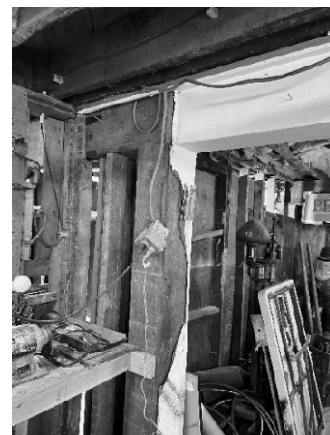
Figure 42 - There are no connections between post and beam.

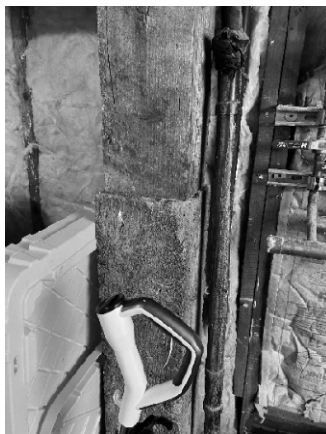
Figure 43 - There are no visible connections from the concrete pedestal to the column.

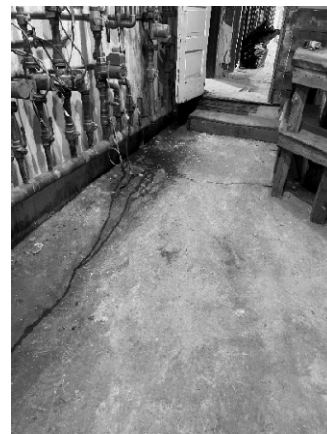
Figure 44 - The slab was cracked, and the floor was sloped.

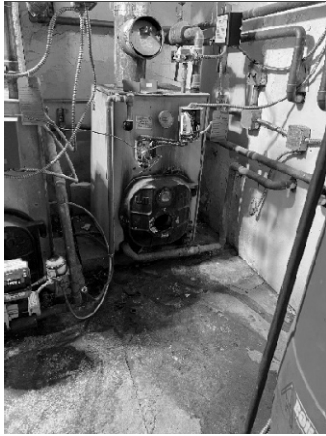
Figure 45 - There are signs of past leaks.

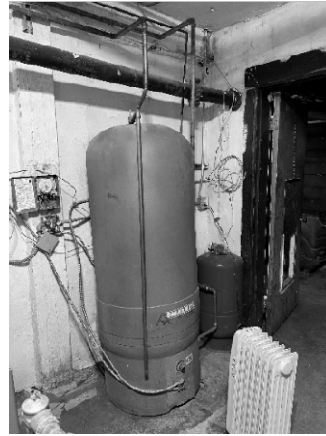
Figure 46 - There is no seismic strap on this tank.

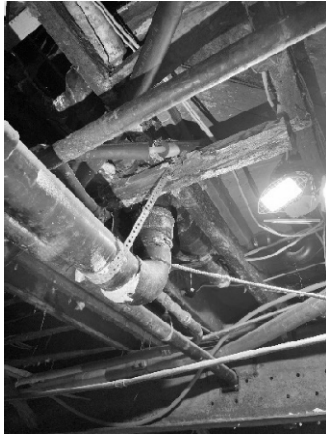
Figure 47- There is a support board, holding up piping, that is rotten.

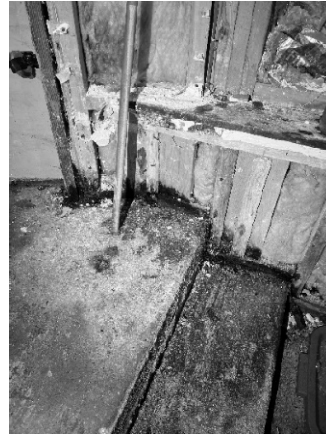
Figure 48 - There is mold at the interface between the wood framing and concrete stairs.

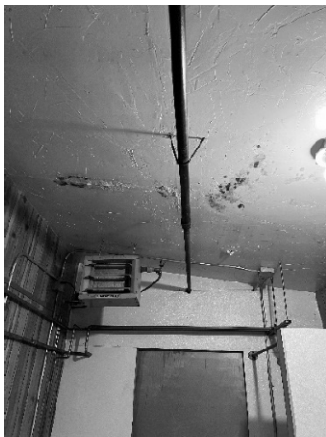
Figure 49 - In the kitchen add-on, there is black mold on the ceiling.

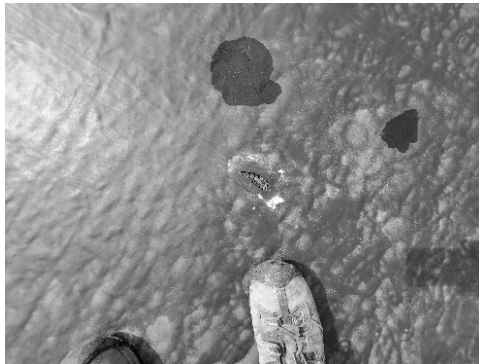
Figure 51 - There are a few small holes in the roof, which allow water to infiltrate.

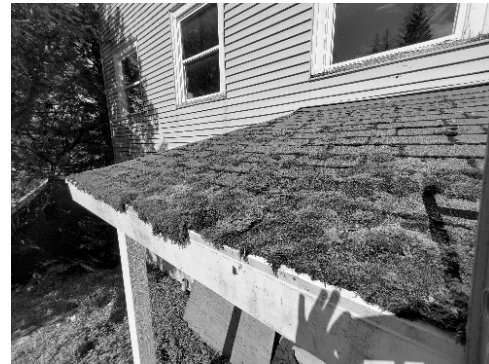
Figure 52 - There is significant moss on the entryway roof.

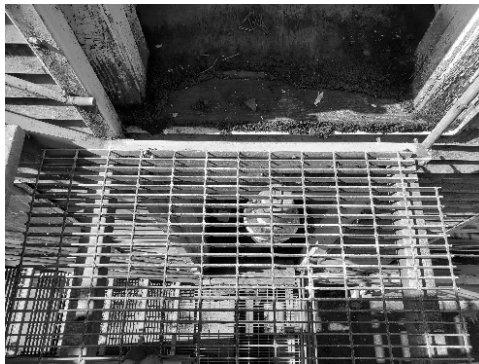
Figure 53 - There is significant moss in an emergency exit way.

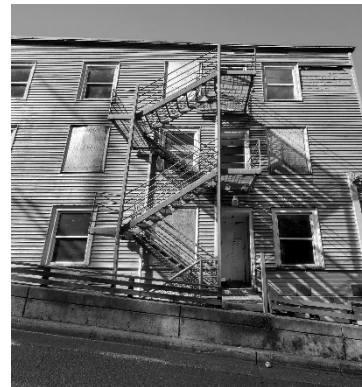
Figure 54 - There is moss on the exterior siding.

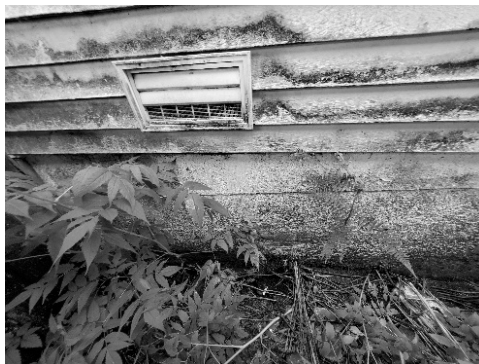
Figure 55 - Some of the exterior siding has black mold.

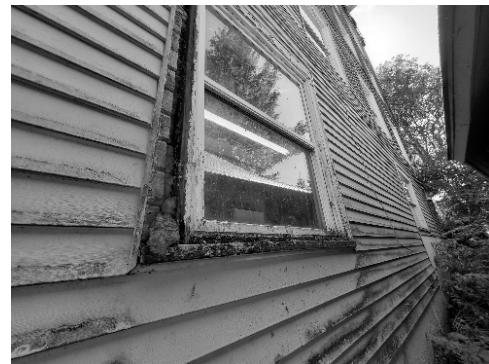
Figure 56 - This window does not have trim around the perimeter to prevent water infiltration.

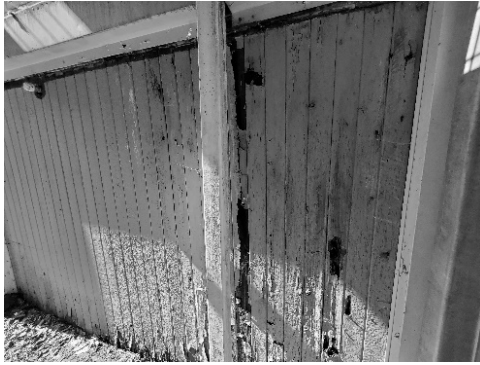
Figure 57 - In many locations, the paint is flaking.

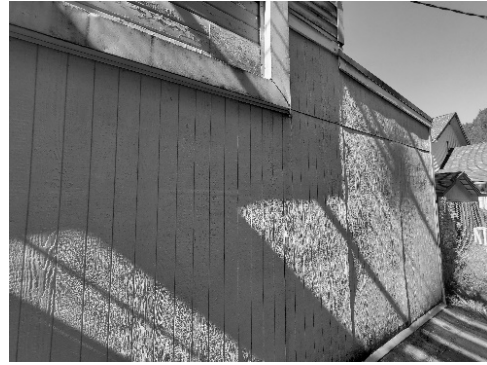
Figure 58 - Some of the siding panels have warped.

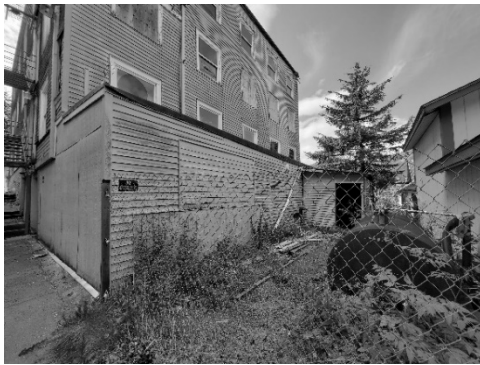
Figure 59 - Many windowsills have moss growing on them. Some windows are broken.

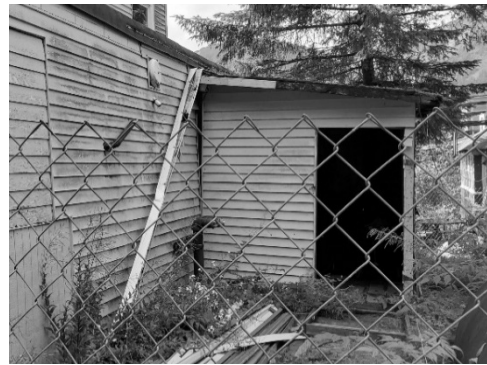
Figure 60 - The small shed on the back has significant moss on the roof, appears to have a roof leak, and is pulling away from the main building.

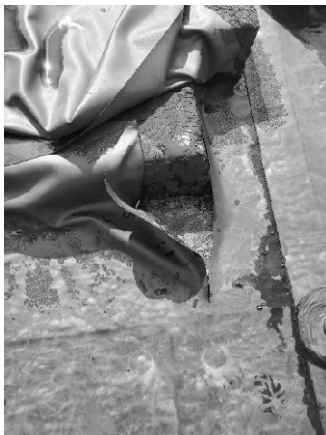
Figure 61 - Roof access hatch sheathing with water damage and shows signs of rot.

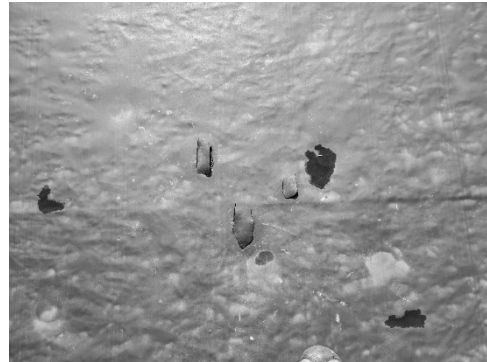
There are several failure points along the roof membrane that exposed the roof OSB sheathing. The roof sheathing along the south side appears to have been exposed due an envelope failure (Figure 63). Gouging in the roof appears intermittently along the south side of the building (Figure 62). The roof service hatch sheathing was not patched and shows signs of water damage where the EPDM was cut and installed (Figure 61). While the structural inspectors were on-site, a roof contractor was also performing an inspection of a roof leak to provide a quote for a re-roof to the owner.

Figure 62 - Gouging in the roof membrane along the South side of the building.

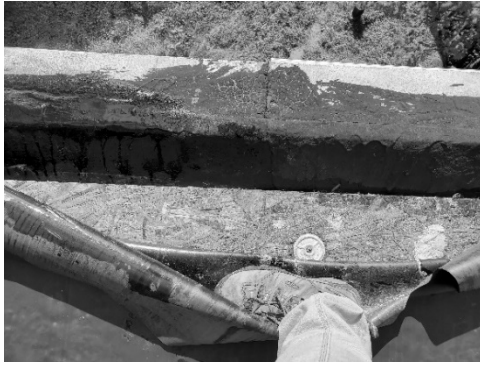
Figure 63 - Leading edge of EPDM membrane exposed roof assembly.
