Stream Bank/Stream Channel Erosion Study – Shady Creek, Harrison Creek, Walnut River and Cole Creek

Summary Report
April 28, 2017

Upper Walnut/El Dorado Lake Watershed Restoration and Protection Strategy (WRAPS)

Project Number: 2015-W071
Year 3 SFY 16 FFY 15
Project Start/End Dates: 10/01/2015 – 3/31/17
KS Grant #: 2015-W071 – Project ID# 756
EPA Grant #C9007405-21

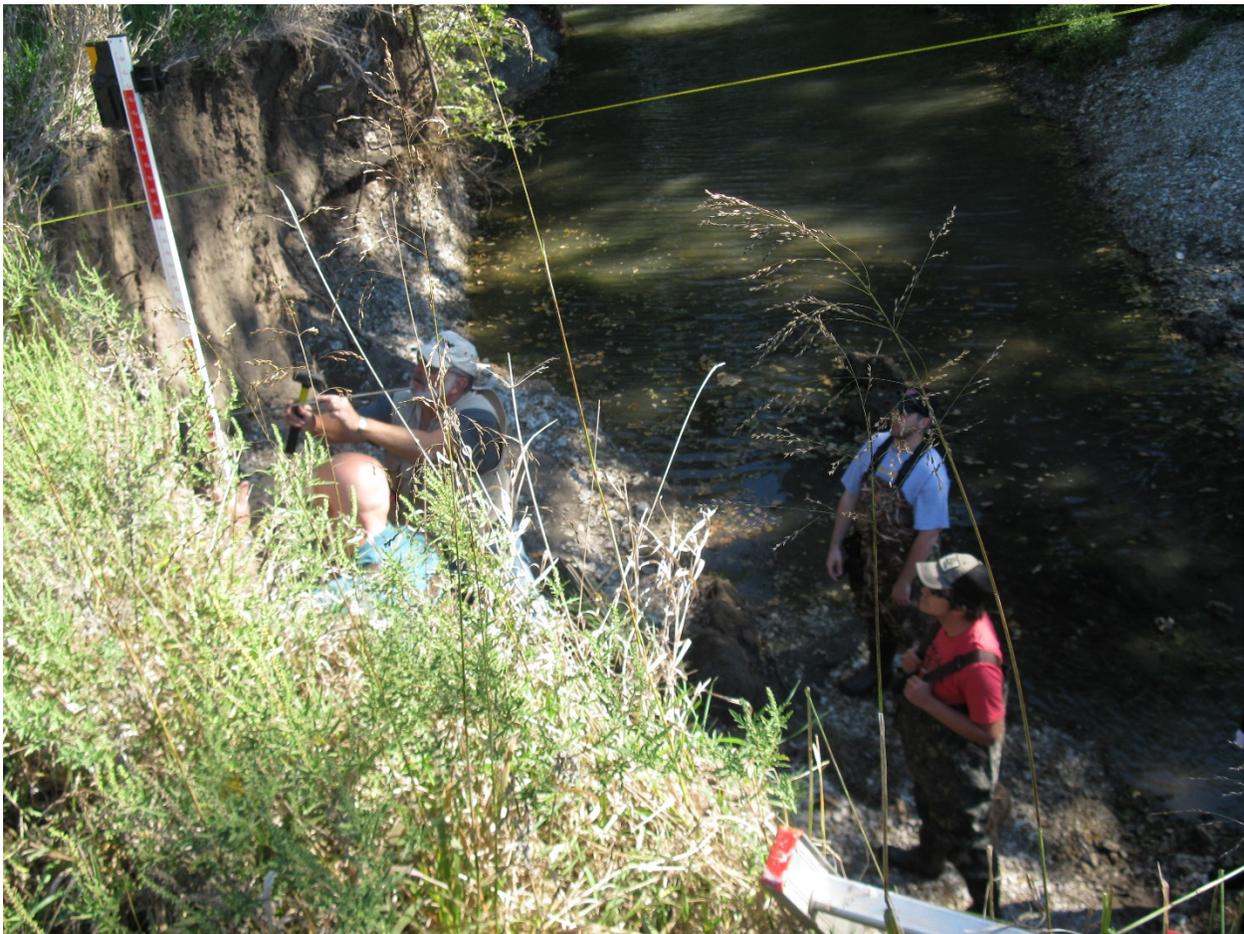
Harrison Creek - Sites #1 and #2 (2010 Photo)

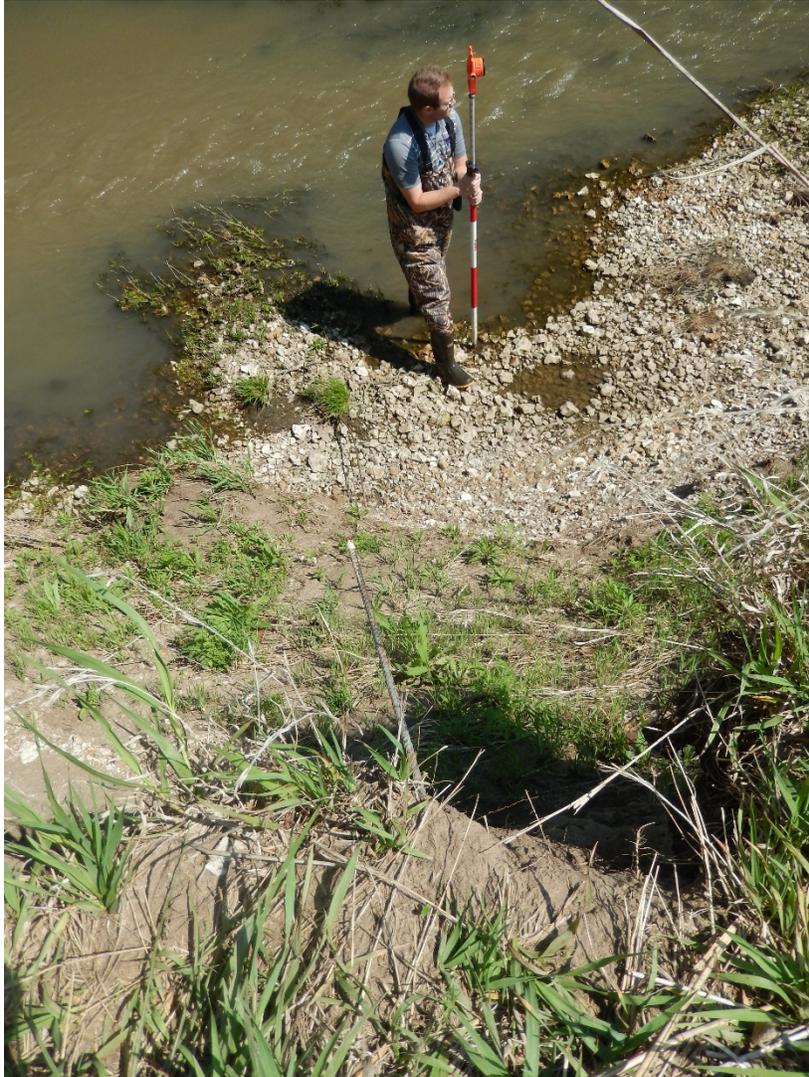
Harrison Creek - Sites #1 and #2 (2017 Photo)
Note exposed rebar in the center of the picture.

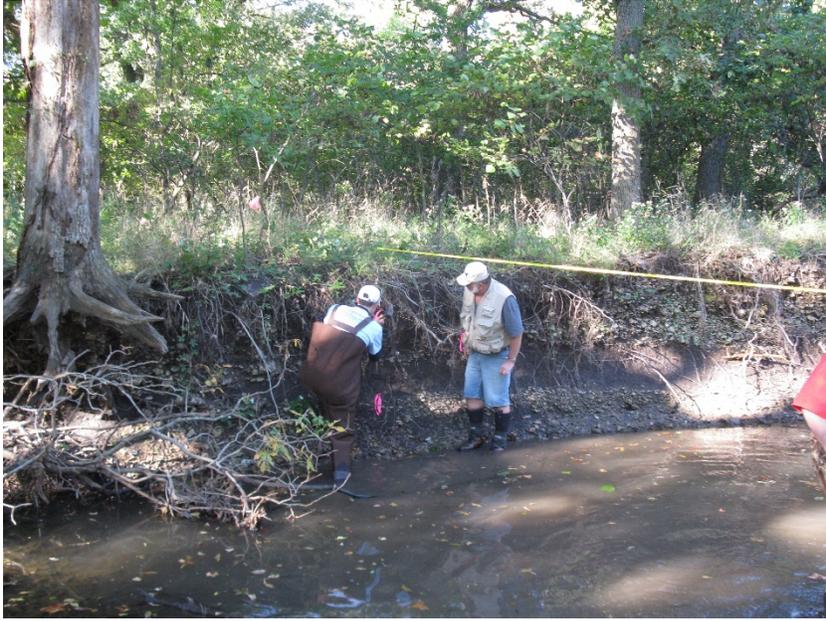
Shady Creek (2010 Photo)

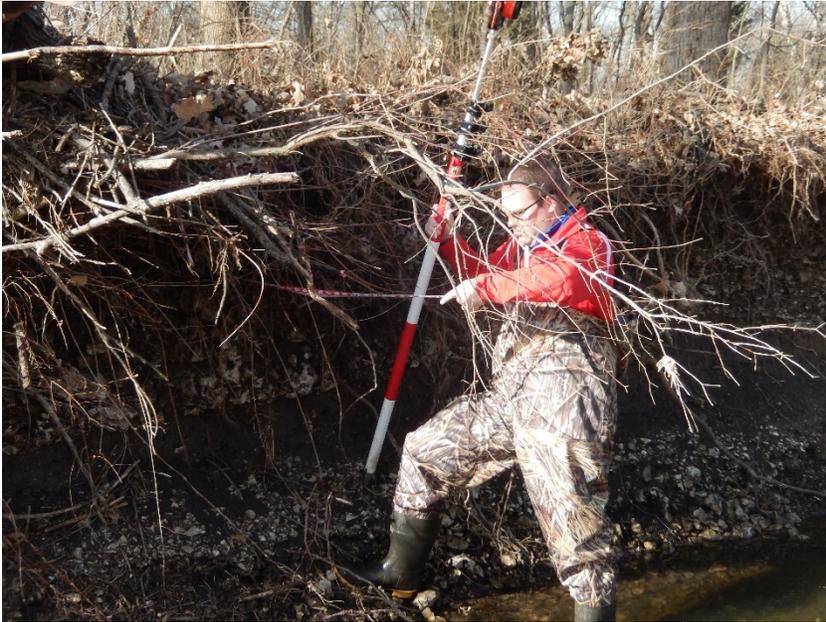
Shady Creek (2017 Photo)

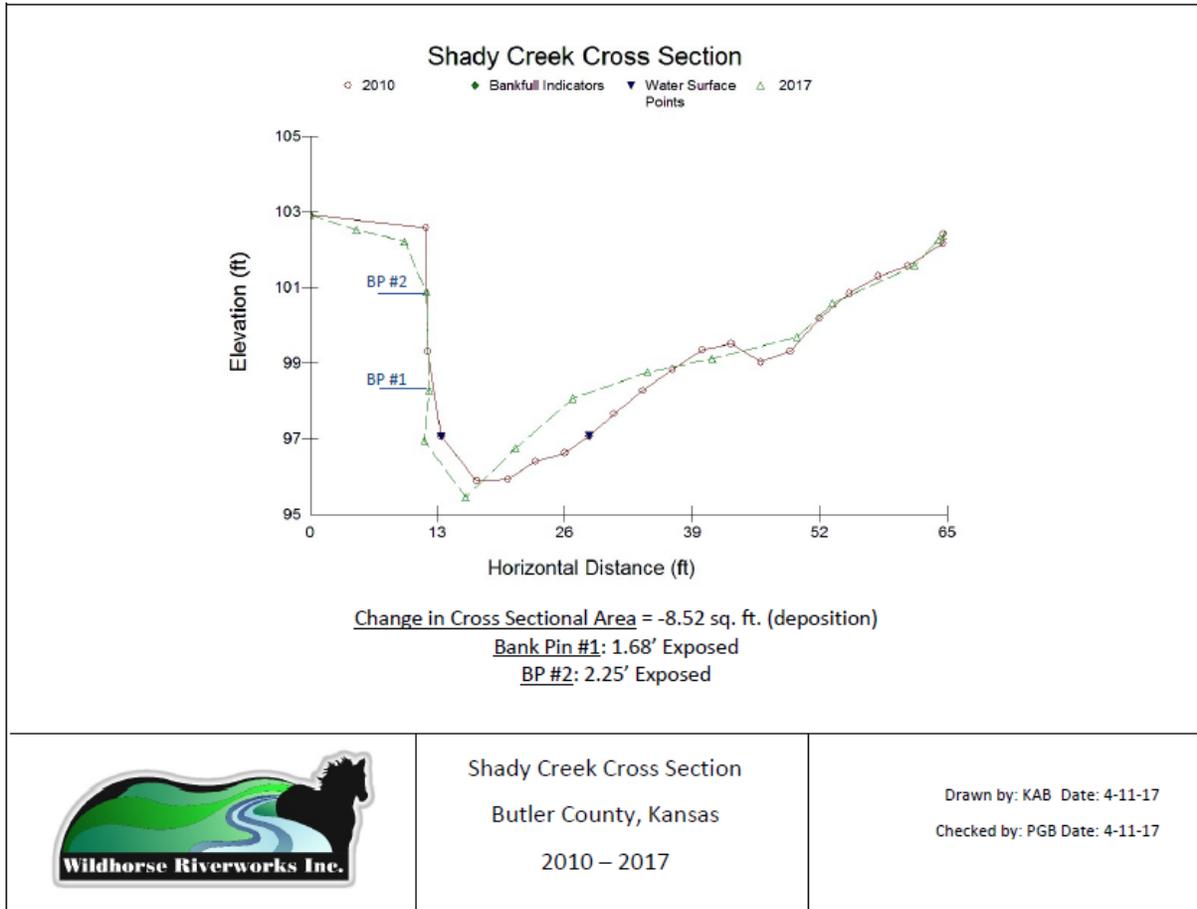
In general, at Shady Creek’s cross section, the survey showed 8.52 square feet (2,360 pounds or 1.2 Ton) of deposition (sediment gained) from 2010 to 2017; the lower bank pin was exposed by 1.68 feet and the upper bank pin was exposed 2.25 feet. Deposition is a naturally occurring process and is to be expected during high flows. Visual observation from 2010 and 2017 showed gravel shifting from one part of the stream to the other and depositing in different places. The stream channel was much wider in 2010 than it was in 2017 (narrower stream channel = more velocity). A deeper channel indicates channel incision and stream bed erosion. More gravel and gravel piled higher on the non-eroding side of the stream bank was observed. The gravel bar deposition or lateral increase normally follows bank erosion. Once the lateral migration (bank erosion) slows, the bar may increase in height. The increase in gravel bar height may be due to excess sediment from upstream, loss of stream power (velocity) in this area due to wider stream channel, or other factors.

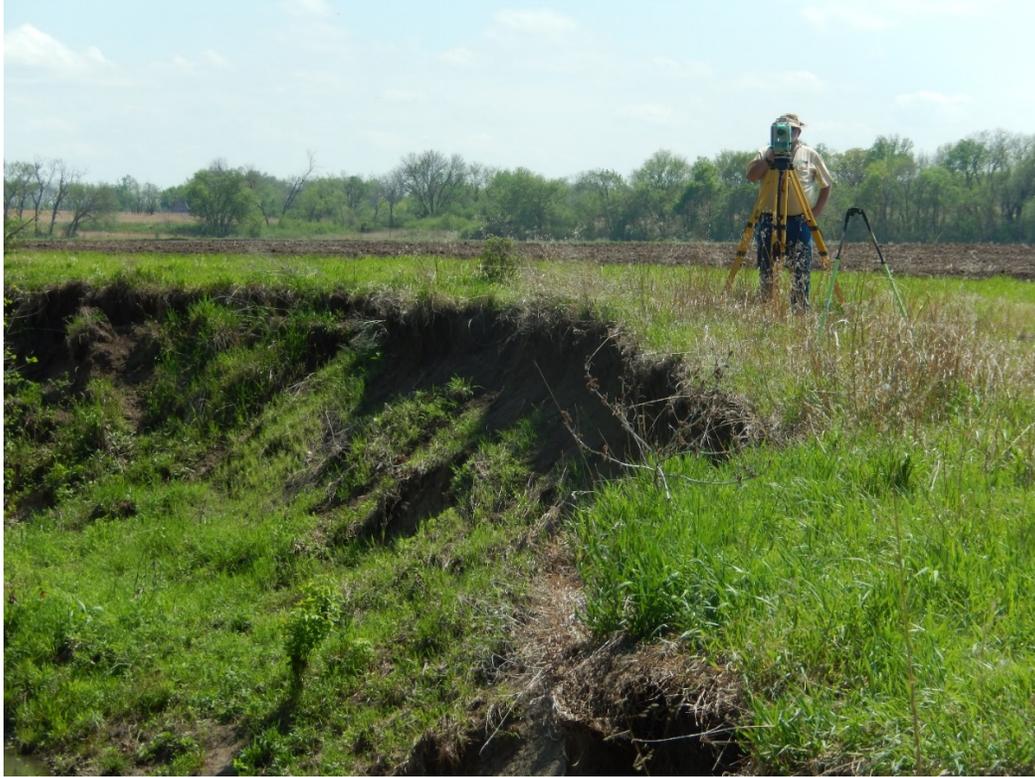
Harrison Creek Simpson Site (2017 Photo)
Notice conventional tilled land adjacent to the buffer along the stream.

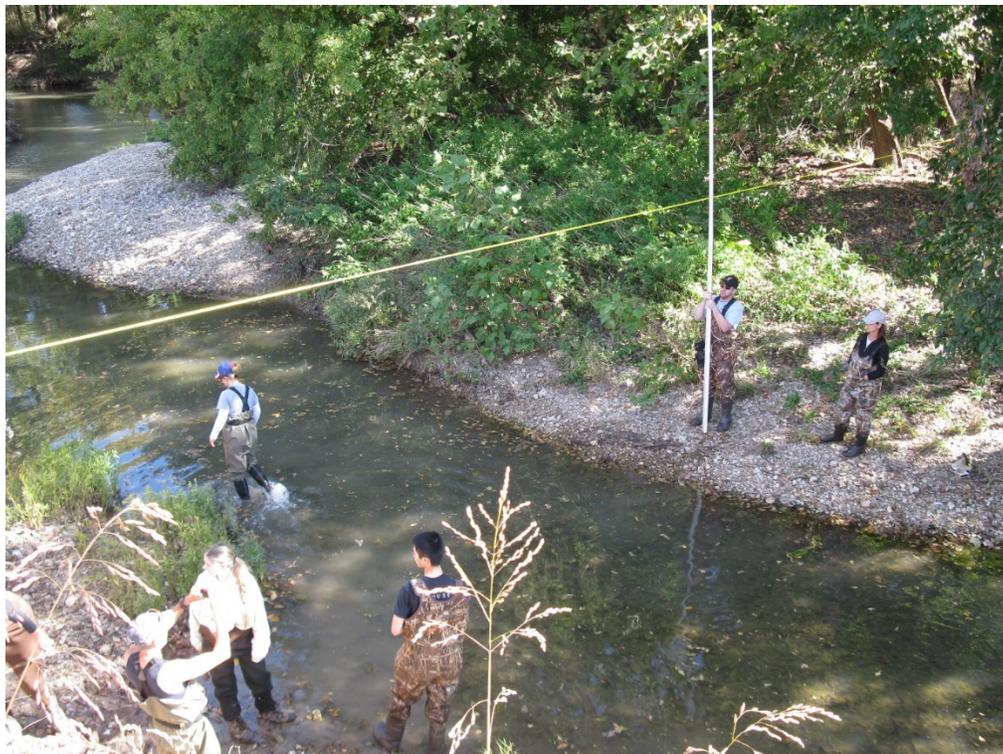
Harrison Creek (Simpson) Sites #1 and #2 (2010 Photo)

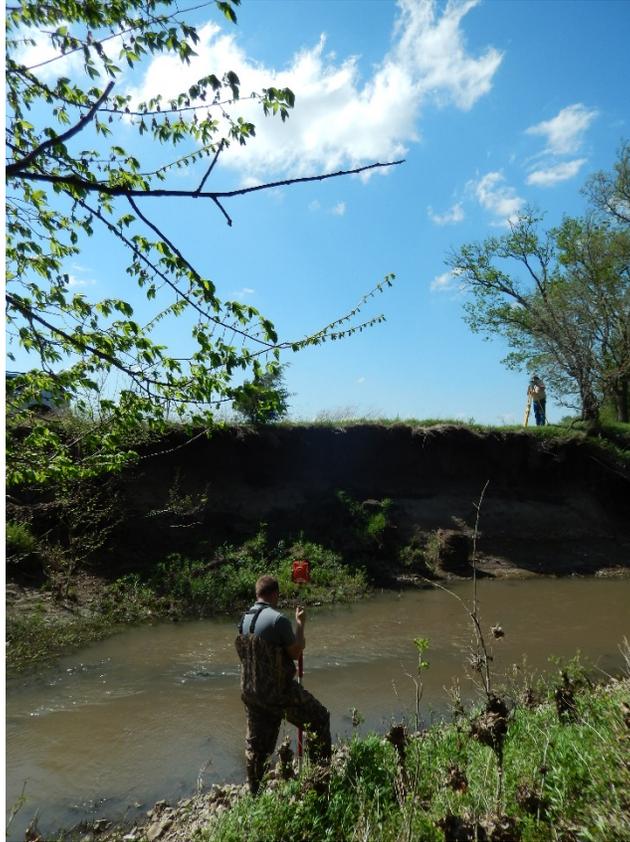
Harrison Creek (Simpson) Sites #1 and #2 (2017 Photo)

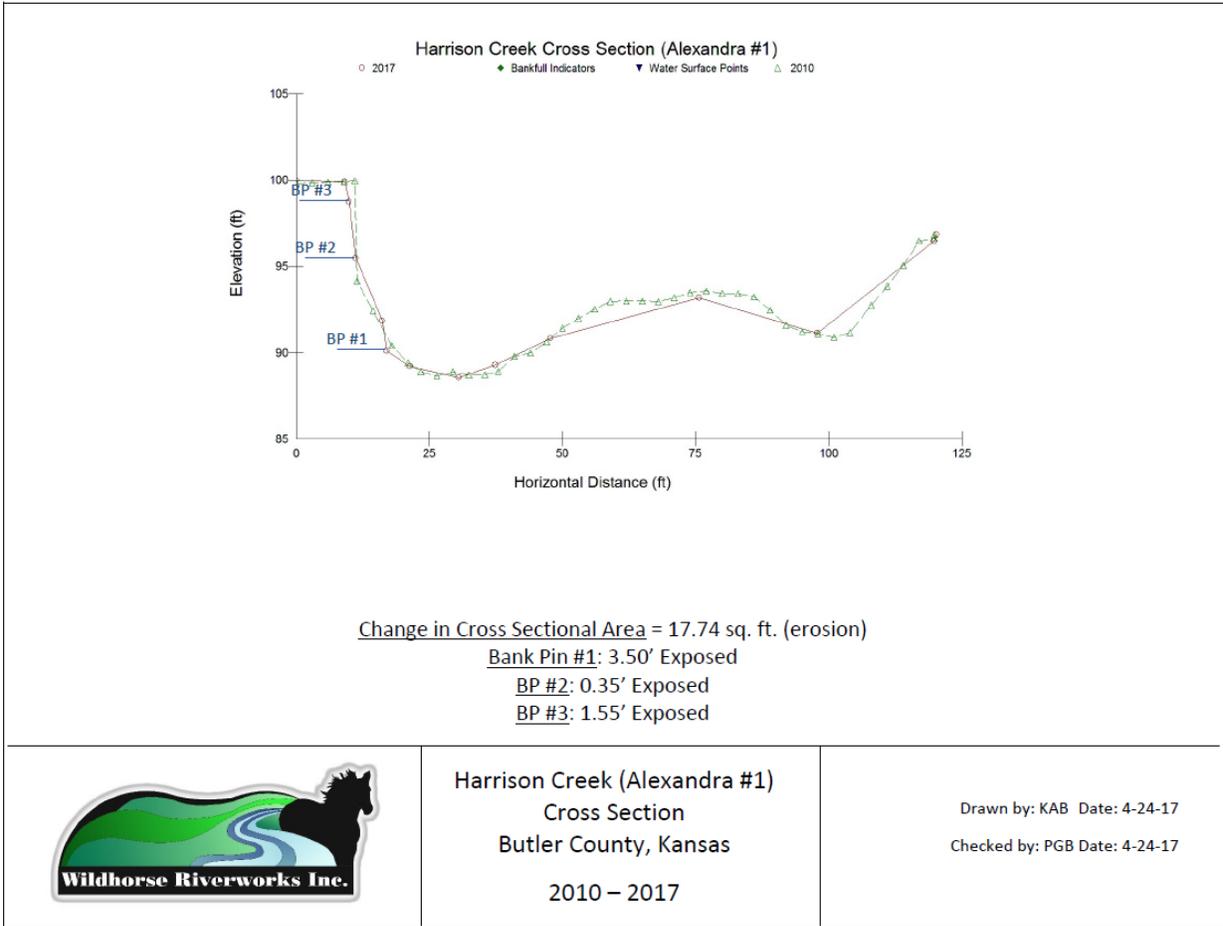
The Harrison Creek (Simpson) Sites #1 and #2 were adjacent to each other on the same eroding stream bank; Site #1 was upstream of Site #2 but within 50 feet of each other. On Site #1, rebar was all exposed to some extent while on Site #2 the bottom rebar was buried. Visual observation showed further upstream the bank had sloughed off but vegetation was growing on the bank that had collapsed.

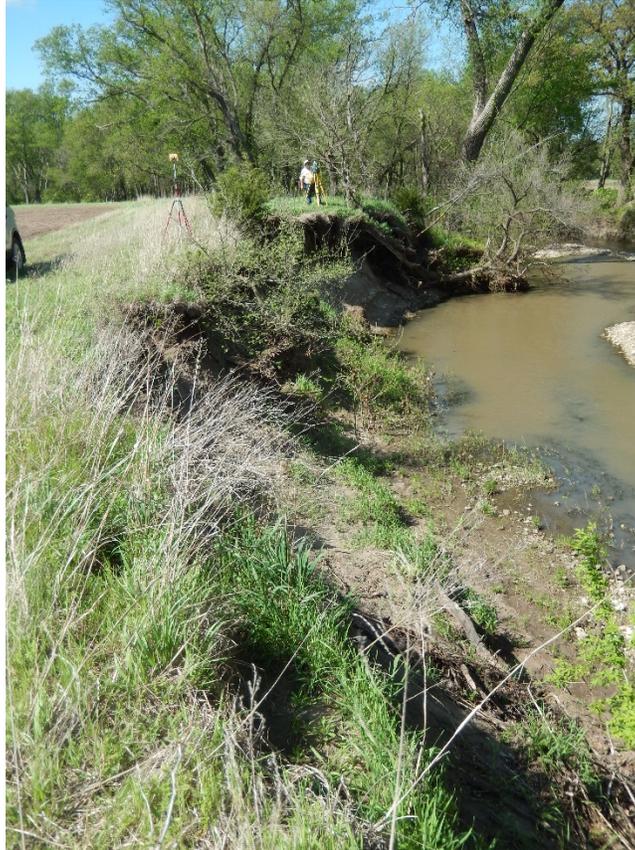
Harrison Creek (White/Simpson) #1 and #2 (2017 Photo)

Compared to 2010, the stream bank had more slope to it in 2017; in 2010, ladders had to be used to get down to the water. The cross section at Site #1 reveals sediment loss and deposition from the stream bank as well as the stream channel. Soil lost at this cross section = 17.74 square feet (7,098 pounds or 3.5 tons) of sediment lost at this site. The width of the channel changed very little from 2010 to 2017.

The cross section survey is just a snapshot of what is occurring along the entire horizontal length of the stream where we see active stream bank erosion. If you were to calculate the sediment loss along the entire length of eroding stream bank (84 feet in length) at this one site, based on 7 years of time elapsed from 2010 to 2017, the amount of soil lost would be 294 tons or 0.5 tons/ft. of bank/year.

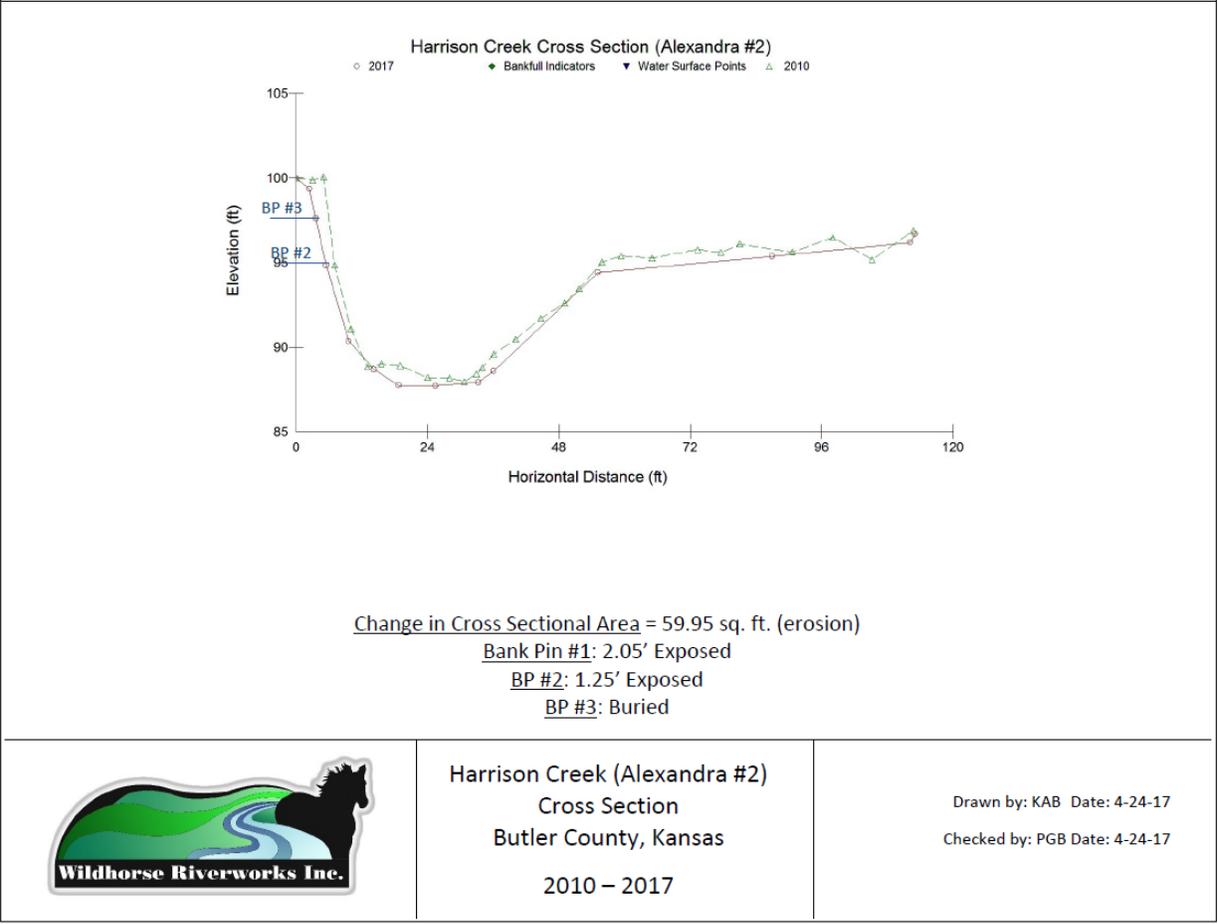
The Harrison Creek (Simpson) Site #2 was adjacent and downstream of Site #1 on the same eroding stream bank. On Site #2, the bottom rebar was buried but the top two rebar pins were exposed. In 2010 the bank was vertical; in 2017, there was more of a slope to the bank; however not as much slope as at Site #1. The cross section at Site #2 reveals sediment loss and deposition from the stream bank as well as the stream channel. Soil lost at this cross section = 59.95 square feet (44,097 pounds or 22 tons) of sediment lost at this site. The width of the channel changed very little from 2010 to 2017.

The cross section survey is just a snapshot of what is occurring along the entire horizontal length of the stream where we see active stream bank erosion. If you were to calculate the sediment loss along the entire length of eroding stream bank (119 feet in length) at this one site, based on 7 years of time elapsed from 2010 to 2017, the amount of soil lost would be 2,618 tons or 3.1 tons/ft. of bank/year.

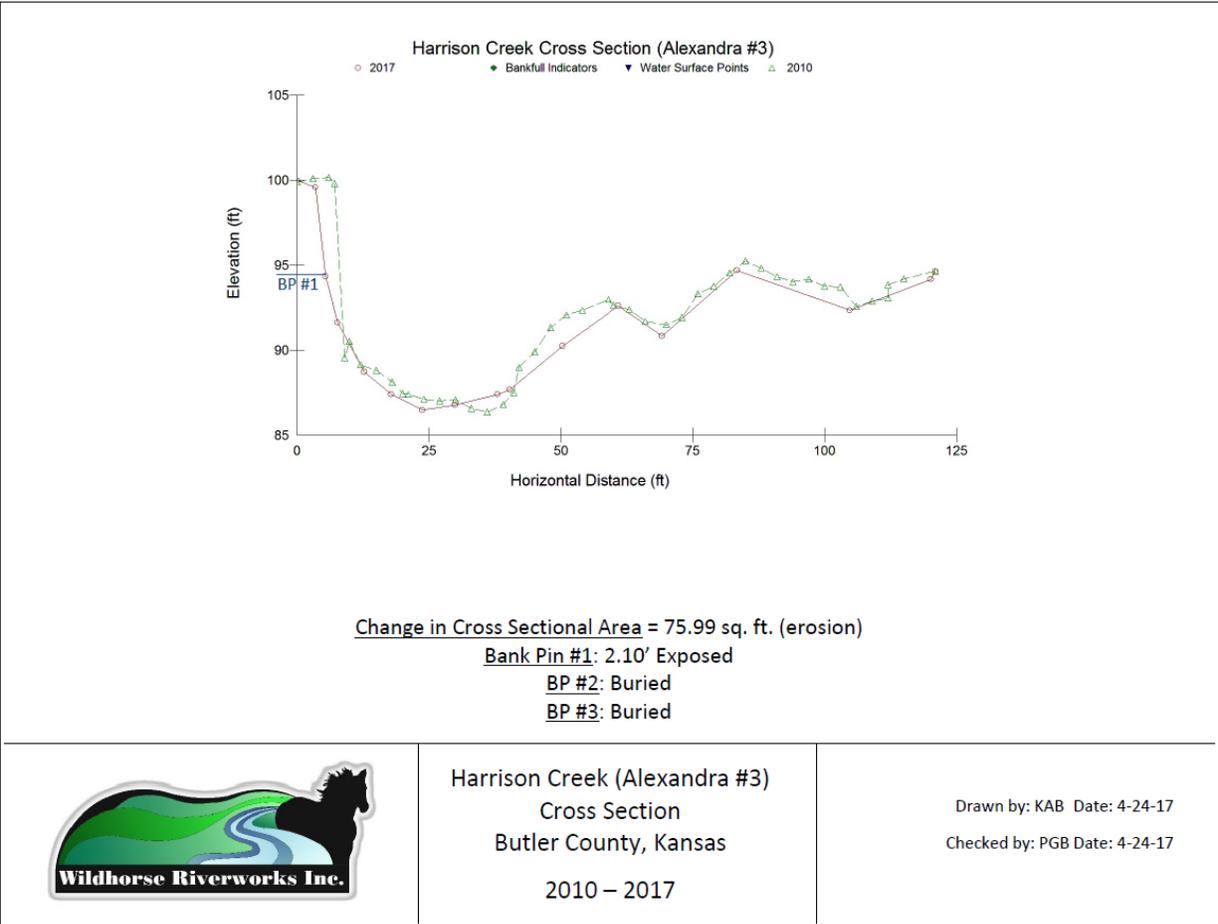
The Harrison Creek (Simpson) Site #3 showed similar erosion as compared to Simpson Sites #1 and #2 as well as the Moore Sites #1 and #2 (discussed later in this report). On this site, the top of the bank sloughed off and buried the rebar closest to the water line. The cross section reveals sediment loss from the stream bank as well as the stream channel. Soil lost at this cross section = 75.99 square feet (62,930 pounds or 31.5 tons) of sediment lost at this site. The width of the channel changed very little from 2010 to 2017.

The cross section survey is just a snapshot of what is occurring along the entire horizontal length of the stream where we see active stream bank erosion. If you were to calculate the sediment loss along the entire length of eroding stream bank (253 feet in length) at this one site, based on 7 years of time elapsed from 2010 to 2017, the amount of soil lost would be 7,970 tons or 4.5 tons/ft. of bank/year.

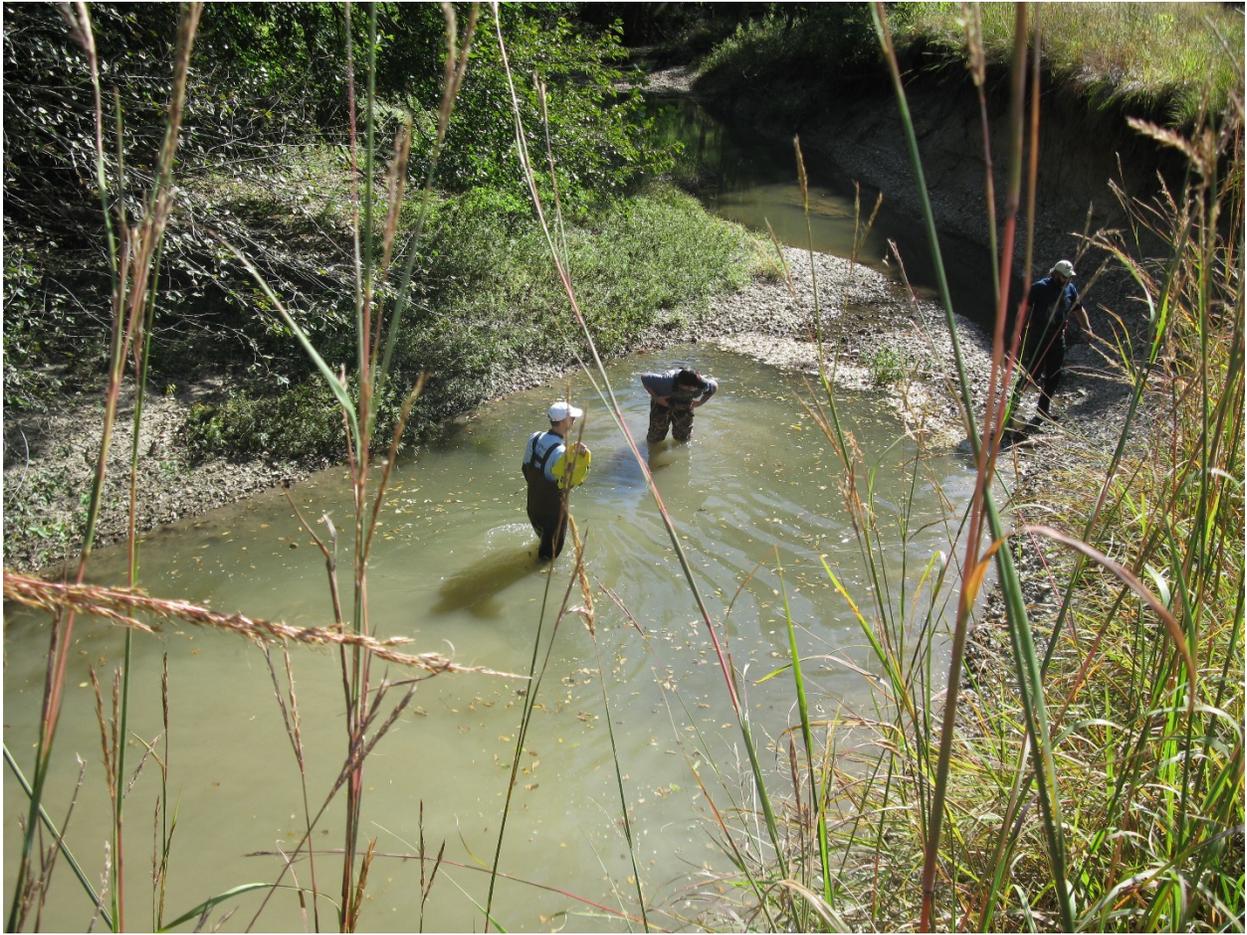
Harrison Creek (Moore) Upstream Site #5 (2010 Photo)

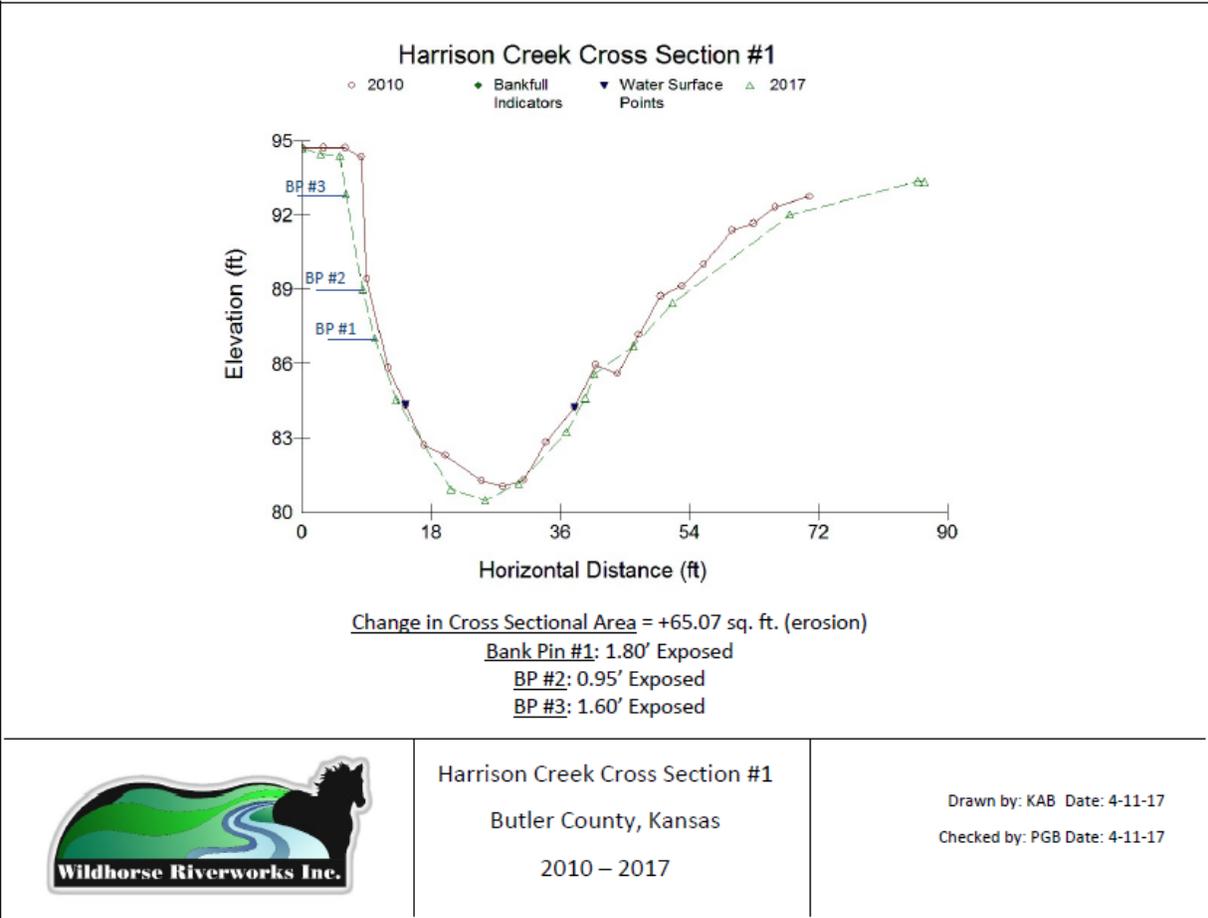
Harrison Creek Site #5 Upstream Site

The Harrison Creek (Moore) upstream site had a lot of deposition occur on the left bank or inside bend, based on visual observation. The stream bank pins (rebar) showed that the brome grass was holding the top of the bank; however, the bottom pin was exposed more so than the top pin which indicates as rainfall saturates the top of the bank and as additional flooding occurs, the top of the bank will eventually fall into the creek and be lost as sediment. This is evidenced by the jagged look of the top of bank as clumps of brome and soil give way. The cross section reveals sediment loss from the stream bank as well as the stream channel. Soil lost at this cross section = 65.07 square feet (49,864 pounds or 25 tons) of sediment lost at this site. The width of the channel changed very little from 2010 to 2017.

The cross section survey is just a snapshot of what is occurring along the entire horizontal length of the stream where we see active stream bank erosion. If you were to calculate the sediment loss along the entire length of eroding stream bank (185.1 feet in length) at this one site, based on 7 years of time elapsed from 2010 to 2017, the amount of soil lost would be 4,628 tons or 3.57 tons/ft. of bank/year.

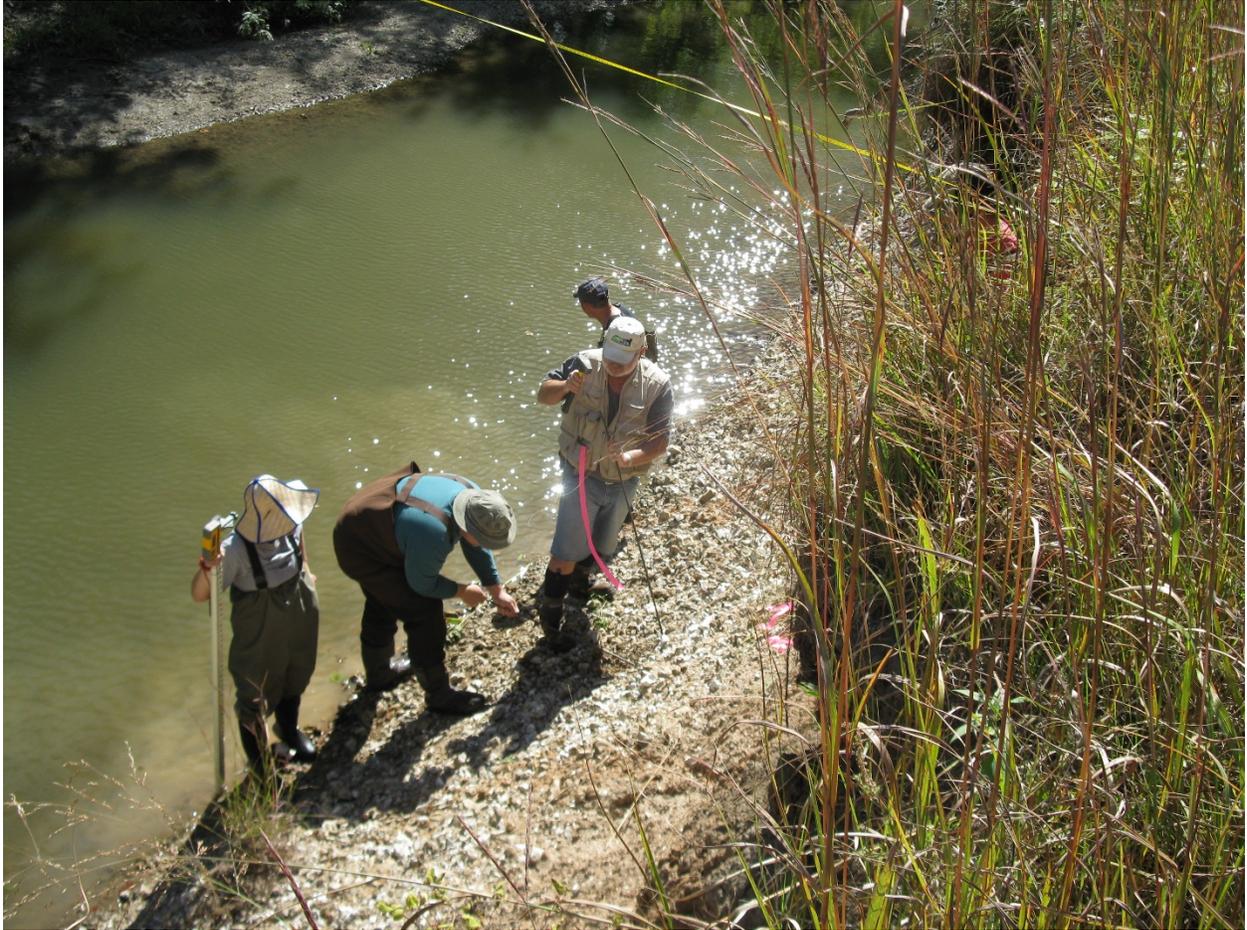
Harrison Creek (Moore) Downstream Site #4 (2010 Photo)

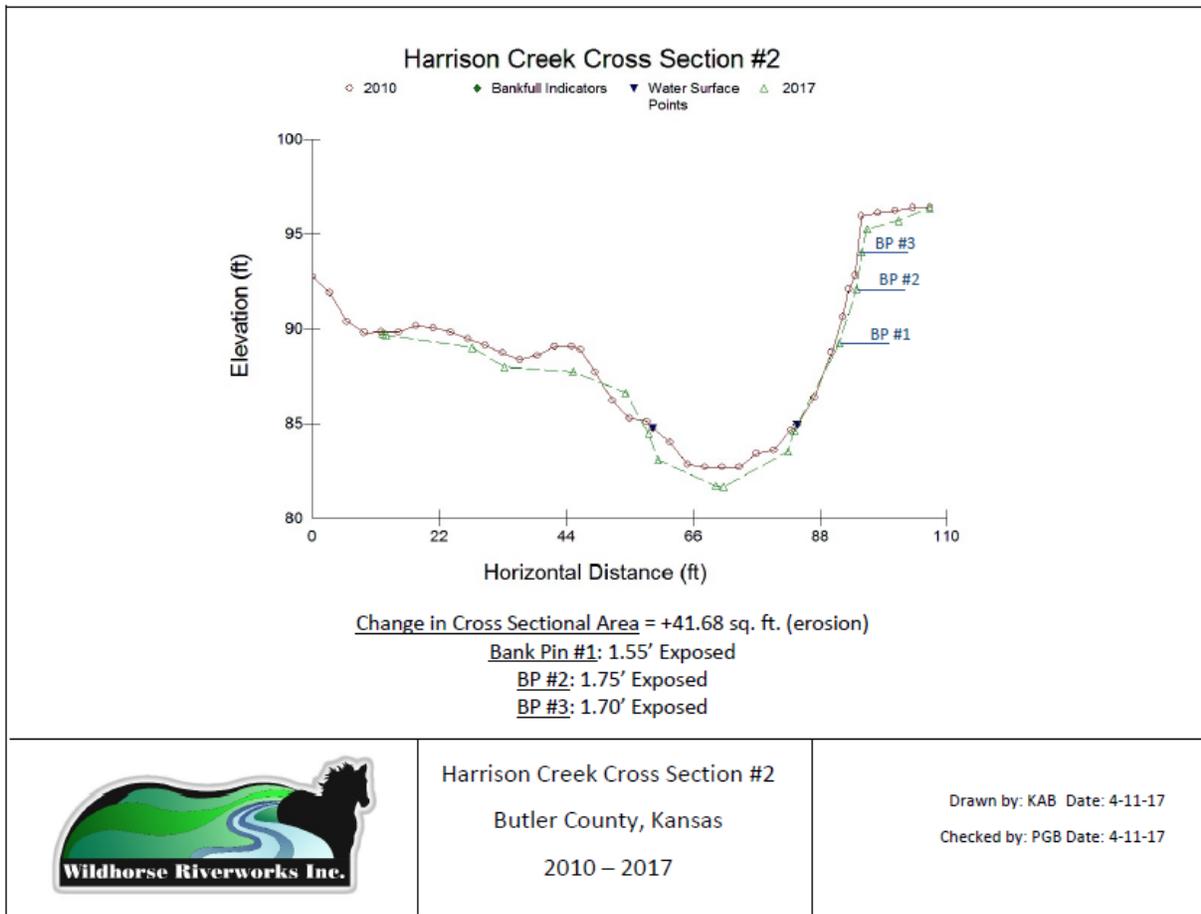
Harrison Creek Downstream Site #4

The Harrison Creek (Moore) downstream site also showed a lot of deposition through the reach of the cross section on the inside bend similar to the upstream site. From visual observation, it didn't appear the site had lost as much of the stream bank as the upstream site. There was more gravel in the bank below the rebar; gravel may have helped protect the bank from erosion. The change in the cross section was 41.68 square feet (25,573 pounds or 12.8 ton) of sediment lost at this site. This was also verified by the rebar; less rebar exposed. The stream in 2017 appeared much as it had in 2010.

The cross section survey is just a snapshot of what is occurring along the entire horizontal length of the stream where we see active stream bank erosion. If you were to calculate the sediment loss along the entire length of eroding stream bank (129 feet in length) at this one site, based on 7 years of time elapsed from 2010 to 2017, the amount of soil lost would be 1,651 tons or 1.83 tons/ft. of bank/year.

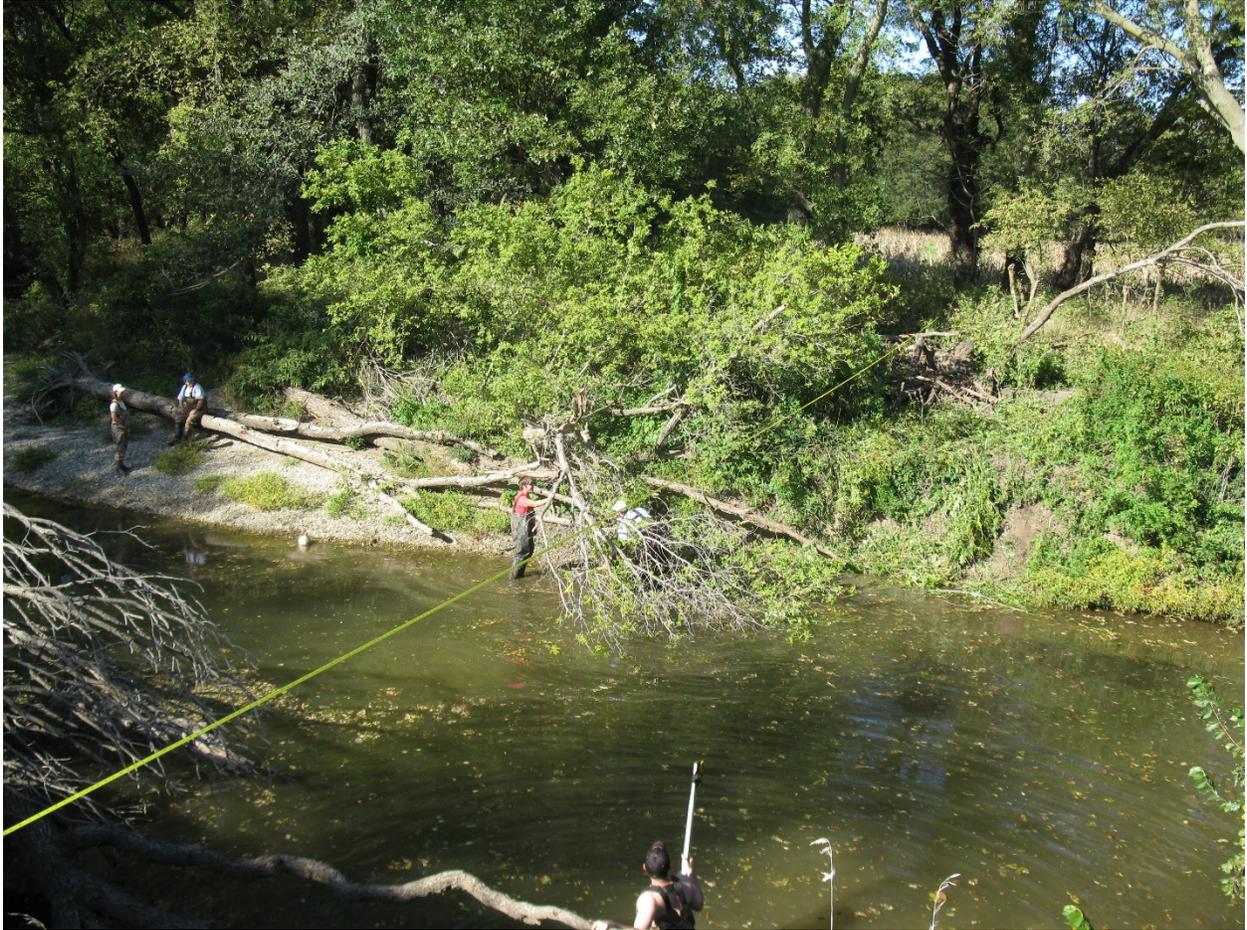
Walnut River (2010 Photo)

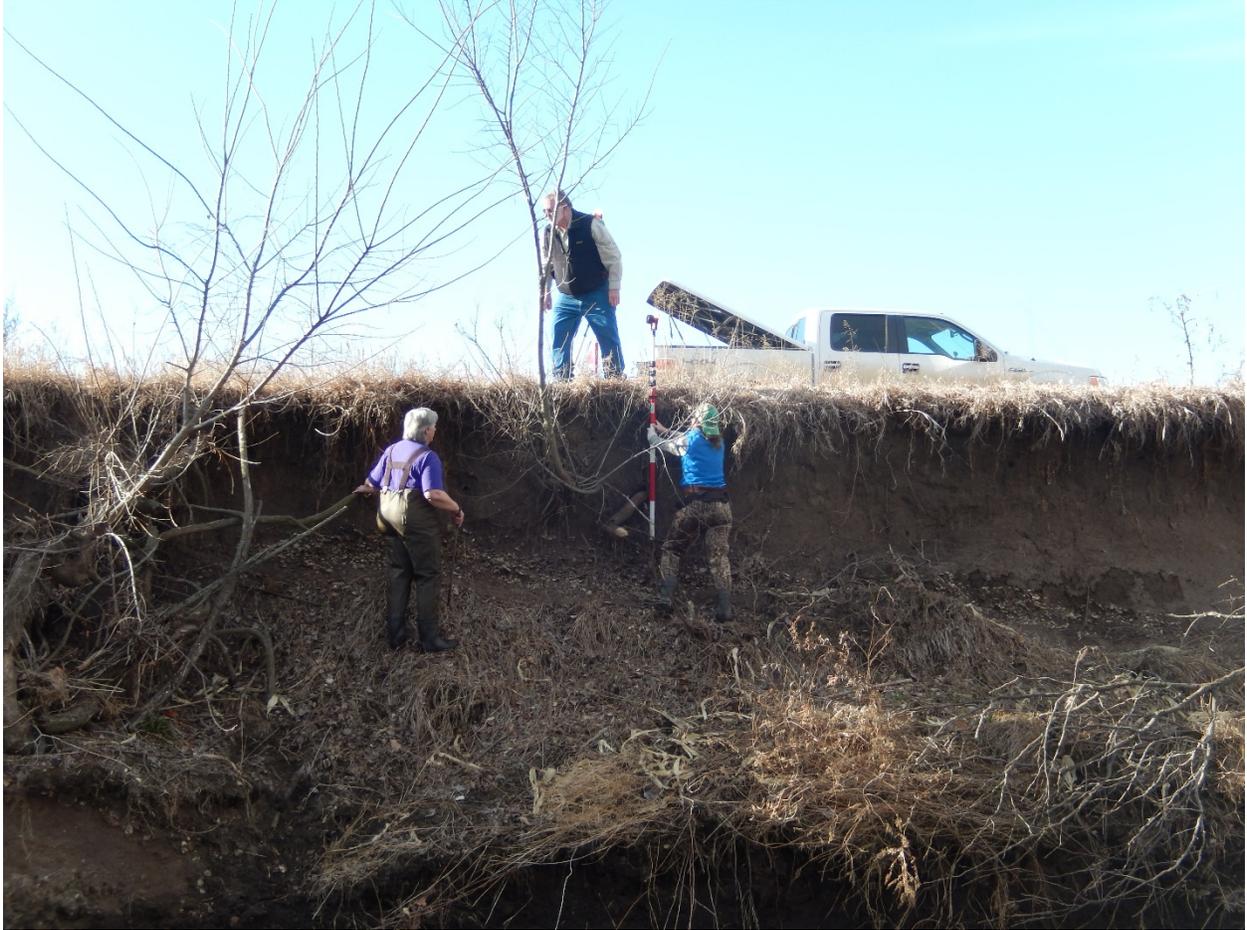
Walnut River (2017 Photo)

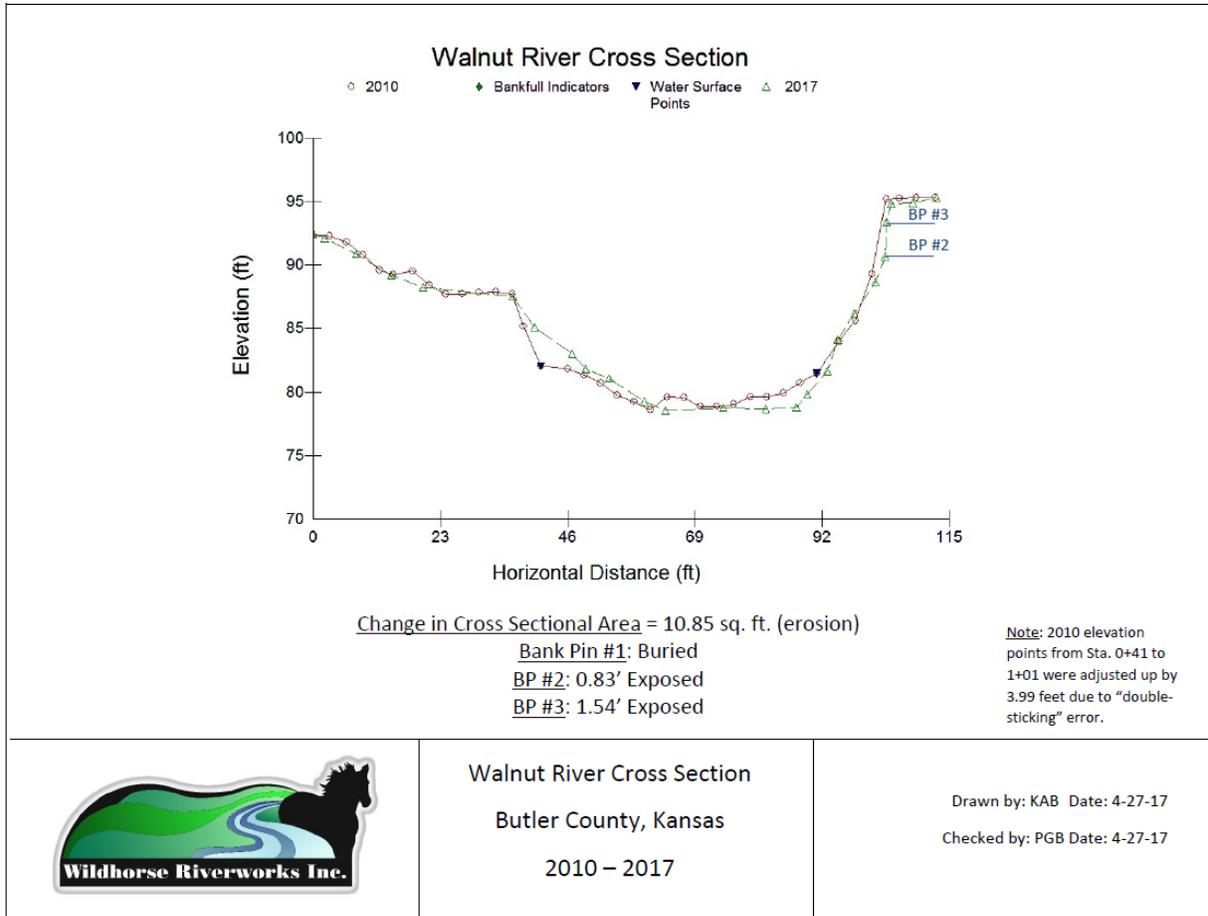
At this site, the visual observation was that in 2010, there was a large log jam just upstream from the cross section; in 2017, the log jam had re-adjusted/moved. In 2010, one of the trees in the log jam had a lot of branches and was helping to protect the bank, in 2017 that large tree was gone but part of the log jam was still intact, it but (before) it wasn't as effective in protecting the stream bank. At the cross section, the top of the stream bank had a large overhang from the top of bank to the first pin. The bank sloughed off in a large chunk and landed about half way down the stream bank covering the bottom bank pin. It was also observed that the gravel bar on the far bank was bigger and longer upstream and downstream of the cross section in 2017. This is most likely also contributing to the change in flow of the stream-diverting the water during higher flows towards the eroding stream bank. The cross section shows that 10.85 square feet (3,395 pounds or 1.70 tons) of sediment was lost at this site.

The cross section survey is just a snapshot of what is occurring along the entire horizontal length of the stream where we see active stream bank erosion. If you were to calculate the sediment loss along the entire length of eroding stream bank (218.1 feet in length) at this one site, based on 7 years of time elapsed from 2010 to 2017, the amount of soil lost would be 371 tons or 0.24 tons per foot per year.

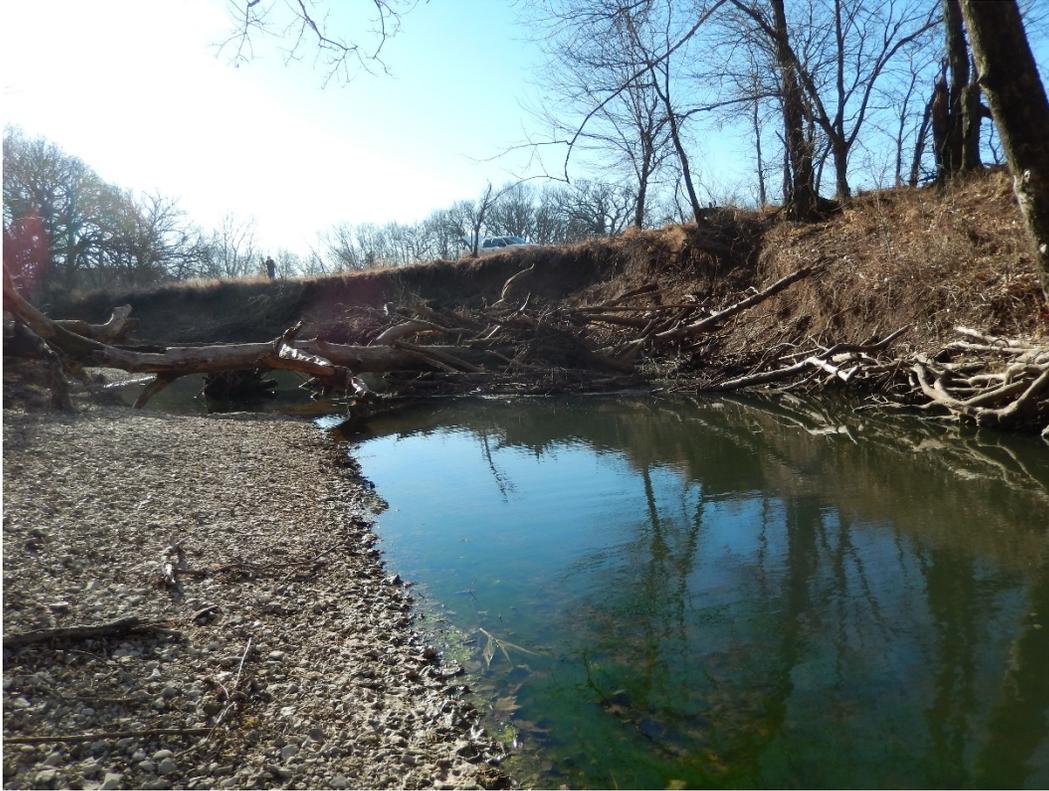
Walnut River (note log jam and gravel bar) (2017 Photo)

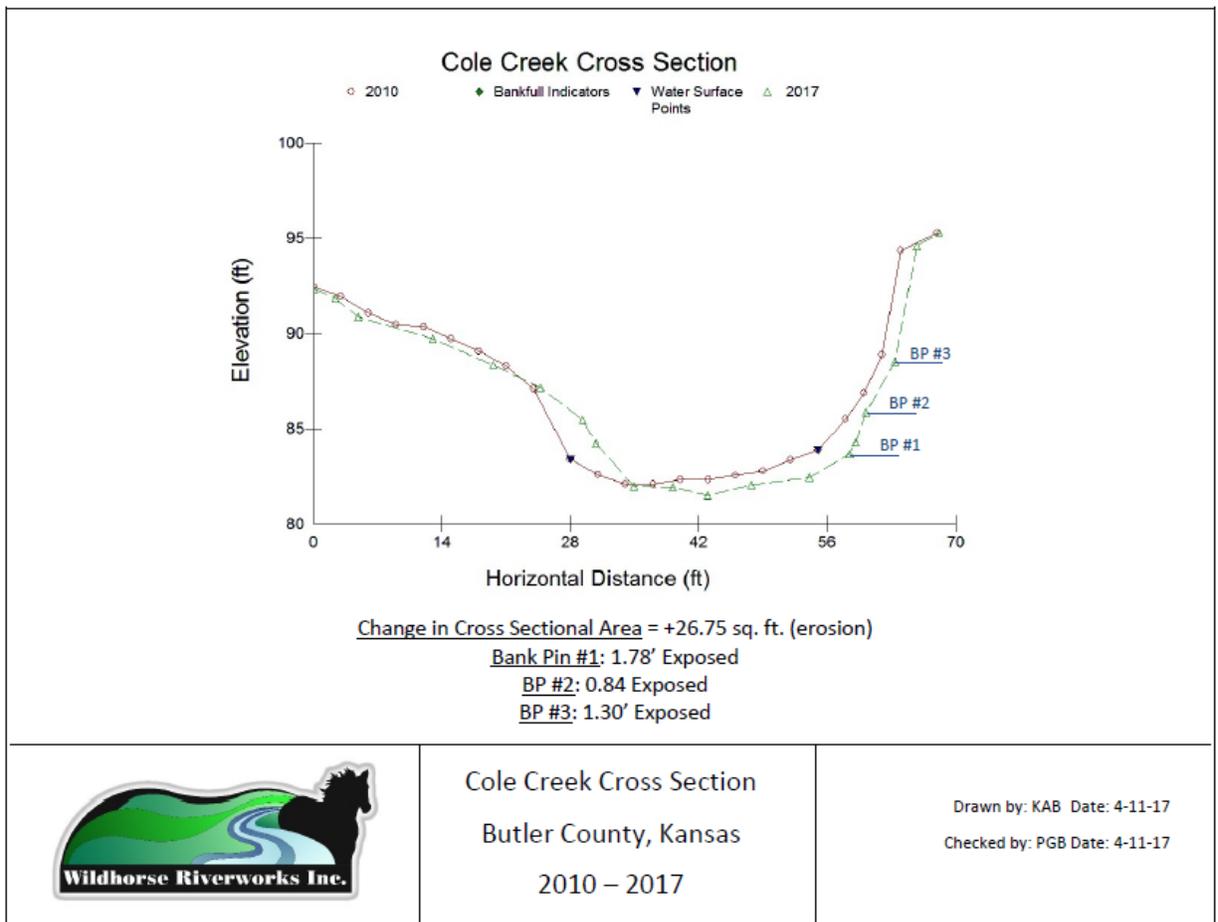
While erosion is evident at the Cole Creek site, large trees and shrubs are still holding in place and preventing large losses of sediment. A gravel shelf is evident at the water line and may be the reason the bank pin at the water line was exposed by 1.78', undercutting this area first. Tree roots are helping to stabilize the upper part of the stream bank in the area upstream and downstream of this cross section. Deposition occurred on the inside bend but erosion was evident as seen by the cross section data and exposed rebar on the right stream bank. In all, 26.75 square feet (13,133 pounds or 6.6 tons) of sediment lost was calculated at this cross section.

The cross section survey is just a snapshot of what is occurring along the entire horizontal length of the stream where we see active stream bank erosion. If you were to calculate the soil lost for the entire length of eroding streambank (203.1 feet), the amount is equal to 1,340 tons or 0.94 tons per foot per year.
