CHERRYFIELD RIVERWALK EXISTING CONDITIONS MEMORANDUM

FEBRUARY 2025

FB Environmental Associates

The Town of Cherryfield, Maine

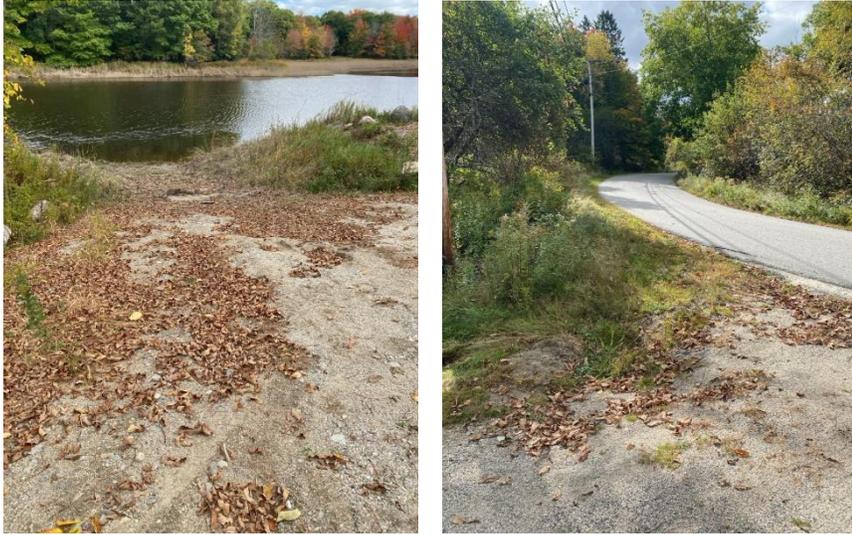
NPS Input 1: Cherryfield Boat Launch

Observations: There are potholes above the boat ramp from spinning tires and excess sediment washing into the river from erosion at the boat launch and from the Wilson Hill Road intersection.

Left: Sheet erosion along boat launch going into river. Right: Erosion on Wilson Hill Road washing sediment down the boat launch access road.

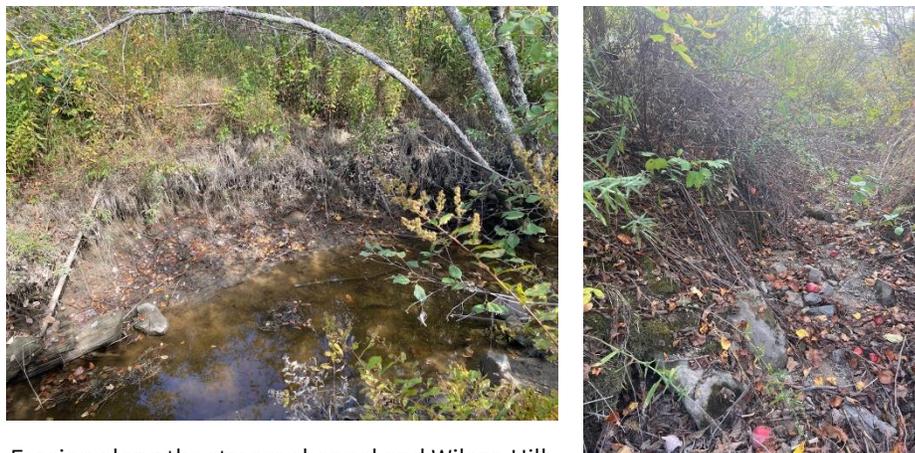
NPS Input 2: Wilson Hill Rd Stream Crossing (just north of the boat launch)

Observations: There is roadside erosion from ditch runoff and tidal influence at the stream crossing on Wilson Hill Road just north of the boat launch. This is causing eroded material to go into the stream/drainage channel and ultimately the Narraguagus River. The culvert itself is in okay condition.

Erosion along the stream channel and Wilson Hill Road ditch.

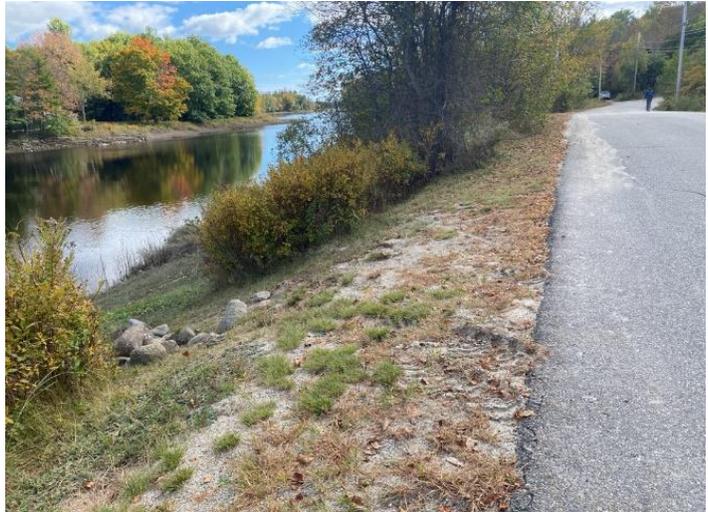
NPS Input 3: Across from 19 Wilson Hill Road
Location (latitude, longitude): 44.5962, -67.9256

Observations: Minor roadside erosion is present and is able to reach the river via a path cut through the riparian zone. Rocks have been dumped near the river as well, potentially attempting to mitigate erosion.

Road shoulder erosion and rocks dumped adjacent to the Narraguagus River.

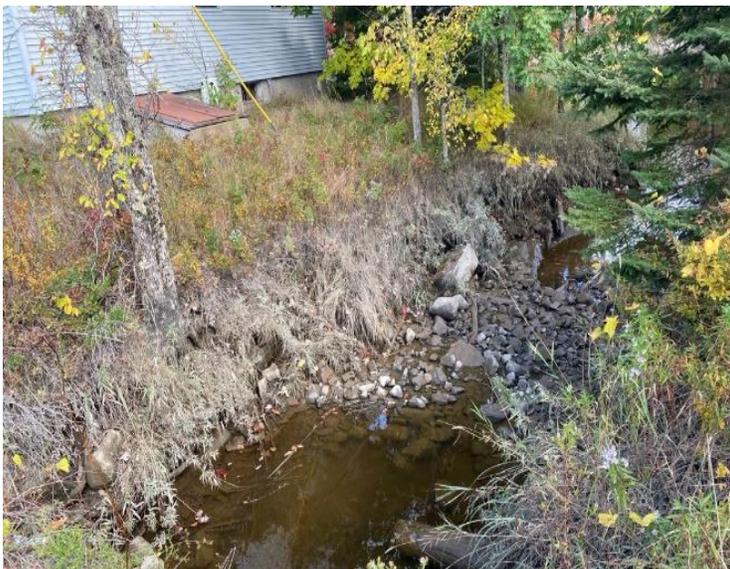
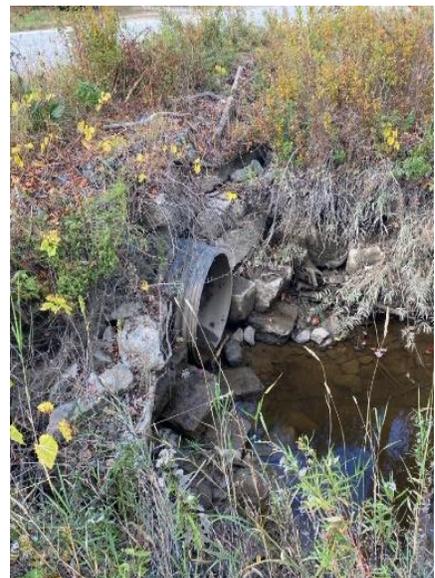
NPS Input 4: Wilson Hill Road Stream Crossing 2
(near 7 Wilson Hill Road)
Location (latitude, longitude): 44.5971, -67.9256

Observations: Road shoulder erosion was observed around the culvert outlet, which is slightly perched. The outlet wall is starting to fail in spots. There is also some stream channel erosion present between the culvert outlet and the confluence with the Narraguagus River.

Left: Streambank erosion along the tributary. Right: Perched culvert outlet and deteriorating wall.

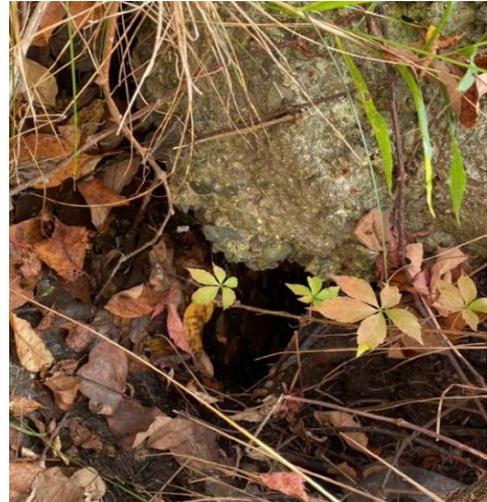
NPS Input 5: Route 1 and River Road Intersection

Observations: There is a rusted-out and crushed metal cross culvert at the intersection of Route One and River Road. The ditch feeding the culvert shows signs of erosion and would benefit from additional stabilization.

Culvert at Route 1 and River Road intersection is rusted out and crushed beneath a large stone.

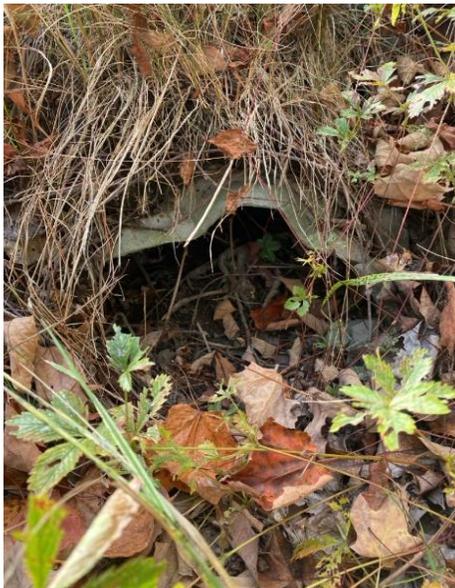
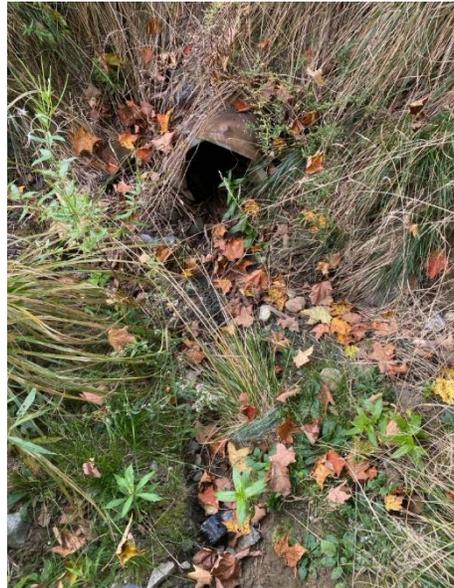
NPS Input 6: River Road Cross Culvert

Observations: There is a rusted-out and crushed metal cross culvert along River Road. The culvert outlet channel shows signs of erosion and would benefit from additional stabilization.

Inlet (left) and outlet (right) of crushed culvert across River Road. Right photo also shows erosion of channel.

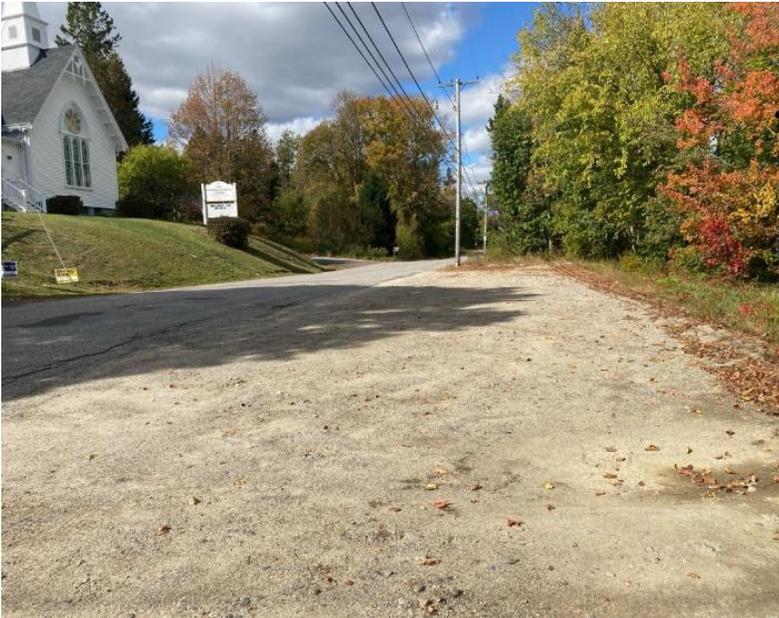
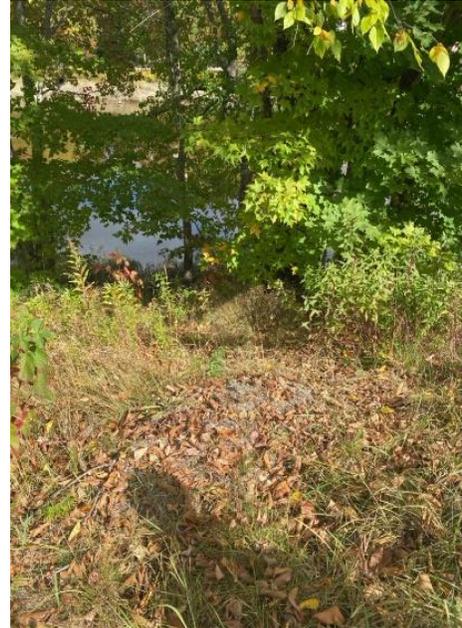
NPS Input 7: Congregational Church Parking Area

Observations: Minor erosion is occurring from the church parking lot adjacent to the Narraguagus River. Sand piles are also present and not covered to prevent washing into the river.

Left: Congregational church parking lot. Right: Sand pile next to parking lot.

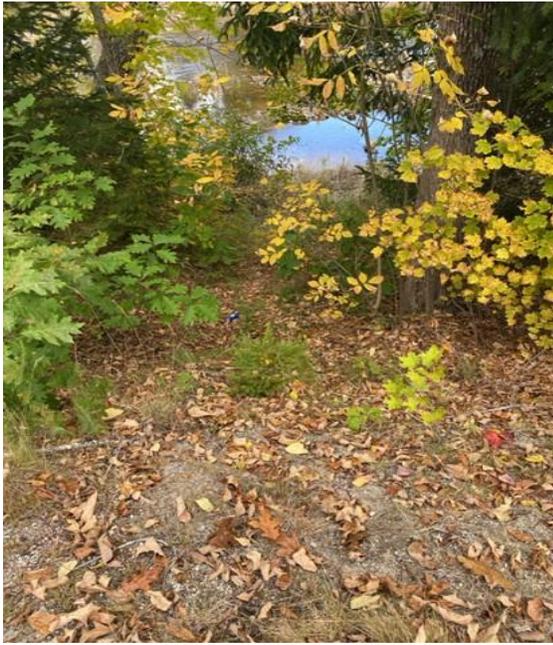
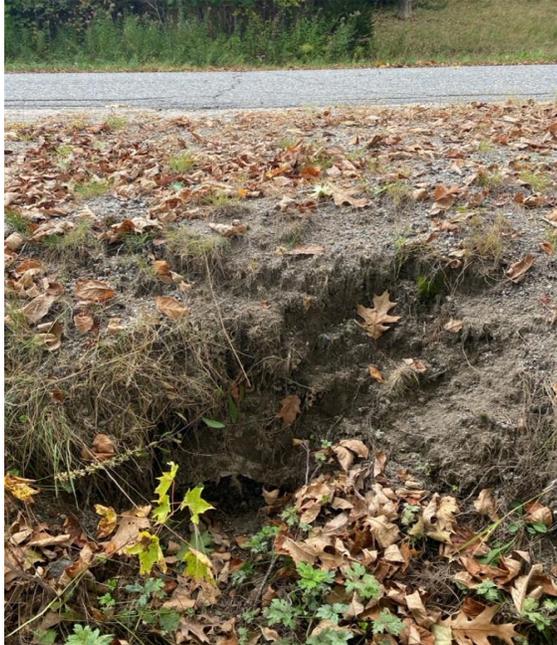
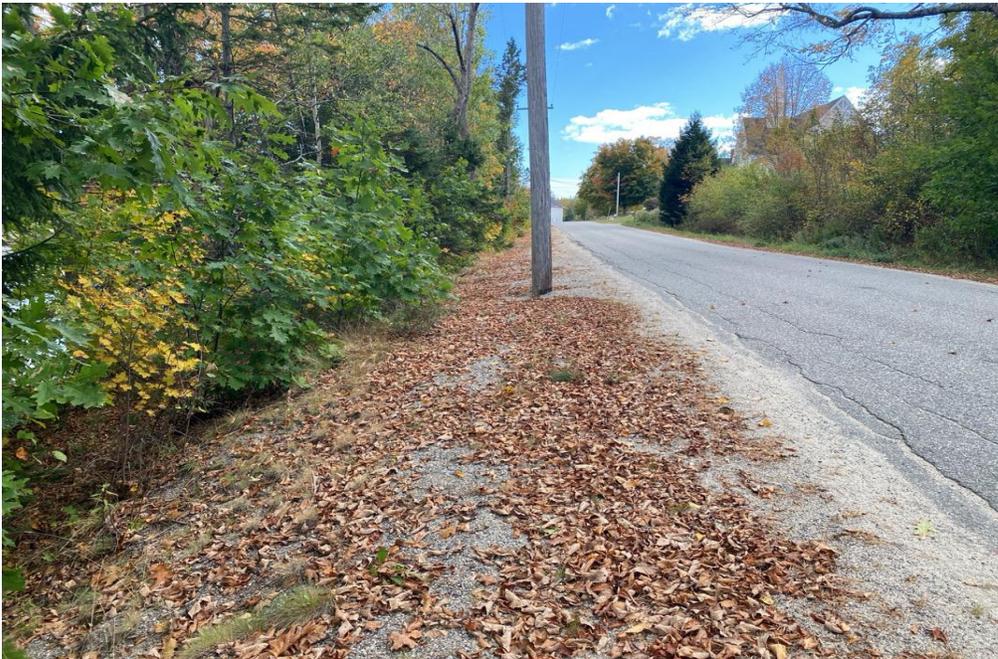
NPS Input 8: River Road Town Right-of-Way

Observations: There is erosion present on the road shoulder of River Road throughout the Town right-of-way as well as excess winter sand. A cross culvert at this location is crushed and does not function properly. The area above the culvert is unstable and eroding.

Top Left: Erosion leading down to the Narraguagus River. Top Right: Crushed culvert and unstable outlet. Bottom: Excess winter sand along River Road.

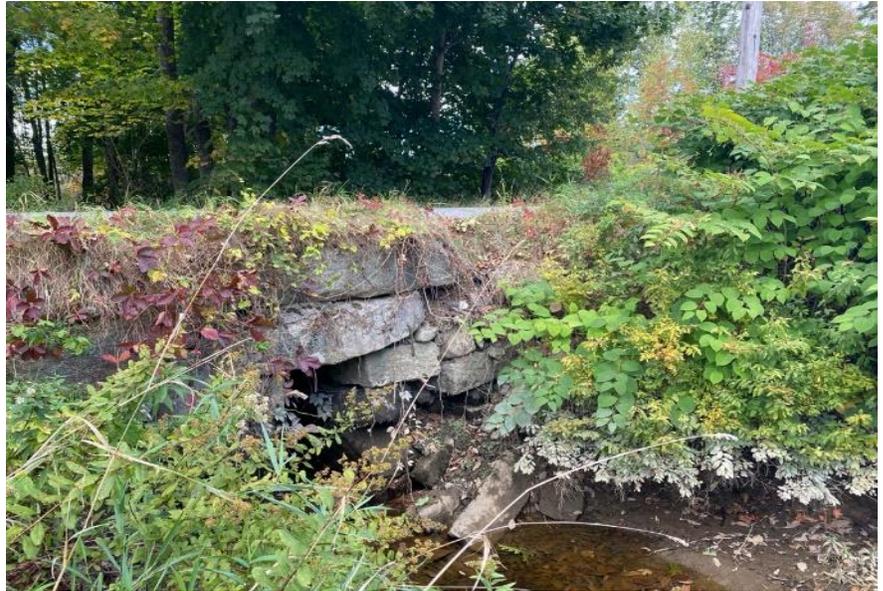
NPS Input 9: River Road Open-Bottom Crossing

Observations: Minor erosion is present along the crossing outlet on the sides and on the top. A few stones of the retaining wall have fallen in, causing additional erosion.

Culvert at crossing outlet with failing wall.

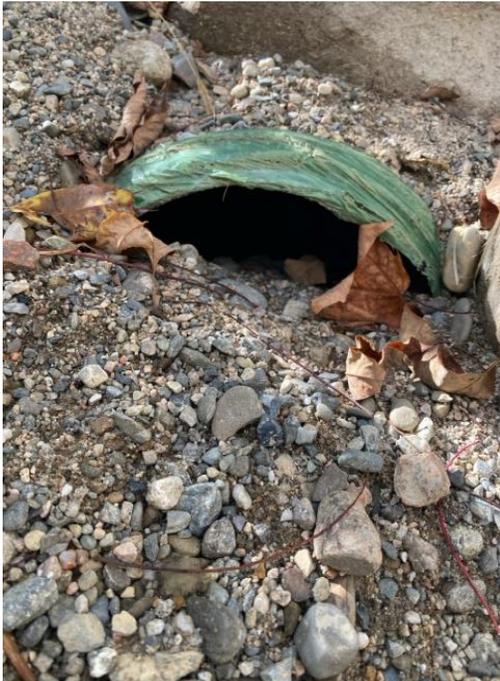
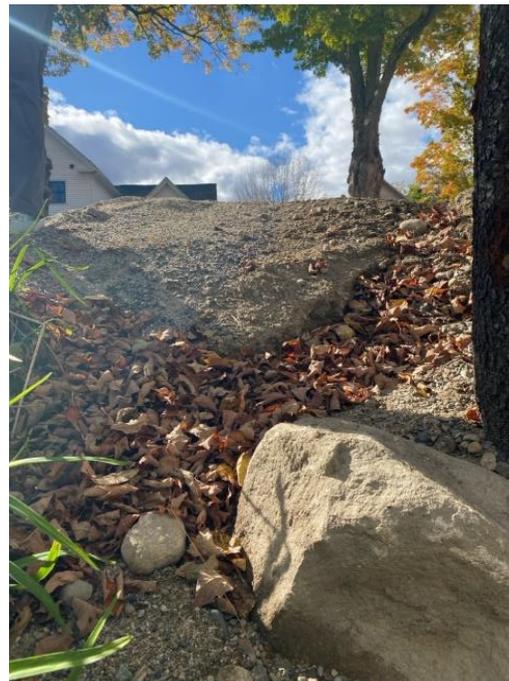
NPS Input 10: River Road Crossing (near #74)

Observations: There is erosion present on the road shoulder of River Road. A cross culvert at this location is filled with sediment and is eroding above the culvert due to undersized material used for stabilization. According to local stakeholders, the Town had recently replaced the culvert and gravel, which has eroded multiple times in the past. The culvert was 90% blocked at the time of the site visit.

Left: Culvert filled with sediment. Right: Erosion coming off River Road adjacent to the culvert.

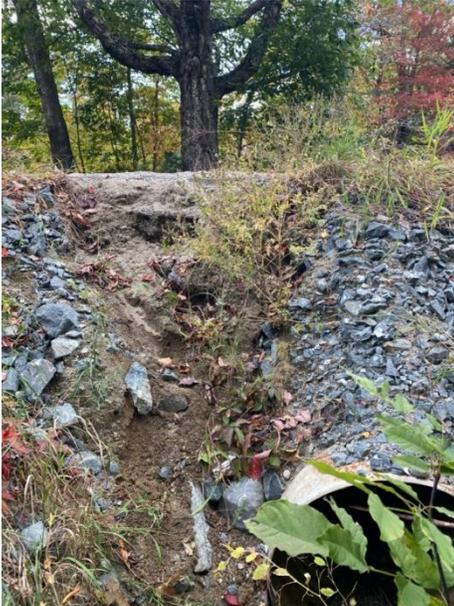
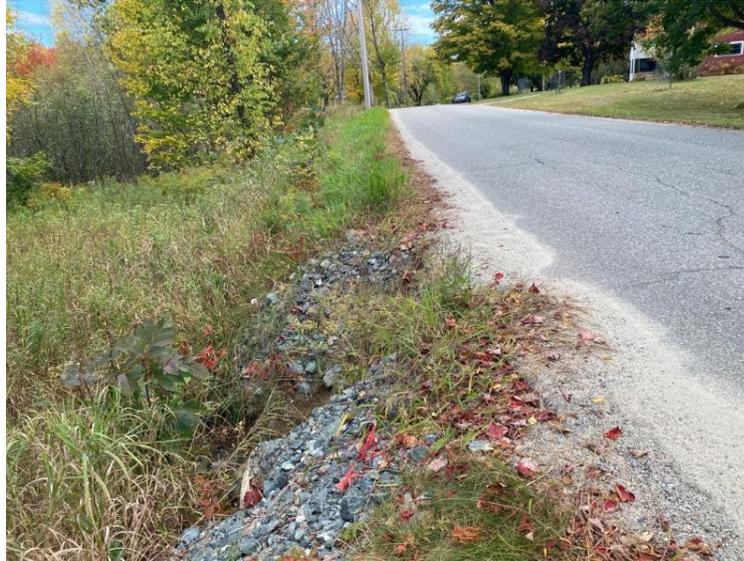
NPS Input 11: Crossing by River Road Skating Pond

Observations: The culvert across River Road by the skating pond is experiencing erosion above the culvert outlet.

Left: Erosion above culvert outlet. Right: Excess winter sand along River Road by the skating pond, and another view of the erosion along the top of the culvert.

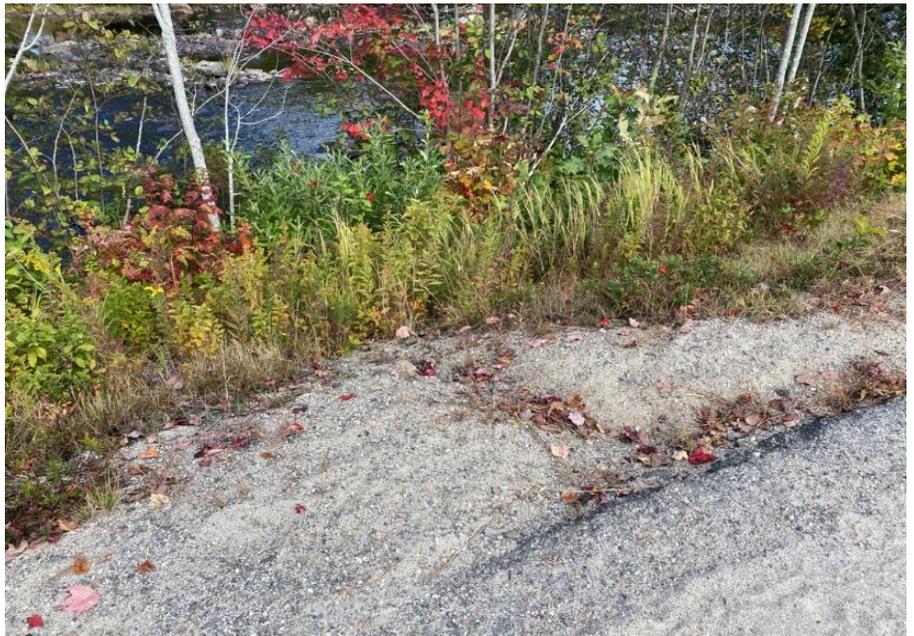
NPS Input 12: River Road Erosion
(Upstream of Skating Pond)

Observations: There is road shoulder erosion at the site that is going directly into the river. There is also excess sediment from winter sand.

Road shoulder erosion and sediment piles from winter sand along River Road by the skating pond.

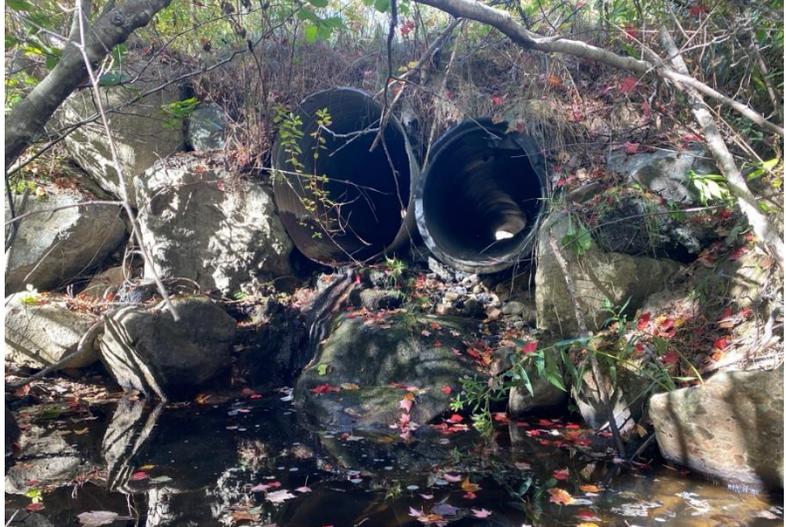
NPS Input 13: Stillwater Road Stream Crossing

Observations: Twin culverts are present along Stillwater Road. The outlets of both pipes are perched above the stream bed, impacting potential fish passage opportunities.

Twin culverts along Stillwater Road with perched outlets.

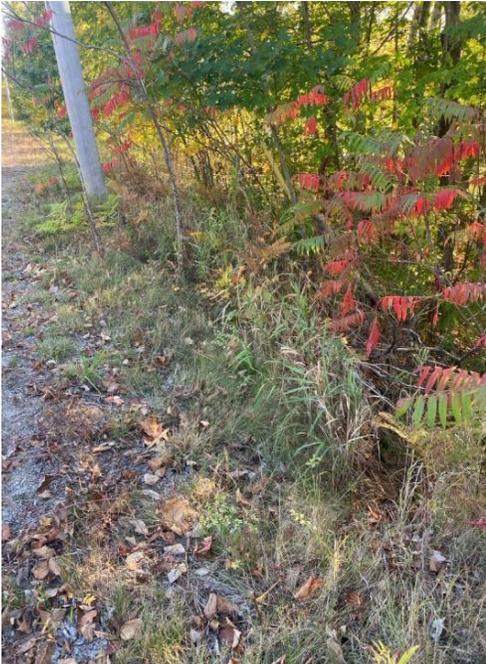
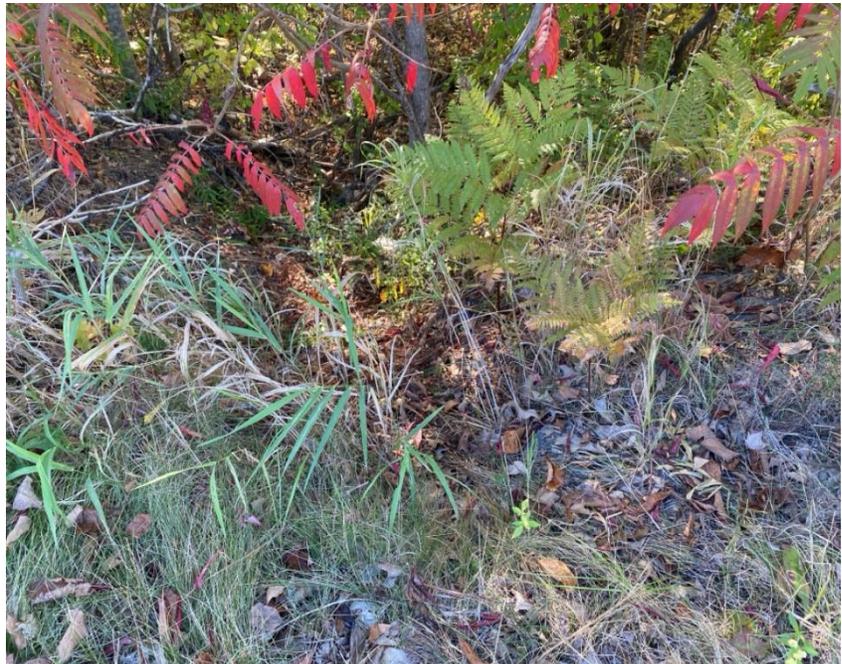
NPS Input 14: Main Street Crossing (Near Cemetery)

Observations: Minor erosion is occurring above the culvert outlet on Main Street near the cemetery. Runoff from the culvert is carving a channel from the outlet that did not appear to be stabilized or armored.

Left: Erosion along Main Street above culvert crossing near cemetery. Right: Main Street culvert outlet with channel heading towards the Narraguagus River.

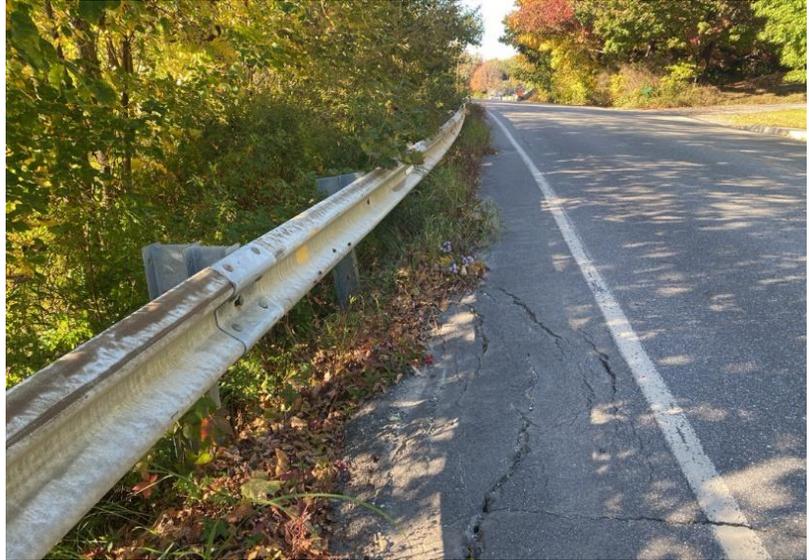
NPS Input 15: Main Street Road Erosion

Observations: Road shoulder erosion is occurring along the Narraguagus River side of Main Street, causing slumping and cracking of the pavement.

Photo shows cracking and slumping of road from stormwater.

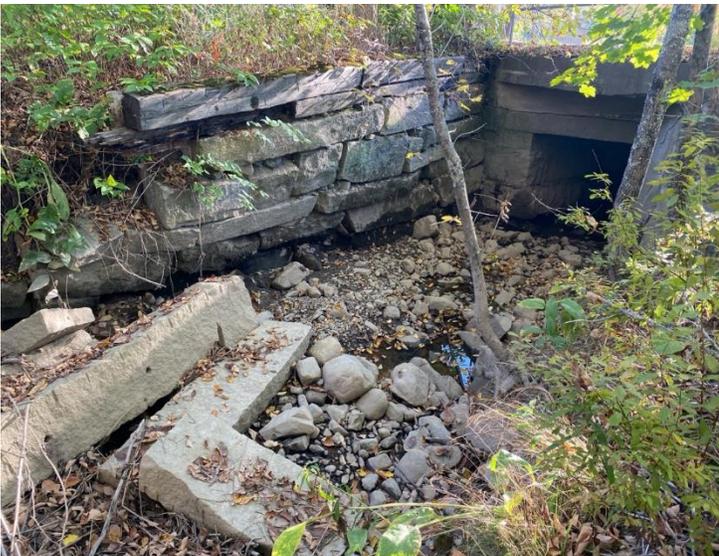
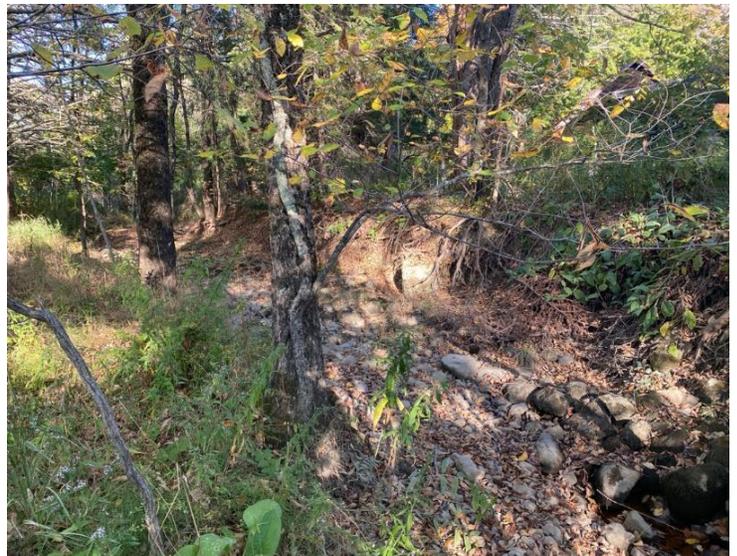
NPS Input 16: Main Street Tributary Crossing

Observations: Streambank erosion is occurring along a tributary to the Narraguagus River. A box culvert is in place to transport the stream under Main Street, but the retaining wall around the culvert inlet is beginning to collapse with large stones falling into the stream. The adjacent landowner notes that there are periodic flooding issues along the tributary.

Left: Collapsing retaining wall around the inlet to a tributary stream crossing along Main Street. Right: Streambank erosion along the Narraguagus tributary upstream of the culvert inlet.

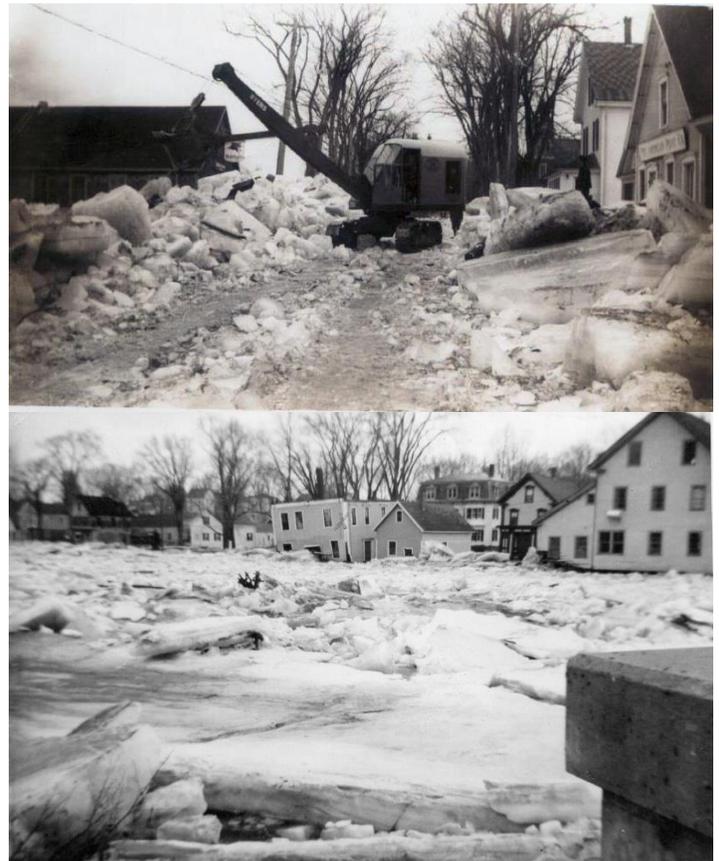
FIGURE 8. (TOP) AFTERMATH OF THE FLOOD OF 1942. (BOTTOM) FLOOD OF 1959 AS SEEN FROM THE ROUTE ONE BRIDGE, DEPICTING DAMAGE TO MAIN STREET HOMES.

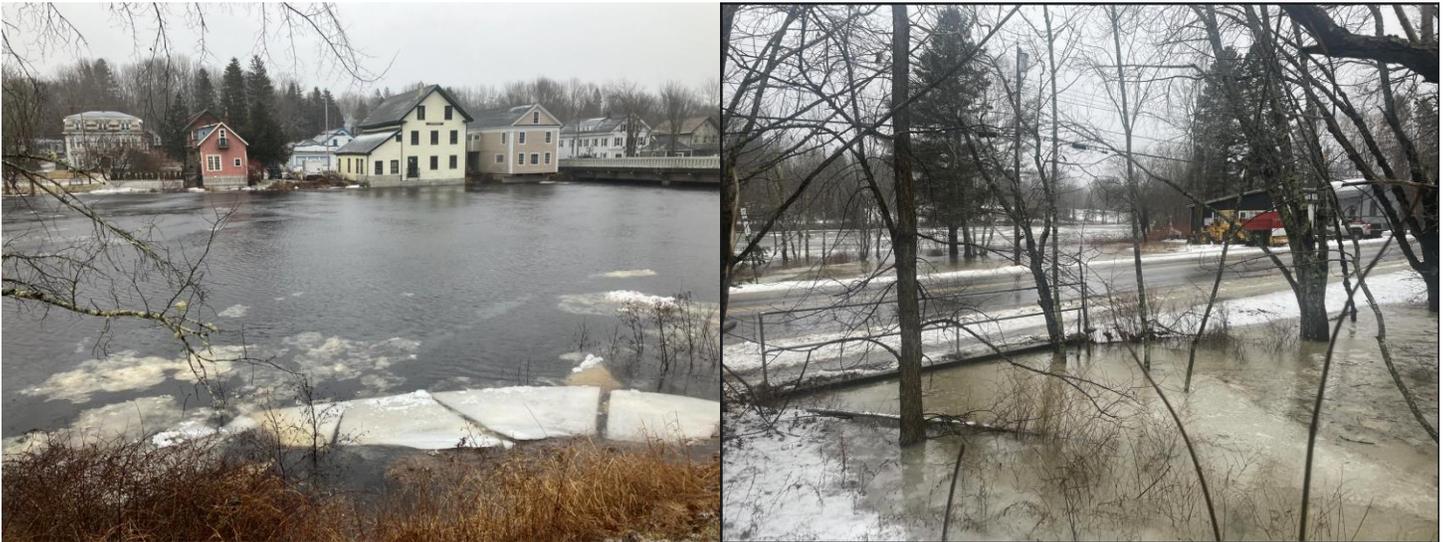
FIGURE 9. FLOODING DURING THE DECEMBER 18, 2023 STORM ALONG THE NARRAGUAGUS RIVER IN CHERRYFIELD.
