IVIE RISK SOLUTIONS

2026 RISK CONTROL ASSESSMENT

The property is an operating wood shop manufacturing facility with active cutting, sanding, and finishing operations observed at the time of inspection. Management presence was evident, and day-to-day operations appear consistent.

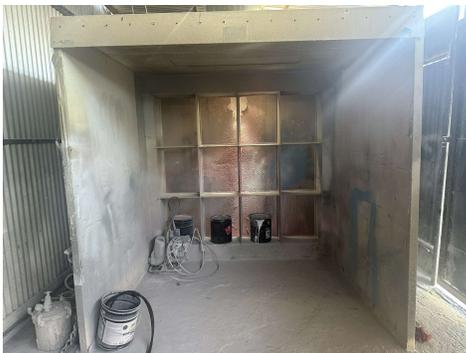
Spray Booth Missing Filters

The spray booth filter banks were observed to be missing and/or heavily deteriorated at the time of inspection. The absence of properly installed and maintained filters allows vapor and overspray accumulation within the booth, significantly increasing the risk of flash fire or explosion and creating non-compliance with recognized spray booth safety standards. It is recommended that properly rated intake and exhaust filters be installed immediately and maintained in accordance with the manufacturer's specifications to ensure safe operation and reduce fire risk

Missing filters in spray booth

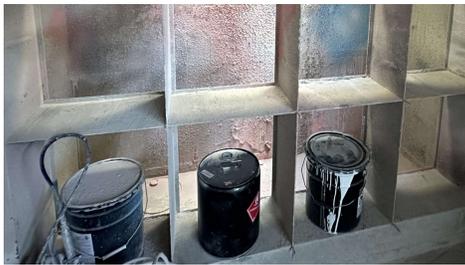
Flammable Materials Stored Inside Spray Booth

Paint and other flammable containers were observed stored directly inside the spray booth at the time of inspection. Storing flammable materials within the booth exposes them to potential ignition sources during spray operations, significantly increasing the likelihood and severity of a fire event. This condition is also a common underwriting concern and may negatively impact insurability if not corrected. It is recommended that all flammable and combustible materials be removed from the spray booth when not actively in use and stored in approved, properly rated flammable storage cabinets.

Flammable liquids stored inside spray booth

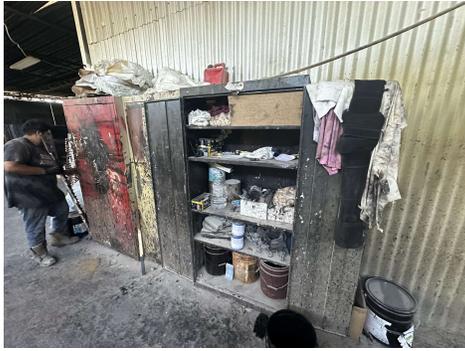
Flammable Storage Cabinets Not UL Rated / Improper Use

Flammable storage cabinets were observed to be unlabeled and potentially not UL-listed, with some flammable containers stored outside of approved cabinets at the time of inspection. Cabinets that are not properly rated or maintained may not provide the required fire resistance protection, increasing the risk of vapor release, ignition, and fire spread. It is recommended that all non-compliant cabinets be replaced with properly UL-listed flammable storage cabinets and that all flammable liquids be stored inside the cabinets with doors fully closed when not in active use.

Storage Cabinets Not UL Rated

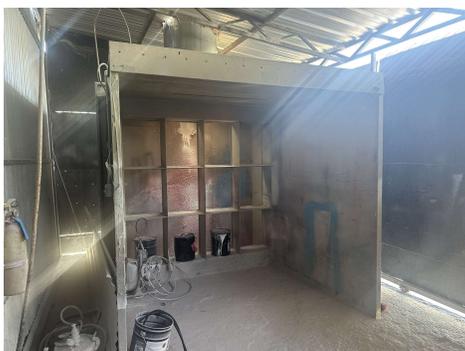
Missing Automatic Extinguishing System (AES) in Spray Booth

The spray booth was observed to be operating without an automatic extinguishing system (AES) installed. Spray finishing operations involving flammable and combustible materials present a significantly elevated fire risk due to vapor generation, overspray accumulation, and potential ignition sources. The absence of an automatic suppression system increases the likelihood of uncontrolled fire growth and substantially elevates potential loss severity. This condition may also create underwriting concerns, as automatic extinguishing protection is a recognized safety standard for spray booth operations. It is recommended that a properly designed and approved automatic extinguishing system be installed in the spray booth and maintained in accordance with applicable fire protection standards and manufacturer specifications.

No Automatic Extinguishing System in Spray booth

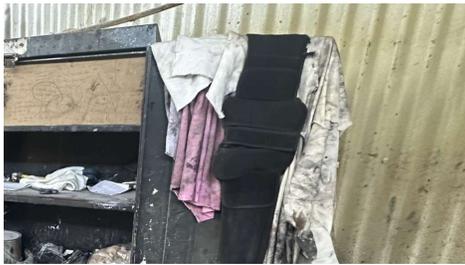
Improper Storage of Solvent-Contaminated Rags

Solvent-contaminated rags were observed without storage in an approved lidded metal container at the time of inspection. Rags containing flammable solvents can generate heat through oxidation and may spontaneously combust if not properly contained. The absence of a self-closing, lidded metal container significantly increases the risk of fire, particularly in a woodworking and finishing environment where ignition sources are present. It is recommended that all solvent contaminated rags be stored immediately after use in approved, self-closing metal containers specifically designed for oily or solvent-soaked waste. Containers should be emptied regularly and maintained in accordance with manufacturer guidelines to reduce fire risk.

Rags improperly stored

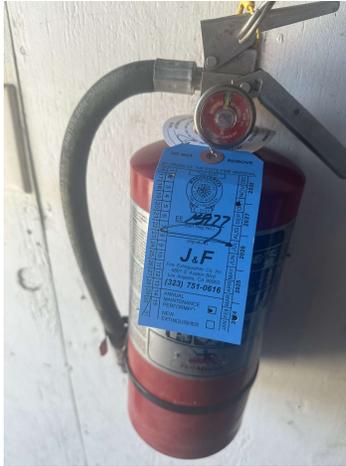
Expired Fire Extinguisher

A fire extinguisher was observed with an expired inspection tag and has not been verified as operational. In a wood shop environment with combustible dust, active machinery, and potential ignition sources, fire extinguishers serve as critical first response protection for incipient-stage fires. An unserviced extinguisher may fail during an emergency, allowing a small fire to escalate rapidly. It is recommended that the unit be serviced or replaced immediately and that all fire extinguishers be maintained with current inspection documentation.

Fire Extinguisher Expired

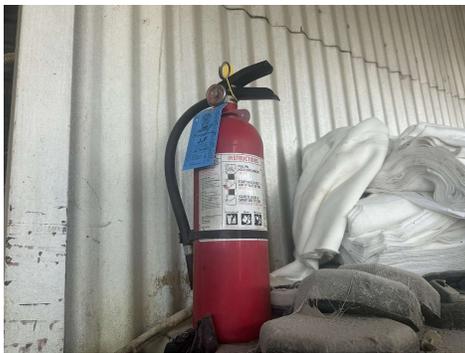
Fire Extinguisher Not Properly Mounted

ABC fire extinguisher observed resting on the cabinet rather than mounted. Unmounted extinguishers may be damaged, obstructed, or inaccessible during an emergency. Mount extinguishers on approved brackets at proper height and maintain clear access.

Fire Extinguisher Not Mounted

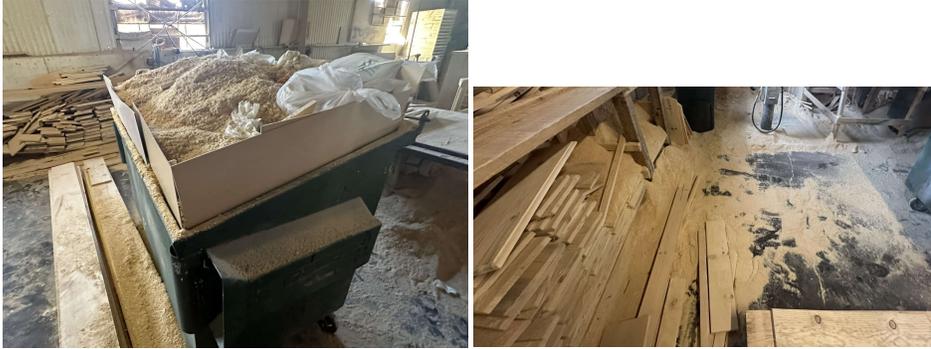
Excessive Sawdust Accumulation

Excessive sawdust accumulation was observed throughout the production area at the time of inspection. In a wood shop environment, accumulated combustible dust significantly increases fire load and can contribute to rapid fire spread if ignited by machinery, electrical equipment,

Sawdust build-Up

or finishing operations. Heavy dust build-up may also indicate inadequate housekeeping and insufficient dust control measures. It is recommended that immediate housekeeping efforts be undertaken to remove accumulated sawdust from the facility and that an effective dust collection system be installed and properly maintained to capture dust at the point of generation and reduce ongoing accumulation.

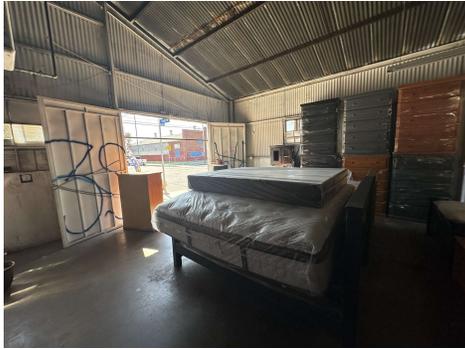
Missing Exit Signage

An exit door was observed without an illuminated and clearly visible exit sign at the time of inspection. In a wood shop environment where combustible materials and active machinery are present, clearly marked and illuminated exit pathways are critical to ensure rapid and safe evacuation during an emergency, including fire or power failure. The absence of proper exit signage may delay egress and increase the risk of injury. It is recommended that approved, illuminated exit signage be installed above all designated exit doors and maintained in proper working condition in accordance with applicable life safety standards.

Missing exit sign in front of building

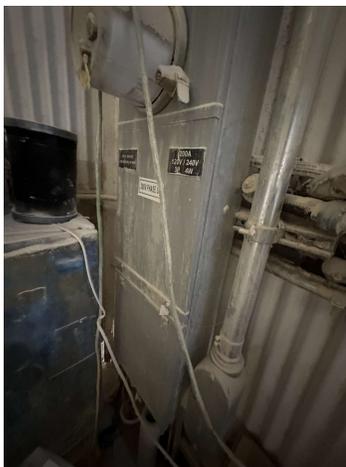
Obstructed Electrical Equipment

Electrical panels and/or disconnects were observed obstructed by equipment, containers, and stored materials at the time of inspection. Obstructed access prevents rapid power shutoff during emergencies, violates required electrical working clearance standards, and increases the risk of electrical shock and fire particularly in a wood shop environment where combustible dust and active machinery are present. It is recommended that a minimum of 36 inches of clear working space be maintained in front of all electrical panels and disconnects at all times and that all stored materials be removed immediately to ensure safe and compliant access.

Obstructed electrical

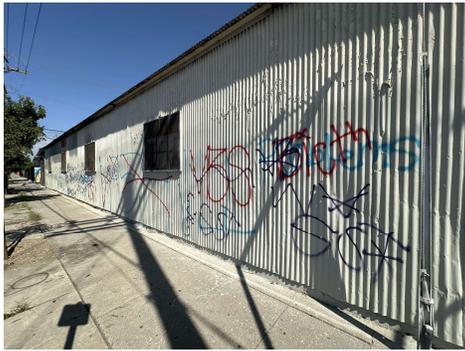
Graffiti on Exterior Walls

Graffiti was observed on the exterior walls of the building at the time of inspection. While this condition does not present a direct fire or life safety hazard, visible vandalism can signal property neglect, attract additional trespassing or vandalism, and negatively impact the facility's overall appearance and security perception. It is recommended that the graffiti be removed promptly and that exterior lighting and general property monitoring be evaluated to help deter future occurrences.

Graffiti noted on the exterior wall (Left Side)

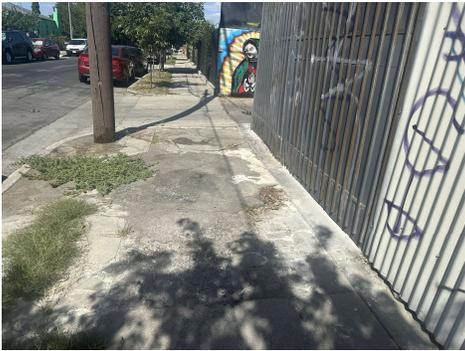
Cracked Municipal Sidewalk (Left Side of Building)

Cracks and uneven sections were observed in the municipal sidewalk along the left side of the building at the time of inspection. Although the sidewalk may fall under municipal jurisdiction, surface deterioration can present a trip-and-fall hazard to employees, visitors, vendors, or pedestrians and may contribute to general liability exposure. It is recommended that property management notify the appropriate municipal authority regarding the condition and document the repair request. In the interim, the area should be monitored and temporary hazard mitigation measures considered if necessary.

Cracks on the left side of the building
