**IVIE RISK SOLUTIONS**

# 2026 RISK CONTROL ASSESSMENT

**[Name of property]**

# PROPERTY & INSPECTIONS DETAILS

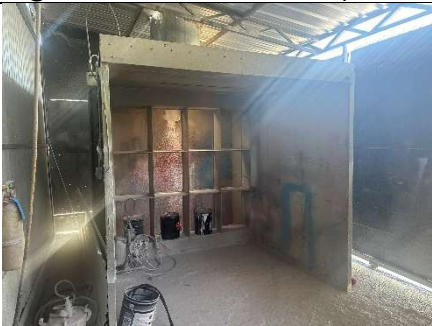
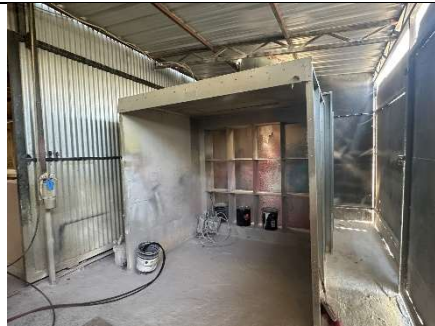
### Missing filters in spray booth

Missing filters in spray booth

**Recommendation:** Install properly rated intake and exhaust filter banks in the spray booth immediately and maintain them in accordance with manufacturer specifications in compliance with National Fire Protection Association NFPA 33, International Code Council IFC Chapter 24, and Occupational Safety and Health Administration 29 CFR 1910.107. Missing or deteriorated filters allow overspray and flammable vapors to accumulate, increasing the risk of fire or explosion.

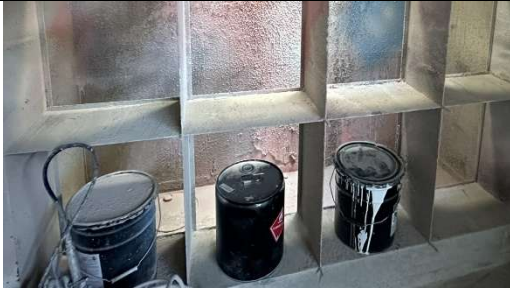
### Flammable liquids stored in spray booth

Flammable liquids stored in spray booth

**Recommendation:** Remove all excess flammable and combustible liquids from the spray area and limit quantities to those necessary for immediate operations, storing all materials in approved flammable liquid cabinets when not in use, in accordance with National Fire Protection Association NFPA 33, National Fire Protection Association NFPA 30, International Code Council IFC Chapter 24, and Occupational Safety and Health Administration 29 CFR

1910.107. Storage of flammable materials within the spray area increases the risk of ignition and fire.

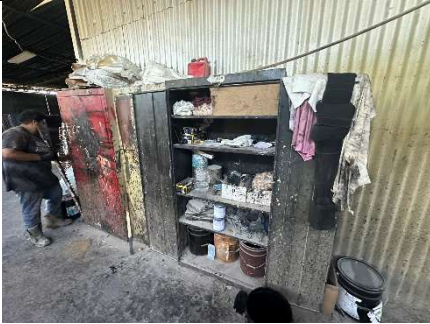
### Improper flammable storage

Improper flammable storage

**Recommendation:** Replace all non-compliant flammable liquid storage cabinets with approved, listed cabinets (e.g., UL 1275) and ensure all flammable and combustible liquids are stored within cabinets with doors kept closed when not in use, in accordance with National Fire Protection Association NFPA 30, Occupational Safety and Health Administration 29 CFR 1910.106, and International Code Council IFC Section 5704. Cabinets should be clearly labeled “Flammable – Keep Fire Away.” Unapproved or unlabeled cabinets and liquids stored outside of cabinets increase the risk of fire.

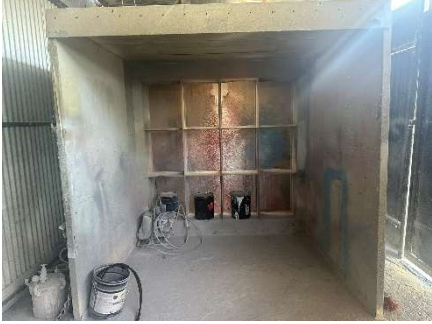
### Missing automatic extinguishing system (AES) in spray booth

No Automatic Extinguisher System in Spray booth

**Recommendation:** Install an approved automatic fire extinguishing system to protect the spray area in accordance with National Fire Protection Association NFPA 33, National Fire Protection Association NFPA 17 / 17A, and International Code Council IFC Chapter 24. The absence of an automatic suppression system in spray operations involving flammable and combustible materials increases the risk of uncontrolled fire growth and loss severity.

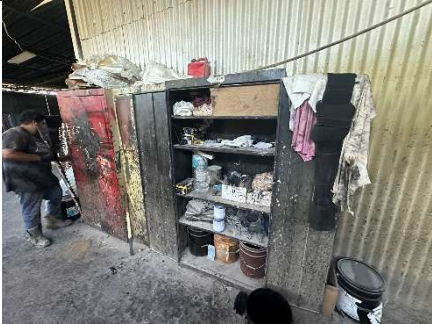
### Improper storage of solvent-contaminated rags

Improper storage of solvent contaminated rags

**Recommendation:** Store all solvent-contaminated rags in approved, listed self-closing metal containers immediately after use and maintain containers in good condition, kept closed, and emptied regularly in accordance with manufacturer specifications, in accordance with National Fire Protection Association NFPA 30, National Fire Protection Association NFPA 1, and International Code Council IFC Chapter 57. Improper storage of solvent-soaked rags can lead to spontaneous combustion and increased fire risk.

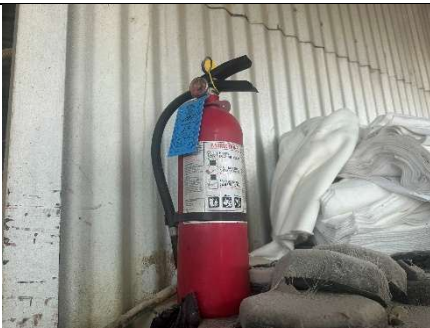
### Fire extinguisher not mounted

Fire extinguisher not mounted

**Recommendation:** Mount all fire extinguishers on approved brackets or in listed cabinets at the proper height and location in accordance with National Fire Protection Association NFPA 10 and International Code Council IFC Section 906. Ensure units are securely mounted, readily visible, and have unobstructed access at all times. One fire extinguisher was observed resting on top of a flammable storage cabinet in the rear area of the building, which may result in damage, obstruction, or delayed access during an emergency.

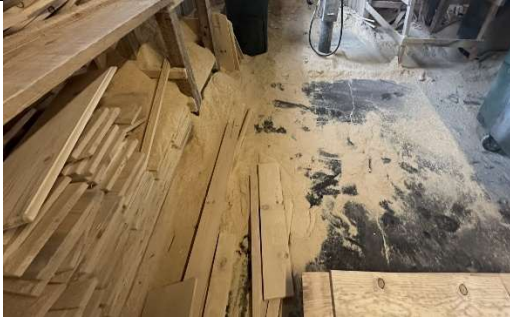
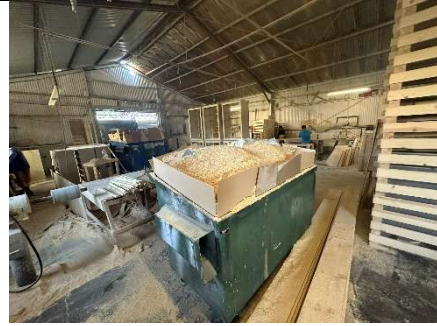
### Excessive sawdust accumulation

Sawdust in work area

**Recommendation:** Implement immediate housekeeping to remove accumulated sawdust and maintain the facility free of excessive combustible dust, and install and maintain an effective dust collection system at the point of generation in accordance with National Fire Protection Association NFPA 1, International Code Council IFC Chapter 22, and National Fire Protection Association NFPA 664. Establish and enforce a regular daily cleaning schedule to prevent accumulation. Combustible dust significantly increases fire load and can contribute to rapid fire spread or deflagration if ignited.

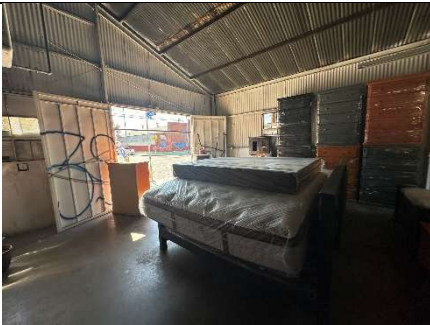
No exit sign (Front)

**Recommendation:** Install approved, illuminated exit signage at all designated exit doors and along the path of egress where exits are not readily visible, and maintain exit access pathways clear and unobstructed at all times, in accordance with National Fire Protection Association NFPA 101, International Code Council IFC Section 1013, and International Code Council IFC Section 1031. Clearly marked and unobstructed exits are critical to ensure safe and rapid evacuation during an emergency.

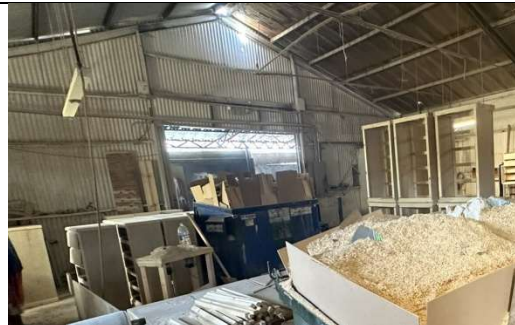
No exit sign (Rear)

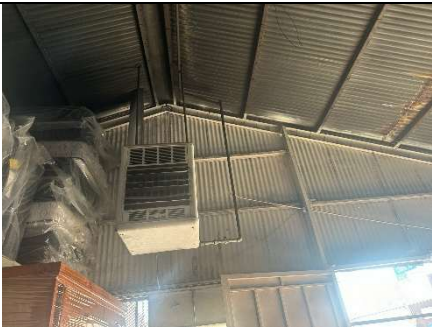
### Inadequate heater clearance

Heater clearance

**Recommendation:** Maintain proper clearance between the suspended heater and all combustible materials and remove or relocate stored items as needed to meet manufacturer-recommended clearances, in accordance with National Fire Protection Association NFPA 54 and International Code Council IFC Section 603. Combustible storage near heat-producing equipment increases the risk of ignition and rapid fire spread.

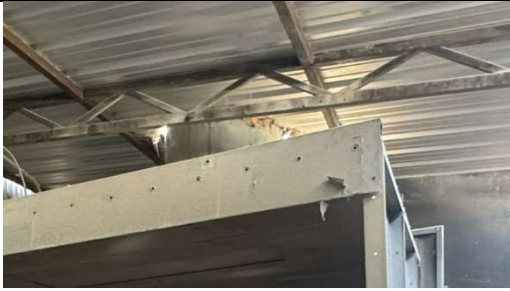
### Improper spray booth enclosure / openings at ceiling

Spray Booth Ceiling Openings

**Recommendation:** Modify the spray operation to function as either a fully enclosed, compliant spray booth or an approved spray area with adequate ventilation and containment, and seal openings as necessary to prevent the escape of vapors and overspray into the building, in accordance with National Fire Protection Association NFPA 33 and International Code Council IFC Chapter 24. Open or unsealed conditions may allow flammable vapors to migrate, increasing the risk of fire.

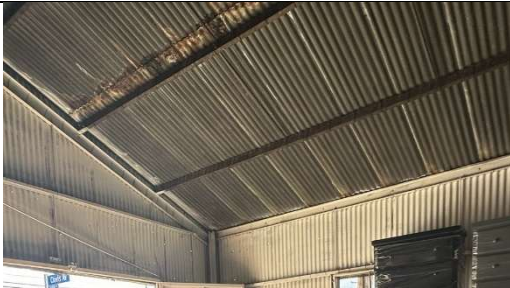
### Deterioration of roof structure (Rust/Corrosion)

Roof Rust / Corrosion

**Recommendation:** Repair and maintain corroded roof panels and structural components to prevent further deterioration and moisture intrusion, in accordance with International Code Council IPMC Section 304 and applicable local building codes. Corrosion may indicate prolonged moisture exposure and can lead to structural degradation if not addressed.

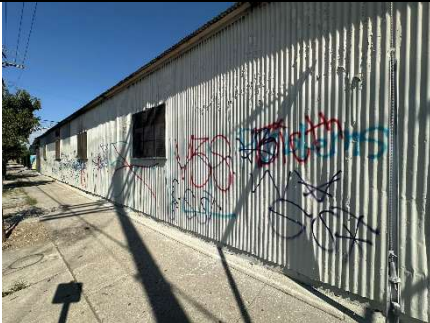
Graffiti on left side

**Recommendation:** Remove graffiti from exterior walls and maintain the property in good condition in accordance with applicable local municipal ordinances. Visible vandalism may attract additional trespassing or property damage. Maintain exterior lighting and monitoring to help deter future occurrences.

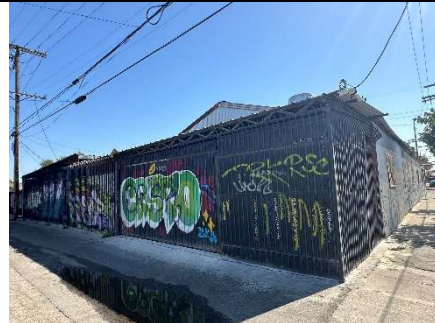
Graffiti in rear

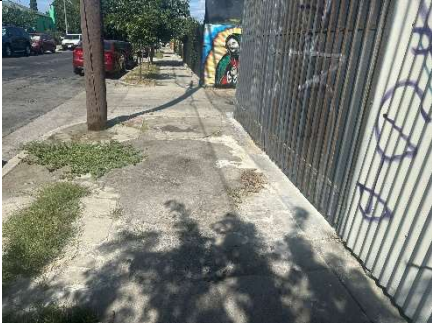
### Cracked sidewalk

Cracked sidewalk on left side

**Recommendation:** Notify the appropriate municipal authority of the cracked and uneven sidewalk conditions on the left side of the building and document the repair request, and implement temporary hazard mitigation measures as needed, in accordance with International Code Council IPC Section 302.3 and applicable local municipal ordinances. Deteriorated walking surfaces present a trip-and-fall hazard and potential liability exposure.
