IVIE RISK SOLUTIONS

2026 RISK CONTROL ASSESSMENT

Property Address:
Full Property Address

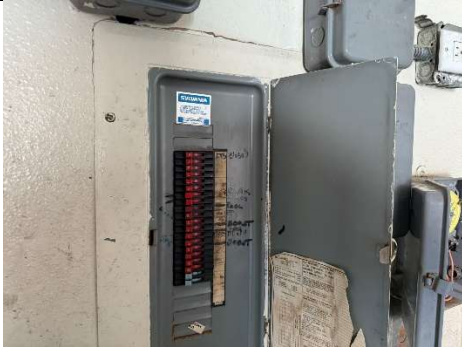
Recommendation: Sylvania / Sylvania-GTE subpanels, potentially re-branded Zinsco-type panels (circa 1973–1981), were observed in units and common areas. These panels are widely recognized to have a history of failure under overcurrent conditions, including breakers failing to trip, which increases the risk of overheating and fire. Have a licensed electrician evaluate the panels and replace any confirmed Zinsco-type equipment with approved, modern electrical panels to ensure compliance with current safety standards (e.g., NFPA 70).

Circuit breaker panel

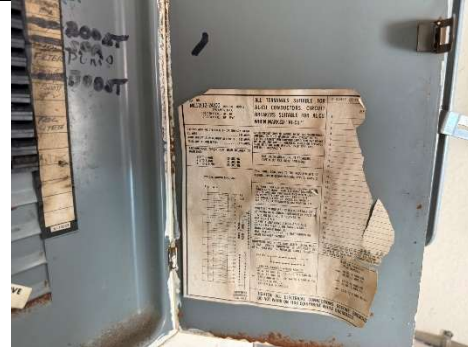
Sylvania manufacturer Label

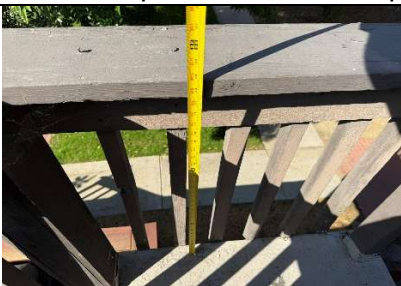
Recommendation: The balcony guardrail near Unit 21 is below the minimum required height, creating a fall hazard. Guardrails at elevated walking surfaces should be a minimum of 42 inches in height for multi-family and common areas. Have a qualified contractor modify or raise the guardrail to meet applicable code requirements and improve occupant safety.

Balcony railing height 34" tall

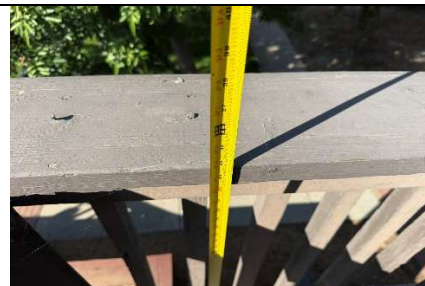
Balcony railing height 34" tall

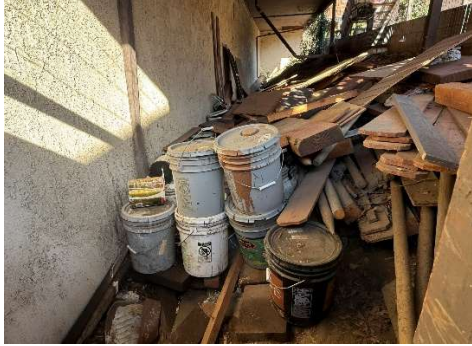
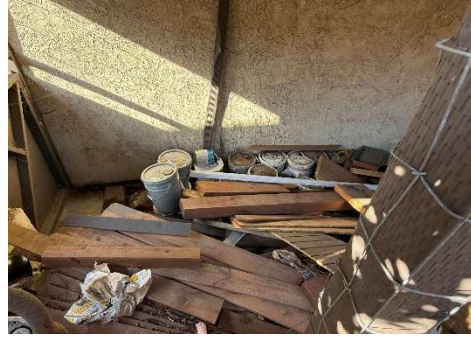
Recommendation: Debris and construction materials were observed improperly stored on the south side of the building beneath the common area balcony of Unit 27. This condition creates an attractive nuisance, presents a housekeeping concern, and increases the risk of injury. Remove all debris immediately and maintain the area in a clean and orderly condition in accordance with applicable property maintenance standards (e.g., ICC/IPMC) to reduce liability exposure.

Stored debris near unit 27

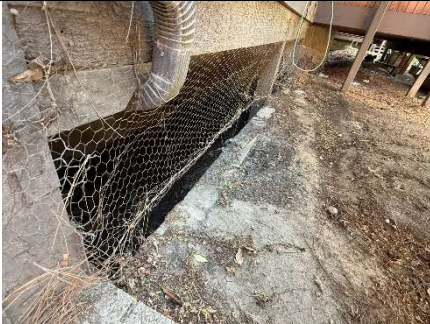
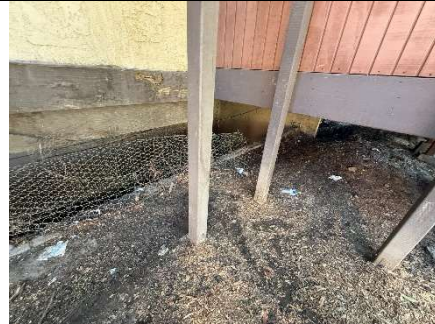
Recommendation: An exposed crawl space opening was observed near Units 20–21 on the south side of the building. This condition creates an attractive nuisance, allows unauthorized access, and increases the risk of moisture intrusion and pest infestation, which may contribute to structural deterioration. Secure and properly enclose the crawl space with approved barriers and provide appropriate ventilation or moisture control. Work should be completed by a qualified contractor in accordance with applicable property maintenance standards (e.g., ICC/IPMC and IRC).

Exposed crawl space

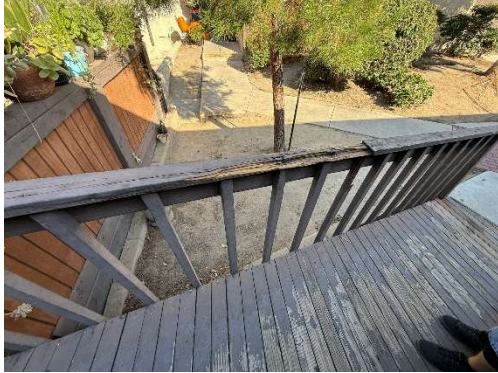
Recommendation: Deferred maintenance was observed, including deteriorated deck rails, worn walking surfaces, cracked steps, and exterior surface deterioration. These conditions increase the risk of slips, trips, falls, and potential structural failure. Have a qualified contractor evaluate and repair or replace damaged components as needed. Implement a routine maintenance program to preserve building integrity and maintain safe conditions in accordance with applicable property maintenance standards (e.g., ICC/IPMC).

Deck rails

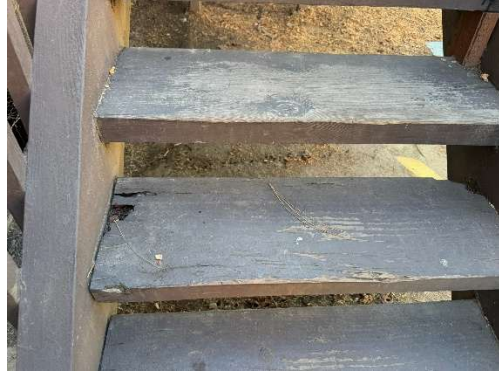
Cracks in steps

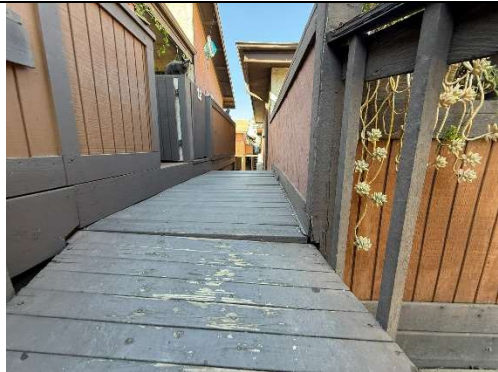
Recommendation: Uplifted and weathered deck and walkway surfaces were observed throughout the property, creating trip hazards. Uneven and deteriorated walking surfaces increase the risk of slips, trips, and falls. Repair or replace affected areas to restore a smooth and stable walking surface, and apply protective coatings to preserve integrity and extend service life. Work should be completed in accordance with applicable property maintenance standards (e.g., ICC/IPMC).

Uplifted section of wood deck

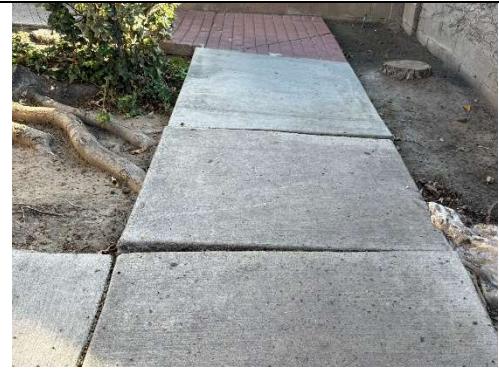
Uplifted section of concrete walkway

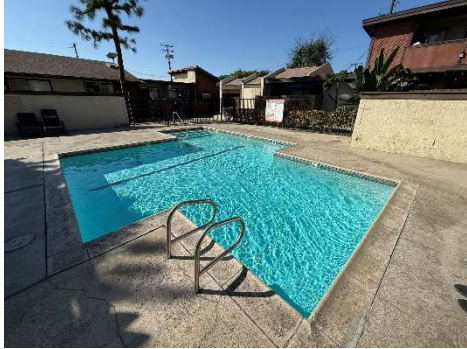
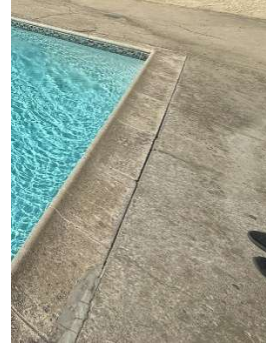
Recommendation: Exterior pool depth markers were not observed. The absence of clearly visible depth indicators increases the risk of diving-related injuries and reduces user awareness of water depth. Install permanent, clearly visible depth markers at the pool deck and perimeter in accordance with

Missing depth markers

applicable standards (e.g., ICC/ISPSC). Markings should identify minimum and maximum depths and be maintained for continued visibility.

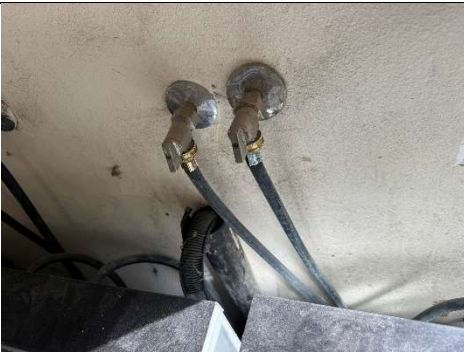
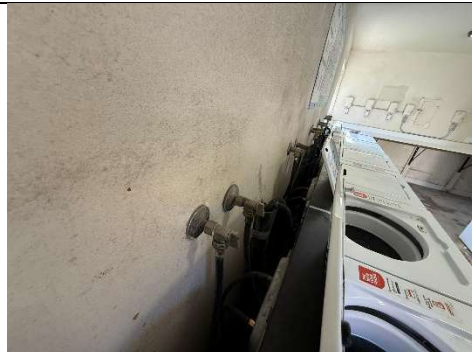
Recommendation: Rubber washing machine supply lines were observed. These types of hoses are more susceptible to deterioration and sudden failure, which can result in significant water damage. As a best practice, consider replacing with braided metal supply lines to improve durability and reduce the risk of leaks.

Rubber supply line

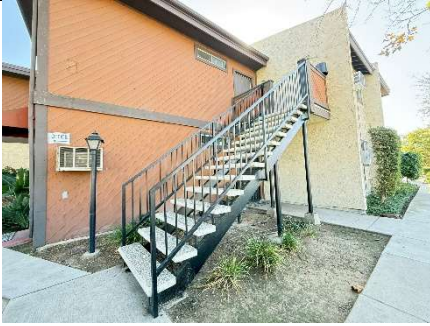
Recommendation: Insufficient fire extinguisher coverage was observed, including limited units and no extinguishers on second floors. Install additional fire extinguishers of appropriate type and rating (minimum 2A:10B:C typical for this occupancy) to ensure maximum travel distance does not exceed 75 feet. Units should be properly mounted, readily accessible, and inspected and maintained in accordance with NFPA 10.

Missing fire extinguishers on 2nd floor

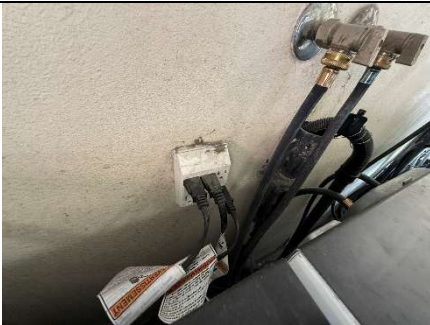
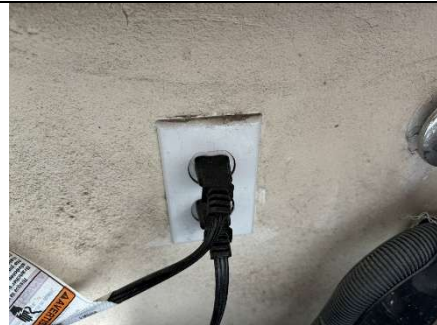
Recommendation: GFCI protection was not observed for receptacles in the laundry room. The presence of water and moisture increases the risk of electrical shock. Install GFCI protection for all applicable receptacles in the laundry area in accordance with NFPA 70.

No GFCI installed near washing machine

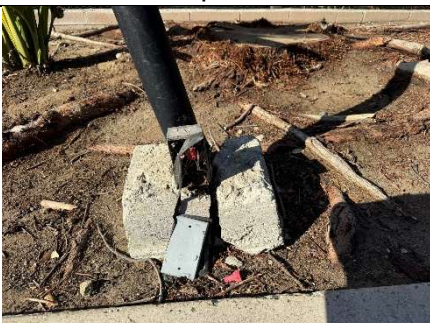
Recommendation: An open junction box housing electrical wiring was observed near Unit #25 (far left side of the premises) adjacent to a pole in the common area walkway. Exposed wiring increases the risk of electrical shock, arcing, and fire, and is not in compliance with NFPA 70. Ensure the junction box is properly covered and secured, and have a qualified electrician inspect the installation to confirm all wiring is enclosed and protected.

Exposed junction box

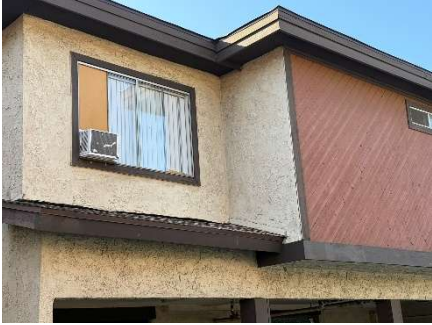
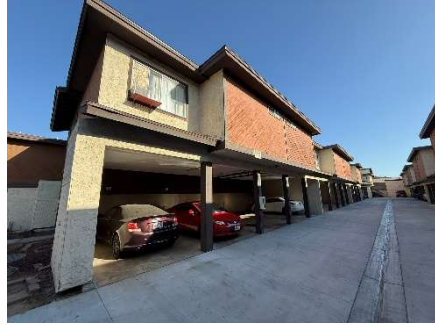
Recommendation: Window and wall-mounted air conditioning units were observed throughout the property, with some units appearing inadequately secured. Unsecured units may detach and fall, creating a risk of injury to occupants and pedestrians. As a best practice, ensure all units are properly supported and secured in accordance with manufacturer installation guidelines. Install brackets or additional support where needed to reduce the risk of displacement.

No bracing for window AC unit

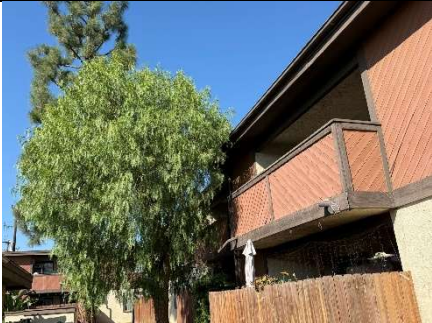
Recommendation: Tree branches were observed contacting or overhanging the rooflines near Units 53–63 and 36–43. Vegetation in contact with structures can damage roofing materials, facilitate pest intrusion, and contribute to fire spread. Trim all branches to maintain adequate clearance from the building (typically a minimum of 18 inches) and implement routine vegetation maintenance to reduce risk and preserve building integrity.

Tree touching building

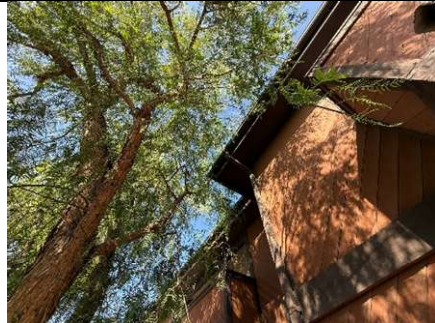
Tree overhanging building

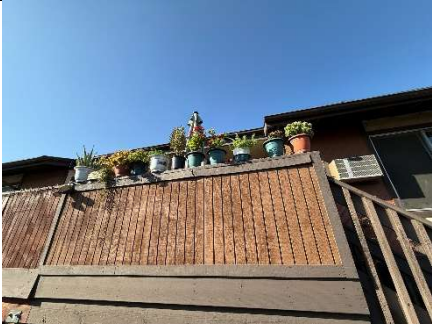
Recommendation: Plant pots, buckets, and other items were observed placed on balcony railings and surfaces. These items can fall from elevated areas, posing a serious risk of injury to pedestrians below and potential property damage. To reduce liability and improve tenant safety, all items should be removed from upper-floor balcony railings and stored safely on the balcony floor or inside the units, keeping railings clear at all times.

Plant pots on edge of balcony

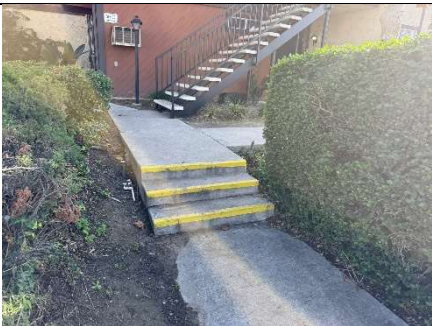
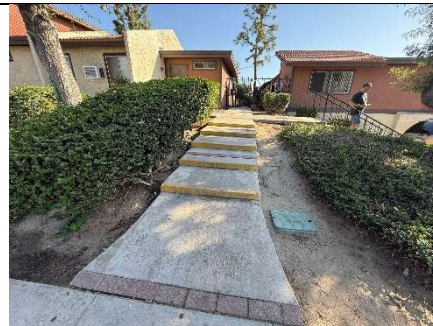
Recommendation: Stairways throughout the property were observed to lack handrails, including stairways with multiple risers, creating a fall hazard for residents and visitors. The absence of handrails reduces stability when ascending or descending stairs, increasing the risk of slips, trips, and falls. Install properly secured, graspable handrails at stairways where required by applicable codes (typically four or more risers) and where otherwise needed to enhance safety. Some insurance carriers may require handrails at stairways with three or more risers, or fewer depending on risk tolerance; therefore, installation on additional stairways should be considered to reduce liability exposure and align with underwriting expectations.

Missing rails on steps

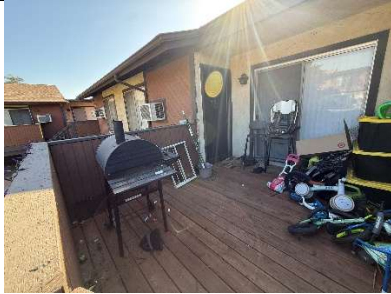
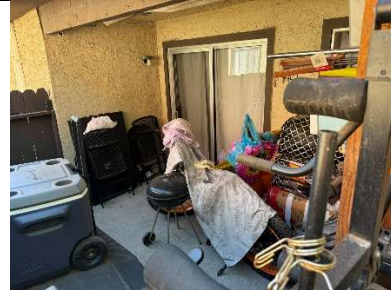
Recommendation: Charcoal grills were observed on decks and balconies. The use of charcoal grills in these locations presents a significant fire hazard, as sparks and hot coals can ignite nearby combustible materials. The use of charcoal grills on balconies, decks, or within close proximity to structures is often restricted by fire codes (e.g., NFPA 1). Discontinue use of charcoal grills in these areas and require that grilling activities be conducted in designated open areas at a safe distance from structures (typically at least 10 feet). Management should establish and communicate a written policy to tenants to reduce fire risk and liability exposure.

Charcoal barbecue grills on balcony

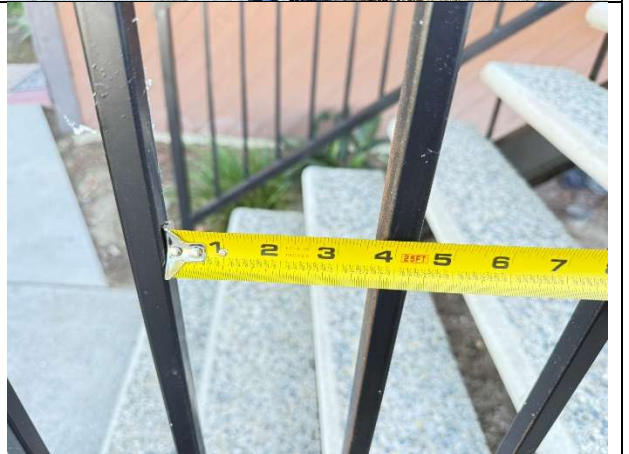
Handrail guard openings 3 ½' wide
