# **RISK CONTROL ASSESSMENT**

Prepared by:  
**Ivie Risk Solutions**

## Woodworking Manufacturing Survey

1000 Central Ave, Los Angeles, CA

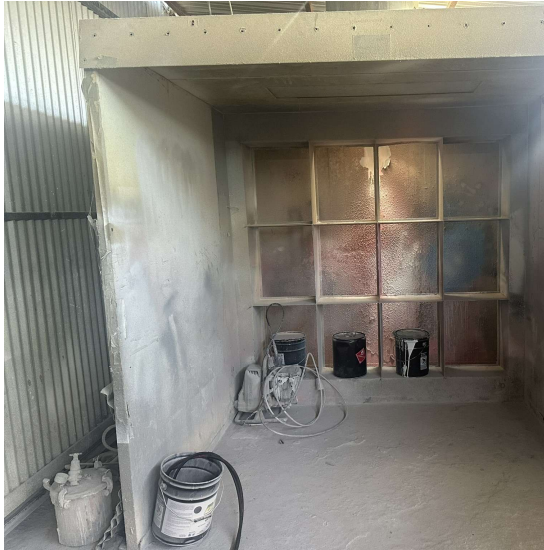
#### Spray Booth Missing Filters

Spray booth filters were observed missing and/or heavily deteriorated at the time of inspection. Missing or damaged filters allow overspray and flammable vapors to accumulate, significantly increasing the risk of fire or explosion. This condition also does not meet recognized spray booth safety standards. It is recommended that properly rated intake and exhaust filters be installed immediately and maintained in accordance with manufacturer specifications.

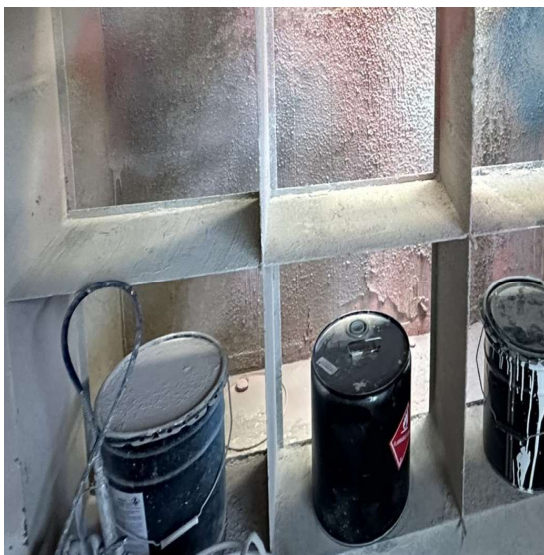
### **Flammable Materials Stored Inside Spray Booth**

Paint and other flammable materials were observed stored inside the spray booth at the time of inspection. Storing flammable materials within the booth exposes them to ignition sources during spray operations and significantly increases fire risk. It is recommended that all flammable and combustible materials be removed from the spray booth when not actively in use and stored in approved flammable storage cabinets.

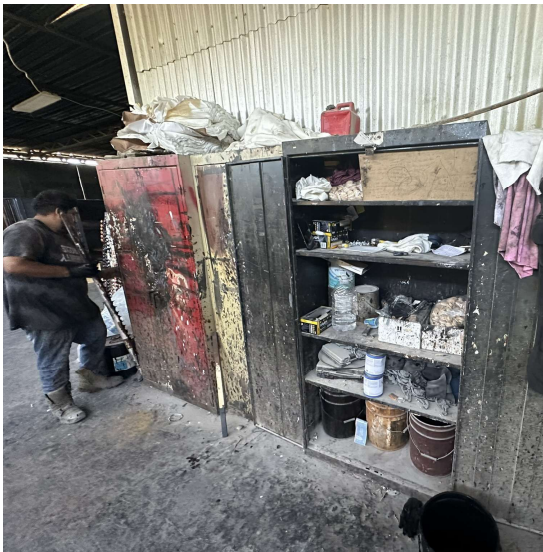
### **Flammable Storage Cabinets Not UL Rated / Improper Use**

Flammable storage cabinets were observed unlabeled and potentially not UL-listed, with some flammable liquids stored outside approved cabinets at the time of inspection. Improper flammable liquid storage increases the risk of vapor ignition and fire spread. It is recommended that all non-compliant cabinets be replaced with properly UL-listed flammable storage cabinets and that all flammable liquids be stored inside cabinets with doors closed when not in use.

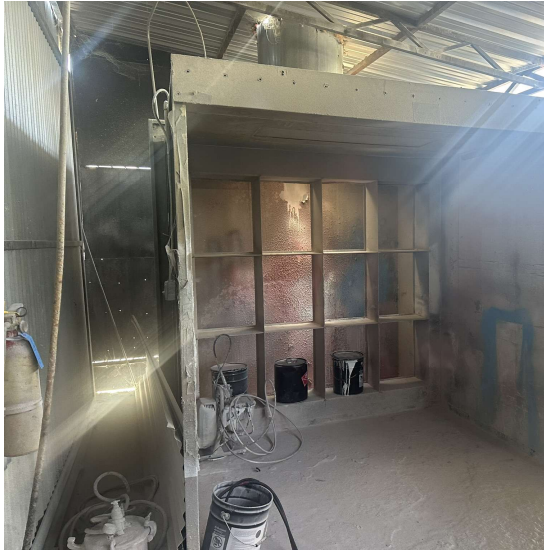
### **Missing Automatic Extinguishing System (AES) in Spray Booth**

The spray booth was observed operating without an automatic extinguishing system (AES) installed. Spray finishing operations involving flammable vapors and combustible materials present a significant fire risk, and the absence of automatic suppression increases the potential for rapid fire spread and severe loss. It is recommended that an approved automatic extinguishing system be installed and maintained in accordance with applicable fire protection standards and manufacturer specifications.

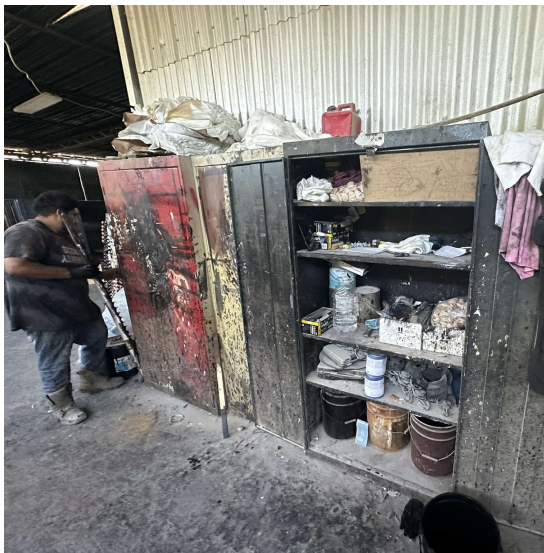
### **Improper Storage of Solvent Contaminated Rags**

Solvent-contaminated rags were observed improperly stored outside approved lidded metal containers at the time of inspection. Improperly stored solvent-soaked rags may spontaneously combust and significantly increase fire risk. It is recommended that all solvent-contaminated rags be stored in approved self-closing metal containers and emptied regularly to reduce fire exposure.

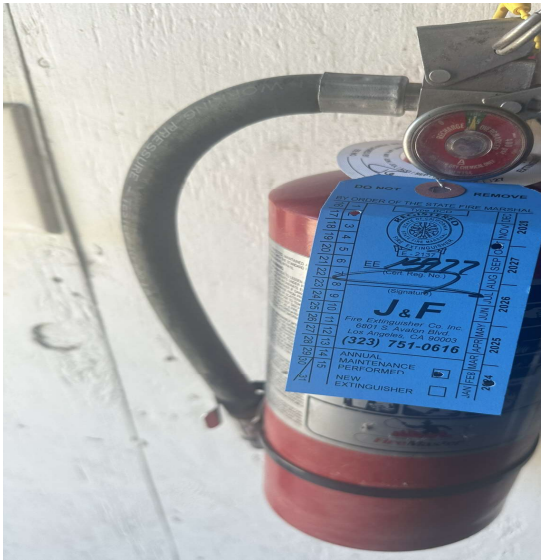
### Expired Fire Extinguisher

A fire extinguisher was observed with an expired inspection tag at the time of inspection. An unserviced extinguisher may fail during a fire emergency and increase potential loss severity. It is recommended that the extinguisher be serviced or replaced immediately and that all extinguishers be maintained with current inspection documentation.

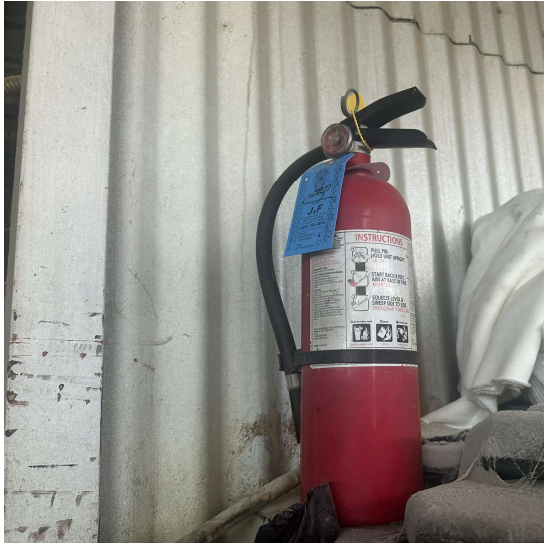
### Fire Extinguisher Not Properly Mounted

An ABC fire extinguisher was observed resting on a cabinet rather than properly mounted at the time of inspection. Unmounted extinguishers may be obstructed, damaged, or inaccessible during an emergency. It is recommended that all fire extinguishers be securely mounted on approved brackets and maintained with clear access.

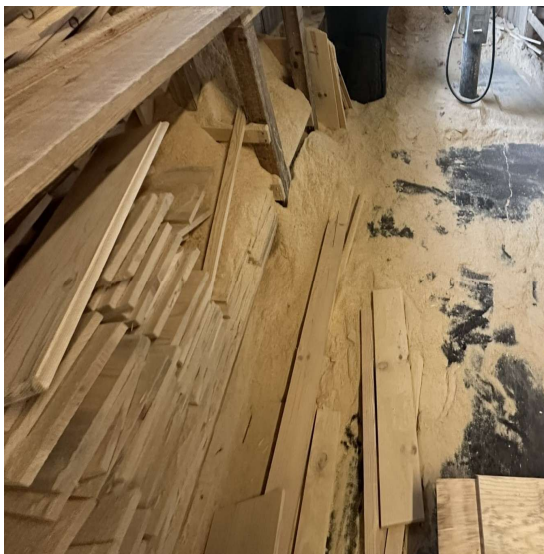
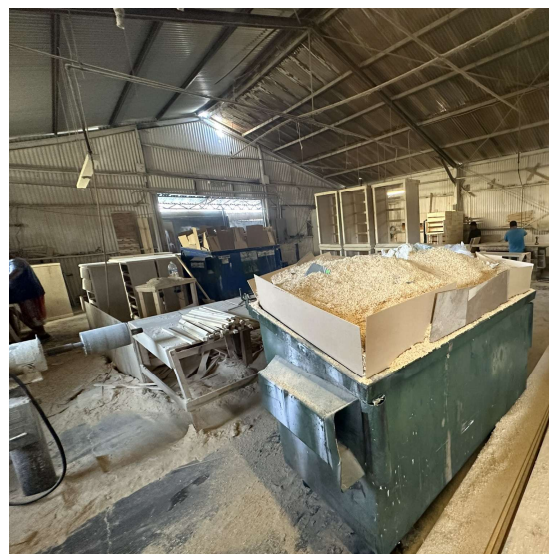
### Excessive Sawdust Accumulation

Excessive sawdust accumulation was observed throughout the production area at the time of inspection. Accumulated combustible dust significantly increases fire risk and may contribute to rapid fire spread if ignited. This condition also indicates inadequate housekeeping and dust control measures. It is recommended that accumulated sawdust be removed immediately and that an effective dust collection system be installed and properly maintained.

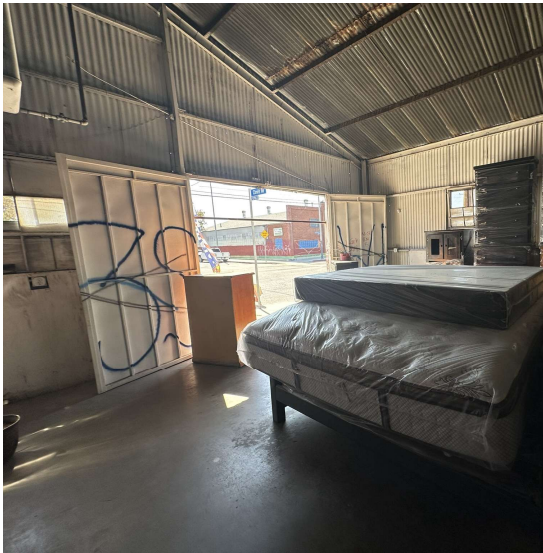
### Missing Exit Signage

An exit door was observed without illuminated exit signage at the time of inspection. Missing or inadequate exit signage may delay emergency evacuation and increase the risk of injury during a fire or power failure. It is recommended that approved illuminated exit signs be installed above all designated exit doors and maintained in proper working condition.

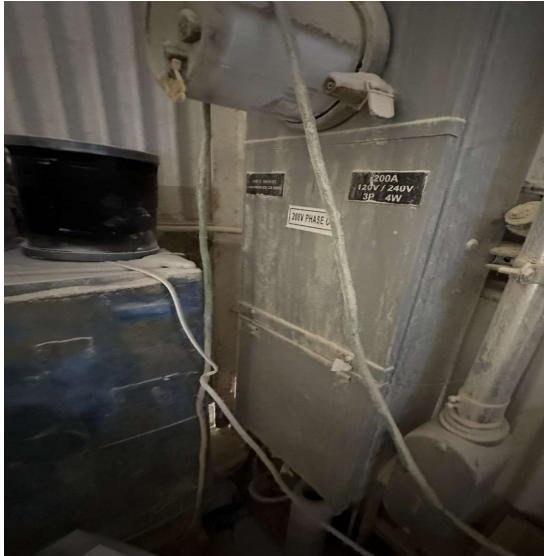
### Obstructed Electrical Equipment

Concerns with electrical panel obstruction were noted at the time of inspection. Electrical panel condition was considered fair due to observed paint/finish overspray residue surrounding breakers and dirty interior cabinet surfaces.

Electrical panels and/or disconnects were observed obstructed by stored materials at the time of inspection. Obstructed electrical equipment may delay emergency power shutoff and increase the risk of electrical shock or fire. It is recommended that a minimum of 36 inches of clear working space be maintained in front of all electrical panels and disconnects at all times.

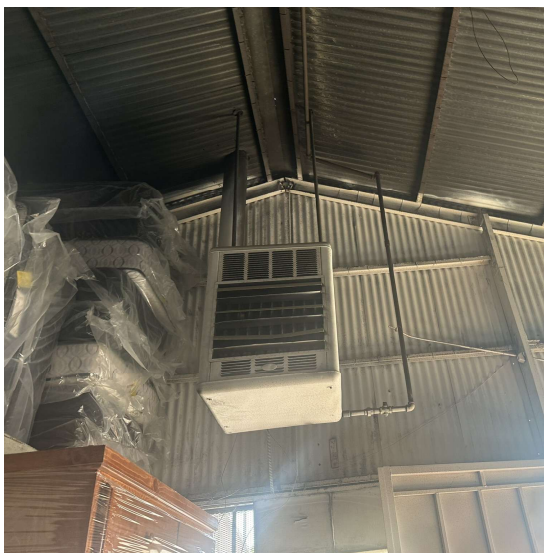
### Heating Equipment Clearance

Combustible materials were observed stored too close to suspended gas-fired heating equipment at the time of inspection. Inadequate clearance from heating equipment increases fire risk. It is recommended that a minimum clearance of approximately 3 feet be maintained between heaters and combustible storage/materials at all times.

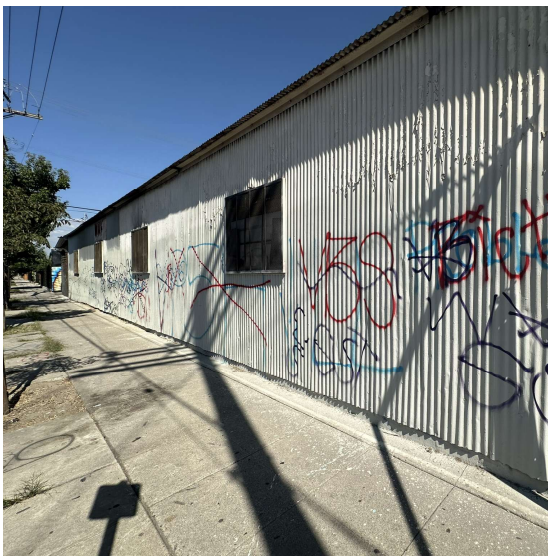
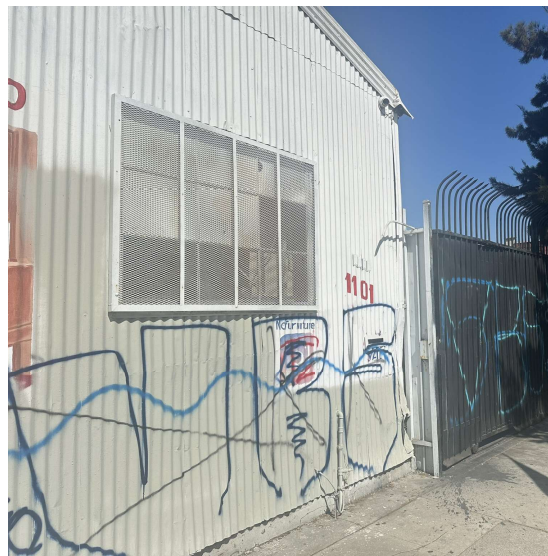
### Graffiti on Exterior Walls

Graffiti was observed on the exterior walls of the building at the time of inspection. Visible vandalism may indicate property neglect and can attract additional trespassing or vandalism. It is recommended that the graffiti be removed promptly and that exterior lighting and property monitoring be evaluated to help deter future occurrences.

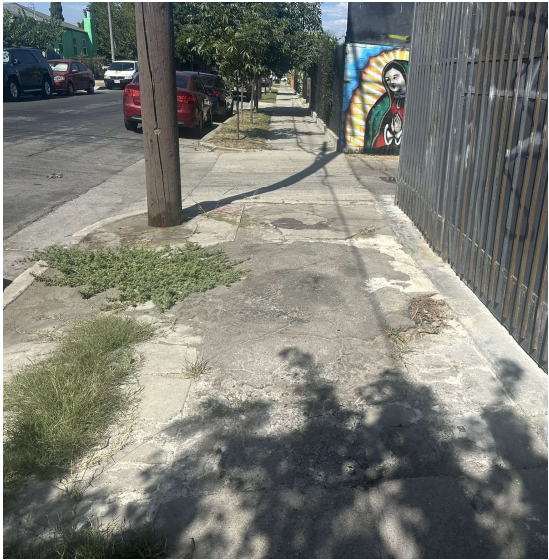
### Cracked Municipal Sidewalk (Left Side of Building)

Cracks and uneven sections were observed in the municipal sidewalk along the left side of the building at the time of inspection. The deteriorated sidewalk presents a potential trip-and-fall hazard and may contribute to liability exposure. It is recommended that property management notify the appropriate municipal authority and document the repair request. In the interim, the area should be monitored for safety.
