## **MACHINERY DAMAGE SURVEY REPORT**

M/Y 'GULFCRAFT' – UVI: 3320198

### **'RUDDER STOCK BEARING FAILURE'**

**Date of report:** 15<sup>th</sup> July 2023

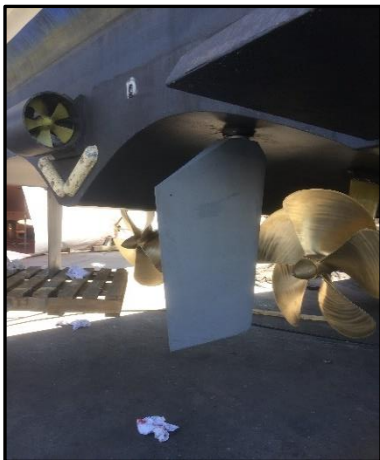
Stbd rudder blade

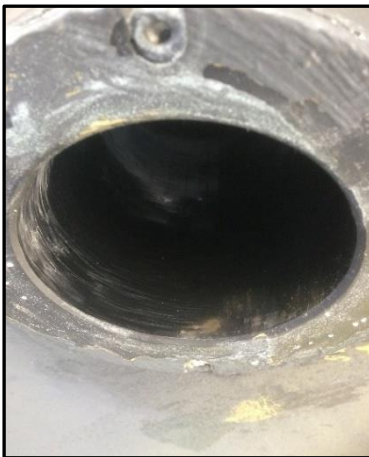
- 4.1 We comment that existing upper and lower rudder bearings were measured, and inside bore diameters were all found to be at least 1.5mm oversize.
- 4.2 We conclude that oversized or incorrect rudder bearings were installed during the construction of the vessel. This was confirmed via official email correspondence between Big Sea Marine Consultants Pty. Ltd and Gulf Craft Inc, United Arab Emirates. The advice provided during our communication with Gulf Craft Inc.'s technical department included an admission that at the time of build, incorrect (oversized) rudder bearings were installed on hull # 3.

Bearing	Correct I.D. Specification	I.D measured
Upper Port	Nominal bore dia. 70mm	71.55mm
Upper Stbd	Nominal bore dia. 70mm	71.63mm
Lower Port	Nominal bore dia. 90mm	91.54mm
Lower Stbd	Nominal bore dia. 90mm	91.57mm

Stbd lower bearing insert

- 4.6 Repairs must include new replacement bearings and stainless-steel cap screws. Repairs must be carried out by an established engineering firm with appropriate experience and manufacturing capability.
- 4.7 'Acetal' load-bearing material must be used for manufacturing new bearings.
- 4.8 A subsequent follow-up survey is required, upon completion of the repair. Alternatively, documented repair processes and supporting images may be supplied for this purpose.

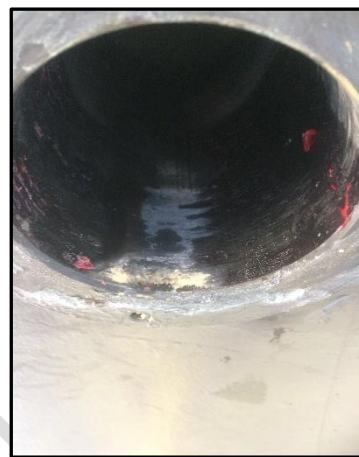
Port lower bearing insert

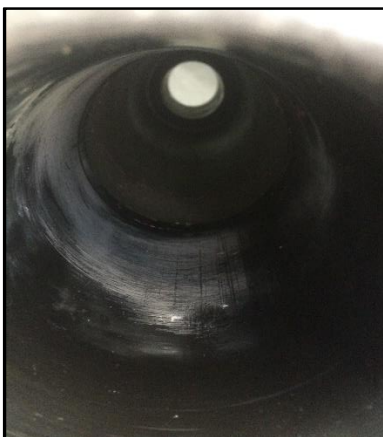
Stbd rudder tube from below

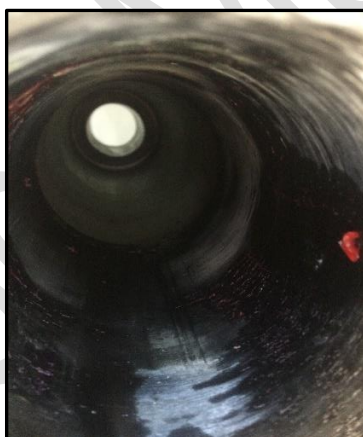
Port rudder tube from below

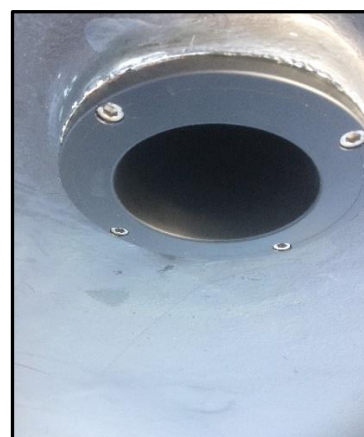
New fitted lower bearing
