New Heights Inspection

4 Way Property Inspection

Jun 14, 2024

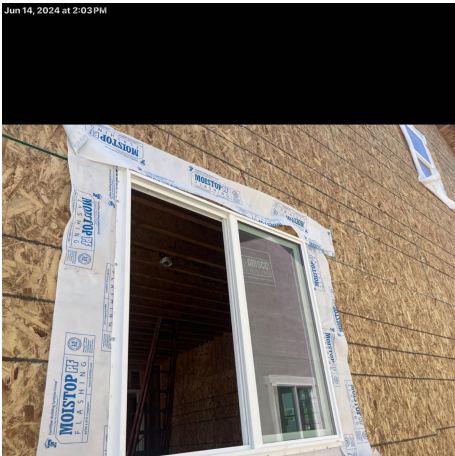
Issue #
2
Issue
Top of garage window Tyvek paper pulling off due to staples pulling up.
Floor
East Elevation

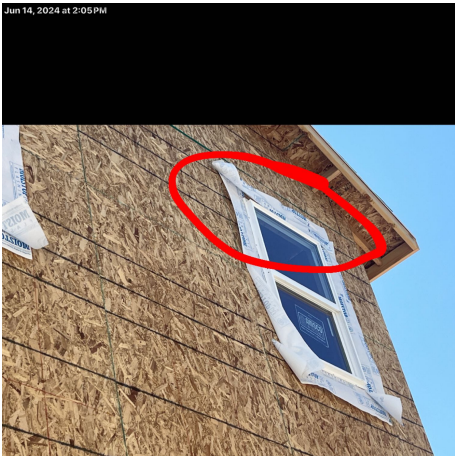
Issue #
3
Issue
Top of paper tyvek pulling off.
Floor
East Elevation

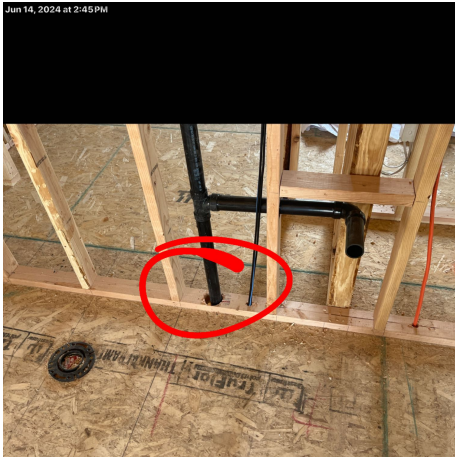
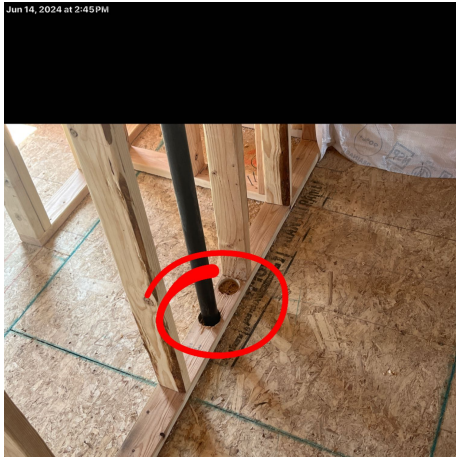
Issue #	Issue		
8	Safety plates missing both sides		
Floor			
2nd floor			
Room			
Bathroom 4			
Sheet	Comment

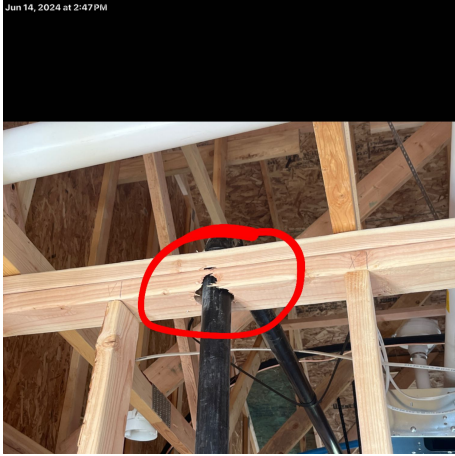
Issue #	Issue		
9	Safety plate missing		
Floor			
2			
Room			
Bedroom 4			
Sheet	Comment

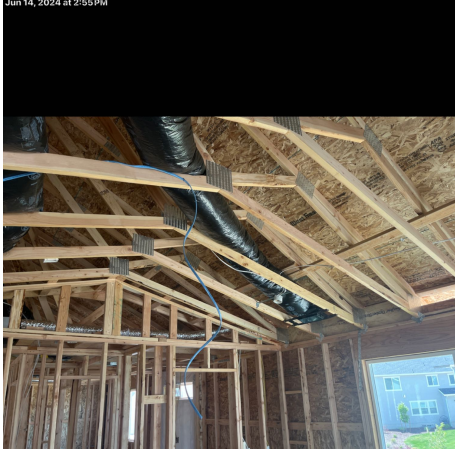
Issue #	Issue		
11	Light junction box not mounted.		
Floor			
2			
Room			
Owner bedroom			
Sheet	Comment

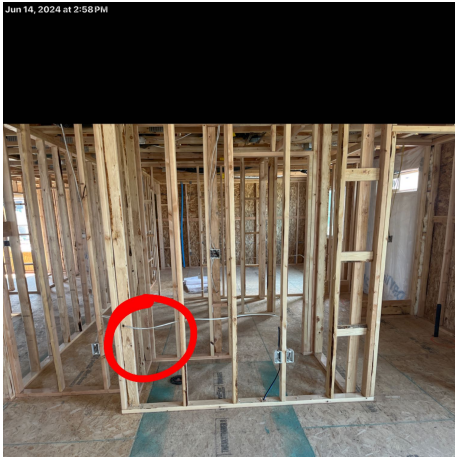
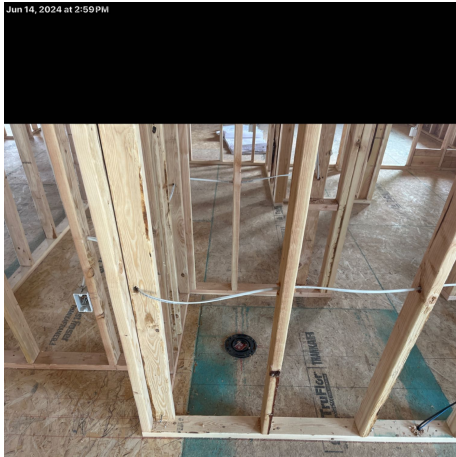
Secure wire with staple

Prior to drywall, ensure wire is more secured to avoid the possibility of being damaged.

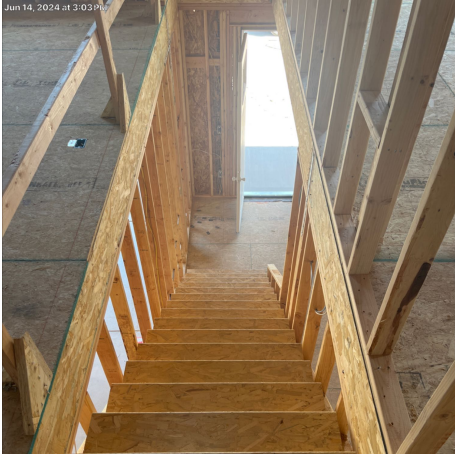
Stair backing for handrail

Owner to verify if backing is required for handrails prior to drywall being installed

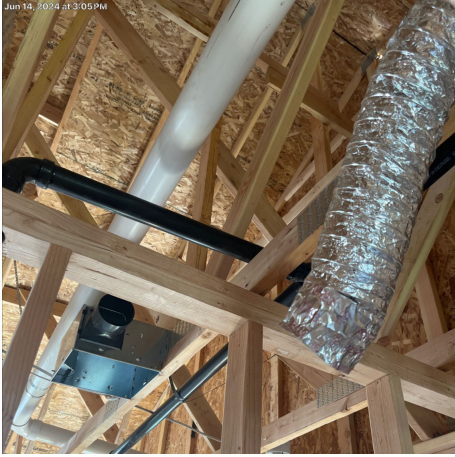
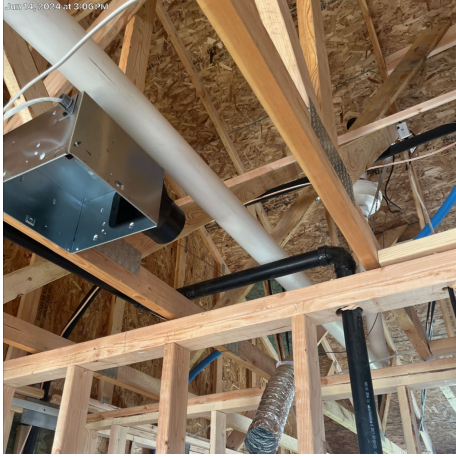
Bathroom Vent duct not attached

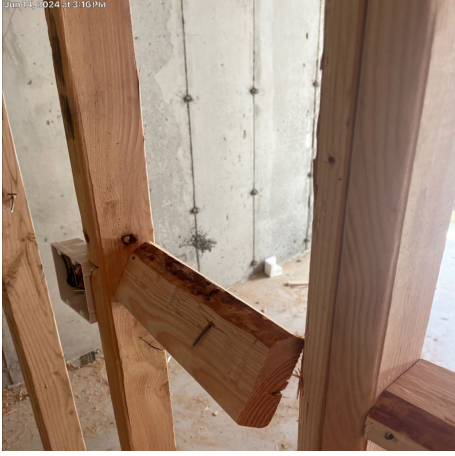
Rescue blocking right side of basement stair wall.

As you walk down the basement stairs, on the right side is a loose blocking 2x4. Rescue for proper stud support.

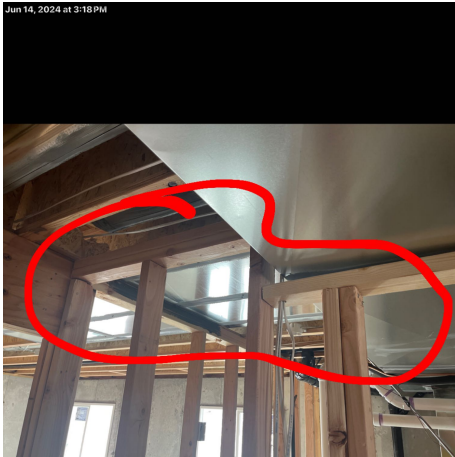
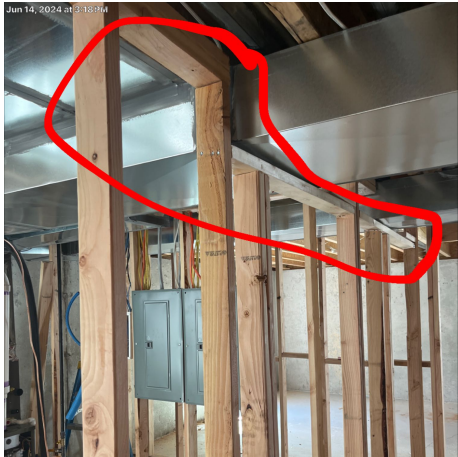
Mechanical stud wall, hallway side loose.

Stud wall is very loose and needs to be properly secured prior to drywall being installed.

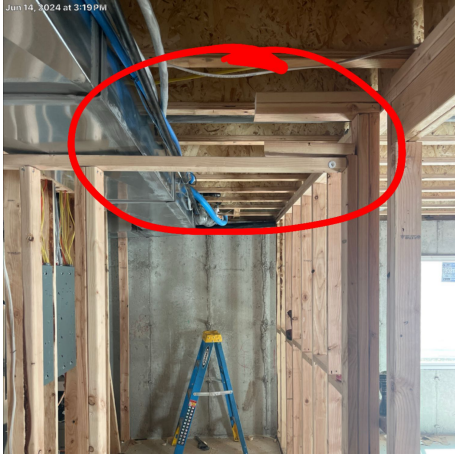
Add additional header support

Understanding that the framing in the basement is tight due to HVAC duct running throughout. Recommending adding where possible additional header support.

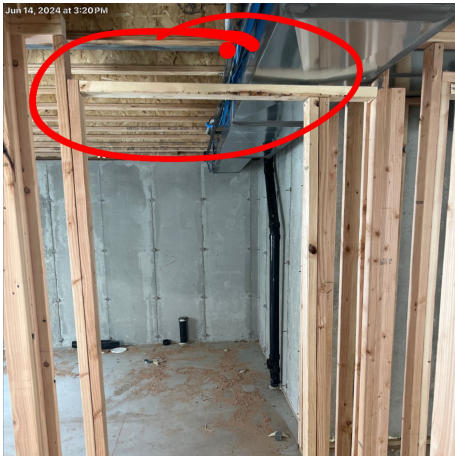
Add additional header support

Understanding that the framing in the basement is tight due to HVAC duct running throughout. Recommending adding where possible additional header support.
