New Heights Inspection

Inspection Description: Home Inspection

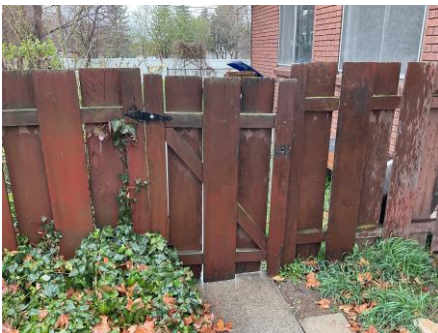
Gate:

Notes: Missing hardware. You need to lift the gate up and open as to not hit the concrete. Hinges need to be adjusted.

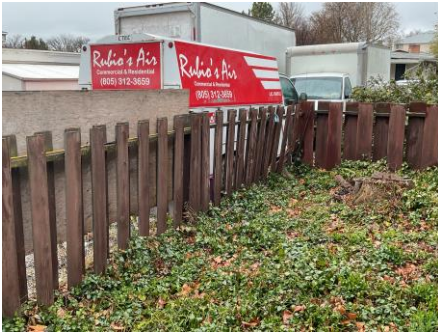
Fencing:

Note: Various parts of the fencing is sagging towards the home. Recommend further evaluation by a fencing contractor to see if the fence can be fixed and also stained to extend the life of the fence. Some locations appear to be warped and may not be salvaged.

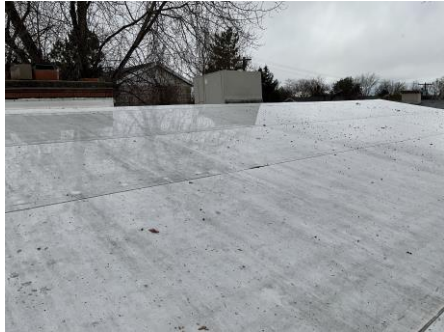
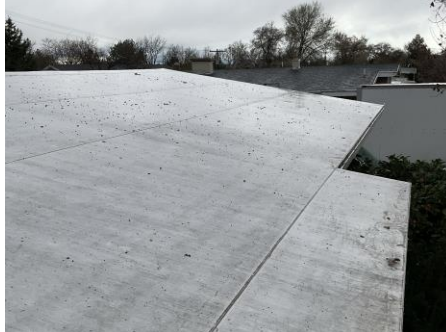
Singles Missing/Damaged?

Notes: It was discovered in front of the home (North Facing), the TPO is pulling up. On the back of the home, there is vegetation which is landing on top of the roof and could penetrate the membrane causing potential water issues.

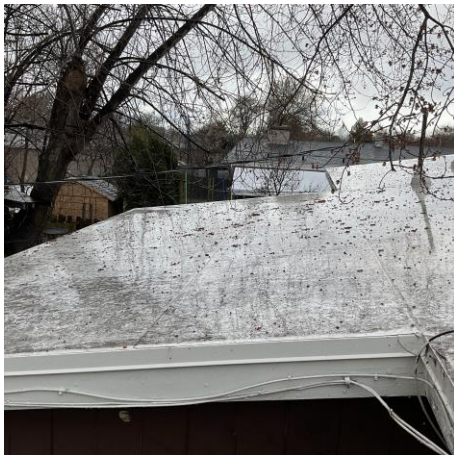
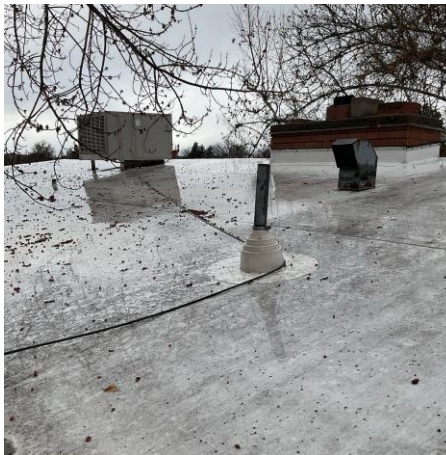
Flashing: Fair

Notes: Boot pipe to be extended 8-12" above roof.

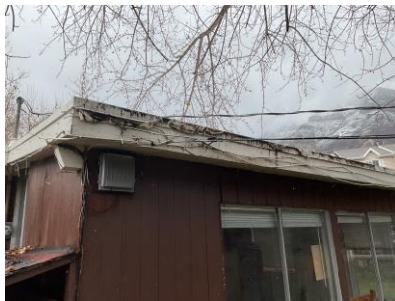
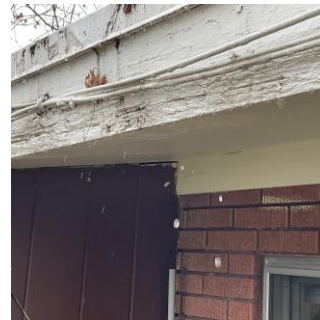
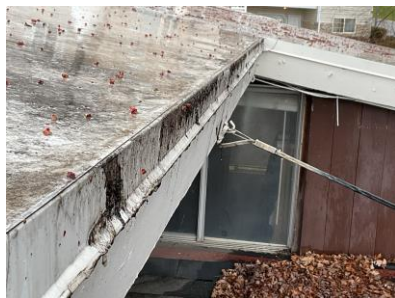
Fascia:

Notes: Between not having gutters installed and the vegetation from the nearby tree, this is causing mildew buildup. Recommend further evaluation by roofing contractor to install gutters and downspouts to help protect the fascia.

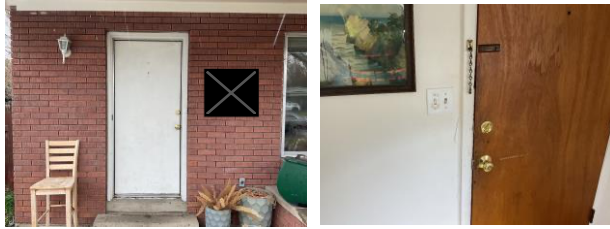
Exterior Doors:

Notes: Exterior door seal is falling off. Recommend repairing to help maintain ambient temperature inside home.

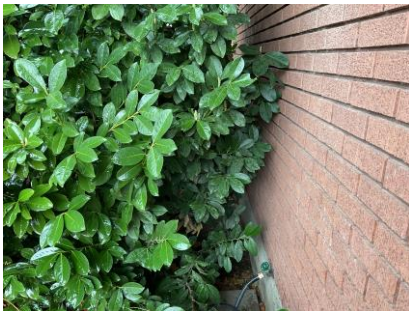
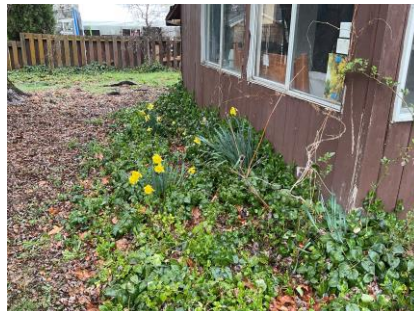
Vegetation: Fair

Notes: On the front and back of home, large trees are overhanging around the home. There are small shrubs next to the home that should be cut back 1'-2'.

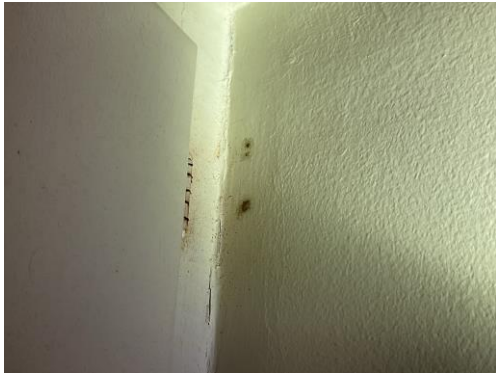
Walls: Fair

Notes: suspicious substance, located behind shower next to towel closet.

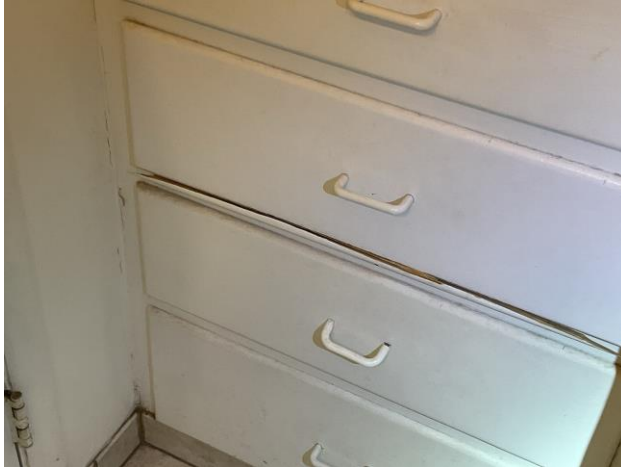
Cabinets: Poor

Notes: Cabinet drawer behind bathroom door is cracked. Some cabinets are hard to open and or do not close properly.

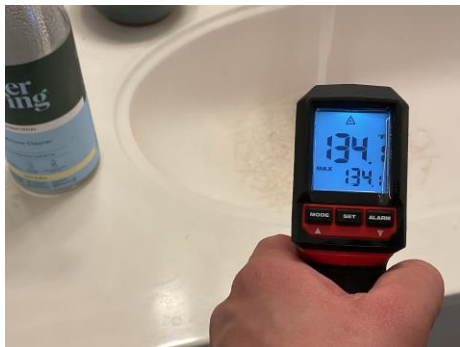
Sinks: Fair

- Scratches inside sink
- The water temperature is at 134 degrees throughout home. Recommend adjusting water heater setting to 120 degrees.

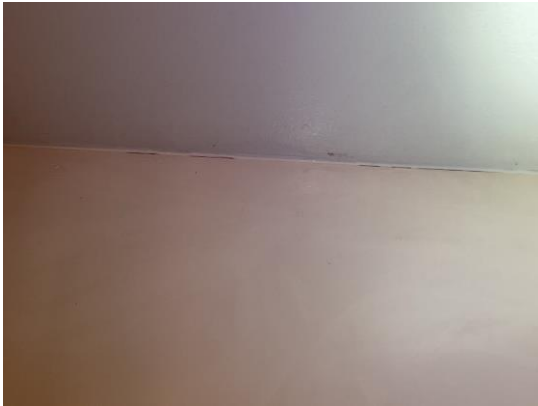
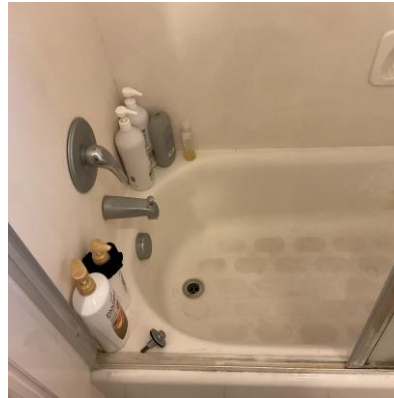
Bathtub/Shower:

Notes: Cracking at ceiling above shower (East Wall)

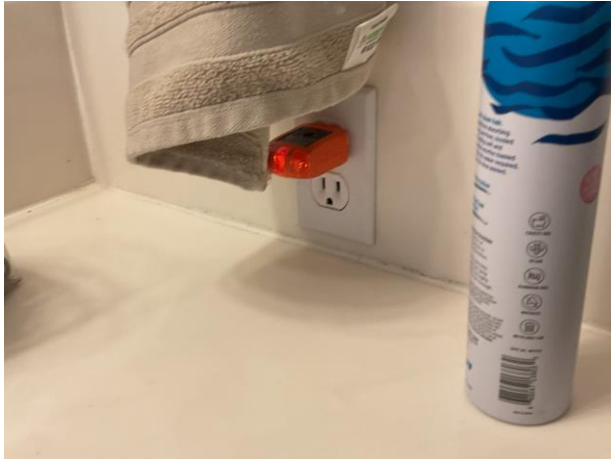
Outlets:

- GFCI was not located inside the bathroom.
- Cover plate loose.

Recommend further evaluation by an electrician.

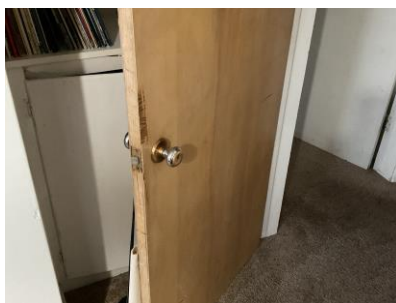
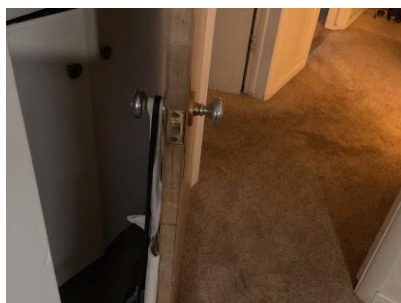
Doors:

Notes: Door was cracked and has loose hardware

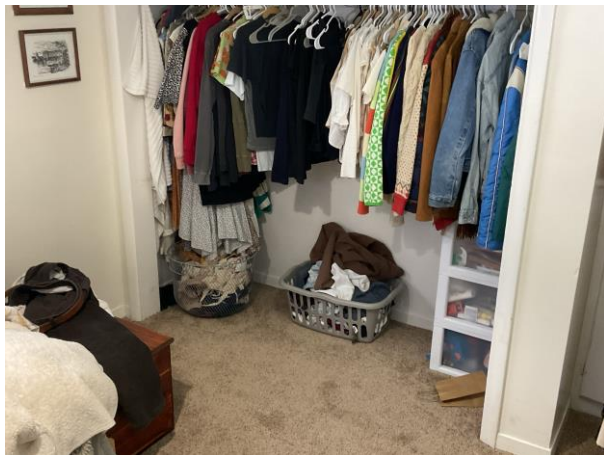
Closets: Fair

Notes: Closet doors missing.

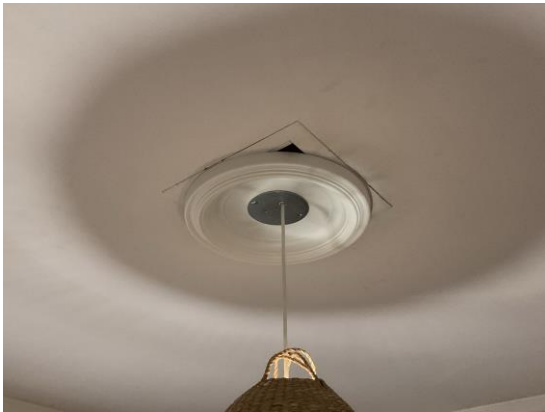
Lighting:

Notes: Gap between light fixture and wall. Recommend patching and repairing.

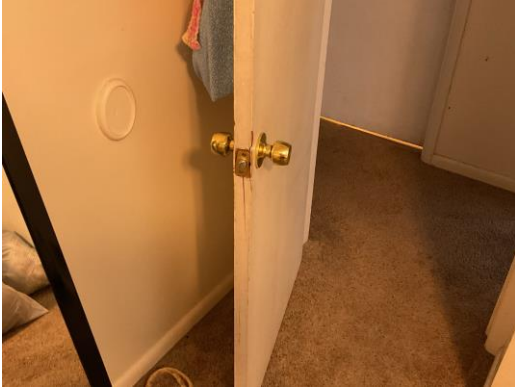
Doors: Poor

Notes: Cracked door

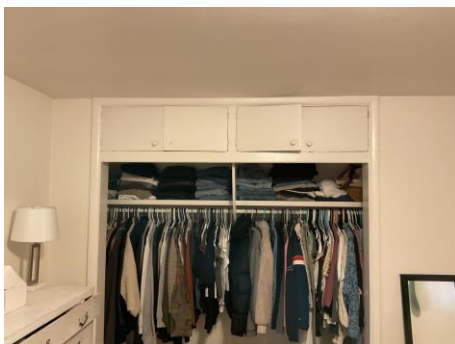
Closets:

- Missing closet doors

- Missing knob to upper left cabinet
- Upper cabinets are hard to open and or close.

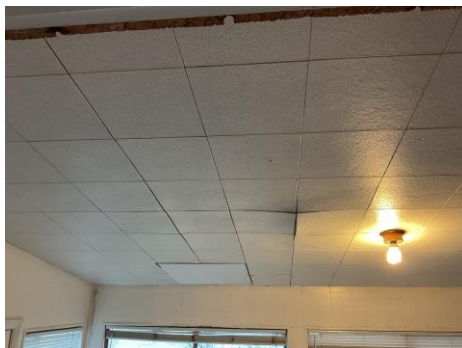
Ceilings:

Notes: Ceiling tile is sagging.

Further evaluation by carpenter.

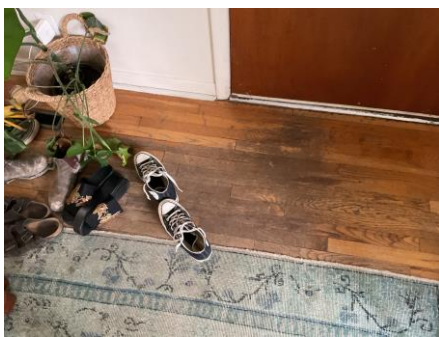
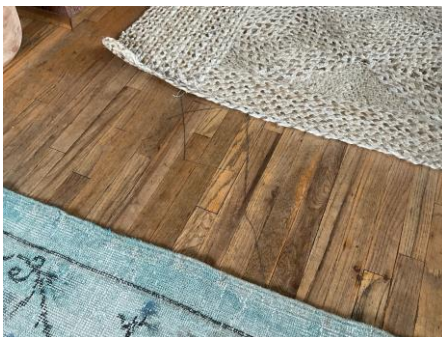
Flooring: Fair

Notes: Entry of home has a lot of wear and tear in the flooring. Scratches were also found in the living room.

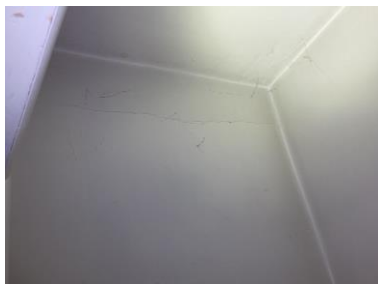
Walls: Fair

Notes: Closet have some signs of cracking. Recommend monitoring to see if cracking worsens.

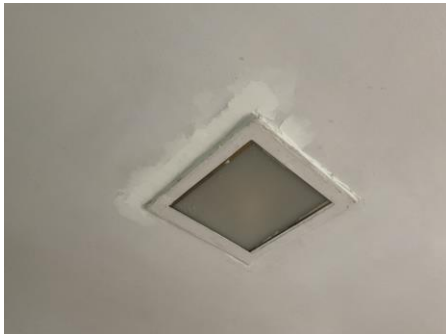
Ceilings:

Note: Patching around light has started but not finished.

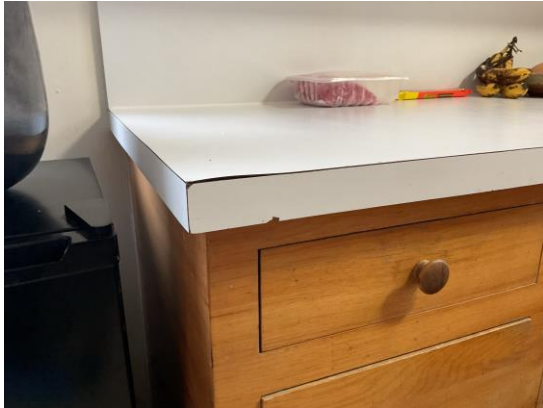
Countertops:

Notes: Plastic laminate is pulling up.

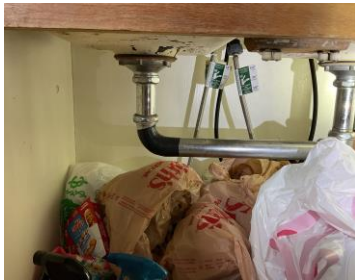
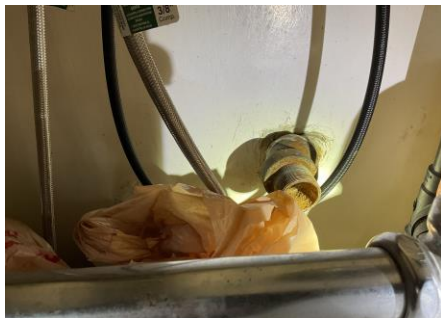
Sink/Garbage Disposal:

- No garbage disposal

- Electrical tape around plumbing line.
- Hot and cold-water connection may not be installed correctly.
- Abandoned pipe under sink should be capped.

Recommend further evaluation by plumbing contractor.

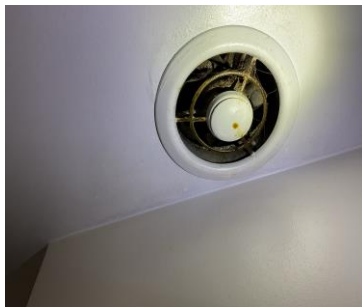
Venting

Notes: Vent is dirty with grease.

Recommend further evaluation by HVAC contractor.

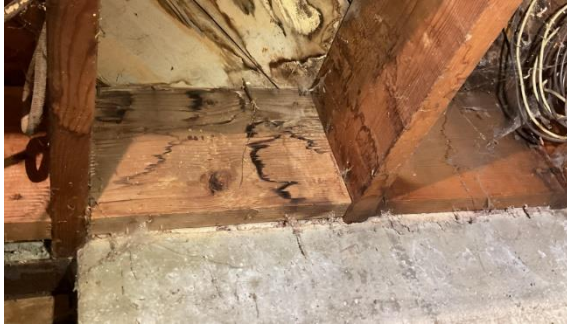
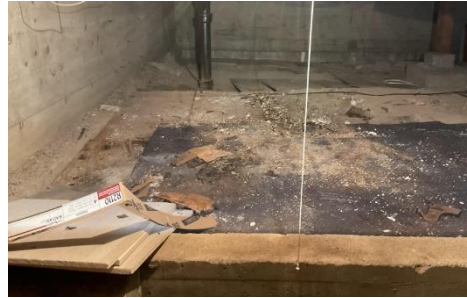
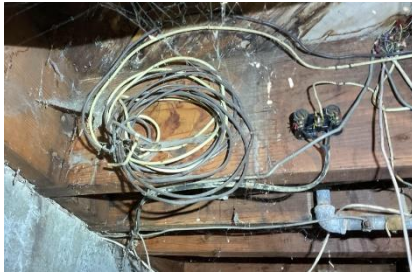
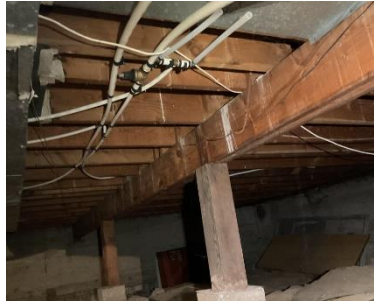
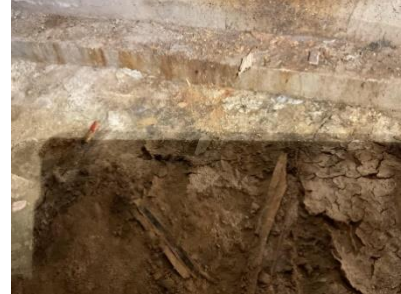
Crawlspace: Fair

- Misc. material is found inside the crawl space, this includes doors, carpet, wood, etc. Recommend removing.
- Appeared to have had water damage on sub-floor. Tested with moisture reader, no moisture at this location.
- Wires are coiled up and not in junction box. Further evaluation by electrical subcontractor
- Pex pipe looks to be abandoned and cut. Recommend further evaluation by plumbing contractor to ensure it is properly abandoned.

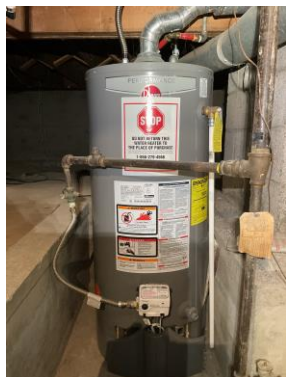
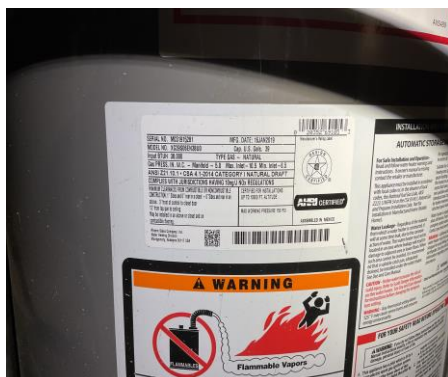
Water Heater: Satisfactory

Notes: Water heater is a 39 gallon, manufactured in 2019

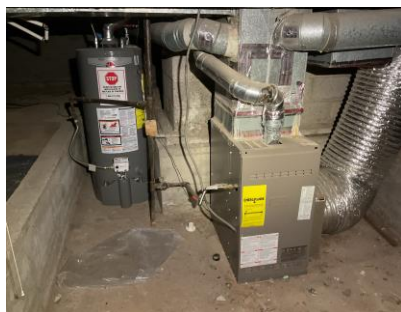
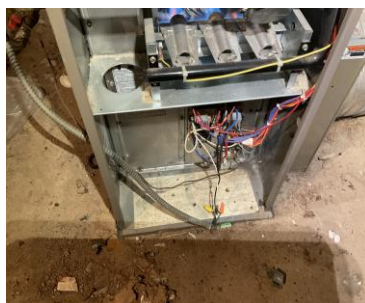
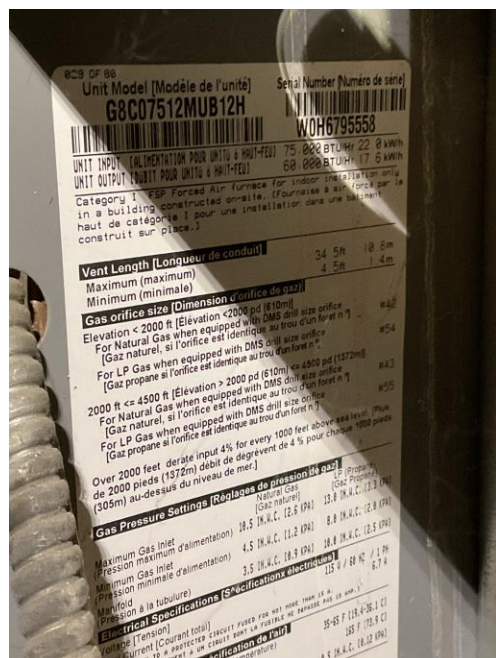
Heating System Operation: Satisfactory

Note: Unit is estimated to be a 2006

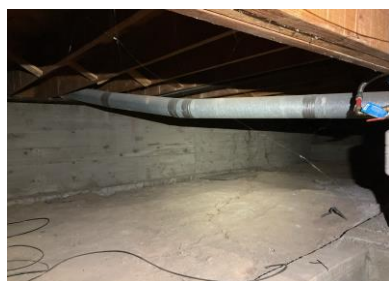
Ductwork/Piping: Satisfactory:

Note: In the crawl space, I discovered duct tape around one of the ducts.

Recommend further evaluation by HVAC contractor.

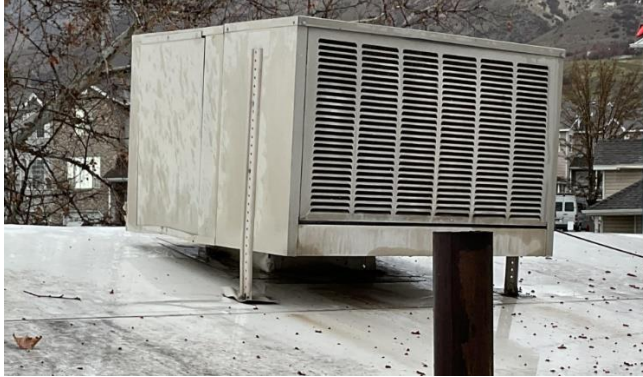
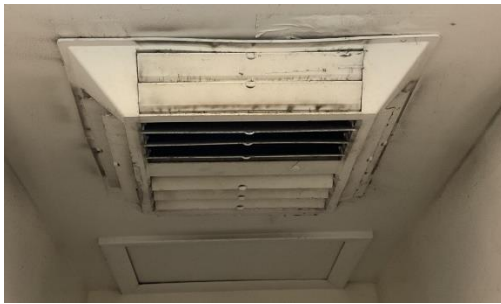
Cooling System: Did not test.

Note: Due to temperatures being below 60's, I was unable to evaluate AC Unit. Unit appears to be an older unit. Inside where the unit drops into dwelling, grill is pretty dirt.

Recommend further evaluation by HVAC contractor.

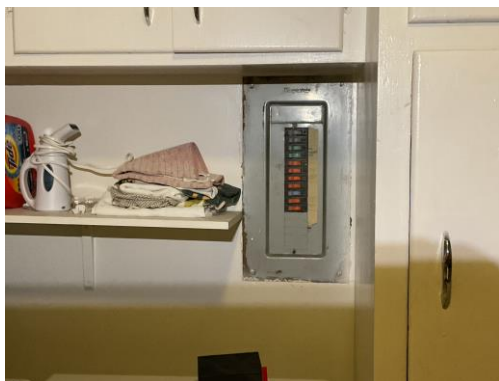
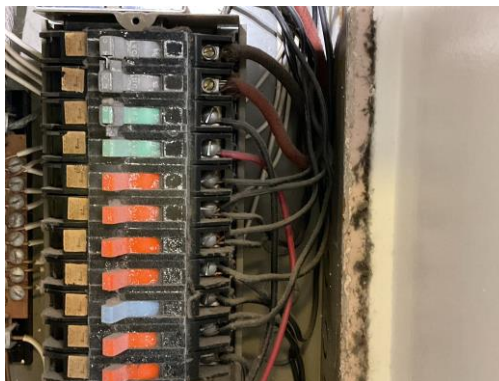
Main Panel and Sub Panel:

Notes: Several breakers have double taping.

Recommend further evaluation by electrical contractor.
