# Longevity Inspections

## Property Inspection Report

123 Main Street, Senoia, GA 30276  
Inspection prepared for: Example Client  
Real Estate Agent: -

Date of Inspection: 5/8/2025 Time: 2:30 PM  
Age of Home: 2025 Size: 2900  
Weather: Sunny - 79F  
Order ID: 43

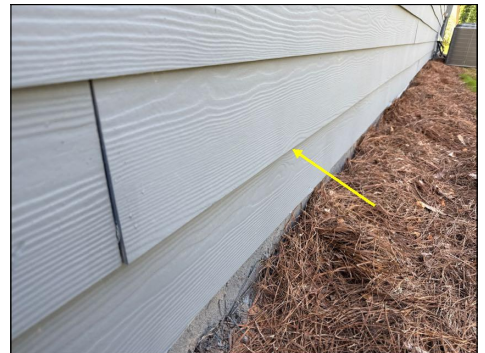
Page 6 Item: 1	Siding and Trim Condition	<ul style="list-style-type: none"><li>• Gaps noted on the front and left side of the residence. Recommend further evaluation and repairs.</li><li>• Loose siding noted around the residence. Recommend further evaluation and repairs.</li></ul>
----------------	---------------------------	--

- *Gaps noted on the front and left side of the residence. Recommend further evaluation and repairs.*
- *Loose siding noted around the residence. Recommend further evaluation and repairs.*

Loose Siding - Left Side

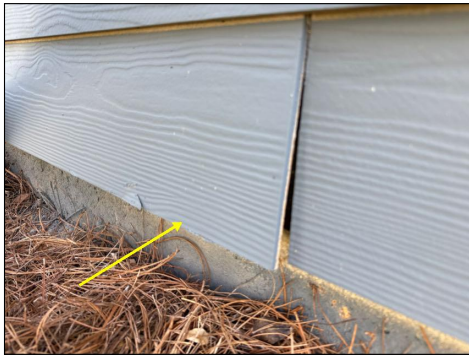
Loose Siding - Left Side

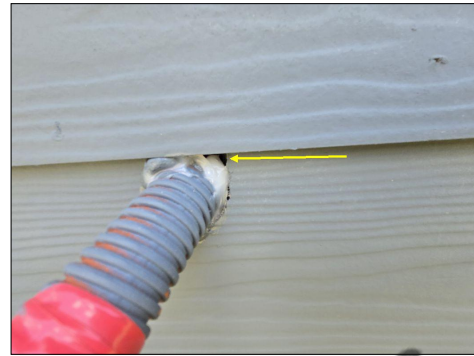
Gap - Left Side

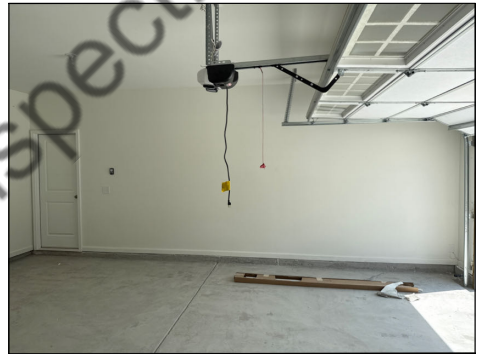
Page 11 Item: 3	Garage Opener Status	<ul style="list-style-type: none"><li>• The garage door opener was unplugged and the garage door was tested manually. Recommend further evaluation.</li></ul>
Page 12 Item: 6	Walls	<ul style="list-style-type: none"><li>• Exposed pipe noted at the garage wall. Recommend further evaluation and repairs.</li></ul>

- *Exposed pipe noted at the garage wall. Recommend further evaluation and repairs.*

Exposed Pipe - Garage
