# Longevity Inspections

## Property Inspection Report

123 Main Street, Senola, GEORGIA 30267  
Inspection prepared for: Example Client  
Real Estate Agent: -

Date of Inspection: 4/30/2025 Time: 02:30PM  
Age of Home: 56 Size: 3900  
Weather: Sunny - 81F

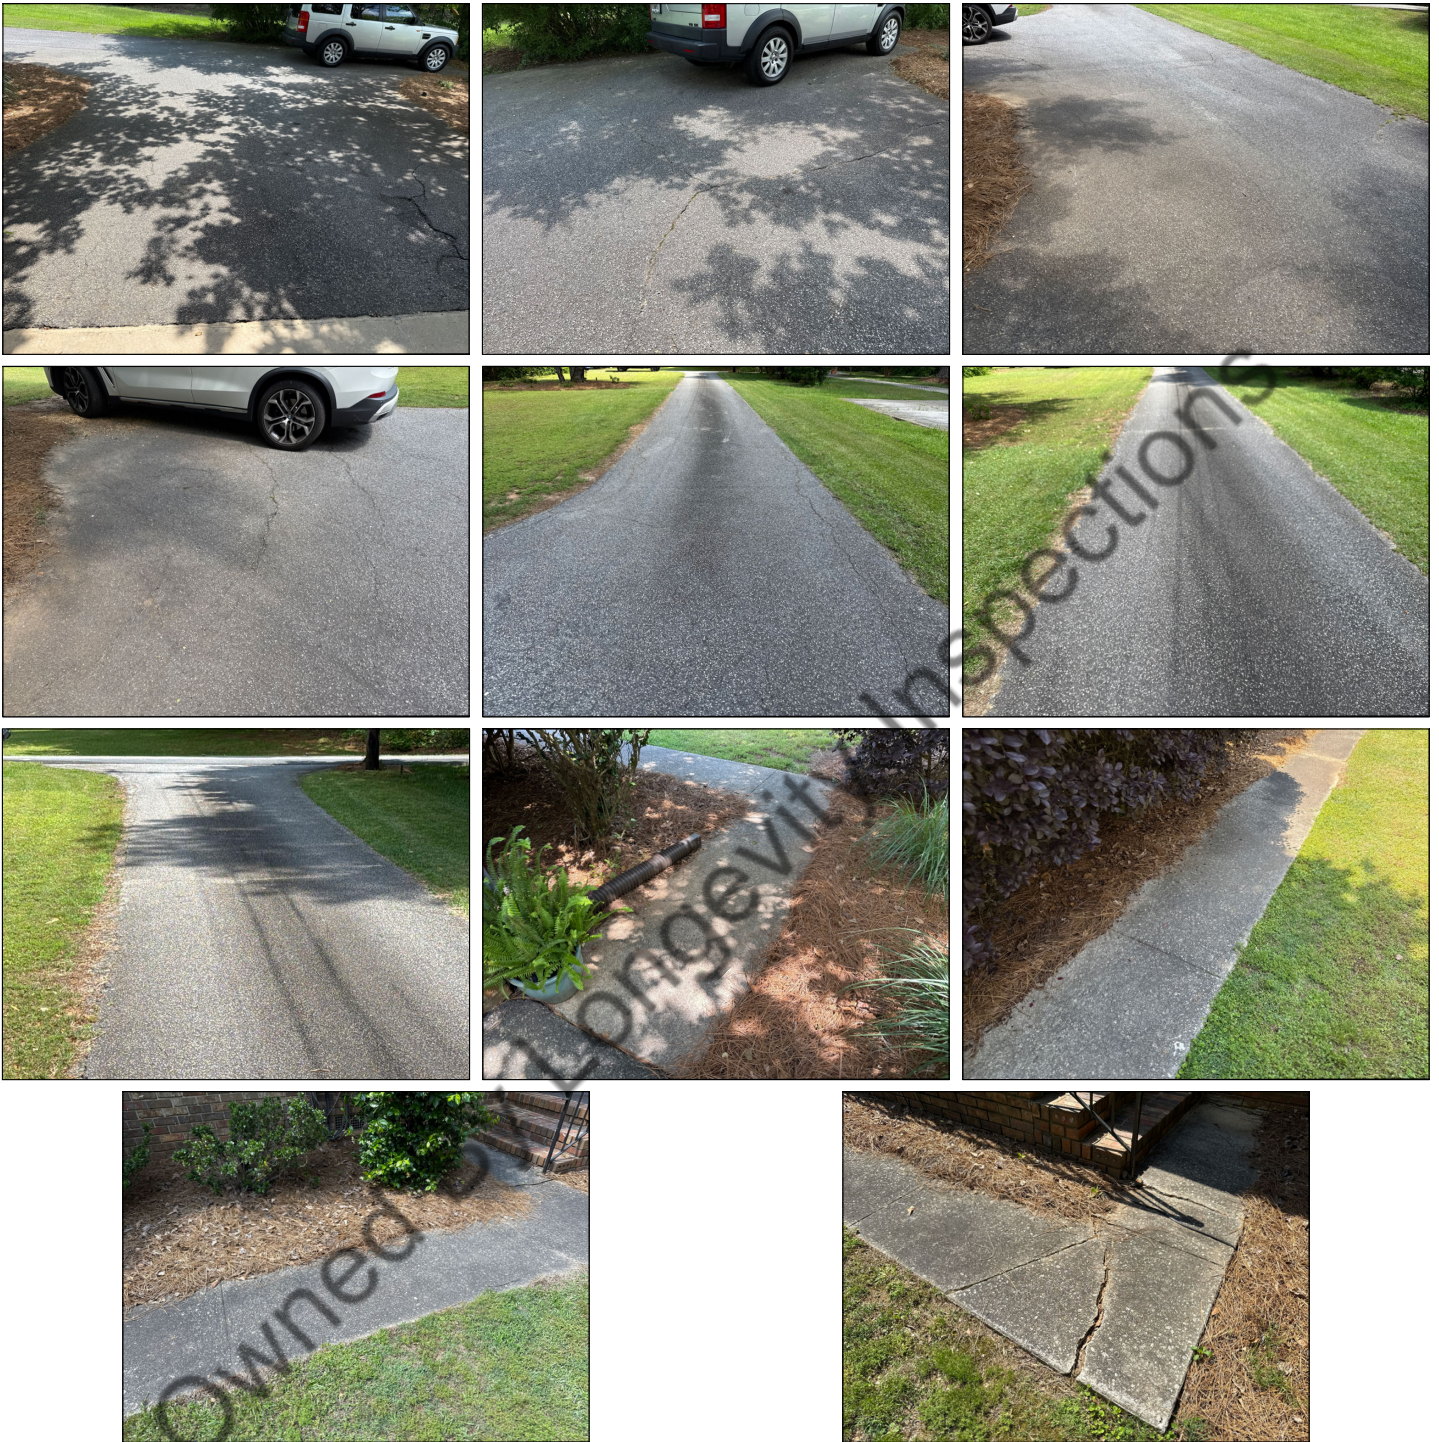
• *Damaged concrete noted in the driveway and/or sidewalk. Recommend further evaluation and repairs to prevent further deterioration.*

Damaged Concrete - Sidewalk

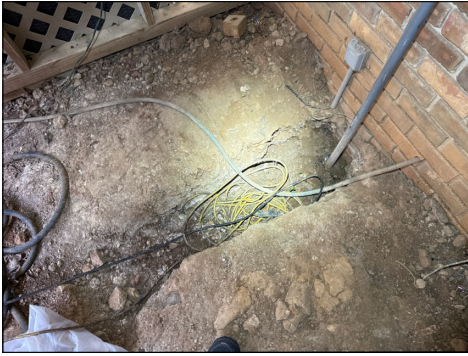
- Hole noted on the rear side underneath the rear deck. Recommend further evaluation and repairs.
- The exterior drainage is generally away from foundation.

Hole - Rear Side Under Deck

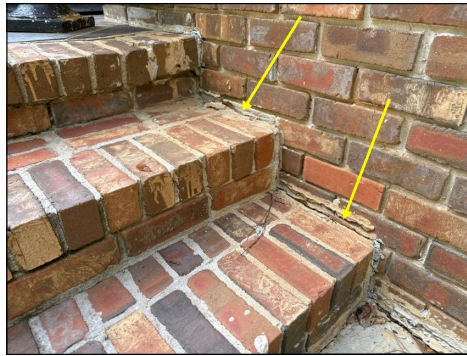
- *Damaged/missing grout noted. Recommend further evaluation and repairs to prevent further deterioration.*
- *Minor settling noted at the front porch. Recommend further evaluation and repairs by a qualified professional.*

Minor Setting - Front Porch

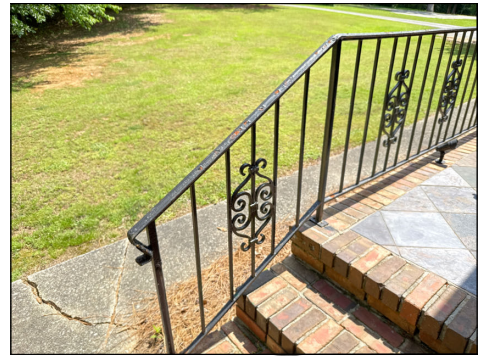
- *Loose handrail(s) noted at the exterior porch and/or deck stairs. Recommend further evaluation and repairs.*
- *Deck ledger board lacking flashing. Flashing protects the ledger and keeps water away from the side of the house and the Rim joist inside the structure. Flashing is required where exterior porches, decks, or stairs attach to a wall or floor assembly of wood frame construction. Flashing should be approved corrosion-resistant flashing shall be applied shingle-fashion in a manner to prevent entry of water into the wall cavity and the flashing shall extend to the surface of the exterior wall finish. Recommend further evaluation and repairs.*

Loose Handrail - Front Porch

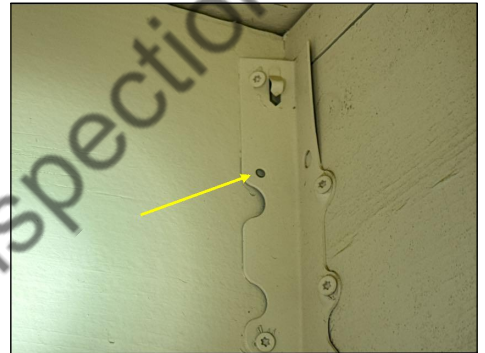
- *Missing/improper fasteners noted at the joist hanger(s). Recommend further evaluation and repairs.*
- *Separation noted at multiple deck floor joist. Recommend further evaluation and repairs.*

Missing Fasteners - Rear Deck

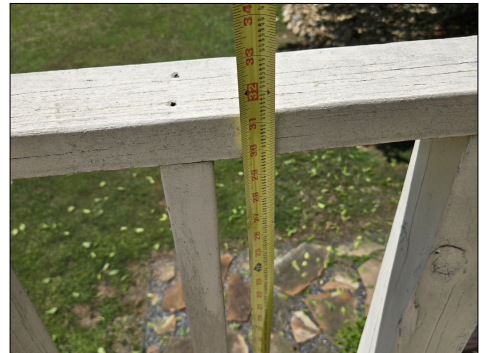
- *Improper guardrail height noted at the rear deck. A 36" rail measured from the top of rail to the deck surface is required. Recommend further evaluation by a qualified professional in the interest of safety.*

Improper Guardrail Height - Rear Deck

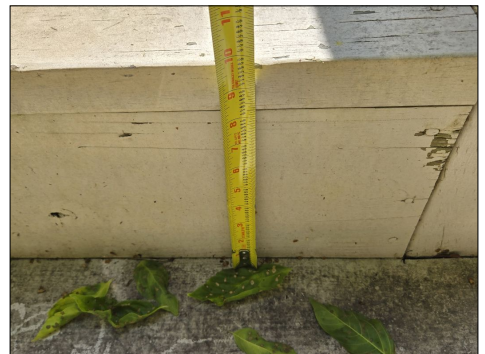
- *Improper stair riser noted at the rear deck stairs. The standard stair riser height is typically between 6 and 7.5 inches. Recommend further evaluation and repairs.*

Improper Stair Riser - Rear Deck Stair

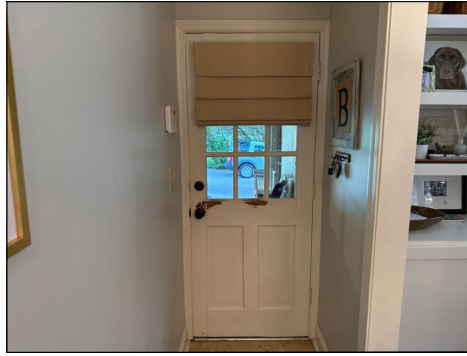
- *The door between the garage & house is not a fire rated door. This may not have been required when originally built. Fire doors are fundamental to the integrity of fire barriers which provide resistance to the spread of fire, smoke, and toxic gasses. Recommend further evaluation and repairs.*
- *Appeared in functional and in satisfactory condition at time of inspection.*

Not Fire Rated - Garage Door

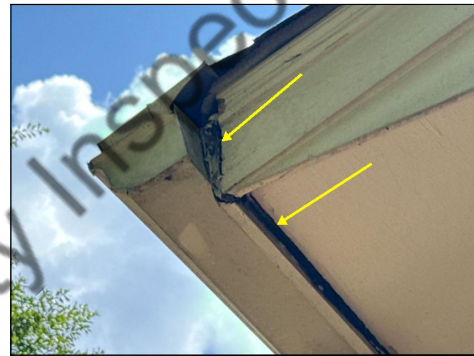
- *Moisture damage/wood rot observed. Recommend repairs/replacement as needed.*

Wood Rot - Front Right Corner

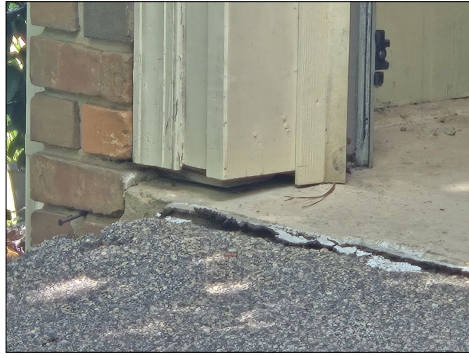
- *Gaps noted around the rear right basement door. Recommend further evaluation and repairs to prevent moisture and insect intrusion.*
- *Gap noted on the left side of the garage. Recommend further evaluation and repairs to prevent moisture and insect intrusion.*
- *Maintenance Tip: Caulking and seal all gaps, cracks and openings is part of routine maintenance to prevent moisture and insect intrusion.*

Gap - Left Side of Garage

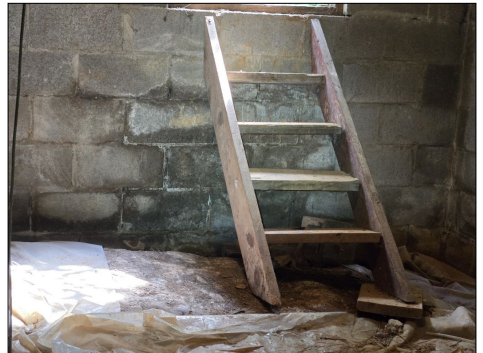
- *Exposed waterproofing material noted on the right side of the residence. Recommend further evaluation.*
- *Efflorescence observed; this is a mineral deposit left behind from previous exterior water infiltration. Recommend a qualified professional further evaluate all areas.*
- *Possible moisture intrusion noted in the foundation wall. Moisture can create high humidity, mold and can damage stored items & finishing materials. Recommend further evaluation by a qualified professional.*
- *Missing foam at the sill plate in the crawlspace. Recommend further evaluation and repairs.*

Efflorescence/Possible Moisture  
Intrusion - Left Rear Side

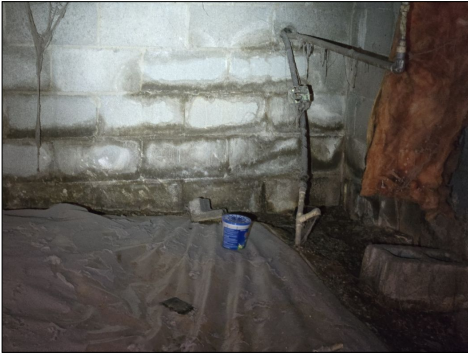
Efflorescence - Front Left Corner

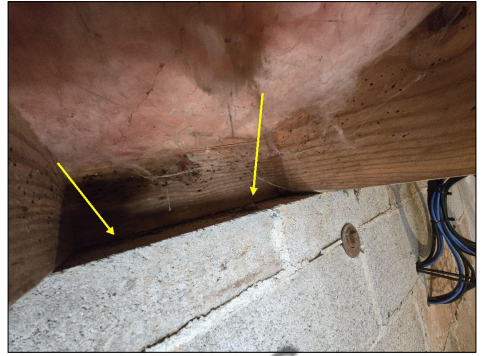
Missing Foam - At Sill Plate

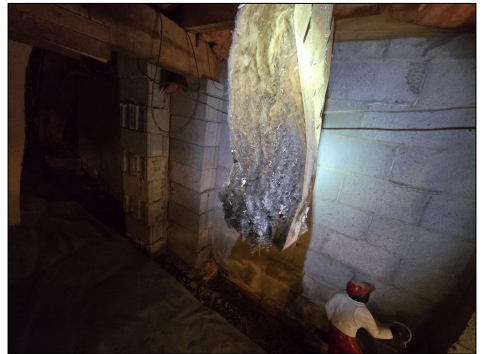
Page 12 Item: 2	Crawlspace	• Suspect fungal growth observed. Recommend further evaluation and repairs following an approved remediation process.
-----------------	------------	---

- *Damaged/missing screens noted at the crawlspace vents. Recommend further evaluation and repairs to prevent vermin intrusion.*
- *Damaged/hanging insulation noted in the crawlspace. Recommend further evaluation and repairs.*
- *Missing vapor barrier noted in the crawlspace. Recommend a continuous vapor barrier for the crawlspace to control moisture levels and prevent possible fungal growth.*
- *Blocked crawlspace vent noted on the rear side. Since this vent is blocked there is no longer crossed ventilation in the crawlspace. Recommend further evaluation and repairs by a qualified professional.*
- *The crawlspace stairs are loose and not properly attached. Recommend further evaluation and repairs.*
- *Suspect fungal growth observed. Recommend further evaluation and repairs following an approved remediation process.*

Suspect Fungal Growth/Loose Insulation - Crawlspace

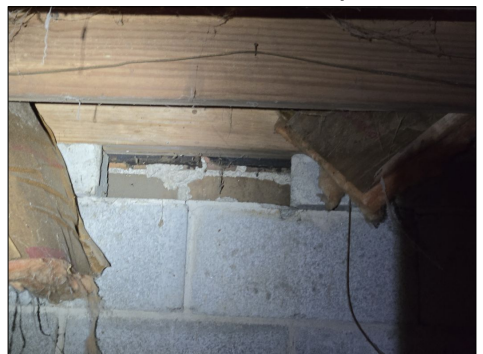
Blocked Vent - Rear Side of Crawlspace

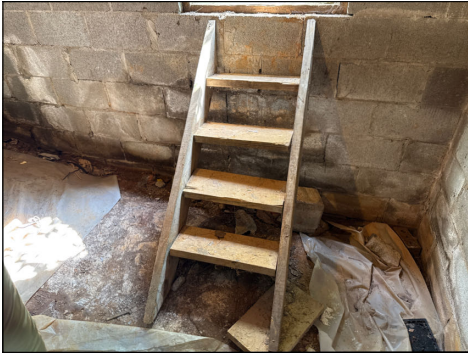
Loose/Not Attached Properly -  
Crawlspace Stairs

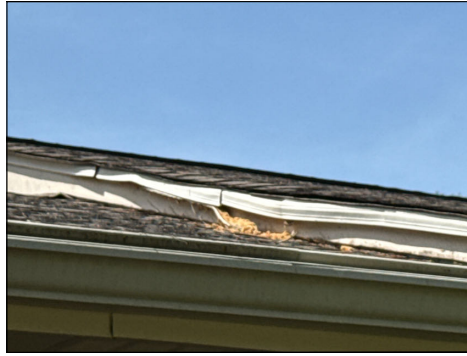
- *Damaged **drip edge** noted on the left side above the garage. Recommend further evaluation and repairs.*

Damaged Drip Edge - Left Side

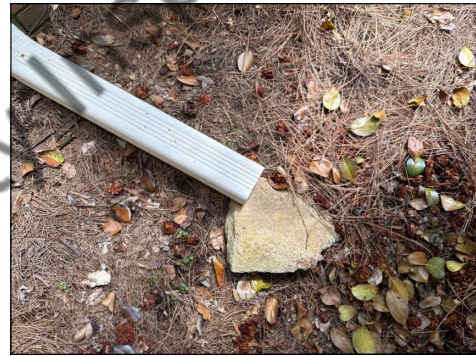
- *Damaged downspout noted on the rear side of the residence. Recommend further evaluation and repairs.*
- *Extensions/splash blocks missing or insufficient. Recommend installation to divert water away from the foundation.*

Missing Splash Block - Rear Side

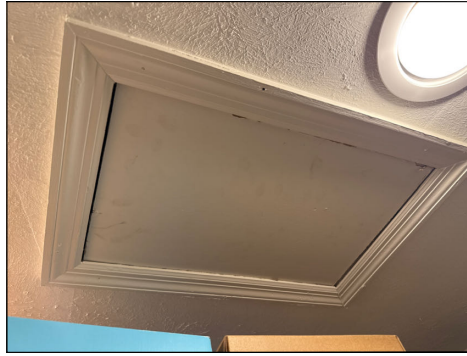
*Recommend adding weatherstripping and insulation for the attic door(s) for energy efficiency reasons.*

Recommend Weatherstripping/insulation - Master Closet

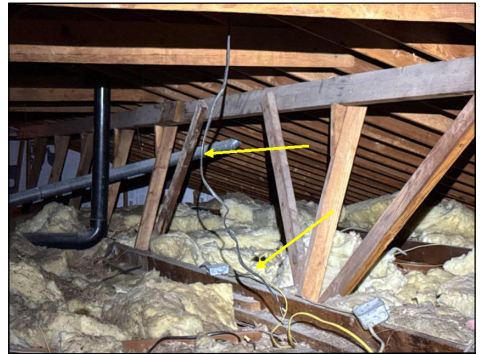
- *Open junction boxes were observed which is a safety concern. Recommend installing covers for safety reasons.*
- *Loose/hanging wires noted. Recommend adding wire nuts to the open-ended wired and then installing inside a junction box.*
- *Connections made outside a junction box which is a potential shock or electrocution hazard. Recommend adding a junction box so the wire connections are completely enclosed inside these boxes.*

Loose/Hanging Wire

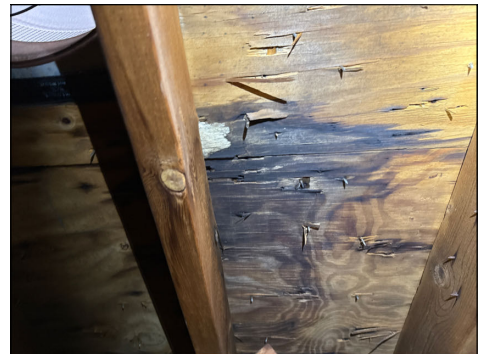
- *Moisture stains on the roof decking indicate a past or present leak. Area(s) were tested via electronic moisture meter/thermal imagery and found to be dry at the time of inspection. Recommend a qualified professional further evaluate for possible repairs.*
- *Gaps/holes in the attic should be sealed to prevent vermin and insect intrusion. Recommend further evaluation and repairs.*
- *Could not access all areas of the attic due to limited space.*

Moisture Stain - Rear Side

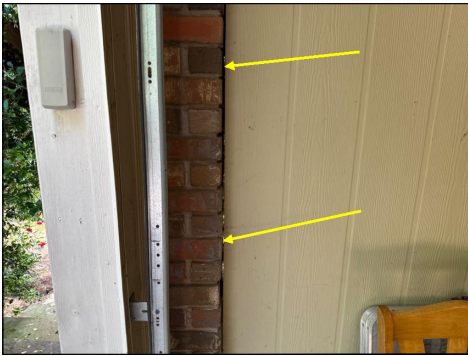
- Gaps noted in the left garage wall. Recommend further evaluation and repairs.
- Personal items prevented complete inspection. Recommend further inspection once items have been removed.

Gap - Left Garage Wall

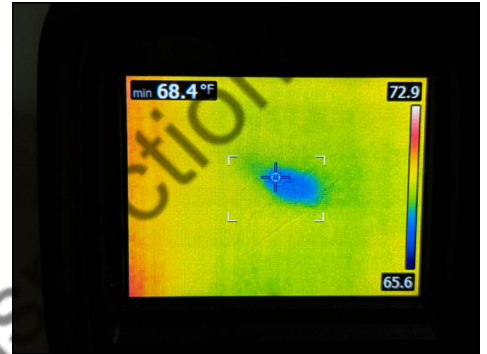
Page 22 Item: 2	Ceiling Condition	• Moisture stain(s) noted on the ceiling were tested using an electronic moisture meter/thermal imagery and found to be active with moisture at the time of the inspection. Recommend further evaluation and repairs.
Page 23 Item: 4	Electrical	• No power noted at the outlet. Recommend further evaluation and repairs.

- *Suspect fungal growth stains present on the ceiling. Recommend further evaluation and repairs.*
- *Moisture stain(s) noted on the Master ceiling were tested using thermal imagery and found to be dry at the time of the inspection. Recommend further evaluation and repairs.*
- *Moisture stain(s) noted on the ceiling were tested using an electronic moisture meter/thermal imagery and found to be active with moisture at the time of the inspection. Recommend further evaluation and repairs.*

Moisture Stain - Front Right  
Basement Bedroom

Wet

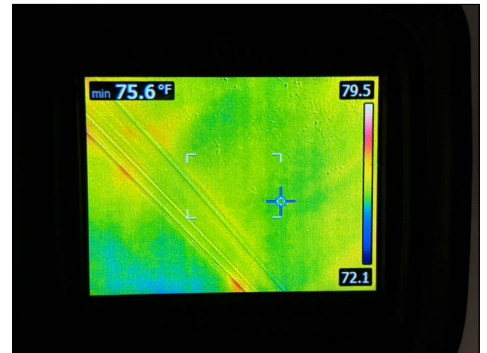
Moisture Stain - Master Bedroom

Dry

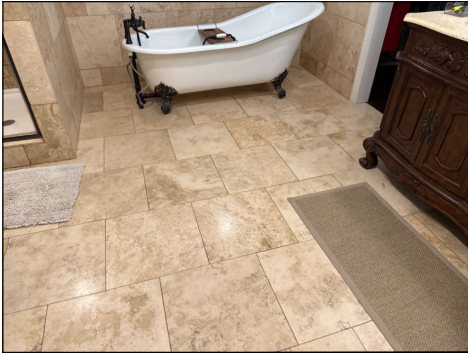
- *Uneven floor(s) noted. Recommend further evaluation by a licensed/qualified professional.*
- *Gap in flooring noted at the front door. Recommend further evaluation and repairs.*
- *Cracked tiles noted. Recommend further evaluation.*

Uneven Floor(s) - Master Bathroom

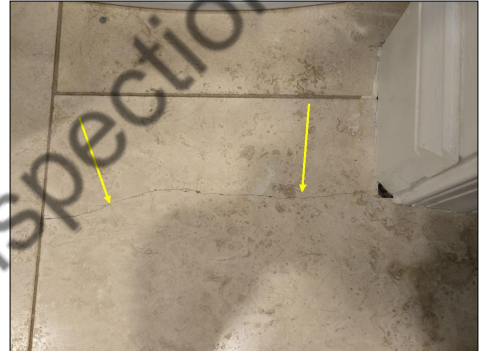
Cracked Tile - Master Bathroom

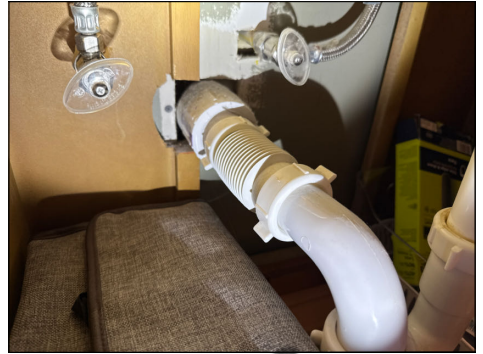
- *Flex drains are subject to frequent clogging. Recommend replacing with a non-flexible **PVC** pipe.*

Flex Pipe - Left Master Sink

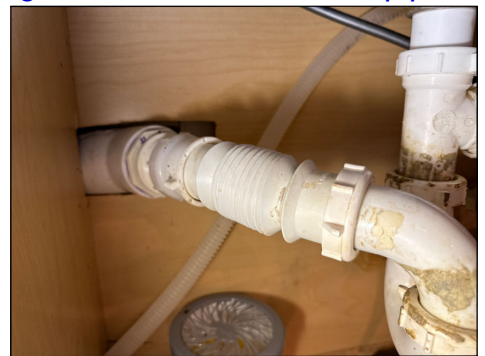
Flex pipe - Kitchen Sink

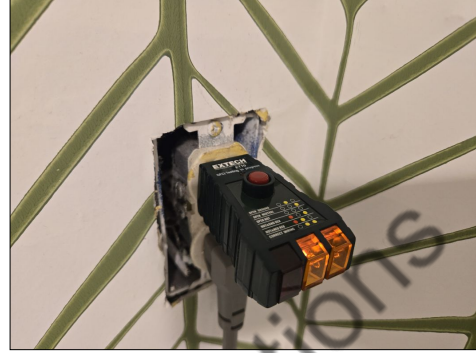
Missing Cover - Laundry Room

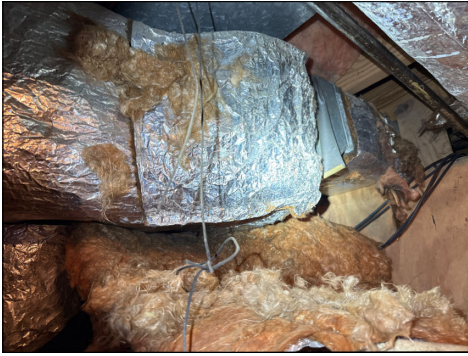
- *Insulation wrapping is torn/damaged in areas and should be addressed for energy efficiency. Recommend further evaluation.*
- *Insulation is missing/damaged and should be replaced/repared. Recommend further evaluation by a HVAC company.*

Torn/Damaged Ductwork -  
Crawlspace

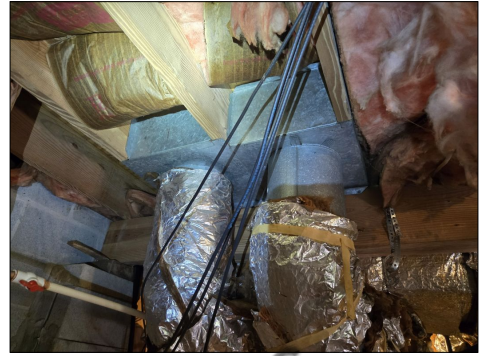
Missing Insulation - Crawlspace

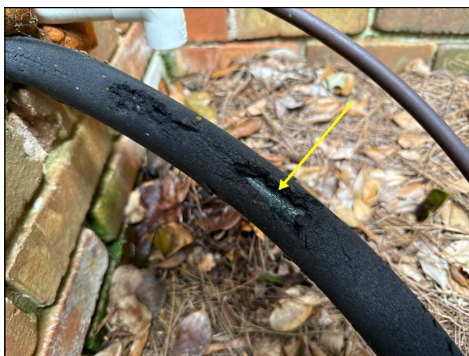
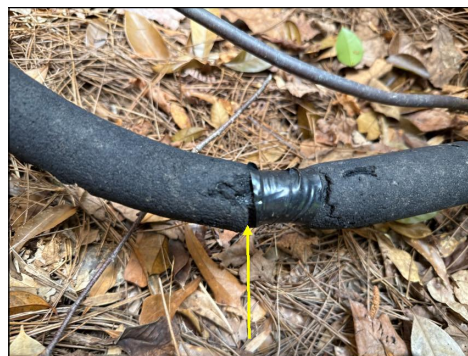
- *Missing/damaged insulation noted on the line set(s) near the A/C compressor. Recommend replacing all missing sections of insulation for energy's sake.*

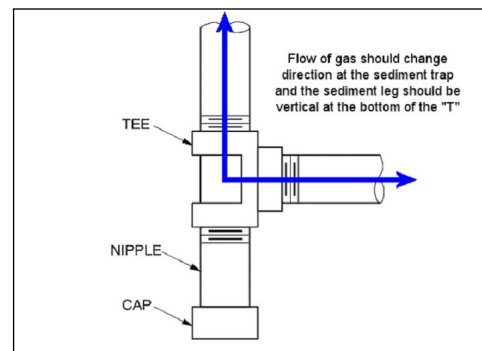
Improper T Fitting

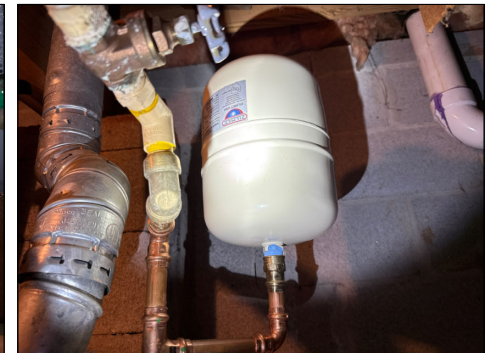
Improper TPR Install
