Site Talcott Glen Storm Sewer System

Date 9/25/2020

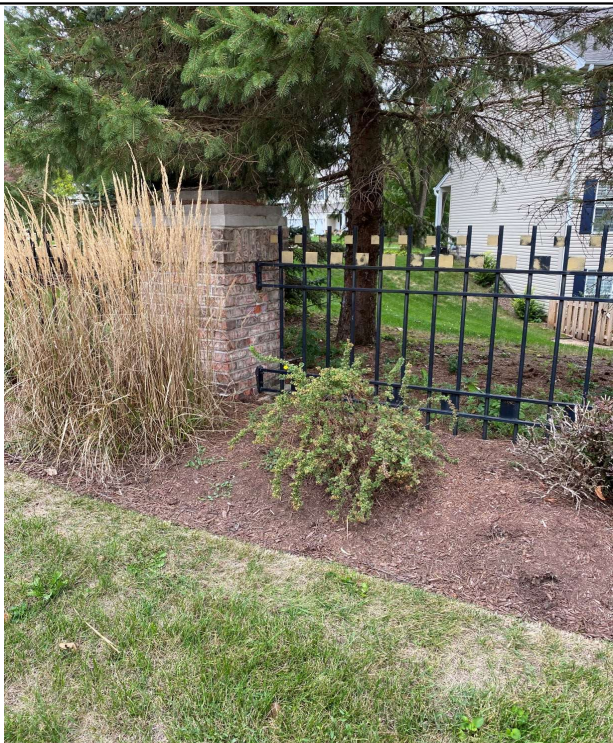
35

Subject Monumentation east side of entrance at Crystal Lake Avenue.

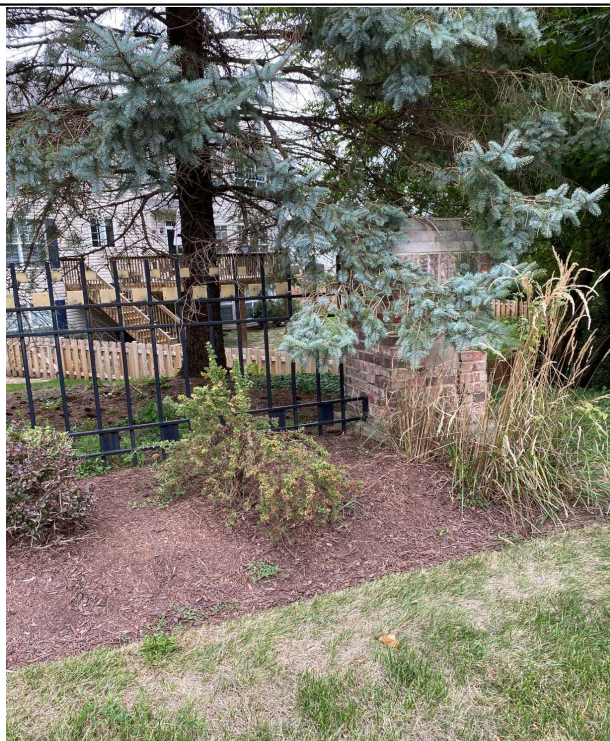
36

Subject Monumentation east side of entrance at Crystal Lake Avenue. Overgrowth of tree branches. Water damage to masonry, requires tuckpointing and brick replacement.

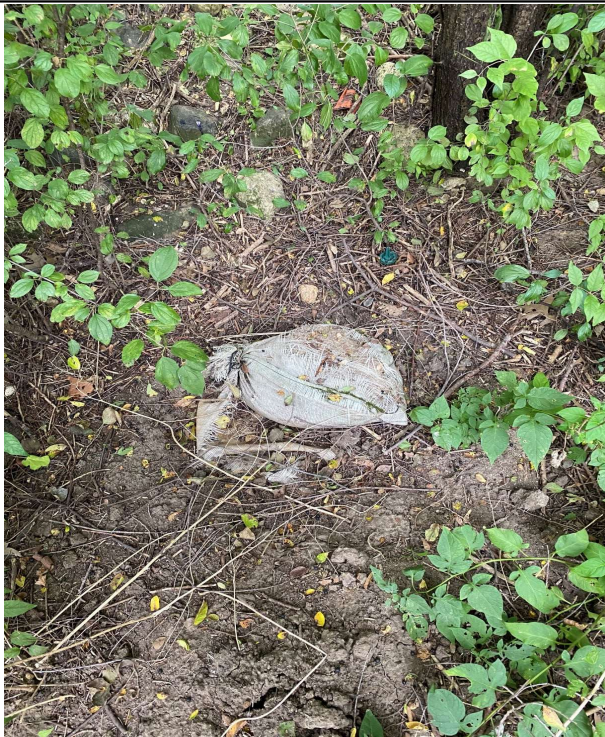
Subject	Manhole #6 behind 86 Talcott Avenue.	37
----------------	--------------------------------------	-----------

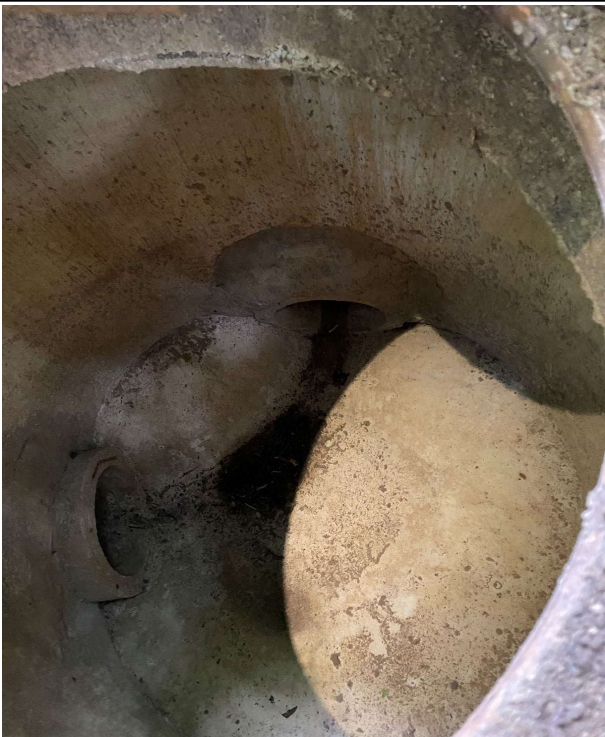
Subject	Manhole #6 behind 86 Talcott Avenue. Covered with broken sandbag. Clean, no sediment.	38
----------------	---	-----------

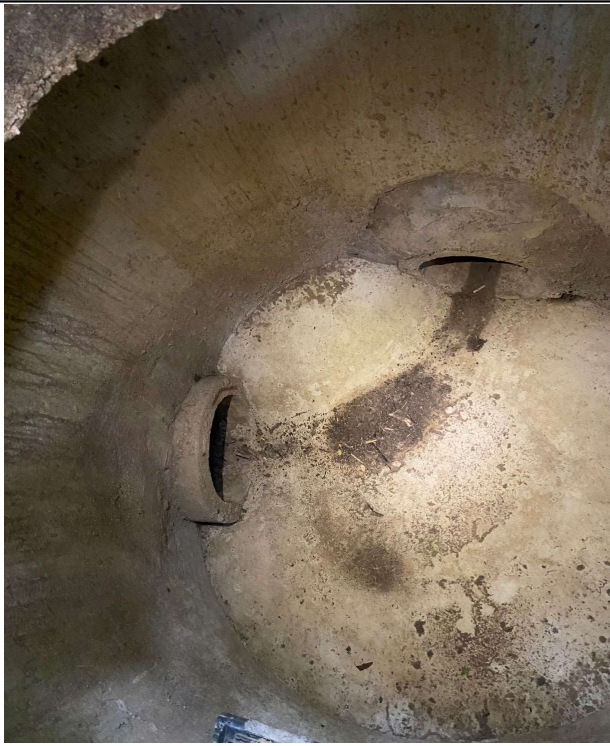
Subject	Manhole #6 behind 86 Talcott Avenue. Covered with broken sandbag. Clean, no sediment.	39
----------------	---	-----------

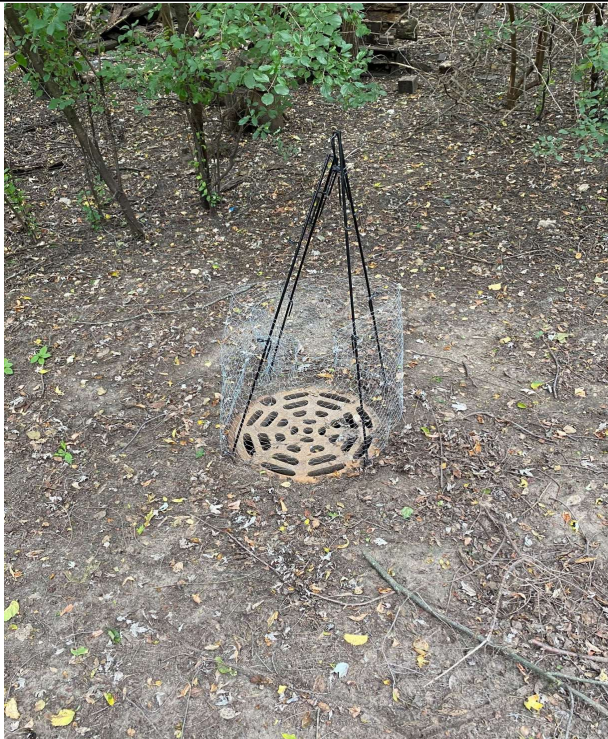
Subject	Dry Well #1 behind 88 Talcott with debris fence. Open grate lid should be solid lid.	40
----------------	---	-----------

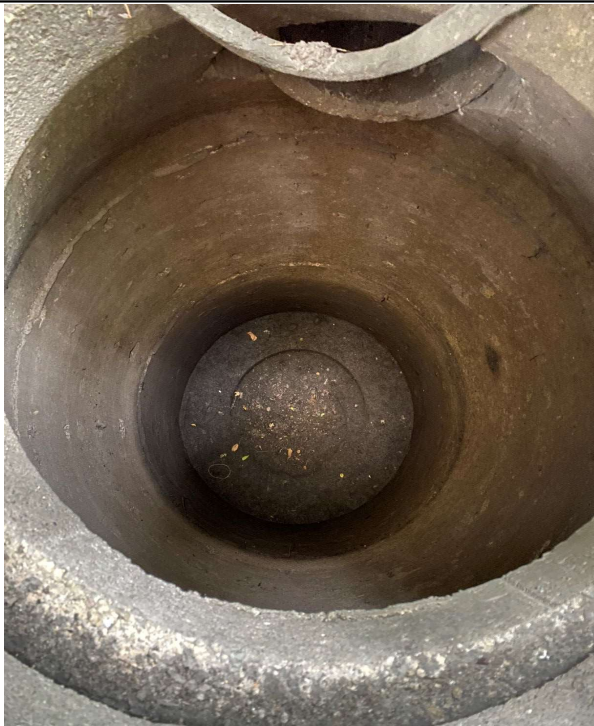
41

Subject Dry Well #1 behind 88 Talcott. Bottom of dry well observable - minor siltation.

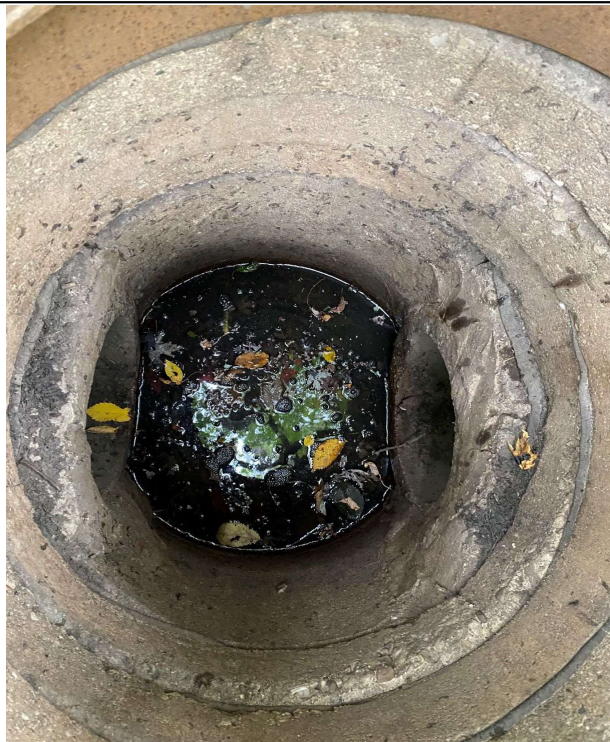
42

Subject Catch Basin #19. Approximately 13 inches of silt, 4 inches below invert.

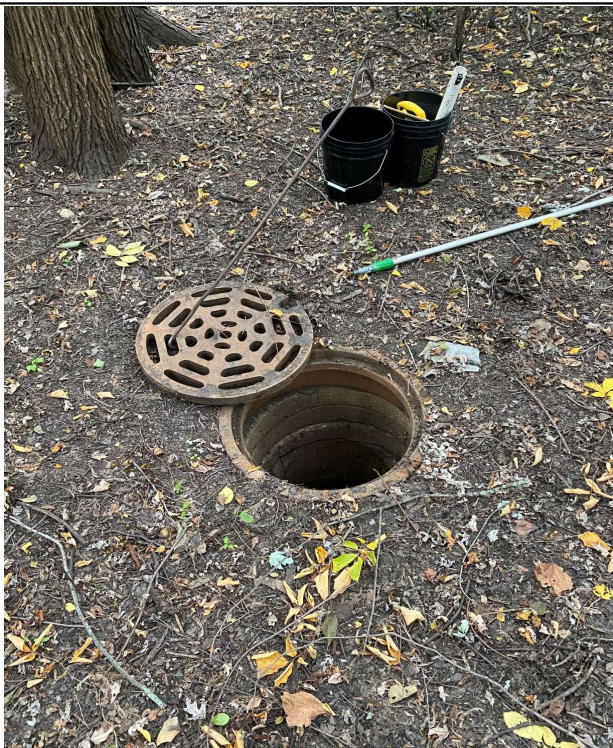
Subject	Catch Basin #19 behind 90 Talcott.	43
Site	Talcott Glen Storm Sewer System	
Date	9/25/2020

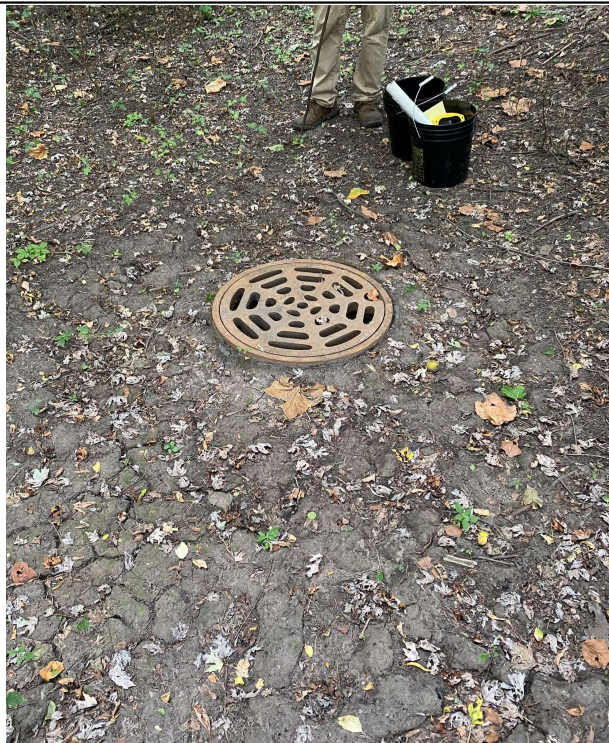
Subject	Dry Well #2 behind 90 Talcott.	44
Site	Talcott Glen Storm Sewer System	
Date	9/25/2020

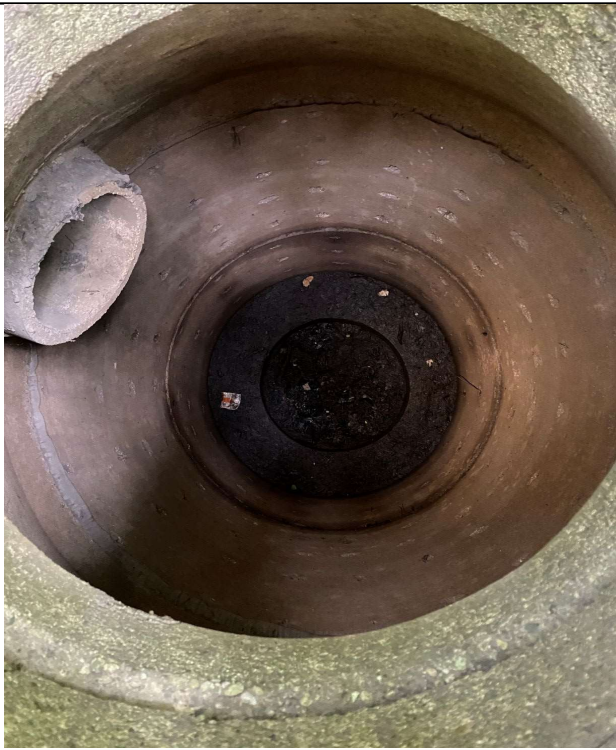
45

Subject Dry Well #2 behind 90 Talcott. Visible to bottom of well. Minor siltation.

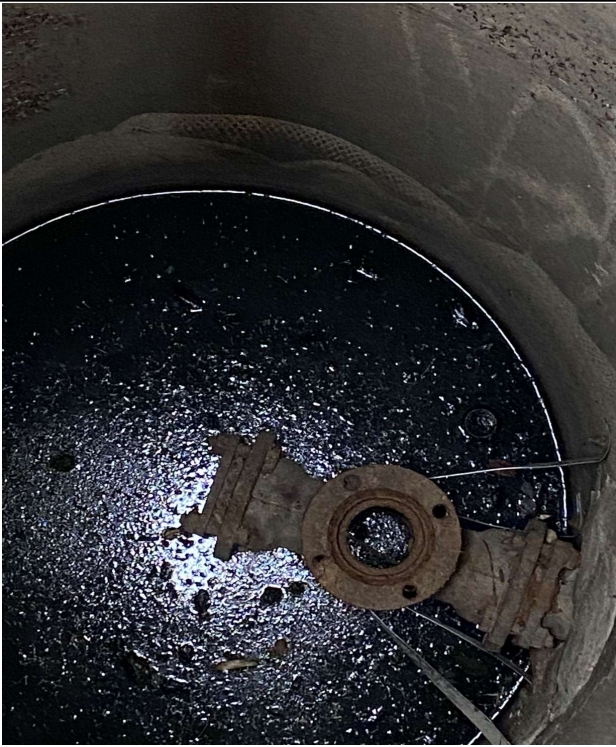
46

Subject Restrictor in City Catch Basin. 4-inch restrictor limits flow into 12-inch storm sewer pipe, can become plugged with leaves/debris from street.

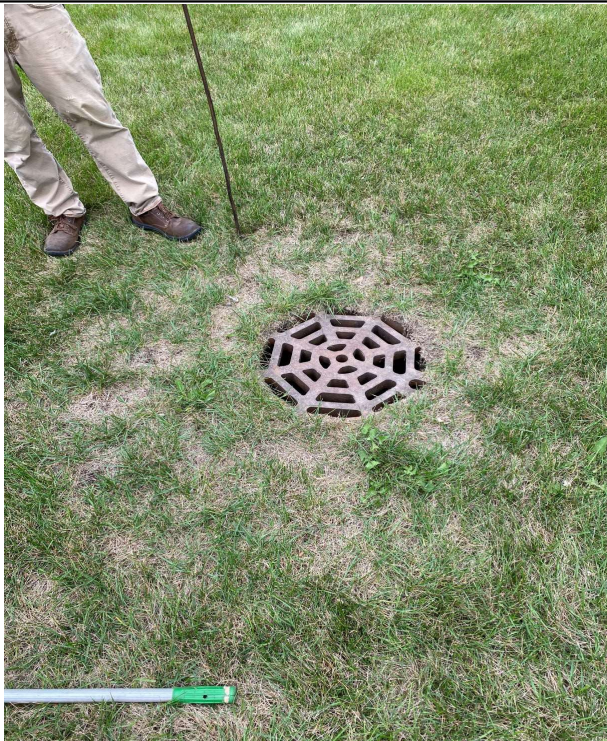
Subject	Catch Basin #30 in detention area.	47
Site	Talcott Glen Storm Sewer System	
Date	9/25/2020

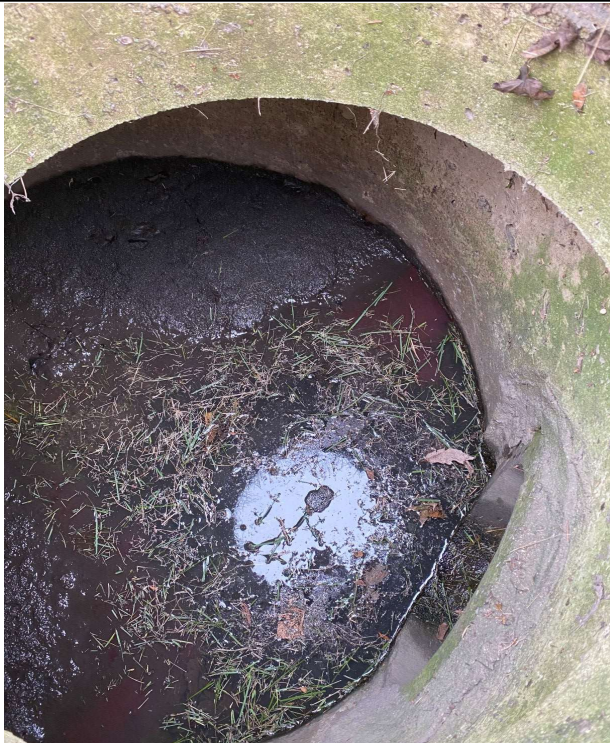
Subject	Catch Basin #30 in detention area. Bottom under water, up to invert. Variable silt thickness: 17 to 30 inches.	48
Site	Talcott Glen Storm Sewer System	
Date	9/25/2020

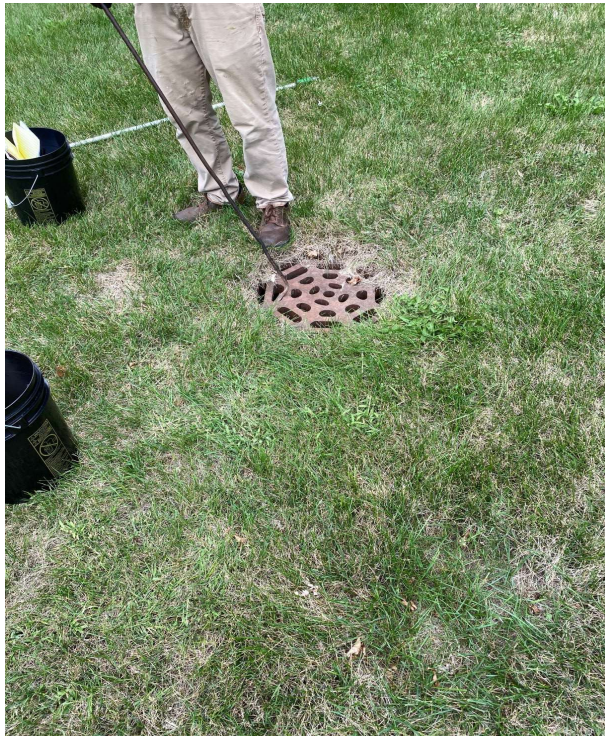
Subject	Catch Basin #20 in detention area.	49
----------------	------------------------------------	-----------

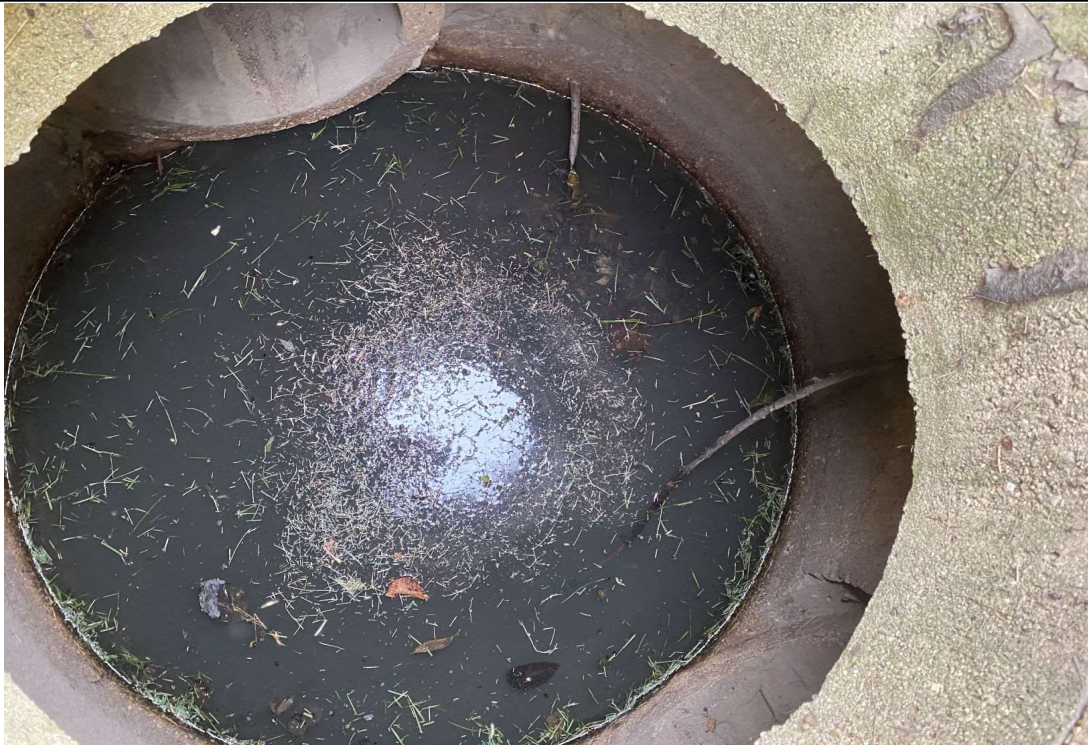
Subject	Catch Basin #20 in detention area. Bottom under water, to 4 inches below invert.	50
----------------	--	-----------

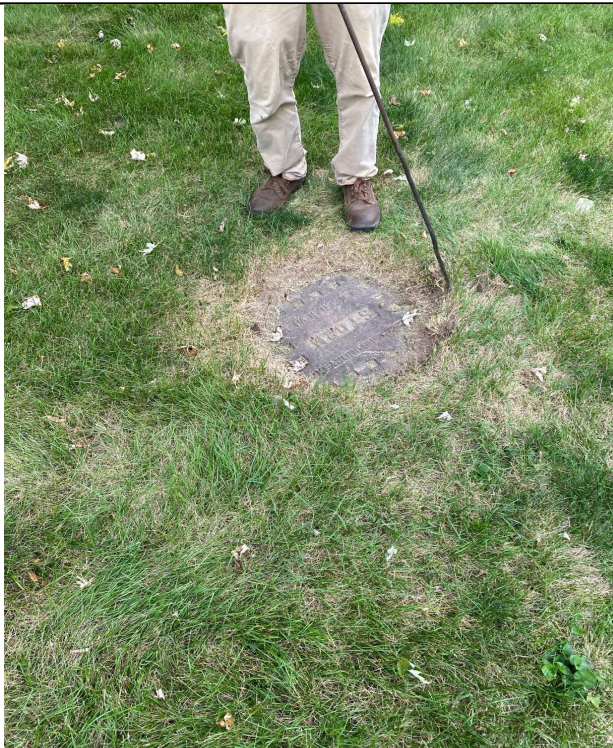
Subject	Dry Well #6 in detention basin.	51
----------------	---------------------------------	-----------

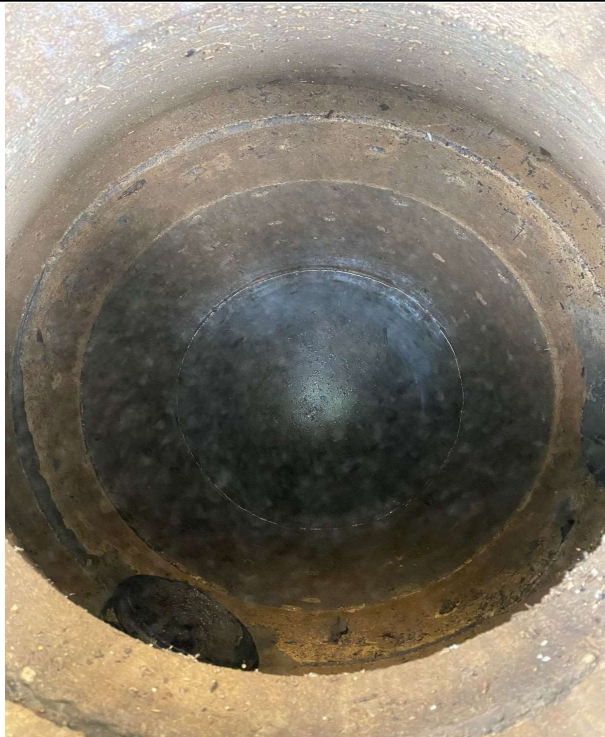
Subject	Dry Well #6 in detention basin. Water and undetermined thickness of silt.	52
----------------	---	-----------

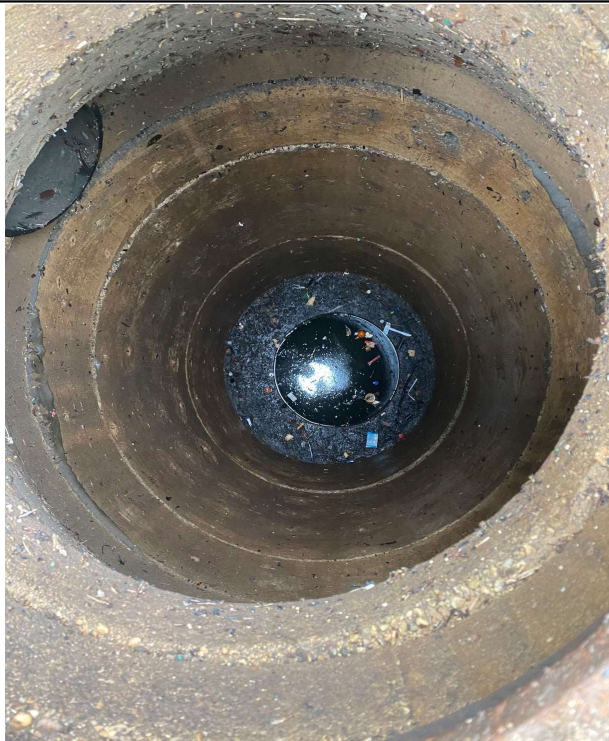
53

Subject Dry Well #3 in detention basin. Visible to bottom. Minimal/no siltation.

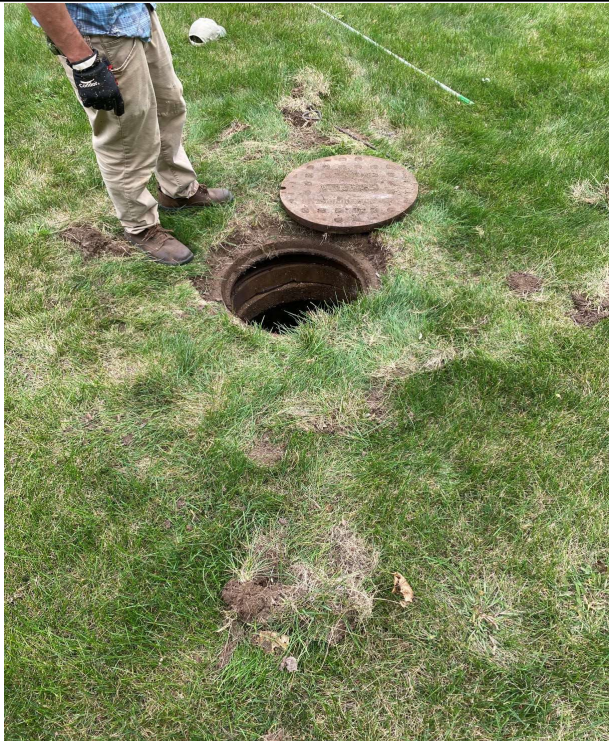
54

Subject Dry Well #4 in detention basin.

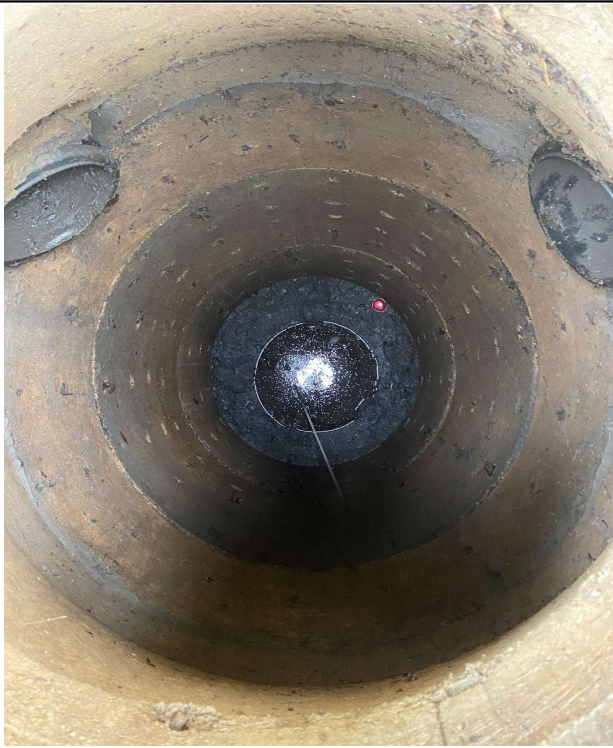
55

Subject Dry Well #4 in detention basin. Visible to bottom. Minimal/no siltation.

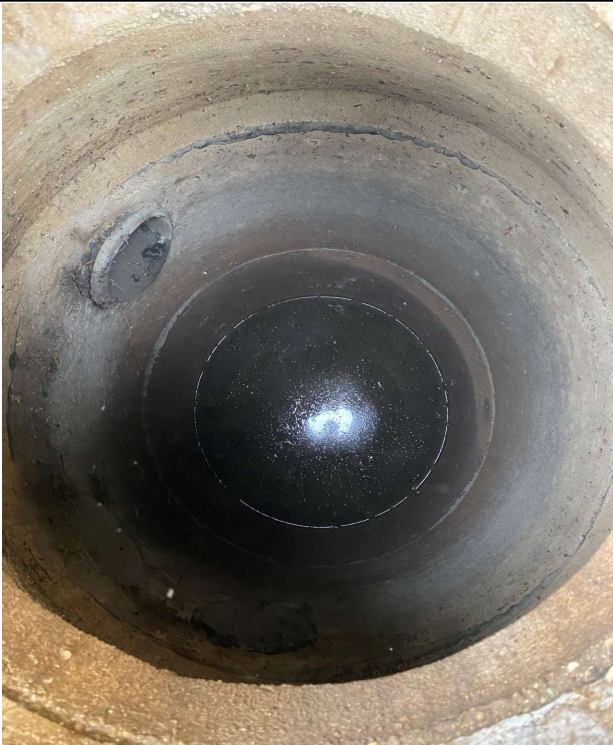
56

Subject Dry Well #3 in detention basin. Bottom under approx 6 feet of water.

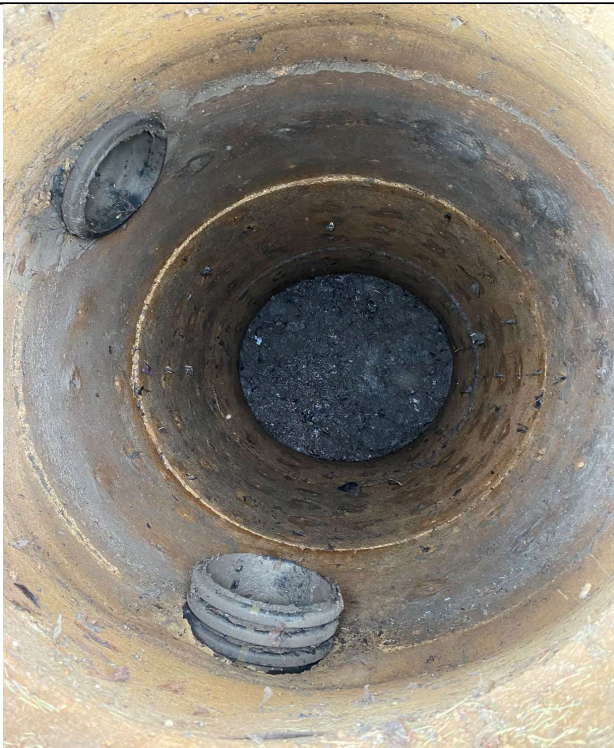
Subject	Dry Well #7 in detention basin. Dry silt at bottom of well, approx 6 inches sediment.	57
Site	Talcott Glen Storm Sewer System	
Date	9/25/2020

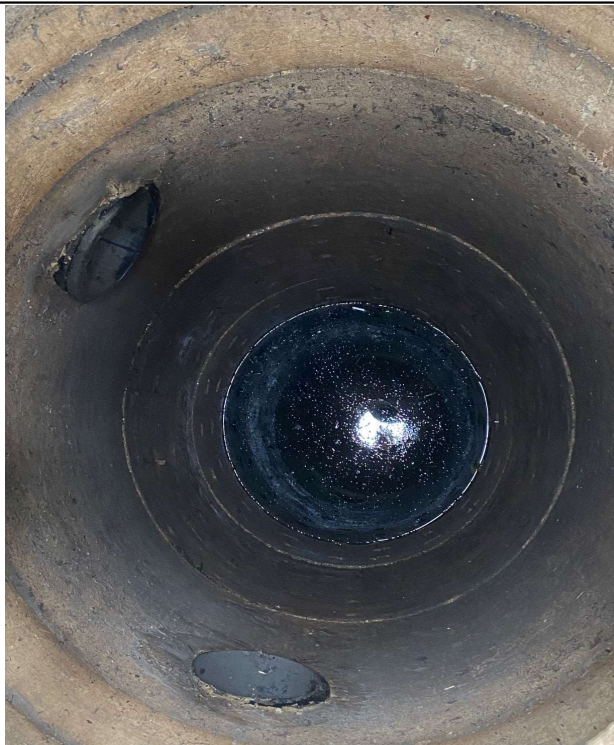
Subject	Dry well #8 in detention basin. Bottom of well under approx 6-1/2 feet water. Minimal siltation (as measured by pole).	58
Site	Talcott Glen Storm Sewer System	
Date	9/25/2020

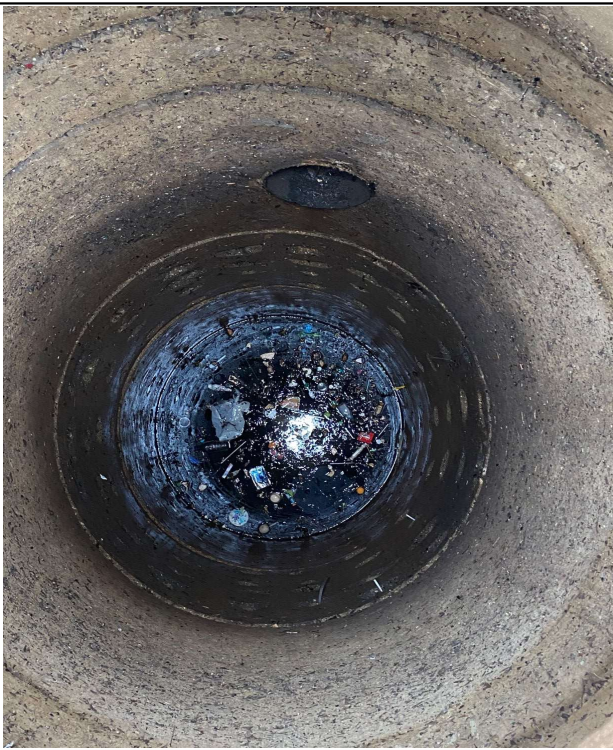
Subject	Dry Well #9 in detention basin. Bottom of well under approx 6 feet water. Floating debris.	59
Site	Talcott Glen Storm Sewer System	
Date	9/25/2020

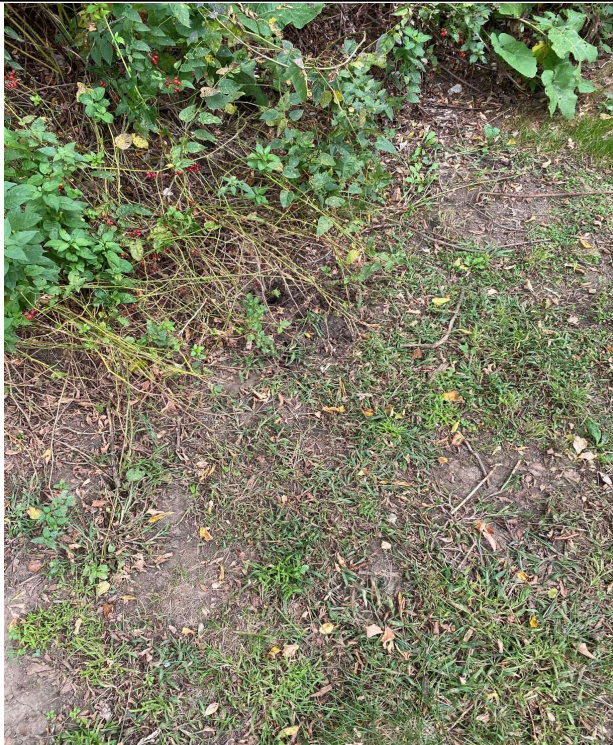
Subject	Inlet #8 behind 531 Primrose, covered with soil and grass.	60
Site	Talcott Glen Storm Sewer System	
Date	9/25/2020

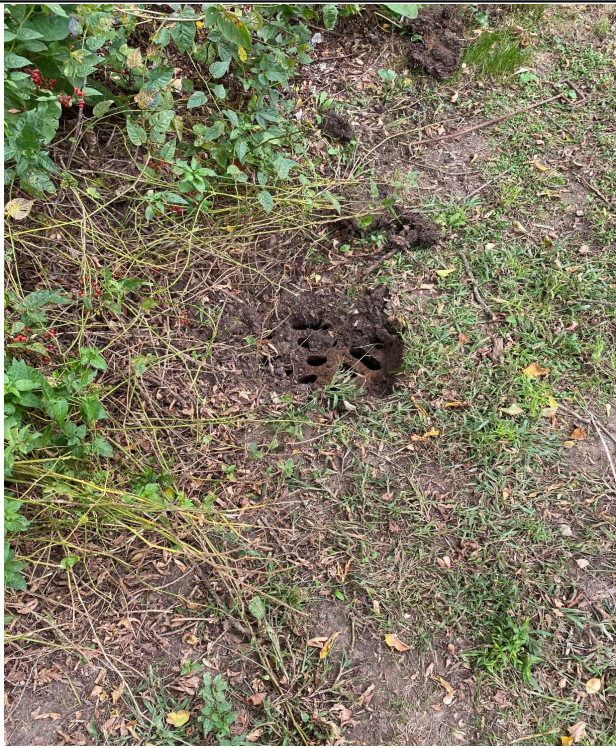
Subject	Inlet #8 behind 531 Primrose, in process of uncovering.	61
----------------	---	-----------

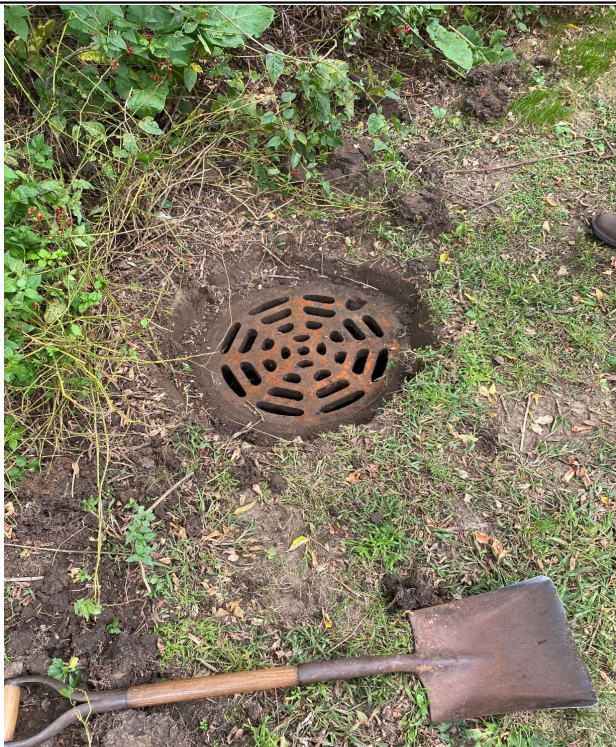
Subject	Inlet #8 behind 531 Primrose, open grate lid revealed.	62
----------------	--	-----------

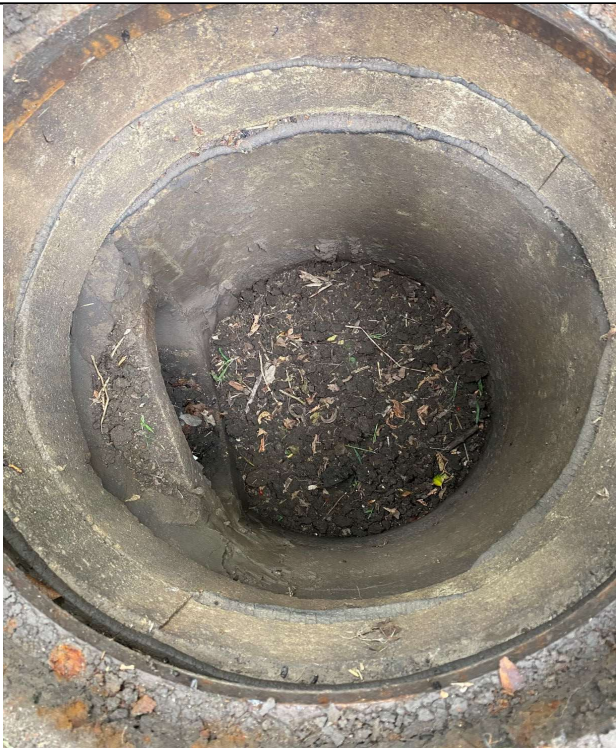
Subject	Inlet #7 front yard of 510 Primrose at border with 76 Talcott. Approx 1/2 sediment.	63
Site	Talcott Glen Storm Sewer System	
Date	9/25/2020
