ENGINEERING/RESERVE ANALYSIS  
FOR  
TALCOTT GLEN HOMEOWNERS ASSOCIATION

PREPARED FOR  
TALCOTT GLEN HOMEOWNERS ASSOCIATION

PREPARED BY  
CODER TAYLOR ASSOCIATES, INC.

SEPTEMBER 4, 2009 - Revised

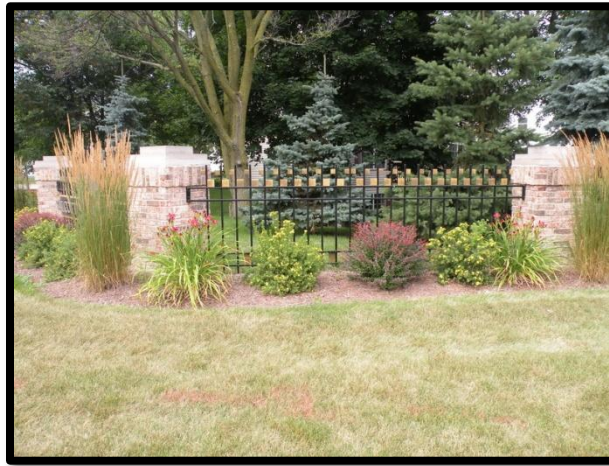
Photograph 0003

- B) **Wrought Iron Fence** – was recently repainted and presently is in satisfactory condition. Painting most likely will be required approximately every ten (10) years. Anchorage should be checked when the tuck pointing is completed. The photograph below shows a typical section of fencing.

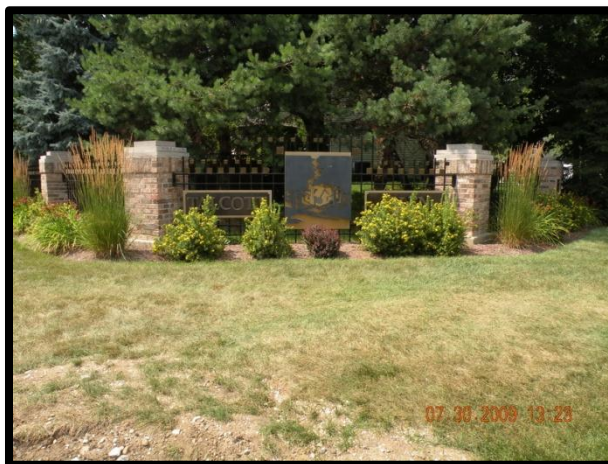
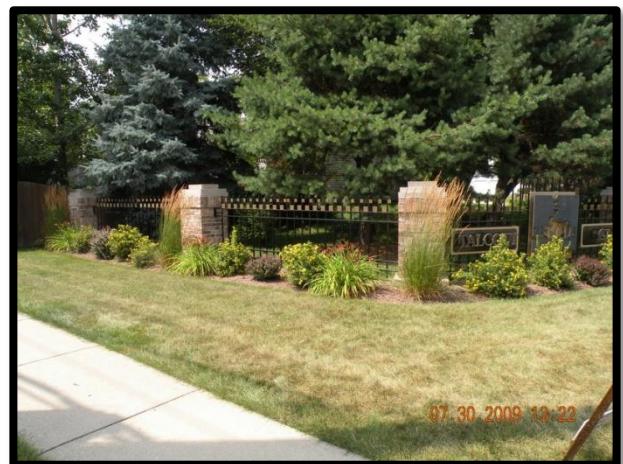
- C) **Signage** appeared in satisfactory condition at the time of our review. Painting will be required every ten (10) years. The sign is mounted very low and is difficult to see from a vehicle passing by.

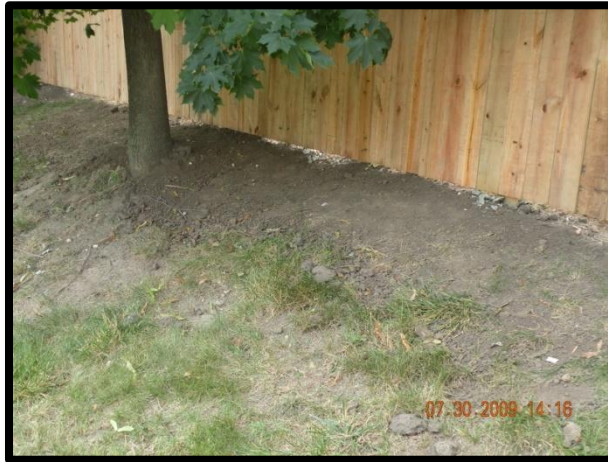
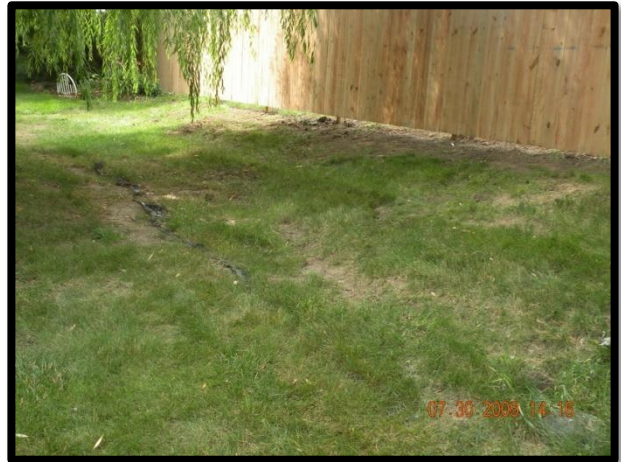
- 1) Grass Areas are generally in satisfactory condition except as noted below.
  - a) Retention area requires seeding across the rear slope as shown in the photograph below.

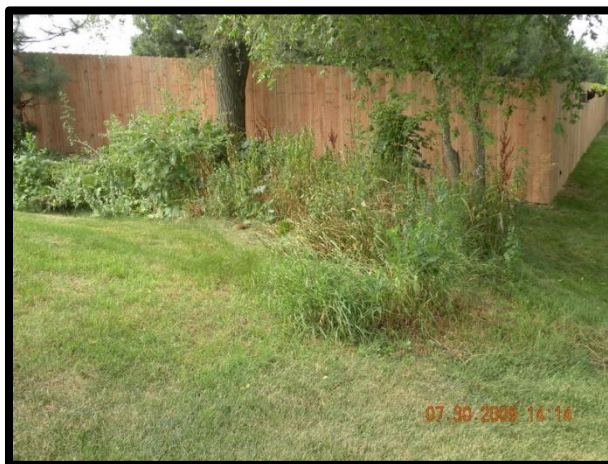
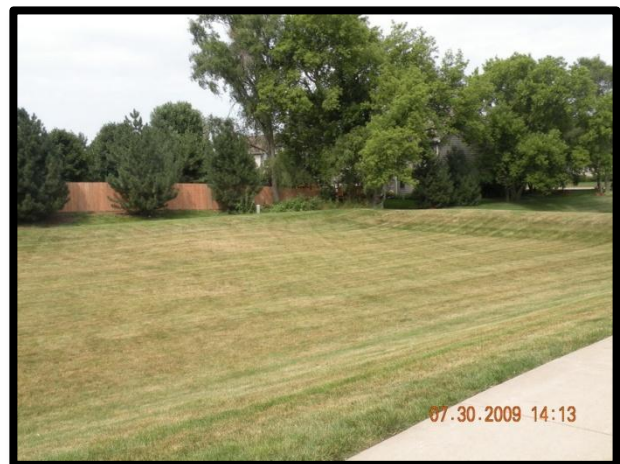
- 4) **Northwest Retention Pond** Very few plantings are provided in this area. There is the potential to upgrade the area for some type of recreational use. Over grown area at northeast corner requires clean-up as shown in the photograph below.

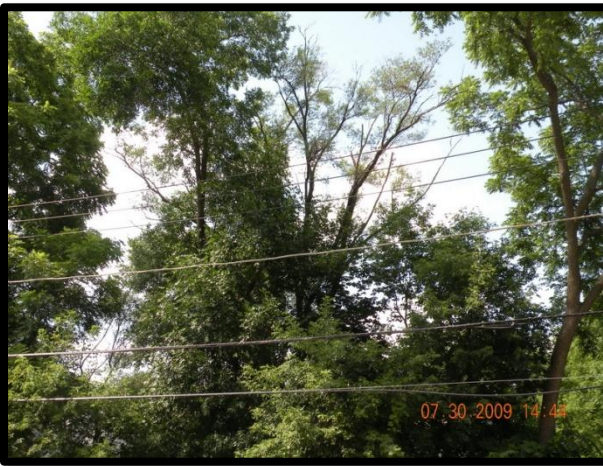
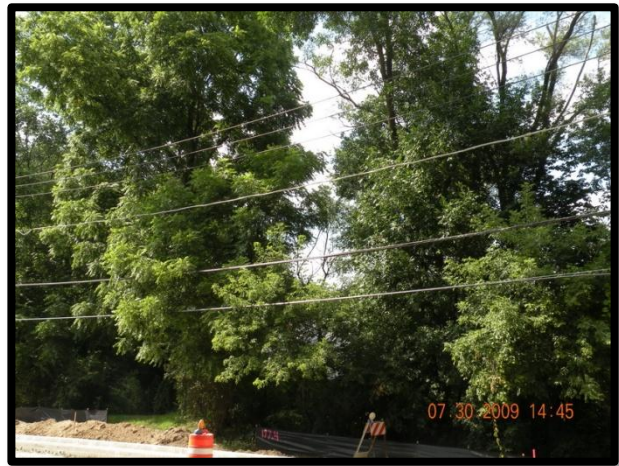
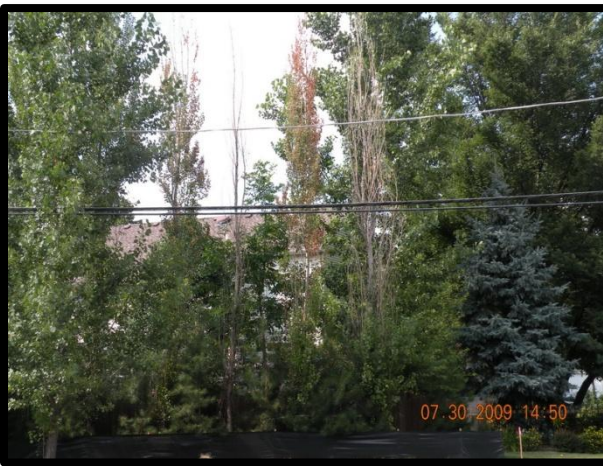
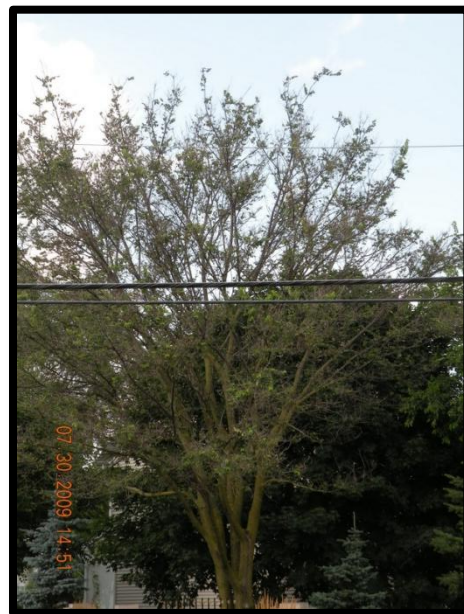
- 1) Between R.O.W. and sidewalk along Crystal Lake Avenue is grossly overgrown and requires major clean up. We suggest a proactive attitude by the Association toward the city may be helpful. There are many dead and/or diseased trees in this area. The diseased trees will have a negative effect on the remaining trees in the Association. The photographs below show the typical conditions observed.

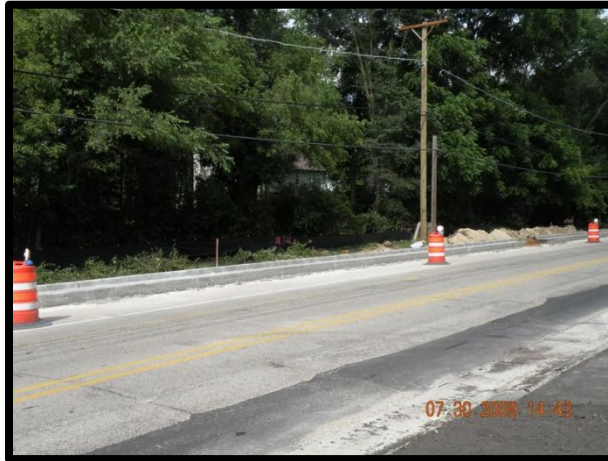
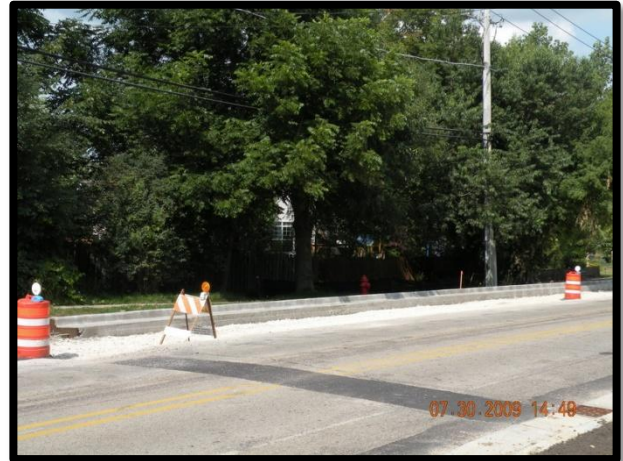
Major trimming and pruning is required along Crystal Lake Avenue as shown in the photographs below.

The responsible parties should be encouraged to get the required work accomplished.

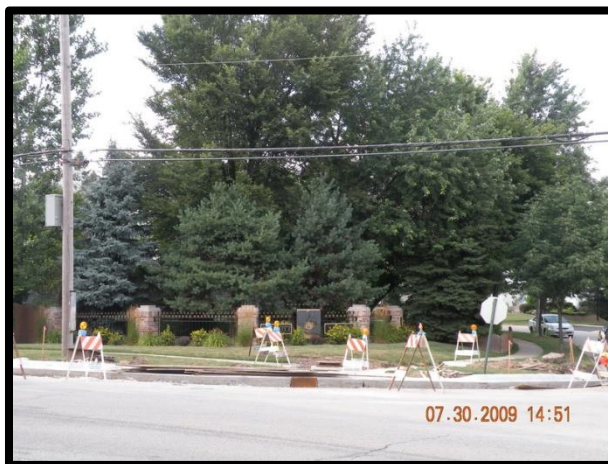
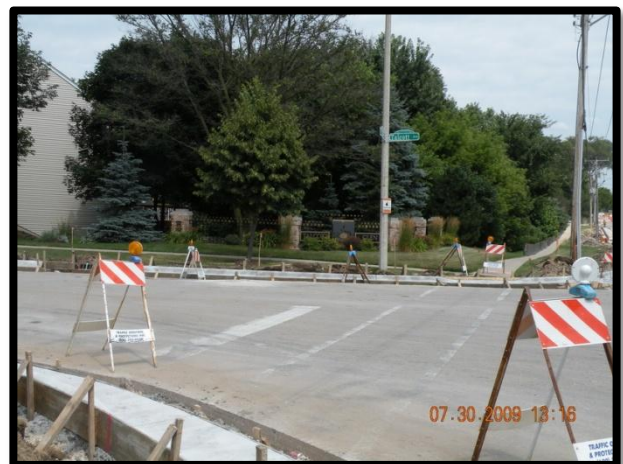
- 2) Entry trees are too close together and have become deformed. Major thinning is required as shown in the photographs below.

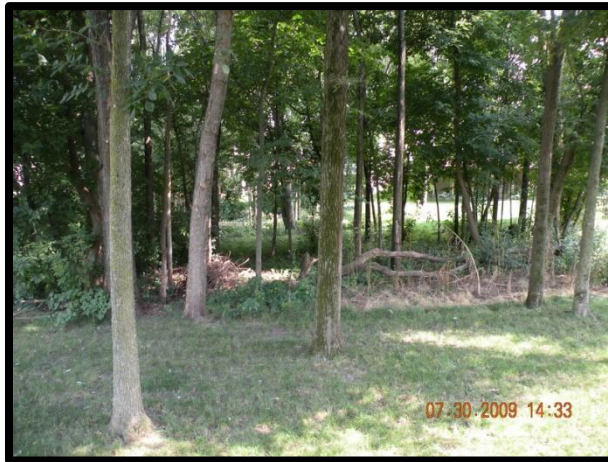
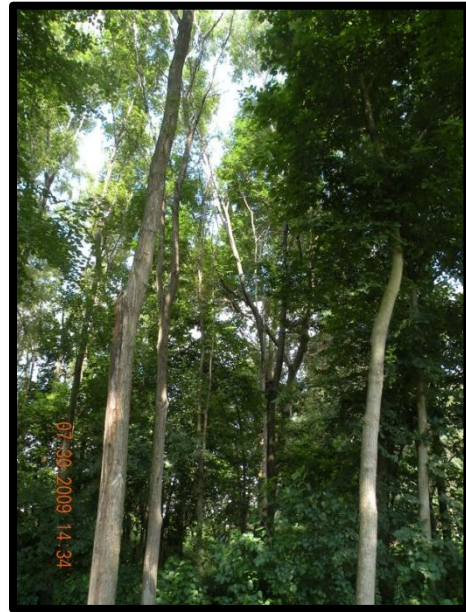
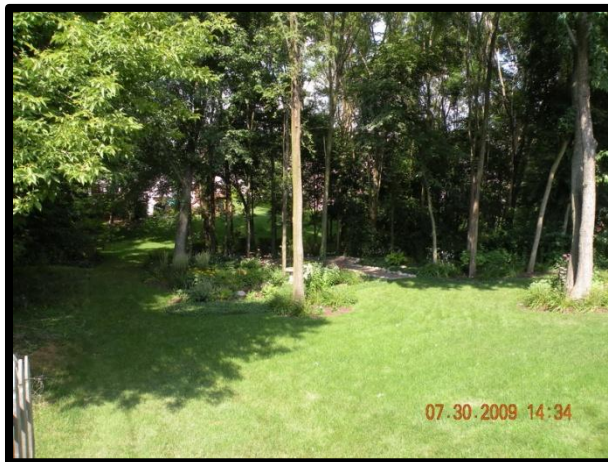
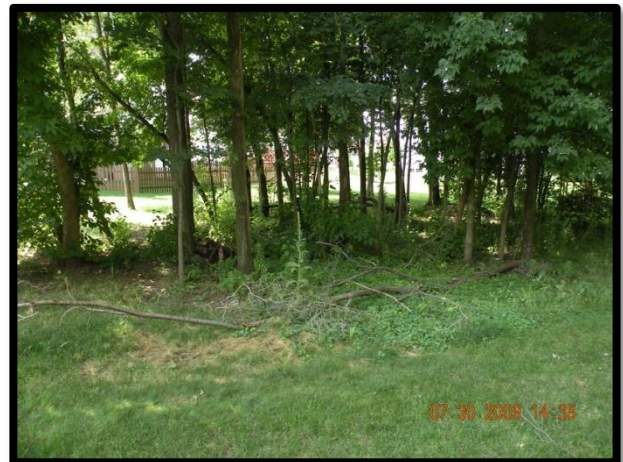
- 3) Center area of the circle contains many dead and possibly diseased trees. We strongly suggest an arborist be consulted on how to go about cleaning up this area. Potentially many of the trees could be affected negatively if proactive thinning and removal is not begun. Photographs below show the seriousness of the existing condition.

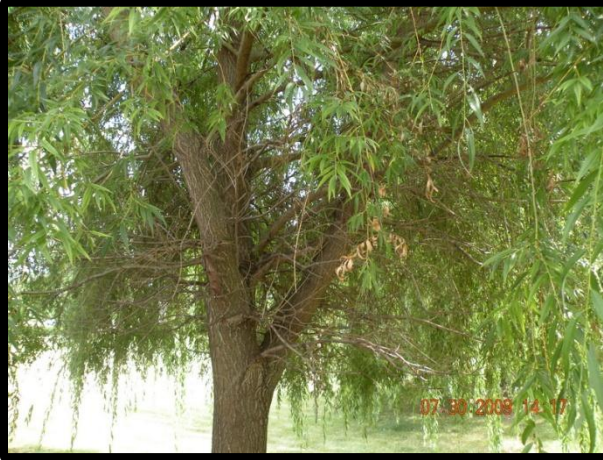
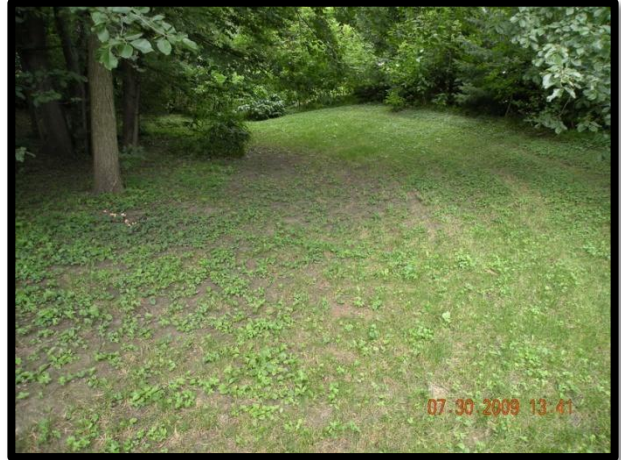
- 4) **Detention Areas** are in desperate need of punning and trimming as shown in the photographs below.

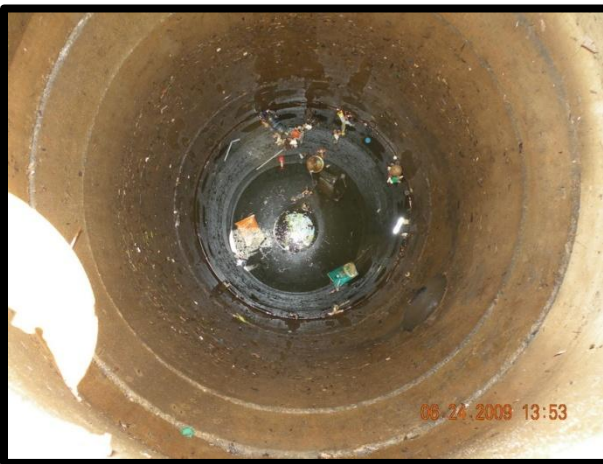
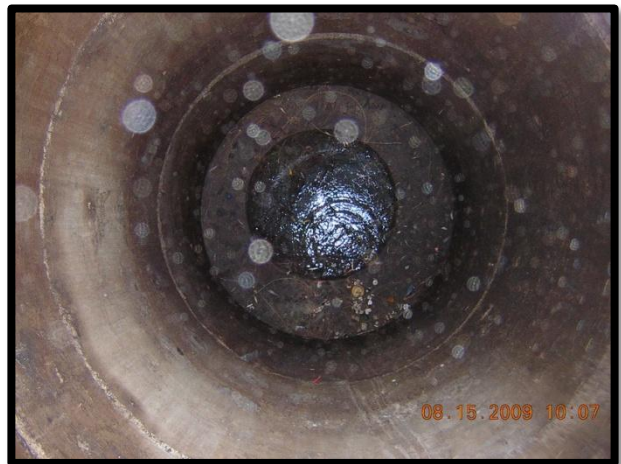
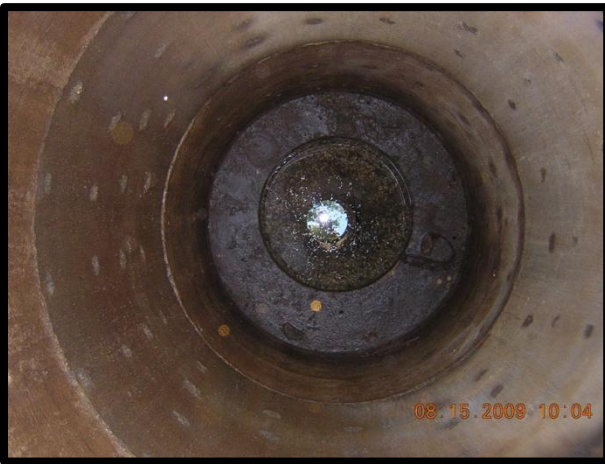
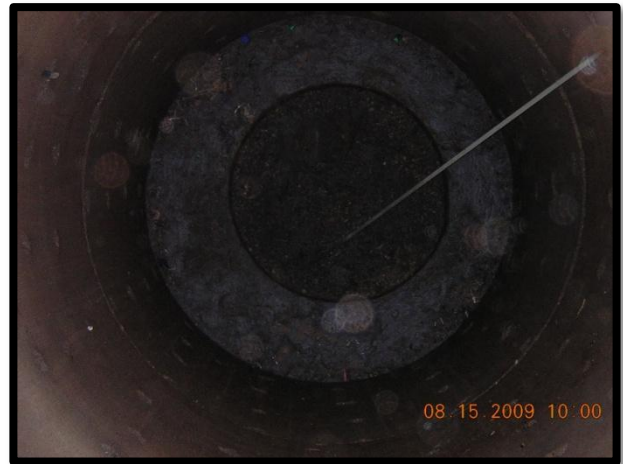
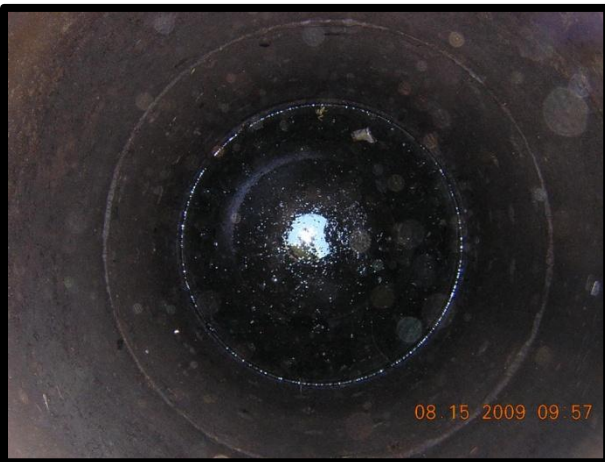
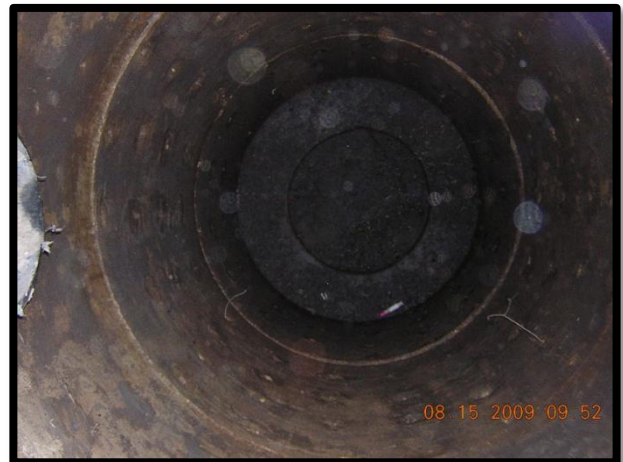
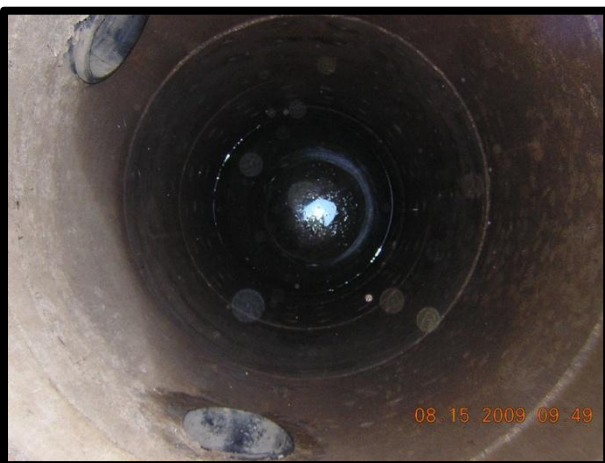
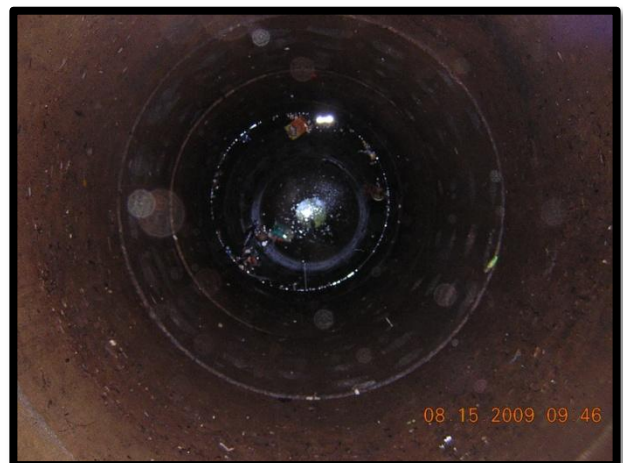
- 1) **Drywells (cleaning)** is required every fifteen (15) years. Cleaning will promote more efficient absorption of storm water into the ground. Photographs show conditions observed.

Drywell functionality is fading and Talcott Glen Homeowner's Association should plan for upgrading the existing drywell system. In today's dollars we estimate the cost to be \$100,000.00.

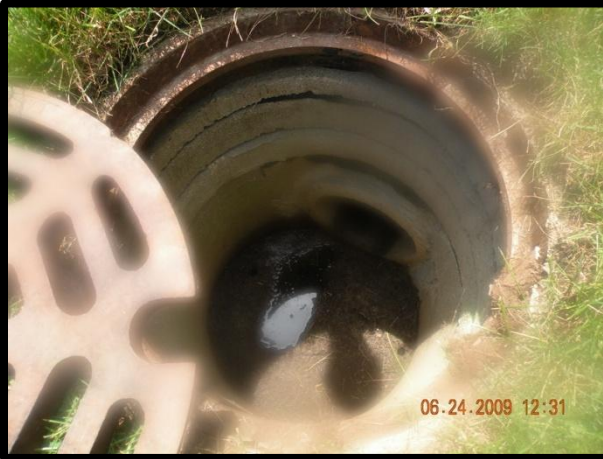
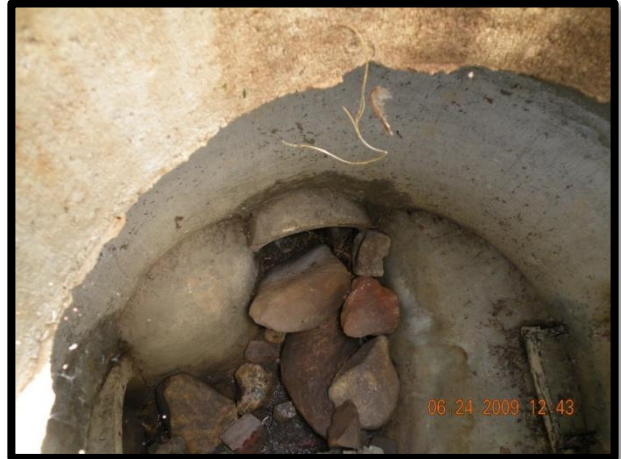
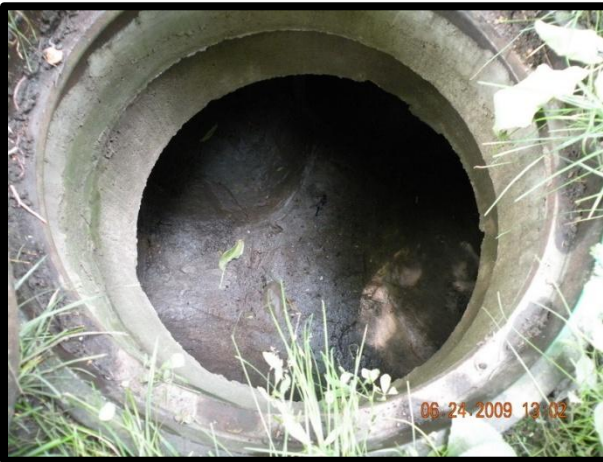
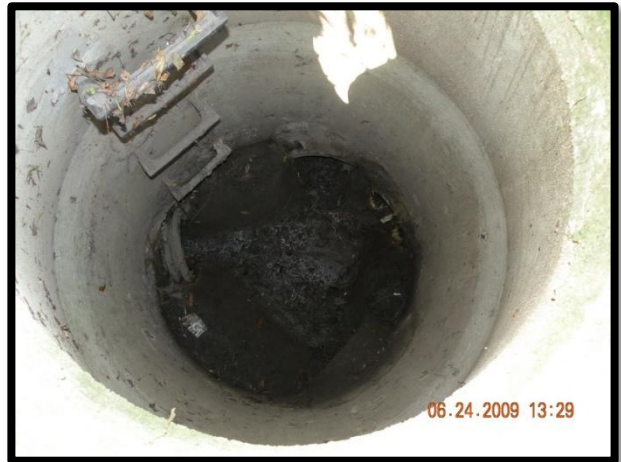
- 2) **Manhole and catch basin** cleaning is required every five (5) years. Photographs show some of the conditions observed.
