Inspection Report

Michael J. Turner Home Inspections LLC

1234 Home Inspection Street

Property Type Single Family Home - **New Construction**

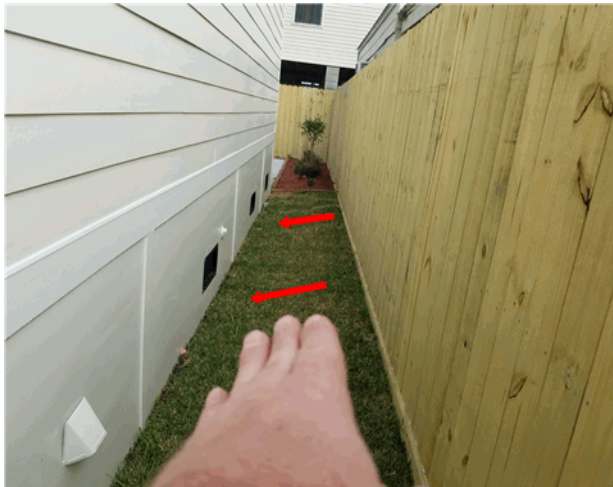
1. The grading slopes toward foundation @ right side. We recommend re-grading to assure all water drains away from the home's foundation to prevent water entry and/or movement to foundation.
2. Pressure treated wood skirting with composite fiber cement board touched the ground. Whenever materials touch the ground moisture related conditions (wicking) can occur. Wood to ground contact is also conducive to wood destroying insects (termites). Clearance should be provided

Grade slopes toward home @ right side

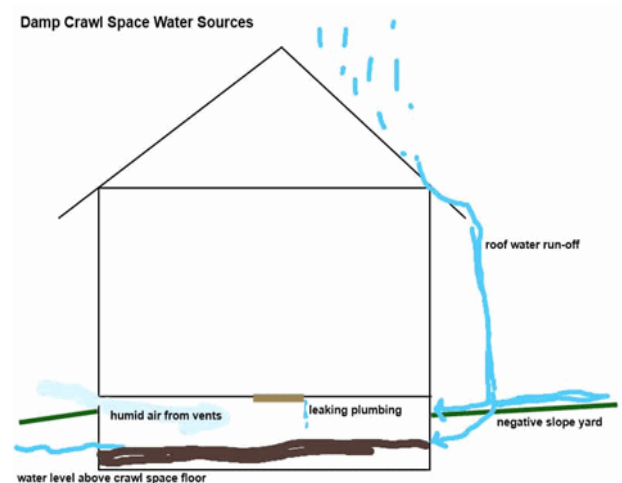
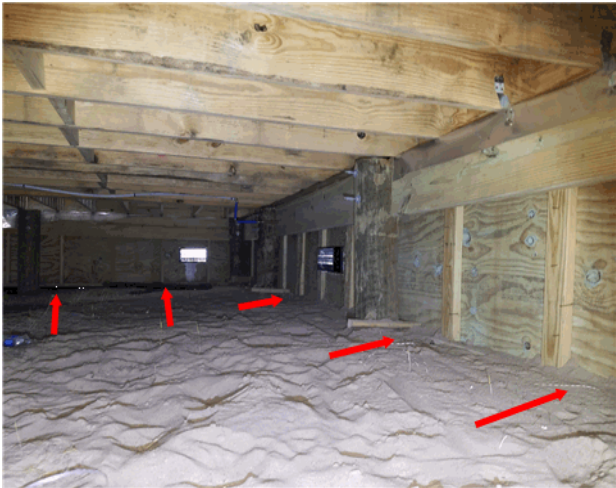
Wood to ground contact

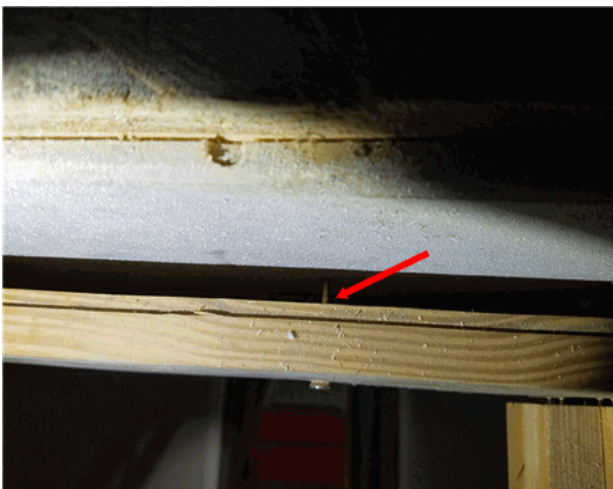
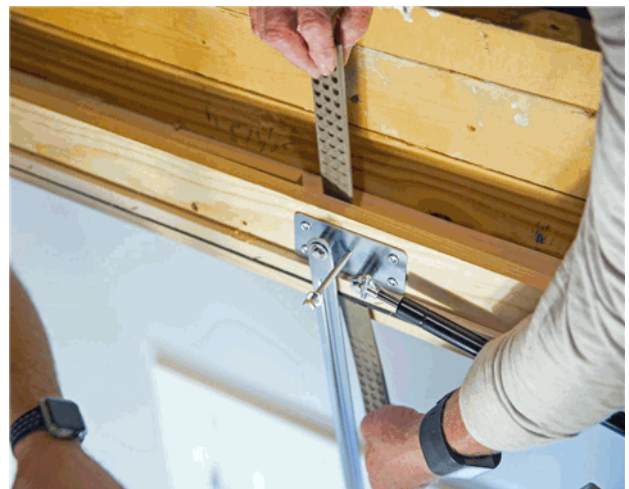
Shims missing between rough frame opening and attic stair casing at hall. A shim is a thin and often tapered or wedged piece of material, used to fill small gaps or spaces between objects. Shims are typically used in order to support, adjust for better fit, or provide a level surface.

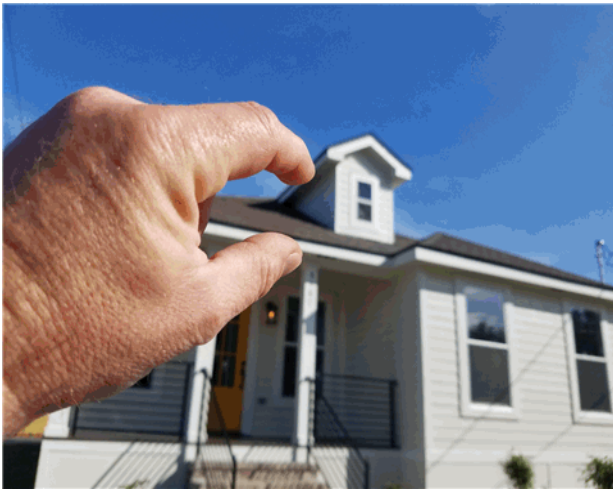
1. The exterior composite fiber cement touched the roof shingles at dormer. To prevent wicking or moisture related damage we recommend proper clearance be maintained. Refer to James Hardie siding installation guide.
2. Openings at exterior walls and/or trim. Recommend sealing **all** openings to prevent water penetration and insect intrusion "including skirting".

Improper clearance @ dormer siding and shingles.

A 1/4-in. clearance must be maintained between James Hardie® siding and trim products and any horizontal flashing.

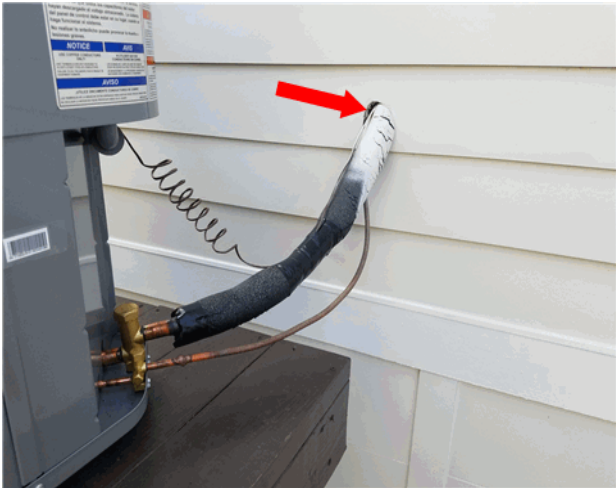
Seal openings

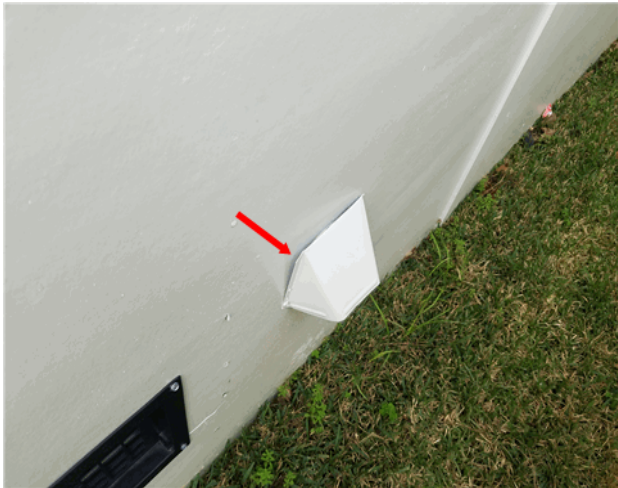
Secure dryer vent and seal

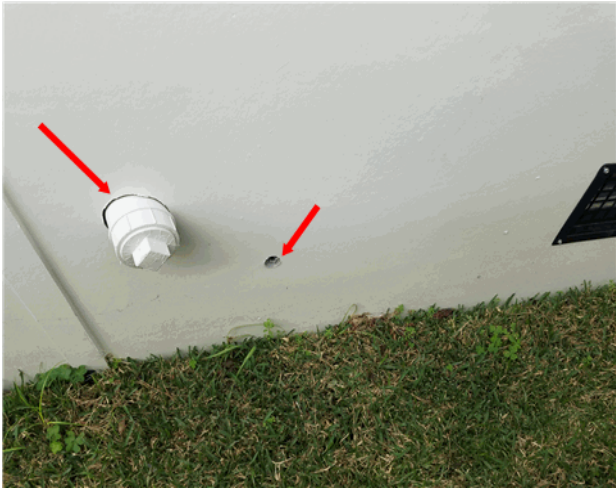
Seal openings

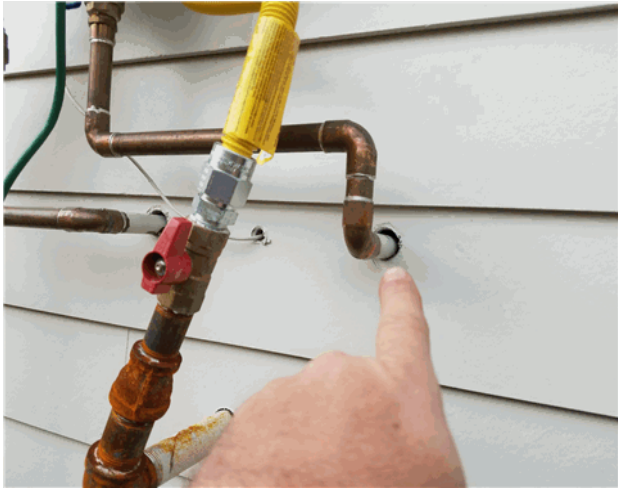
Seal openings @ water heater

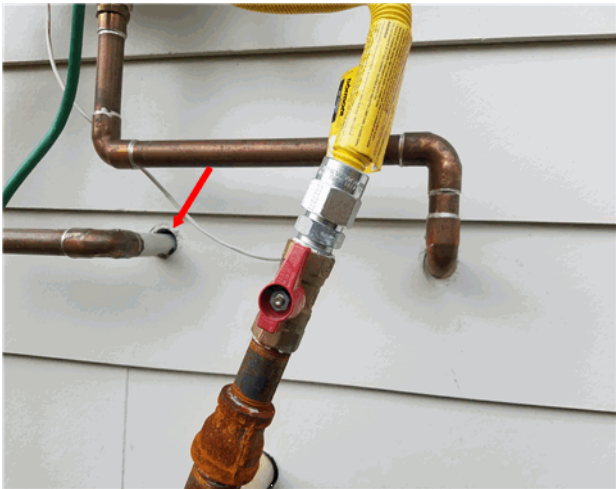
Seal openings @ water heater

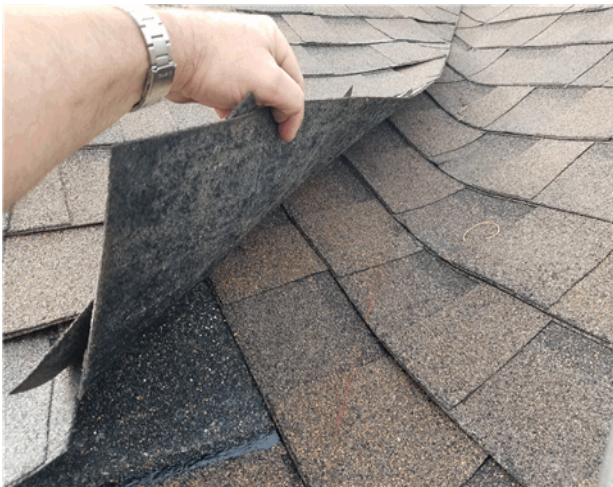
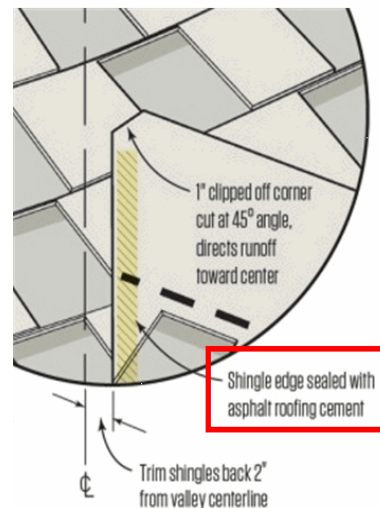
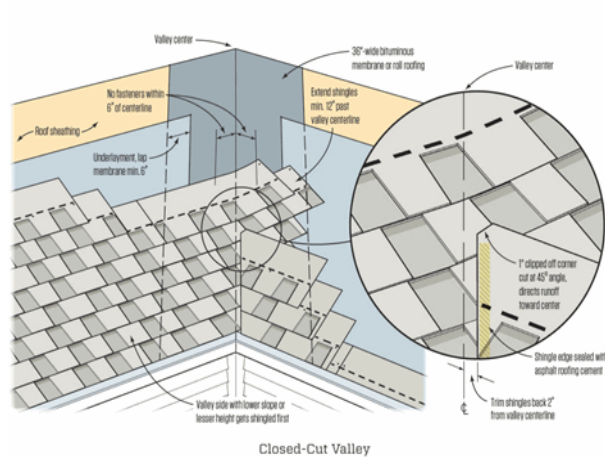
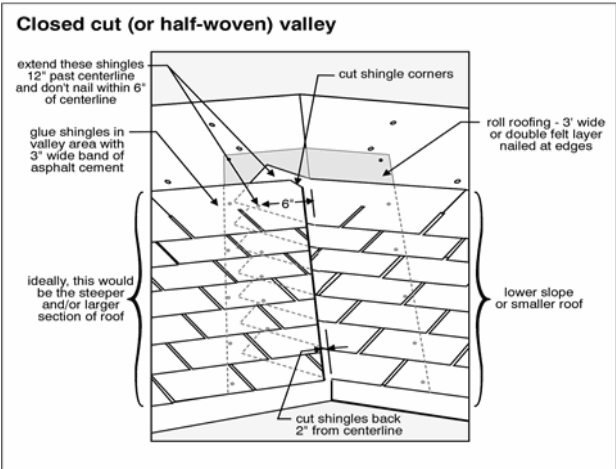
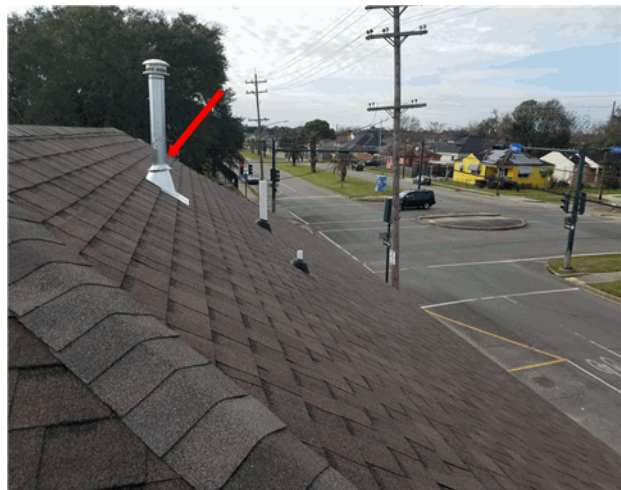
1. Recommend all valleys be sealed with a roofing cement to prevent water entry.
2. Recommend the gas heater metal flue (B-vent) be sealed @ roof rain shield. Day light visible entering attic. Use support straps to secure B-vent.

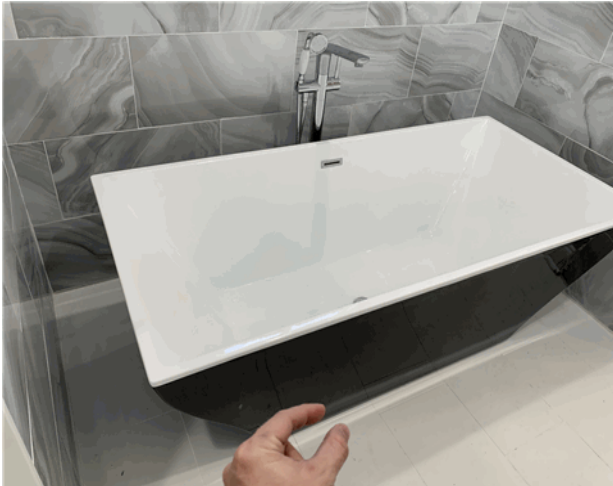
1. The master bath tub and floor mount faucet was loose. Secure tub and install wall mount bracket at faucet to prevent movement. Most of these baths are acrylic and without water are easy to nudge and can be a concern to the waste pipe below "leaks". You can place a bit of silicone sealant under which will restrict the bath tub from being moved while empty but also means that when it comes to maintenance, unnecessary force has to be used! Bracket arms can help to stabilize water faucet riser stand.
2. Dyer vents under home. To prevent lint and moisture related damage - dryer vent should be routed to exteriors and secured. Flex lines should "not" be used - hard metal smooth wall pipe to prevent clogs.
3. Water meter @ curb was leaking as evident from standing water. Contact City or

Tub moves when leaning over tub to turn on water

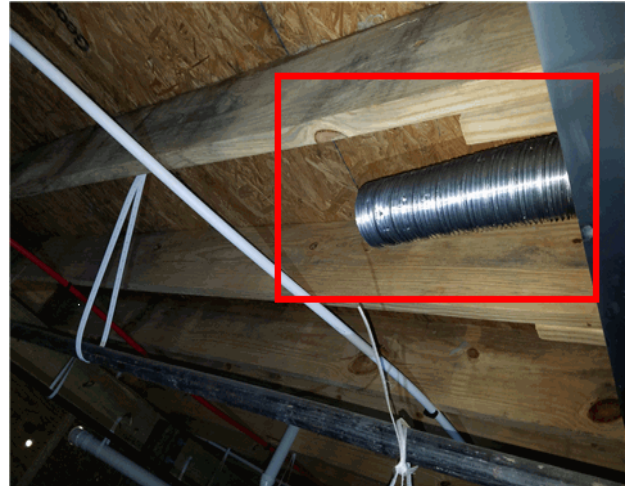
Dryer vent open under home - back-center

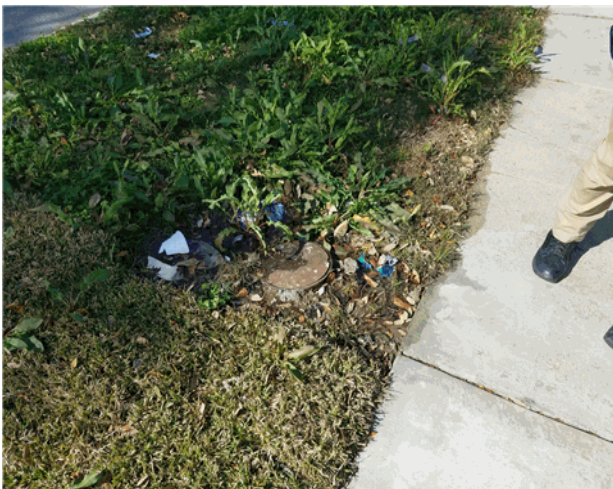
City Connection @ street - leaking

LMP (licensed master plumber) for repairs.

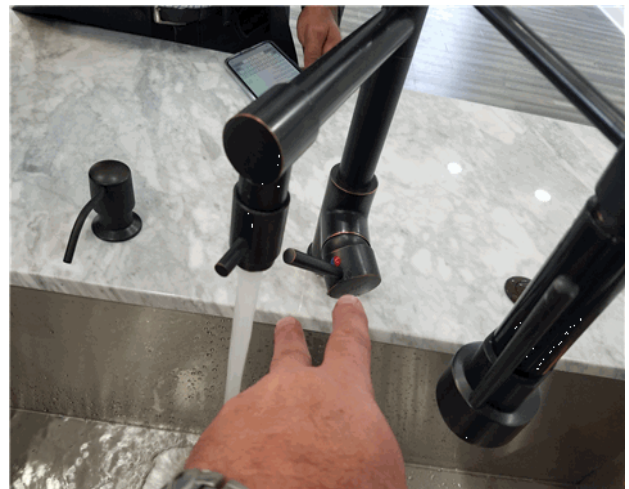
4. Hot and cold handle @ kitchen sink faucet was facing front - which when looking at fixture was confusing for my client. Recommend adjusting handle to side so when pulling forward its cold (as it is now) and hot when pulling back (as it is now) just adjust handle to the right side. Refer to illustration.

Adjust fixture handle to right side

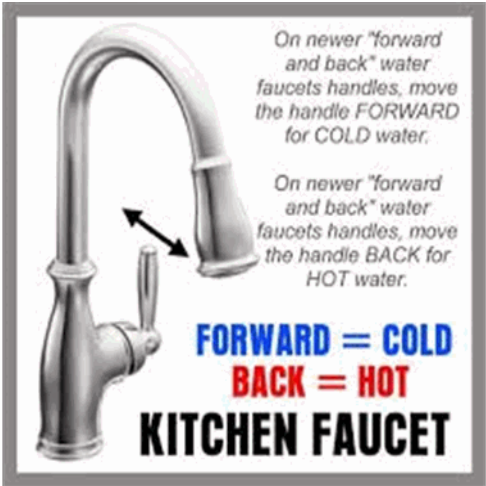
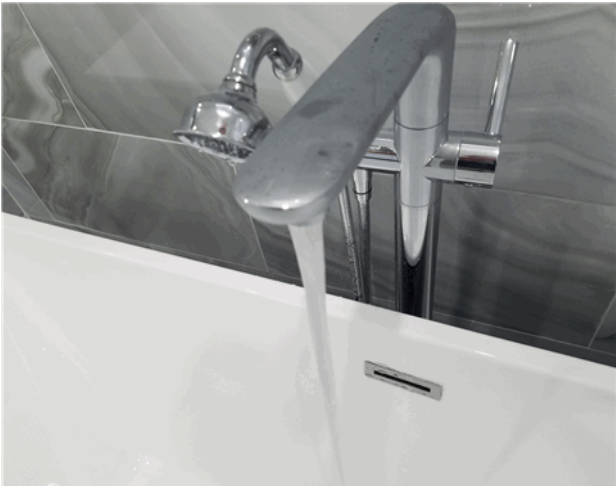
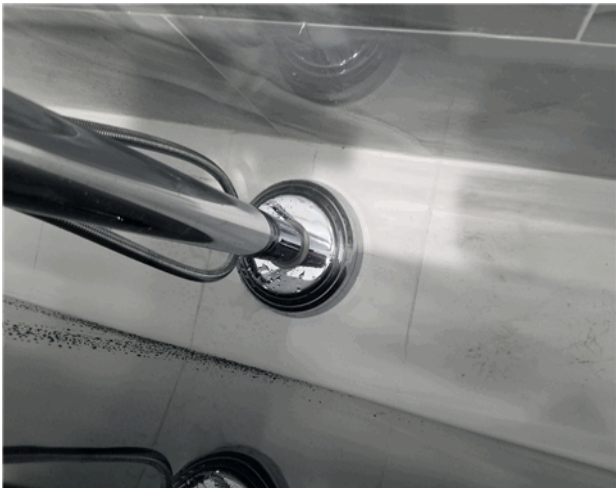
6. Leaks found under home @ both bath left and back right. Fill tubs - drain and run water when checking for leaks. Make appropriate repairs.

Water on floor from leaking

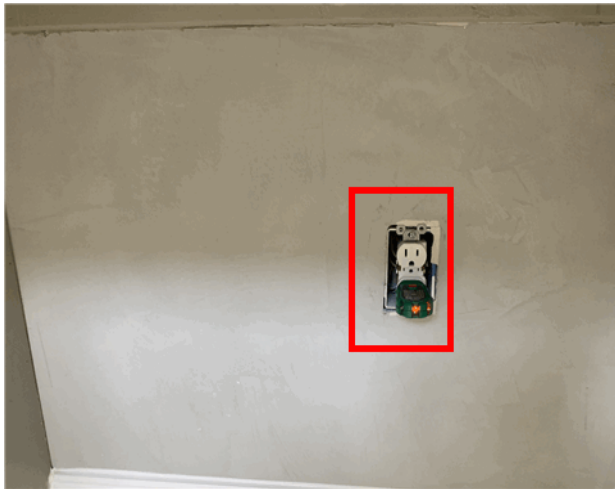
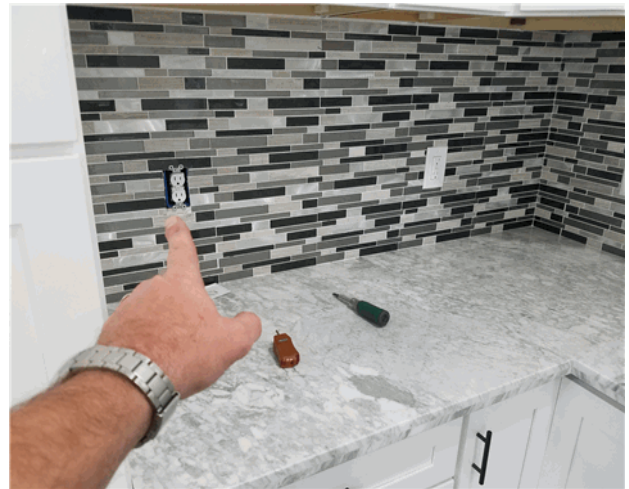
1. Cover plate missing at master bath outlet under cabinet. Recommend installing covers on all junction/switch/outlet boxes for safety.
2. Loose kitchen counter outlet on right side of refrigerator wood panel. Secure outlet and install outlet cover plate.
3. Trim kit for recessed can at back-left was missing. Install trim kit (LED)
4. The service outlet was not protected by GFCI in attic. Recommend a GFCI device be added for safety.
5. Kitchen island was missing outlet(s) with GFCI protection. Recommend GFCI be installed @ both sides of cabinet island. The GFCI under kitchen island counter-top is not for use for kitchen appliances since counter-top extends more than 6-inches and outlet was lower than 12-inches from top of counter-top. Refer to illustration photo's

Loose outlet - secure - install outlet
cover plate (damaged)

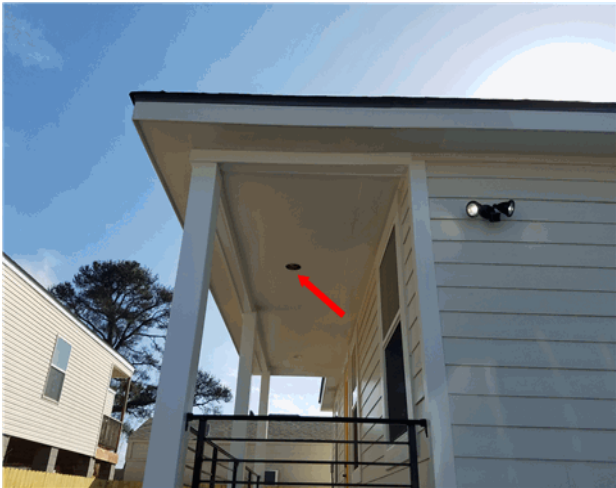
Install missing can trim @ back patio

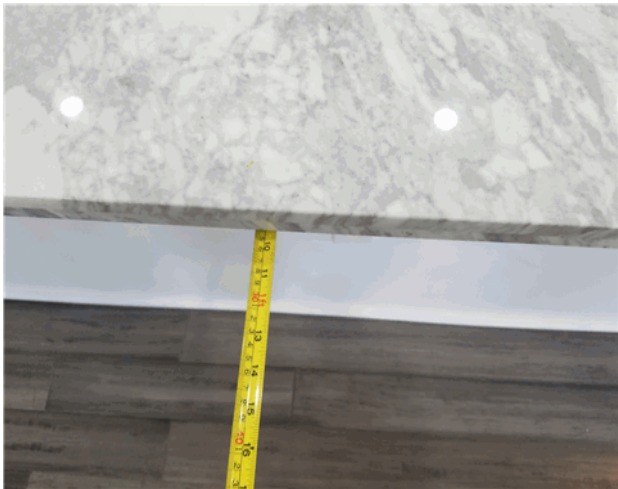
Counter-top extend out pass cabinet by 9.5 inches

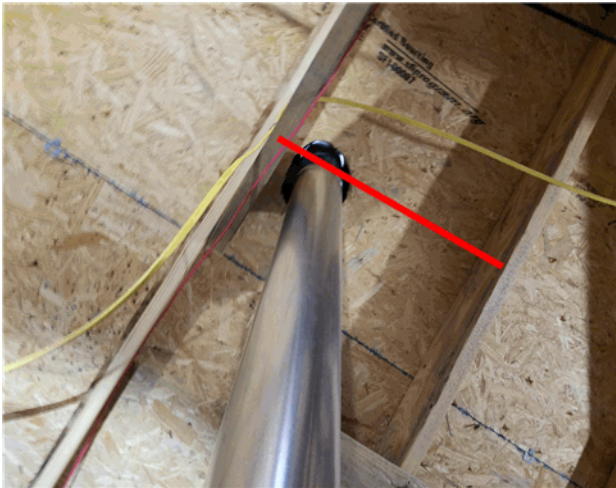
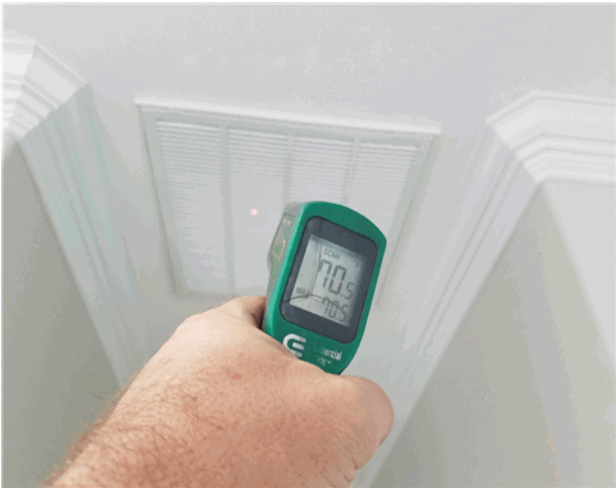
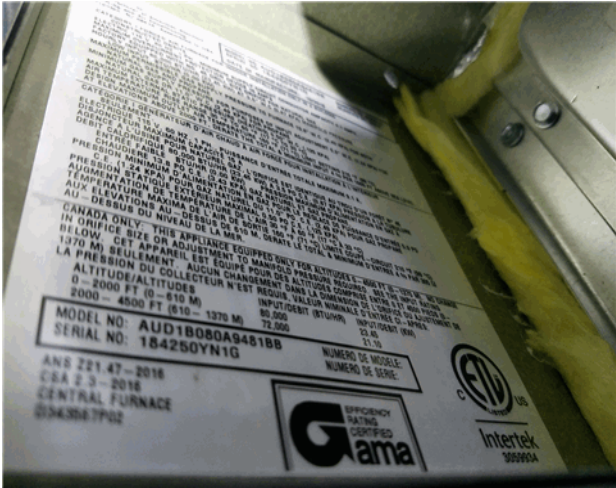
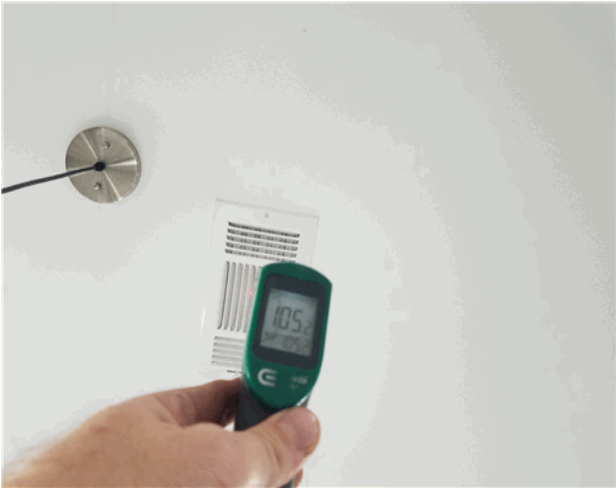
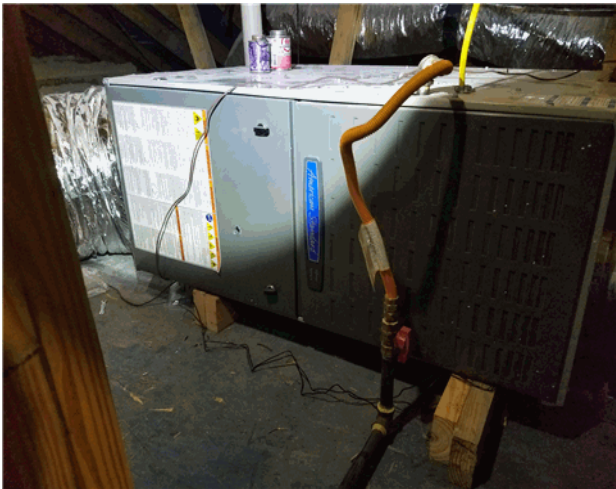
1. The B vent pipe for the gas furnace was missing strap support in attic. Recommend the flue vent pipe be secured/strapped and the vent sealed using high temperature sealant. Straps prevent movement / clearance from combustibles and sealant prevents premature leaks.

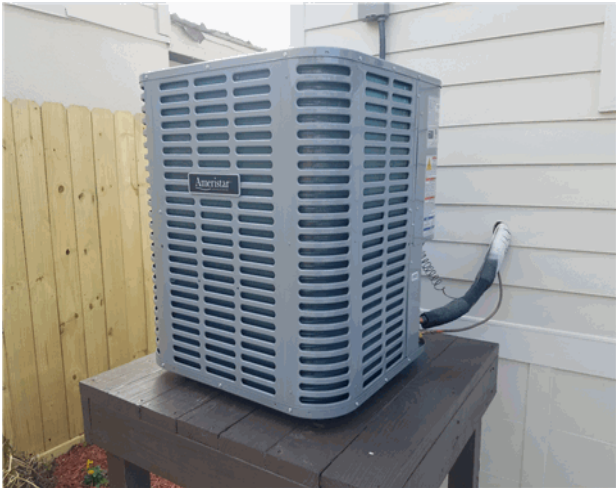
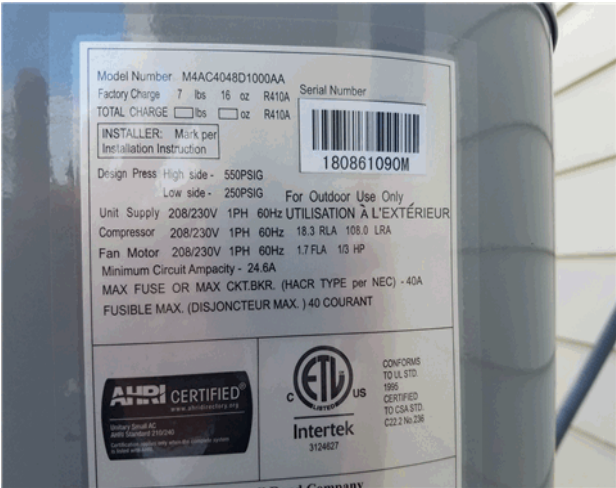
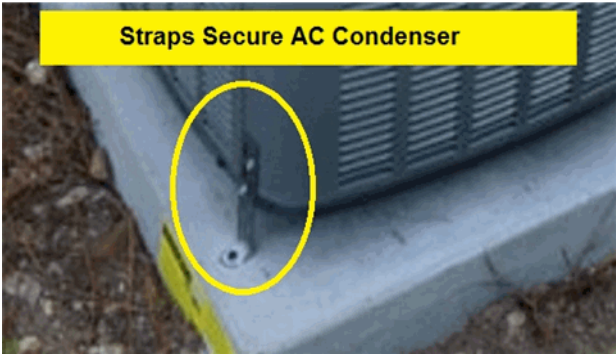
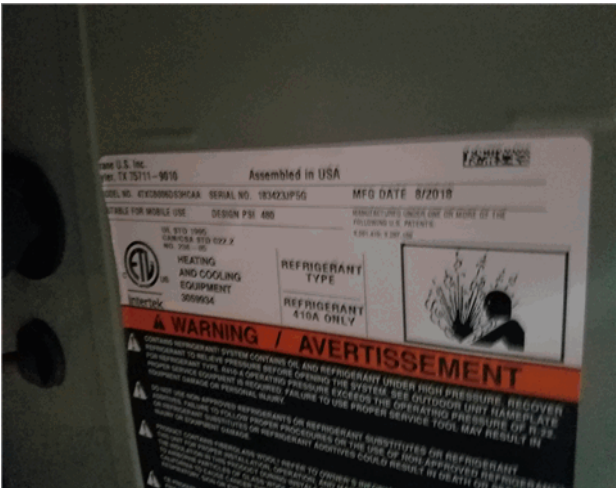
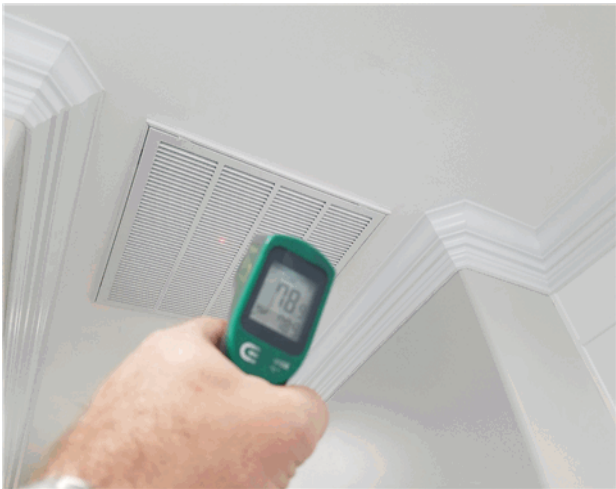
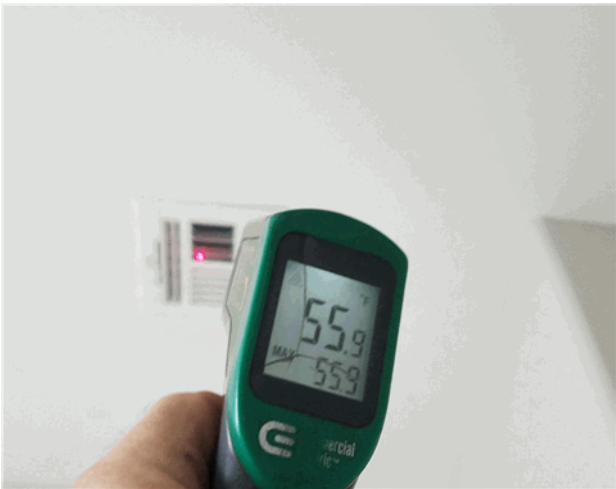
1. The outdoor condenser should be secured / anchored down for storms

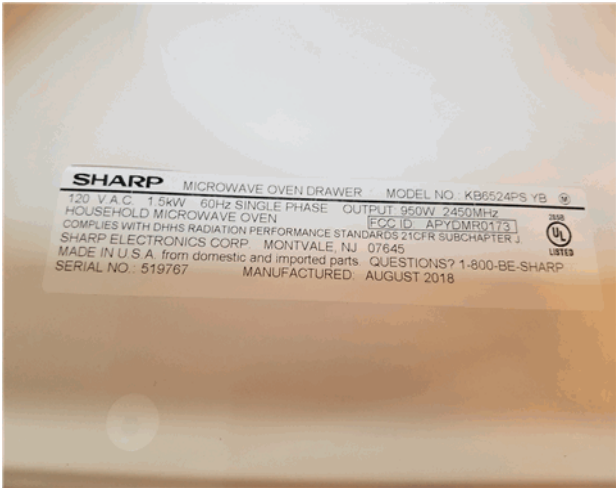
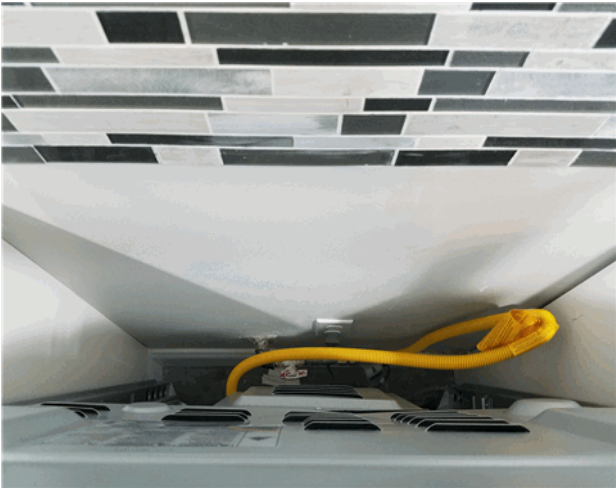
1. Range anti-tip bracket was missing. To prevent tipping client should consider installing for safety.

Anti-tip bracket was missing @ range.
Install to prevent tipping
