GP-016 DOCUMENTATION REPORT

Dam No. 03908 Sluice Gate Replacement

Eastford, CT

December 2025

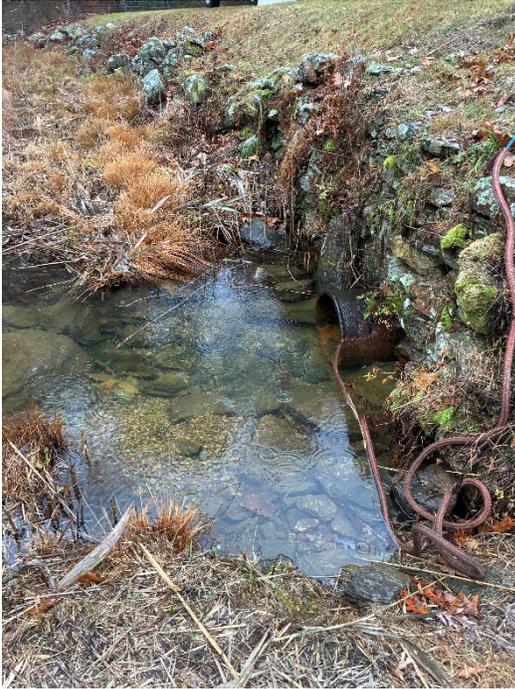
The sluice gate was closed at 5:00 AM on the morning of November 22, 2025, to allow the water level on the backside of the dam to normalize before the work began. It is noted that the presence of a substantial beaver dam several hundred yards downstream of the Crystal Pond Dam creates an impoundment and backwater at the low-level outlet pipe. The backwater elevation varies with storm events and the amount of the gate opening. On the morning of construction, the backwater elevation was just above the mid-point of the 24" outlet pipe. (Figure 1)

Figure 1 - Outlet pipe with pipe plug in place

An inflatable pipe plug was inserted into the 24" cast iron outlet pipe and pressurized to 20 psi. The pipe plug pressure was determined based on product literature and based on a calculation of the static pond water pressure to be retained. Approximately 2.5' of static head was the pressure that the plug was required to resist. It is noted that the use of the blocking plug to stop flow during the gate replacement was a deviation to the proposed work plan in the General Permit application which reflected the intent to use a sandbag cofferdam and steel plate at the inlet side of the low-level outlet structure. This change was made as an improved construction method with less effort to deploy, increased safety and a shorter duration for deployment. At the time of the initial application, it was not known that CPA would have access to a commercial grade pipe plug.

A timber strut was deployed at the outlet to provide redundancy against slip for the blocking plug, and the gate was opened a small amount to allow the outlet pipe to fill and to test the stability and water tightness of the blocking plug. The plug held without any sign of movement or leakage.

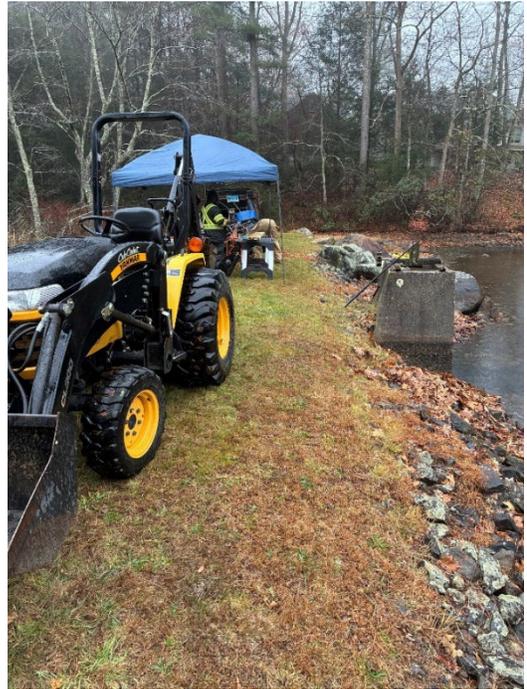
on the dam where power equipment was being used for the on-site fabrication of the replacement timber gate and post. (Figure 2)

Figure 2 – Work tent in place on dam for fabrication

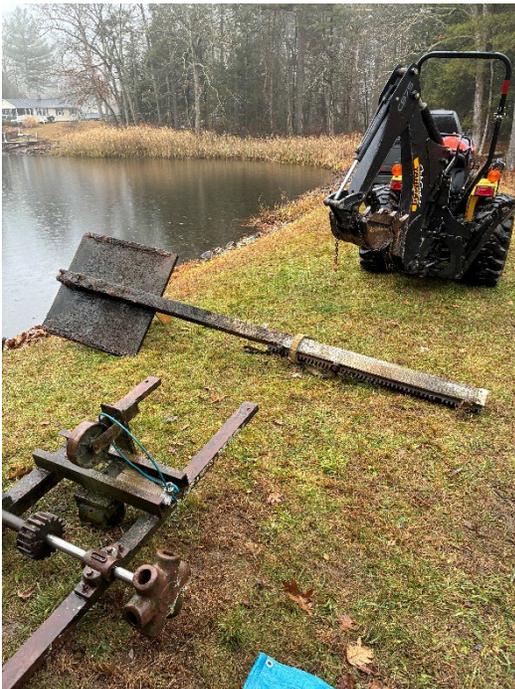
Figure 3 – Mechanical drive and gate assemblies removed from concrete outlet structure

The gate was closed and the steel frame with the attached mechanical system including the pinion gear was raised from the concrete outlet structure while the pinion gear was turned effectively "walking" the frame off the track gear mounted to the timber gate hanger. The frame assembly was set aside. The timber gate and attached hanger were then removed using the backhoe. (Figures 3 and 4)

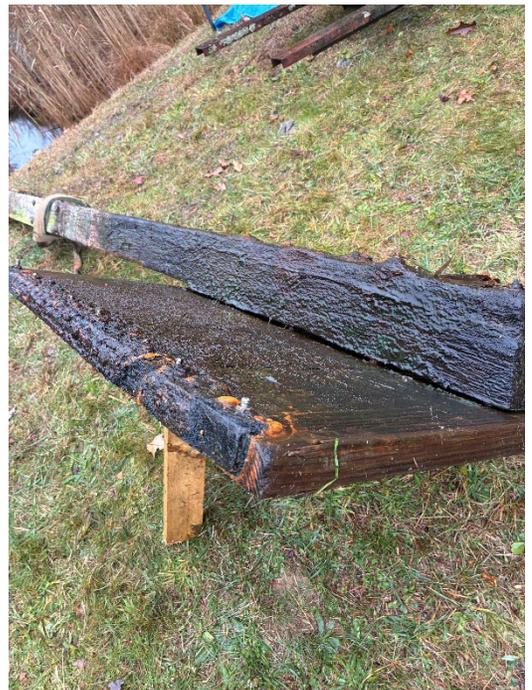
Figure 4 – Existing timber gate and hanger post with moderate deterioration

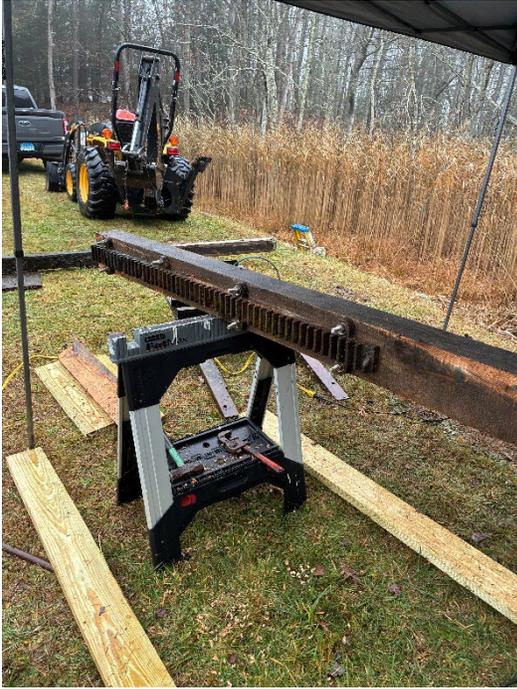
Figure 5 – Fabrication of replacement gate hanger with track gear secured

Detailed measurements of the timber gate and hanger were made, and replacement members matching the dimensions were fabricated and assembled. (Figure 5) The track gear was removed from the original post and mounted to the replacement post with stainless hardware.

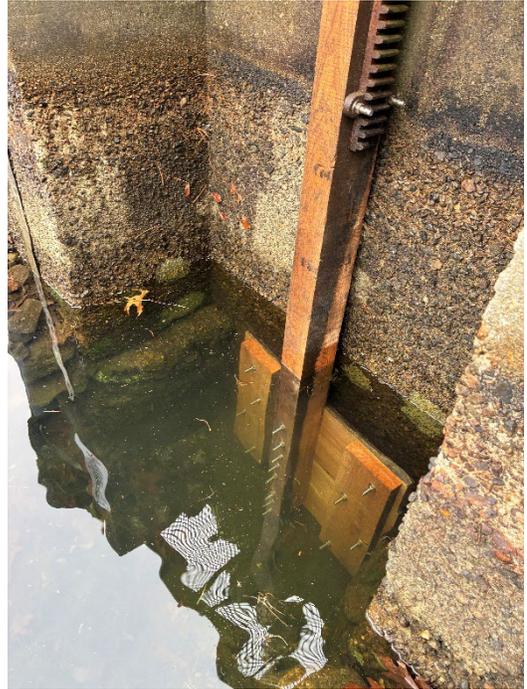
Figure 6 – Replacement gate and hanger in position prior to trash rack installation

The replacement gate and post were then lowered into its position within the concrete outlet structure. (Figure 6) The steel frame with pinion gear was then lowered back onto the post track gear reversing the removal process. The nuts were installed on the threaded anchors that protrude from the concrete outlet structure securing the gate assembly.

The gate was opened and closed several times to confirm proper alignment and operation. There were no issues and the gate was closed, and the blocking plug was deflated and removed from the outlet pipe.

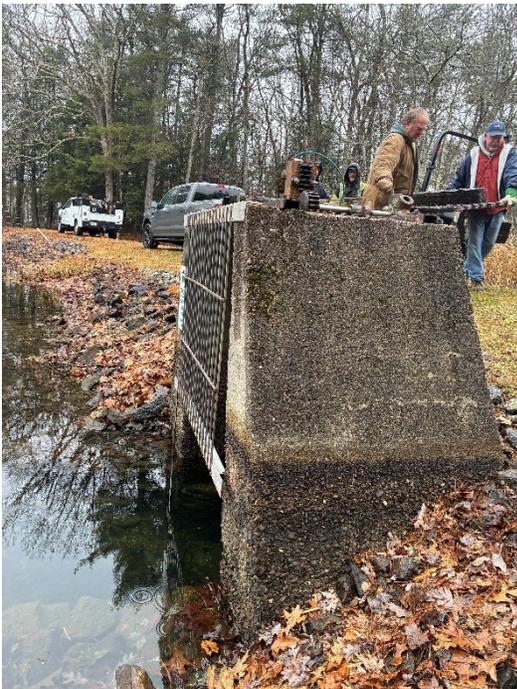
Figure 7 – Concrete outlet structure with replacement gate and trash rack installed

The trash rack was then lifted into place and secured to the anchor studs that were reused. (Figure 7) This completed the replacement, and all excess materials including waste were removed from the site for disposal in accordance with applicable federal, state and municipal law.

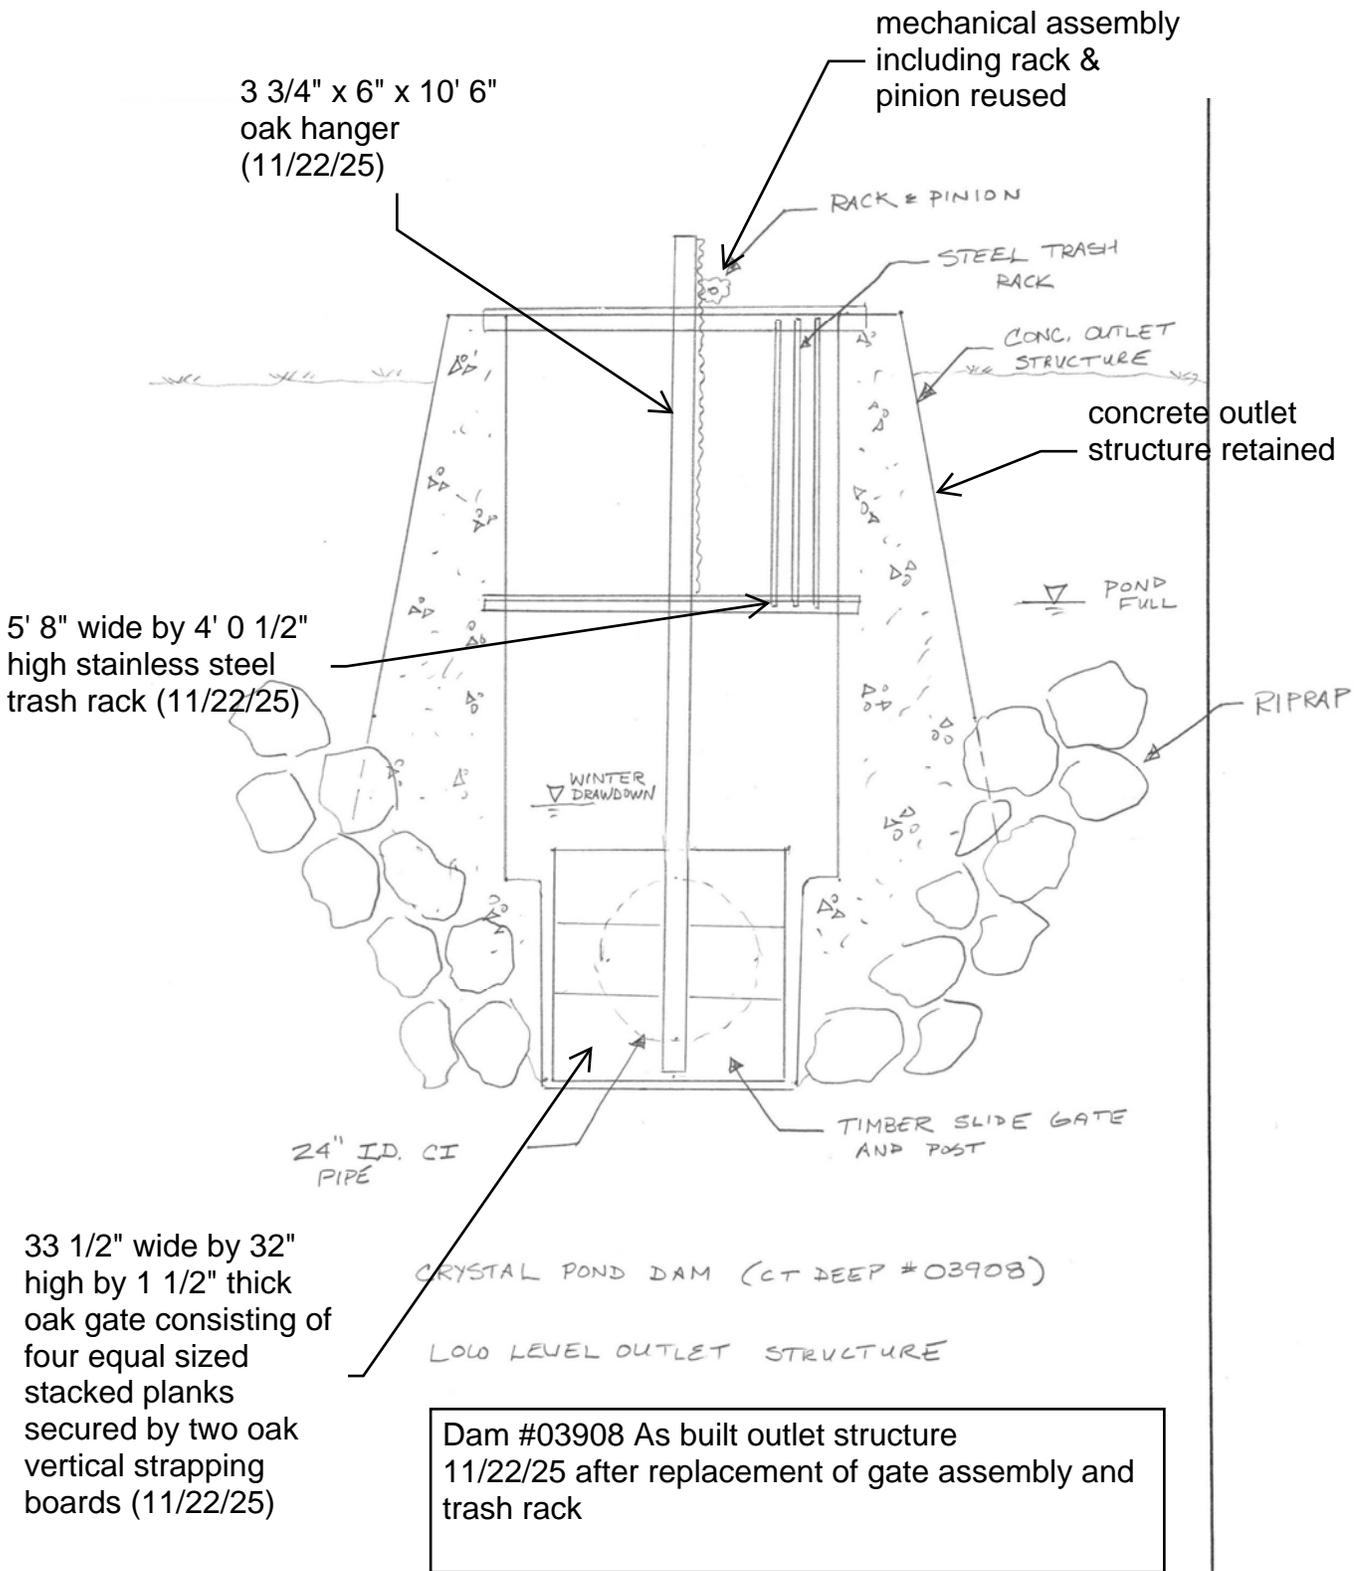
ENCLOSURE 2

The timber sluice gate and hanger post were fabricated from red oak to dimensions matching the members replaced. The gate is 33 1/2" wide with a height of 32" and a thickness of 1 1/2". It is comprised of four equal pieces 8" in height butted and stacked. Oak strapping timber runs vertically on each side of the gate to secure the planks together. Countersunk stainless steel 1/2" diameter carriage bolts were used to connect the strapping and gate planks.

The hanger post is 3 3/4" x 6" x 10'-6". Countersunk stainless steel 1/2" diameter carriage bolts were used to connect the hanger post with the gate planks and the cast iron track gear.

The trash rack was fabricated from stainless steel with the same out to out dimensions as the gate being replaced – 5'-8" wide by 4'-0 1/2" in height. The top and bottom support angles were 3 x 3 x 1/4" and the rack screen was comprised on 3/8" square bar stock. Individual bars were spaced at 3" and secured to the support angles with fillet welds. (enclosure No. 2)
