November 10, 2009

RE: Crystal Pond Dam – Eastford
Emergency Repairs Construction Report

CRYSTAL POND ASSOCIATION
 AREA OF EMERGENCY REPAIR
 CRYSTAL LAKE DAM EMERGENCY REPAIRS

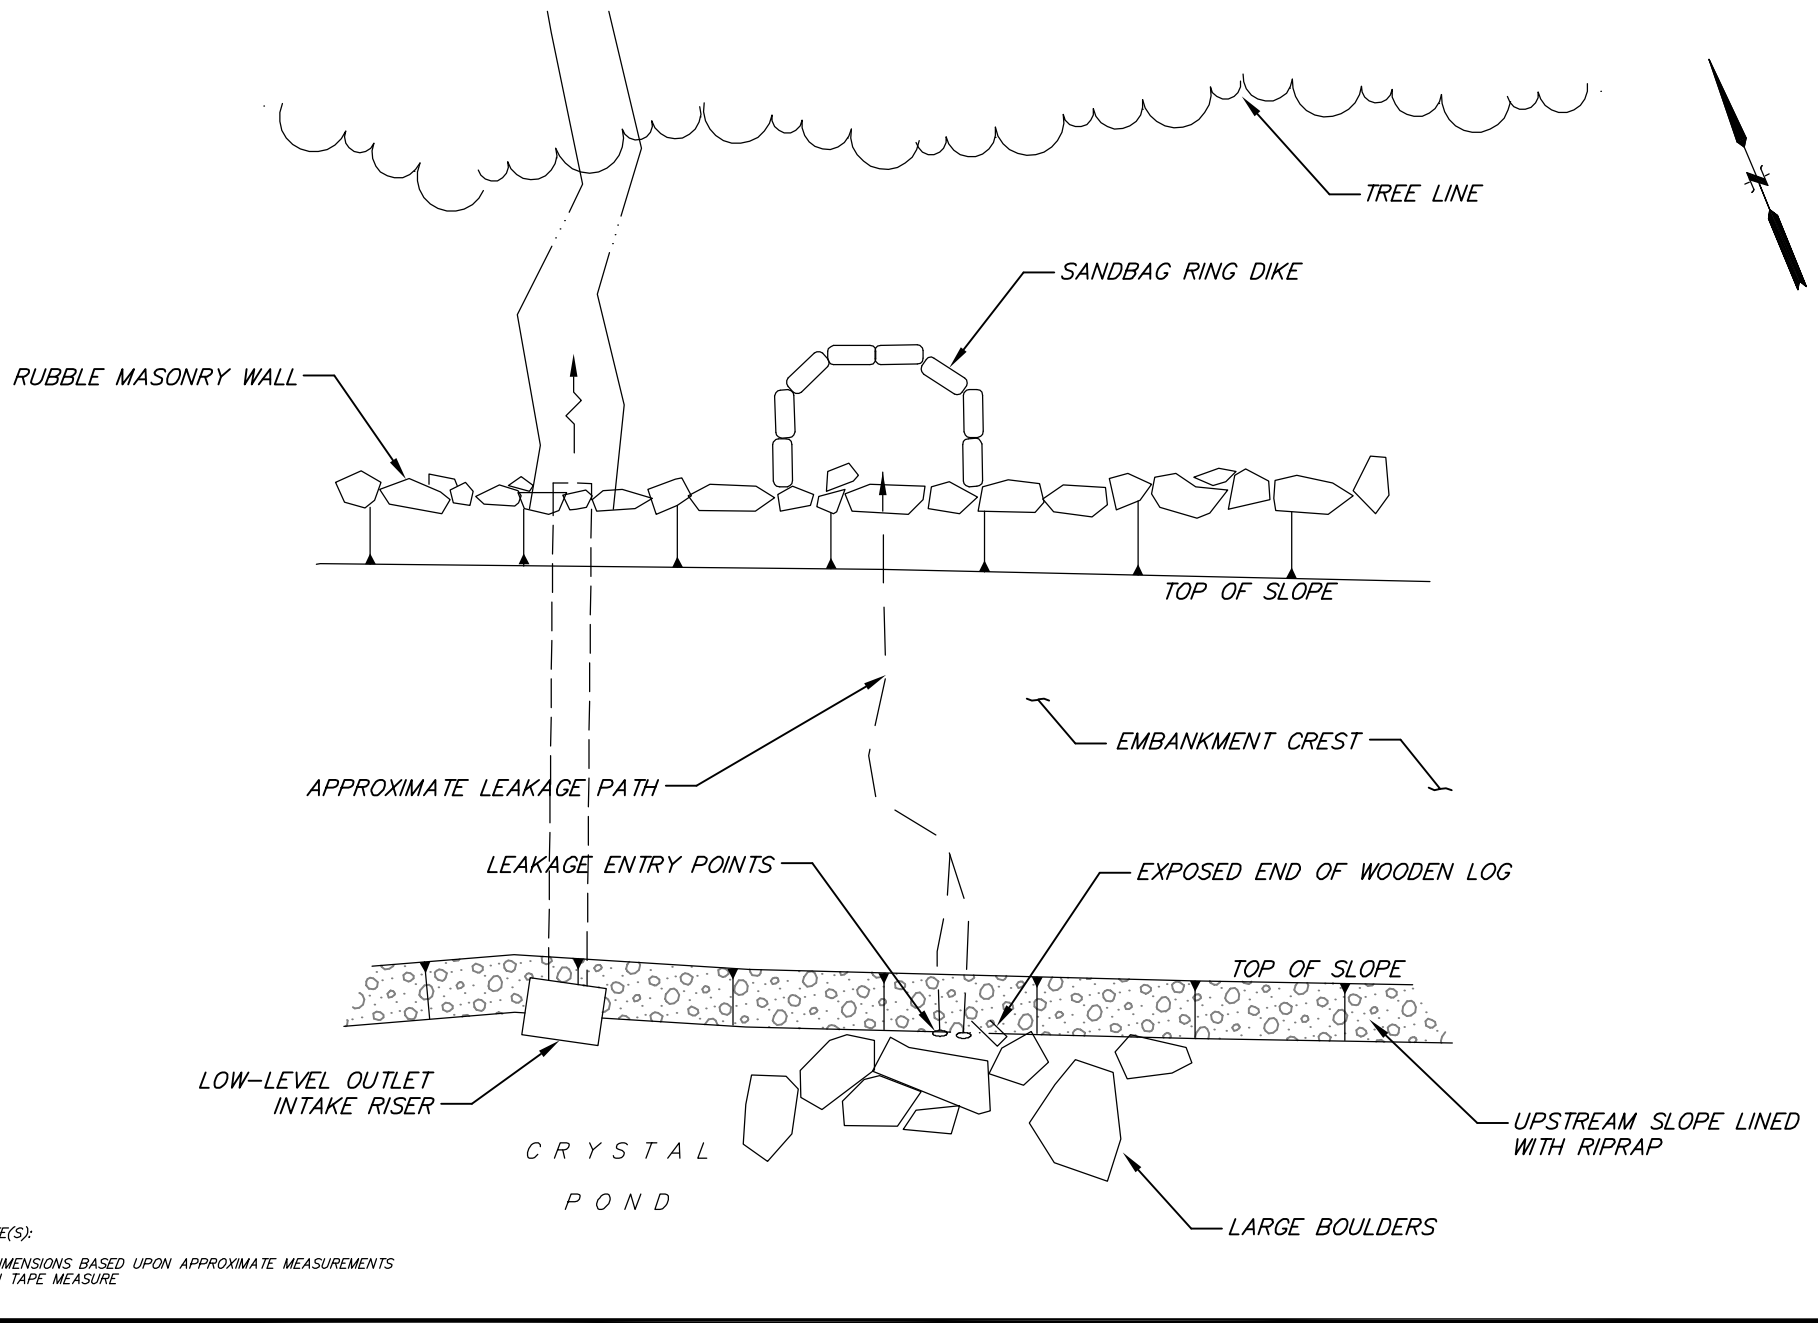
FIG 3

The purpose of the dam construction was to repair leakage and piping erosion that had been discovered, originating approximately six inches below the pond's normal water surface elevation on the dam's upstream face and emerging at the downstream toe. In addition the end of a wooden log had been observed embedded in the dam embankment near the leakage entry point.

CRYSTAL POND ASSOCIATION
 PREEXISTING CONDITIONS
 CRYSTAL LAKE DAM EMERGENCY REPAIRS

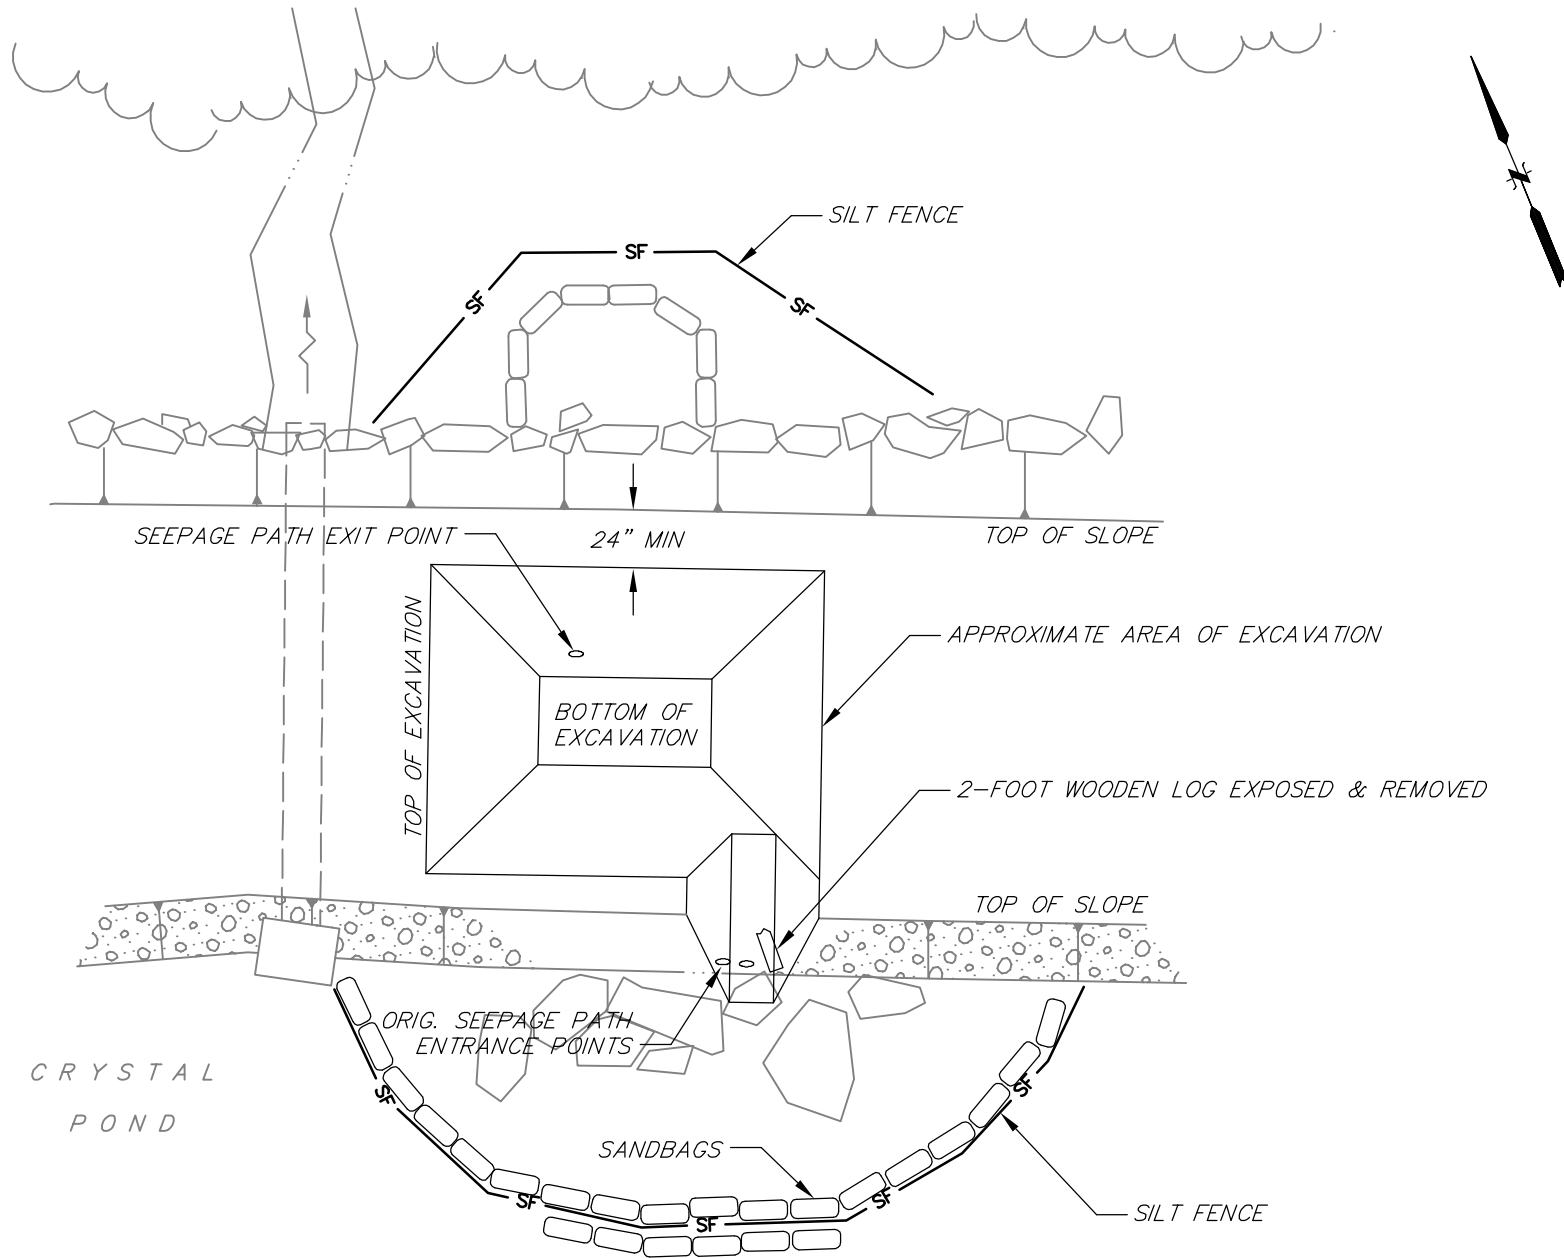
FIG 4

CRYSTAL POND ASSOCIATION
 EMERGENCY REPAIRS PLAN
 CRYSTAL LAKE DAM EMERGENCY REPAIRS

The completed excavation, with a depth of approximately 5 feet, was surrounded on 3 ½ sides by intact embankment. This facilitated placement and compaction of fill. The contractor lined the downstream face and bottom of the excavation with a permeable filter fabric, covering the leakage path exit point. New embankment fill was placed in 8-inch lifts and compacted using a plate vibrator and jumping jack. When the embankment had been reconstructed in this manner a 4-inch lift of topsoil was placed over the excavation site, and topsoil was also used to fill ruts left by the machinery along the dam crest. These areas were seeded and covered by straw matting to prevent erosion. Riprap was re-installed along the upstream face of the dam at the location of the excavation.

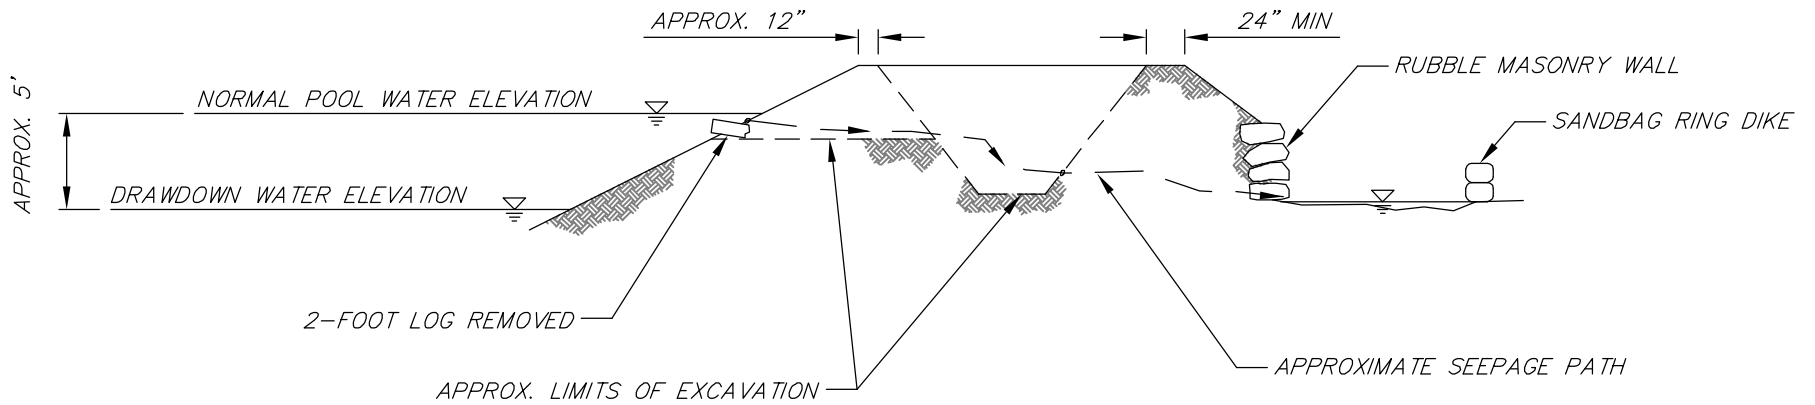
FIG 5

CRYSTAL POND ASSOCIATION
 EMERGENCY REPAIRS SECTION
 CRYSTAL LAKE DAM EMERGENCY REPAIRS

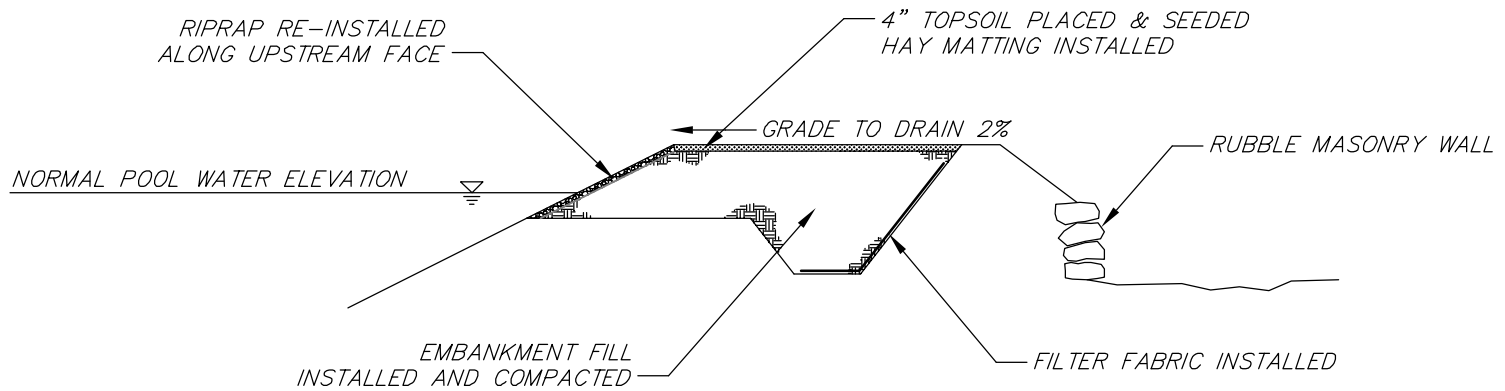
FIG 6

CRYSTAL POND ASSOCIATION
 FINISHED CONDITIONS
 CRYSTAL LAKE DAM EMERGENCY REPAIRS

1. DIMENSIONS ARE APPROXIMATE.
2. EXCAVATION FACES WERE LIGHTLY SCARIFIED PRIOR TO PLACING FILL.
3. FILL WAS PLACED IN 8" LOOSE LIFTS, THEN MECHANICALLY COMPACTED.
4. EMBANKMENT FILL SELECTED BASED ON SOIL GRADATION TESTING OF EXISTING EMBANKMENT.

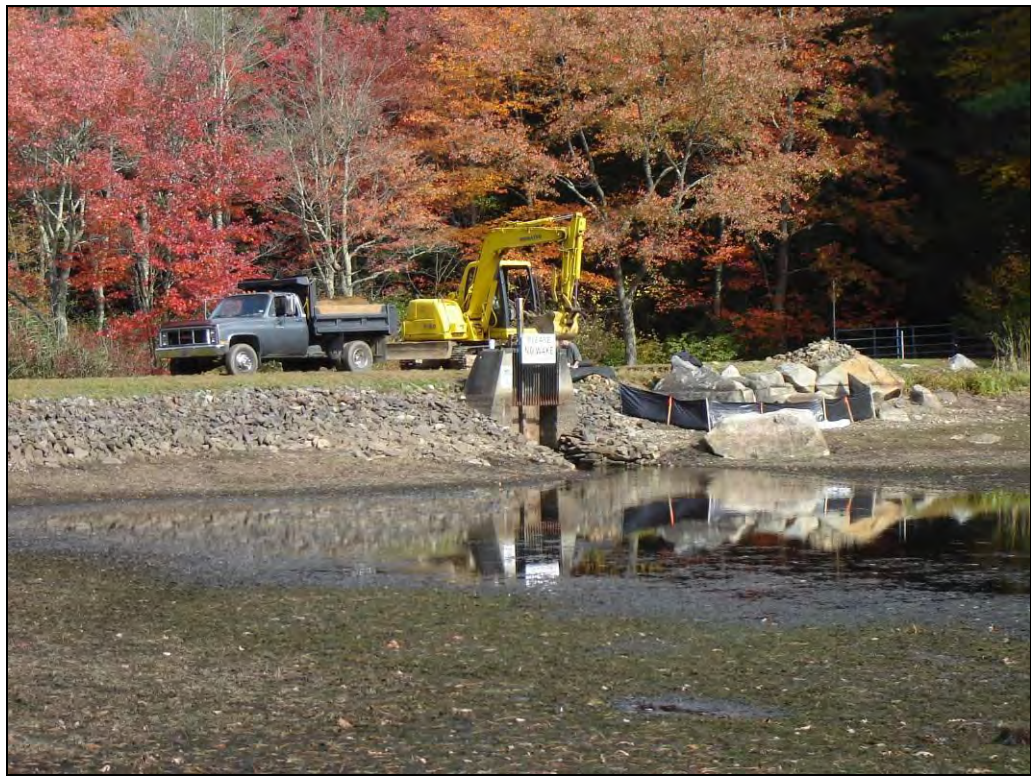
Photo 2: Overview of construction location on dam, right of low-level outlet intake riser.

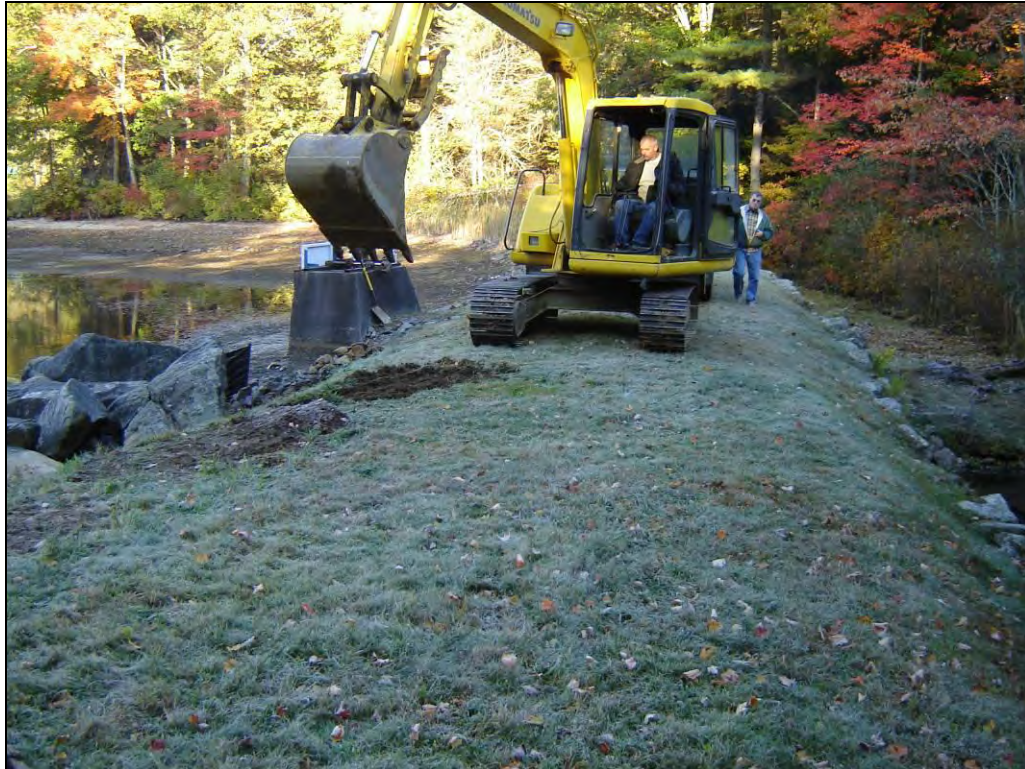
Photo 3: Start of excavation

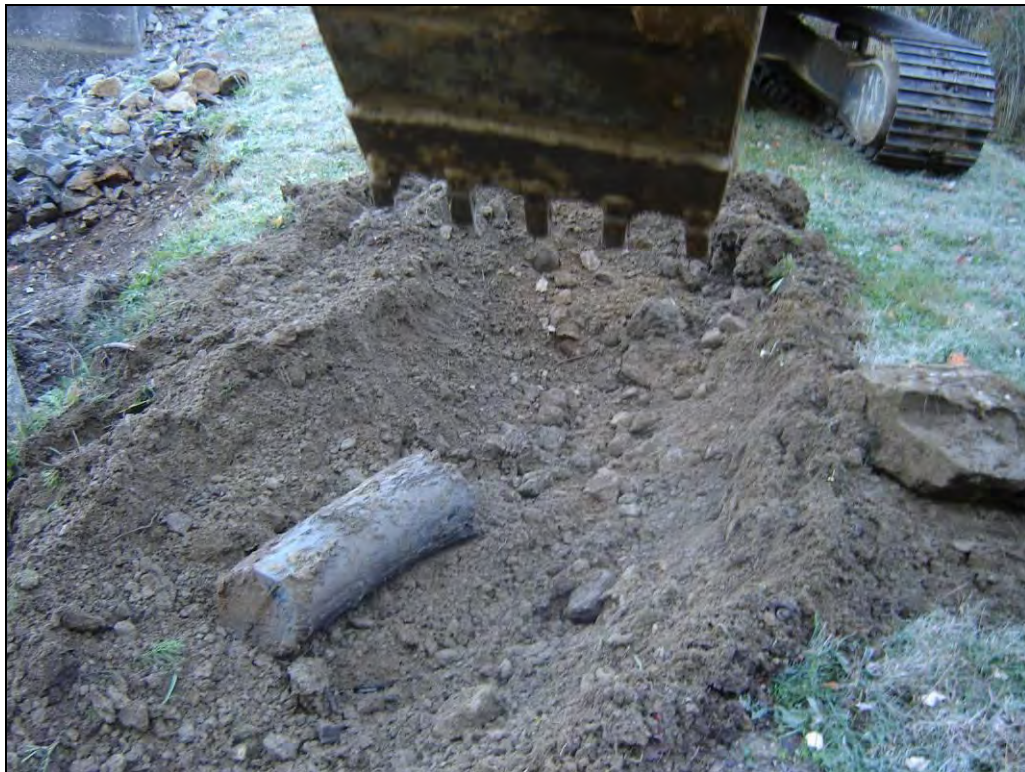
Photo 4: Embedded log was found to be only 2 feet in length and was easily removed.

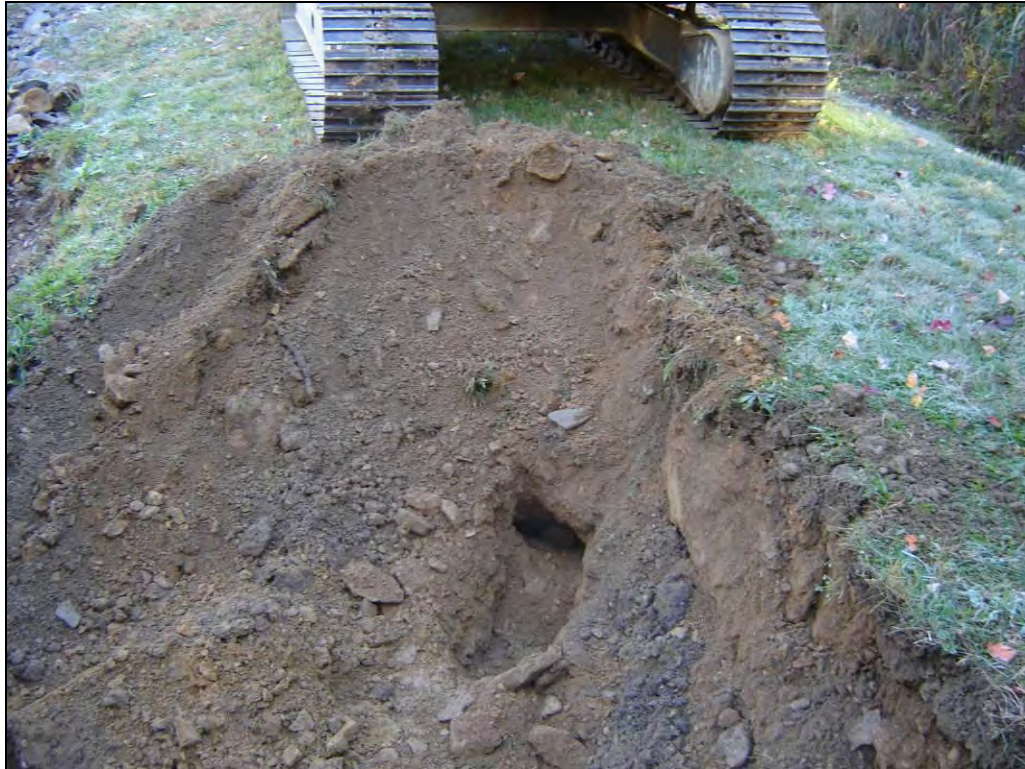
Photo 5: Excavation followed the seepage path. At this point it opened up to nearly the size of a basketball.

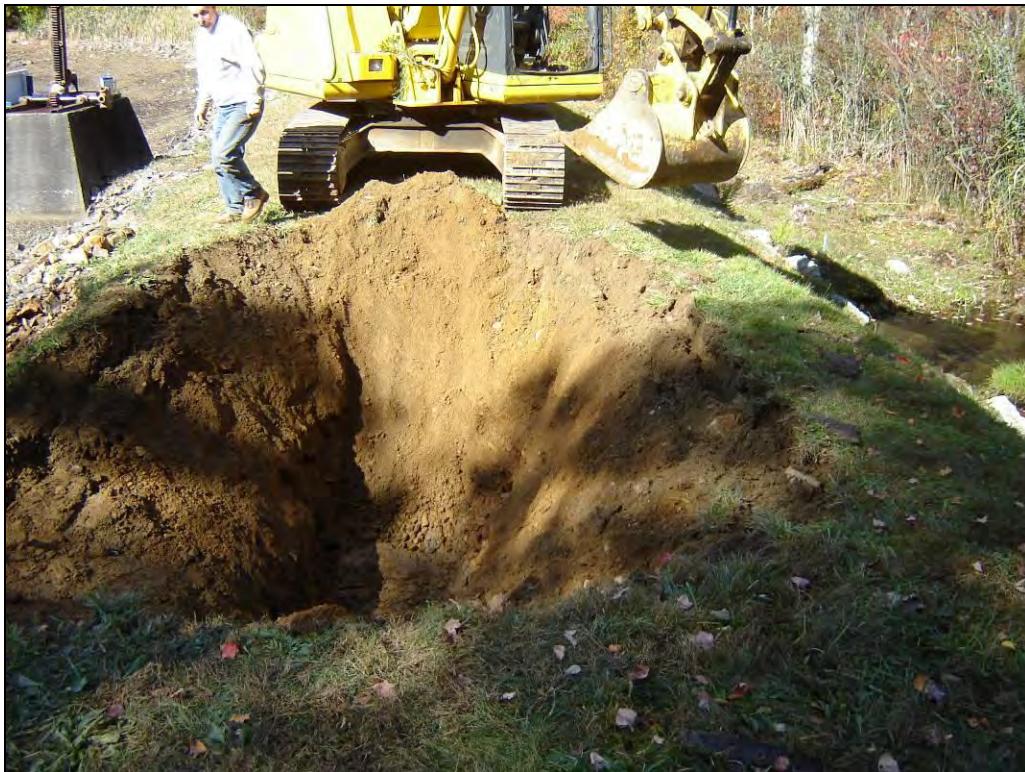
Photo 6: The completed excavation retained intact embankment on the downstream side and along much of the upstream side.

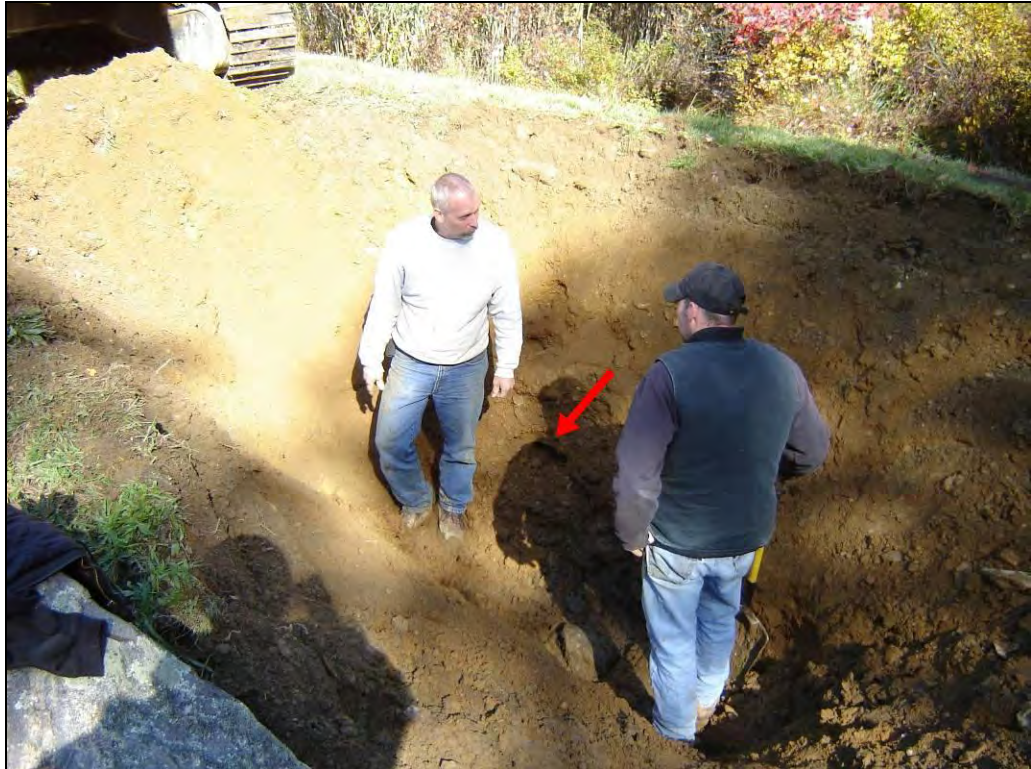
Photo 7: Location of seepage path exit point on downstream face of excavation

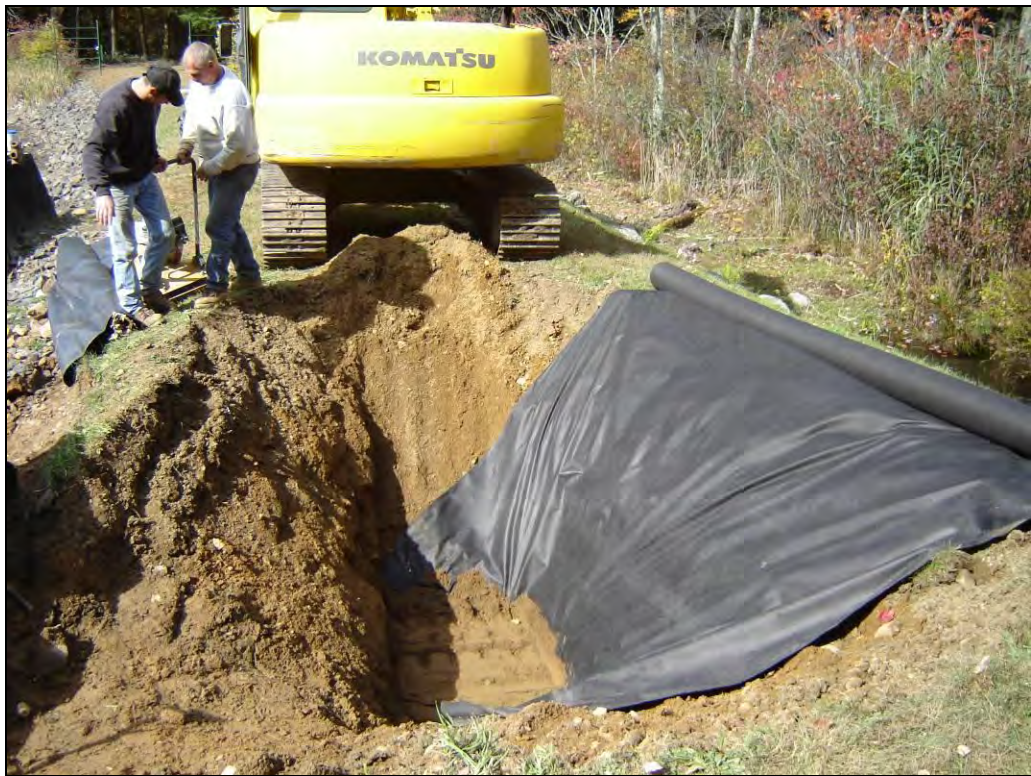
Photo 8: Permeable filter fabric installed, lining the downstream face of the excavation.

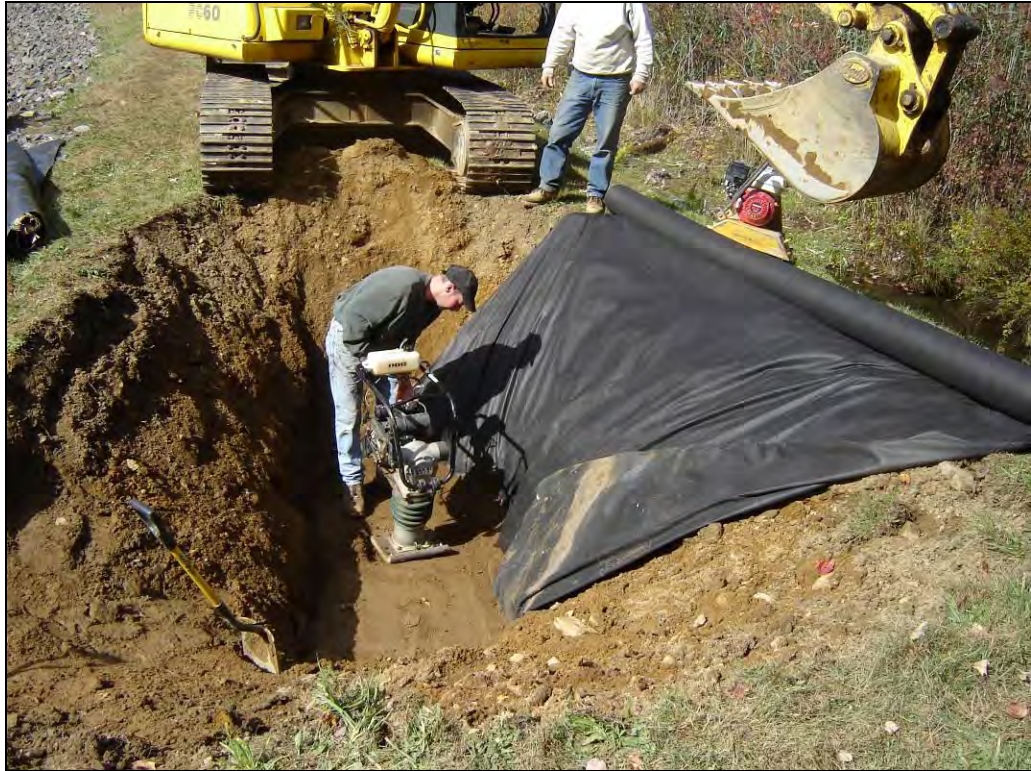
Photo 9: Embankment fill placed and compacted in 8-inch lifts (1 of 4)

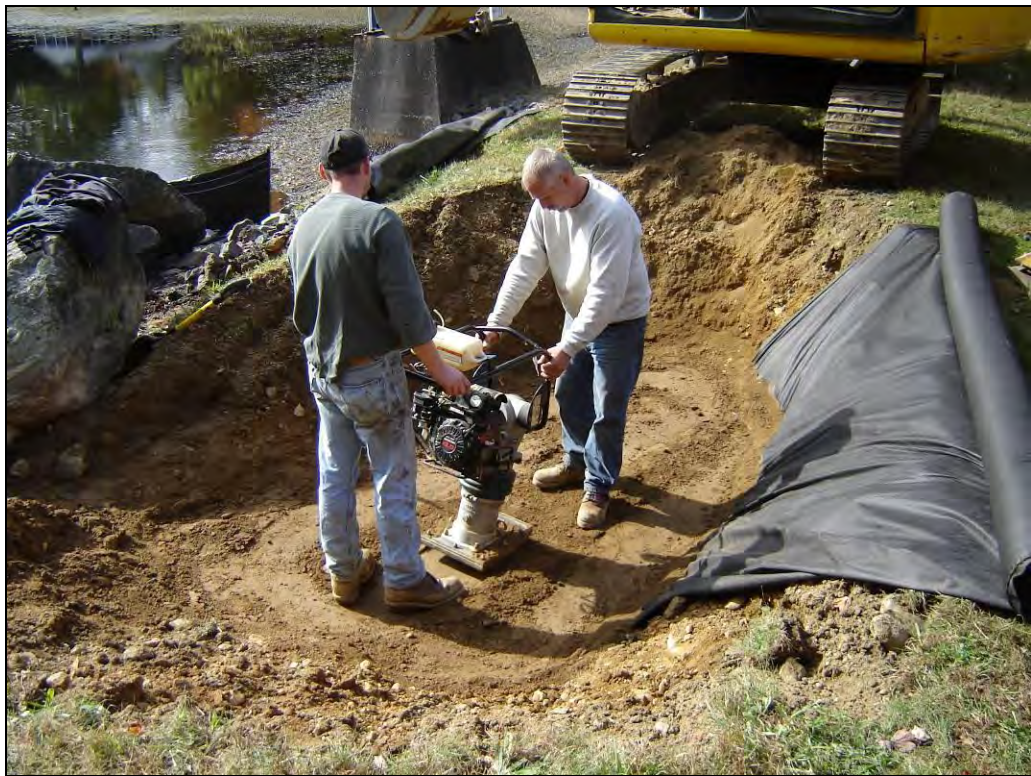
Photo 10: Embankment fill placed and compacted in 8-inch lifts (2 of 4)

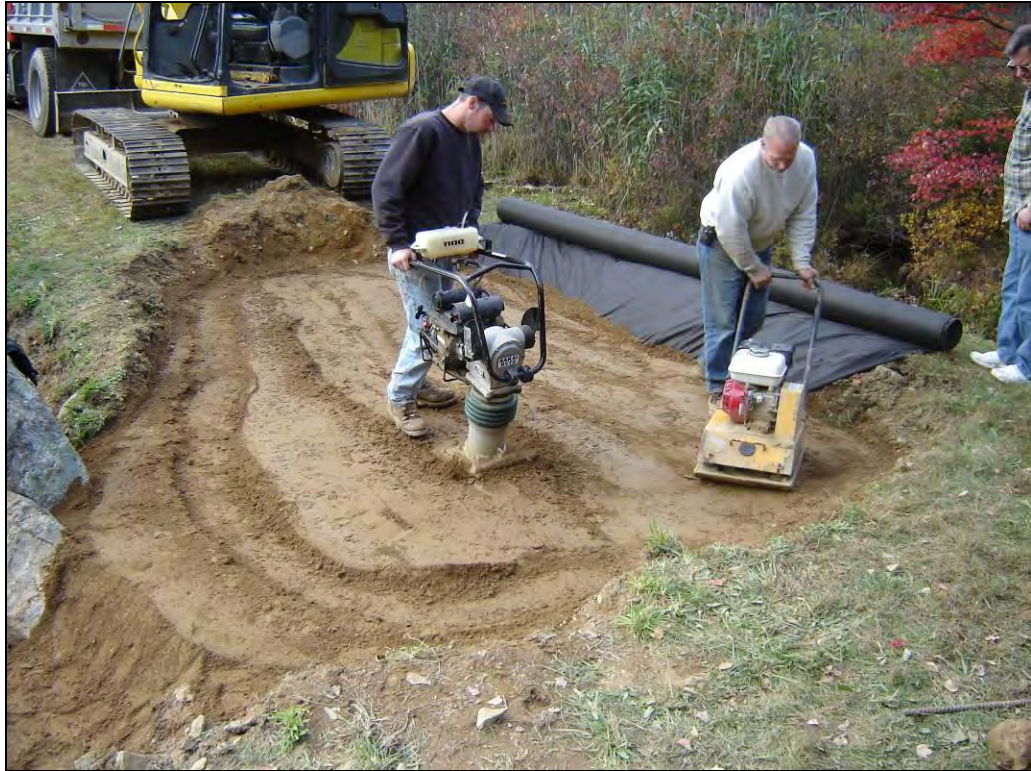
Photo 11: Embankment fill placed and compacted in 8-inch lifts (3 of 4)

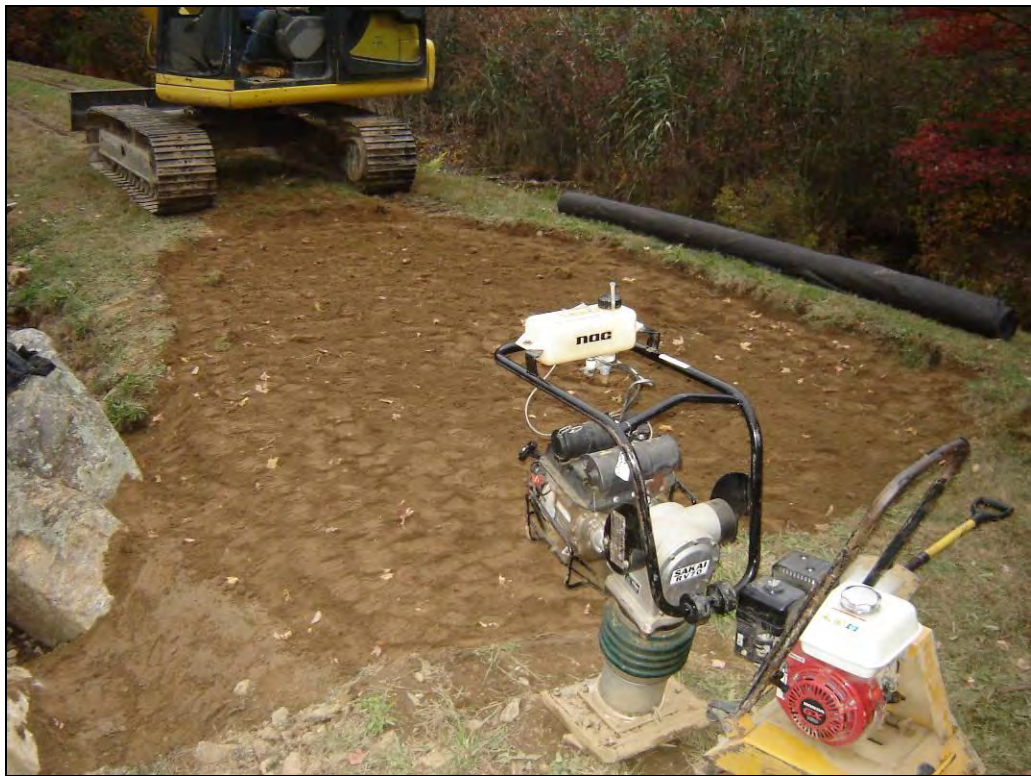
Photo 12: Embankment fill placed and compacted in 8-inch lifts (4 of 4)

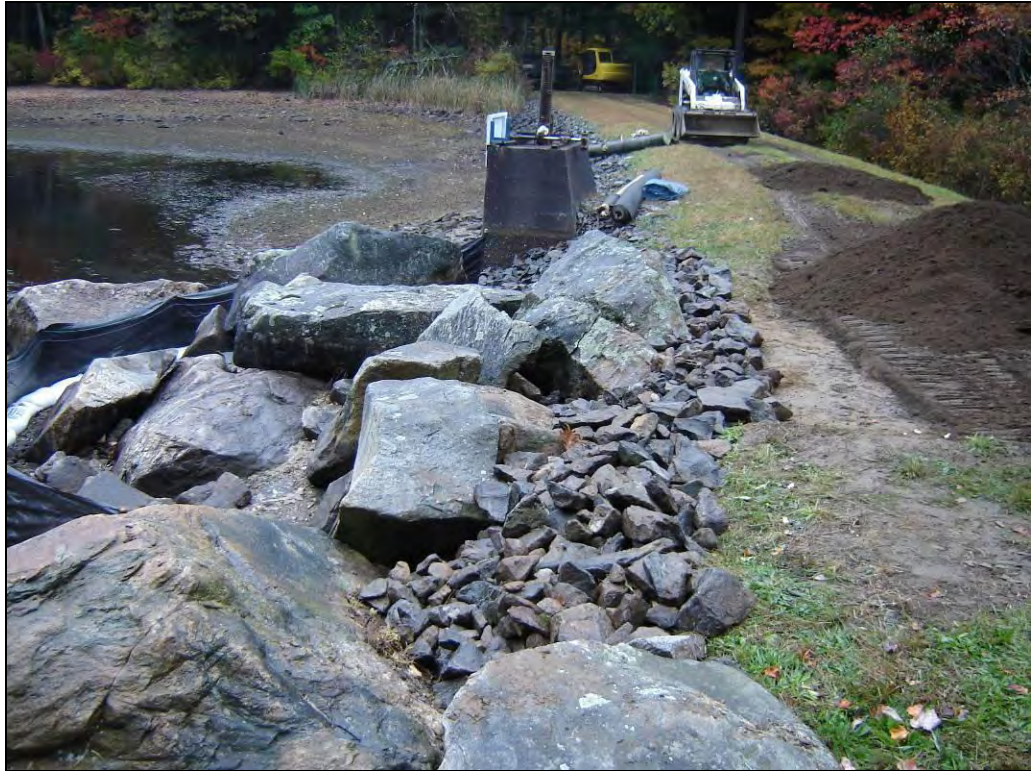
Photo 13: Riprap re-installed along the dam's upstream face for erosion protection

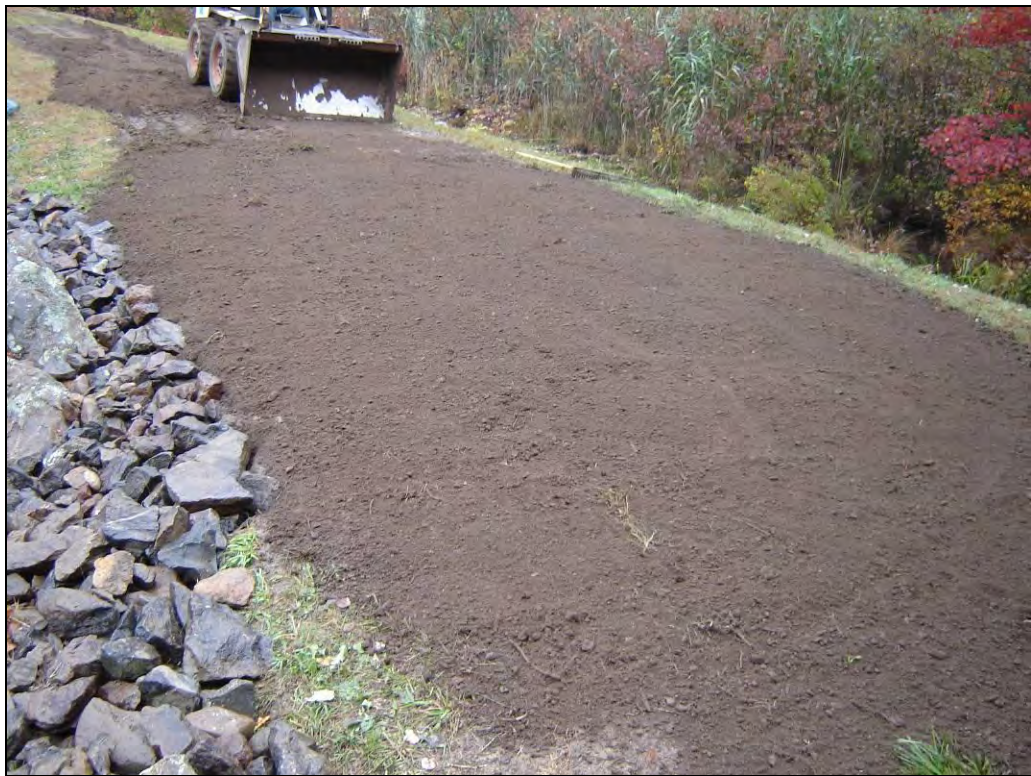
Photo 14: 4-inch layer of topsoil placed and seeded over excavation site and to fill ruts from machinery.

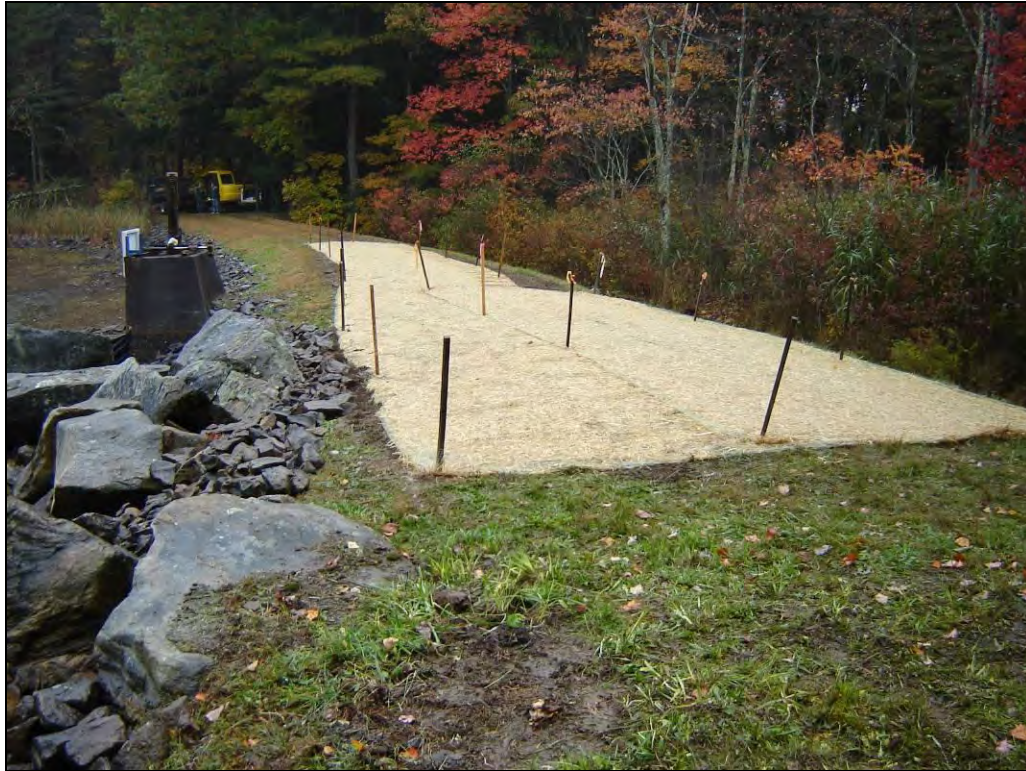
Photo 15: Hay matting placed and staked for erosion protection.
