DAM SAFETY PROGRAM DAM INSPECTION REPORT FORM – FOR REGULATORY INSPECTION

Dam Name:	Crystal Pond Dam	Inspection Date(s):	August 27, 2018 (Follow-up on September 13, 2018)
Alternate Dam Name(s):	None	CT Dam ID #:	3908
Location (Municipality):	Eastford	Temperature / Weather:	8/27/18: 85 deg F, no precip. in the 7 days prior to inspection 9/13/18: Heavy rain on the previous day
Registered?: Yes or No If yes, provide the 9 digit registration number found on the notification letter.	Yes (Reg. No. not available)	Pool Level: See Instructions	Approx. 4" below the auxiliary spillway invert/normal pool level.
Emergency Action Plan?: Yes or No If Yes, see instructions	No	Impoundment Use: use options listed in instructions	Recreation
Hydraulic and Hydrologic Analysis?: Yes or No If Yes, see instructions	No	Stability Analysis?: Yes or No If Yes, see instructions	No
Overall Condition: (refer to Appendix A located at the end of this form) Poor

CRYSTAL POND ASSOCIATION
 SITE SKETCH
 CRYSTAL POND DAM VISUAL INSPECTION
 EASTFORD CONNECTICUT

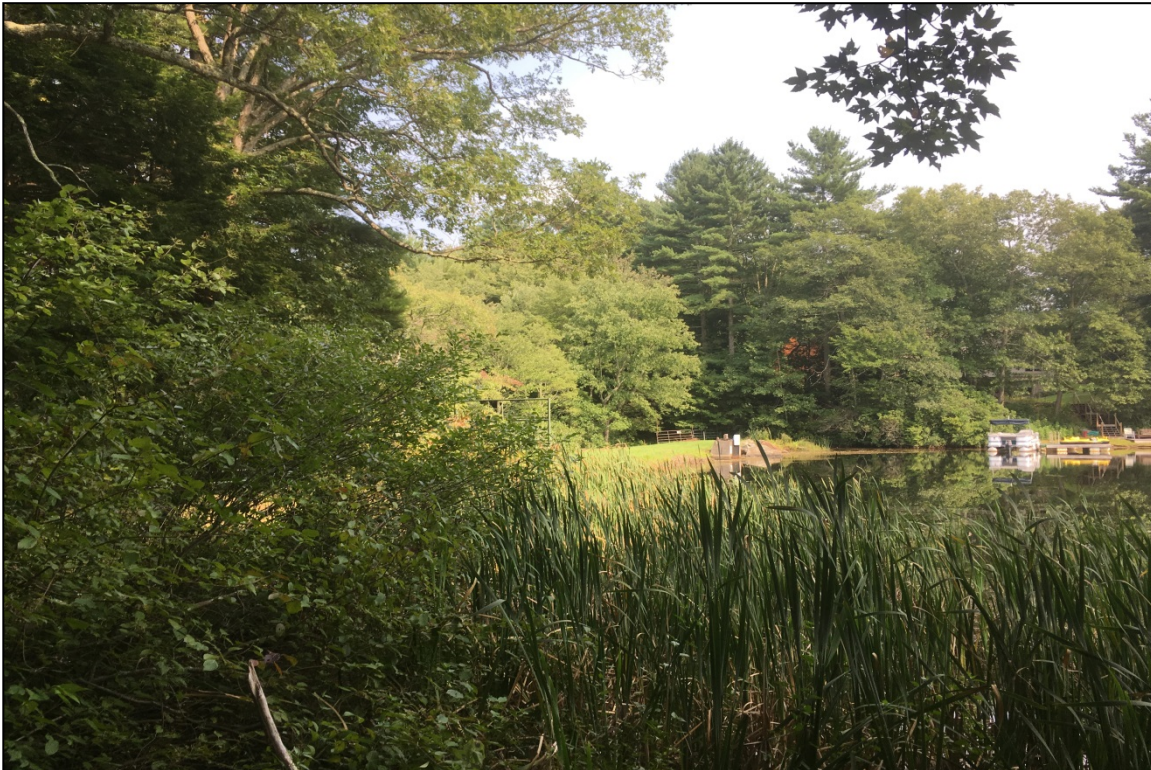
Photo 1: Overview of the dam from upstream

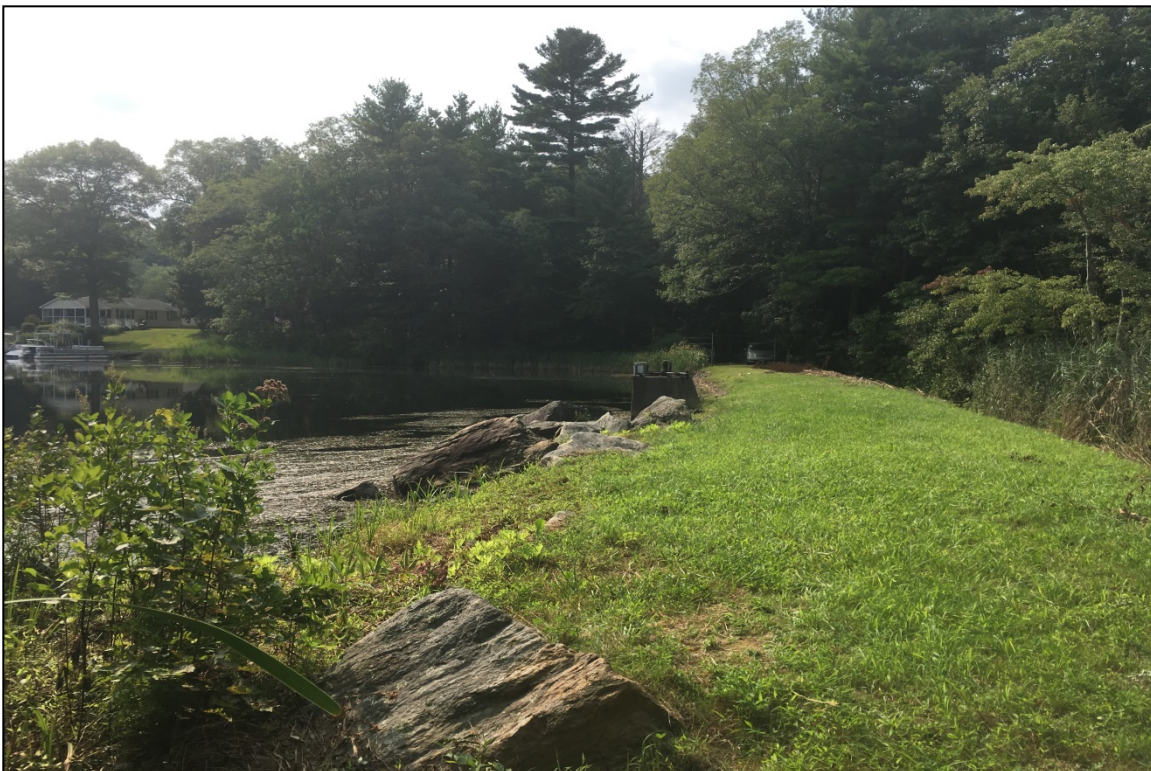
Photo 2: Overview of upstream face from right abutment.

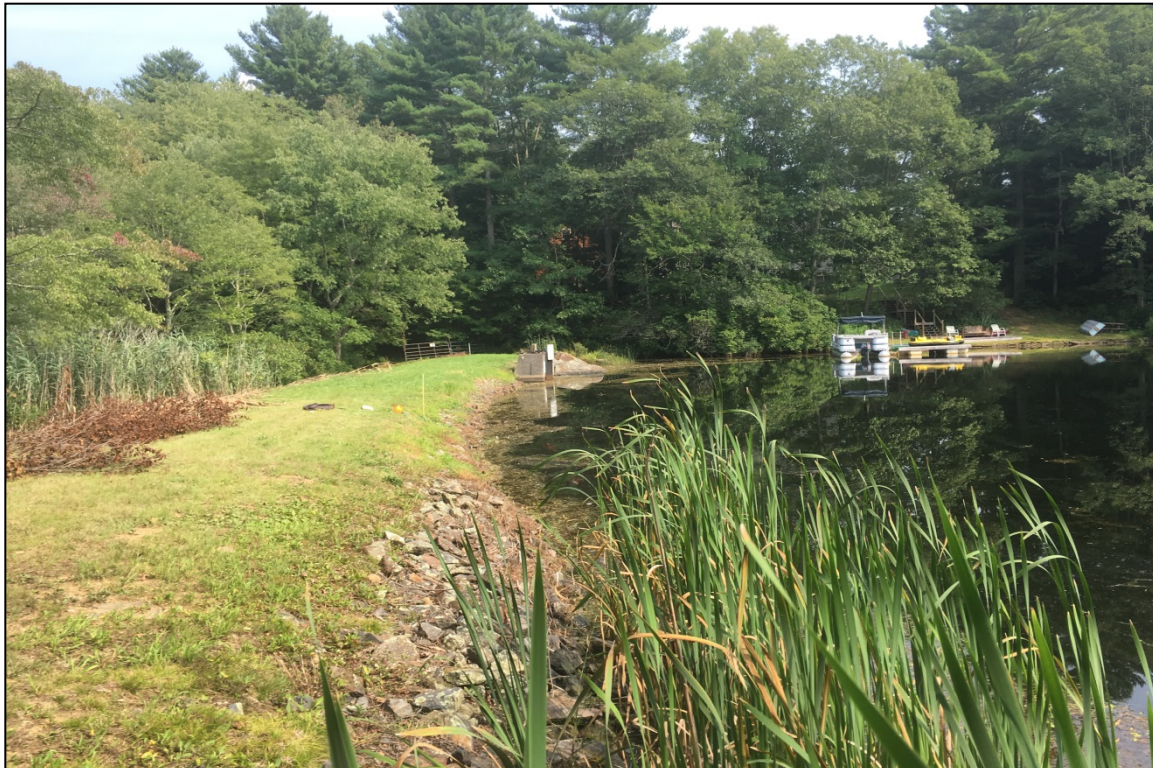
Photo 3: Overview upstream face from left abutment.

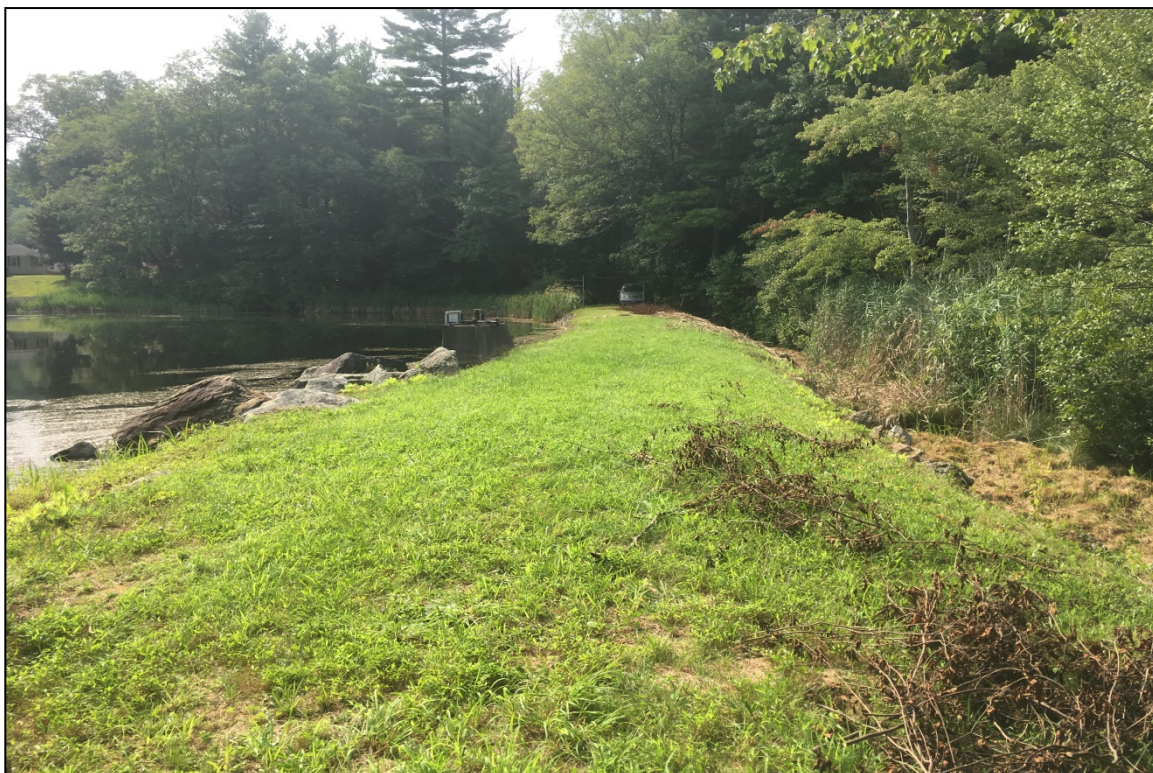
Photo 4: Overview of dam crest from right abutment.

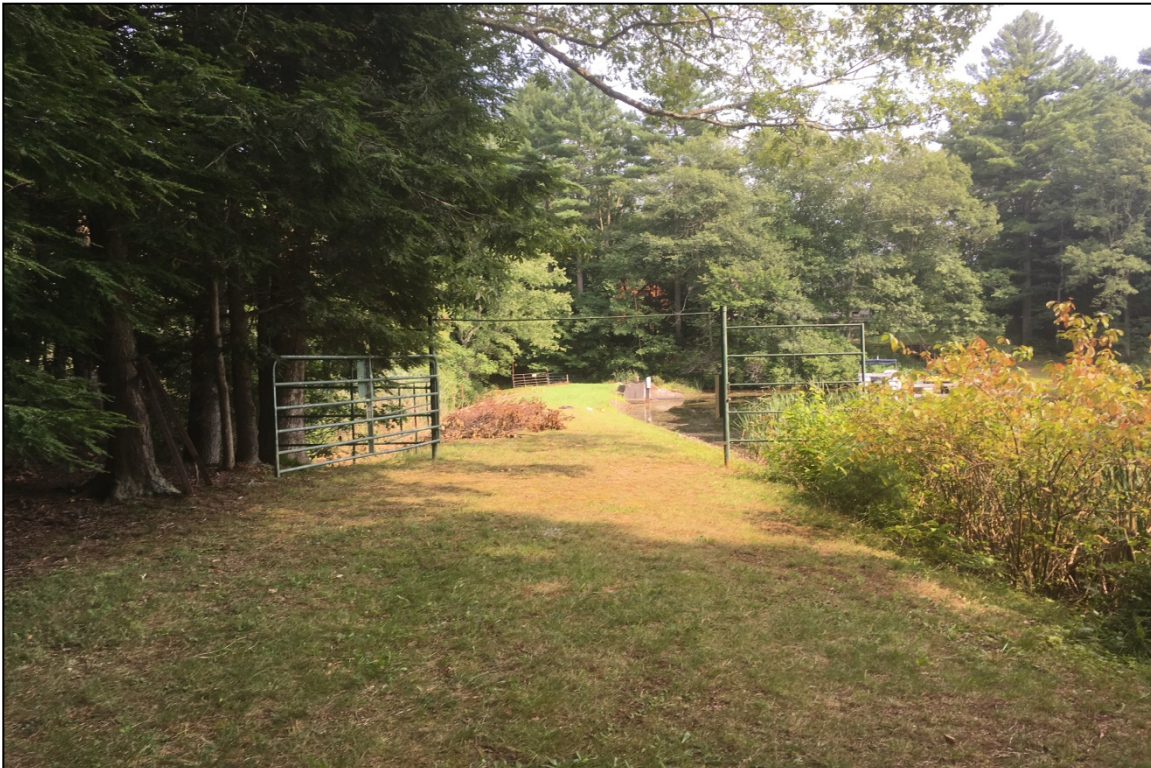
Photo 5: Overview dam crest from left abutment.

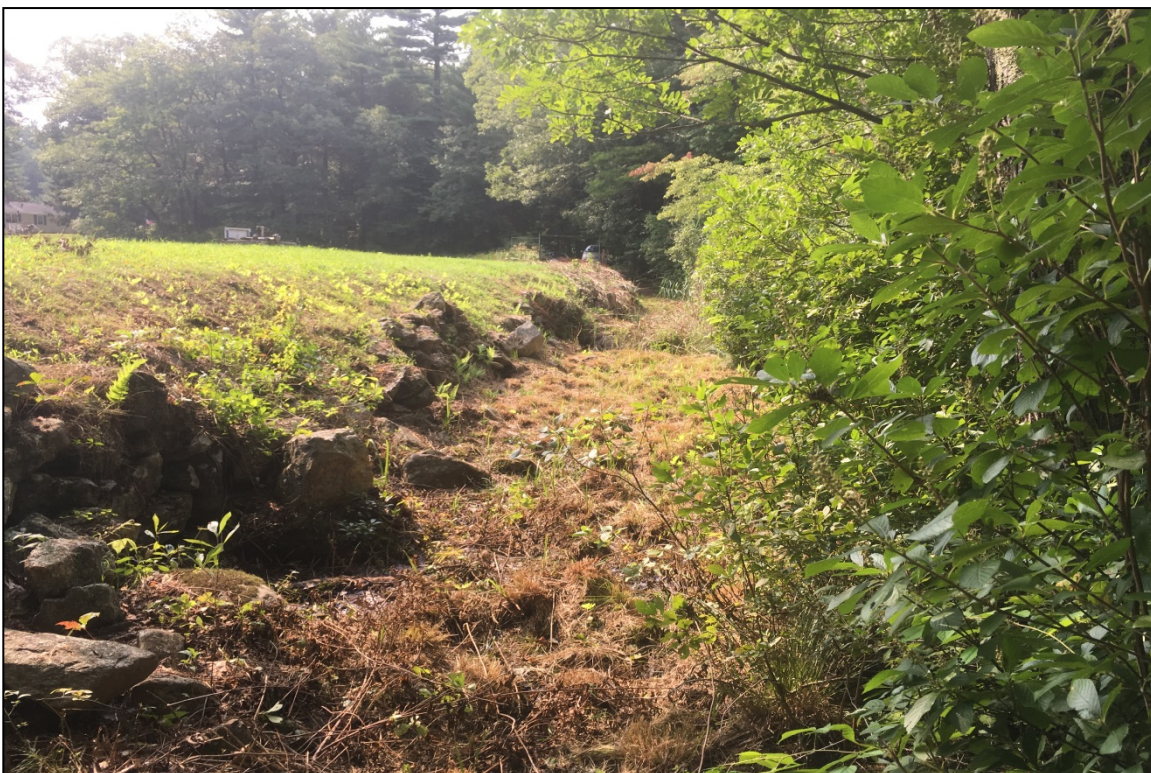
Photo 6: Overview of downstream face from right abutment

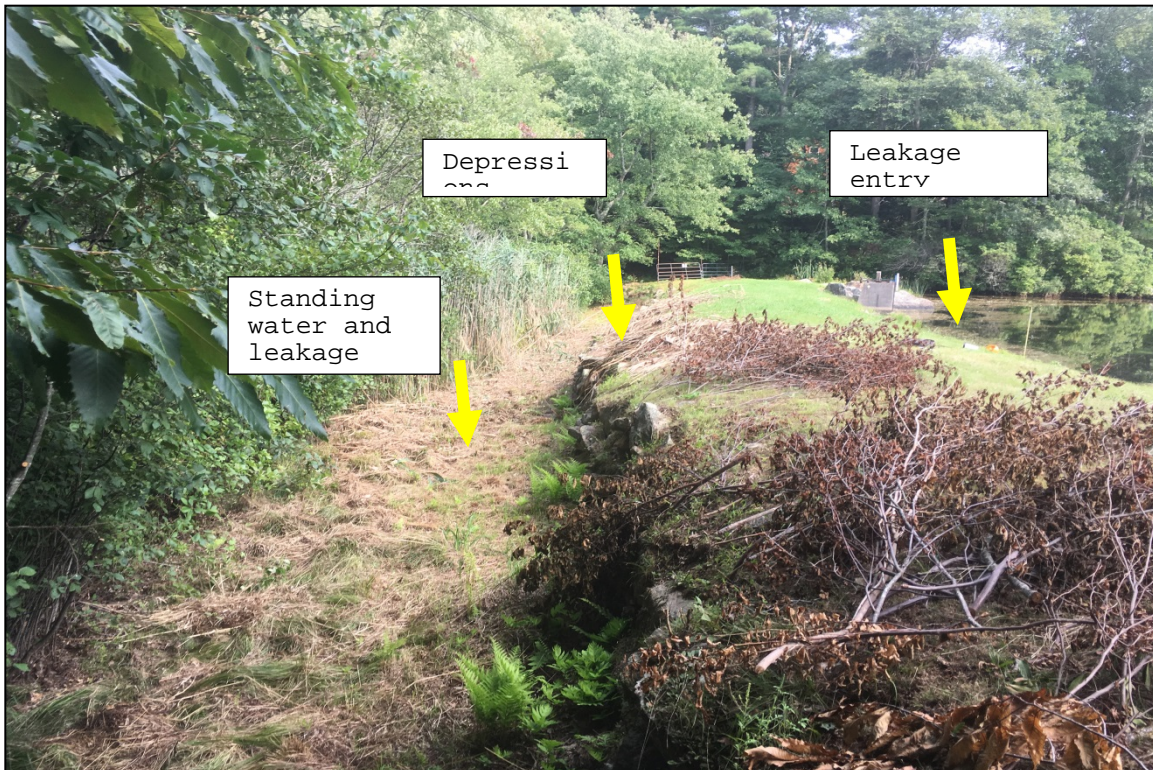
Photo 7: Overview downstream face from left abutment.

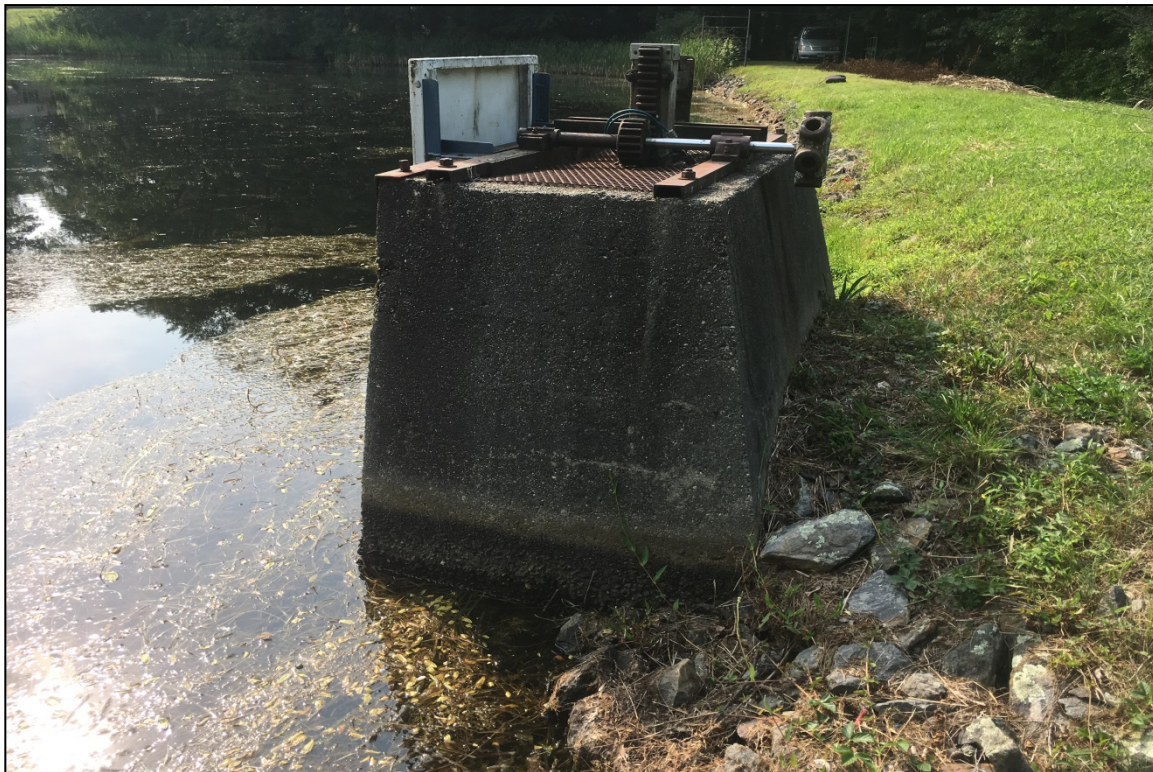
Photo 8: Overview primary spillway from the right side (Owner uses low level outlet as the primary spillway).

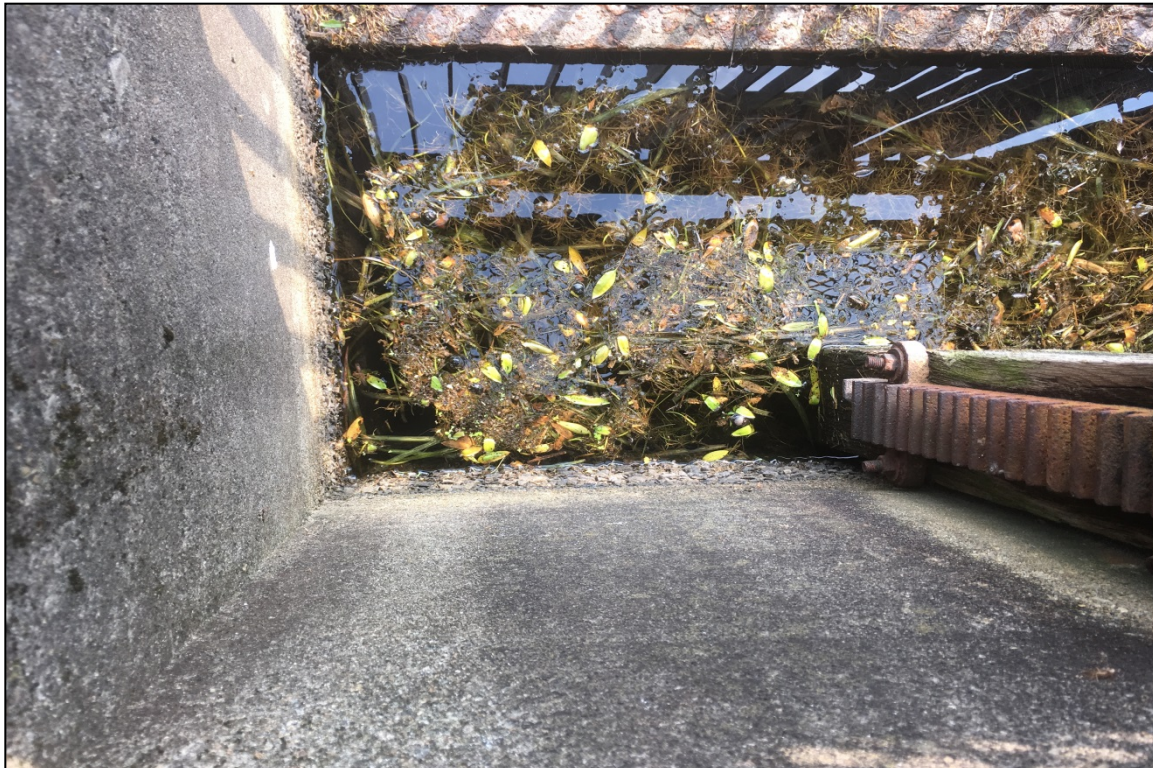
Concrete Condition: The concrete is heavily abraded at the water surface; however no major cracking or spalling was noted.

Photo 9: Overview of primary spillway/low level outlet interior.

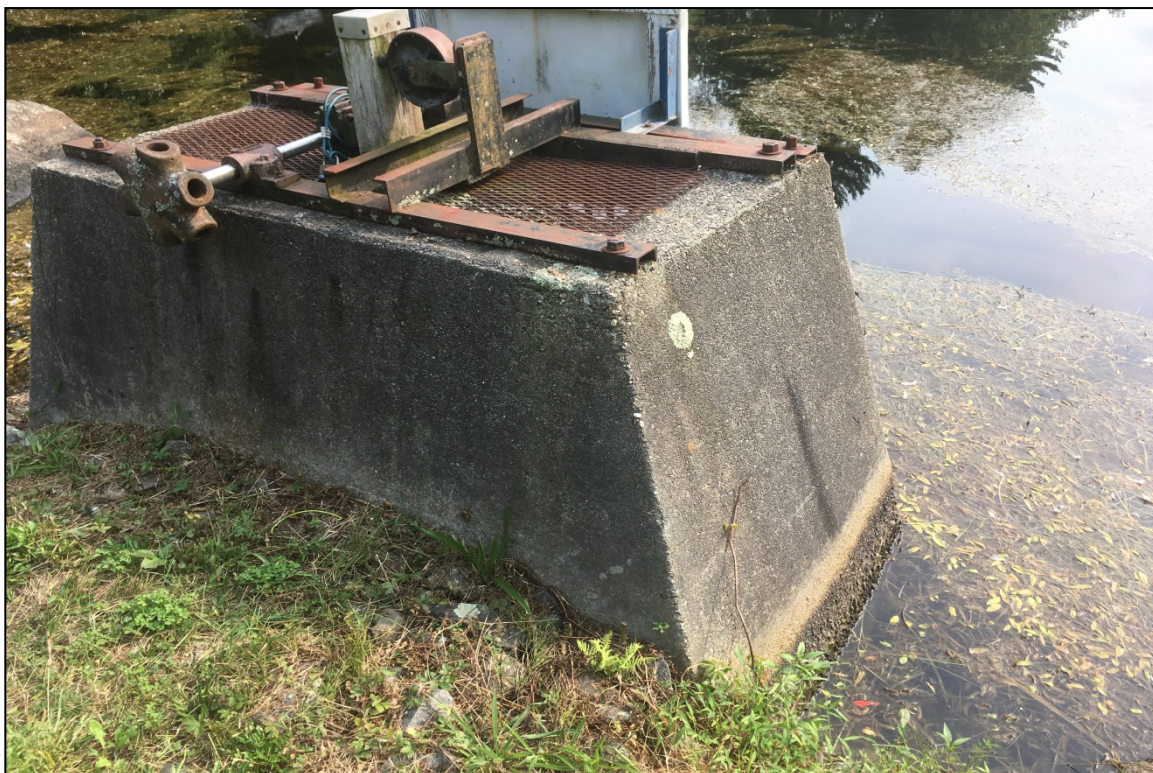
Photo 10: Overview of primary spillway/low level outlet exterior.

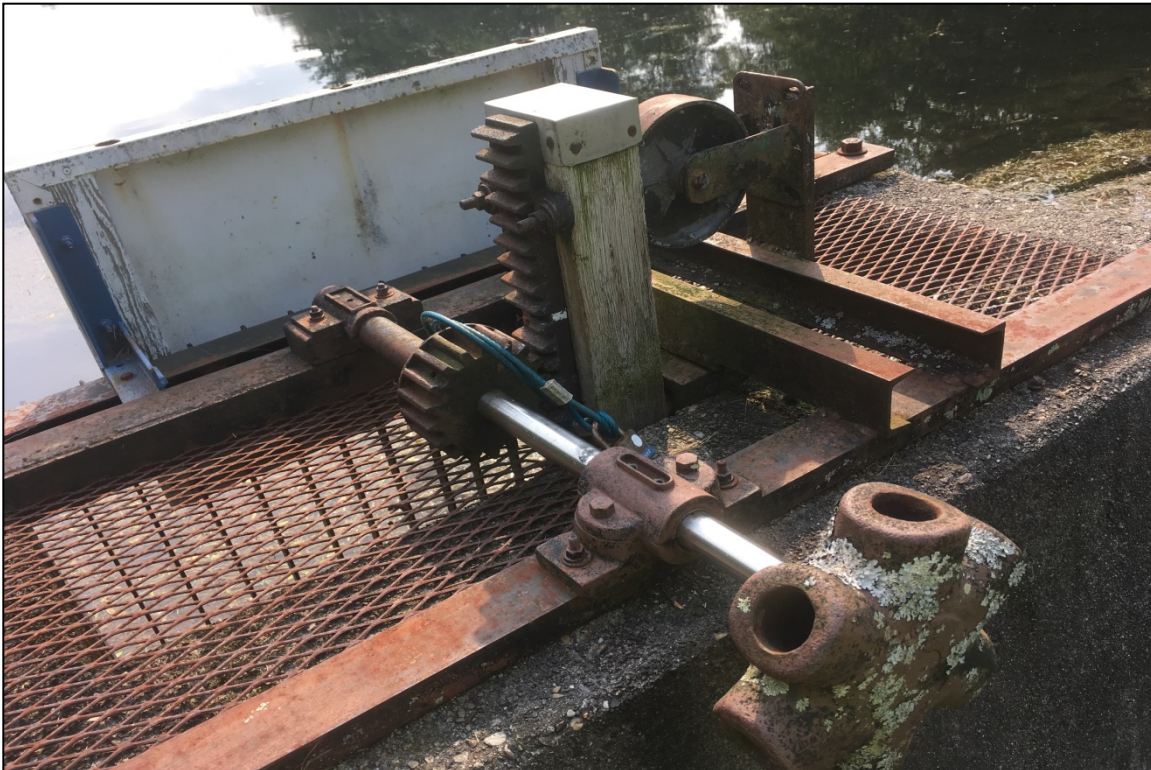
Photo 11: Overview of operators.

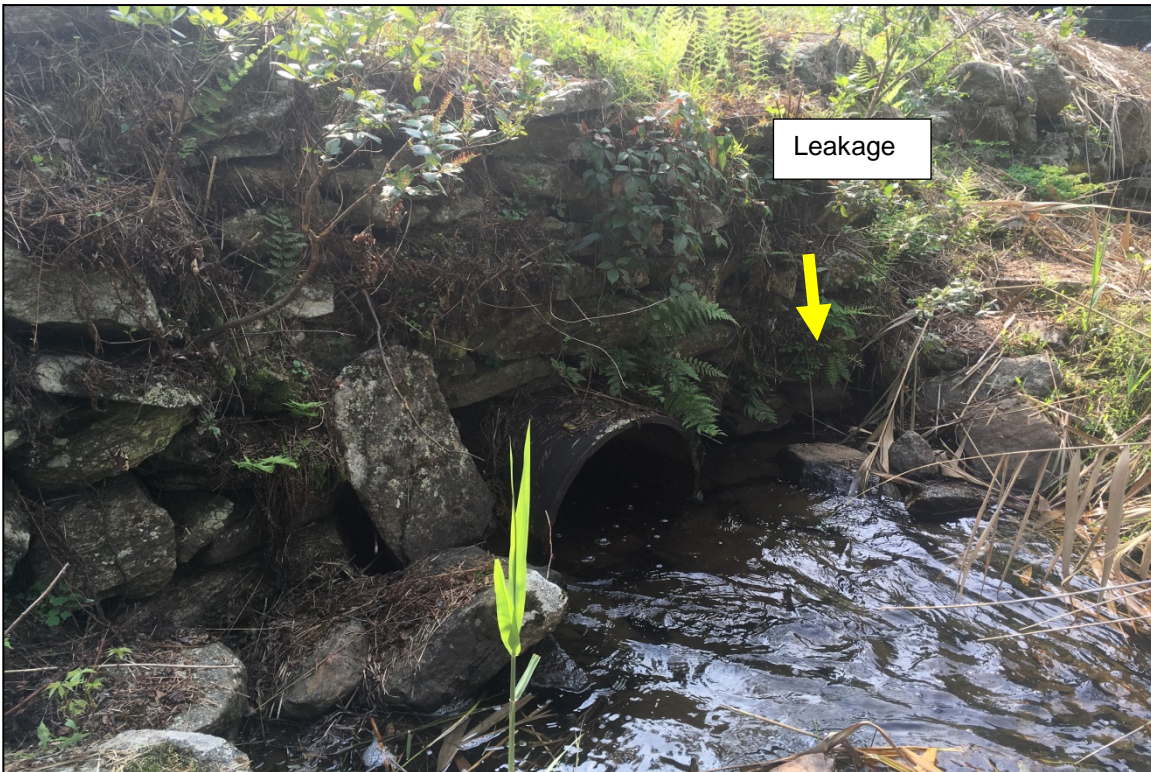
Other: The Owner is not aware of when the pipe was installed. During the site visit on September 13, the upward operating gate was closed to facilitate access to the downstream channel. On this occasion leakage was observed exiting the downstream wall approximately 2 to 3 feet to the left of the outlet pipe. It is not apparent if the leakage is associated with the pipe.

Photo 12: Overview of spillway outlet and stilling basin from downstream channel area. Leakage was subsequently observed on September 13 when the low level outlet was closed.

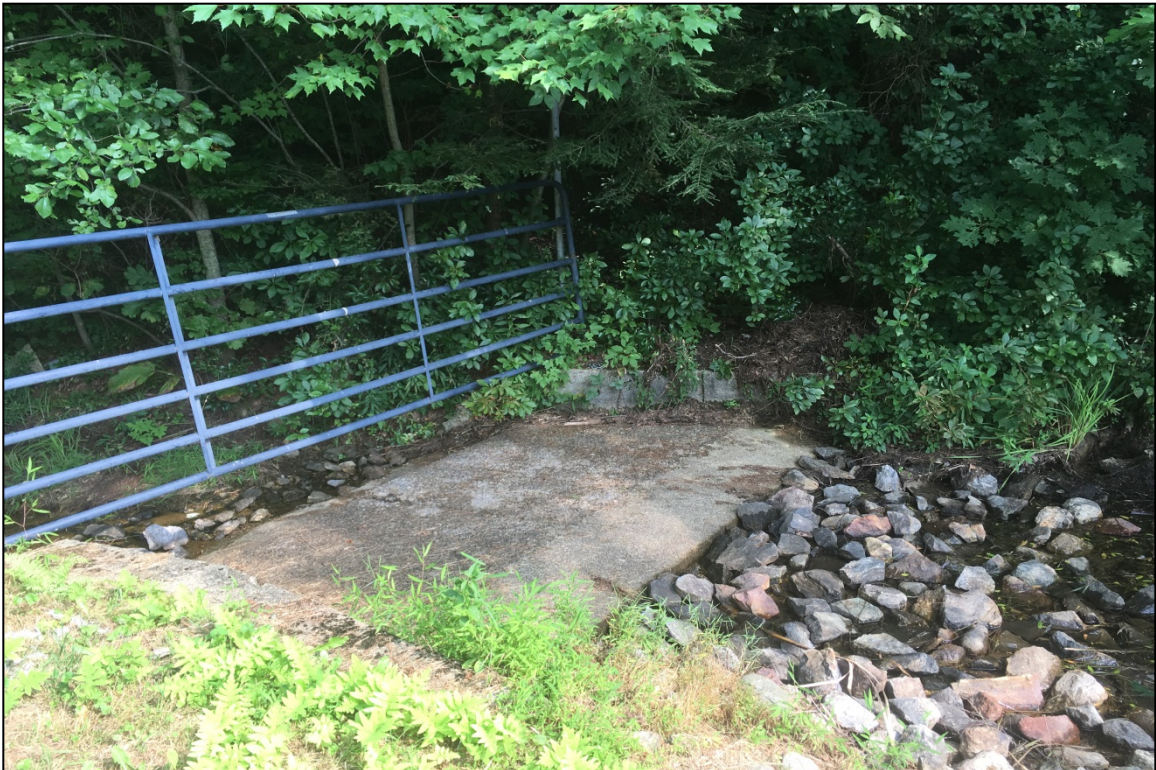
Photo 13: Overview auxiliary spillway from the left side of the spillway.

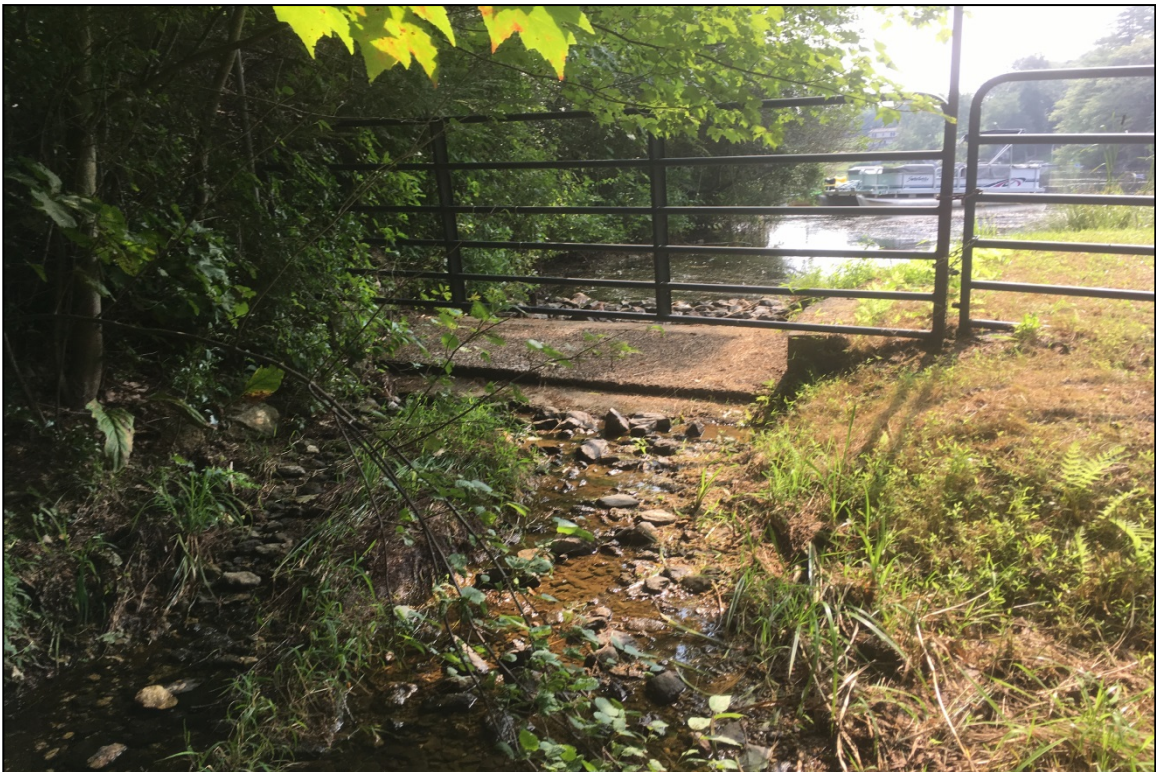
Photo 14: Overview of auxiliary spillway from downstream channel area.

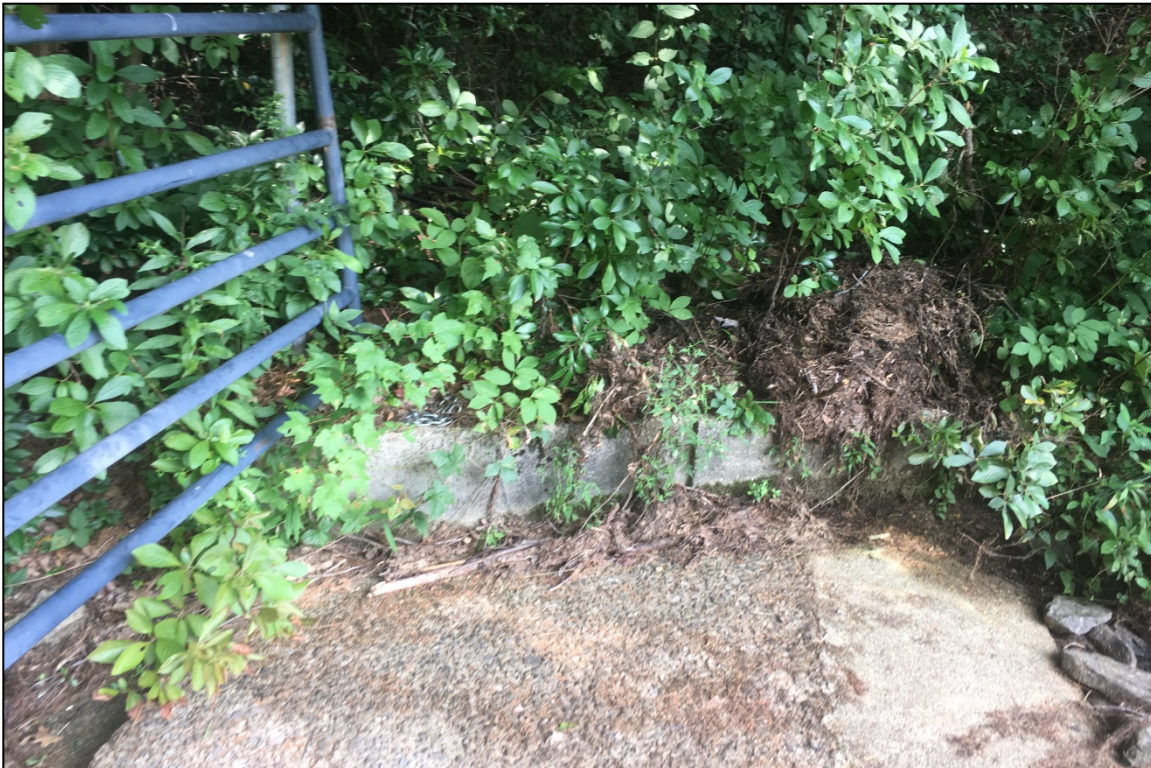
Photo 15: Overview of right training wall.

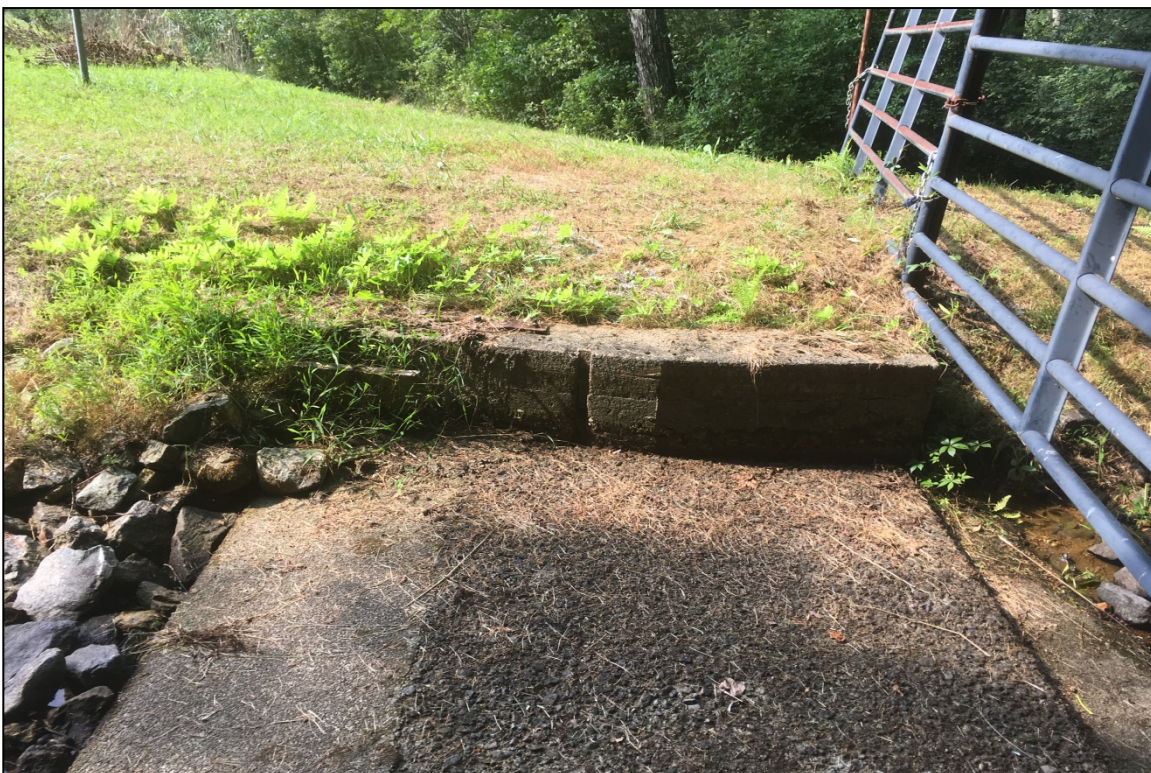
Seepage/Foundation Drainage: On 8/27/18 Excess red dye that remained after the assesment of the reported leak at the abutment was applied at the spillway as leakage was suspected based on visual observations. The dye applied upstream of the spillway discharged to the downstream side of the left training wall, confirming that a leak is present beneath the left side of the auxiliary spillway. At the time of the inspection, the water level was approximately 3 inches below the upstream side of the approach apron at the auxiliary spillway.

Photo 16: Overview of left training wall.

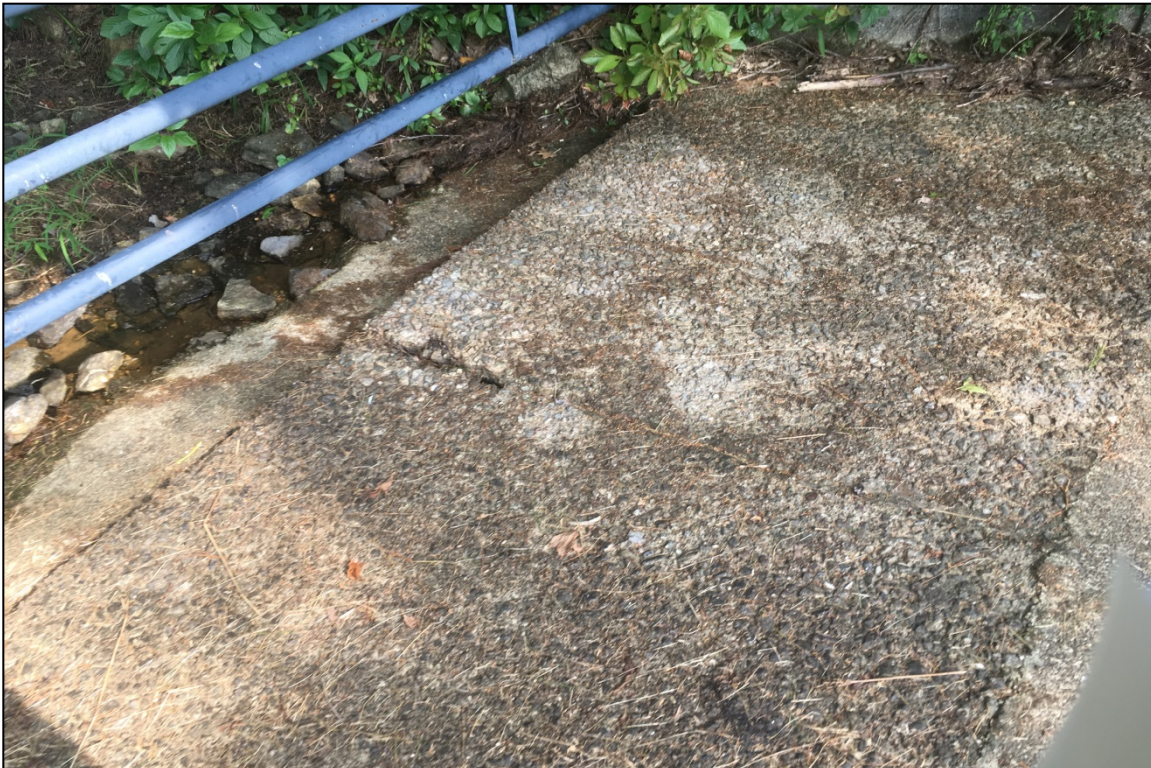
Concrete Condition: Poor, the concrete is heavily scoured and the approach apron panels show differential settlement. The apron was sounded, however no audible indication of voids beneath the panels were noted.

Settlement/Alignment/Movement: The upstream approach apron consists of two concrete slab panels. An approximately 1/4 inch space and differential settlement was noted at the joint on the panels.

Cracks: The apron at the auxiliary spillway has a longitudinal crack with differential settlement as noted above.

Photo 17: Overview of weir, note the differential settlement on the slab.

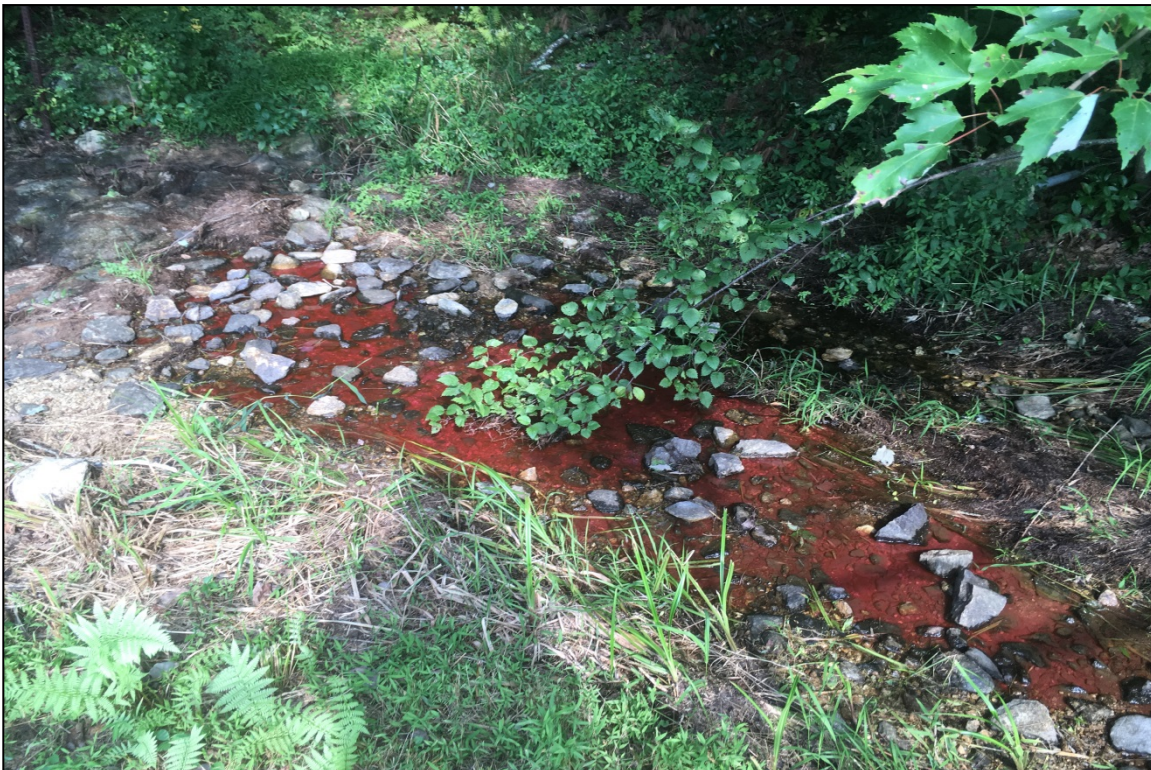
Photo 18: Overview of downstream channel at primary spillway. The water is colored with excess dye that was used to assess leakage at the upstream side of the dam.

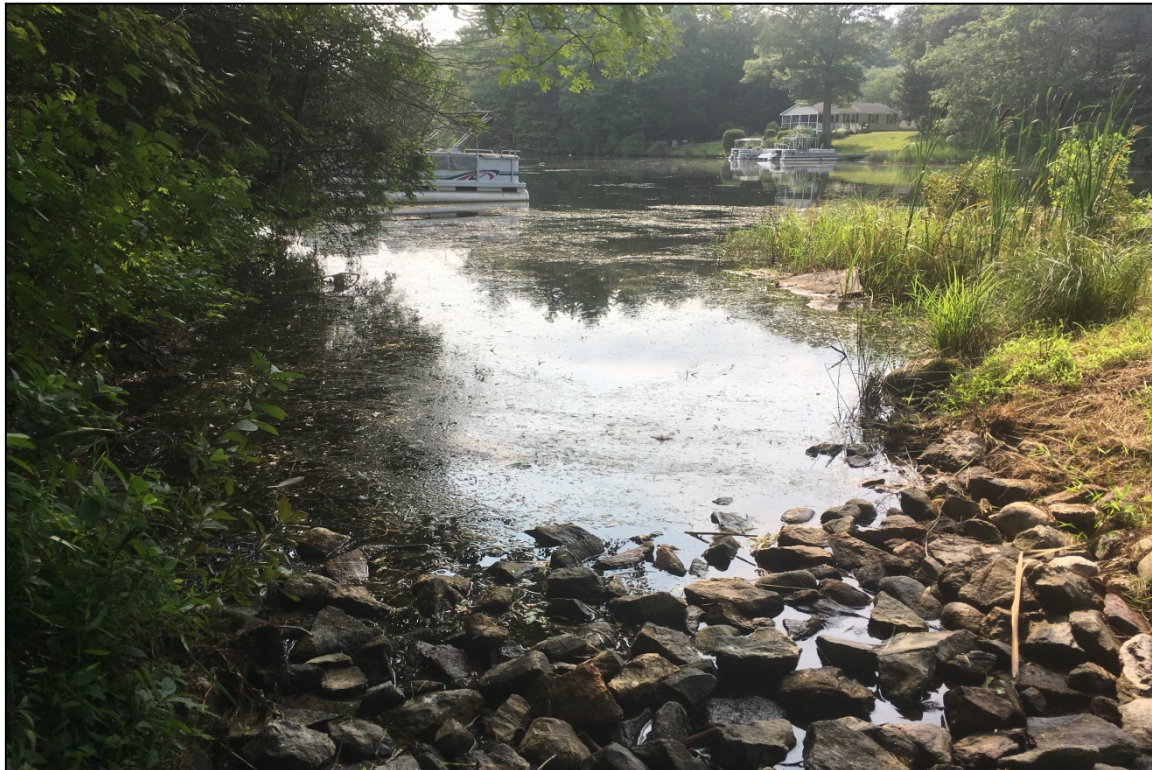
Photo 19: Overview of reservoir area.

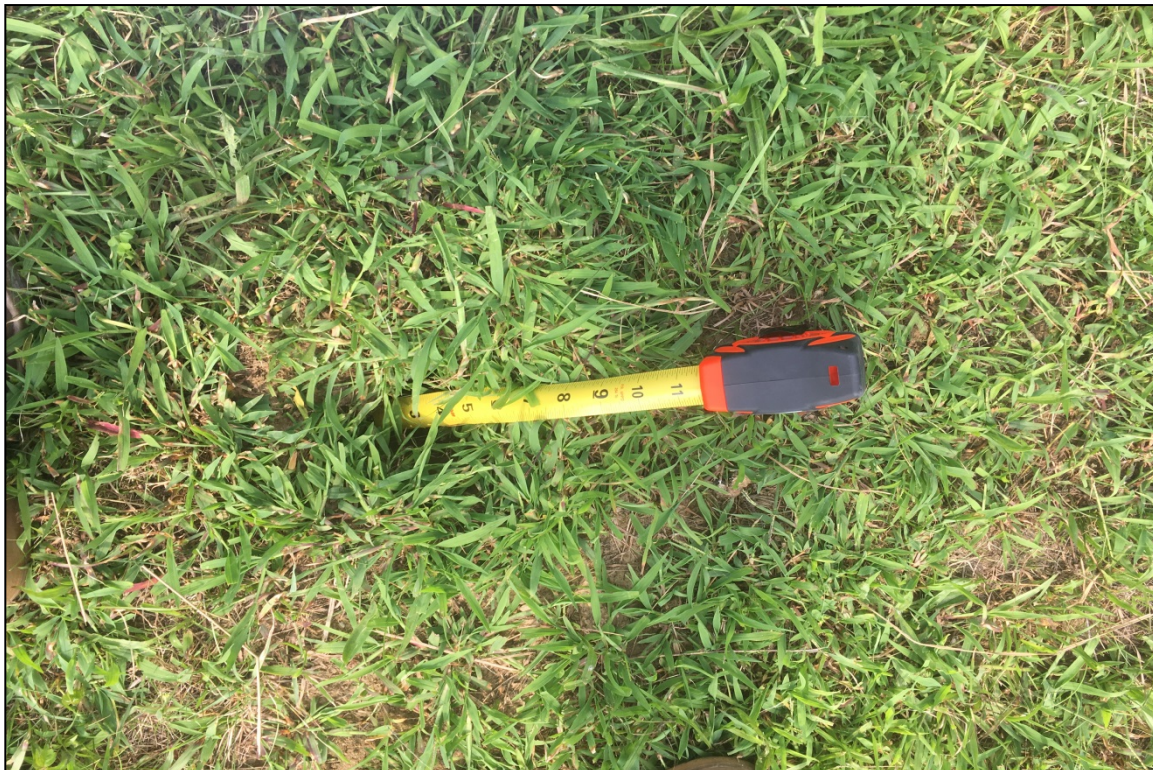
Erosion/Burrows: Two 4-inch diameter animal borrows were observed at the crest.

Photo 20: Areas of specific deficiencies – Rodent hole on the crest (typ.).

5. Eradicate nuisance animals and repair (fill) animal holes.
6. Provide a filter berm at the downstream side of the dam. The filter berm should be designed to reduce the potential for damage to the embankment by internal soil erosion, provide support to the downstream wall, and facilitate maintenance access to the downstream side of the dam.

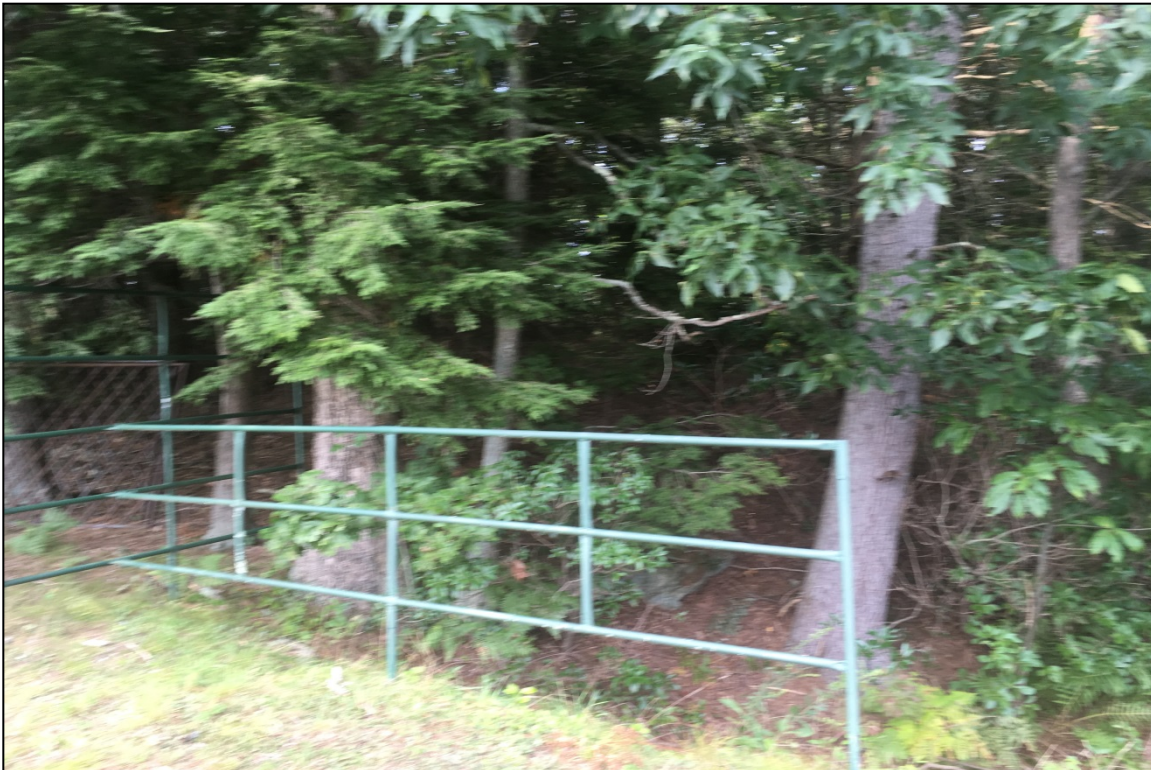
Photo 21: Areas of specific deficiencies – tree growth at the left abutment.

2. Continue completing routine mowing and brush clearing at the dam.
3. Remove all trees and woody vegetation within 15 feet of the dam and dike embankments, including along the toe of downstream stone masonry wall and the trees located at the left and right abutments of the dam. Should removal at this time be infeasible due to ownership/property boundary issues, the trees should be monitored and ultimately removed if later determined to be causing damage to the dam.

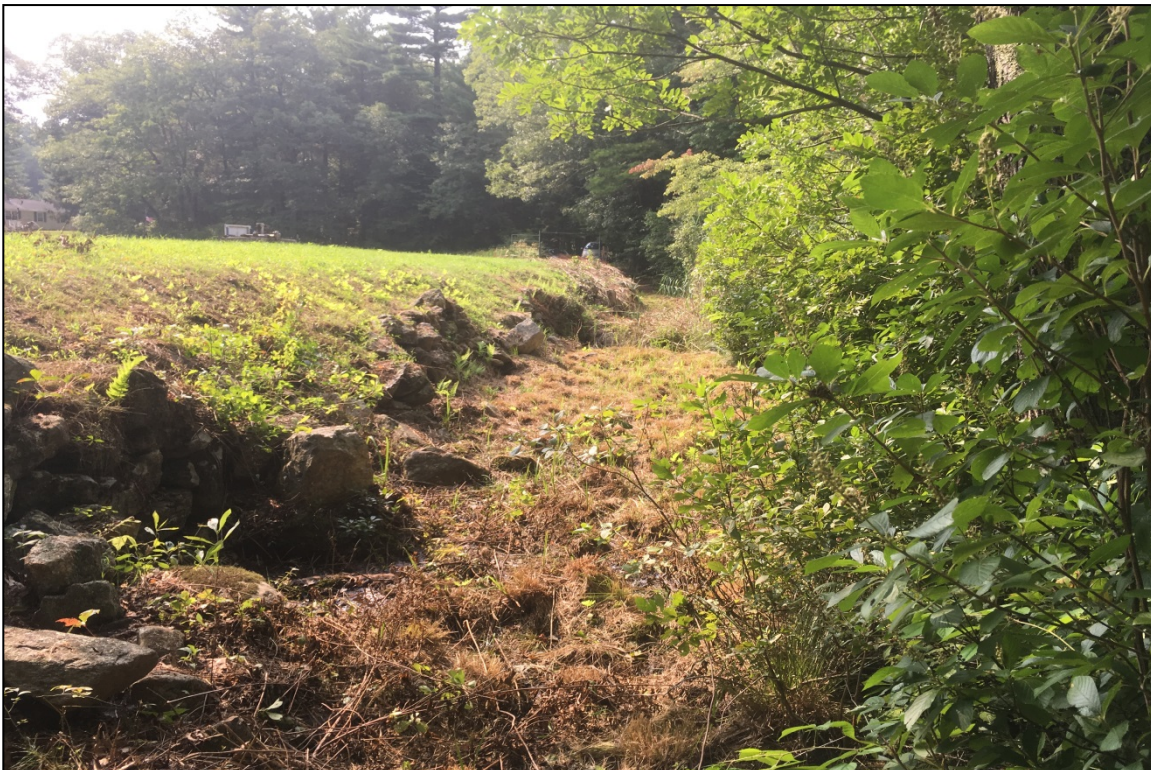
Stone Masonry: Poor condition, several collapsed portions, undulations and bulges in the downstream wall.

Photo 22: Areas of specific deficiencies – the downstream wall is leaning and collapsed, however, the toe is otherwise clear of vegetation.

4. Monitor leaning stone masonry wall on downstream face and repair if necessary to correct stone displacement to provide plumb wall, minimizing the potential for future stone displacement.

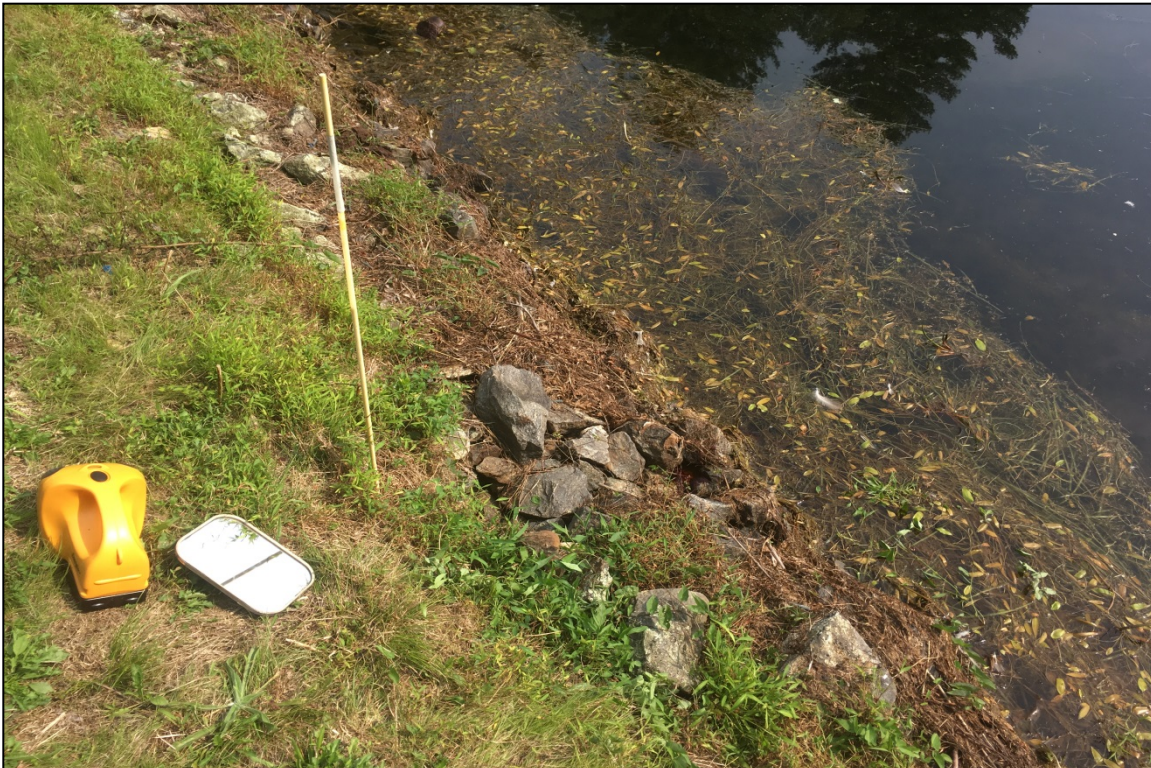
1. The Owner utilizes the gate controlled conduit as a primary outlet as well as a low level outlet.
2. The Owner has observed audible leakage that is inferred to be entering into the embankment on the upstream slope near the height of the normal pool level. At the time of the visual inspection on August 27, 2018, the Owner had drawn down the level of the impoundment 4 inches below the normal level as a precaution. The audible leakage was not detected at the time of the visual inspection. Dye was placed in the vicinity of the leakage point at the upstream side of the pond. The dye was not observed to be seeping to the downstream side of the dam during the inspection.

On September 13, 2018, the Owner requested that Fuss & O'Neill revisit the dam as they had detected the leakage sound at the upstream side of the embankment. At the time of the second field visit, the impoundment level was 3 inches below the normal level and the outlet was closed at the time that Fuss & O'Neill arrived at the site. The sound of water was detected leaking into the embankment and leakage was observed at the downstream side of the dam. In addition to the leakage noted near the middle of the embankment, leakage was observed approximately 2 to 3 feet to the left of the low level outlet. The water leaking from the downstream side of the dam at both locations was clear and there was no evidence of active particle transportation or internal erosion.

Photo 23: Areas of specific deficiencies – area of leakage entry (reported by Owner). Leakage was not detected on August 27, 2018 but was confirmed on September 13.

1. Continue to monitor the dam for increased signs of leakage, particularly after storm events. A repair should be designed to address the deficiency to ensure that it does not continue to deteriorate.
