DAM SAFETY PROGRAM DAM INSPECTION REPORT FORM – FOR REGULATORY INSPECTION

Dam Name:	Crystal Pond Dam	Inspection Date(s):	August 27, 2018 (Follow-up on September 13, 2018)
Alternate Dam Name(s):	None	CT Dam ID #:	3908
Location (Municipality):	Eastford	Temperature / Weather:	8/27/18: 85 deg F, no precip. in the 7 days prior to inspection 9/13/18: Heavy rain on the previous day
Registered?: Yes or No If yes, provide the 9 digit registration number found on the notification letter.	Yes (Reg. No. not available)	Pool Level: See Instructions	Approx. 4" below the auxiliary spillway invert/normal pool level.
Emergency Action Plan?: Yes or No If Yes, see instructions	No	Impoundment Use: use options listed in instructions	Recreation
Hydraulic and Hydrologic Analysis?: Yes or No If Yes, see instructions	No	Stability Analysis?: Yes or No If Yes, see instructions	No
Overall Condition: (refer to Appendix A located at the end of this form) Poor

CRYSTAL POND ASSOCIATION
 SITE SKETCH
 CRYSTAL POND DAM VISUAL INSPECTION
 EASTFORD CONNECTICUT

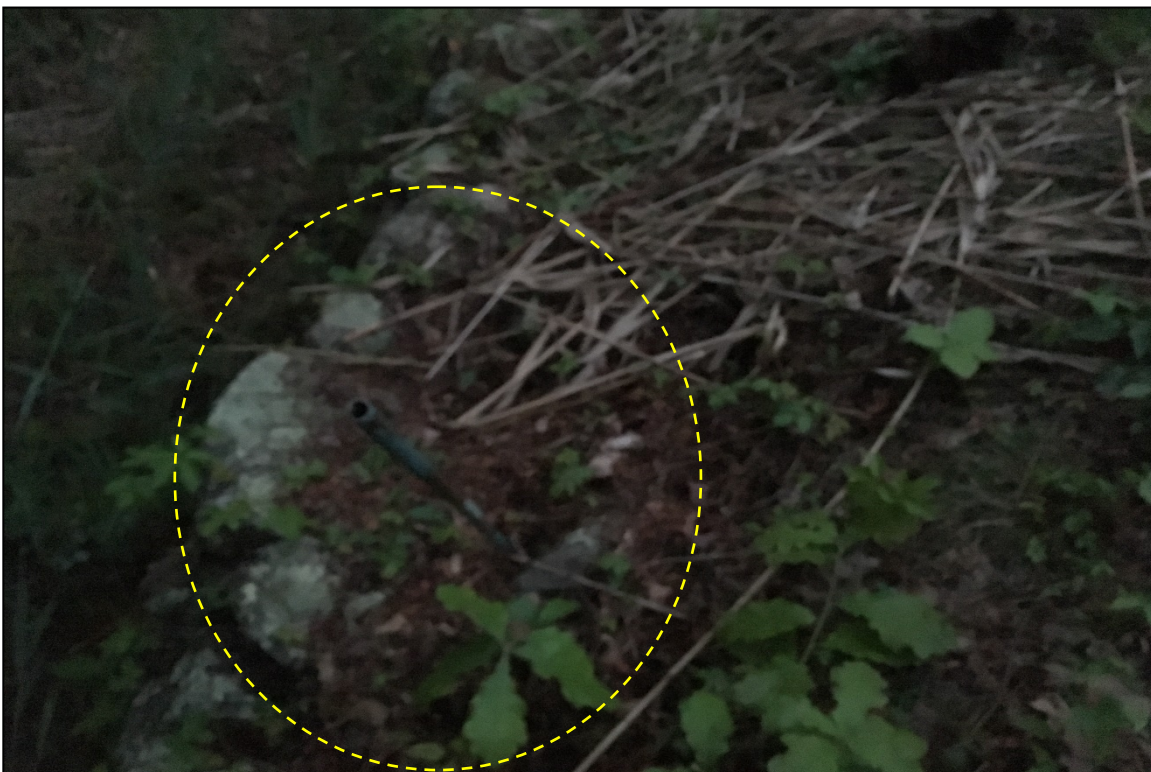
Settlement/Alignment/Movement: The center of the crest appears level with no evidence of depressions or other internal soil erosion. There are several 12" and greater diameter depressions behind the top of the stone masonry wall at the downstream side of the crest. The depressions are aligned with the areas of standing water and seepage at the toe of the dam as well as the reported leakage entry point at the upstream embankment. One depression was probed with a 1" dia rod to resistance at approximately 24 inches deep. Portions of the downstream side of the dam crest were obscured by vegetation debris that remained onsite from the Owner's clearing efforts. The downstream wall is collapsed in several areas, with several bulges and horizontal undulations. The downstream side of the crest shows some areas of prior shallow slope movement associated with the irregularities at the downstream stone masonry wall that has revegetated.

Photo 24: Areas of specific deficiencies – depressions at the downstream side of the crest.

5. Eradicate nuisance animals and repair (fill) animal holes.
6. Provide a filter berm at the downstream side of the dam. The filter berm should be designed to reduce the potential for damage to the embankment by internal soil erosion, provide support to the downstream wall, and facilitate maintenance access to the downstream side of the dam.
