INSPECTION REPORT

CRYSTAL POND DAM CT DEEP #03908 / HAZARD CLASS "BB"

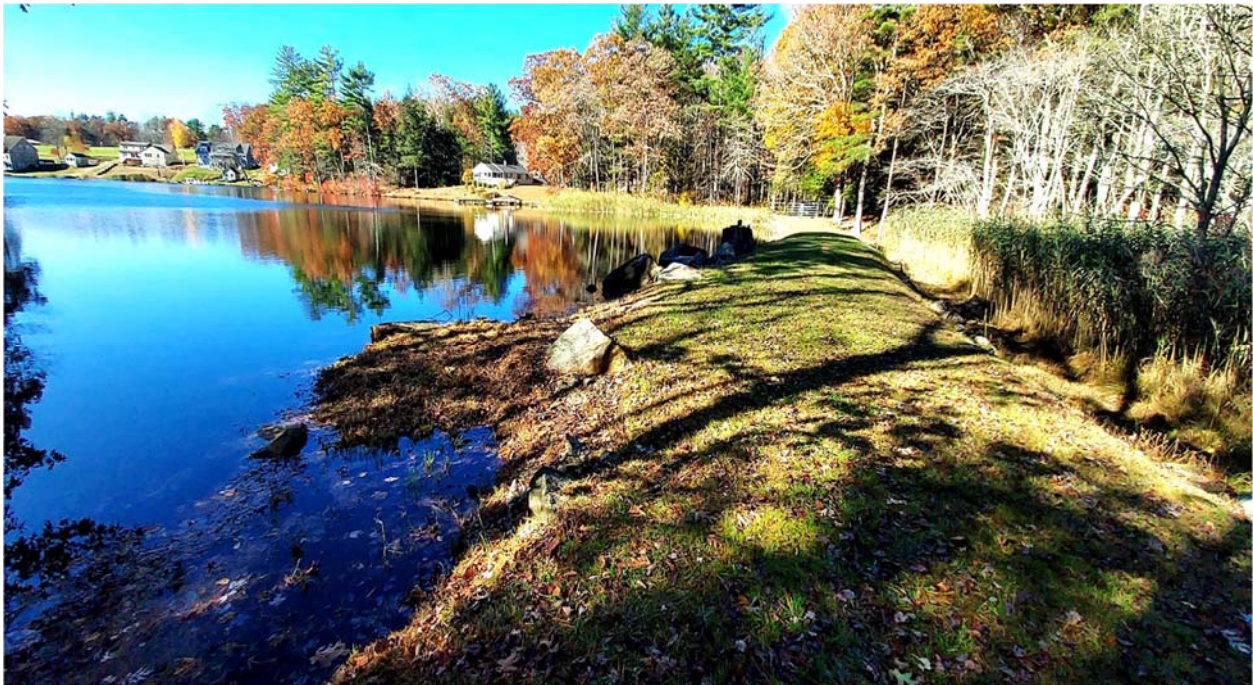
CRYSTAL POND BROOK
COVE ROAD EAST & WEST
EASTFORD, CONNECTICUT

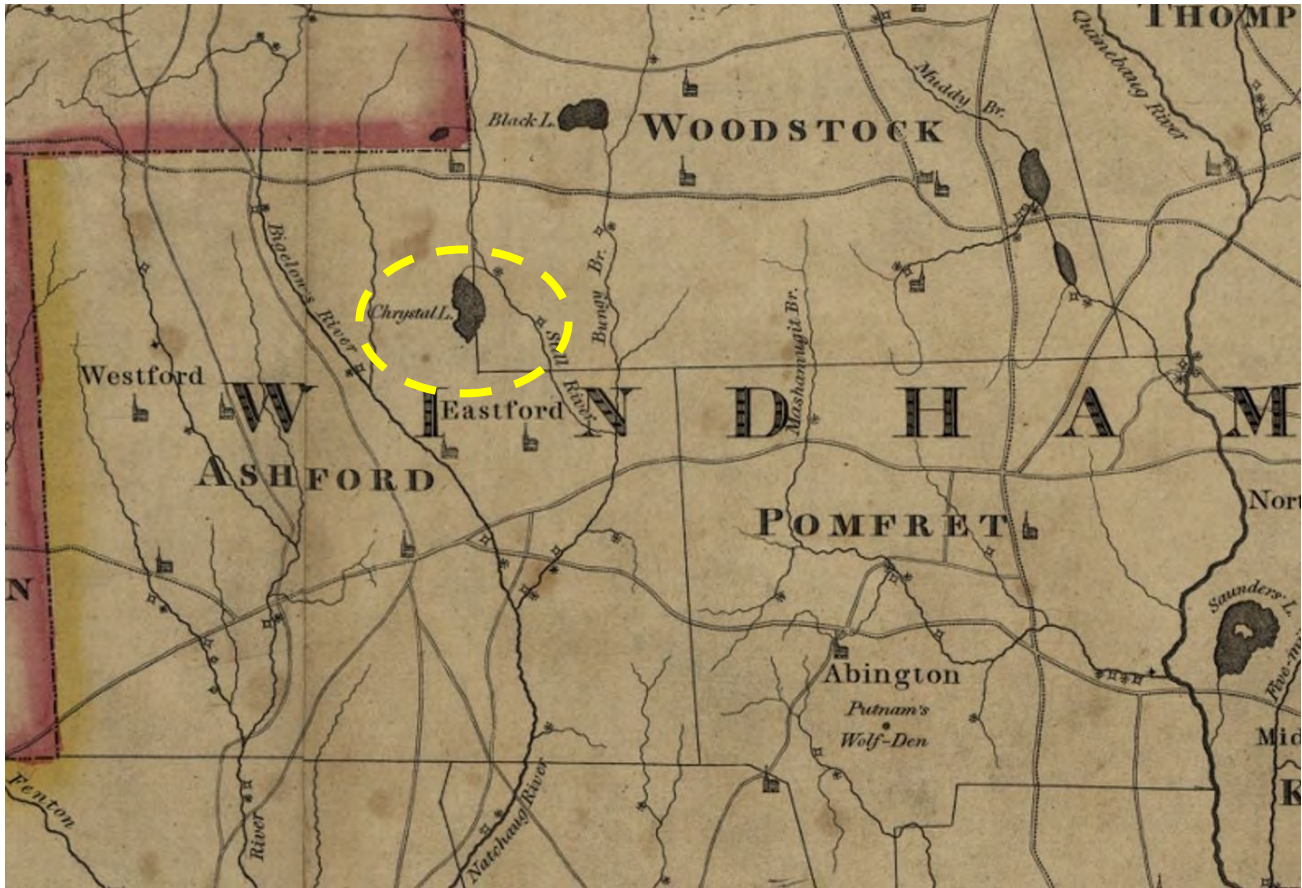
1811 Warren Map of Connecticut

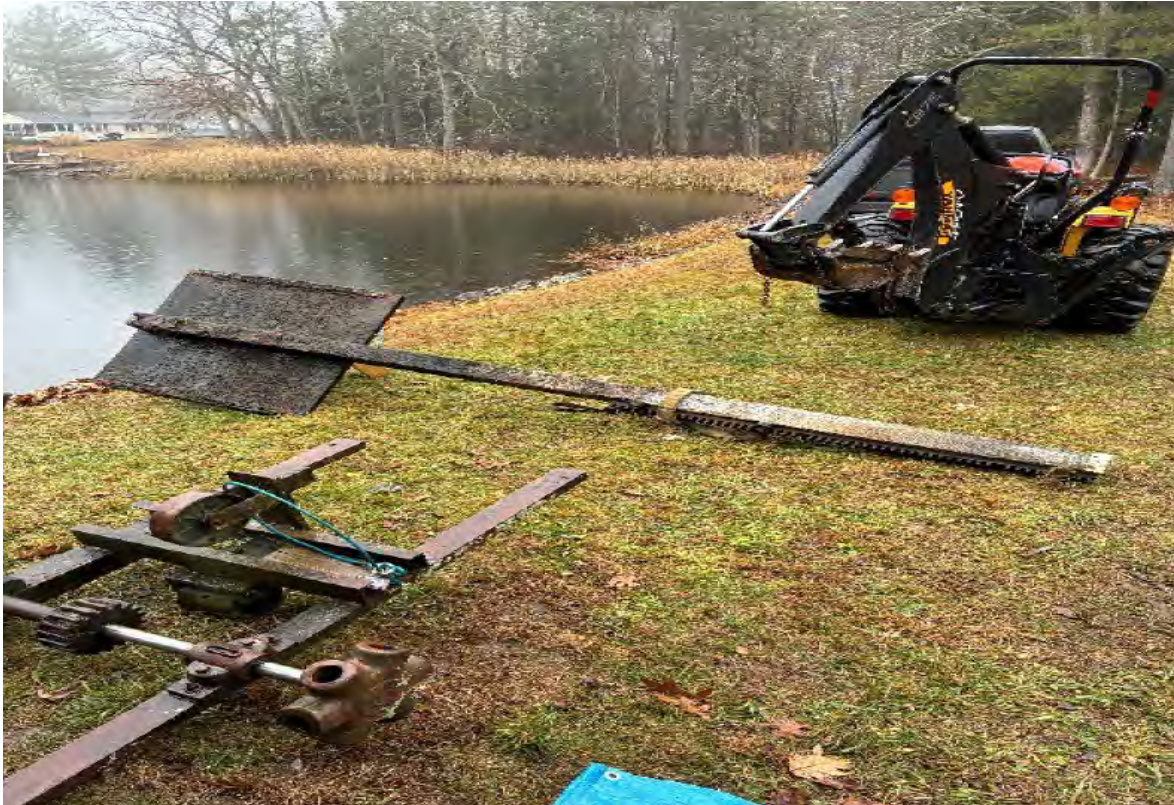
Photo 18 – A view of the gate operator, at bottom left, taken during the structure refurbishment noted in the previous photos.

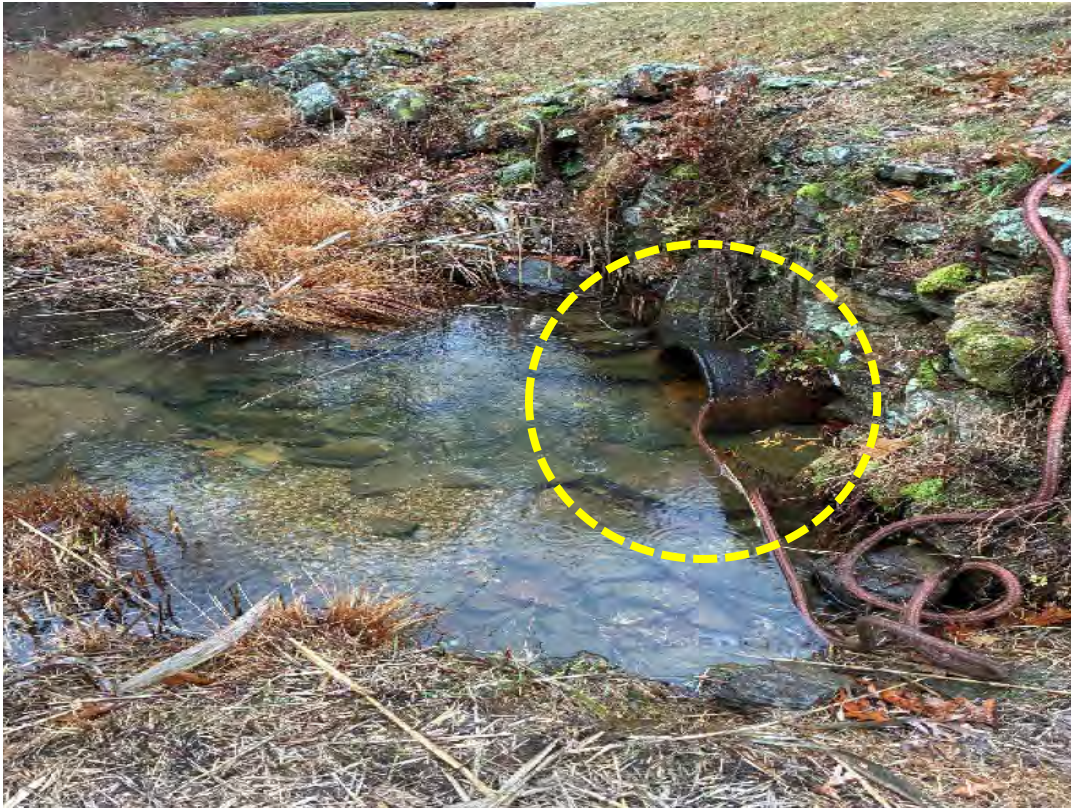
Photo 19a – The discharge point of the 24-inch cast iron low level outlet pipe on the downstream embankment slope, taken during the outlet structure's repair.

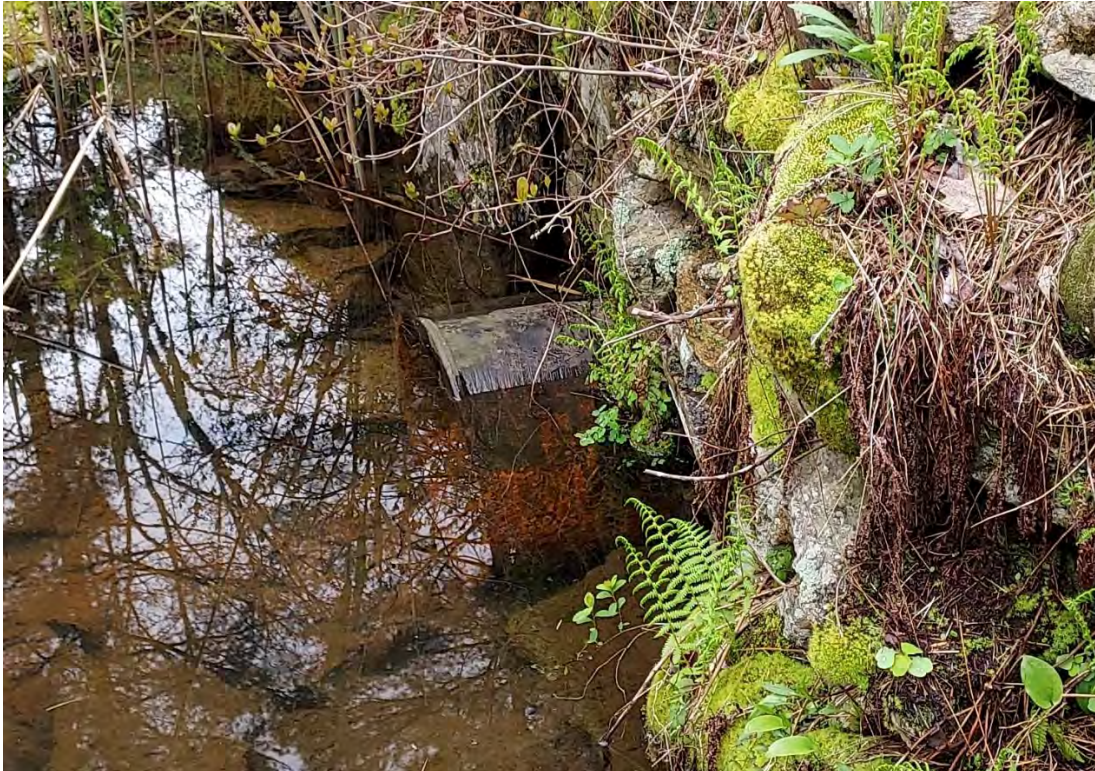
Photo 19b – A closeup view of the discharge end of the outlet pipe.

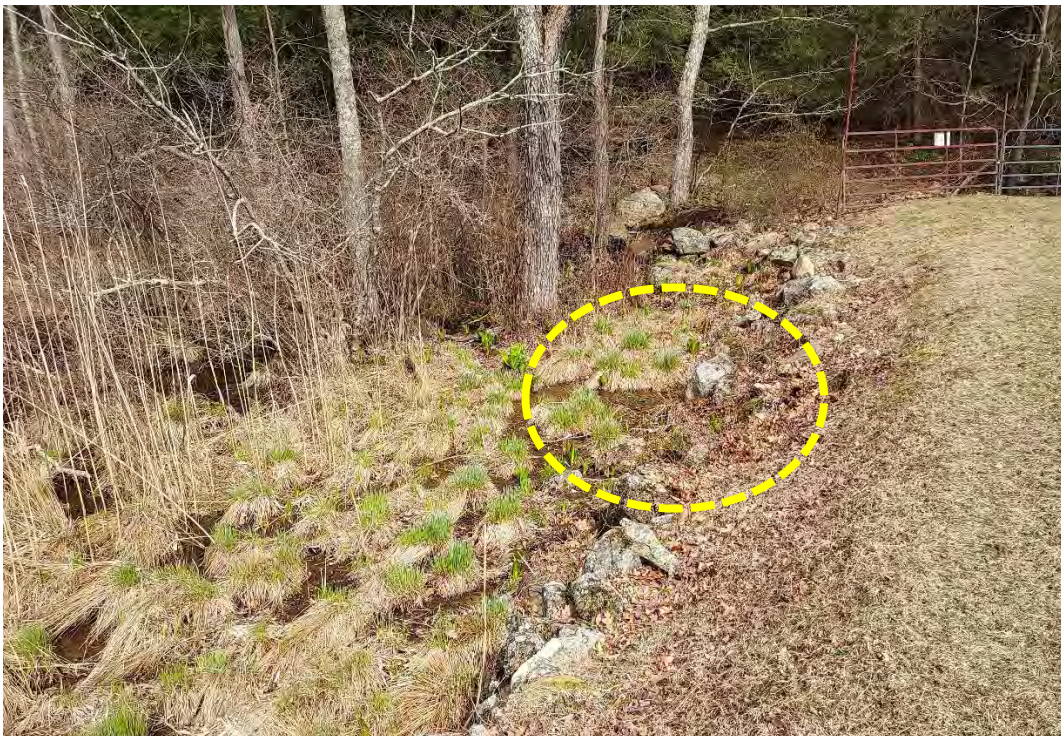
Photo 21d – An overview of a leakage area along the base of the downstream slope, approximately 35 – 40 ft. left of the spillway

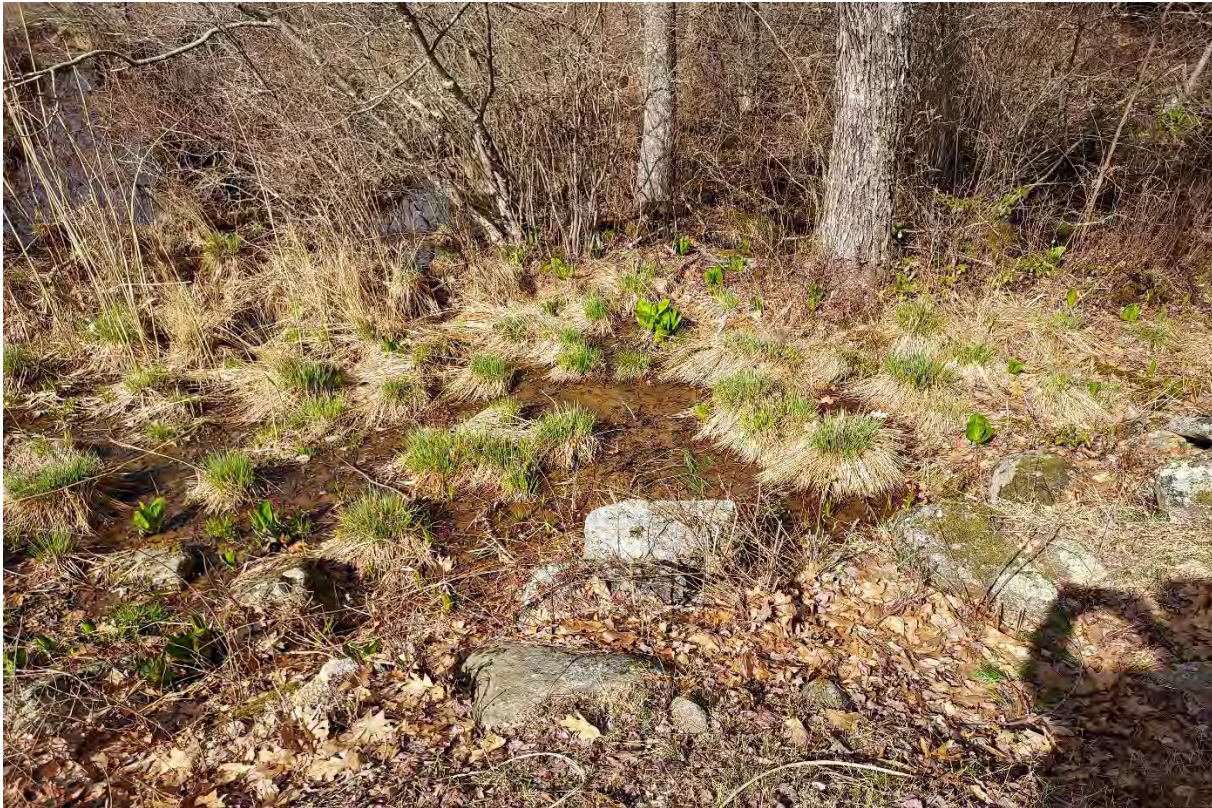
Photo 21e – A closeup of the leakage area in the previous photo, looking from the dam crest to the downstream toe area.

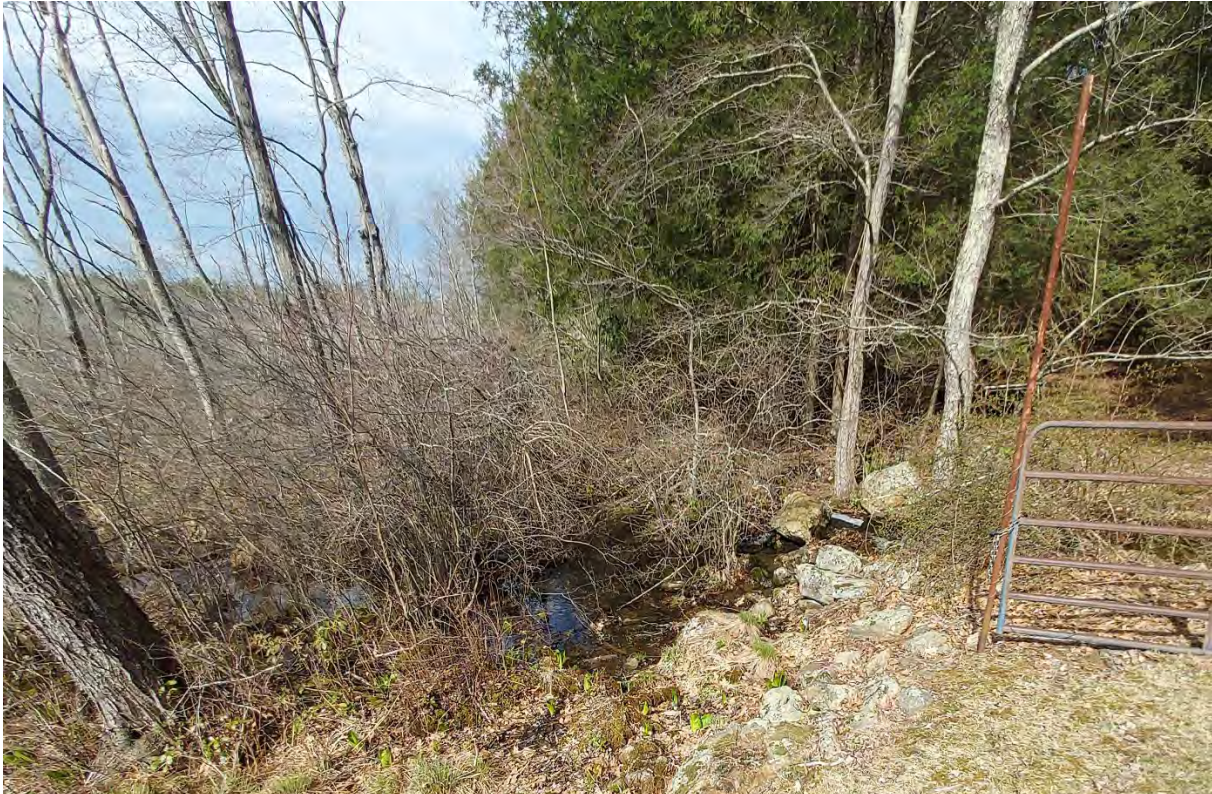
Photo 21f – Trees, brush and tall vegetation at the right downstream side of the dam and just left of the spillway discharge channel within the 25-ft. limits of the areas to be maintained clear of trees and brush.

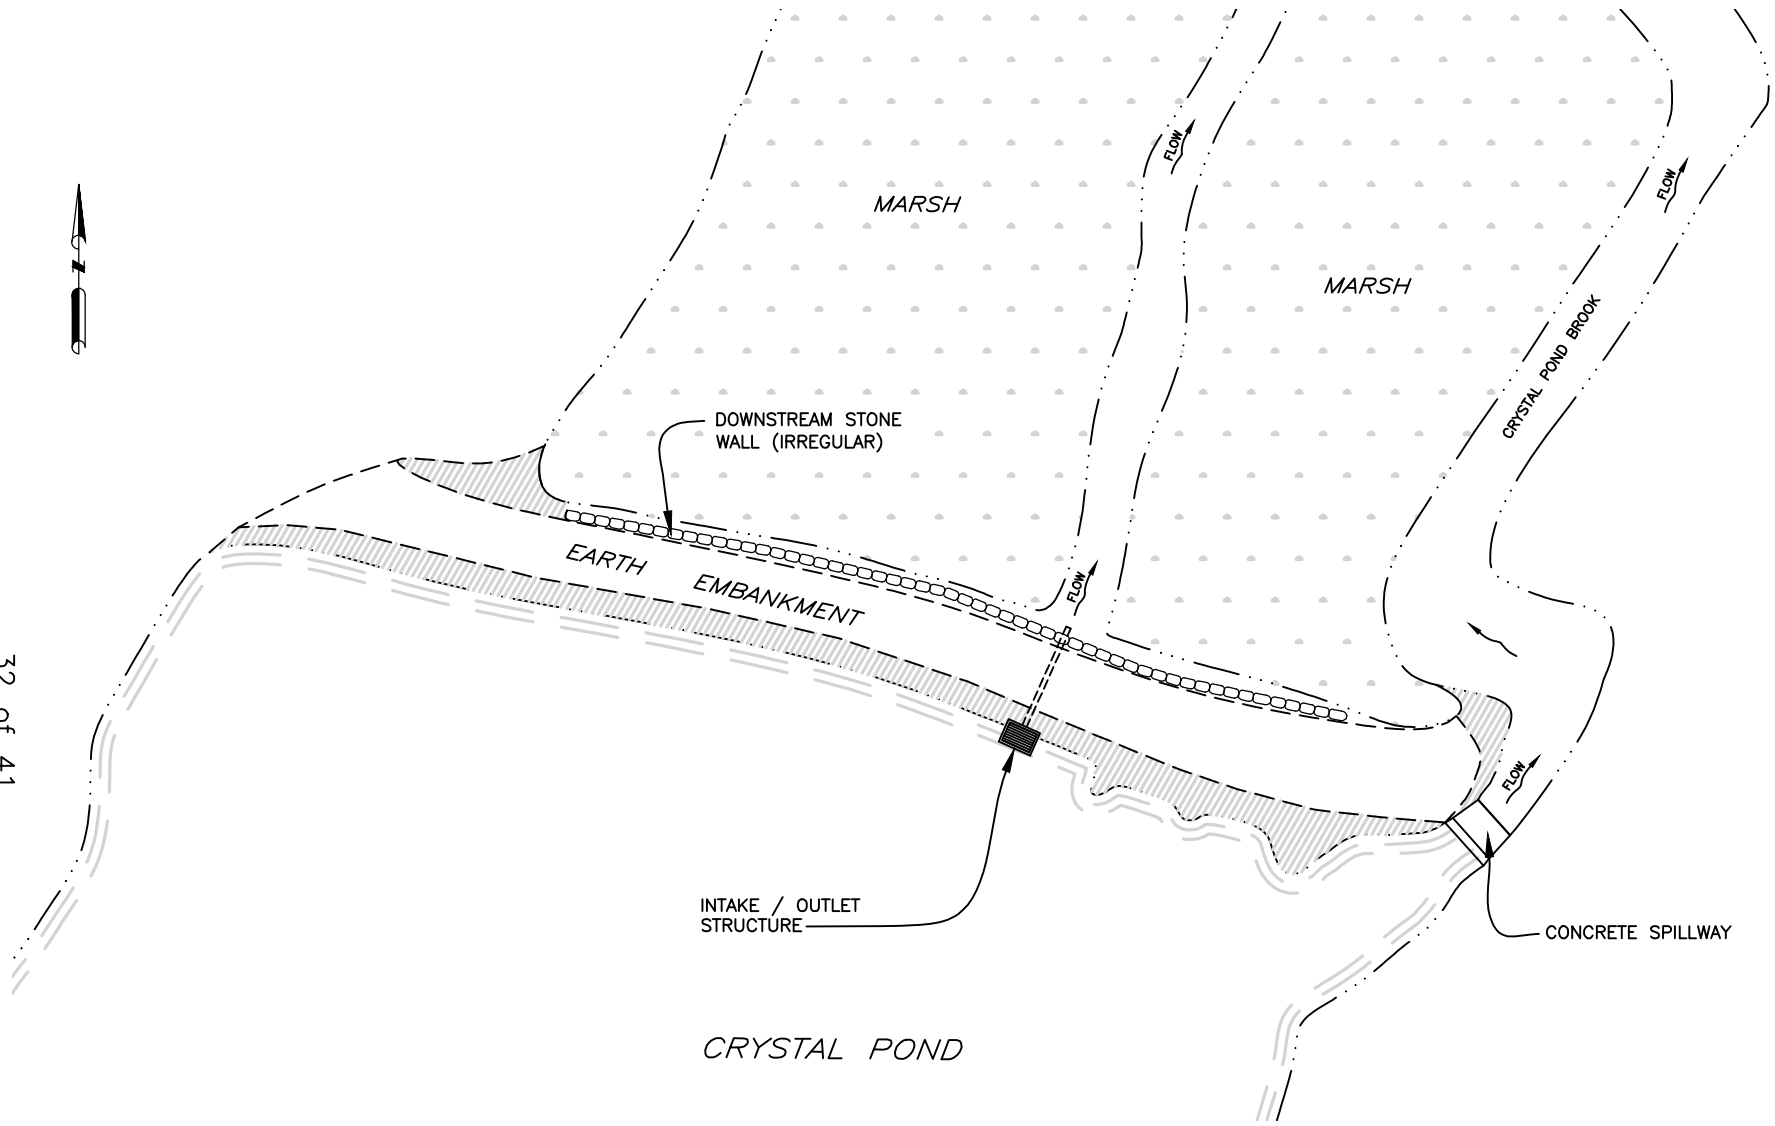
CRYSTAL POND DAM
EXISTING CONDITIONS
SCALE: 1" = 40'

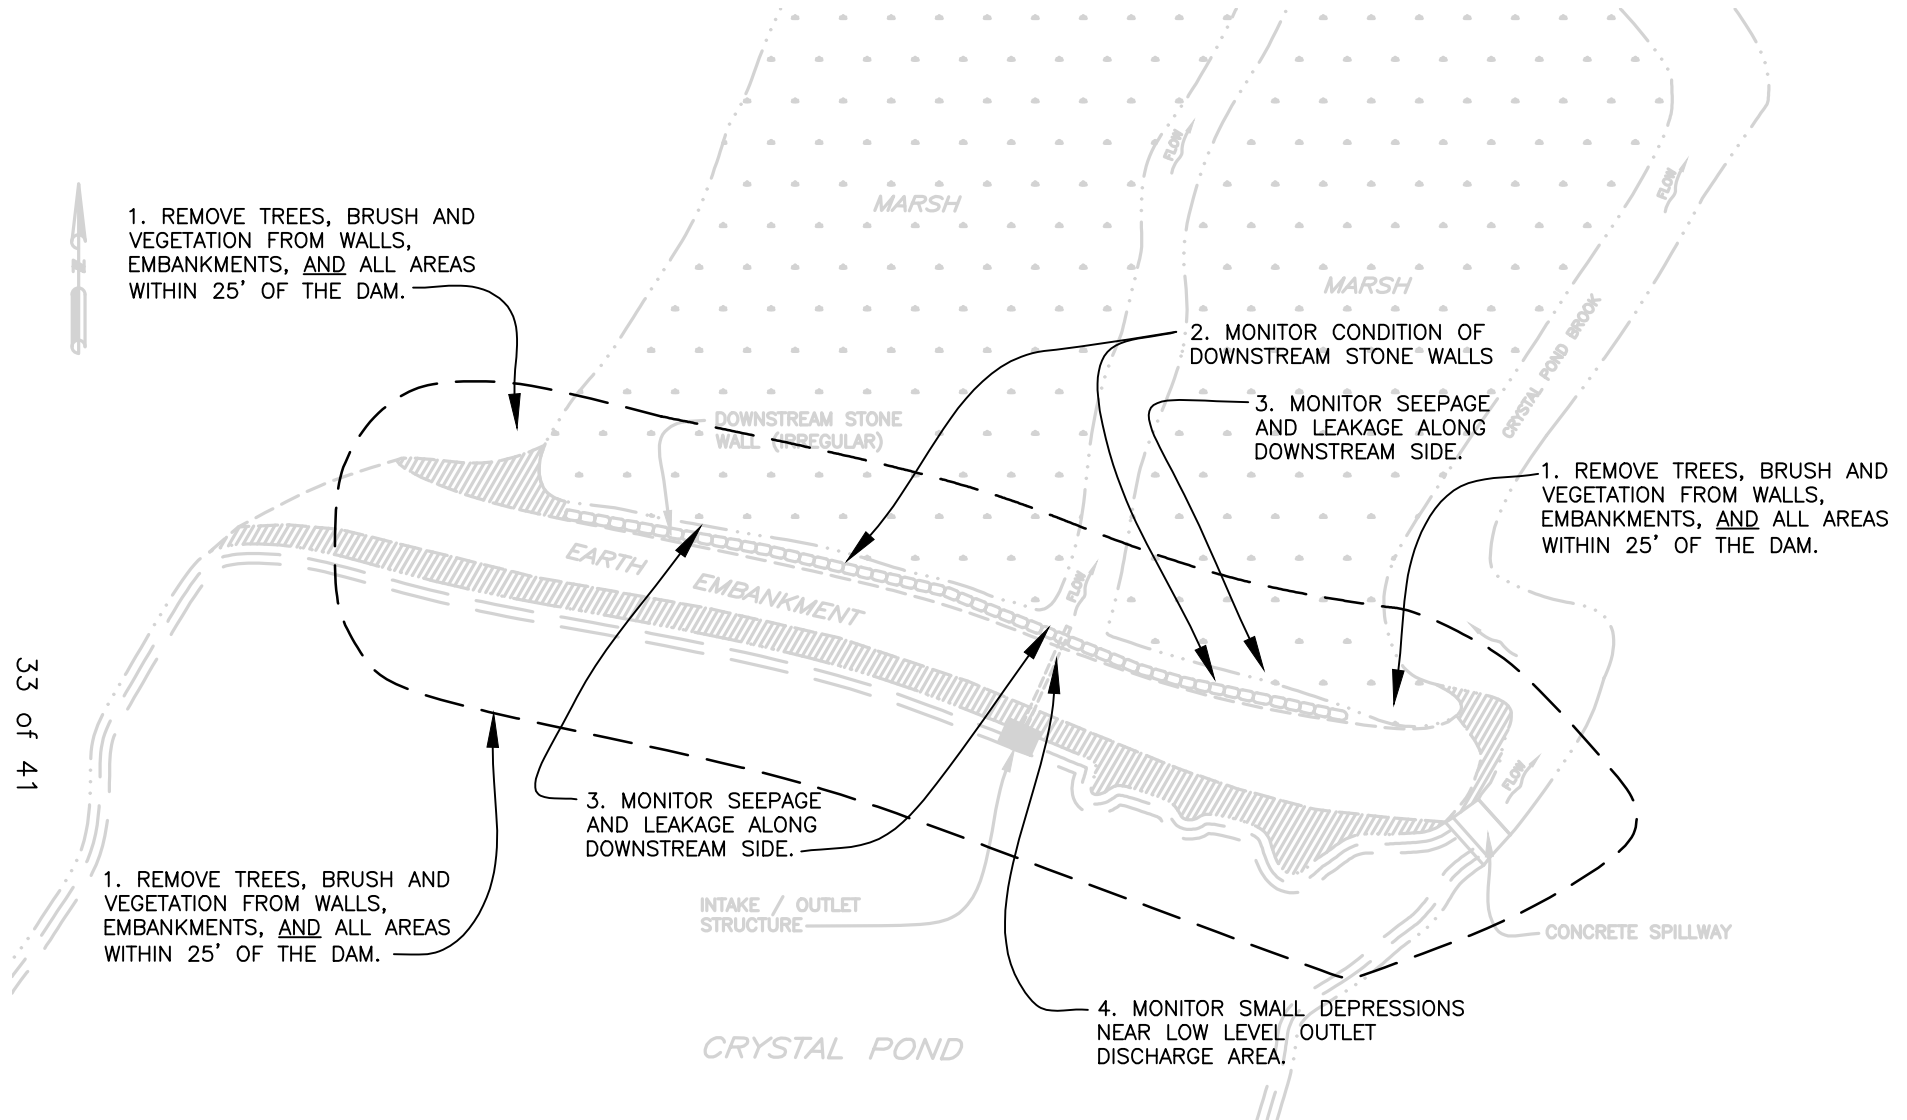
FOR NUMBERS 5 AND 6, SEE PART XII, THE RECOMMENDATIONS SECTION OF THE REPORT.

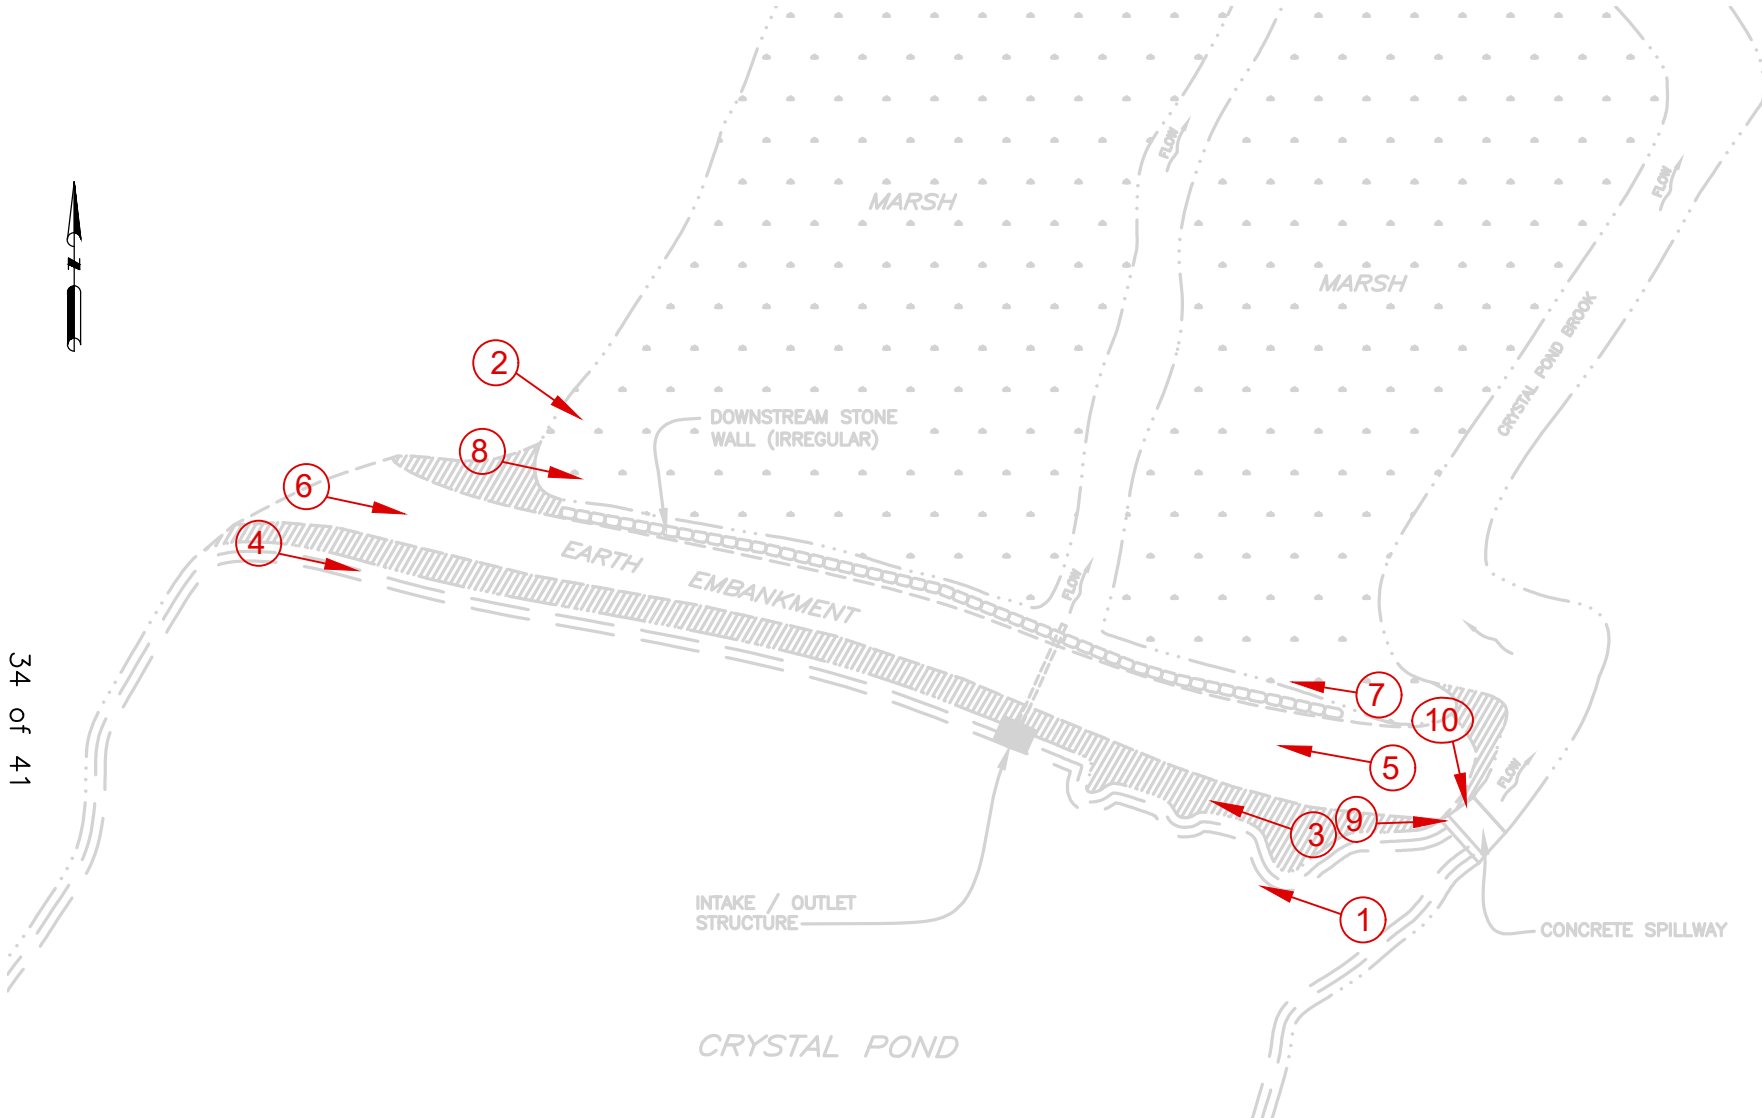
CRYSTAL POND DAM
PHOTO INDEX 1-10
