# ***INTERIM INSPECTION REPORT***

## ***CRYSTAL POND DAM CT DEEP #03908 HAZARD CLASSIFICATION "BB"***

COVE ROAD EAST & WEST  
CRYSTAL POND BROOK  
EASTFORD, CONNECTICUT

JUNE 2023

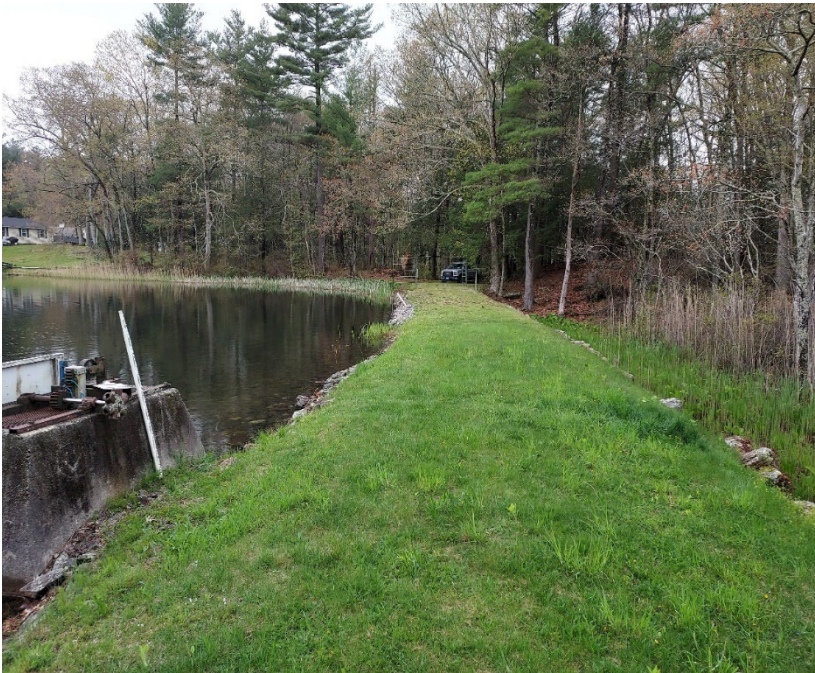
The dam is composed of an earth embankment with a downstream masonry wall, an upstream slope of riprap and a crest of well-maintained grass. The grass cover atop the crest was in good condition throughout the length of the embankment. As noted in the previous report, it is recommended that routine mowing be continued in order to maintain a strong grass cover in the event of embankment overtopping.

Photo 1 – The crest as seen from the right side of the dam looking toward the left side.

- (1) **Vegetation** – As noted in the report, the grass surface along the crest and a portion of the downstream slope was in good condition and should continue to be mowed and / or weed whacked to maintain a firm stand across the top in the event of potential overtopping. With respect to trees and brush, significant clearing had been completed since the prior inspection. More, however, needs to be done to remain in compliance with DEEP guidelines which recommend a 25-foot clearing limit from all points of the dam. Should clarification be required as to individual trees, an engineer should be consulted.

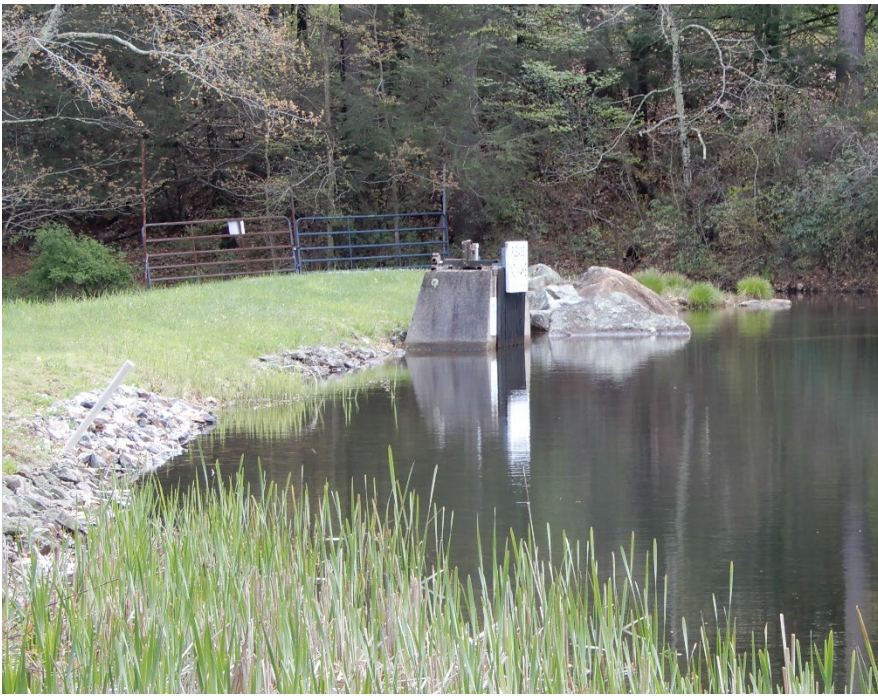
The upstream side, composed of a small to intermediate sized riprap slope to the left of the outlet structure and a mix of large stones and small boulders to its right side. The riprap was in good condition throughout and extended from the exposed dry portion of the embankment to a varied area extending 6 – 8 feet below water level.

Photo 2 – Riprap along the upstream shoreline of the dam on the left side and a mix of large rocks and small boulders on the right side.

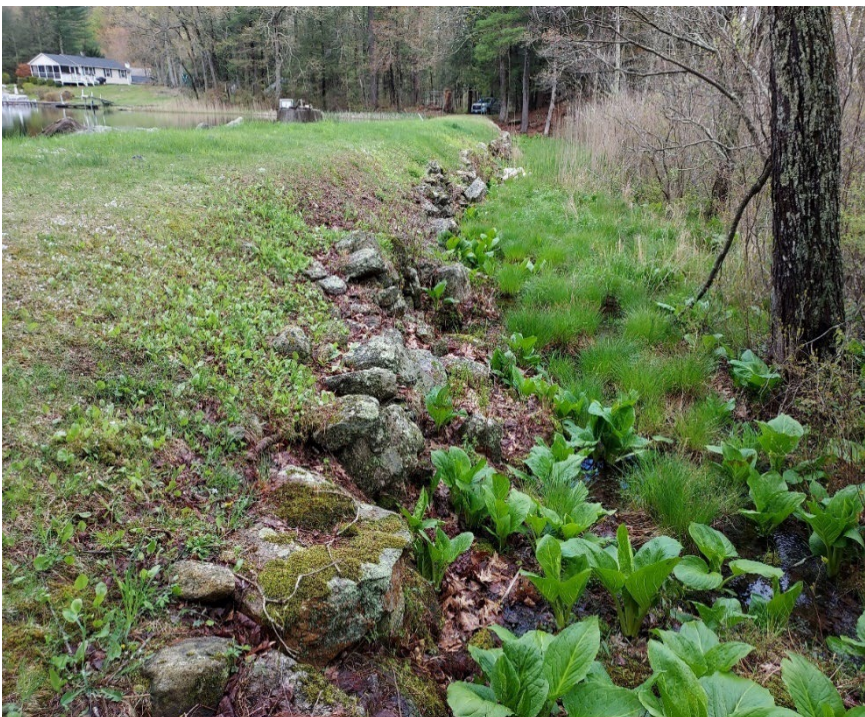
The downstream side is composed mostly of stone masonry wall on the bottom, with a combination of grassed upper slope area extending approximately half way down the slope to the top of the masonry sections. While the masonry wall appears to be in poor condition in several locations, it is on the whole firmly held in place along the slope with a good grass cover between many of the stones. There are some voids within the wall and some stones displaced by having fallen to the base toe area. We recommend that voids within the wall be chinked to fill in gaps under or between rocks for added stability, and that stones fallen or displaced from the wall be reset firmly into their original position to the extent possible and practical.

Photo 3 – The downstream side of the embankment as seen looking from the right to the left side. Note the extension of the grass area to approximately halfway down the slope along most of the length of the dam.

- (2) **Downstream Stone Masonry Wall** – Gaps and voids were noted in several locations along the downstream face of the stone masonry. As noted within the report, we recommend that these voids be chinked to fill in gaps under or between rocks for added stability. In addition, we also recommend that stones fallen or displaced from the wall be reset firmly into their original position to the extent possible and practical. Any questionable areas should be reviewed with the assistance of an engineer.

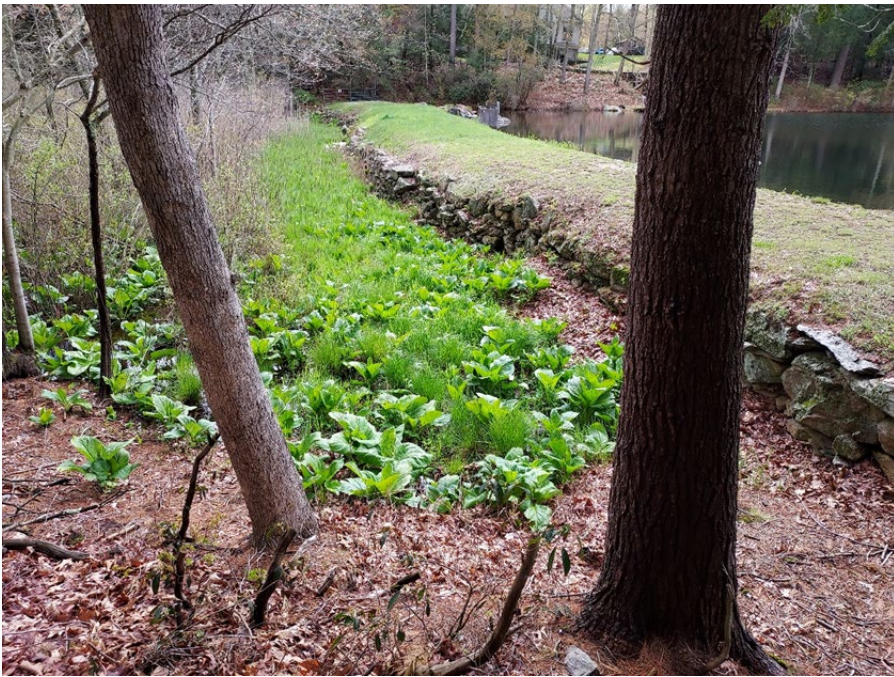
Photo 4 – The downstream slope, as seen in this view from the left side looking toward the right side. Note that, as with the previous view, there is an extensive marshy area directly at the base of the dam and extending northward therefrom.

Leakage and / or seepage was noted in the previous inspection report. Some minor seepage was noted at the time of the current inspection, but none that was serious in nature. There was no evidence of heavy flow or the transport of sediment from within the dam (i.e., no visible turbidity). As seen in the above photos, however, this must be tempered or balanced against the fact that the downstream wetland area or marsh extends at a consistent elevation northerly for approximately 3,000 feet toward Bigelow Hollow Road (Route 171). It appears that there may be substantial beaver activity in the marsh as well, as evidenced by the presence of a beaver slide at the downstream end of the low level outlet. This combination creates a saturated base area, but one that has been in existence for a long period of time, as noted by the presence of the dam and wetland area in aerial photos dating from the 1934 aerial survey of the State.

- (5) **Monitoring Activities** – While no significant seepage issues were noted during this inspection, we would recommend continued monitoring on a monthly basis during high water level conditions, and at least once every three months during low water level periods. In particular, two areas to be specifically examined include: the downstream toe approximately 70 feet to the right of the left abutment area and the outlet area where sand bags had been noted.

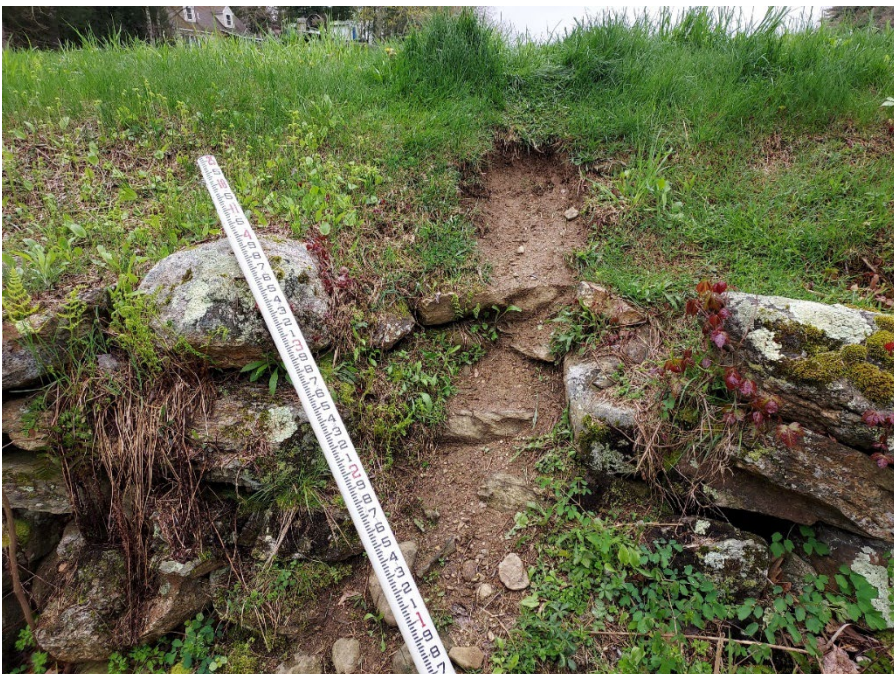
Photo 5 – Looking at the beaver slide area adjacent to the left side of the downstream pipe outlet. This area needs to be filled in and otherwise reconstructed to firm up the embankment, using on site stone and fill material from the bottom of the slide.

- (4) **Embankment Slopes** – The area of erosion left of the outlet pipe, caused by beaver activity, needs to be cleared, then filled in and otherwise re-constructed to firm up the embankment, using on site stone and fill material from the bottom of the slide.

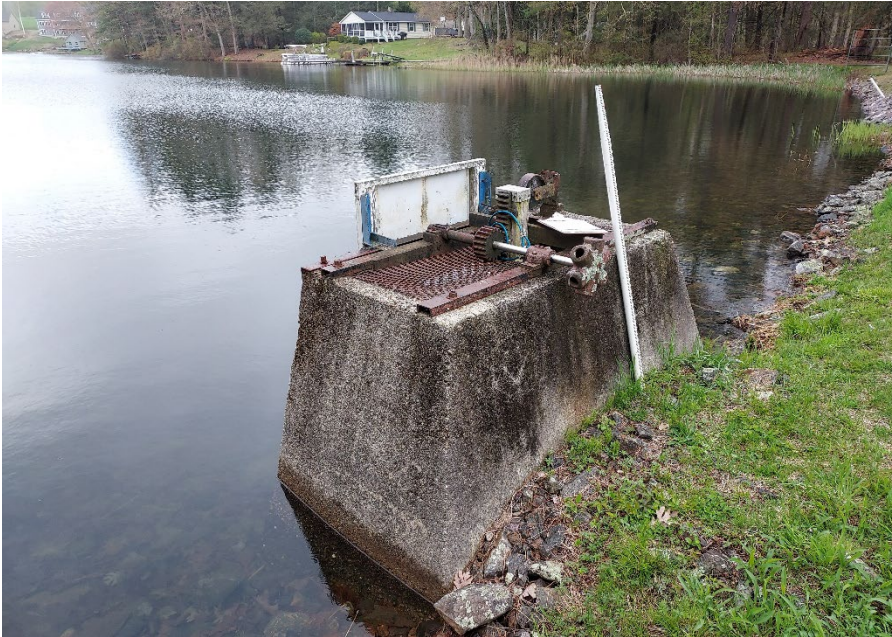
The intake consists of an upstream concrete structure with a rack and pinion type hoisting mechanism for the underlying sluice gate. Although the concrete is weathered from age, there were no apparent cracks or other issues that would indicate structural deficiencies. The gate is operated on a consistent basis for control of seasonal water levels and there were no reported problems at the time of inspection. The upstream side of the structure has a steel trash rack, which was also found to be in good condition and clear of obstructions.

Photo 6 – The gate structure as seen from its right side.

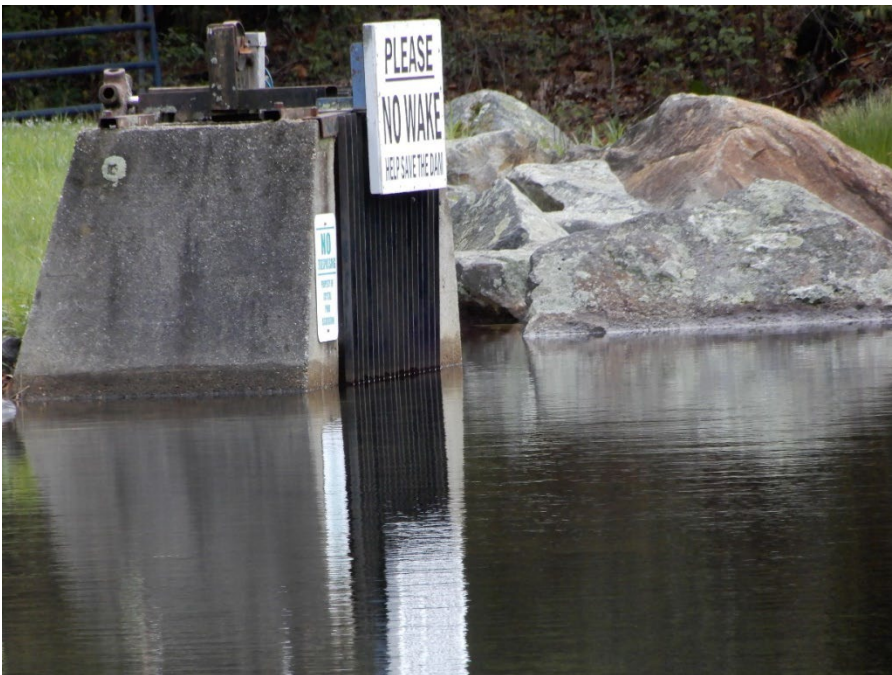
Photo 7 – The intake as seen from the upstream side, with the trash rack in place and a sign to minimize damage to the shoreline area in its vicinity.

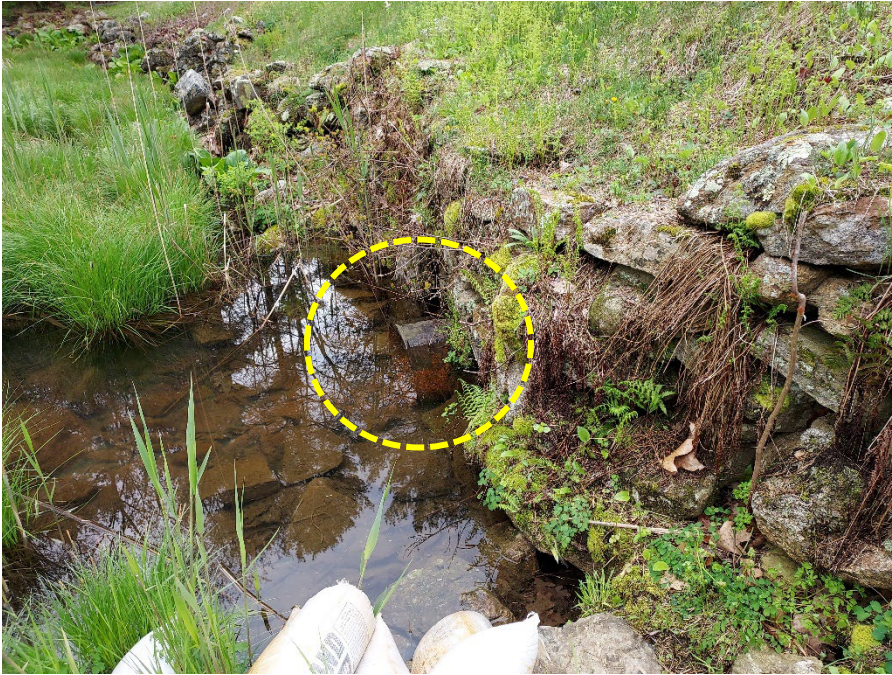
The low level outlet consists of a 24-inch cast iron pipe running from the intake to the base toe area of the downstream stone masonry wall. Although the interior was inaccessible for viewing, the end of the pipe appeared in good condition and there were no reported issues with flow through the pipe. Seepage was noted in the prior inspection report and, during the course of the current inspection, there were sandbags present along the left downstream side of the outlet. However, though the area was saturated due to the presence of the marsh, there was no noticeable sign of seepage. The water surface at the downstream base is a direct reflection of the water level in the marsh, presumably set by beaver activity in the northern sections of the wetlands.

Photo 8 – The end of the low level outlet pipe at the base of the downstream stone masonry wall. Note that there were no signs of seepage from the earthen portion of the embankment and no signs of movement on the water surface at the time of inspection.
