May 24, 2017

RE: Pavement Replacement Plan for The Common at Sinnott Farm

**The Common at Sinnott Farm**  
**Bloomfield, CT**

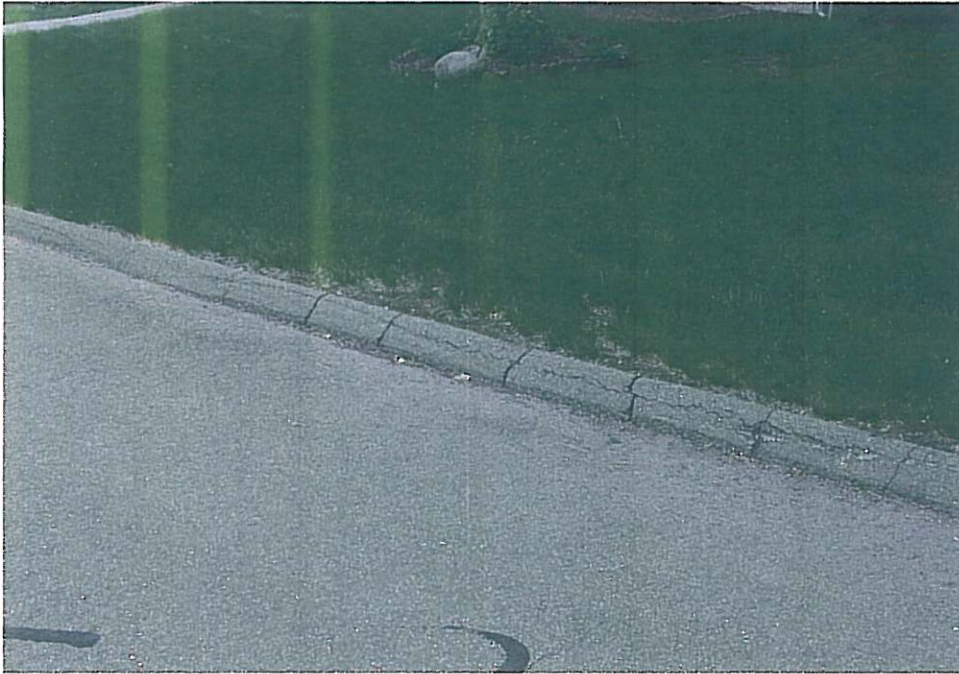
QUAIL

These two streets as mentioned previously have had an overlay. They are still in better condition than the Spring Hill Lane and Arrowwood Lane areas. However, they are starting to show a fair amount of reflective cracking which is the transmission of the failures that likely were in the pavement below and has a very similar appearance in most cases to block cracking and also are showing alligating as well, albeit far less. Probably the best approach to these two streets would be to relook at them in two or three years and make a better determination with regard to timing then. At this point in time if needed for planning purposes, I would assume that they probably have a three to five year useful remaining life.

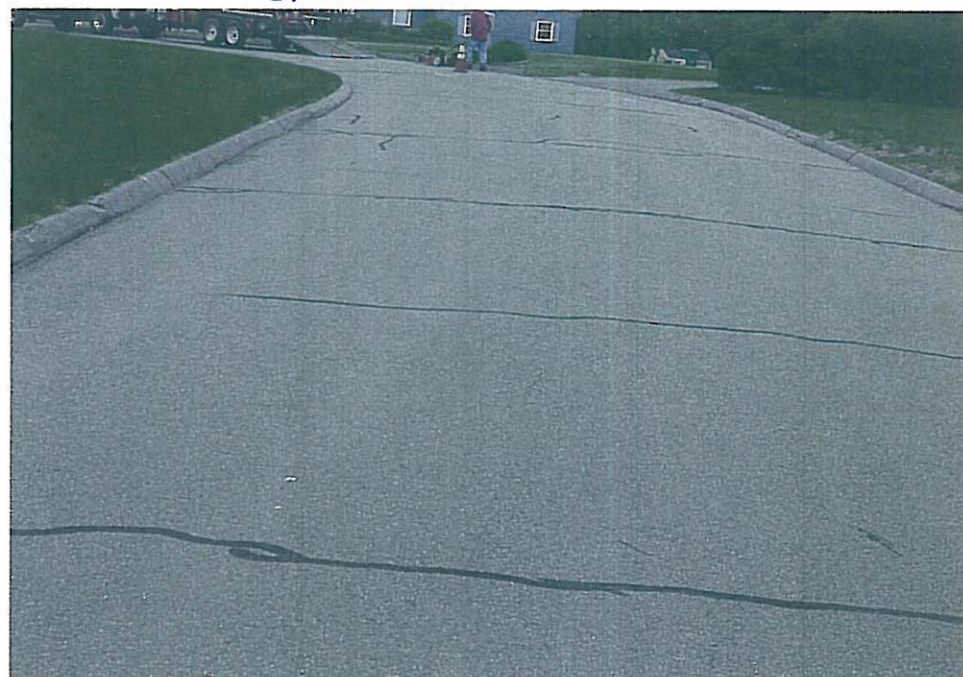
SPRING

The only real limitations on timing with regard to the Spring Hill Lane area is the Association's cosmetic tolerance as the reclaiming process grinds up the existing base the continued alligatoring and cracking has no effect on the process and therefore, this can be scheduled at any time in the near future. What should be understood is that when significant alligatoring in particular starts to occur, it tends to accelerate at a greater rate, i.e. this deterioration of the pavement should not be considered linear as once an increased level of

cracking is occurring in pavement, the stresses are greater around the adjoining pieces of asphalt and are therefore more likely to fail far more rapidly resulting in eventually potholes and other pavement failures.

In the Spring Hill area as discussed previously, the appropriate methodology would be an in-place reclaiming and this should include replacement of both curbs and catch basin caps. Additionally, in many of these programs that we have done the individual unit owners may want to participate in the program either as separate agreements with the paving contractor or coordinated through the Association to have their driveways paved as they typically find it is surprising how much lower the cost is as part of a combined project. We recently undertook one where the contractor bid the addition of driveways at \$2.00 per square foot for a full 3-inch repaving process which is far below the cost that you normally expect to pay doing them on a one-by-one basis. There are some benefits to this as grading can be somewhat smoother and simplified where driveways meet the pavement.

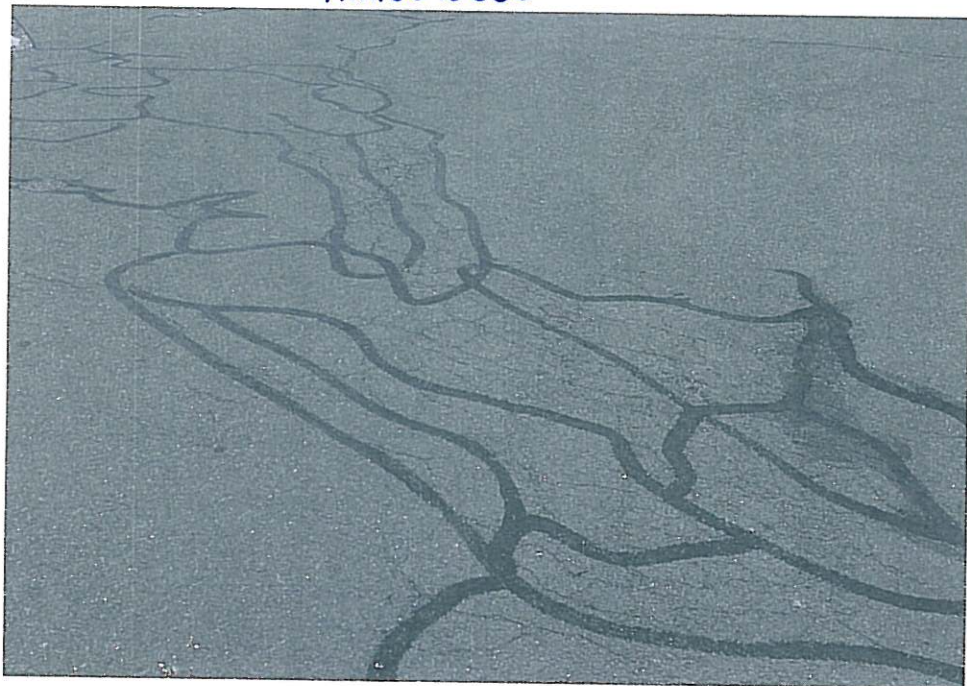
ARROWWOOD

Arrowwood Lane is in slightly better condition than Spring Hill Lane, however, not as much better as might be assumed from a quick visual look. It also is in a condition where the appropriate methodology is reclaiming. As it likely is only a couple years behind in the deterioration process, consideration may even want to be given to doing it in a joint program with Spring Hill Lane. Although being slightly better in condition the savings associated with a larger project may somewhat offset in a sense what is being done "prematurely". Once again, driveways may want to be included in this program and therefore is really somewhat up to the association whether this might want to be a combined program for both streets or put off for up to two to three years, albeit I suspect not more than that.

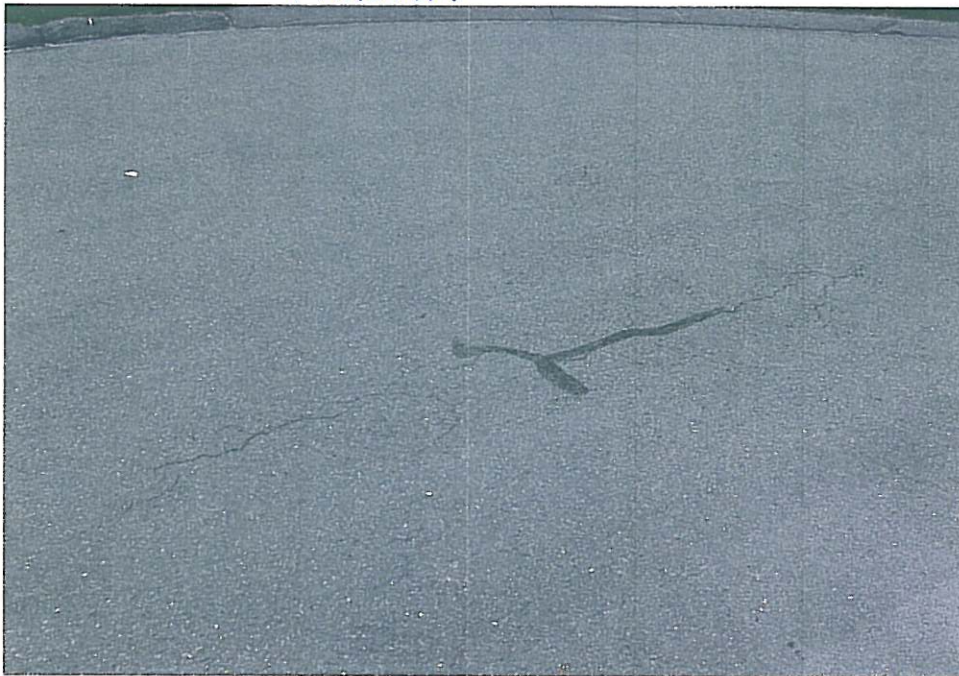
TIMOTHY

As mentioned previously Timothy Lane is in the best condition, albeit with a fair amount of catch basin distress. This area, like some previous areas, should be monitored overtime perhaps looking at it in the same two to three year period, albeit I would expect that this area probably has 7 to 10 years of useful remaining life. However, as mentioned numerous times in this report the projection of life is a little bit trickier as it deteriorates more and more. In some cases a pavement that can seem to be in excellent condition for 10 to 15 years all of a sudden appears to deteriorate within a very short time period.
