STRUCTURAL INTEGRITY RESERVE STUDY

**The Fairways of Brevard Association #1,
Inc.**

**725 Port Malabar Blvd NE
Palm Bay, Florida 32905**

Project Number: 23278111

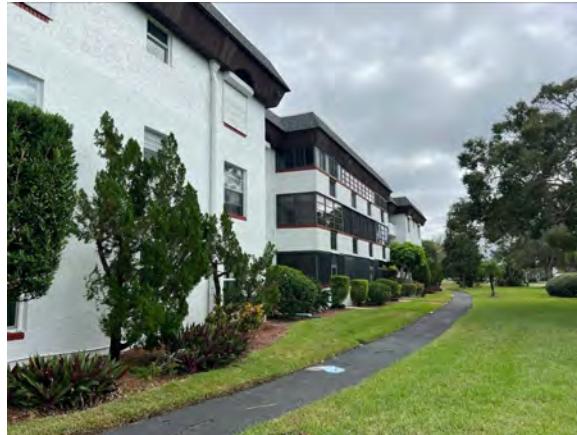
PHOTO 1

GENERAL VIEW OF PROPERTY

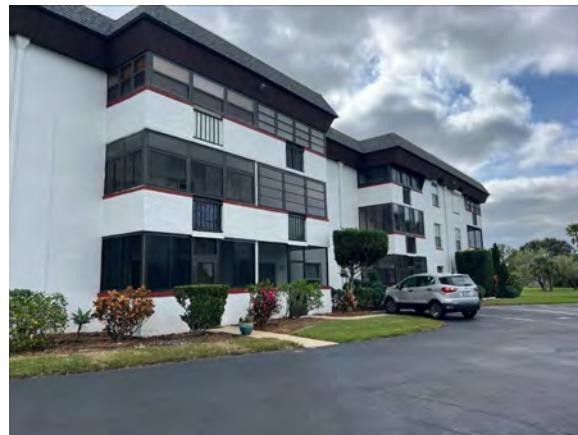
PHOTO 2

GENERAL VIEW OF PROPERTY

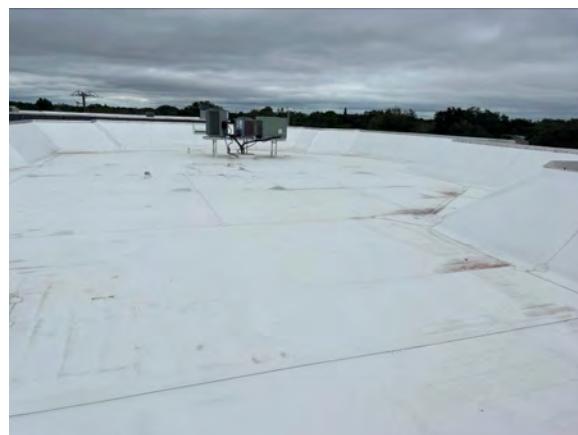
PHOTO 3

GENERAL VIEW ROOFTOP

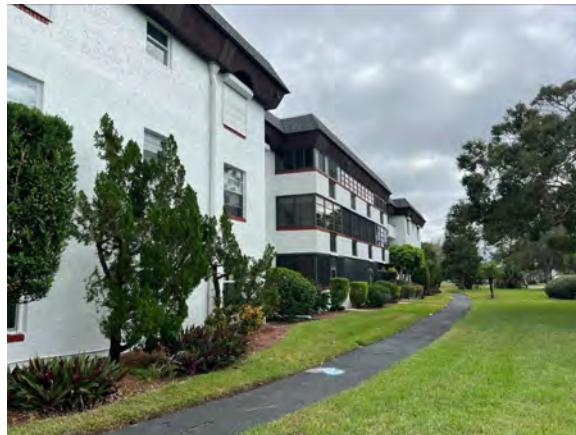
PHOTO 4

GENERAL VIEW OF LANDSCAPING

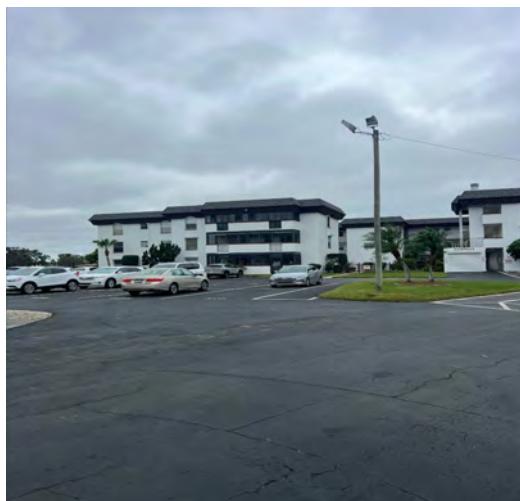
PHOTO 5

GENERAL VIEW OF PARKING AREA

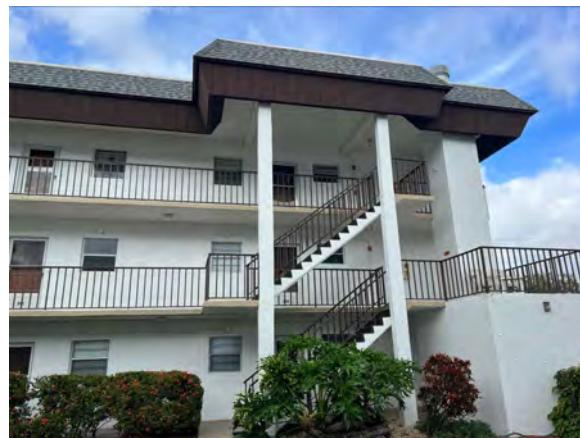
PHOTO 6

VIEW OF EXTERIOR STAIR SYSTEM

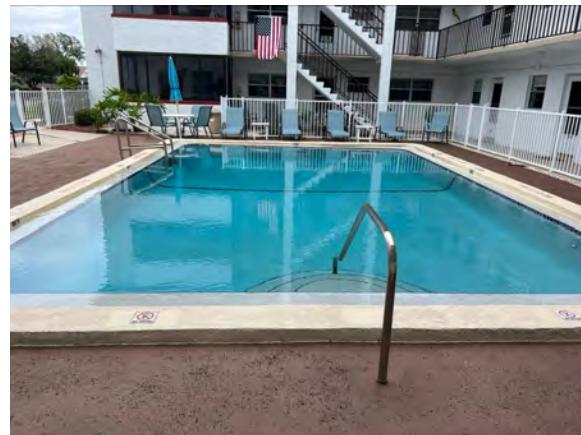
PHOTO 7

GENERAL VIEW OF SWIMMING POOL

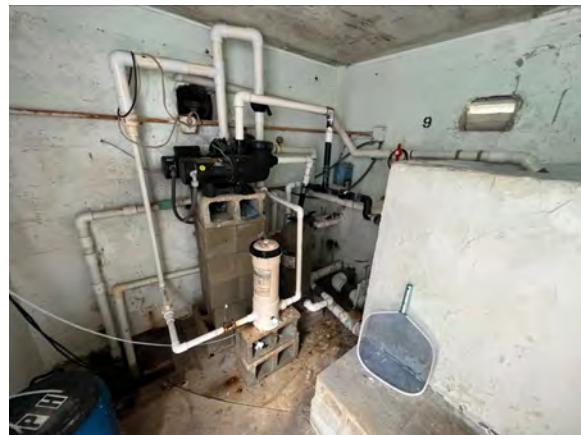
PHOTO 8

GENERAL VIEW OF SWIMMING POOL EQUIPMENT

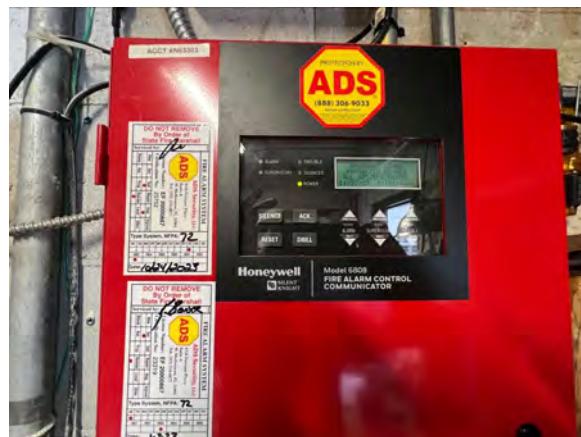
PHOTO 9

VIEW OF FIRE ALARM SYSTEM EQUIPMENT

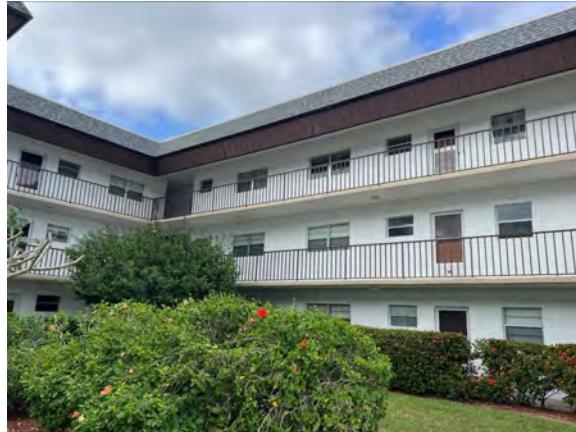
PHOTO 10

GENERAL VIEW OF BUILDING EXTERIOR FINISHES

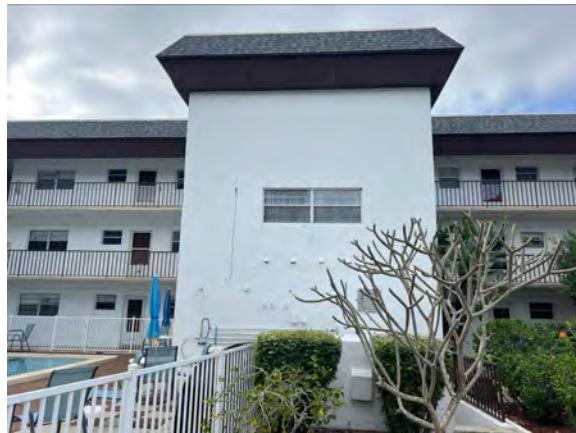
PHOTO 11

GENERAL VIEW OF BUILDING EXTERIOR FINISHES

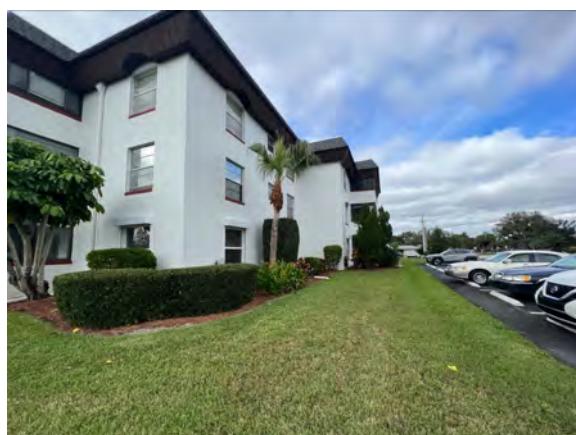
PHOTO 12

VIEW OF BUILDING EXTERIOR FINISHES

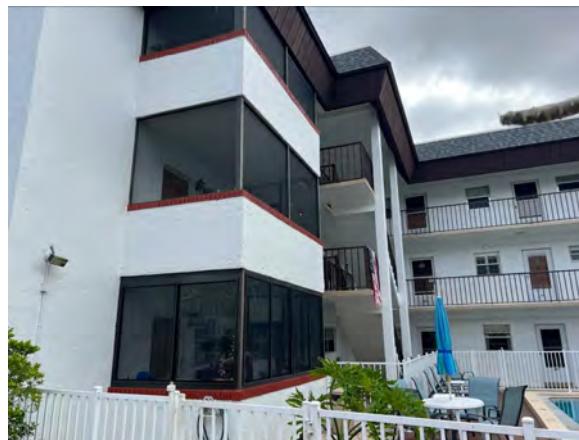
PHOTO 13

VIEW OF TYPICAL BALCONY

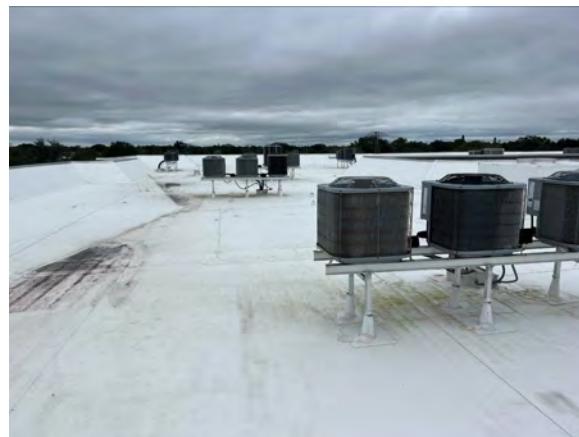
PHOTO 14

VIEW OF HVAC EQUIPMENT

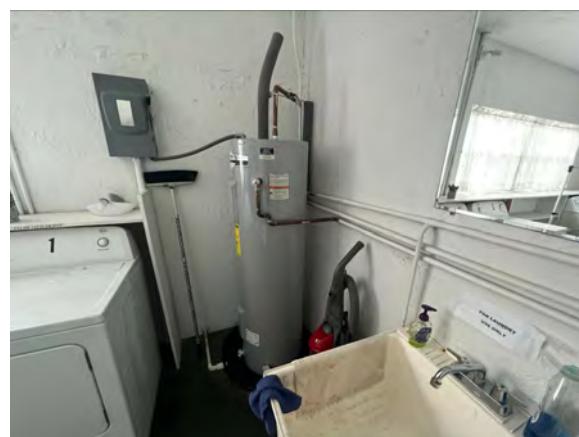
PHOTO 15

GENERAL VIEW OF COPPER DOMESTIC WATER PIPING

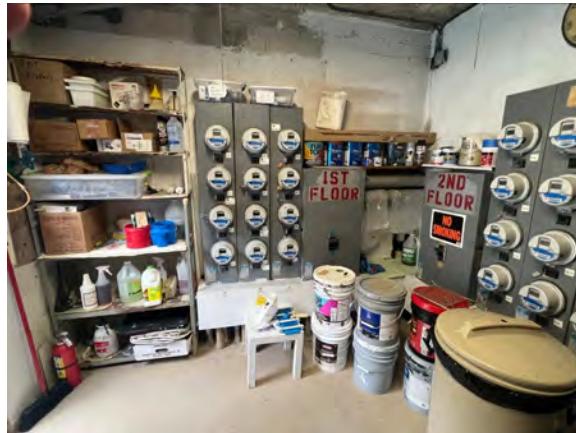
PHOTO 16

VIEW OF ELECTRICAL EQUIPMENT

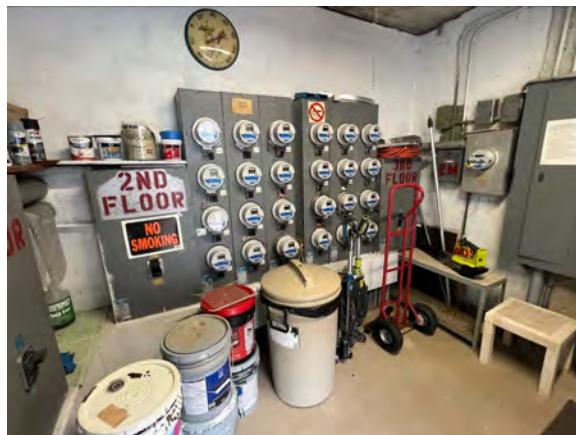
PHOTO 17

VIEW OF ELECTRICAL EQUIPMENT

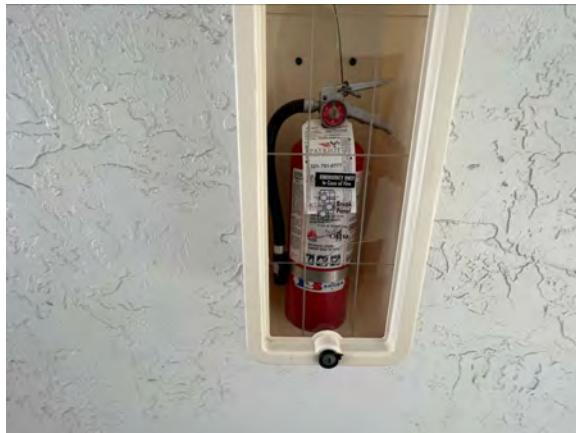
PHOTO 18

VIEW OF FIRE EXTINGUISHER

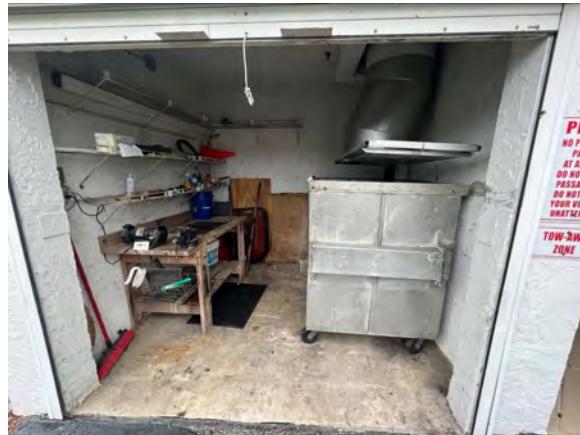
PHOTO 19

VIEW OF GARBAGE COLLECTION AREA

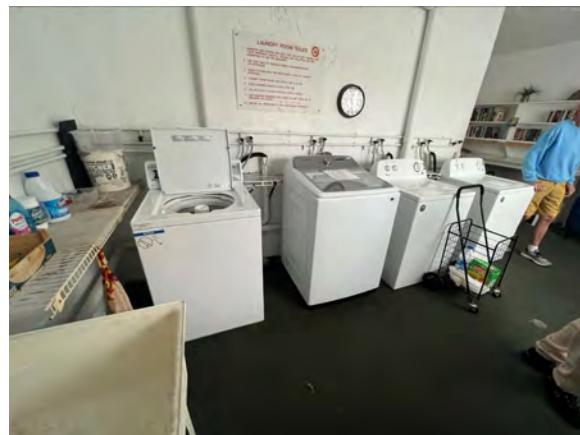
PHOTO 20

VIEW OF LAUNDRY ROOM

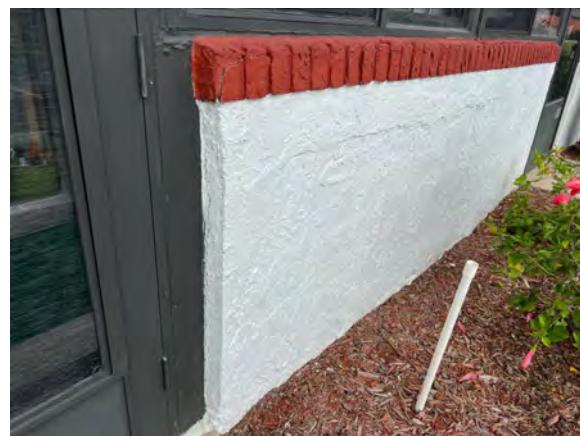
PHOTO 21

MINOR CRACKING IN EXTERIOR WALL

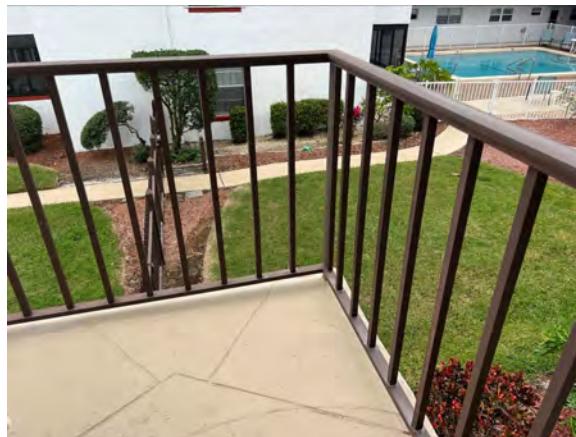
PHOTO 22

LOOSE HAND RAIL ON ELEVATED WALKWAY

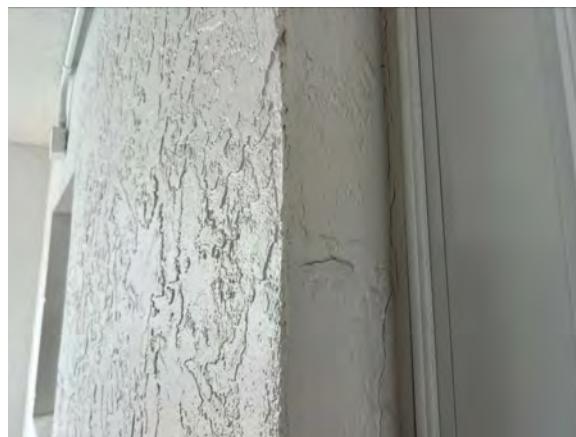
PHOTO 23

CRACKING AROUND DOOR FRAME

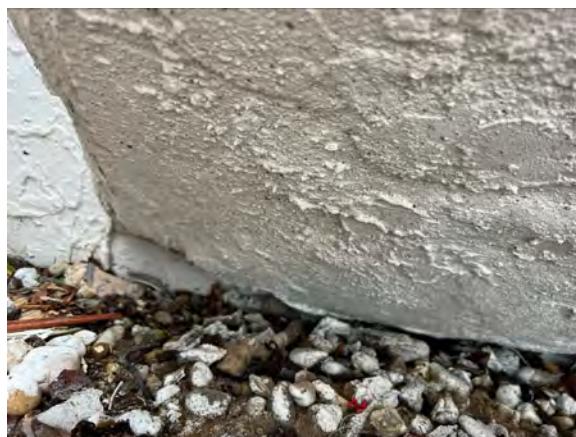
PHOTO 24

SPALLING UNDER STAIRS

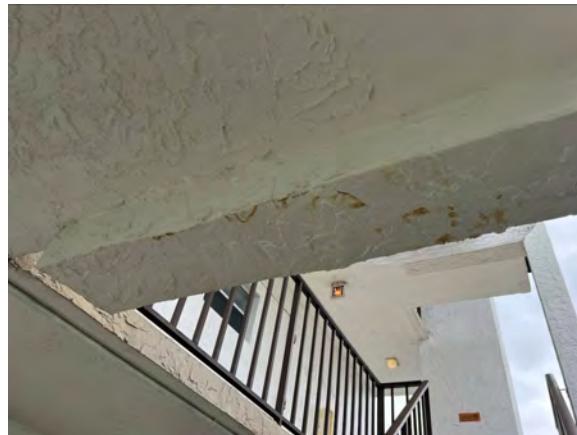
PHOTO 25

SPALLING IN BEAM SUPPORTING LANDING

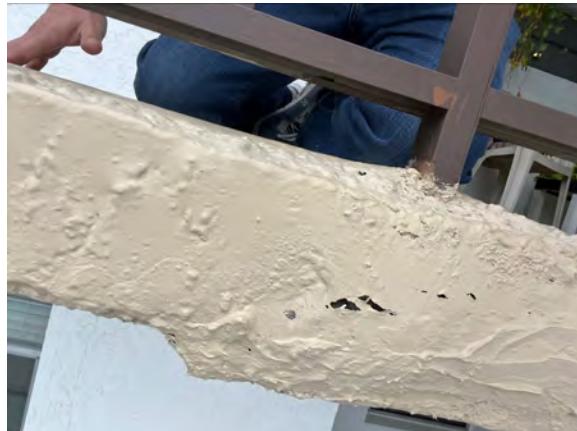
PHOTO 26

EXAMPLE OF SPALLING IN EDGE OF Elevated WALKWAYS

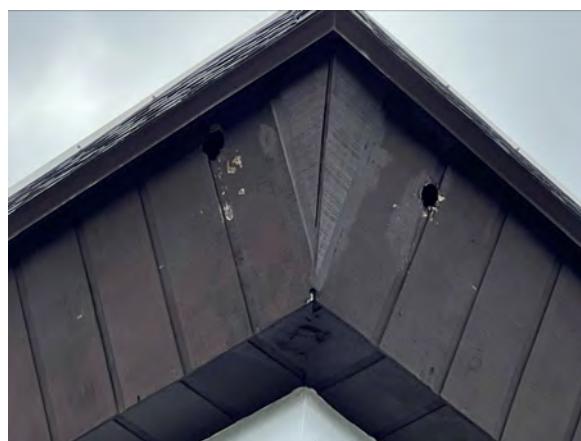
PHOTO 27

DAMAGED WOOD FACIA
